DENMARK HALL

Historic Structure Report

Prepared by:
Rebecca McManus
Alexandra Green
Sophia Latz

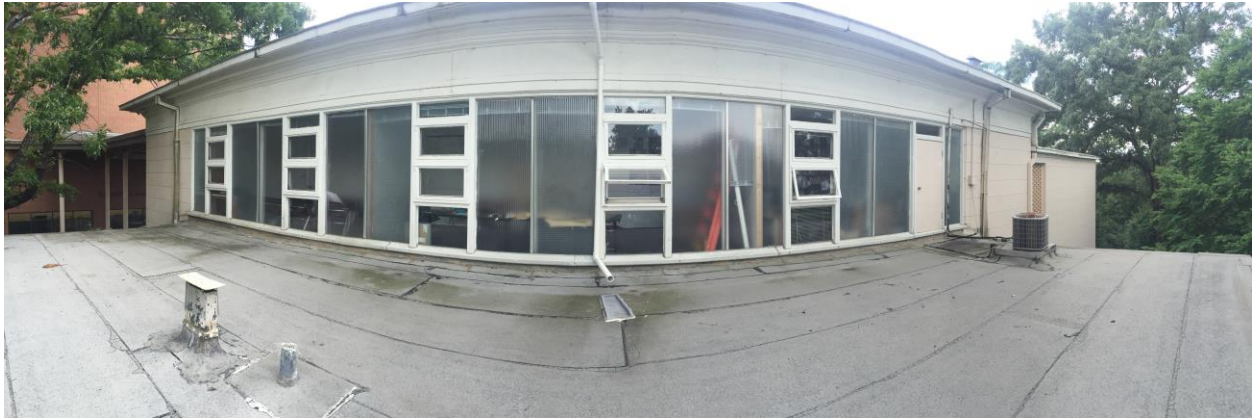
While the decorative cornice on the edge of the former porch is in sore need of repair (the almost-nonexistent gutter system retrofitted into it has no actual downspouts), the former porch itself is suffering an immense deal of damage. The majority of this damage is from issues both related to water and extraneous equipment (wiring, plumbing, pipes, air conditioning systems, et cetera) that still clings to the building's walls. Much of this satisfies no purpose and is non-functional. The louvered windows cannot easily be opened without a special crank, and there is no weather-strip on the door that leads into the interior of the building.

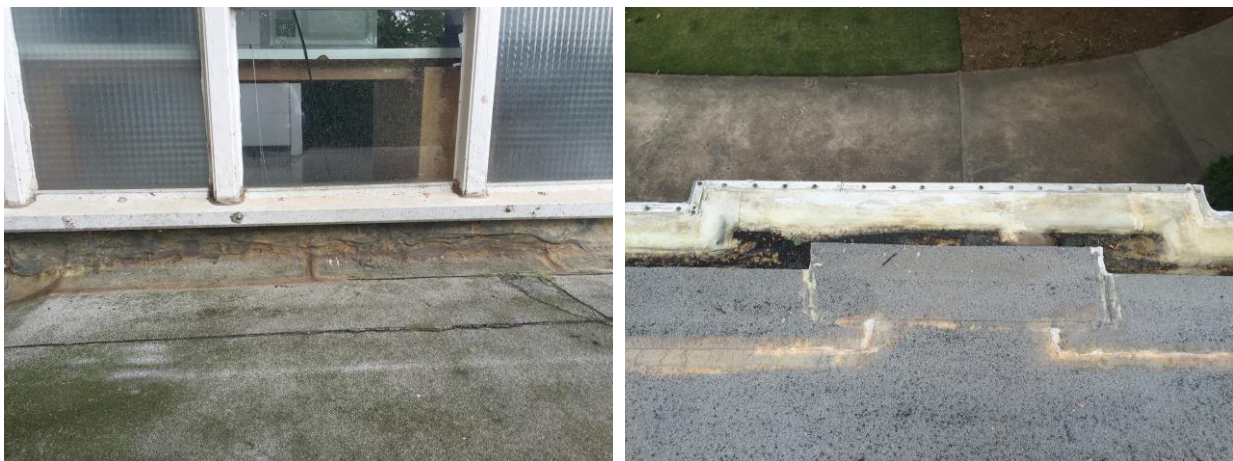
The roof here itself is extremely problematic and this is largely due to its change from an open porch to covered asphalt. In its time, the porch would have been angled toward the north façade, to better facilitate the drainage of water. Currently the asphalt roof has no slope and therefore water pools on its surface. This has led to extreme cases of water penetration along the running board at the base of

the window wall, and in various pockets spotting the roof. The asphalt itself is long past its due date for replacement, cracked in many places and bubbling up from the roof. Close to the window wall and on the left edge of the former porch it is evident that mosses and lichens have been growing on the asphalt. The gutters are full of organic detritus and two vents peeking out from the middle of the roof have not been appropriately waterproofed. Most of running board along the window wall has been “repaired” with bathroom caulking, which is neither appropriate nor beneficial in the long run. Its removal would damage original historic elements of Denmark Hall. On the right side of the former porch is a non-functioning air conditioning unit.

RECOMMENDATIONS: Replace the asphalt roofing in kind or, to assure better debris and water drainage, create a minimum slope of 2:12 and install a metal standing seam roof similar to that which covers the main building block. At minimum, the vents and HVAC units on the roof should be reflashed to avoid moisture intrusion.

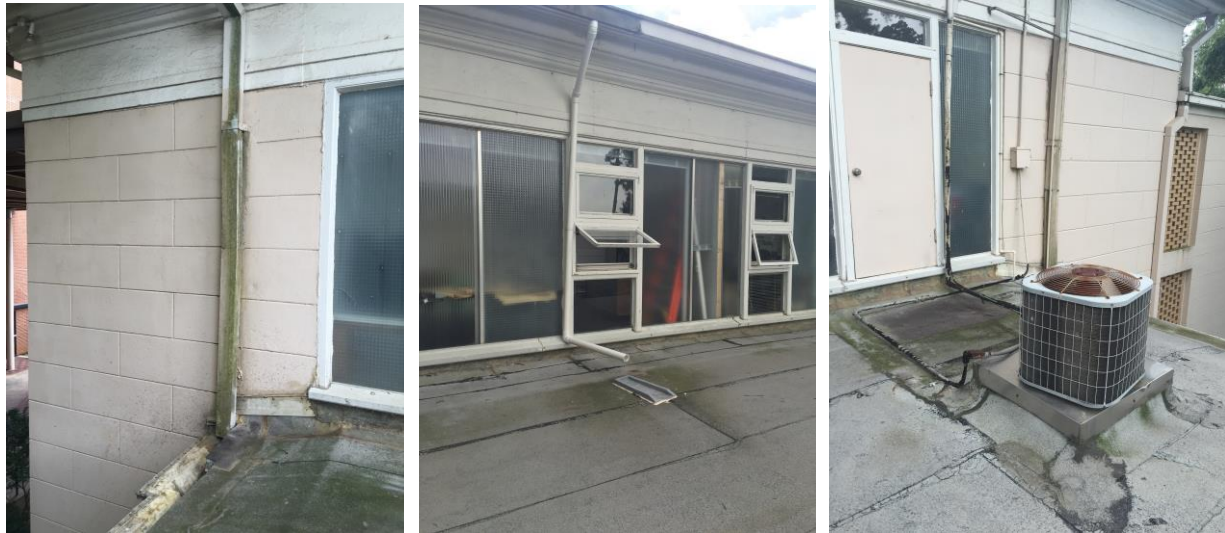
The center of the porch has recently – within the last month – sustained a halfhearted attempt at redirecting water on the rooftop and mitigating the sorry state of the gutters attached to the historic cornice. This PVC pipe, installed haphazardly to the gutter and the exterior wall, leads water two feet from the window wall to pool on the asphalt sheathing of the first story roof, where it then sits.

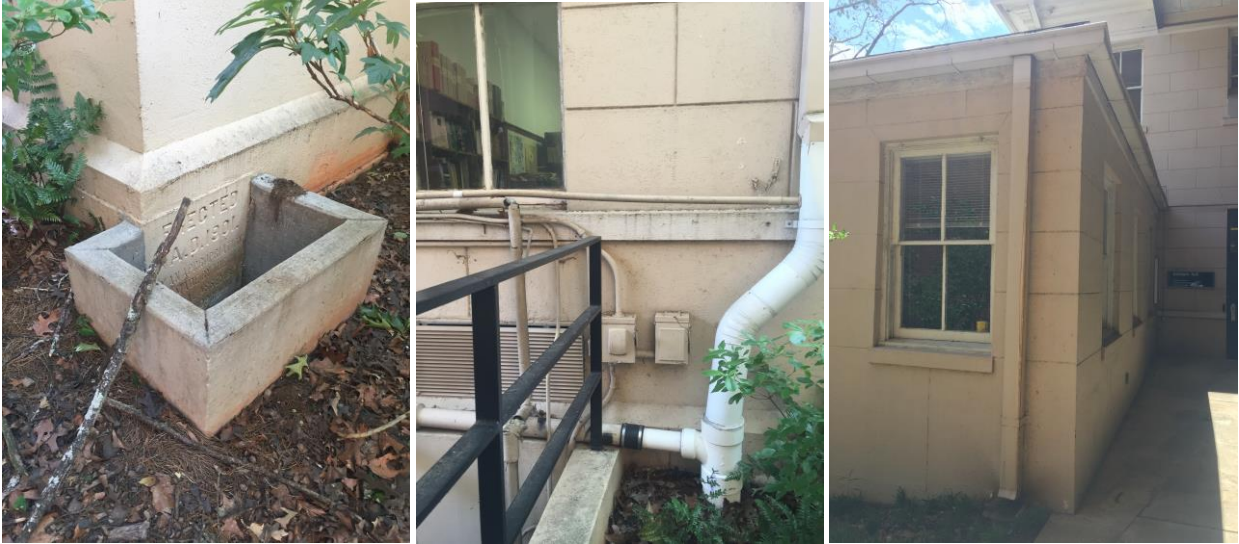
The eastern façade also has the cornerstone of the building, and the changing grade is most evident here: a protective barrier of concrete has been built around the cornerstone, as it sits a foot below grade. This side of the building also has an abundance of needless and nonfunctioning equipment, including multiple wires and pipes.

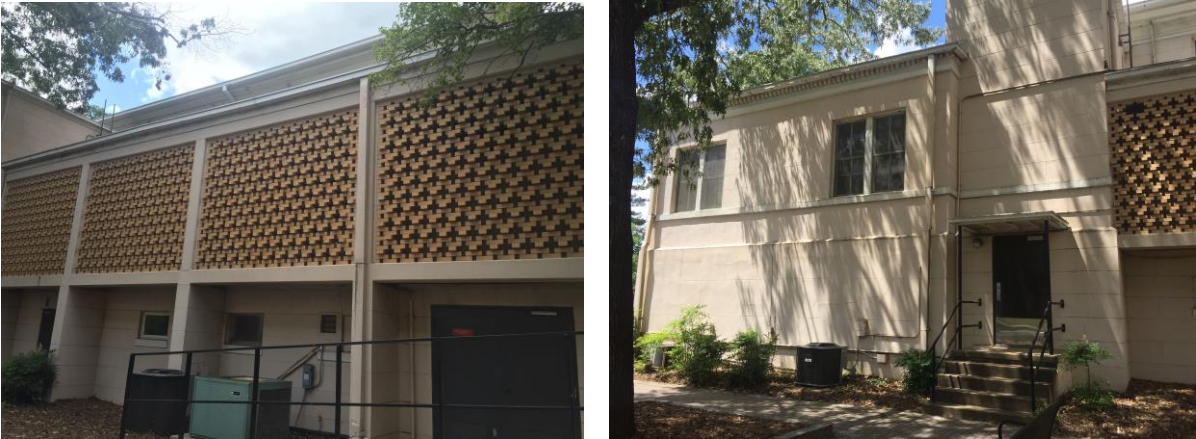
The south façade of Denmark Hall is the widest and spans a number of different levels. It also has the newest additions to the building, contributing a large amount of square footage by 1945 that includes offices, storage space, and classroom areas. The southwest corner of Denmark Hall has two characteristic double-windows on the first floor, added to contribute to the original design of the building. The remainder of the first floor features an enormous window wall that spans the length of three offices for professors. This window wall is shielded by a screen wall constructed of brick on stone piers that attach to the basement level. This screen wall is not structural in any regard, and the mortar has been compromised to the extent that several bricks have fallen from place.

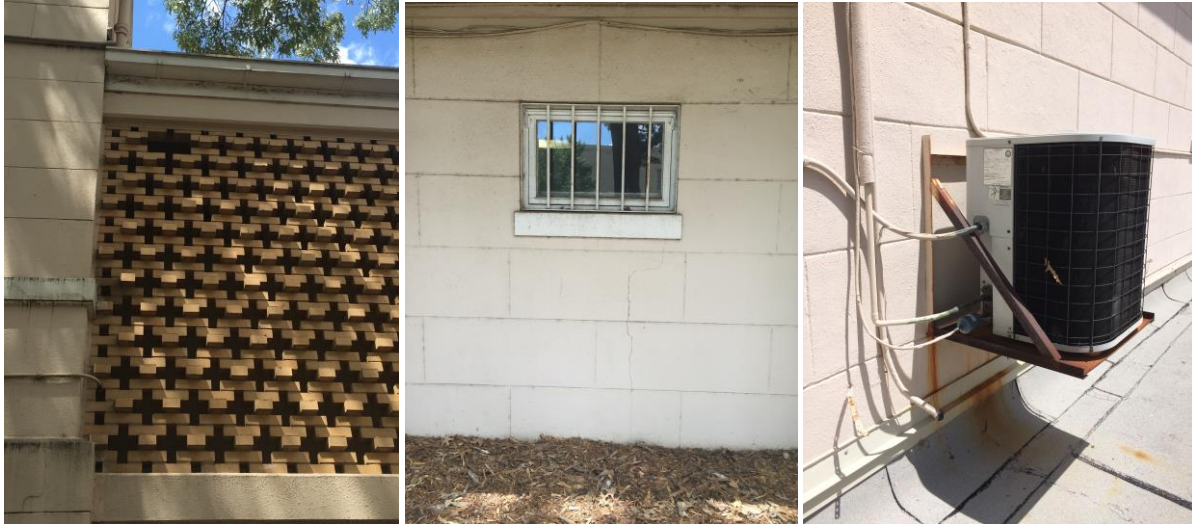
Another problem with the south side of Denmark Hall is an excess of equipment (pipes, wires, air conditioning units) that is non-functional and serve no purpose to the building. They add to the load that the building must support, and have been largely painted over to “camouflage” them. This attempt has been ineffective, at best.

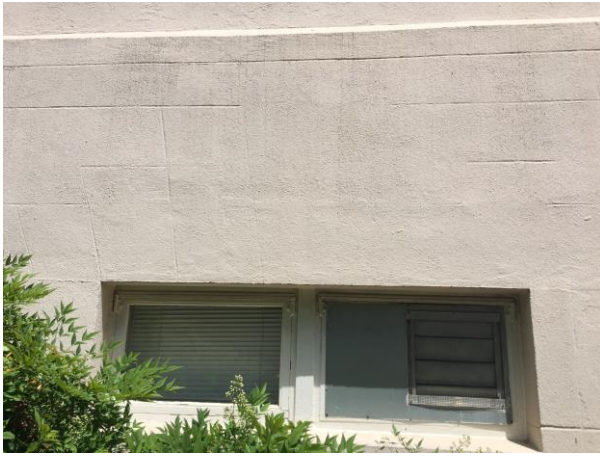
This side of the building does not suffer any serious moisture damage except in the southwest corner, which is where the Cultural Landscapes Lab is located. Reports have stated that the CLL flooring has withstood intensive and persistent water penetration, which has caused minor flooding and forced many of the interior floor tiles to peel away. The small windows looking into the Cultural Landscapes Lab, built into the by-1935 addition, have been mostly blocked up (partly with a vent) due to a threat of burglary. The decorative keystone lintel over the windows is precisely that: decorative, and etched into

the stone rather than being structural.

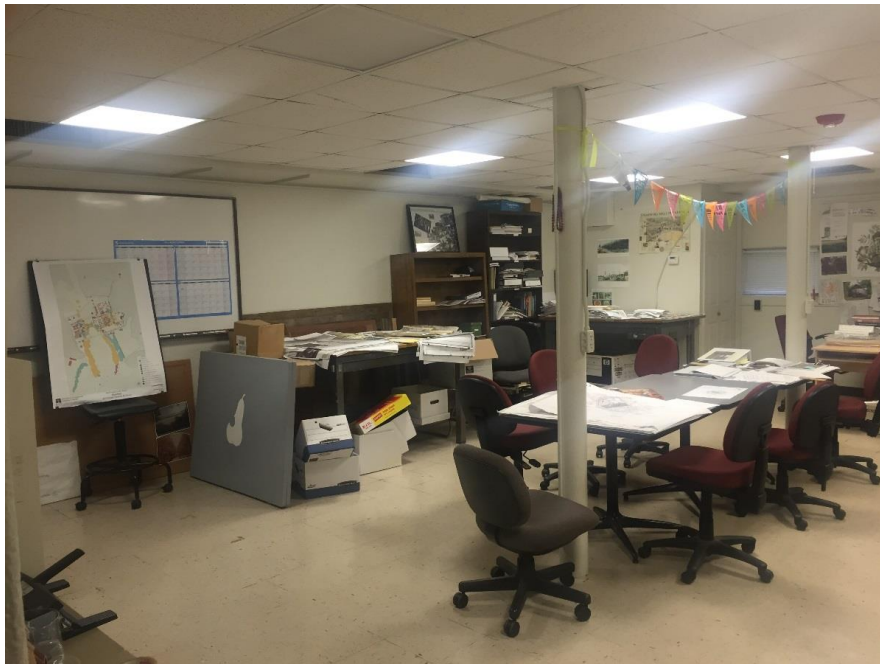
Room 0018 currently houses the Cultural Landscape Lab, which aims to assist in cultural landscape management. It is a large room with tile flooring, drywall, and a drop ceiling. This room is subject to damp and flooding, and as such the tile flooring adhesive is coming loose and seeping between the individual tiles. It is in poor condition.

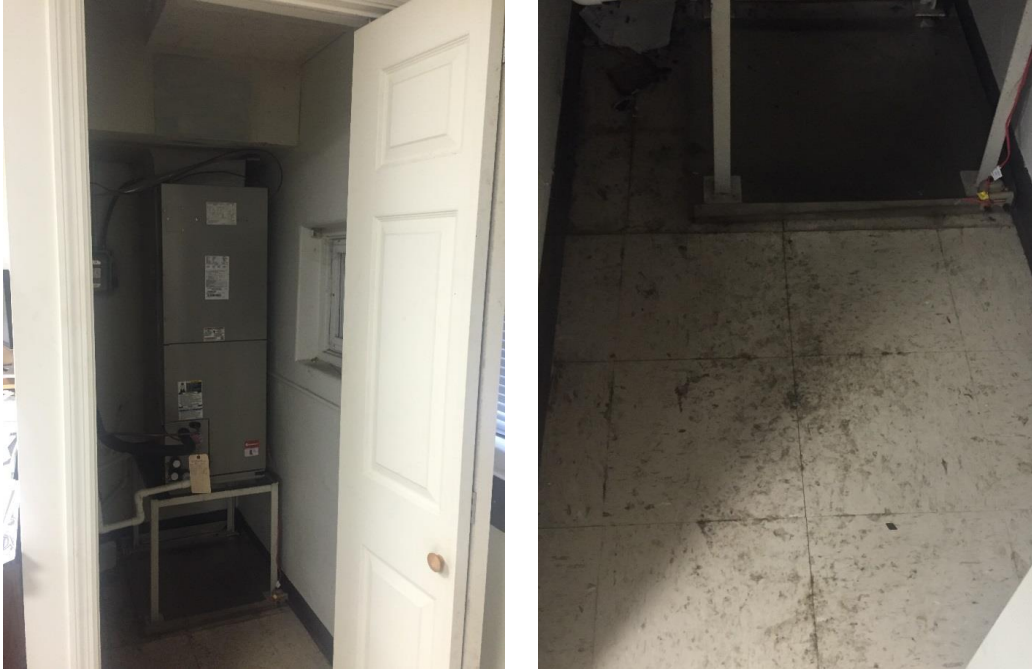
Room 0018A is an extension of the Cultural Landscape Lab and its features are the same. The mechanical room has sustained some of the worst water damage. It is in poor condition.

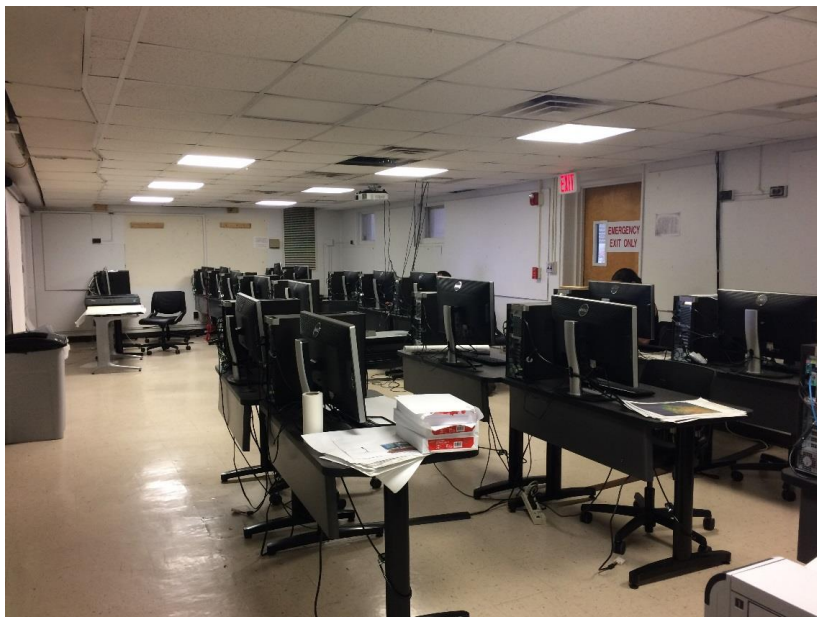
Room 0019 is Denmark Hall's computer lab. A large rectangular room with a gradual slope in grade, it has vinyl tile flooring, drywall covered in pin board, and a drop ceiling. The height of the room to the drop ceiling is approximately 7'2". The pin board has many areas covered in mold, primarily in the corners. Other elements are in fair condition.

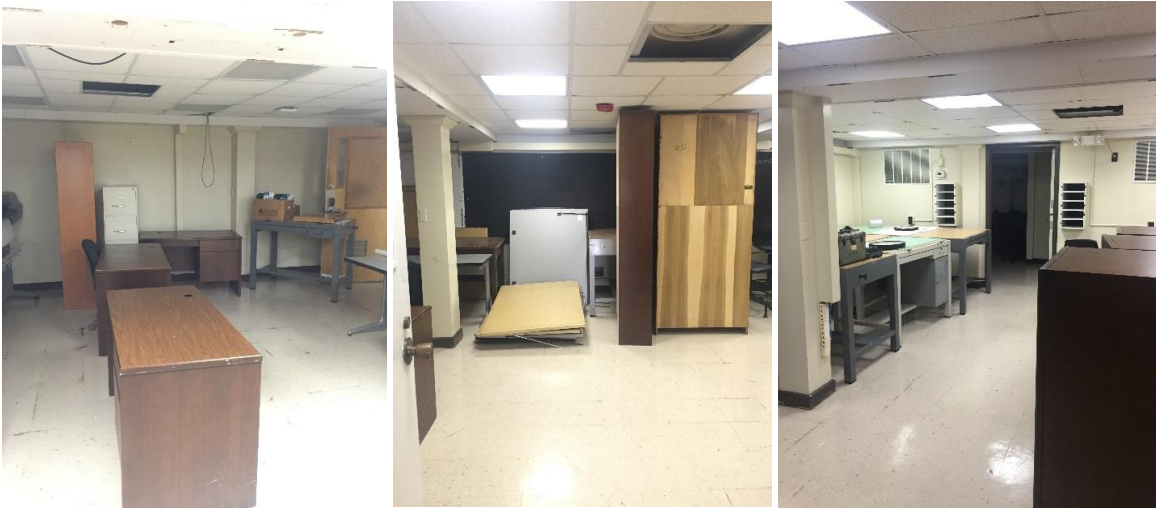
0020

Behind the drop ceiling is some acoustic tiling. This acoustic tile is particularly damaged and crumbling. The original ceiling, as well as the rest of the flooring and walls, seems to be in good condition.

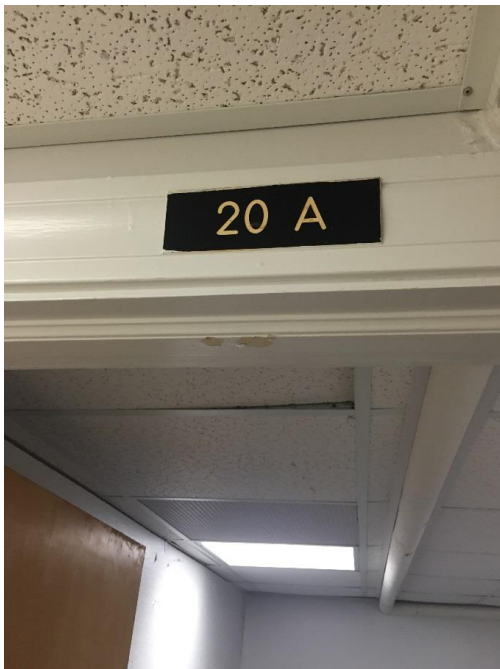
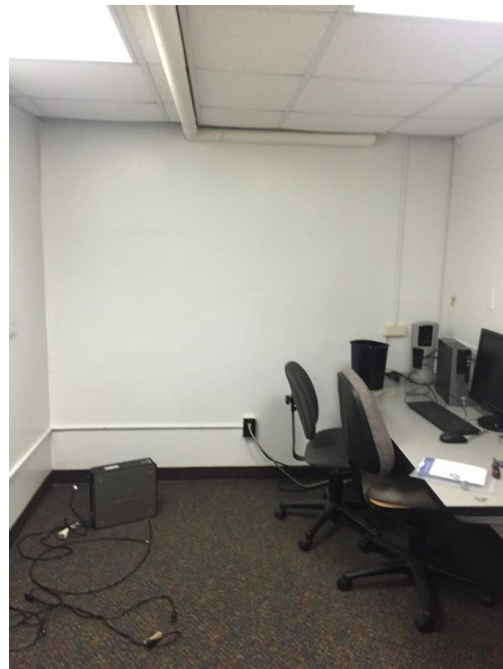
0020A

0020 is a small office space. It has carpeting, drywall, and a drop ceiling. It is in fair condition, and smells of mold.

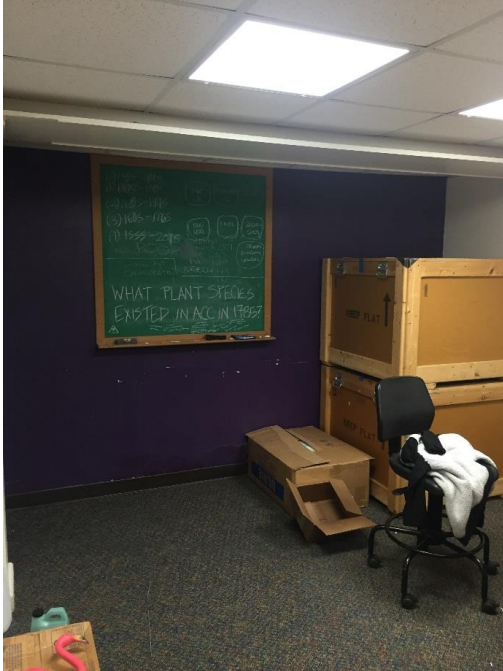
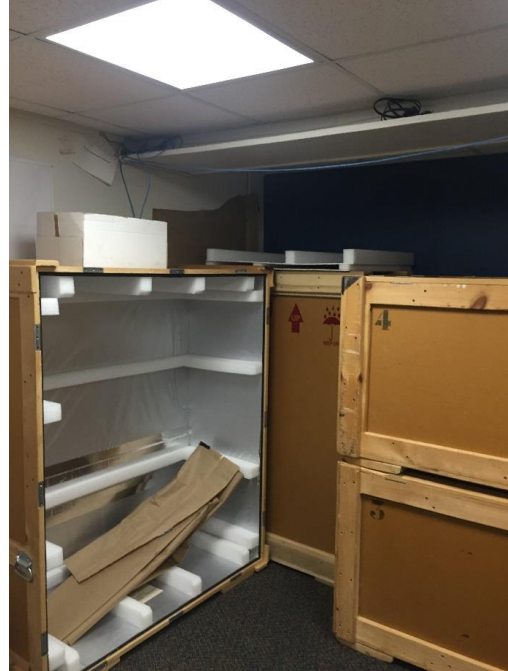
0020B is a larger rectangular office space currently being used as storage for large wooden crates. It has carpeting, drywall, and a drop ceiling. It is in fair condition, and smells of mold.

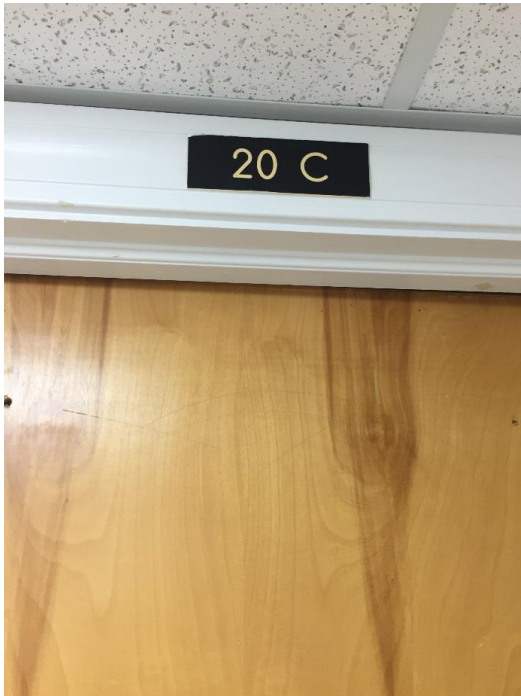
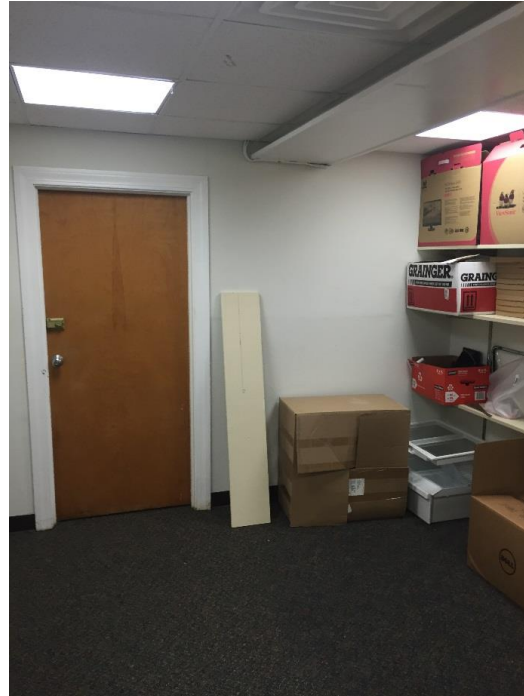
0020C is a small office, also currently being used as storage. It has carpeting, drywall, and a drop ceiling. It is in fair condition, and smells of mold.

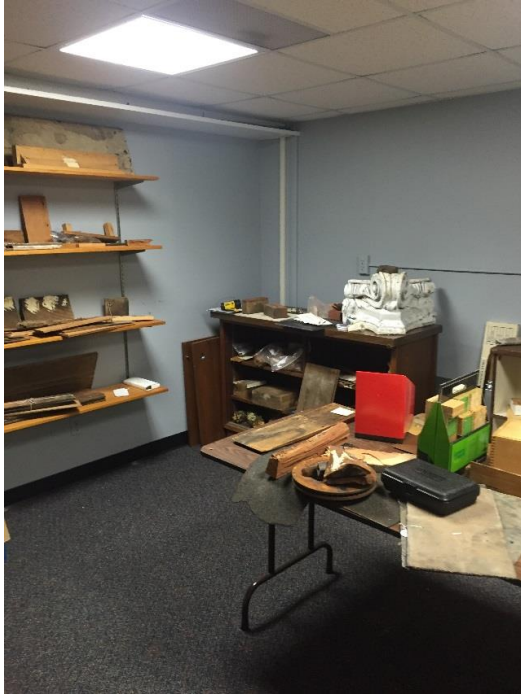
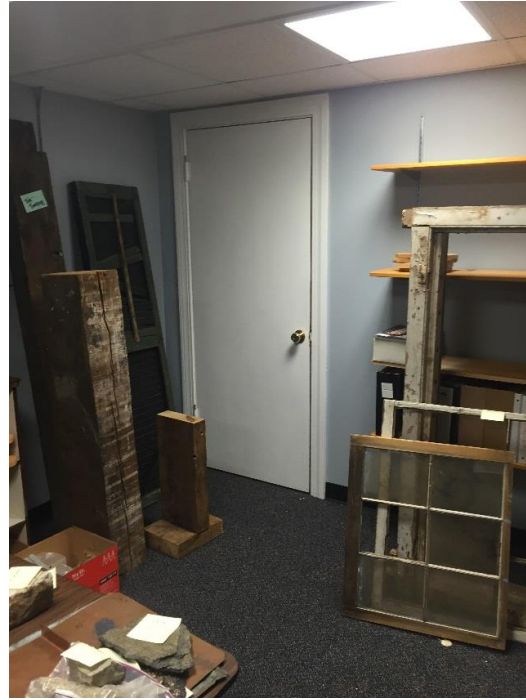
0020D is an office being used as a Building Materials Conservation library. Larger and rectangular like 0020B, it has carpeting, drywall, and a drop ceiling. It is in fair condition, and smells of mold.

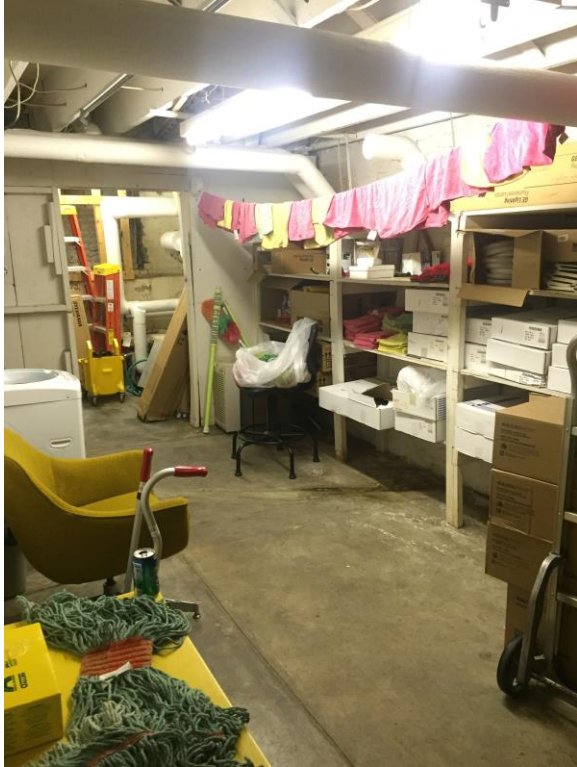
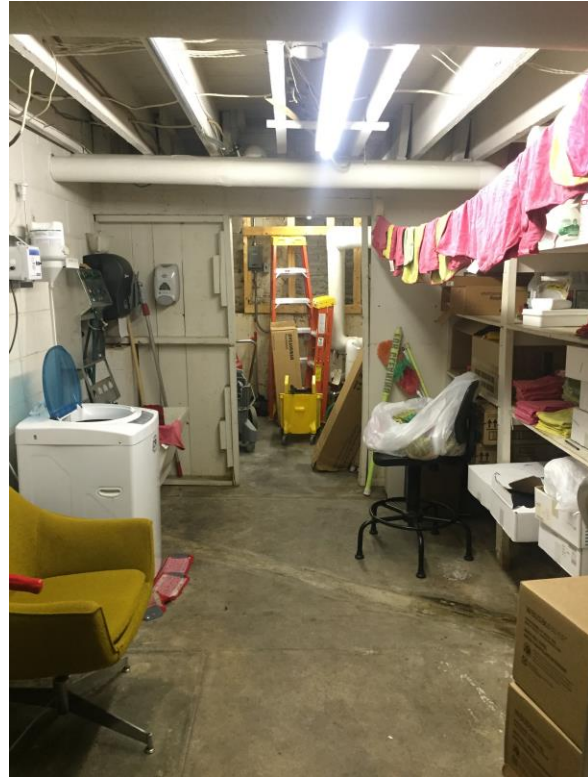
0022A is an unfinished custodial closet. The floor is concrete, the walls are brick and concrete, and the ceiling is open to the underside of the original flooring from the first floor. The concrete flooring has calcium built up in some areas, likely a by-product of the small washing machine that custodial staff uses, but the walls and the ceiling are otherwise in good condition.

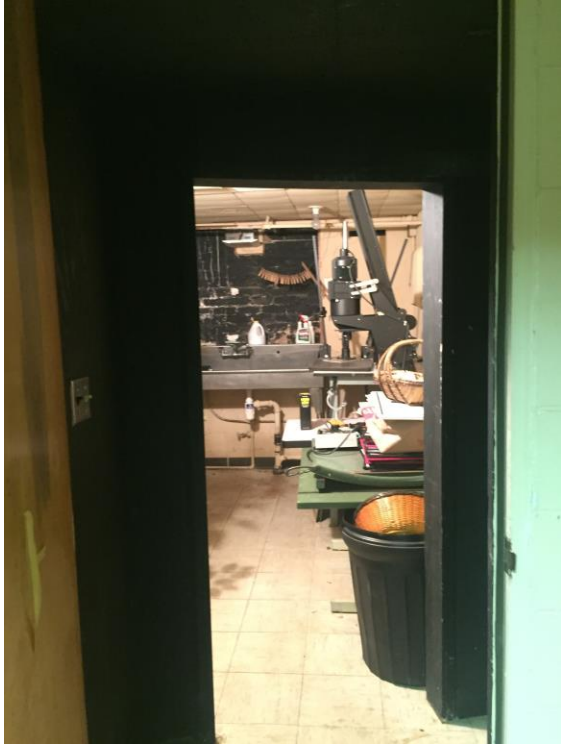
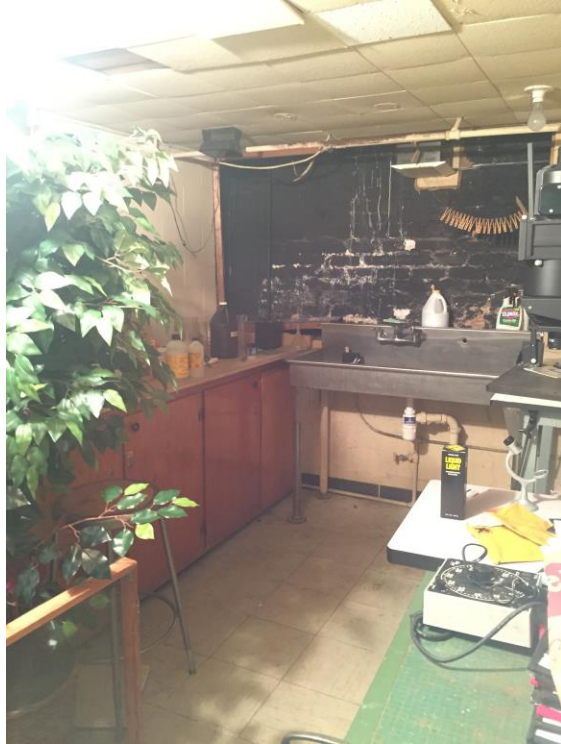
0022B

The brick exterior walls have severe deterioration and efflorescence. The interior concrete block walls and acoustic tiles are in fair condition.

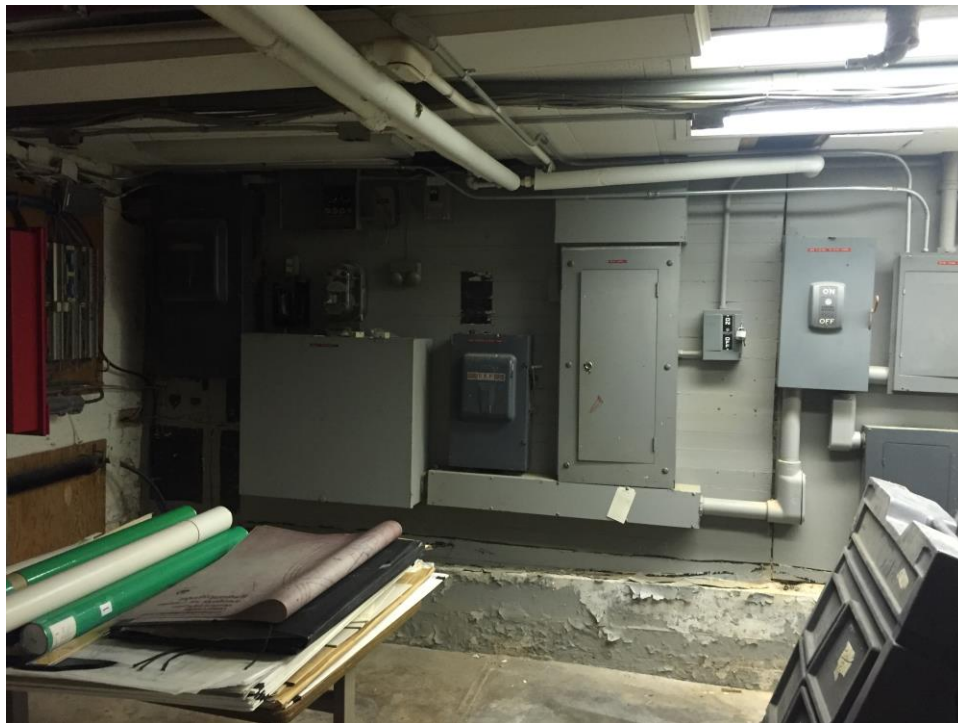
The brick in the north wall is immensely deteriorated; almost dust, while the northeast corner of the ceiling is saturated with water penetration. The flooring is fair and the acoustic tiles have been tremendously damaged by moisture. It is possible there is a leak somewhere in the ceiling. Much of the equipment in this room is non-functional, and the bricks on the north wall are spalling. Salt crystals have formed on the mortar.

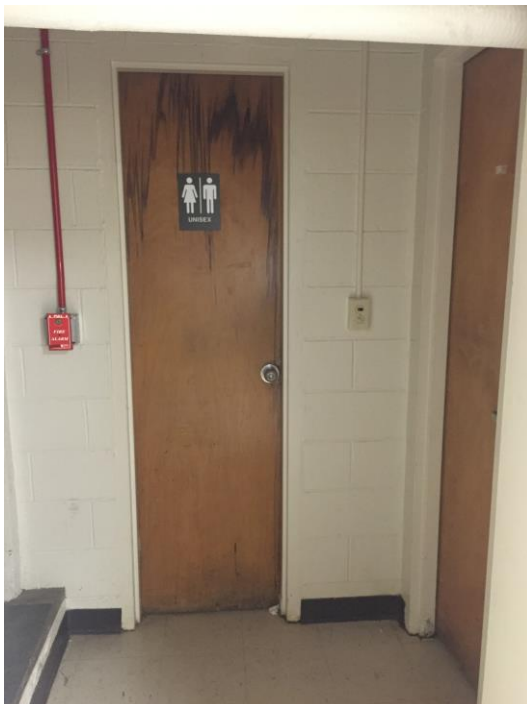
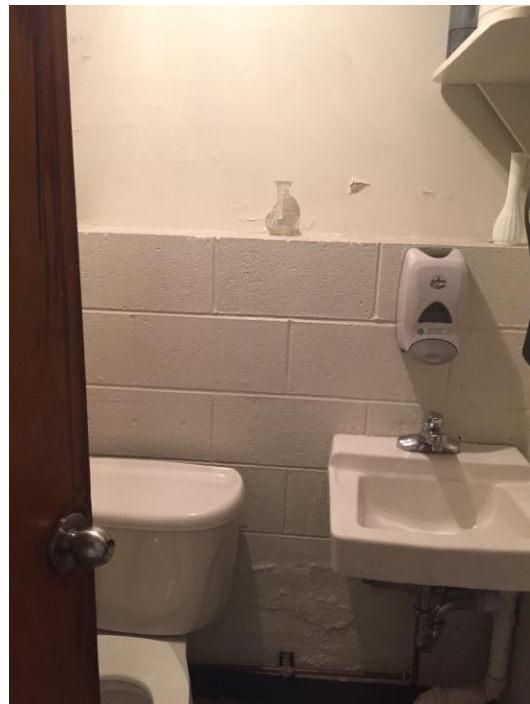
0023M was the men's restroom, now unisex. It is very small, with the door hitting the toilet as it opens. It has vinyl tile flooring, plaster and concrete walls, and a concrete ceiling. It is in poor condition, as the bricks and concrete on the west wall of the restroom sustain spalling and efflorescence.

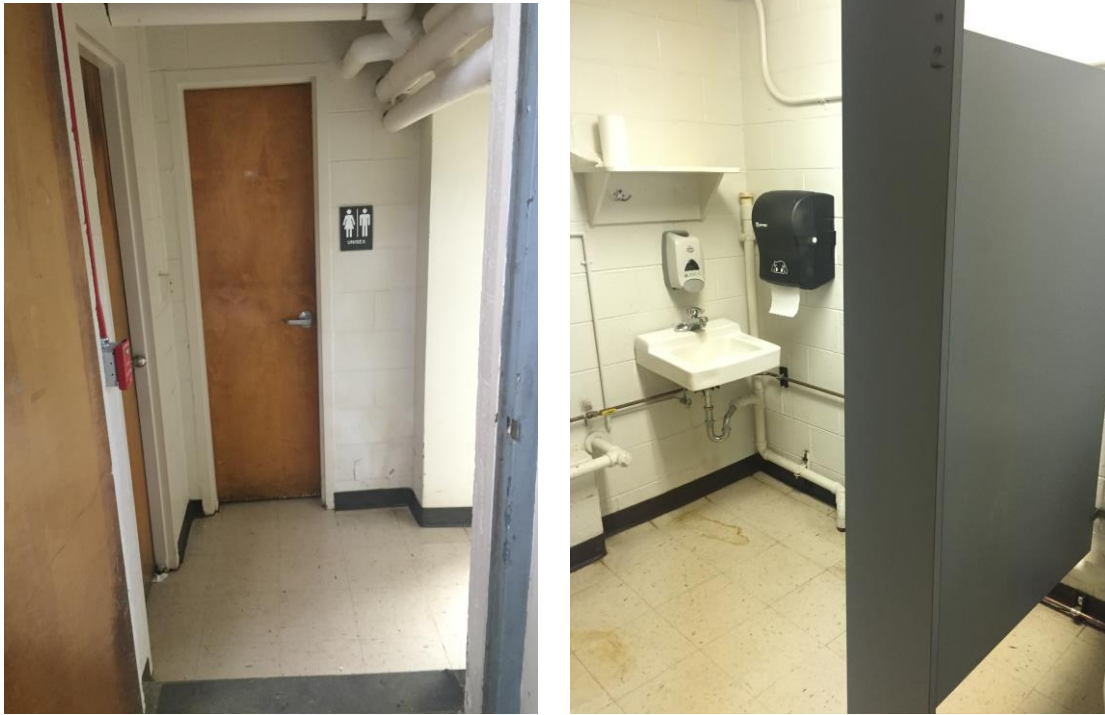
0023W was originally the women's restroom, now unisex. It is larger than the former-men's, has vinyl tile flooring, plaster wall and brick walls, and a concrete ceiling. The floor has some water damage and the walls have sustained efflorescence: salt crystals have formed on the concrete.

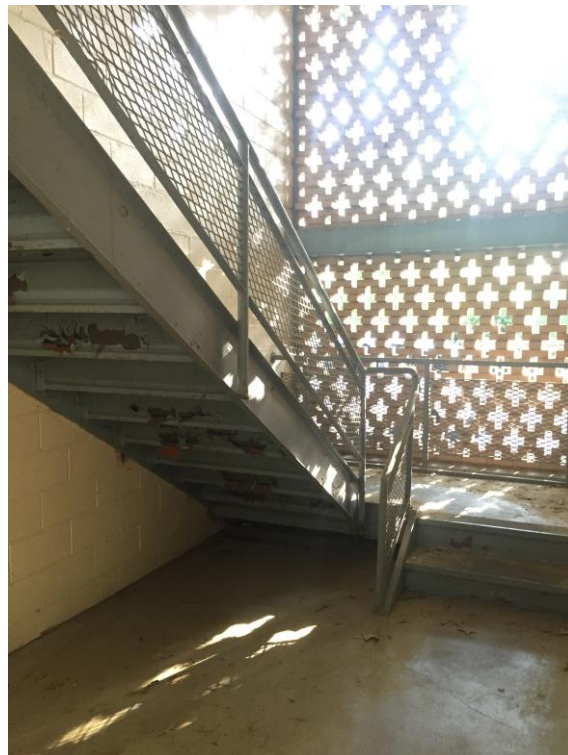
0098B is another stairway. It has concrete flooring, concrete and brick walls, and a concrete ceiling. The paint is peeling and has exposed the metal beneath it. It is in poor condition.

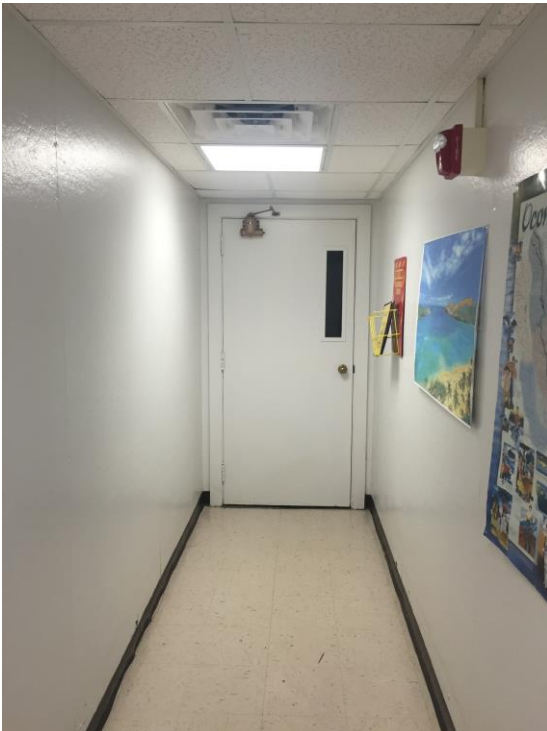
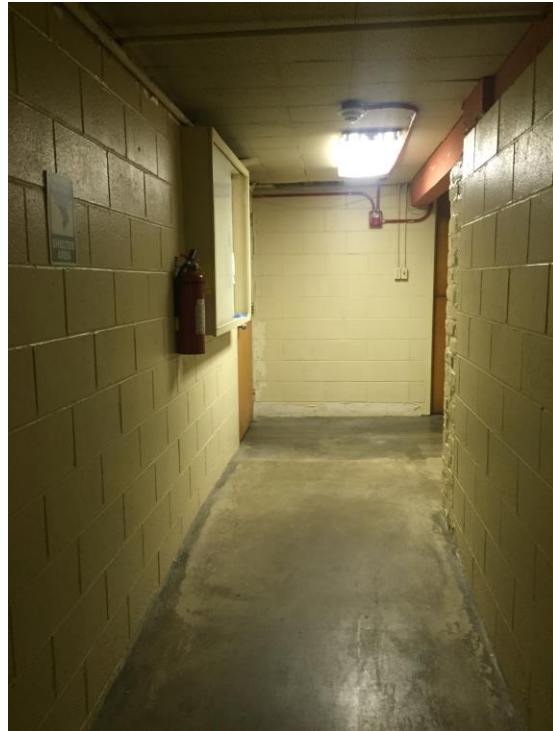
0099B is a hallway originating from the 0099A hall, between 0020B and 0020C, and dead-ending into the north wall of Denmark. A door severs the passage between the two halls. The hall leads to the 0019 and 0022A, C, F, and D storage units. It has concrete flooring with a slight incline, concrete block walls, and an acoustic tile ceiling. There is an original exposed beam in fair condition, as well as some water stains. The floor, walls, and ceiling otherwise are in fair condition.

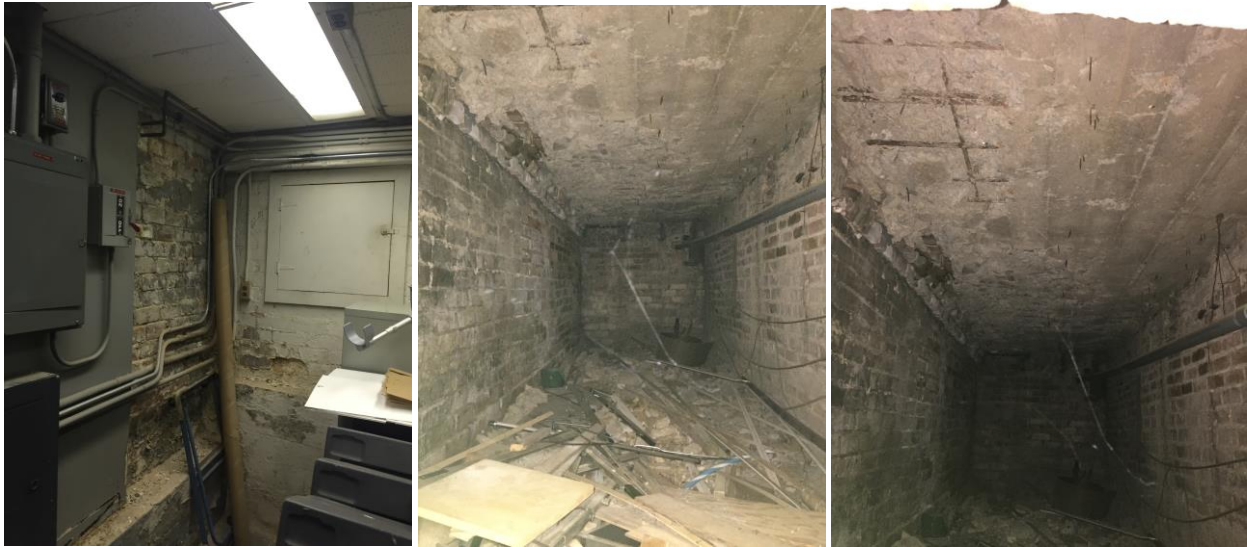
Unexcavated

This is a major source of strain and one of the predominant issues in Denmark Hall. The walls glitter with efflorescence and the brick decay is catastrophic, particularly on the north wall. There is a 2' long tension crack on the south wall running at a 45-degree angle. The concrete ceiling has suffered iron oxide jacking: the concrete itself has deteriorated and the rebar is exposed. This is a serious structural issue, as this failure of a support system is immediately underneath Denmark Hall's entrance steps.

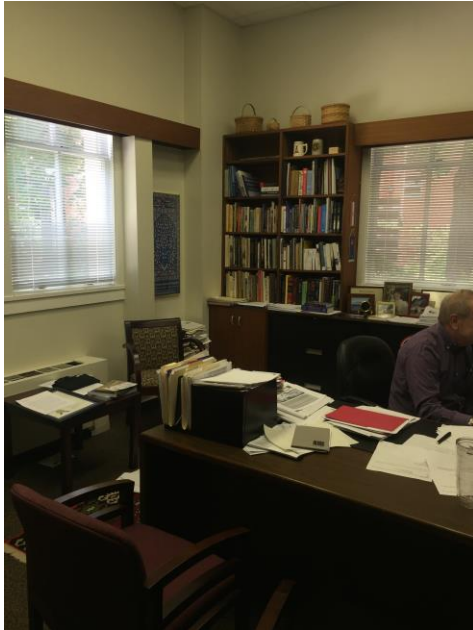
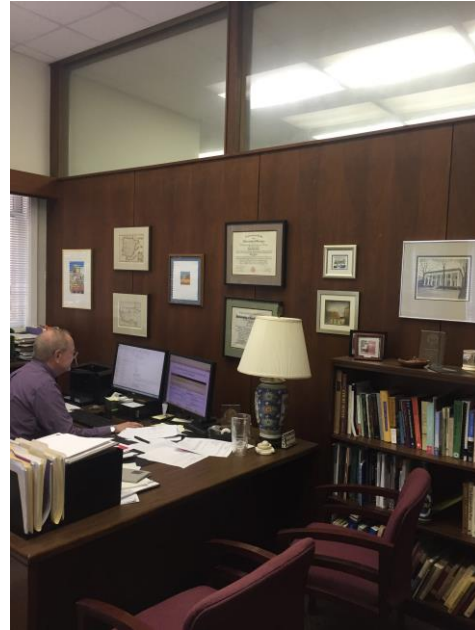
0101 is the graduate coordinator's office. A large room, it has an exterior entrance. It has carpeting, drywall, and a drop ceiling. It is in fair condition, but some of the original features have been covered up with extraneous material for no apparent reason (see window, at left).

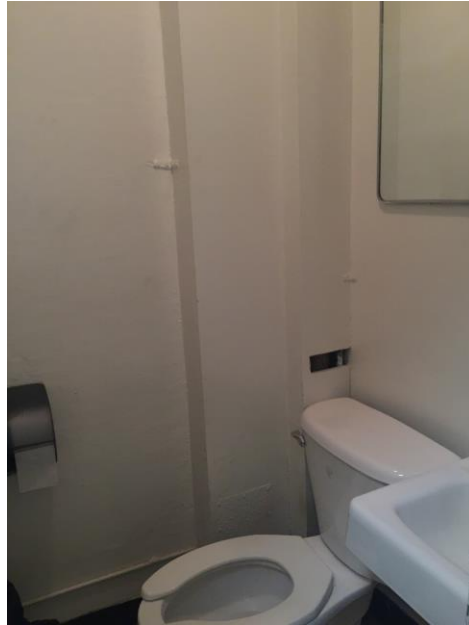
0104R is a small bathroom adjacent to the west entrance to Denmark. It has vinyl tile flooring, drywall, and a drop ceiling. It is in fair condition, as the paint is peeling from the walls and the plumbing lines are exposed.

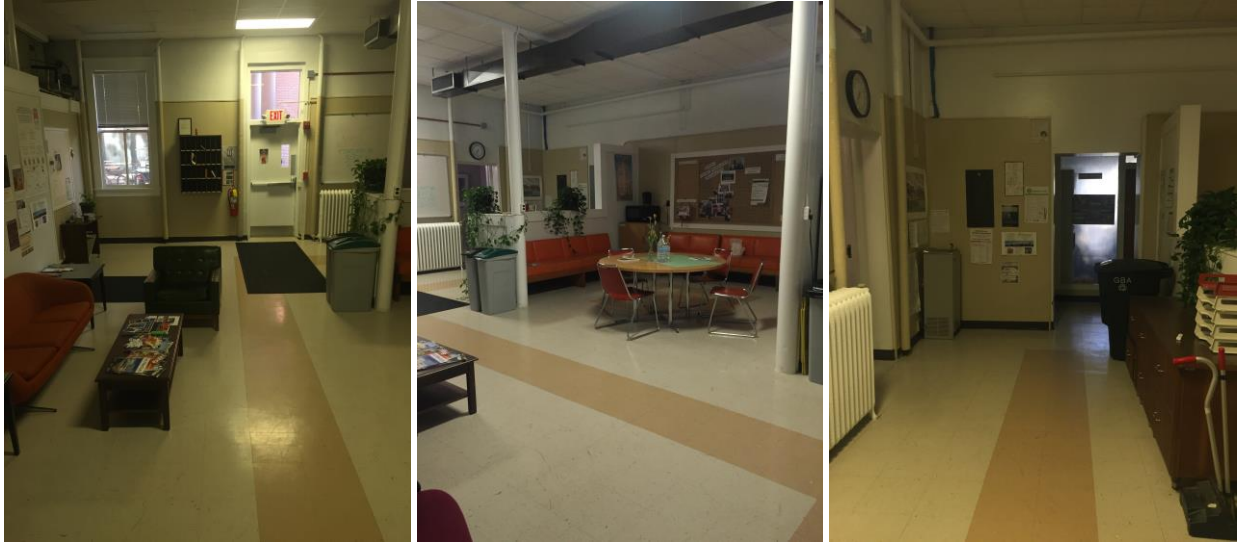
0104D is the large lounge area housing a small kitchenette, tables, and couches. It is separated from the studio by partition walls. It has vinyl tile flooring, drywall, and a drop ceiling. It is in poor condition.

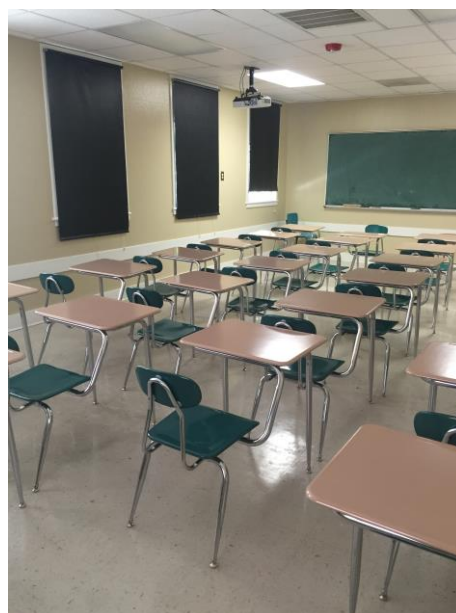
0110 is one of two classrooms on the first floor of Denmark. It has vinyl tile flooring, drywall and concrete walls, and a drop ceiling. The windows are painted shut. It is in fair condition.

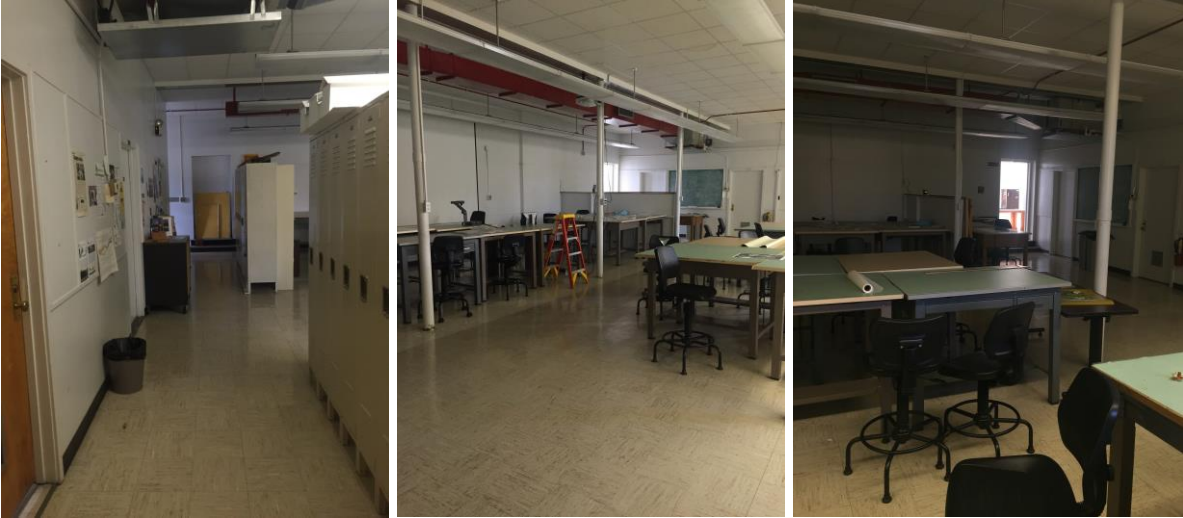
There is some water damage to the acoustic tile ceiling (above the drop ceiling) - in turn leaking to the drop ceiling. The leak is coming from an unknown source in the inaccessible attic. This is causing the acoustic tile to fall from the original ceiling, which will eventually lead to the collapse of the drop ceiling. The rest of the elements are in fair condition.

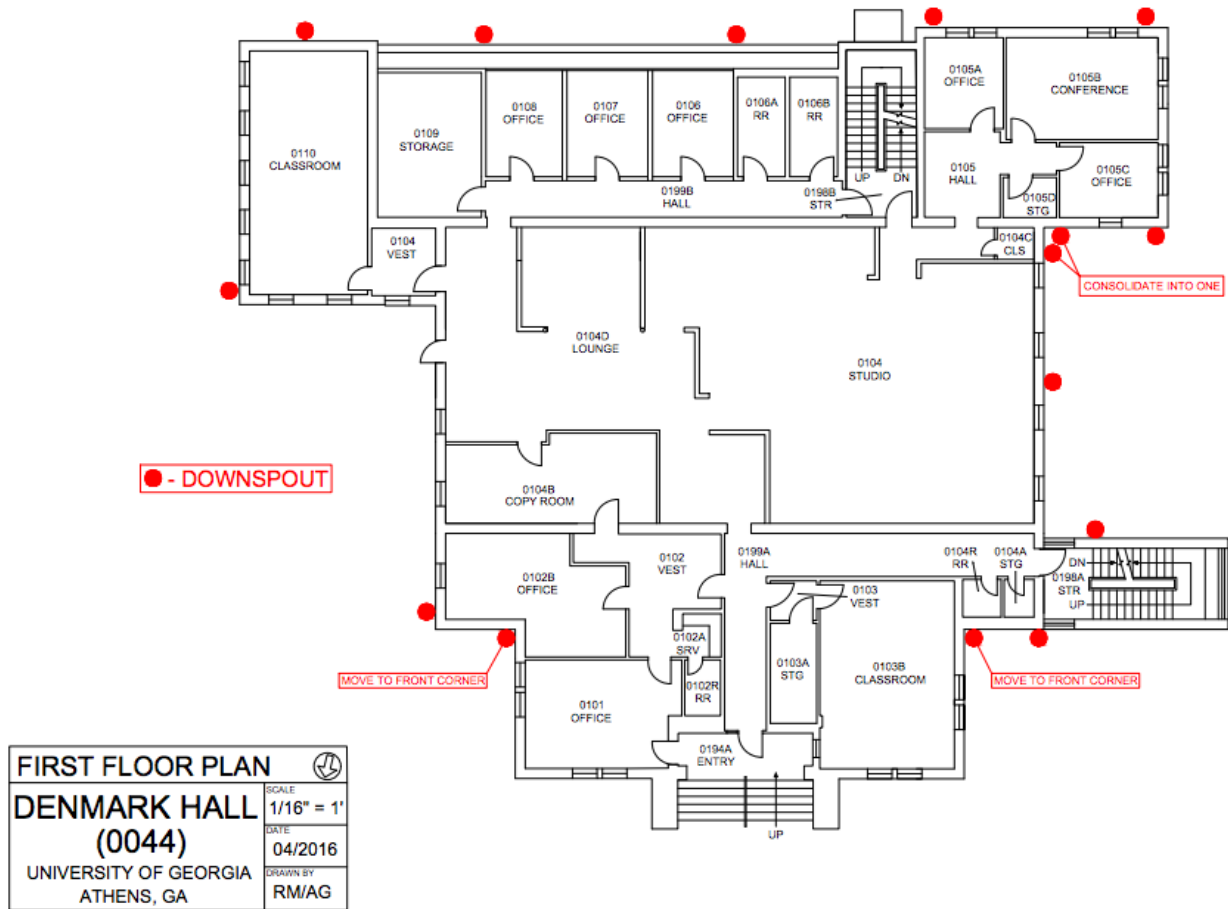
[Current Gutter System]

The **water drainage systems** (including the gutters, downspouts, and ground drainage systems) of Denmark Hall are in poor condition. There is no indication that the downspouts or the ground drainage systems are compromised, but the horizontal gutter system suffers from both deferred maintenance and material degradation. The overhanging trees have dropped considerable debris into the gutters that is not being regularly removed. This accumulation of debris encourages frequent overflows of water which saturates the fascia boards to which the gutters are attached and splashes onto the face of the building. Dark water marks show where water is flowing over the exterior walls, despite an adequate overhang and the gutter system. The same vegetation that is the source of the debris in the gutters shades the building and encourages the growth of moss and mold. In particular, the northeastern corner of the building is very cool and damp. During our investigation on a hot, sunny week with no rain, there was standing water in this corner.

RECOMMENDATIONS: A thorough cleaning of the gutters is the first step to mitigating these problems. The overhanging branches should be trimmed back to avoid continued debris accumulation. Gutter cleaning should be made an ongoing maintenance priority. The fascia boards only require spot replacement, but overflows should be monitored for continued impact on the cornice and lower roof members. Downspouts should be moved to logical locations on the corners of the roofs. If the gutter capacity or function continues to be insufficient after cleaning and regular maintenance, a new system should be installed.
