Outbuilding of the Wright House

Lincolnton, Georgia

HISTORIC STRUCTURE REPORT

Prepared by: Mark Reinberger, Tim Brown
and Caitlyn McSwigan
University of Georgia, 2020

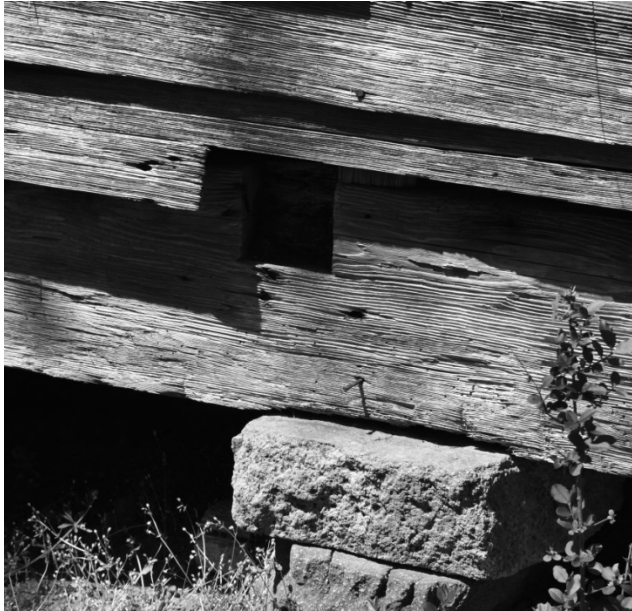
Other notable feature of the floor frame are the two mortises in the rear sill, which symmetrically fall on either side of the rear kitchen door, indicating a porch or stoop at this location, perhaps

Figure 6: mortise in sill for former rear porch

- Reconstruct the fireplace and chimney using plans from similar structures.
- Restore floor plan through removal and moving of partitions.
- Repair rotted floorboards in porch area.
- Remove window to the left of the fireplace.
- Remove dirt and items in attic; study artifacts if relevant.
- Reconstruct rear porch and steps after examination of ground.

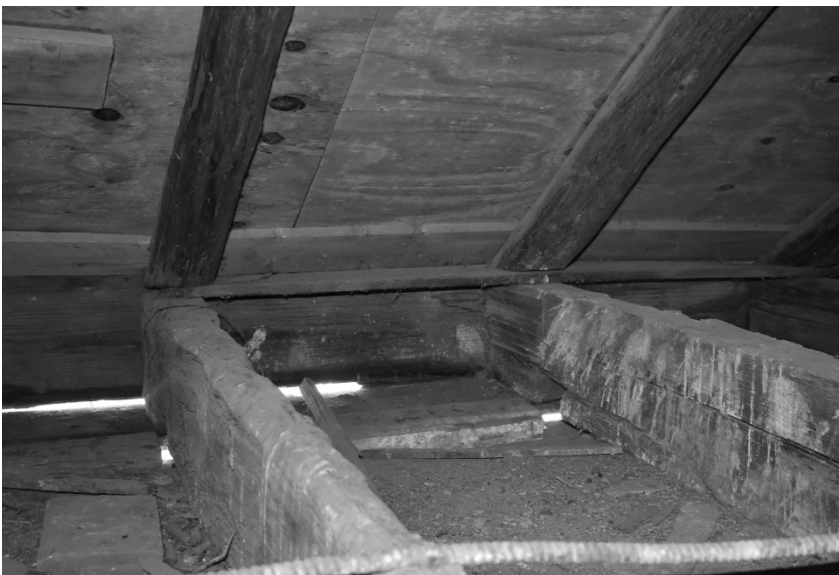
Figure 11: Ceiling joists, false plate, and rafters in attic

In addition to the bottom of the frame, some repairs will be necessary in the attic. Several ceiling joists are rotted and in need of sistering for continued stability, especially near the end of the building with the fireplace. There are both old and current leaks in this area, and there have been leaks around both stove chimneys. For both structural liability and historical accuracy it is recommended that both stove chimneys be removed. The rest of the attic frame appears sound, though some roof lath may need replacement when the roof is restored with wood shingles.

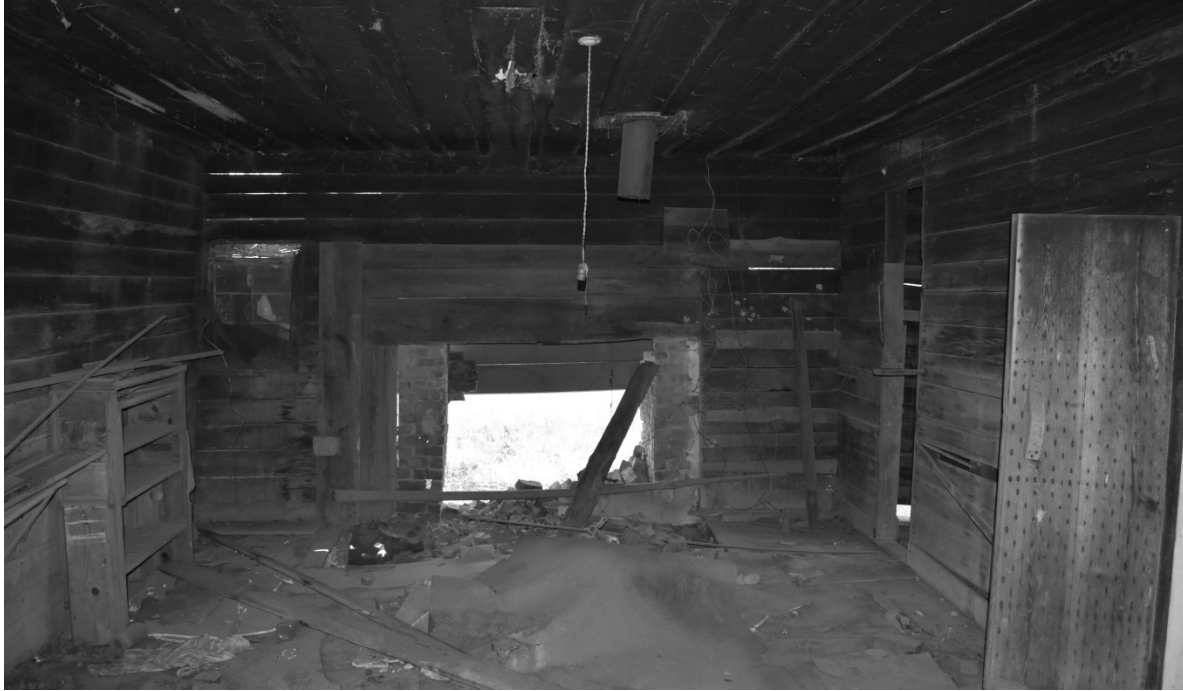
Figure 18: Room 101, Kitchen, looking west towards fireplace

The fireplace, five feet wide and four high, was very substantial and clearly intended for cooking. Its hearth was brick, laid over a sand base which was underpinned with stone, which can be seen in the crawl space. Two wooden lintels were found in the rubble, both badly scorched. One formed the top of the fireplace opening; the other presumably held the inner wall of the chimney which rose outside of the exterior house wall and gable. Exactly how this assembly was put together cannot be known because of brick collapse, but contemporary examples will give a fairly good idea for restoration. A hand-forged iron trammel rod,

Enough remains of the fireplace and chimney base to make a fairly accurate restoration, and the chimneys on the house may furnish additional clues, as might other contemporary kitchen fireplaces in the region. The size of the fireplace can accurately be determined: width, depth and height; as can the fact of its having square corners instead of flared sides. It may have been plastered inside; at least it was so patched. The fireplace's lintels were originally heavy timbers, and these should be restored for accuracy's sake. However, they should be supplemented with a combination of steel angles and plates for additional strength. The original hearth was brick laid over sand, but we recommend a concrete slab under the restored hearth. Existing bricks should be used as much as possible for restoration of the fireplace and chimney, but close matches in new bricks will have to be found for much material.

The restoration of the chimney is more speculative, and in the drawings some elements have been determined by modern standards where these seemed wise for safety and functioning and would be invisible. Thus the form of the throat could not be determined, nor could the exact size of the flue. The flue shown was determined by modern standards for the size of the fireplace, to ensure that it would draw properly if cooking demonstrations were desirable. The original would not have had a damper but, again, this may be desirable and invisible. The chimney's size was determined by the size of the flue, plus eight inches of masonry all around for fire safety. The height was determined by modern building code. A skilled mason, preferably one experienced with historic buildings, should be consulted about all aspects of the fireplace and chimney.

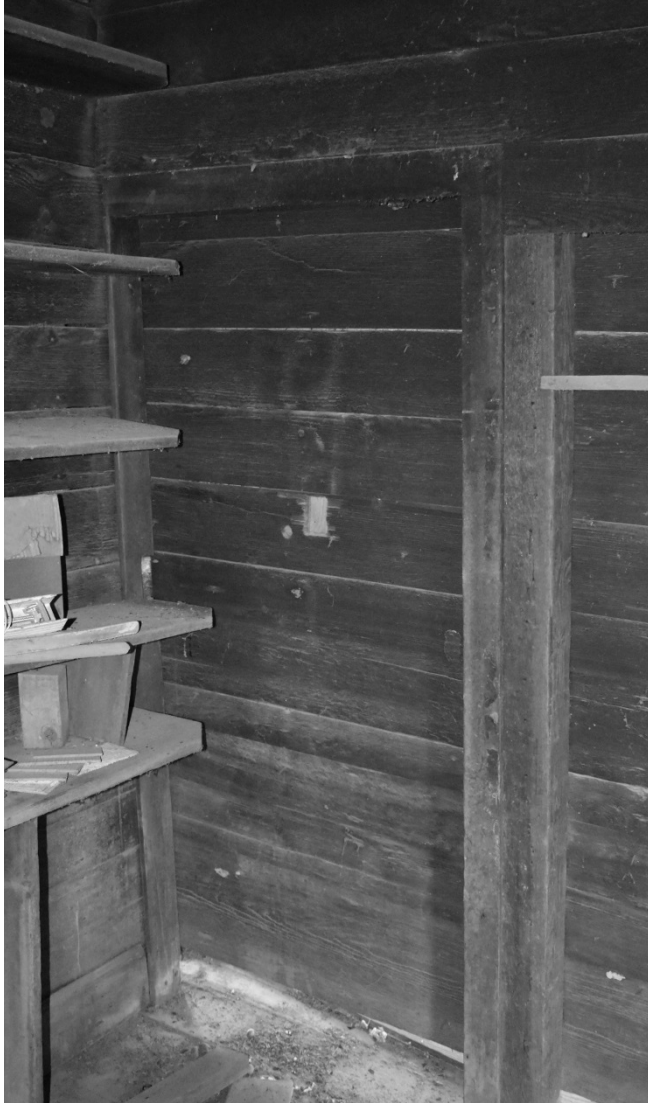
Figure 19: Room 101, former door frame in NE corner to quarters

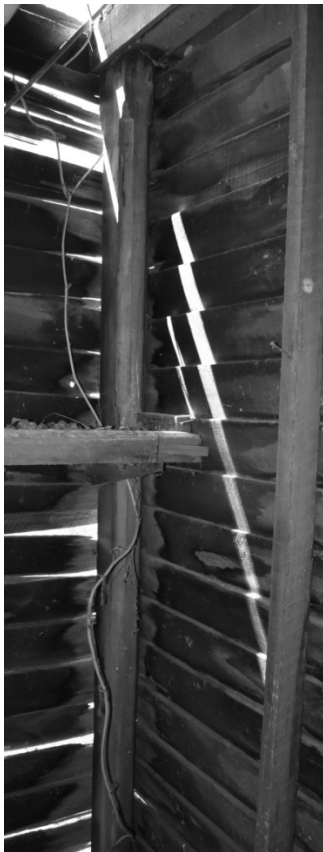
This space originally formed part of the porch and retains at its outer corner the only remaining original porch post. Its wall with the kitchen is original, while the other three are lightly framed later constructions, sealed only on their outer surfaces, towards either the exterior or the porch (103). These boards are circularly sawn and attached to the circularly-sawn studs with cut nails, suggesting a date in the second half of the 19th century. The doorway to the kitchen was not original, as shown by its ragged edges. The door itself is board and batten fastened with wire nails, so perhaps even later than the room itself.

Figure 23: original porch post in northwest corner of Room 102

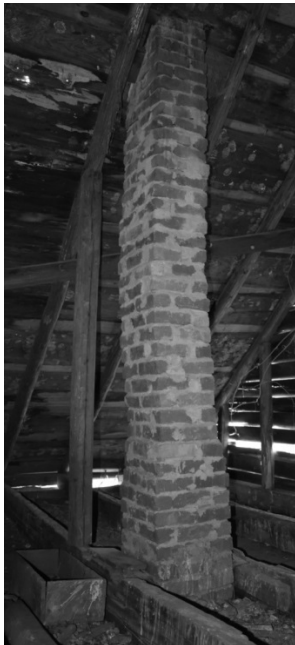
Two brick square stove chimneys pierce the roof near the center and east end, on the rear slope; they have fairly crude metal flashings. The original fireplace chimney is long gone, its remains covered with a sloping wood hood. The base of the fireplace is stepped out as it drops below hearth level, with seven steps, a typical treatment for the antebellum period.

Figure 29: later chimney in attic

Similarly, the exterior of the outbuilding can also be faithfully restored with a high probability of accuracy. The two later stove chimneys should be removed, and the roof restored with cedar shingles as discussed in the Exterior section above. The porch can be restored to its original open condition by removing two partitions, the clapboard walls around present Room 102, and the return of six new posts matching the one surviving in the northwest corner of Room 102. Some interior finishes will have to be restored in the quarters space and the part of the porch in front of it. All existing modern windows should be removed and their "holes" patched with clapboards, honestly leaving the ghosts to recall the later state. Structural repairs to the frame are covered in an earlier section of this report. The propane tank in the front yard should be removed.
