Historic Structures Report  
Oconee County High School Complex:  
Rocket Hall and School Street Studios

Prepared by Sophia Latz, Alex Green and Jackson Beck

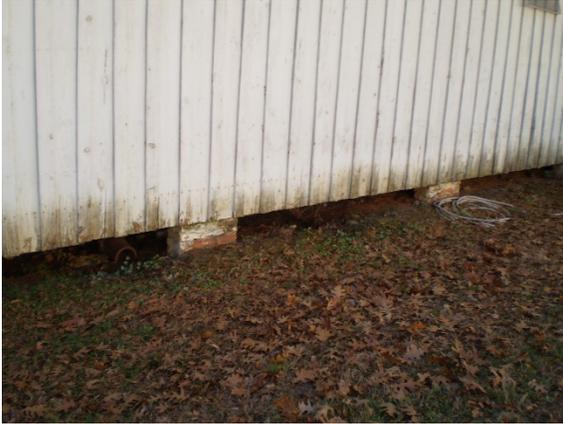
Overlapping wood siding with backsplash damage

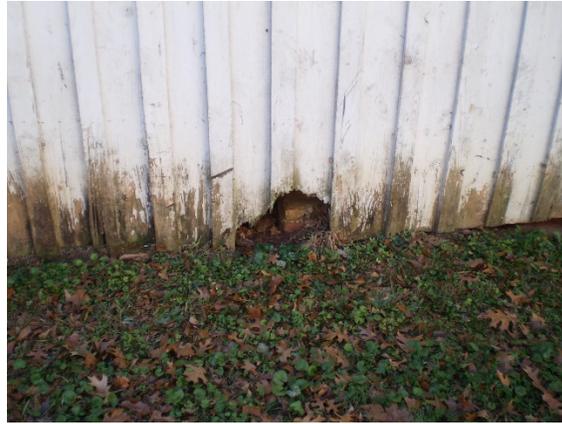
Termite damage on southeast corner, exposing brick pier

The southeast corner, on a much higher grade than the rest of the building and sinking into the earth, is constantly damp and much of the wooden sill has been eaten away by insects. Moss grows on the edge of the corner and the wood is stained with dirt and decaying organic material.

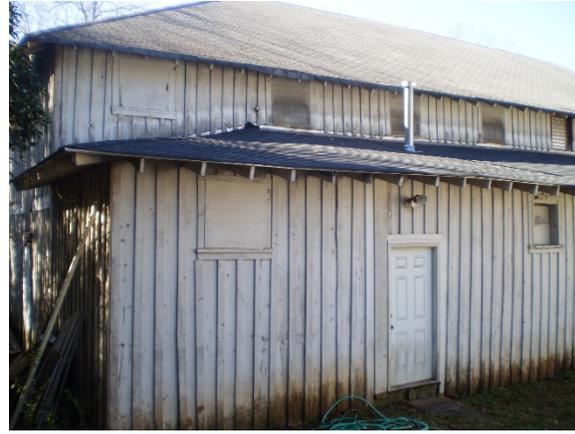
Note moss growing beneath the door

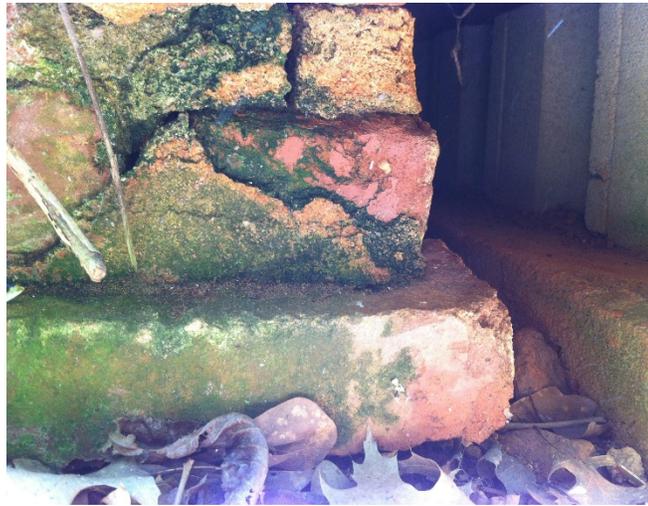
Brick pier at rear of building, overgrown with moss

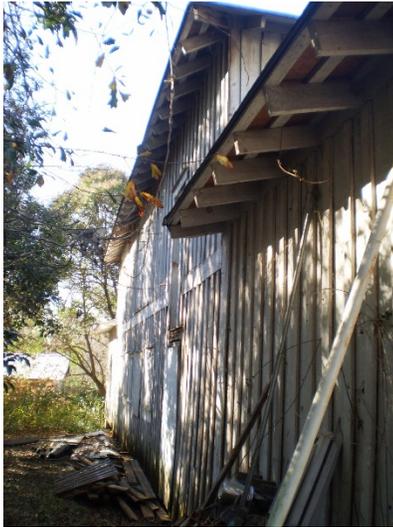
Piles of refuse

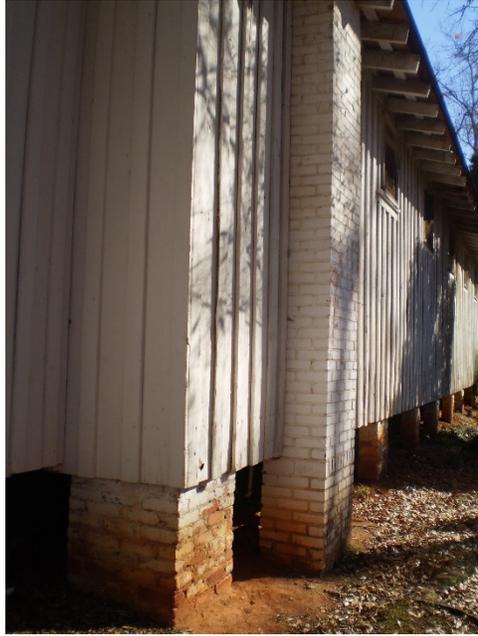
Red clay backsplash on brick piers and southwest chimney

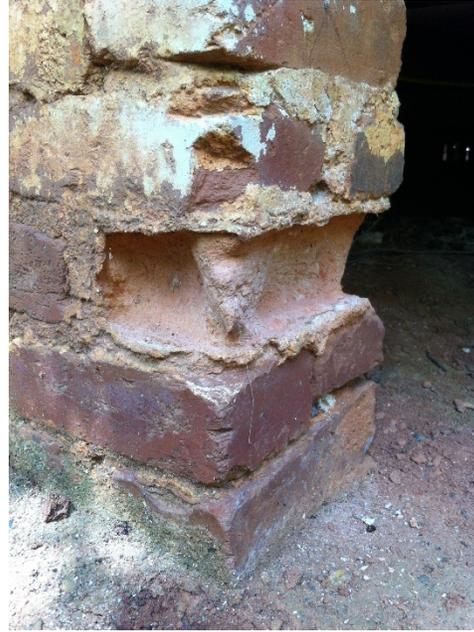
Moisture damaged, compromised brick

- Brick piers
  - Some bricks of the piers are deteriorated, replace and repoint when necessary.
  - Brick piers under the east corner should be investigated and replaced or repaired when necessary.

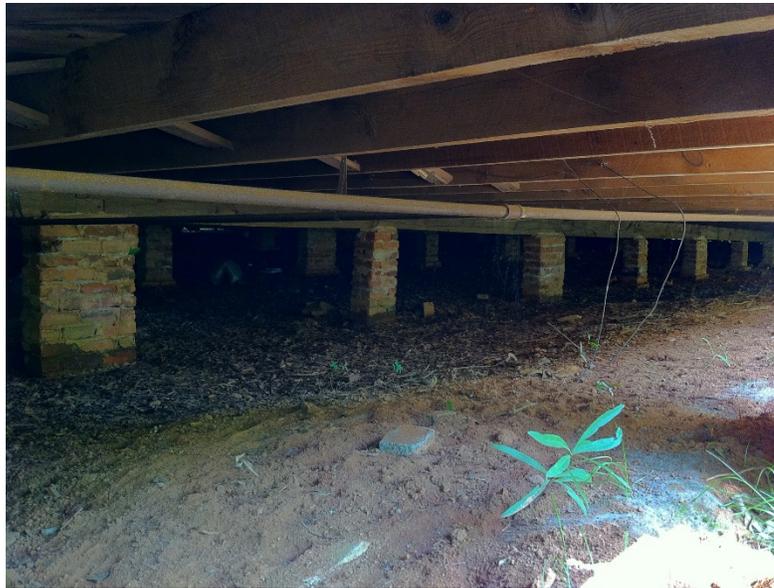
Brick piers beneath the gym, as seen from the southwest side

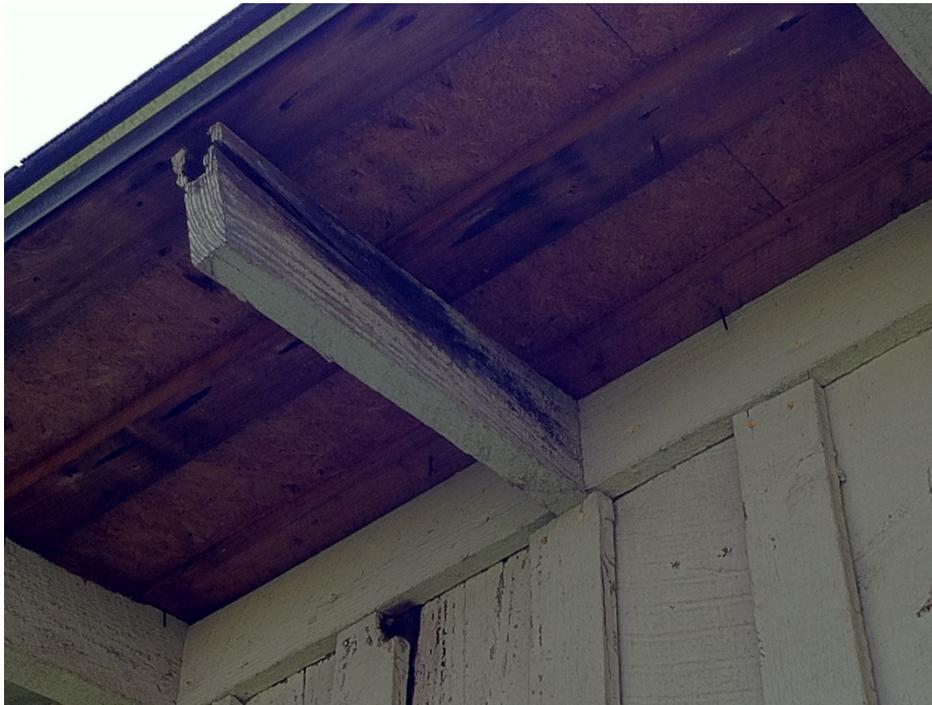
East corner rafter, a victim of black rot

- Roof
  - Moisture is penetrated the roof structure near the chimney openings at each corner of the gym. We recommend investigation as to the source of this failure. The chimneys will likely need to be re-flashed.
  - Rafters on the east corner of the building are deteriorating and should be replaced when necessary and spliced when material is salvageable.
  - When the shingles are replaced we recommend re-roofing using metal sheets, preferably standing seam. This is authentic to the original roof and will serve as a long-lasting replacement.
  - A drip edge and flashing should be installed at roof overhangs.

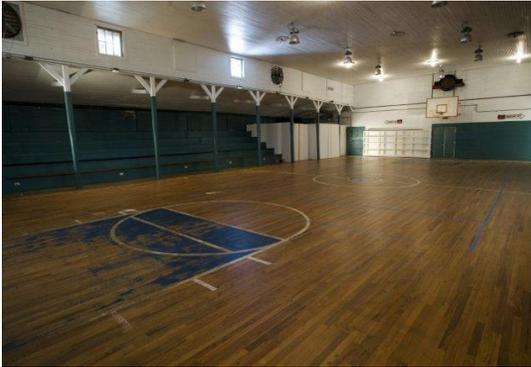
Interior view from W corner, looking at damaged SE corner

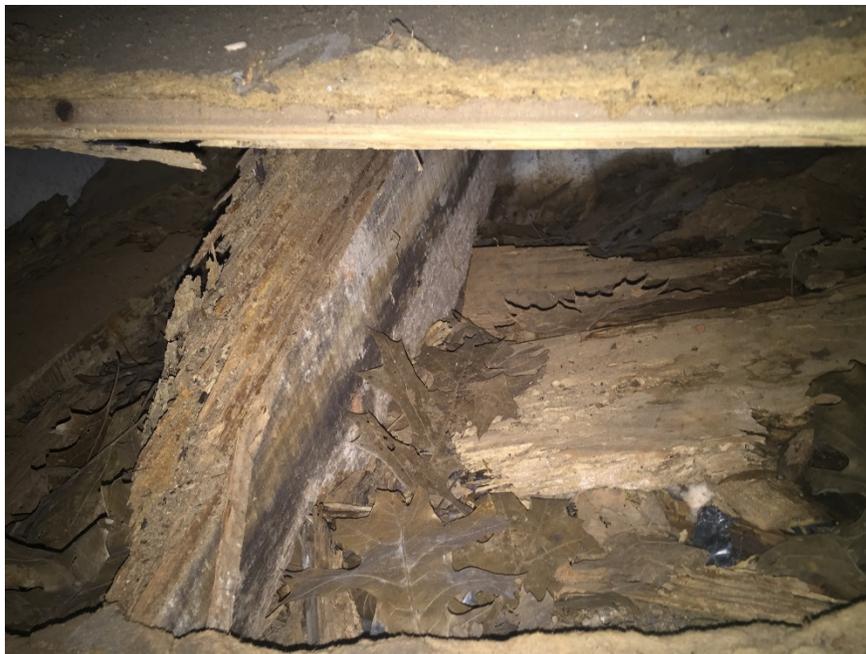
Floor of Home Team locker room, collapsed due to moisture and insect damage

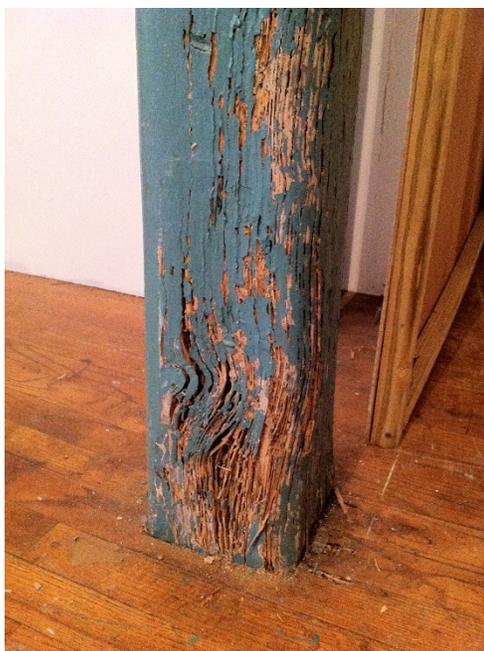
Supporting post in east corner of gym interior, termite damage

- The third post from the southeast end of the row should be braced with tie rods to prevent further cracking.
  - The post at the east end of the gym has suffered considerable termite damage; it should be strengthened with an epoxy or other consolidate.

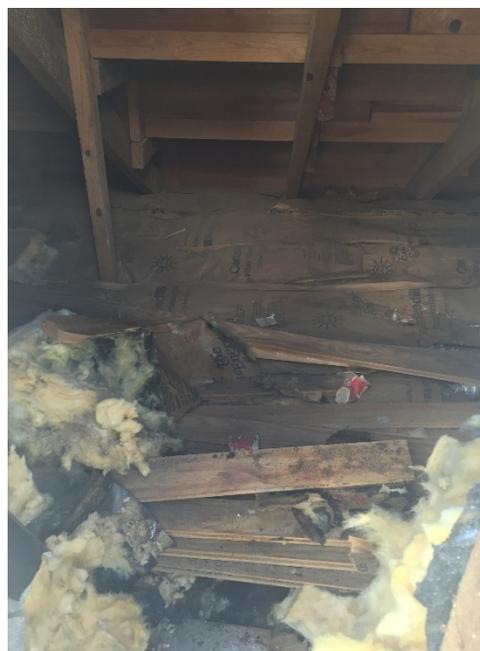
East corner, beneath the built-in bleachers

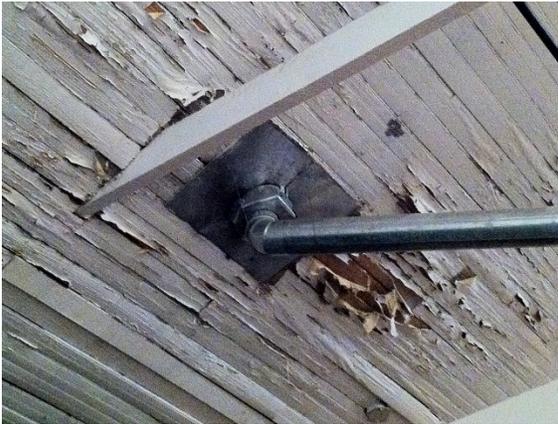
South corner heating exhaust damage

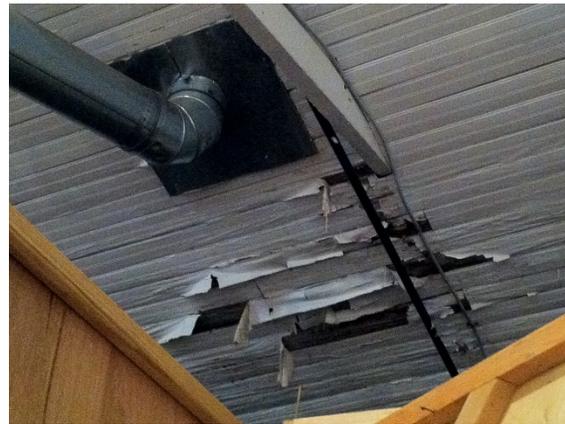
East corner heating exhaust damage

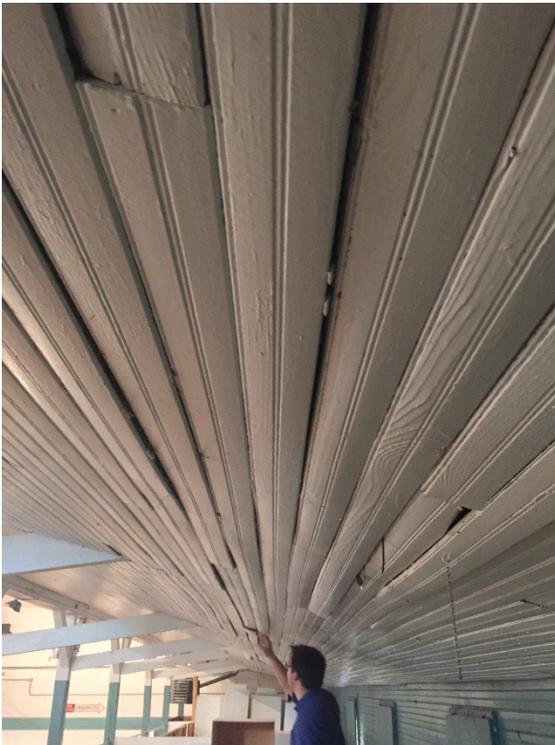
Damaged beadboard of southwest side over bleachers

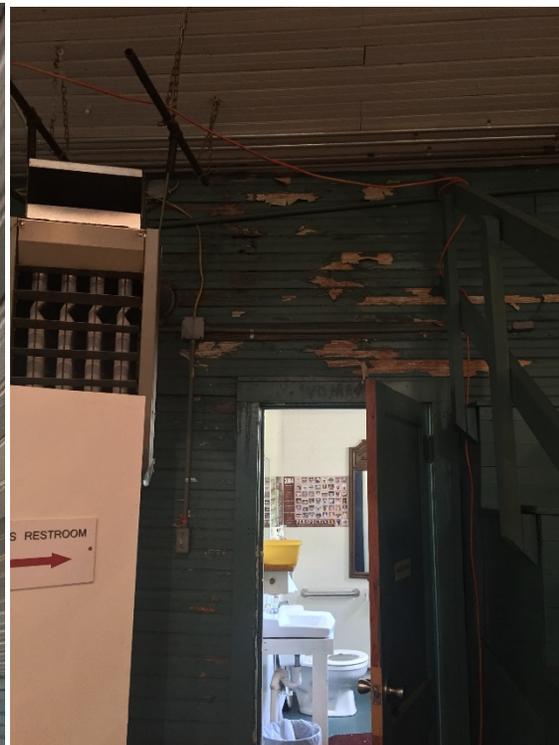
North corner bathroom additions with water damage

- Bathrooms
  - There is considerable floor sagging in center of bathroom addition.
  - Foundation of bathrooms should be investigated and likely be reinforced.
  - We recommend adding a foundation pier with additional wood joisting and perhaps another beam to stabilize the center of the floor.

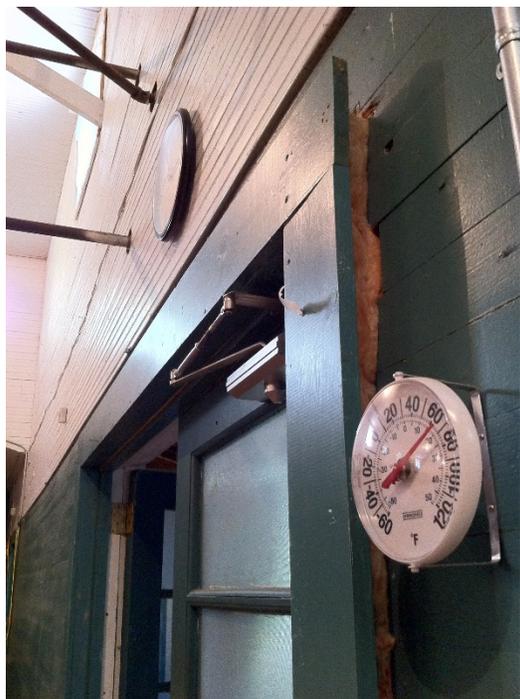
Interior of front gym wall, wall pulling away from door frame porch  
(exposed fiberglass insulation visible)

- Northwest wall of gym
  - This wall is bowing considerably.
  - Not much is known of the source, but it could be from roof bracings, foundation settlement, or perhaps the porch addition.

- We recommend investigation as to the wall structure and condition of the wooden stud walls.
  - Possible remediation efforts could include tie rods to brace the wall from continued bowing and/or opening up the wall and reinforcing the structure with additional braces and studs.

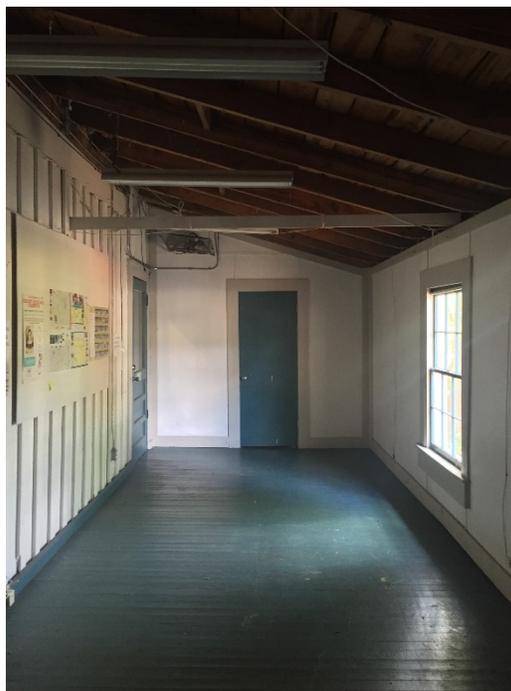
Exterior of same gym wall on left, as seen from porch  
(visibly bowing outward)

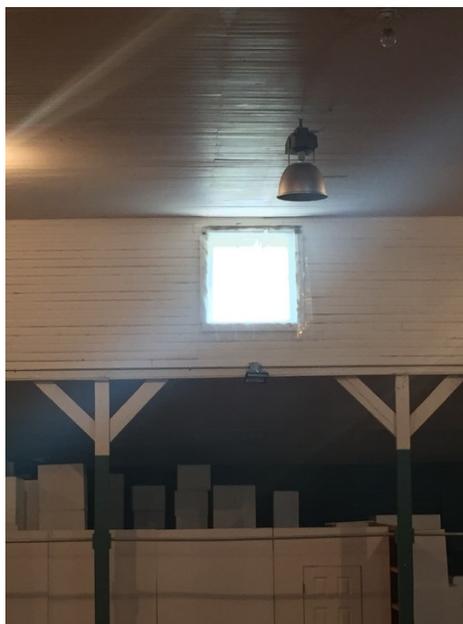
SW clerestory window, covered with plastic sheeting
