Shields-Ethridge Heritage Farm

Historic Structures Report
Building Materials Conservation Class 2009
Master of Historic Preservation Students
The University of Georgia

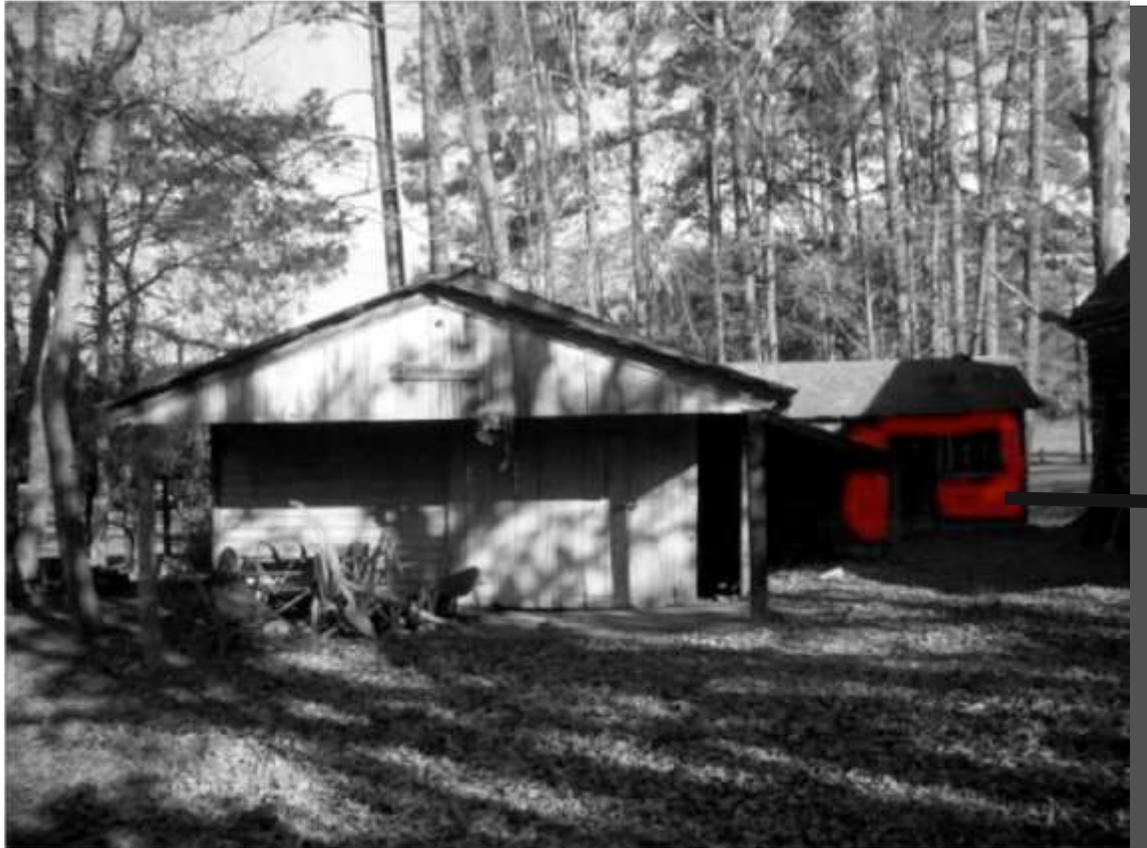
Figure B-7: Weatherboards on this facade need to be replaced.

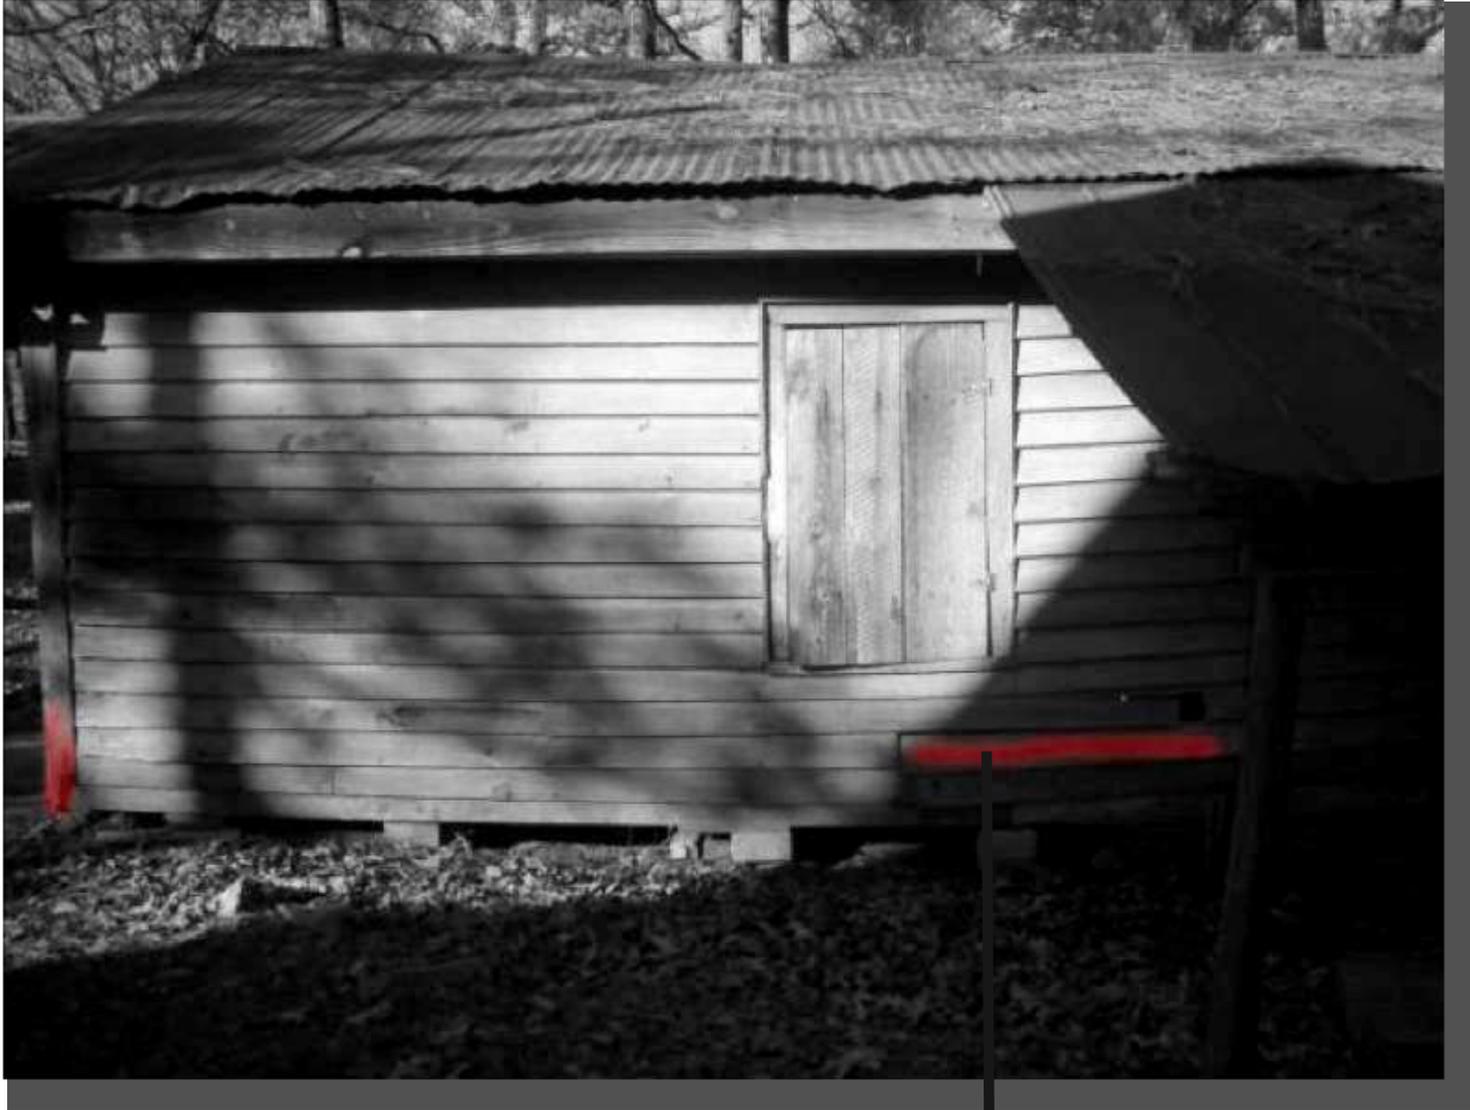
Figure B-8: Replace this weatherboard

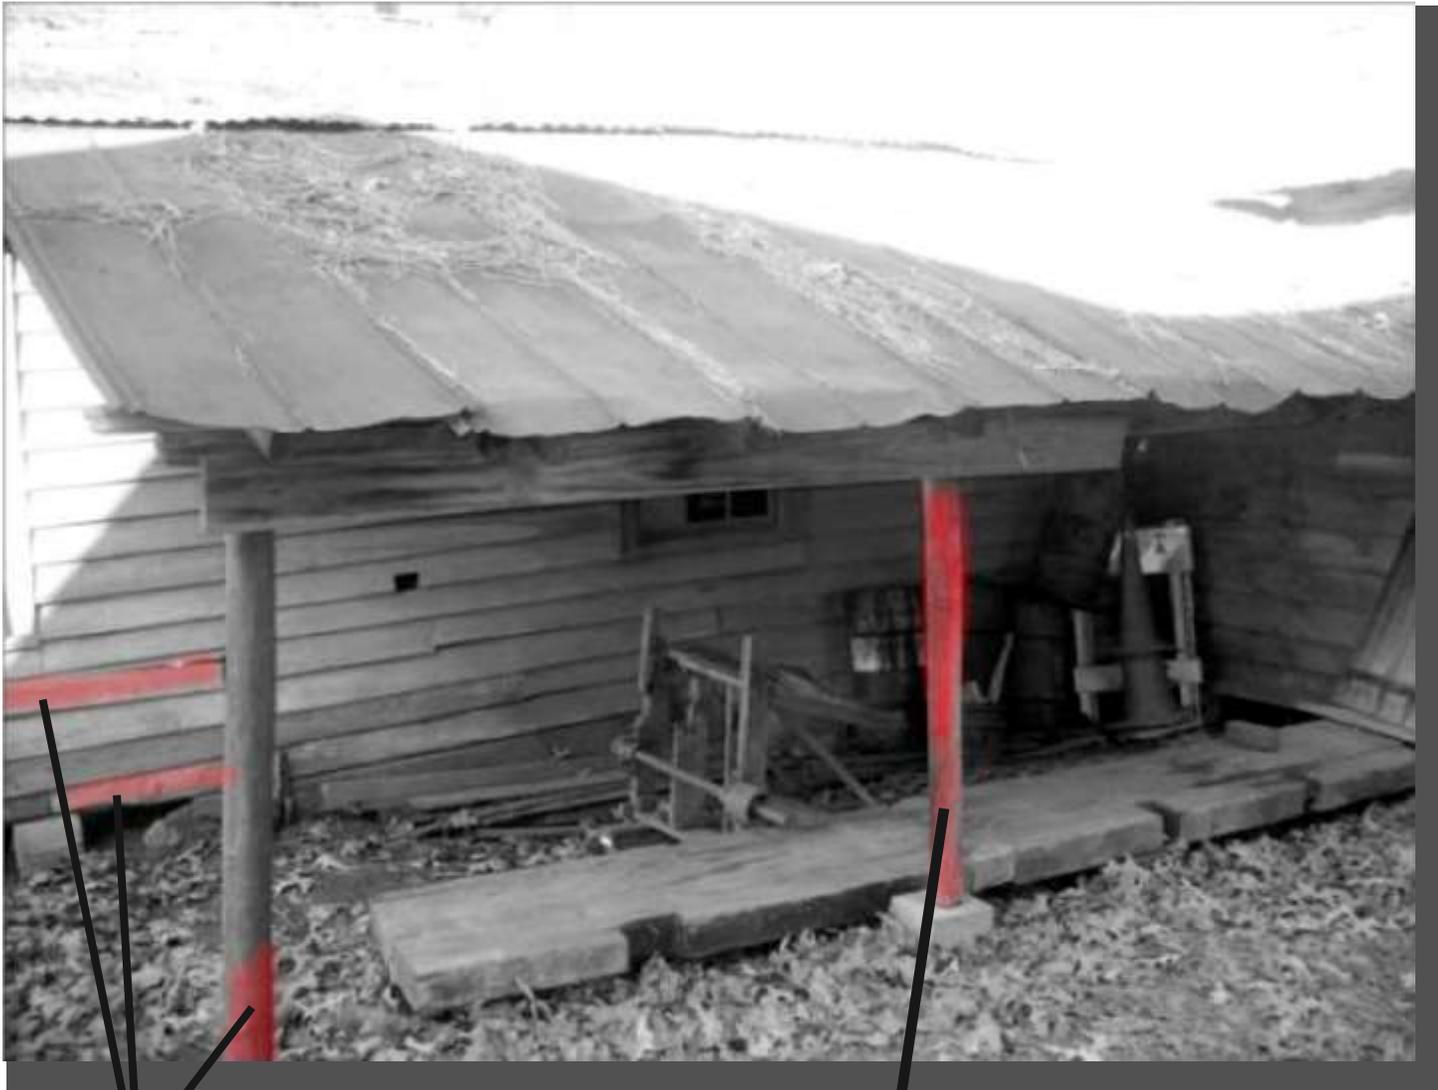
Figure B-9: Replace these weatherboards and post.

This post should also be replaced.

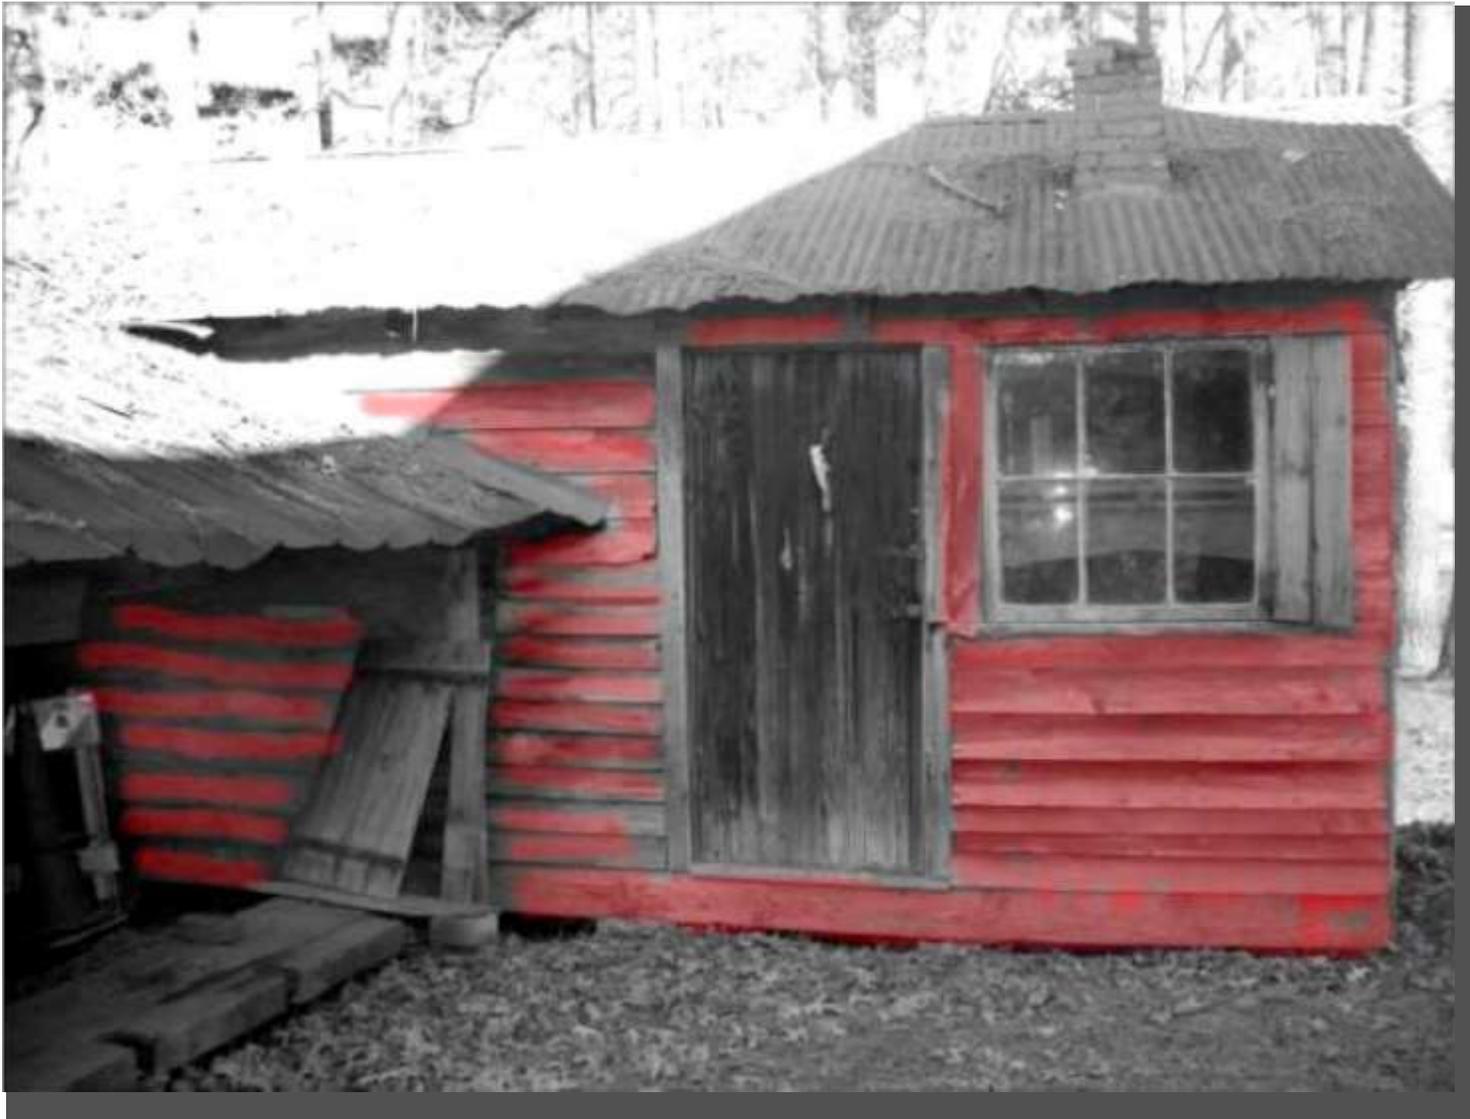
Figure B-10: All clappingboards on this facade should be replaced.

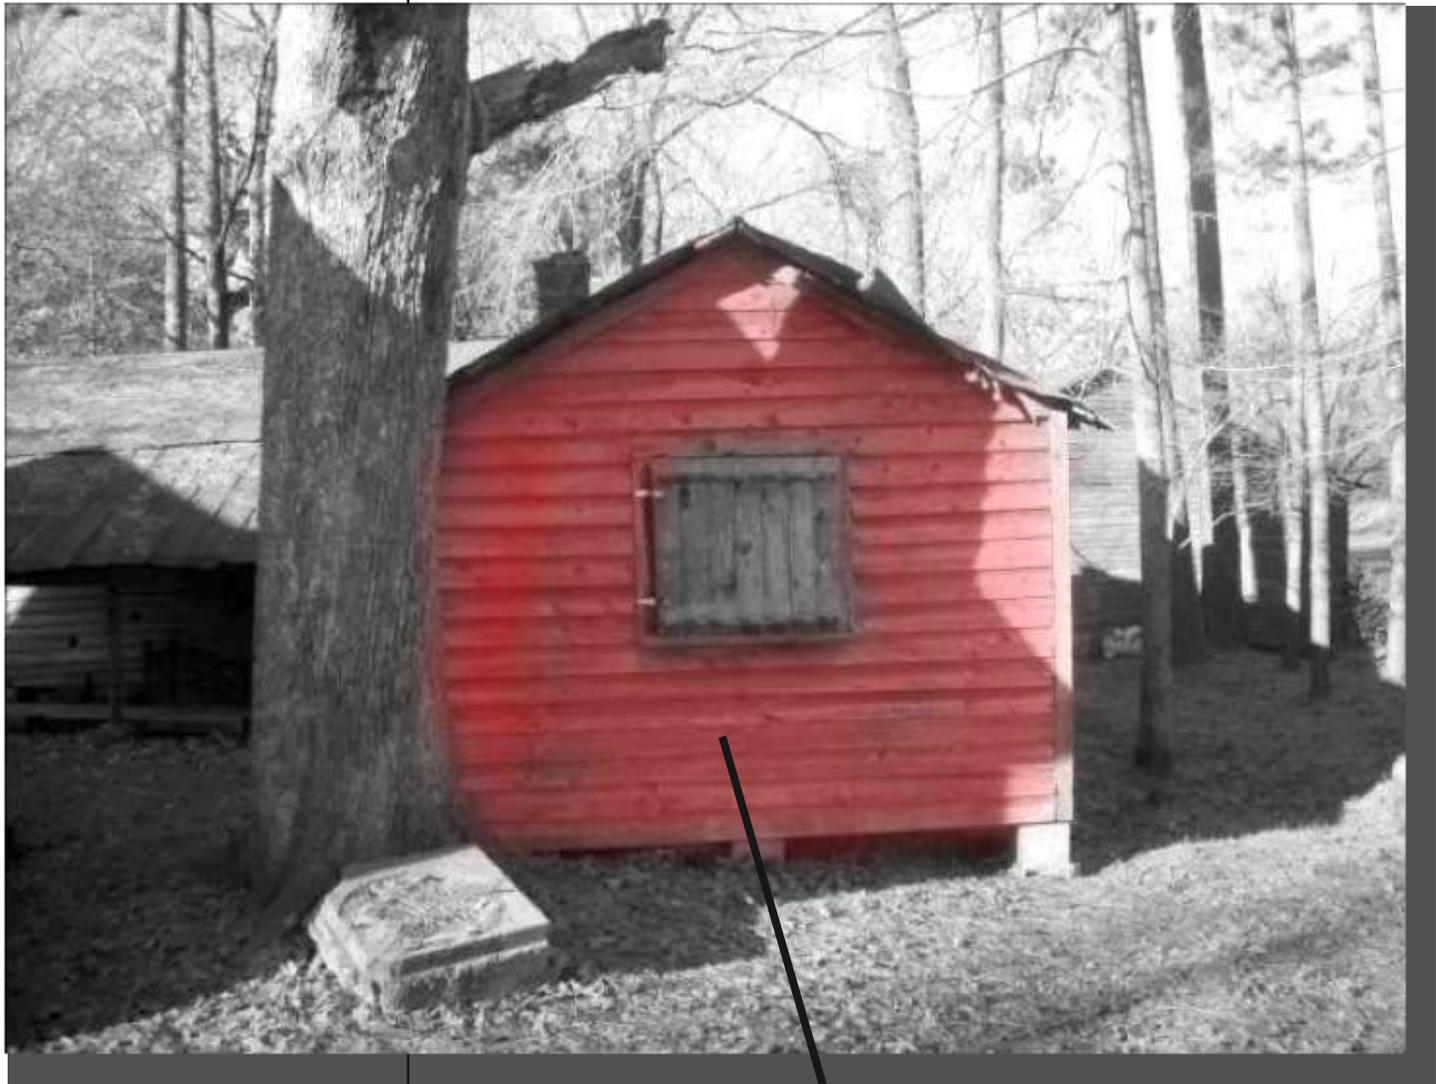
Figure B-11: All clapboards on this facade should be replaced.

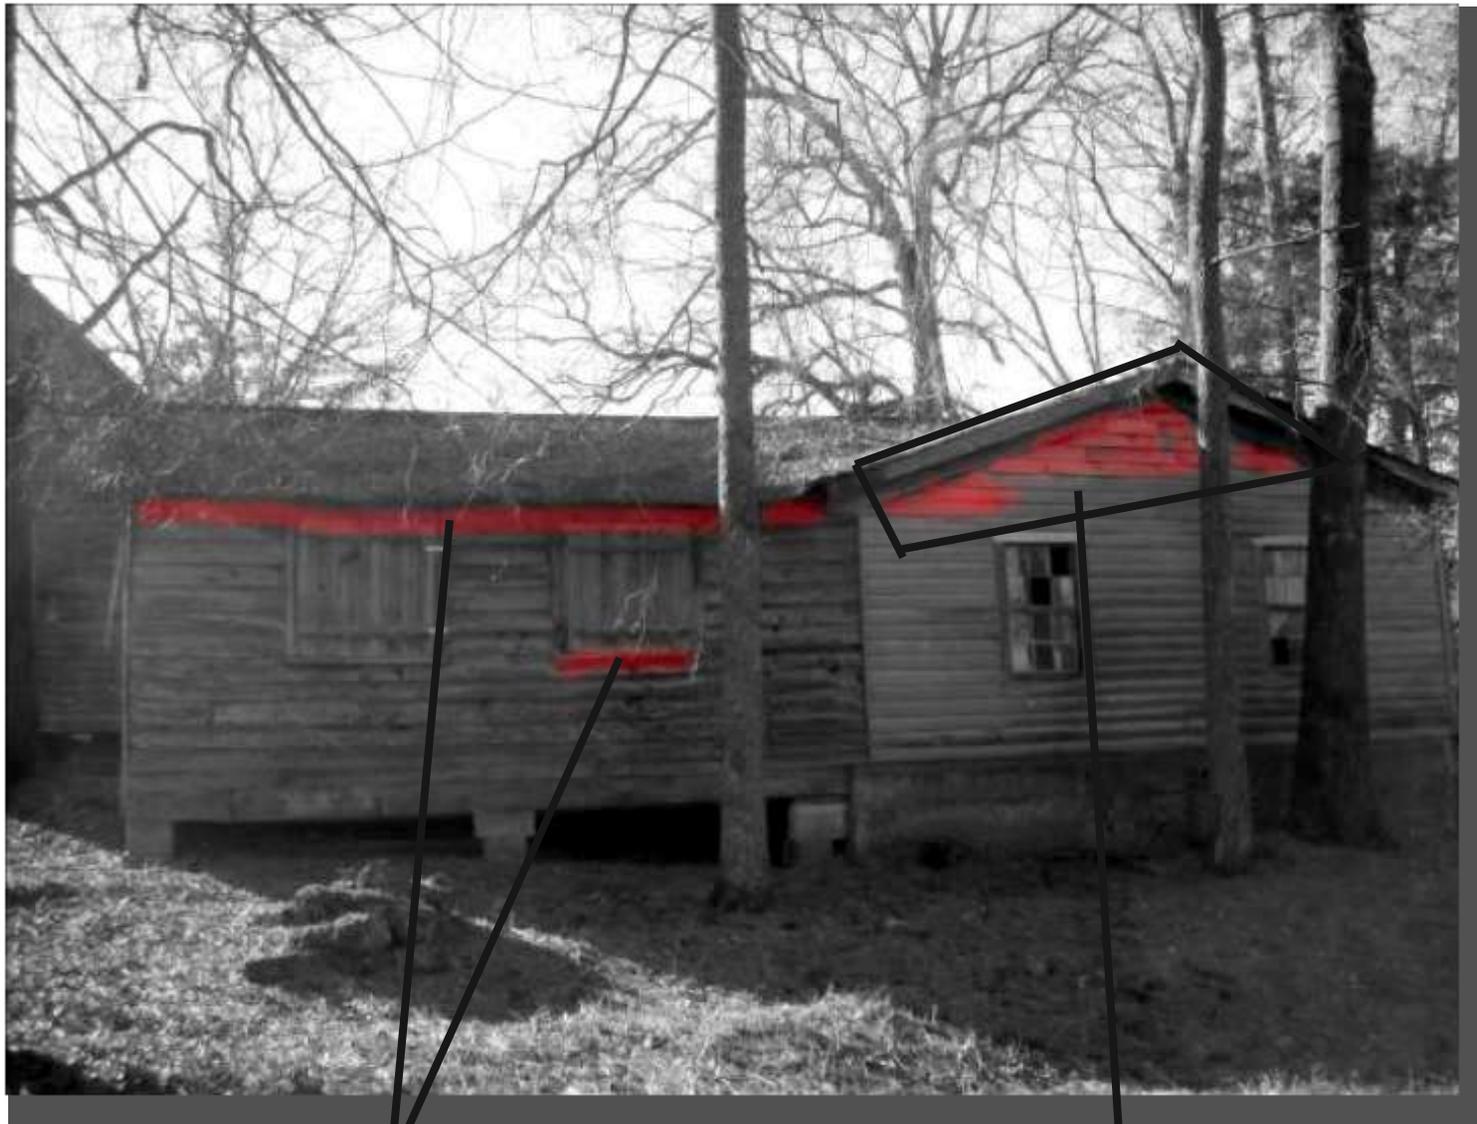
Figure B-12

Replace these two clapboards.

Clapboards within this area should be replaced.

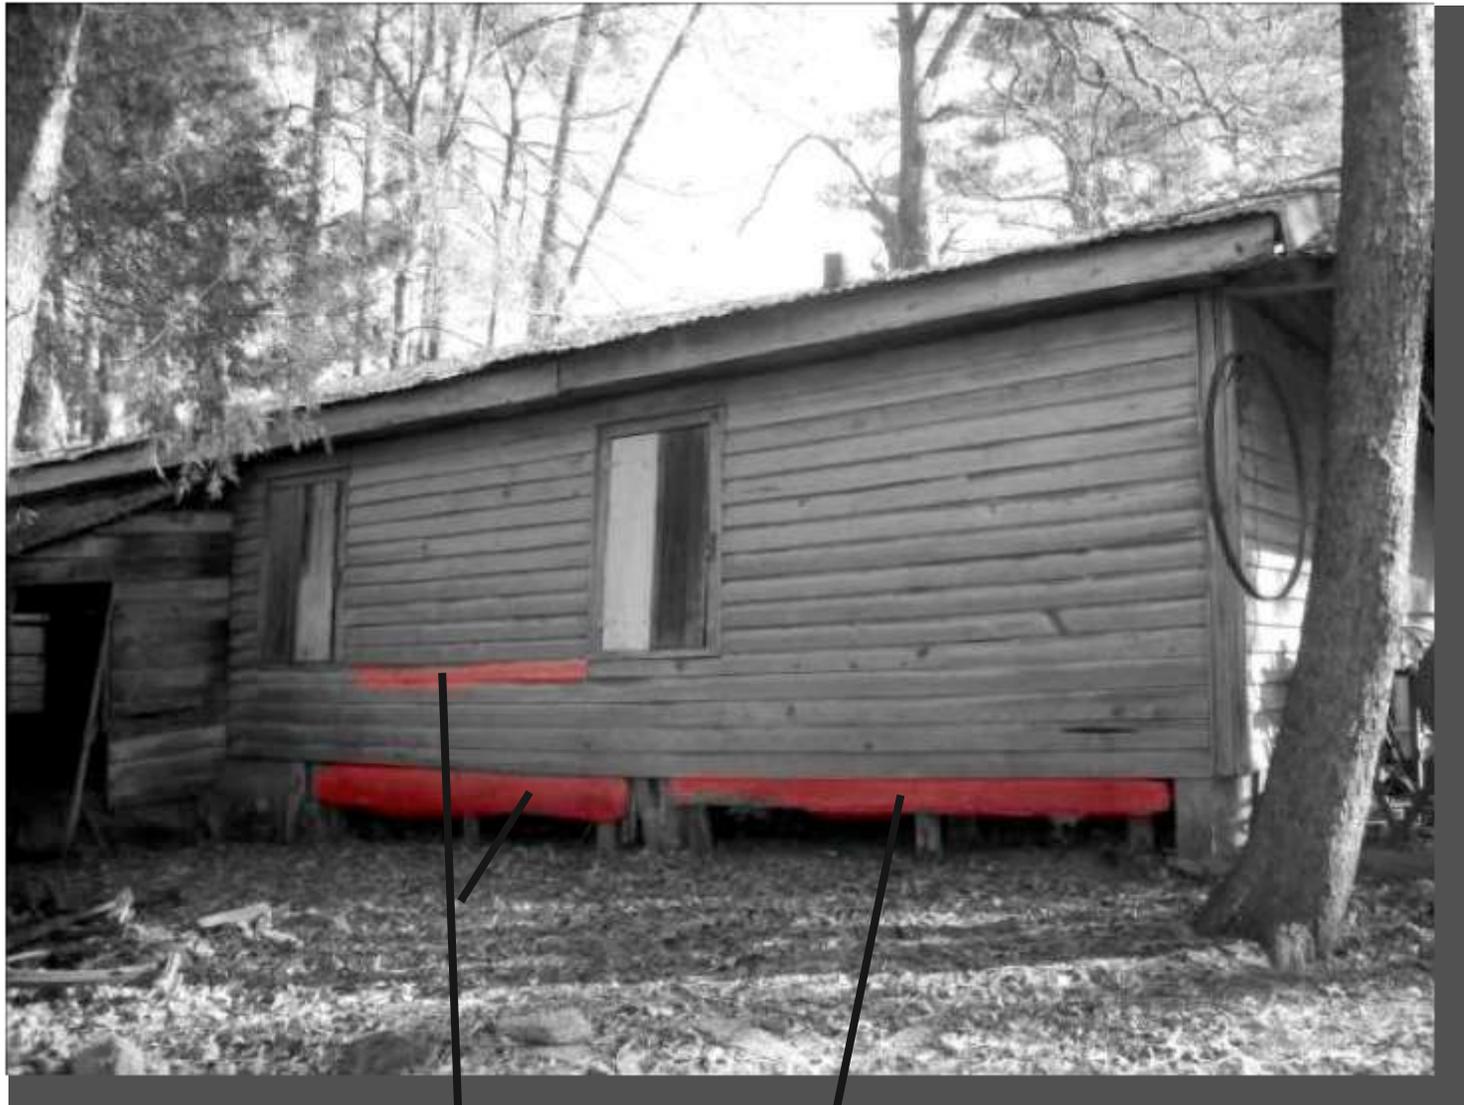
Figure B-13: Replace these clapboards.

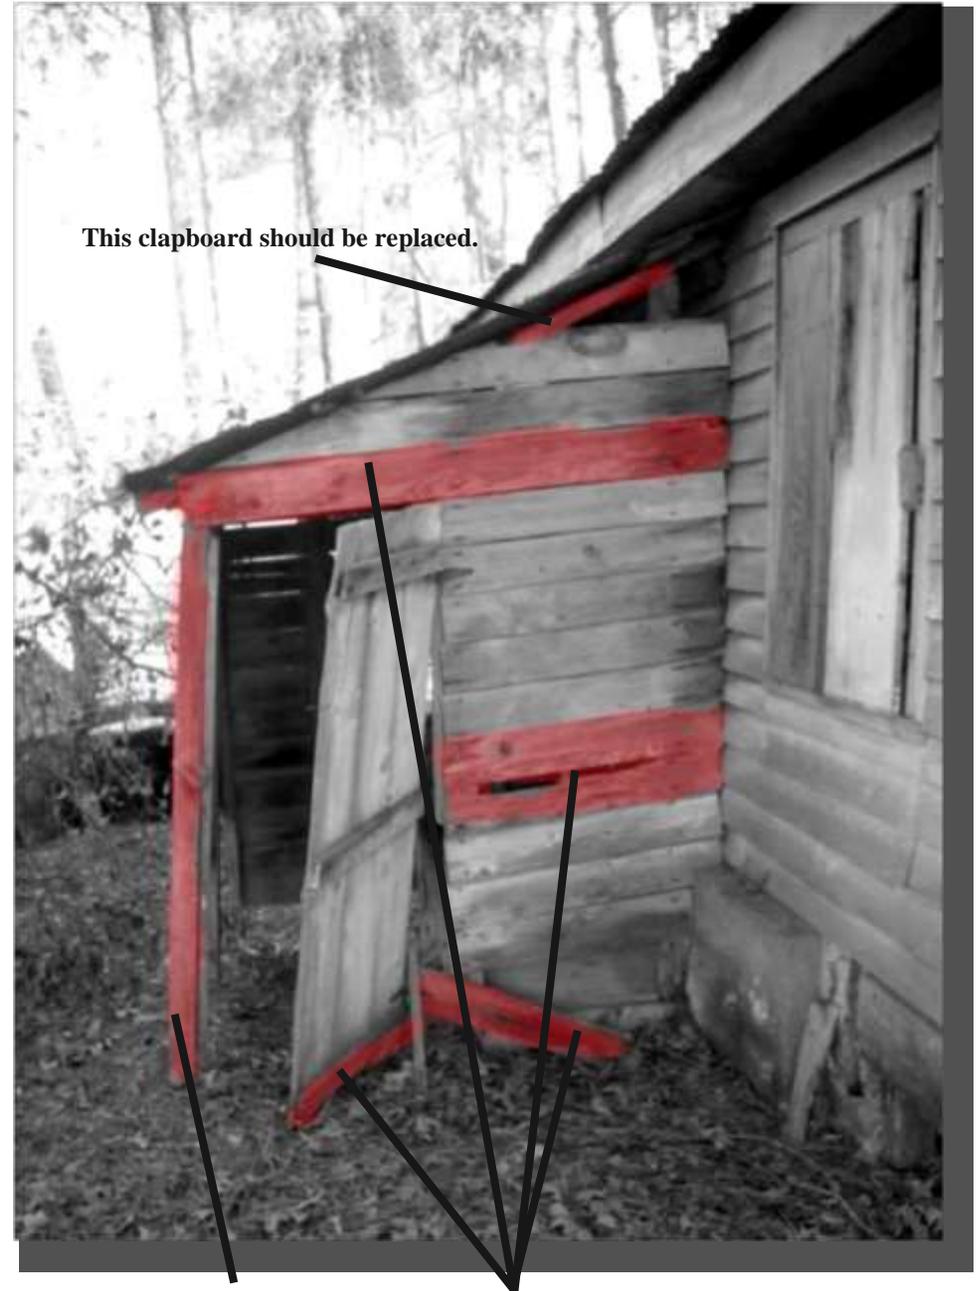
Figure B-14: All of these boards should be replaced.

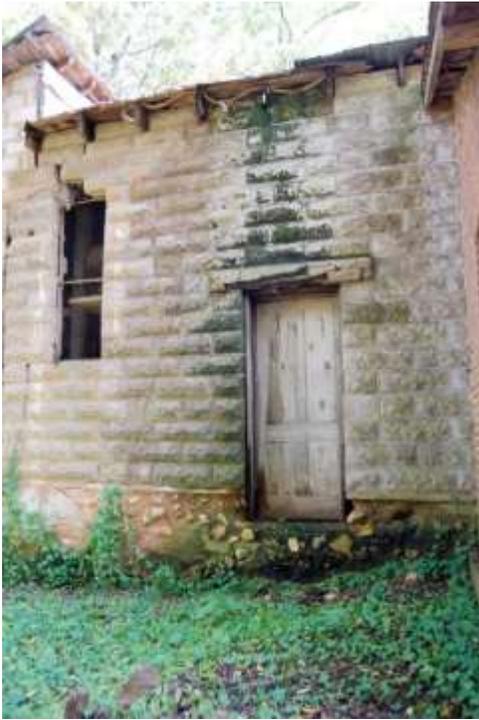
Figure C-3: Deterioration of foundation on the northern end of the western facade

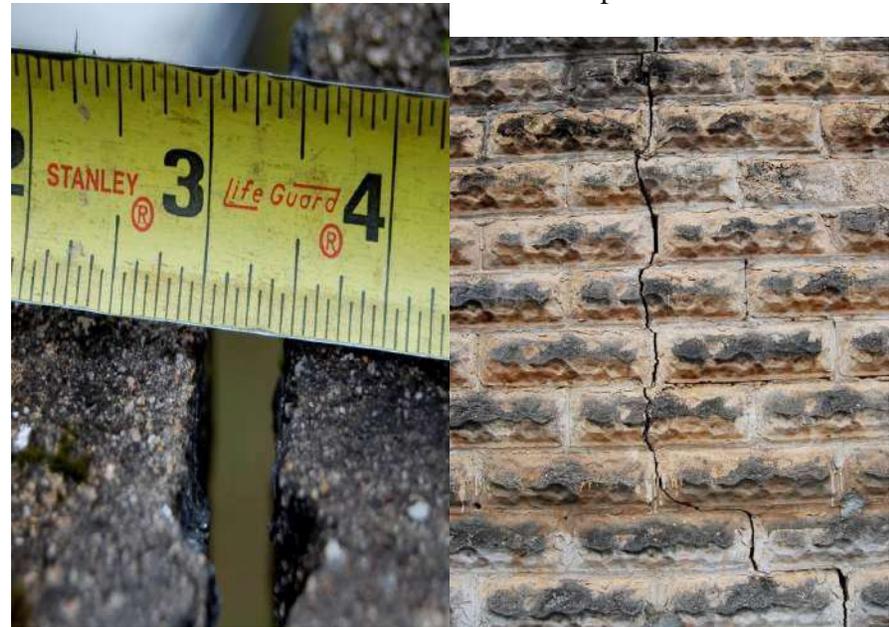
Figure C-5: The crack measures 1/2" at the parapet cap.

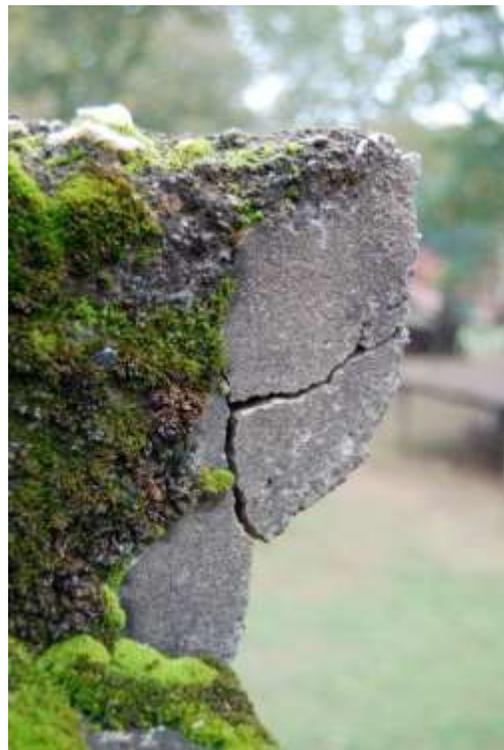
Figure C-8: Parapet cap with evidence of organic growth

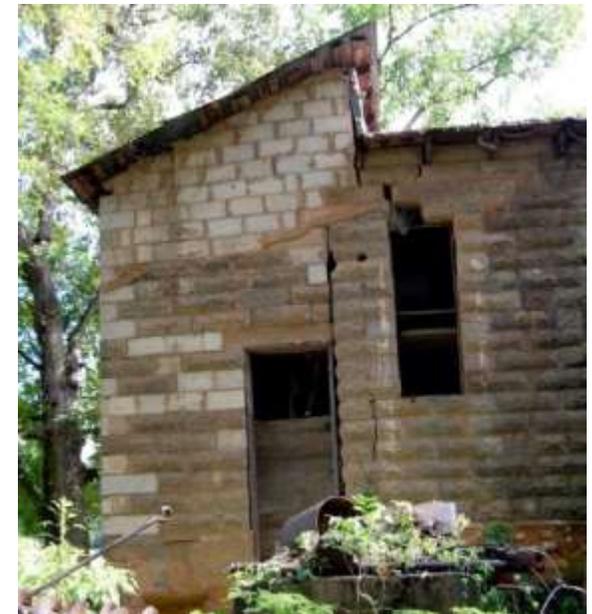
Figure C-10: Crack between the main structure and the north extension

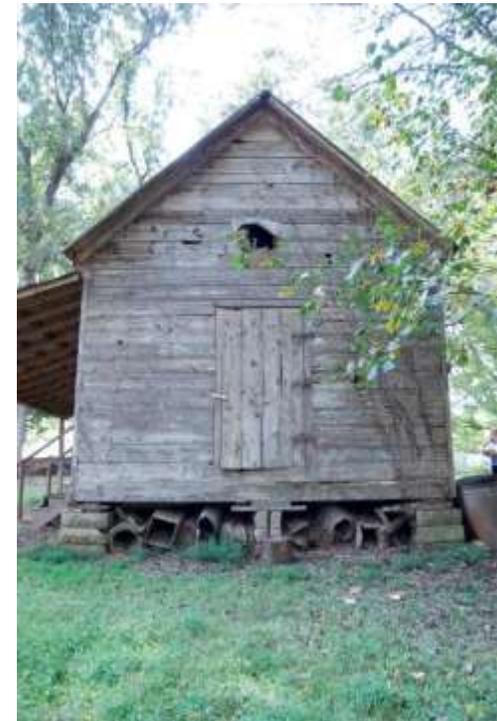
Figure D-2: North elevation of the Seed House; open foundation with items stored underneath and evidence of plant-growth on the right side

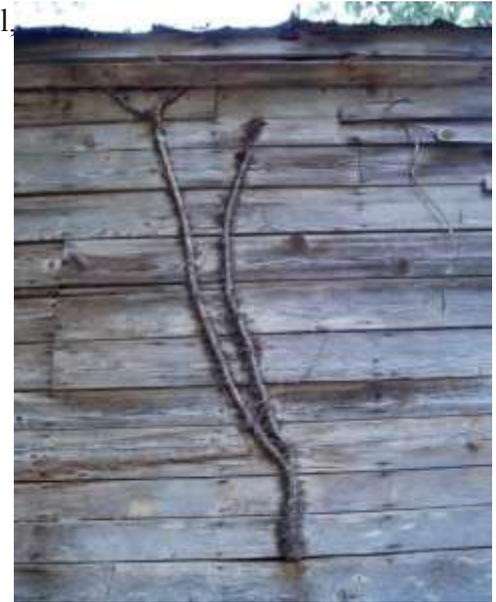
Figure D-4: Plant-growth on the west facade of the seed house

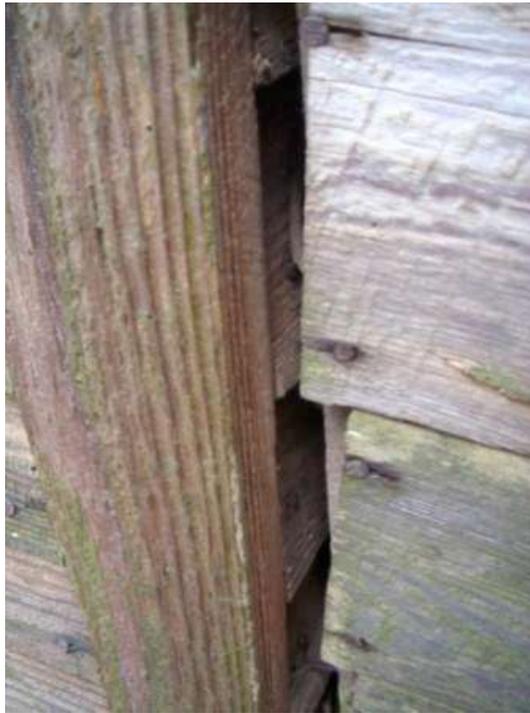
Figure F-18: Gap between storage closet and main structure

- The south elevation and the east elevation of the shed attachment needs to have the entire wall replaced, including the top plate, sill, and multiple studs, because of extensive rot, termite damage, and structural failure which has caused sagging in the door. The new wood should be the same kind as the original.
Replace sill and foundation on closet.
The closet is separating from the main structure because of settling of the foundation. To close the gap the foundation should be lifted.

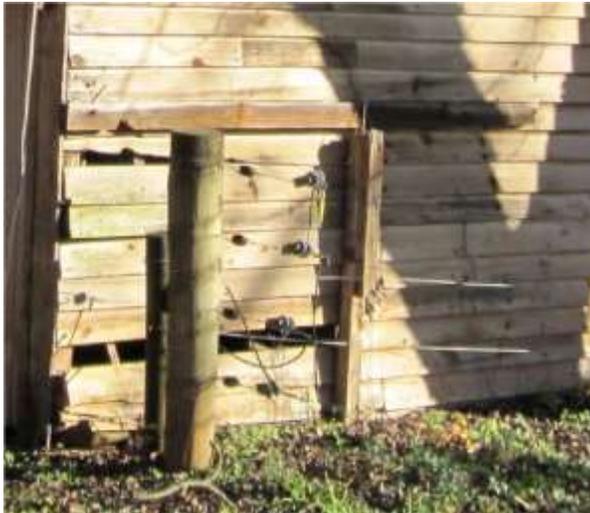
Figure G-13: Insect and water damage to the northwest corner post and first nine courses of siding.

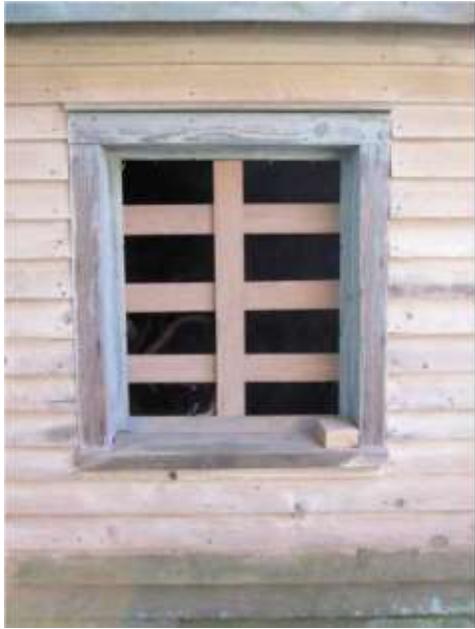
Figure G-17: Window with missing panes and muntins.

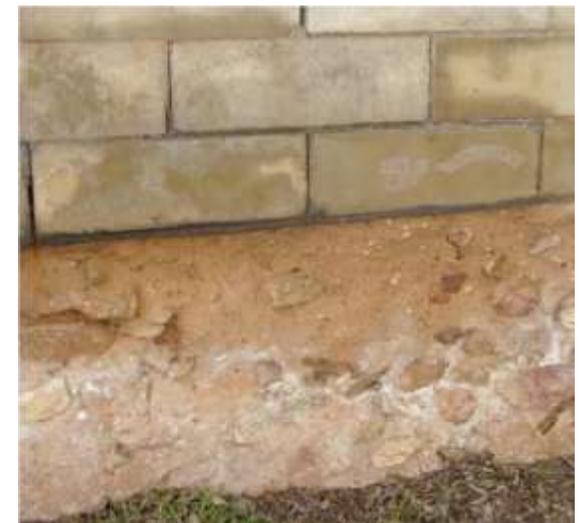
Figure H-11: Foundation aggregate

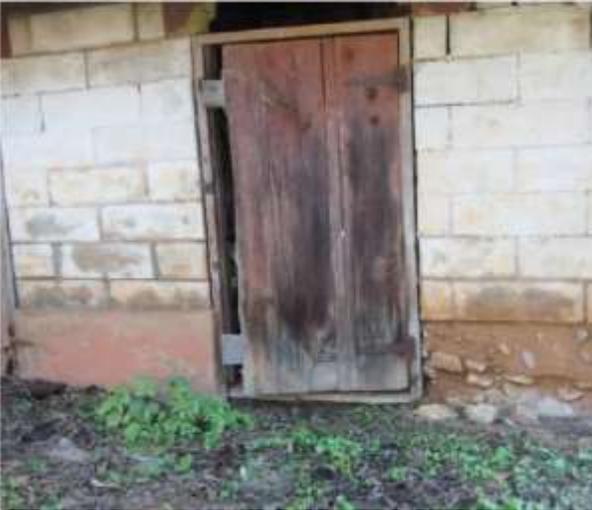
Figure H-12: Patched and unpatched foundation sections

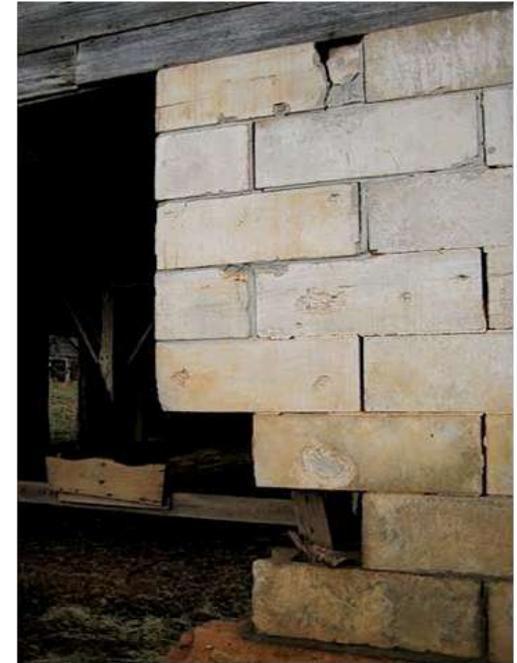
Figure H-14: Mechanical damage to masonry units

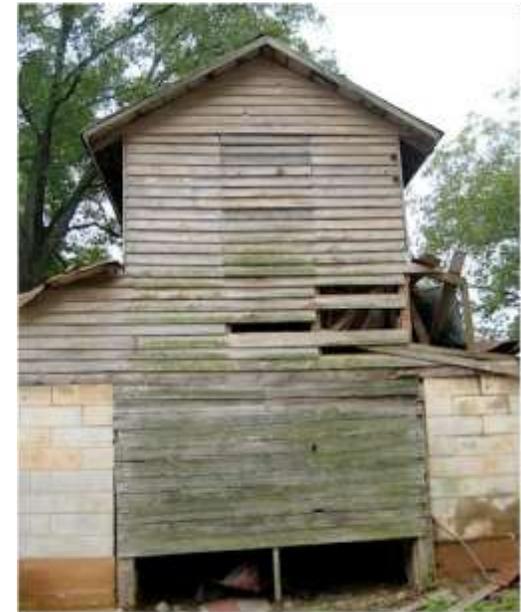
Figure H-22: Enclosed window opening

**Treatment Recommendations: In all cases, the lintels have failed from being over spanned. [?]Existing lintels should be reinforced with steel. The reinforcements should extend beyond the width of door opening, as previous lintel reinforcements did not.*

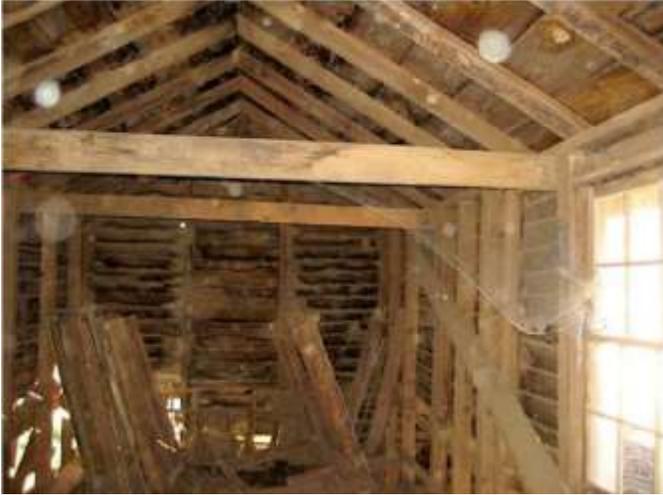
Figure H-25: Cross ties, staining in decking

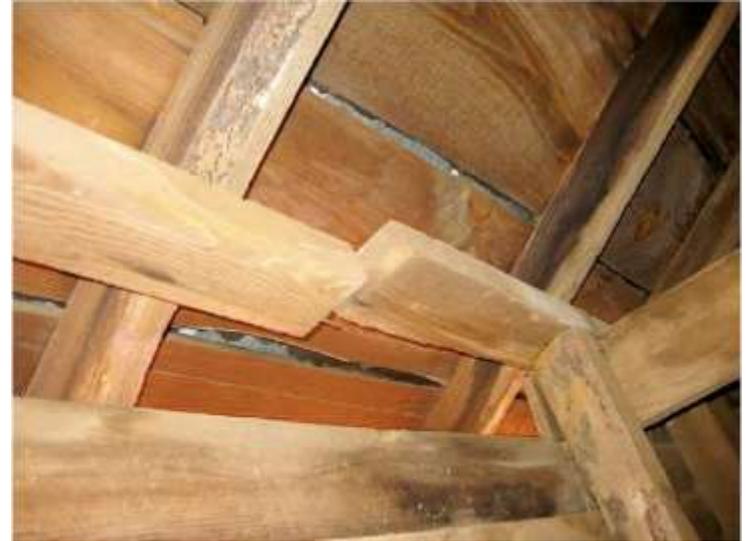
Figure H-27: Top plate failure

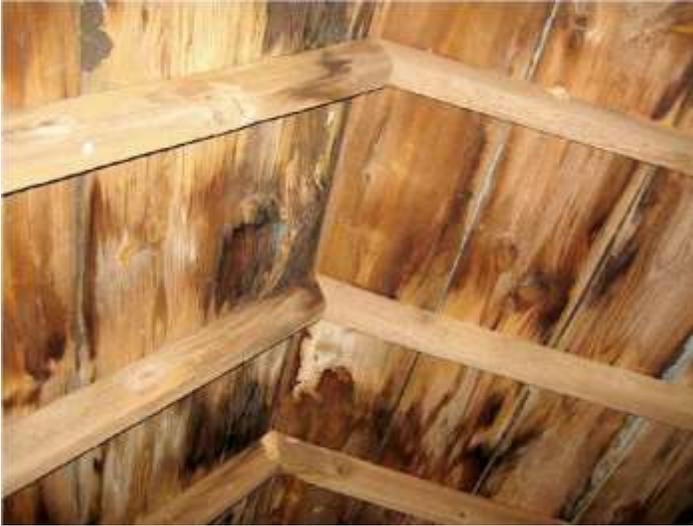
Figure H-26: Rafter connection and stained decking

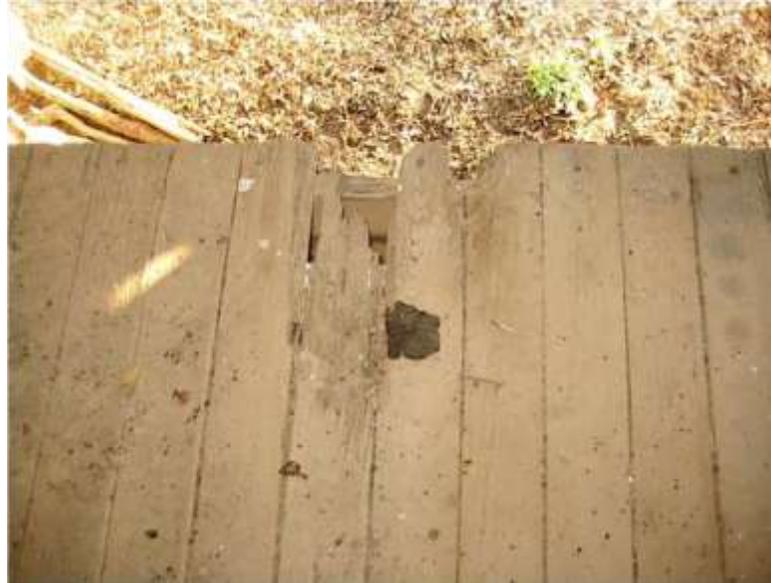
Figure H-28: Floor board deterioration on southern end

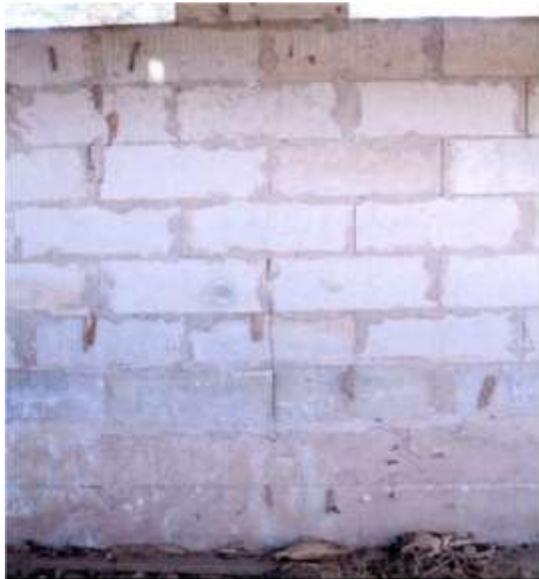
Figure I-6: Interior view of north elevation cracks

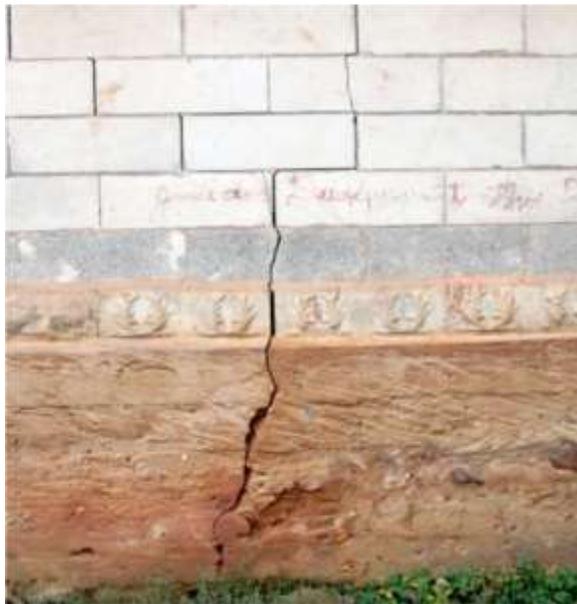
Figure I-9: Exterior view of South elevation cracks

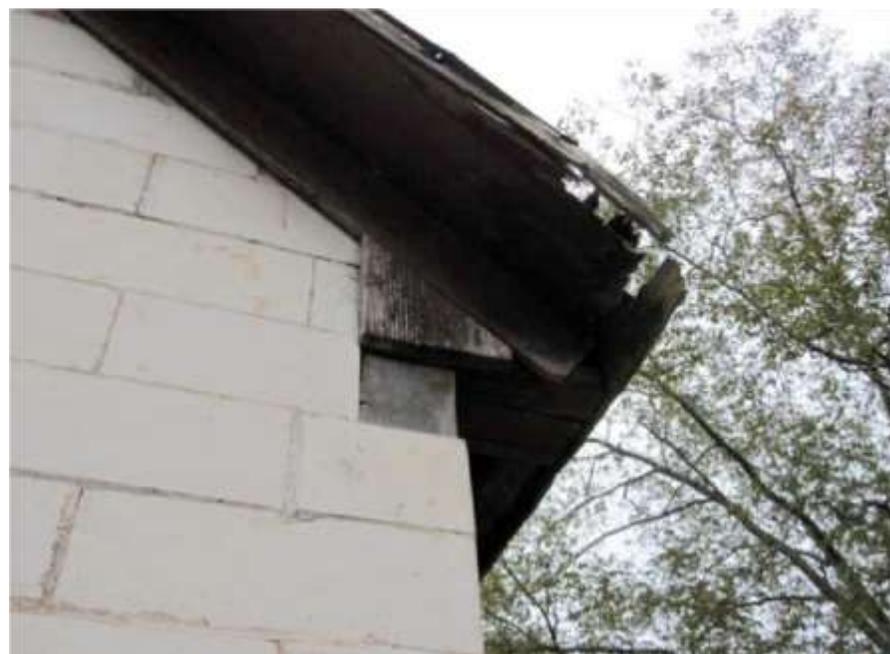
Figure I-18: Southwest corner of roof, missing

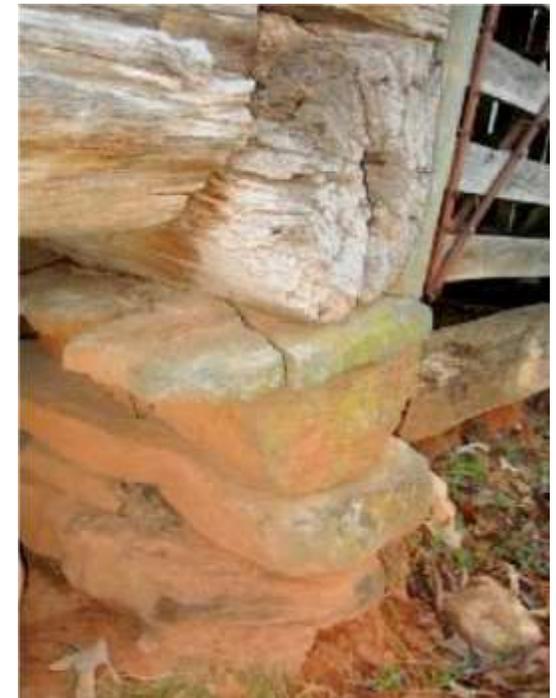
Figure J-12: End of sill resting on foundation pier on northeast corner

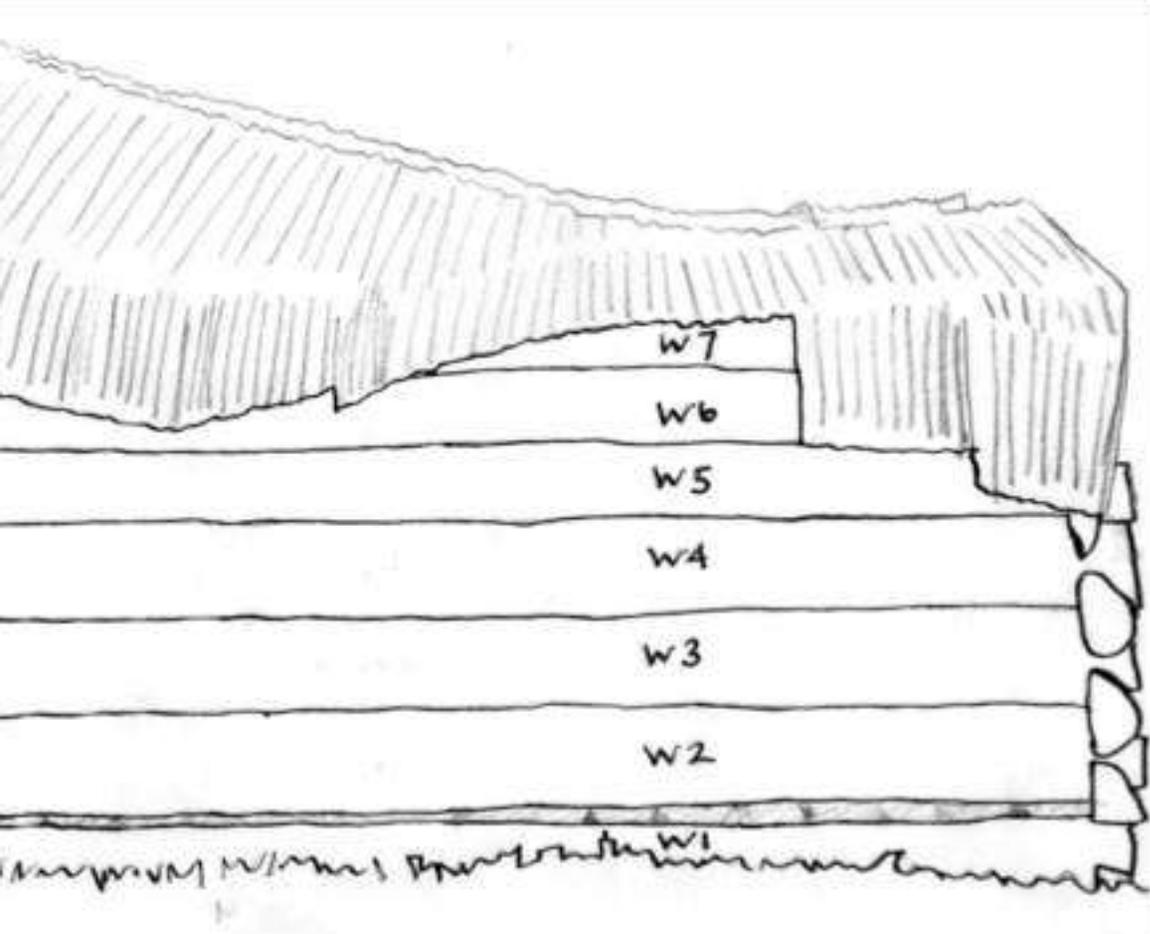
Figure J-17: Rafter conditions of the log crib

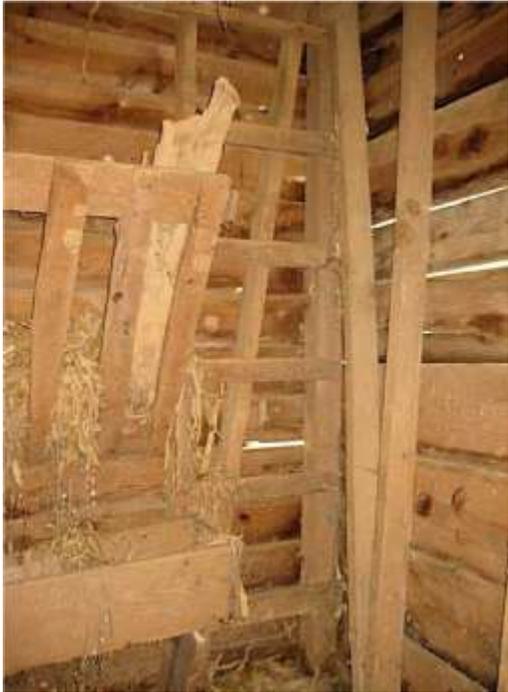
Figure L-2: Ladder leading to the loft

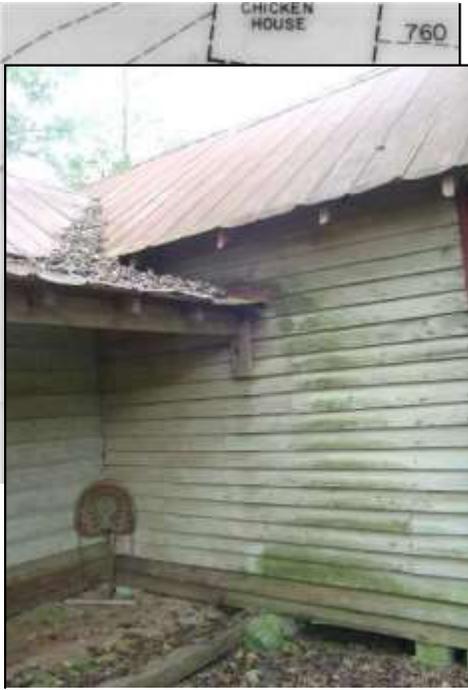
Figure O-6: Water damage from the flow of water off the shed roof of the addition can be clearly seen on the western facade of the original structure

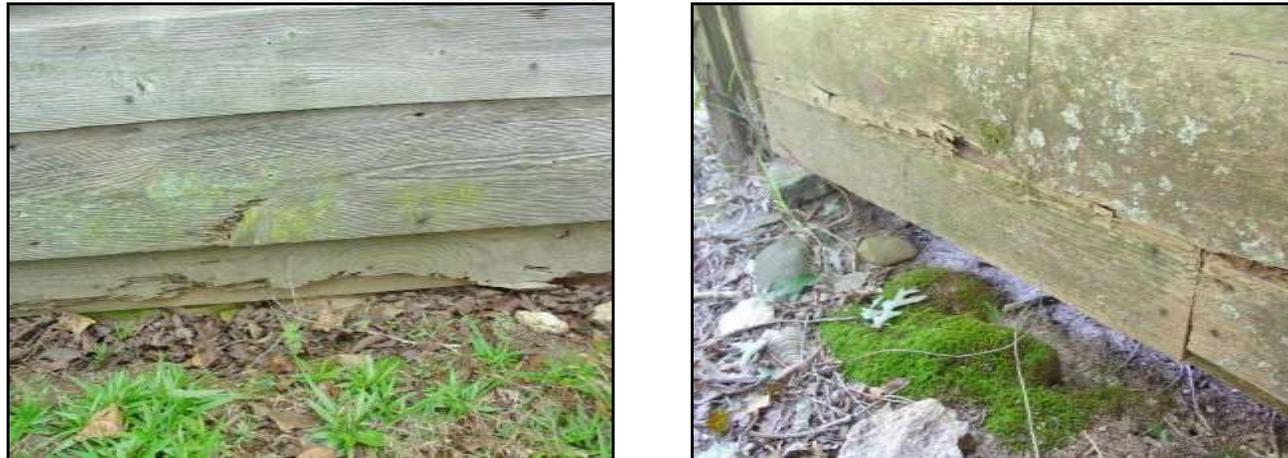
Figure O-7: Examples of the deterioration of the lower portion of the addition on the house due to grade, built up organic matter and other moisture issues; there is a significant amount of rot on the lower boards all the way around the structure

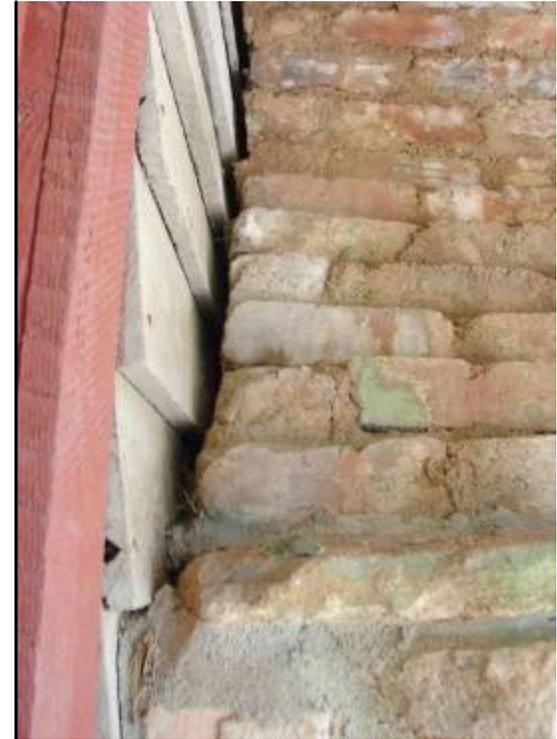
Figure O-10: The gap between the chimney and the house, which is contributing to moisture issues
