Historic Resources Survey Report

Bacon County, Georgia

June 2016

The University of Georgia
College of Environment and Design
Center for Community Design & Preservation
Historic Resources Survey Report
Bacon County, Georgia 2016

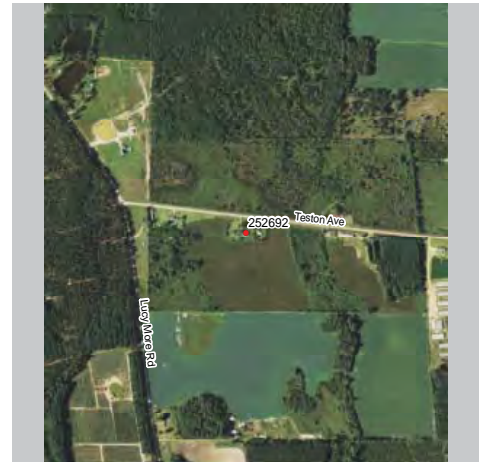
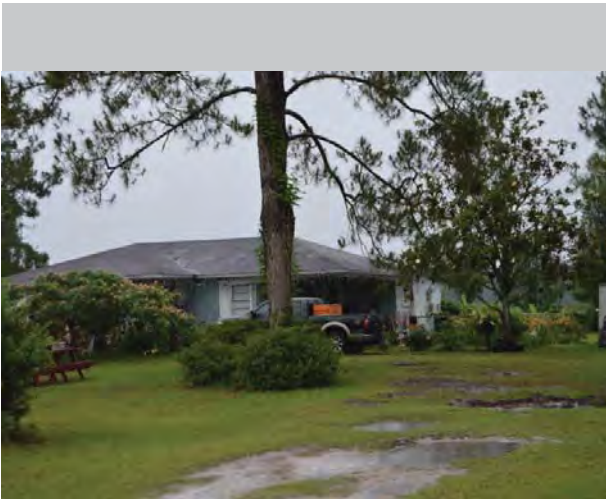
Field ID: BC-1
GNAHRGIS ID: 252692
County: Bacon
Preliminary NR Assessment: Does Not Meet

- Resource Type** Building
- Resource Use** Residential: Single Family Dwelling
- Date of Construction** c.1960
- Building Type** Ranch
- Structural System** Balloon Frame
- Style** No Academic Style
- Roof** Hip
- Exterior Cladding** Wood: Weatherboard
Masonite Siding
- Foundation** Unknown
- Porch** Portico
- Windows** Double Hung Sash: 2/2
- Chimney** No chimney observed
- Additional Notes** -linear ranch
-4 window bays across
-scrolled metal porch support

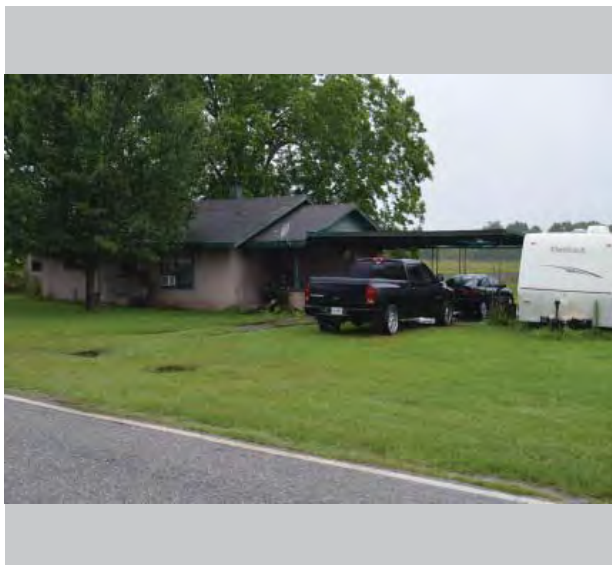
Coordinates: 31.48771, -82.58580

- Resource Type** Building
- Resource Use** Residential: Single Family Dwelling
- Date of Construction** c.1960
- Building Type** Ranch
- Structural System** Balloon Frame
- Style** No Academic Style
- Roof** Gable: Side
- Exterior Cladding** Concrete: Concrete Block
- Foundation** Unknown
- Porch** Verandah, Stoop
- Windows** Double Hung Sash: 6/6 rectangular
- Chimney** Off-ctr in roof surface
Material: brick
- Additional Notes** -original brick porch piers
-double metal carport added
-sloped plywood addition

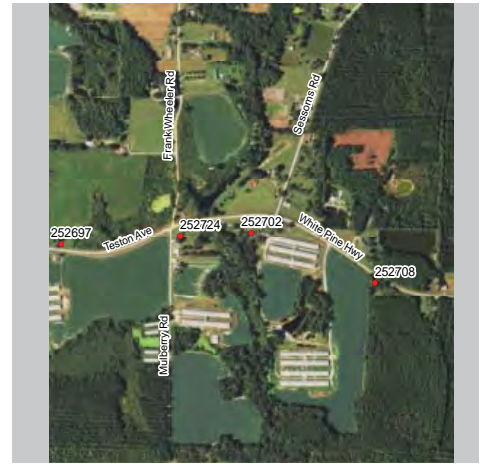
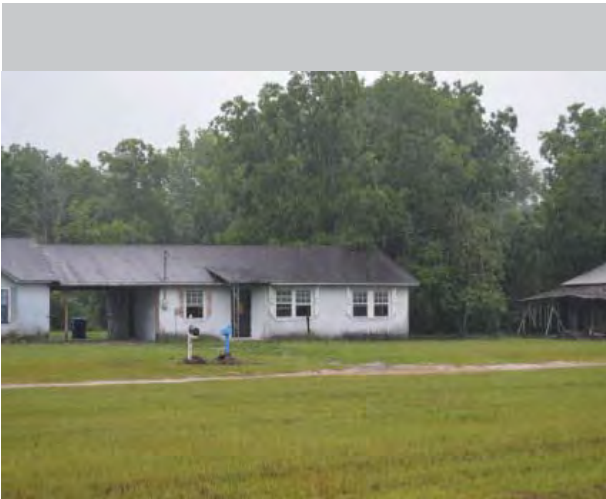
Field ID: BC-03
GNAHRGIS ID: 252702
County: Bacon
Preliminary NR Assessment: Does Not Meet

- Resource Type** Building
- Resource Use** Residential: Single Family Dwelling
- Date of Construction** c.1950
- Building Type** Side Gable Cottage
- Structural System** Balloon Frame
- Style** No Academic Style
- Roof** Gable: Side
- Exterior Cladding** Brick: Common
- Foundation** Unknown
- Porch** Stoop
- Windows** Double Hung Sash: 6/6 rectangular
- Chimney** No chimney observed
- Additional Notes** -original American small house; multiple additions
-2 houses connected with walk; separate ranch

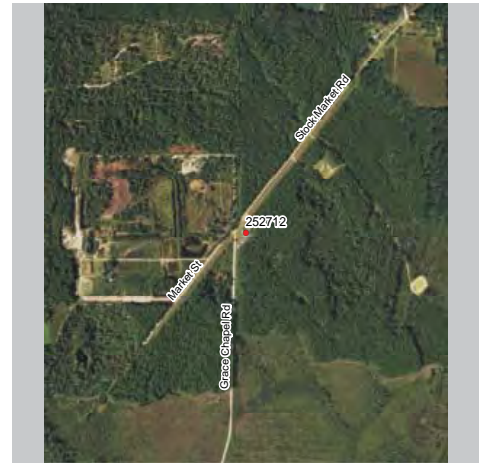
Field ID: BC-05
GNAHRGIS ID: 252712
County: Bacon
Preliminary NR Assessment: Does Not Meet

- Resource Type** Building
- Resource Use** Religious: Church
- Date of Construction** c.1960
- Building Type** Front Gable Church
- Structural System** Balloon Frame
- Style** No Academic Style
- Roof** Gable: Cross
- Exterior Cladding** Concrete: Concrete Block
- Foundation** Concrete: Poured
- Porch** Recessed
- Windows** Double Hung Sash: 6/6 rectangular
- Chimney** No chimney observed
- Additional Notes**
 - 3 level spire
 - rounded arch entry
 - double entry door
 - two rear additions

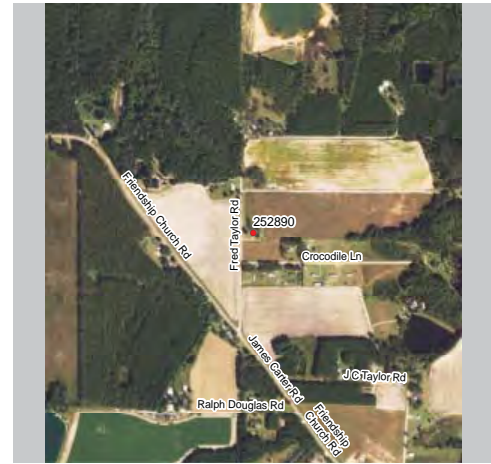
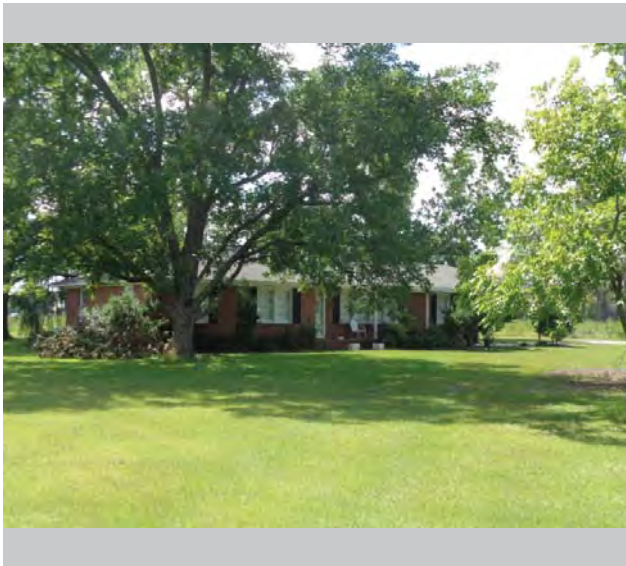
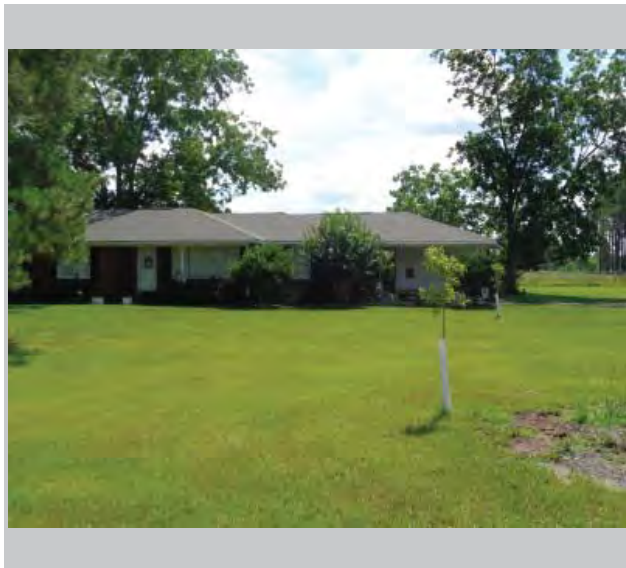
Field ID: BC-6
GNAHRGIS ID: 252890
County: Bacon
Preliminary NR Assessment: May Meet

Foundation Brick:Continuous

Chimney No chimney observed

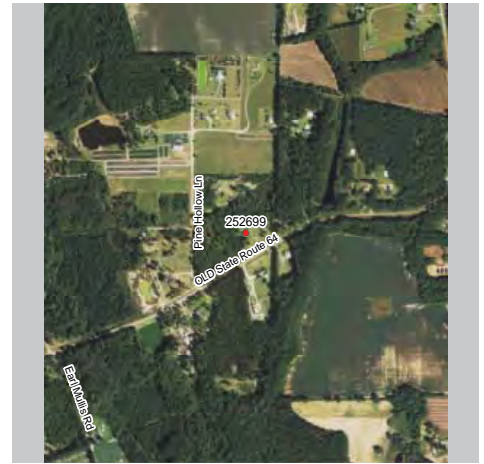
Field ID: BC-07
GNAHRGIS ID: 252699
County: Bacon
Preliminary NR Assessment: May Meet

- Resource Type** Building
- Resource Use** Residential: Single Family Dwelling
- Date of Construction** c.1970
- Building Type** Ranch
- Structural System** Balloon Frame
- Style** No Academic Style
- Roof** Gable: Side, Front
- Exterior Cladding** Brick: Common
- Foundation** Unknown
- Porch** Portico
- Windows** Double Hung Sash: 2/2 rectangular
- Chimney** No chimney observed
- Additional Notes**
 - 3 light mid-century door
 - paired double hung sash windows
 - large Chicago window

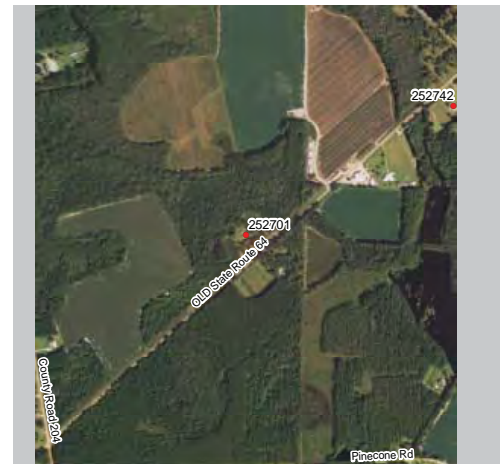
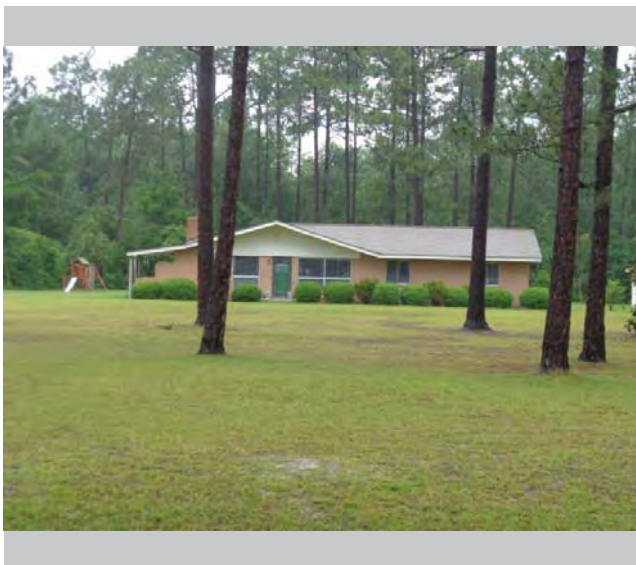
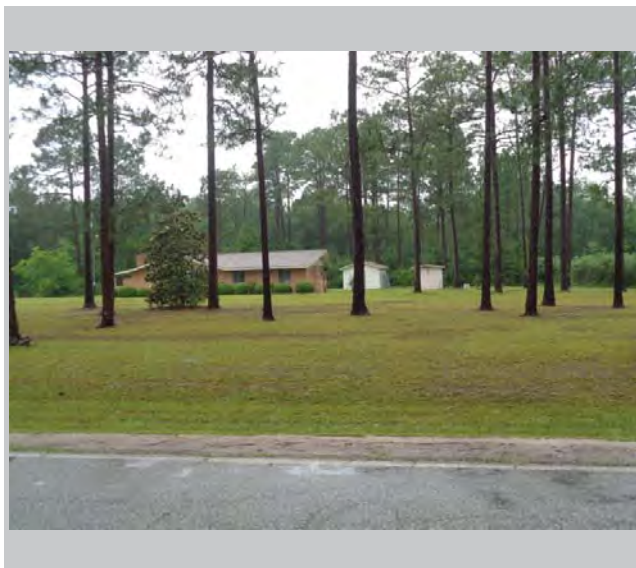
Field ID: BC-08
GNAHRGIS ID: 252701
County: Bacon
Preliminary NR Assessment: May Meet

Foundation Unknown

Chimney No chimney observed

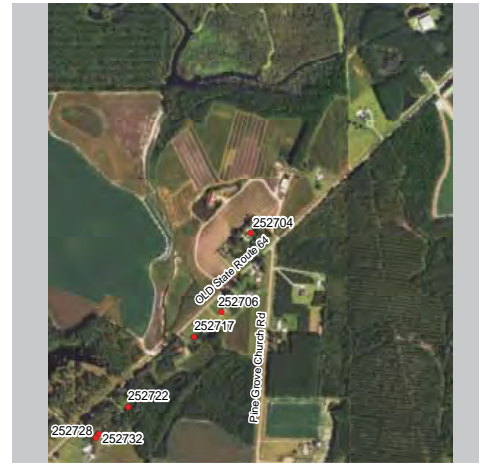
Field ID: BC-09
GNAHRGIS ID: 252704
County: Bacon
Preliminary NR Assessment: Does Not Meet

- Resource Type** Building
- Resource Use** Residential: Single Family Dwelling
- Date of Construction** c.1970
- Building Type** Ranch
- Structural System** Balloon Frame
- Style** No Academic Style
- Roof** Gable: Side, Front
- Exterior Cladding** Brick: Common, Prism
Synthetics: Vinyl Siding
- Foundation** Unknown
- Porch** Stoop
- Windows** Top Transom Windows
- Chimney** No chimney observed
- Additional Notes** -large overhanging eaves
-double entry door
-exposed mid-century rafters

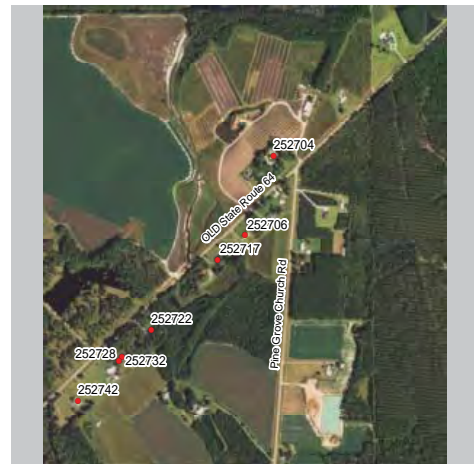
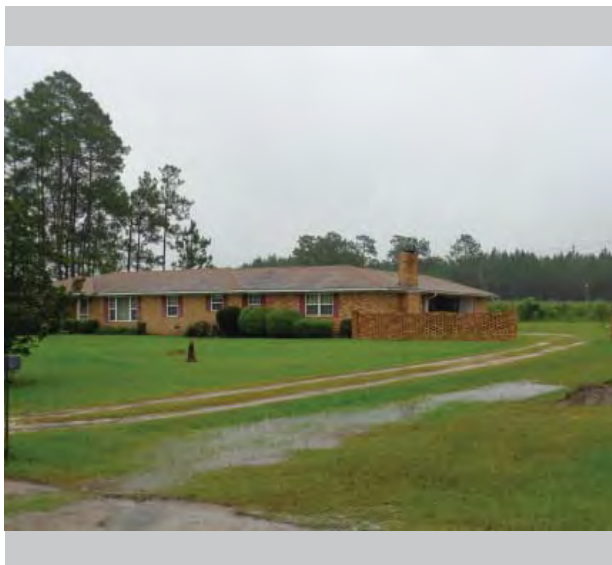
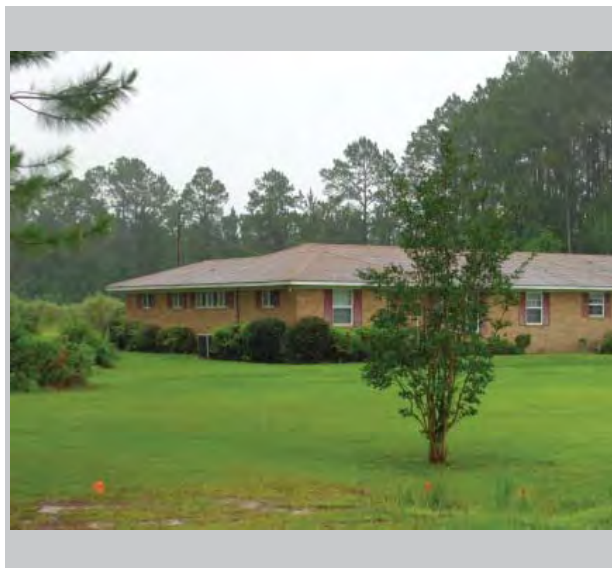
Field ID: BC-10
GNAHRGIS ID: 252706
County: Bacon
Preliminary NR Assessment: May Meet

Foundation Unknown

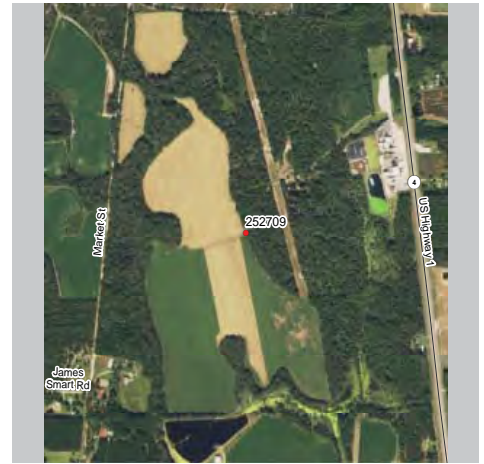
Field ID: BC-11
GNAHRGIS ID: 252709
County: Bacon
Preliminary NR Assessment: May Meet

- Resource Type** Building
- Resource Use** Residential: Single Family Dwelling
- Date of Construction** c.1970
- Building Type** Ranch
- Structural System** Balloon Frame
- Style** No Academic Style
- Roof** Gable: Side
- Exterior Cladding** Brick: Common
- Foundation** Unknown
- Porch** Recessed
- Windows** Double Hung Sash: 6/6 rectangular
- Chimney** Off-ctr in roof surface
Material: Brick
- Additional Notes**
 - polychromatic brick
 - large Chicago window
 - vinyl in side gables
 - brick steps to porch

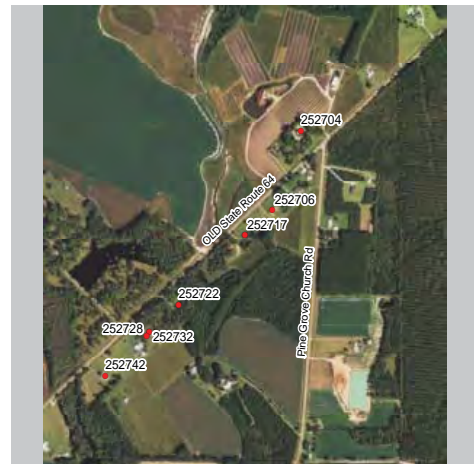
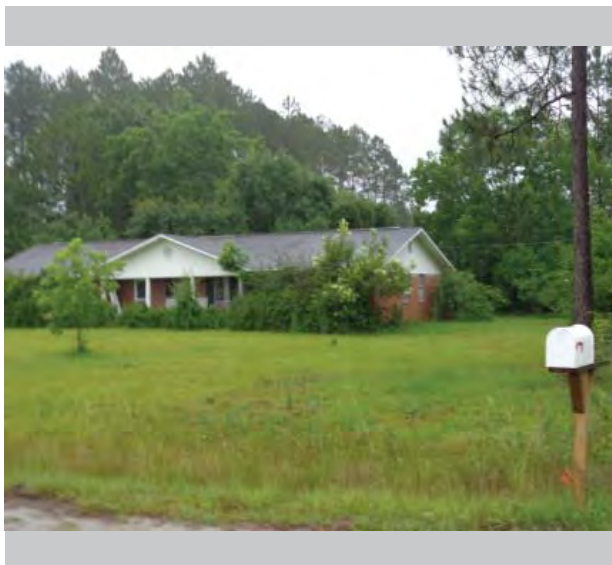
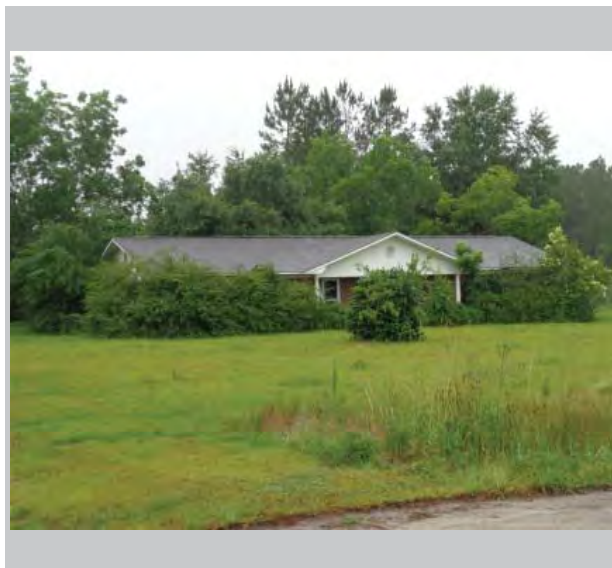
Field ID: BC-12
GNAHRGIS ID: 252717
County: Bacon
Preliminary NR Assessment: May Meet

Foundation Unknown

Chimney No chimney observed

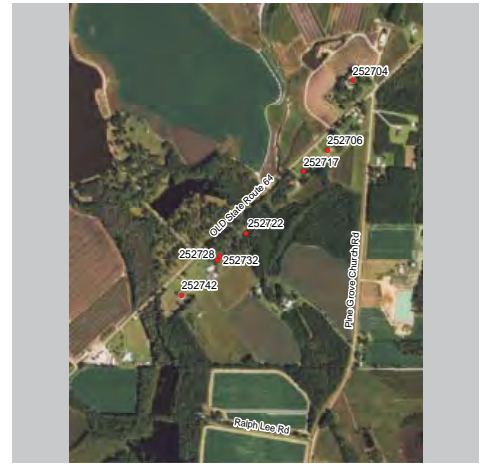
Field ID: BC-13
GNAHRGIS ID: 252722
County: Bacon
Preliminary NR Assessment: May Meet

- Resource Type** Building
- Resource Use** Residential: Single Family Dwelling
- Date of Construction** c.1980
- Building Type** Ranch
- Structural System** Balloon Frame
- Style** No Academic Style
- Roof** Gable: Side
- Exterior Cladding** Brick: Common
- Foundation** Unknown
- Porch** Recessed
- Windows** Double Hung Sash: 6/6 rectangular
- Chimney** No chimney observed
- Additional Notes** -white painted brick
-integrated carport
-tripartite 6/6 window
-octangular vent in gable

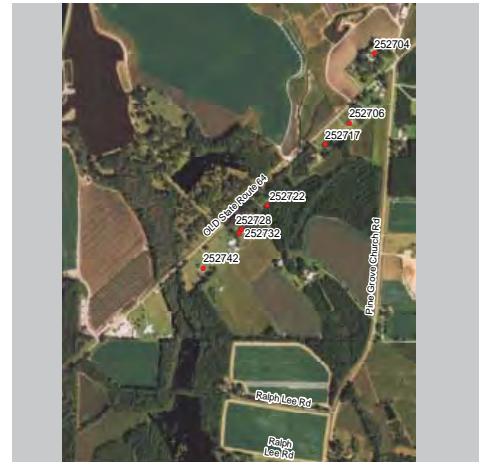
Field ID: BC-15
GNAHRGIS ID: 252732
County: Bacon
Preliminary NR Assessment: May Meet

- Resource Type** Building
- Resource Use** Residential: Single Family Dwelling
- Date of Construction** c.1980
- Building Type** Ranch
- Structural System** Balloon Frame
- Style** No Academic Style
- Roof** Gable: Side
- Exterior Cladding** Brick: Veneer, Prism
Synthetics: Vinyl Siding
- Foundation** Unknown
- Porch** Verandah
- Windows** Double Hung Sash: 6/6 rectangular
- Chimney** No chimney observed
- Additional Notes** -linear with center cluster
-4 turned porch supports
-polychromatic brick
-paired windows

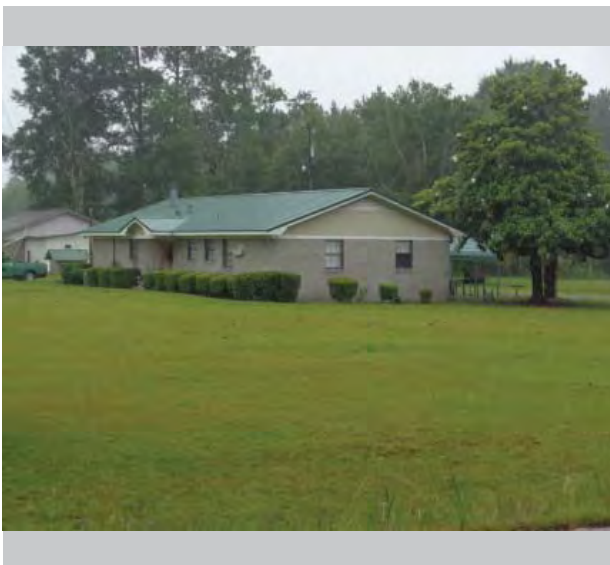
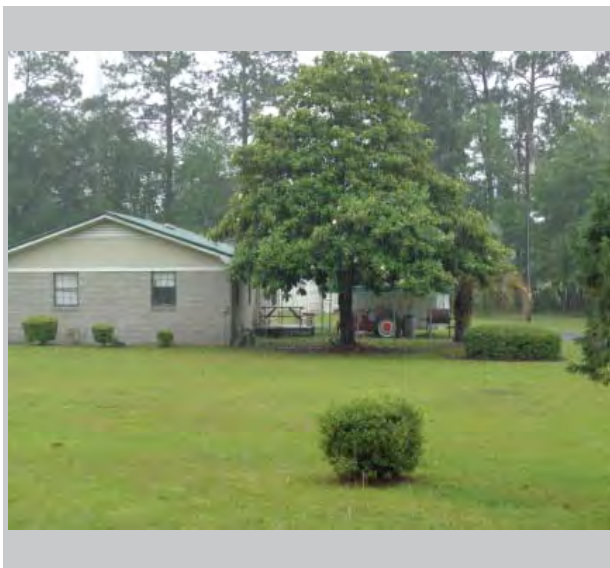
Coordinates: 31.50946, -82.50199

- Resource Type** Building
- Resource Use** Residential: Single Family Dwelling
- Date of Construction** c.1970
- Building Type** Ranch
- Structural System** Balloon Frame
- Style** No Academic Style
- Roof** Gable: Side, Front
- Exterior Cladding** Brick, Prism Synthetics: Vinyl, Aluminum Siding
- Foundation** Unknown
- Porch** Stoop
- Windows** Double Hung Sash: 6/6 rectangular
- Chimney** No chimney observed
- Additional Notes** -linear ranch with carport
-replacements include roof, vinyl, aluminum siding

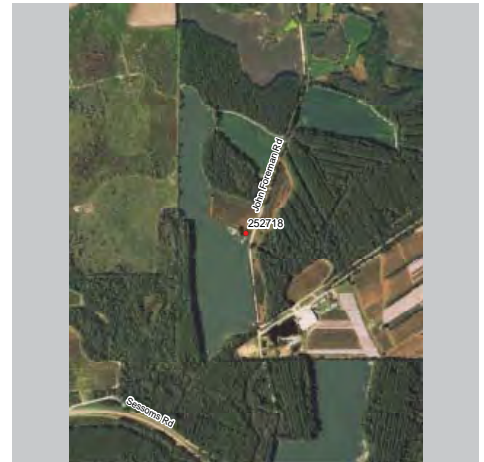
Field ID: BC-17
GNAHRGIS ID: 252718
County: Bacon
Preliminary NR Assessment: May Meet

- Resource Type** Building
- Resource Use** Residential: Single Family Dwelling
- Date of Construction** c.1935
- Building Type** Bungalow: Front Gable
- Structural System** Balloon Frame
- Style** No Academic Style
- Roof** Gable: Front
- Exterior Cladding** Prism Synthetics: Masonite Siding
- Foundation** Unknown
- Porch** Verandah
- Windows** Double Hung Sash: 6/6 rectangular
- Chimney** Lateral Interior
Material: Brick
- Additional Notes** -hipped roof on porch
-obscured by vegetation
-simple wood porch supports

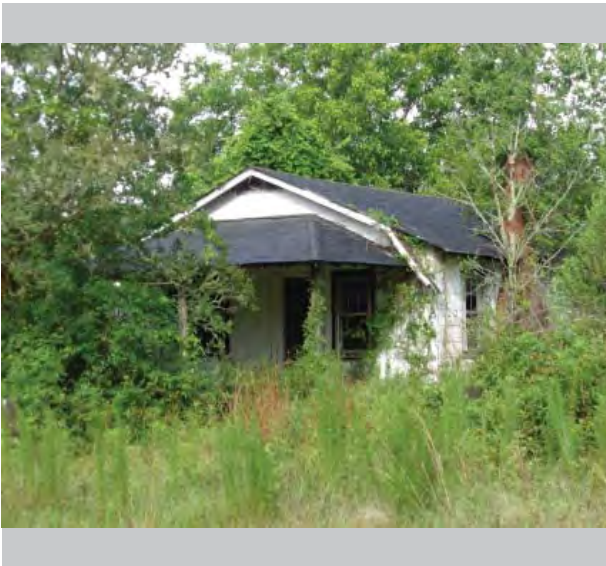
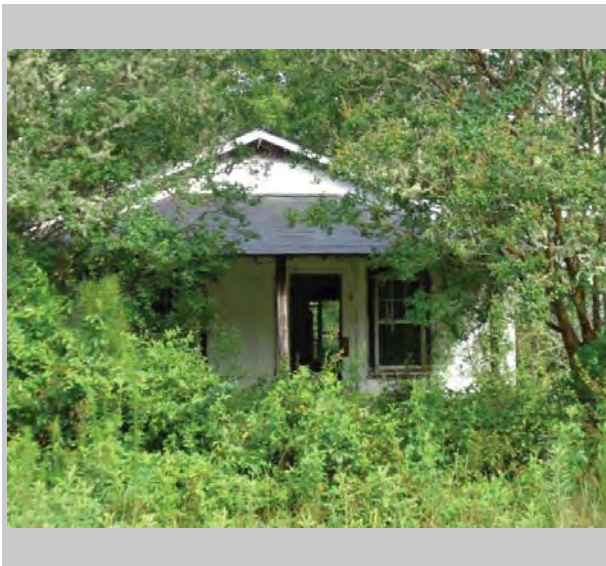
Coordinates: 31.52153, -82.57880

Additional Notes -crescent plan
-rear addition
-double front door, replacement

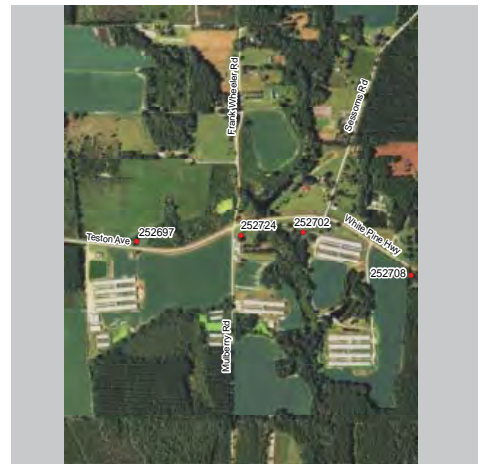
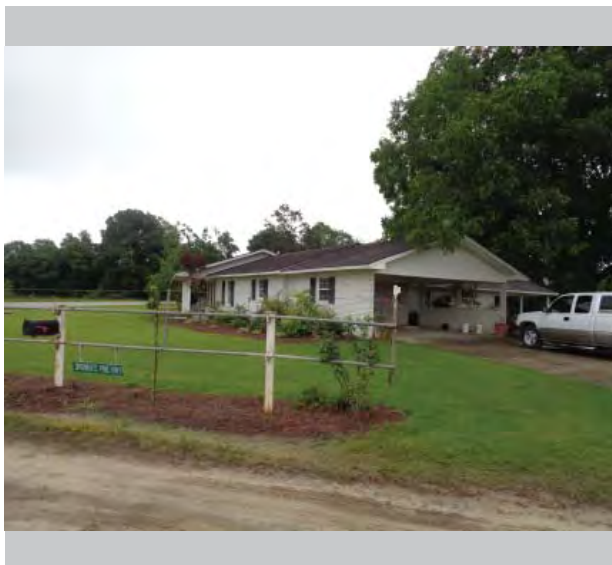
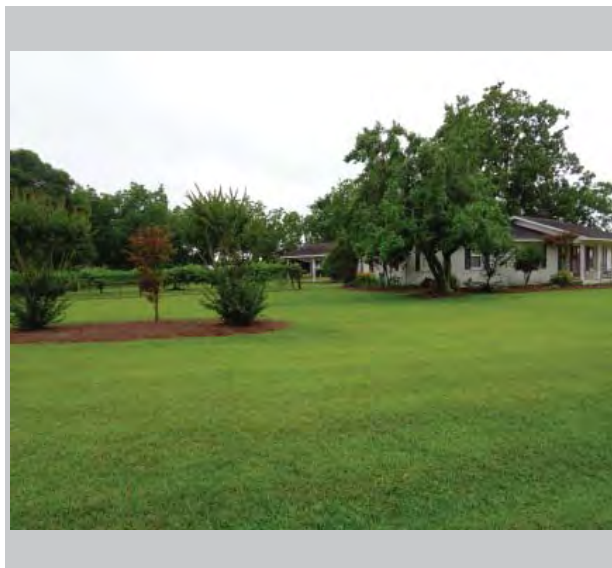
Field ID: BC-18
GNAHRGIS ID: 252724
County: Bacon
Preliminary NR Assessment: May Meet

Foundation Unknown

Chimney No chimney observed

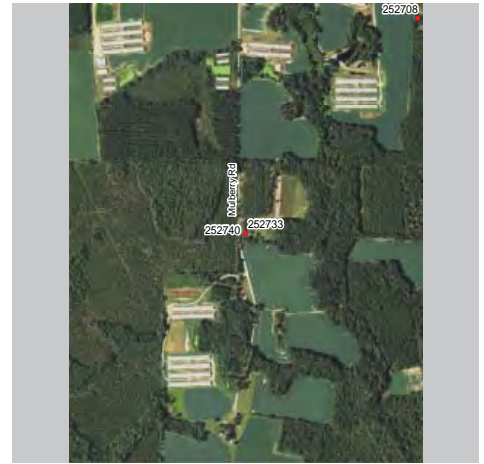
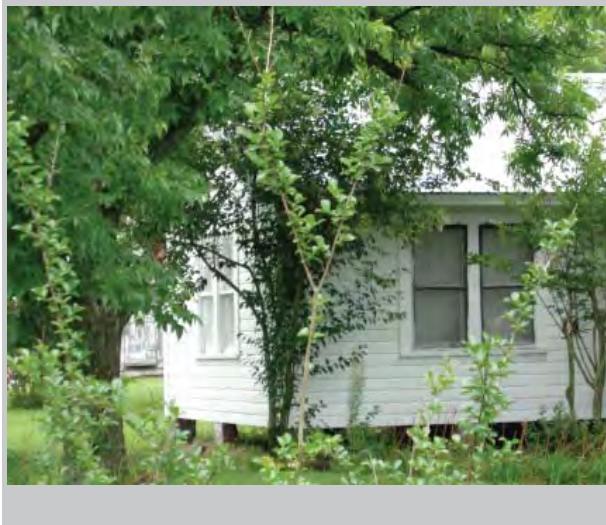
Field ID: BC-19
GNAHRGIS ID: 252733
County: Bacon
Preliminary NR Assessment: May Meet

- Resource Type** Building
- Resource Use** Residential: Single Family Dwelling
- Date of Construction** c.1925
- Building Type** Bungalow: Front Gable
- Structural System** Balloon Frame
- Style** Craftsman
- Roof** Gable: Front
- Exterior Cladding** Wood: Clapboard
- Foundation** Pier: Brick
- Porch** Portico
- Windows** Single Hung Sash: 1/1 rectangular
- Chimney** Lateral Interior: Brick
- Additional Notes**
 - battered columns on brick piers
 - replacement materials
 - additions on rear, side

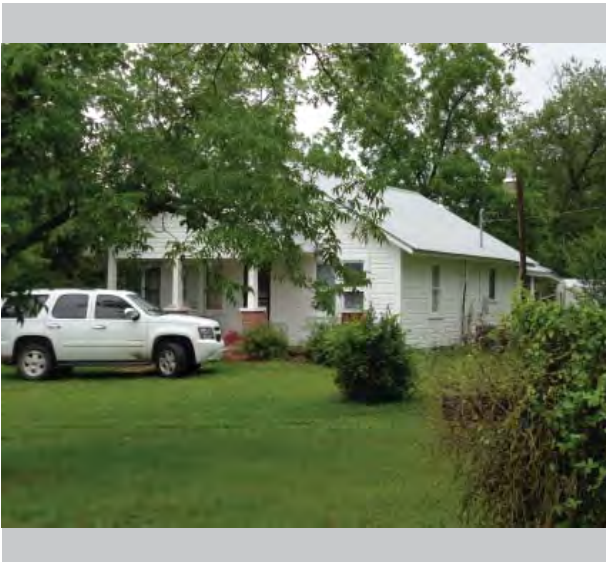
Coordinates: 31.4798, -82.58173

Additional Notes -brick piers on portico
-exposed rafter tails
-chimney replaced with pipe

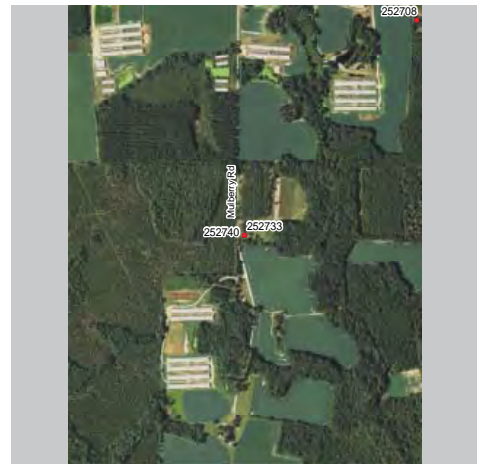
Field ID: BC-20
GNAHRGIS ID: 252740
County: Bacon
Preliminary NR Assessment: May Meet

Foundation Unknown

Chimney No chimney observed

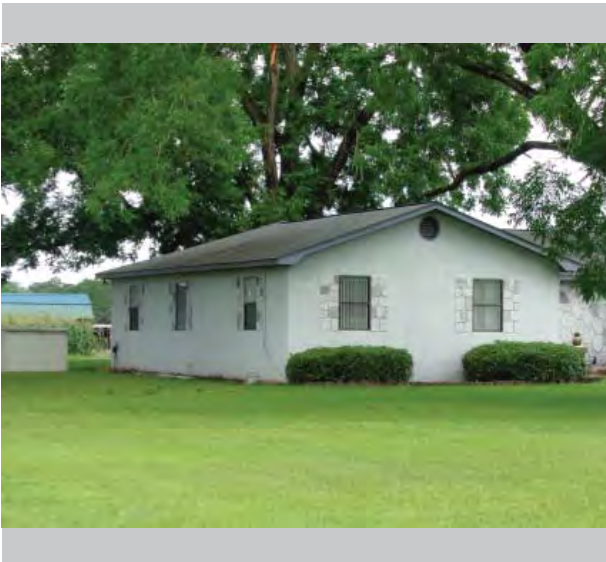
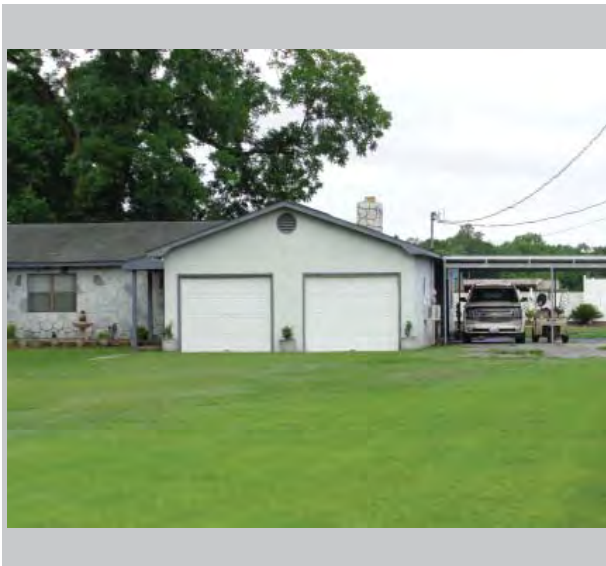
Coordinates: 31.47321, -82.55324

- Resource Type** Building
- Resource Use** Residential: Single Family Dwelling
- Date of Construction** c.1960
- Building Type** Ranch
- Structural System** Balloon Frame
- Style** No Academic Style
- Roof** Gable: Side, Front
- Exterior Cladding** Stucco
- Foundation** Unknown
- Porch** Stoop
- Windows** Double Hung Sash: 1/1 rectangular
- Chimney** No chimney observed
- Additional Notes** -courtyard ranch
-faux random course stone in stucco on recessed facade and shutters

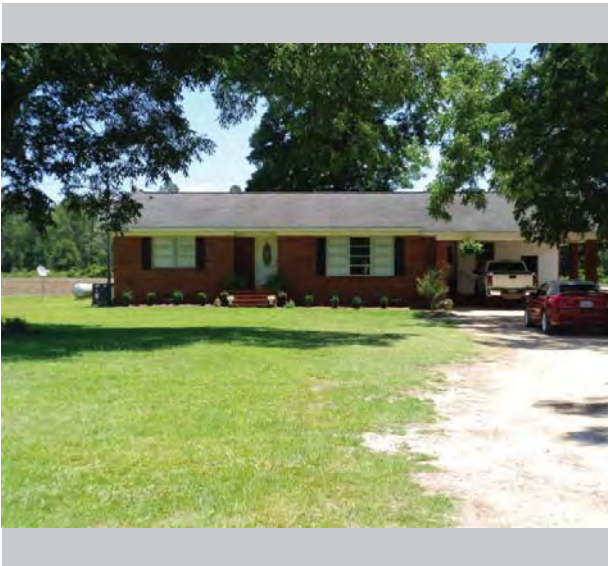
Coordinates: 31.56902, -82.62457

- Resource Type** Building
- Resource Use** Residential: Single Family Dwelling
- Date of Construction** c.1960
- Building Type** Ranch
- Structural System** Balloon Frame
- Style** No Academic Style
- Roof** Gable:Side
- Exterior Cladding** Brick; common Synthetics; vinyl
- Foundation** Unknown
- Porch** Recessed
- Windows** Jalousie; 3/1 and 4/1 rect
- Chimney** No Chimney Observed
- Additional Notes** -integrated carport on the right front
-the entry door is a replacement

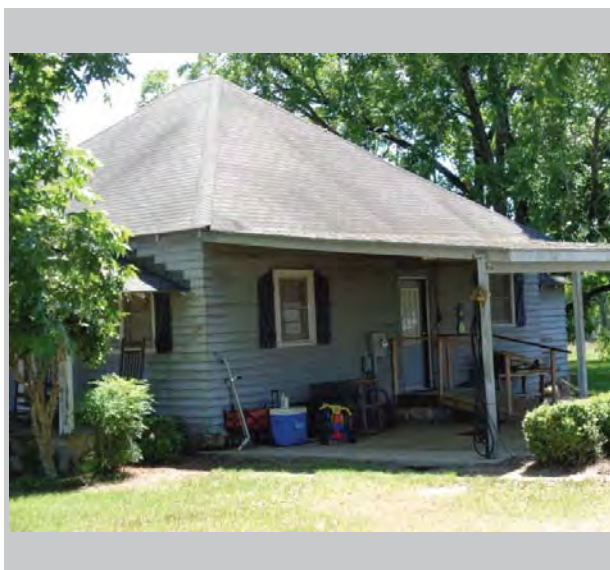
Coordinates: 31.66325, -82.57519

- Resource Type** Building
- Resource Use** Residential: Single Family Dwelling
- Date of Construction** 1915
- Building Type** Georgian Cottage
- Structural System** Balloon Frame
- Style** No Academic Style
- Roof** Pyramidal
- Exterior Cladding** Wood: Clapboard
- Foundation** Unknown
- Porch** Verandah
- Windows** Double Hung Sash: 2/2, Rectangular.
- Chimney** No Chimney Observed
- Additional Notes** Front verandah with ornamented wood supports. Stone decoration foundation.

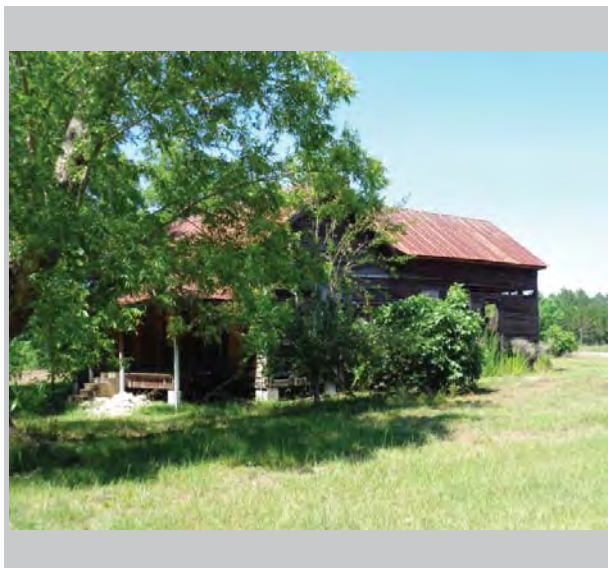
Coordinates: 31.65562, -82.58672

- Resource Type** Building
- Resource Use** Vacant
- Date of Construction** c.1910
- Building Type** Central Hallway
- Structural System** Balloon Frame
- Style** No Academic Style
- Roof** Gable:Side
- Exterior Cladding** Wood: Clapboard
- Foundation** Concrete Block Piers: No Infill
- Porch** Verandah
- Windows** Fixed: 4/4 rectangular
- Chimney** Gable end: exterior
Material: brick
- Additional Notes** -large rear gable addition
-enclosed transom and sidelight
-some windows boarded

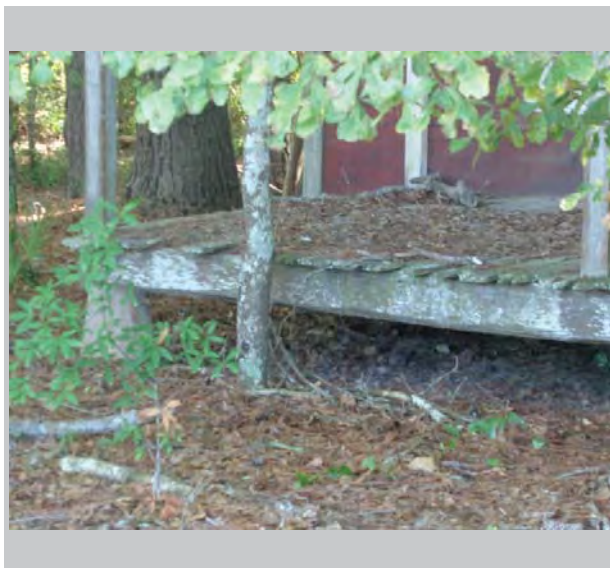
Coordinates: 31.61081, -82.58225

- Resource Type** Building
- Resource Use** Vacant
- Date of Construction** c.1930
- Building Type** Bungalow: front gable
- Structural System** Balloon Frame
- Style** No Academic Style
- Roof** Gable:front
- Exterior Cladding** Insulbrick Siding
- Foundation** Concrete: pier
- Porch** verandah
- Windows** Double-hung sash: 6/6 rectangular
- Chimney** Lateral: exterior
Material: brick
- Additional Notes** -Two lateral exterior chimneys
-hand-hewn log supports
-mostly original

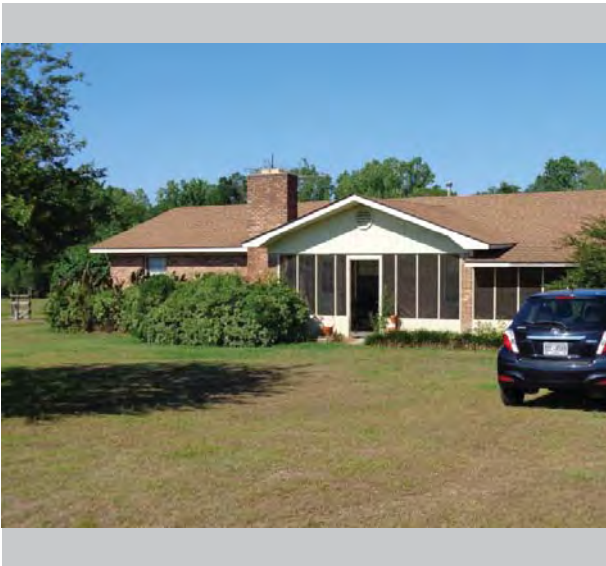
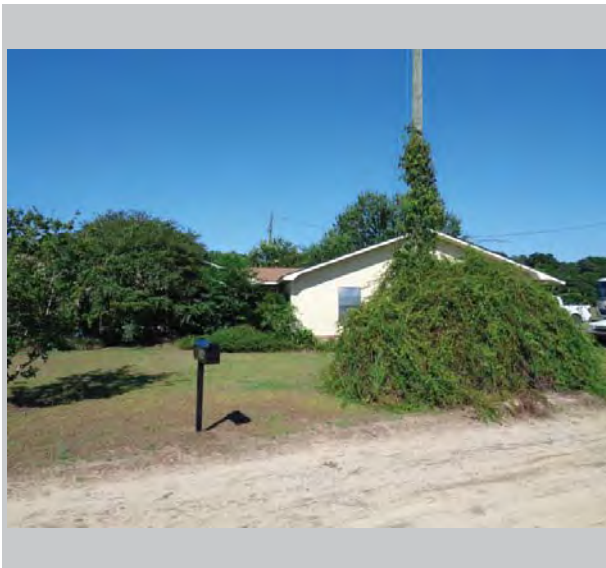
Coordinates: 31.59951, -82.57524

- Resource Type** Building
- Resource Use** Residential: Single dwelling
- Date of Construction** c.1975
- Building Type** Ranch
- Structural System** Balloon Frame
- Style** No Academic Style
- Roof** Gable:cross
- Exterior Cladding** Board-and-batten
Brick
- Foundation** Concrete: continuous
- Porch** recessed
- Windows** Double-hung sash: 6/6 rectangular
- Chimney** Lateral: exterior
Material: brick
- Additional Notes** -rambling ranch
-brick mixed with vertical board
-screened in porch

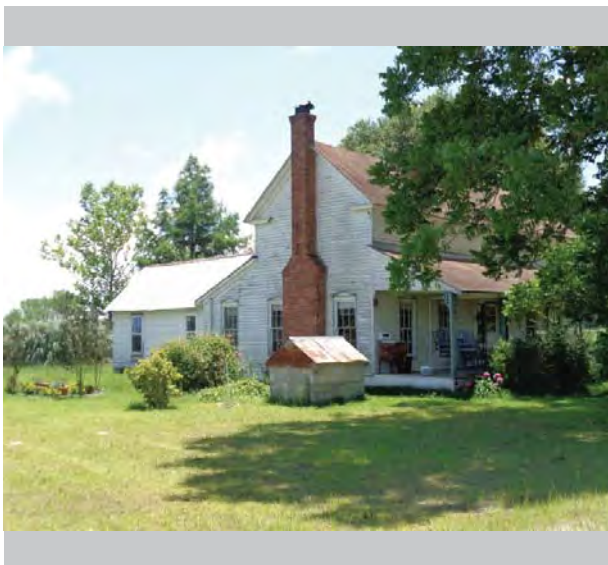
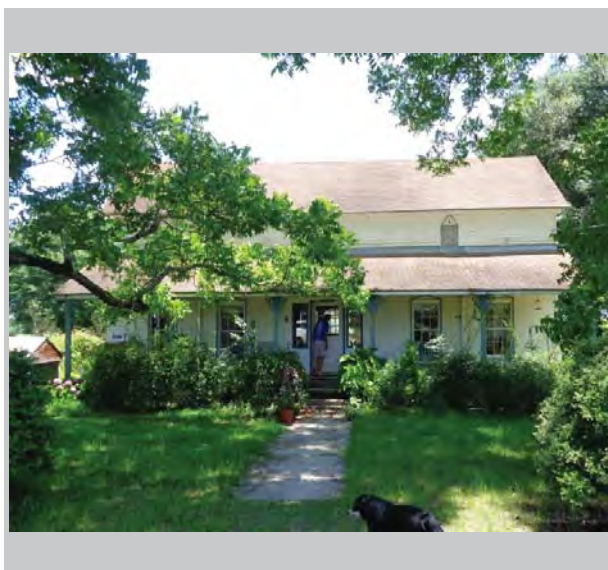
Coordinates: 31.59984, -82.59885

- Resource Type** Building
- Resource Use** Residential: Single dwelling
- Date of Construction** c.1890
- Building Type** Plantation Plain
- Structural System** Balloon Frame
- Style** No Academic Style
- Roof** Gable: side
- Exterior Cladding** Wood:clapboard
- Foundation** unknown
- Porch** Verandah
- Windows** Double-hung sash: 6/6 rectangular
- Chimney** Gable end: exterior
Material: brick
- Additional Notes** -verandahs back and front
-scroll saw porch posts
-windows have pediments

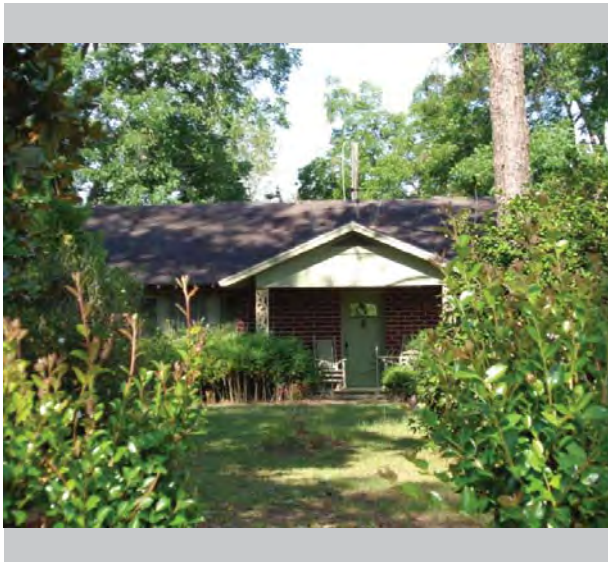
Coordinates: 31.54970, -82.56009

- Resource Type** Building
- Resource Use** Residential: Single dwelling
- Date of Construction** c.1960
- Building Type** Ranch
- Structural System** Balloon Frame
- Style** No Academic Style
- Roof** Gable: side and front
- Exterior Cladding** Wood:clapboard
Brick
- Foundation** unknown
- Porch** Portico
- Windows** Double-hung sash: 1/1 rectangular
- Chimney** Gable end: interior
Material: brick
- Additional Notes** -1/1 windows in sets of 4
-wrought iron porch posts
-exposed rafter tails

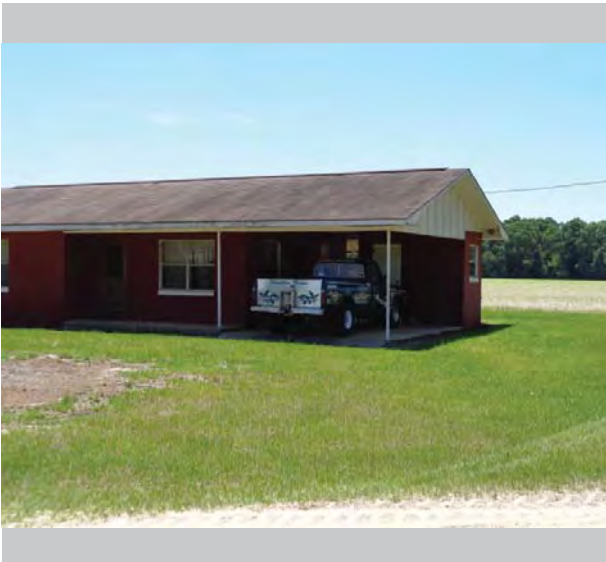
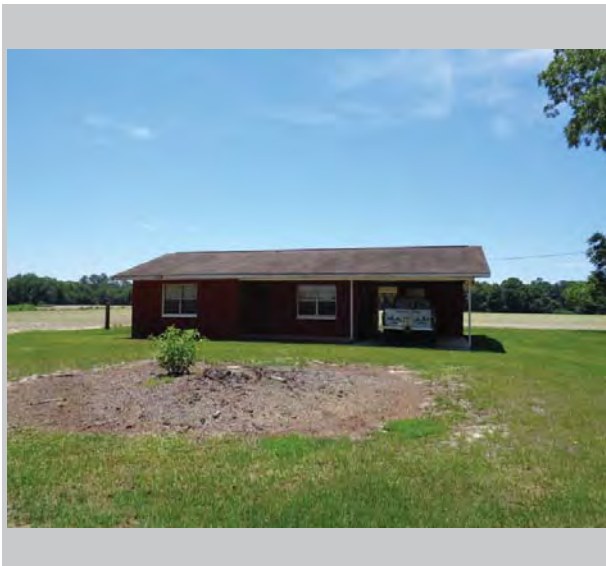
Coordinates: 31.66275, -82.47278

- Resource Type** Building
- Resource Use** Residential: Single dwelling
- Date of Construction** c.1950
- Building Type** Ranch
- Structural System** Balloon Frame
- Style** No Academic Style
- Roof** Gable: side
- Exterior Cladding** Concrete Block
- Foundation** Unknown
- Porch** Recessed
- Windows** Double-hung sash: 2/2 rectangular
- Chimney** No chimney observed
- Additional Notes**
 - compact ranch
 - detached integrated tool shed
 - front door recessed

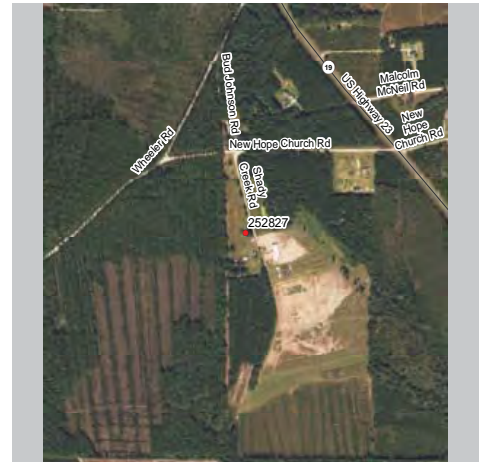
Field ID: BC-49
GNAHRGIS ID: 252827
County: Bacon
Preliminary NR Assessment: May Meet

147-153 Sandy Creek Road

- Resource Type** Building
- Resource Use** Residential: Single dwelling
- Date of Construction** c.1890
- Building Type** Saddlebag
- Structural System** Balloon Frame
- Style** No Academic Style
- Roof** Gable: side
- Exterior Cladding** Wood: weatherboard
- Foundation** Unknown
- Porch** Verandah
- Windows** Double-hung sash: 6/6 rectangular
- Chimney** Lateral Exterior
Material: brick
- Additional Notes** -Central Hall Saddlebag house
-corbelled chimney
-replacement windows

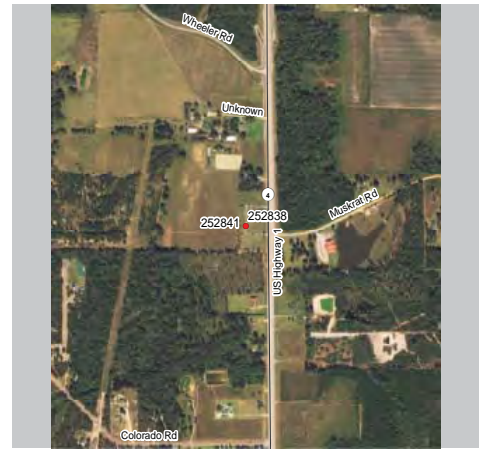
Field ID: BC-51
GNAHRGIS ID: 252838
County: Bacon
Preliminary NR Assessment: Does Not Meet

Pike Cemetery
At U.S. Highway 1-Muskrat Road

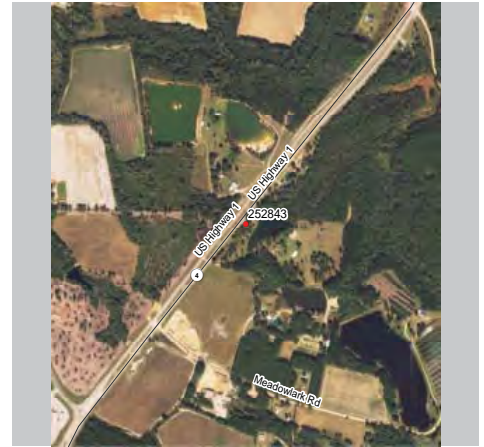
Field ID: BC-55
GNAHRGIS ID: 252843
County: Bacon
Preliminary NR Assessment: May Meet

Harrison Cemetery
NE of U.S. Highway 1 Meadowlark Road intersection

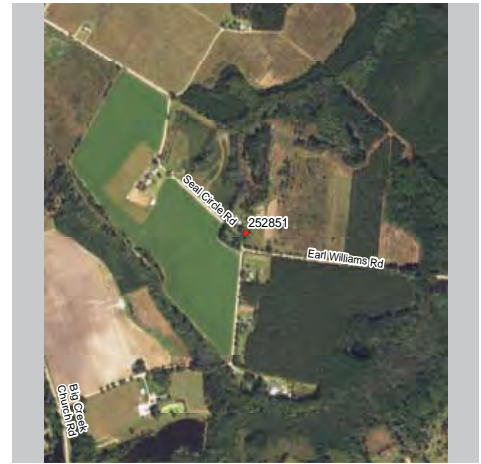
Field ID: BC-57
GNAHRGIS ID: 252851
County: Bacon
Preliminary NR Assessment: May Meet

At the intersection of Seal Circle Road
and Bluejay Road

- Resource Type** Building
- Resource Use** Residential: Single Family Dwelling
- Date of Construction** c.1930
- Building Type** Bungalow: Front Gable
- Structural System** Balloon Frame
- Style** No Academic Style
- Roof** Gable:Front
- Exterior Cladding** Wood: Clapboard
- Foundation** Pier: Concrete
- Porch** Verandah
- Windows** Double Hung Sash: 2/2 rectangular
- Chimney** Lateral Interior
Material: brick
- Additional Notes**
 - In character back addition
 - Some replacement porch supports
 - Some windows screened

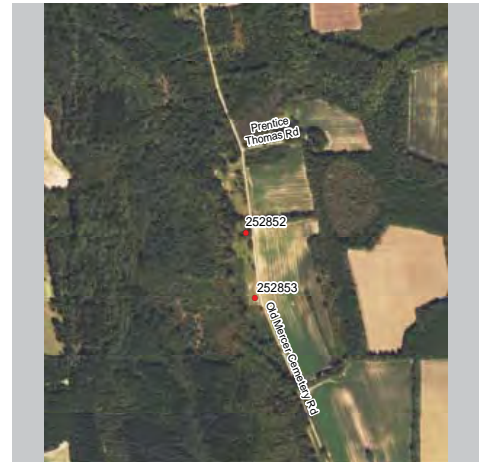
Field ID: BC-59
GNAHRGIS ID: 252852
County: Bacon
Preliminary NR Assessment: Appears to Meet

South of Copper Lake Road-
Swordfish Road intersection

- Resource Type** Building
- Resource Use** Residential: Single Family Dwelling
- Date of Construction** c.1925
- Building Type** Bungalow: Front Gable
- Structural System** Balloon Frame
- Style** No Academic Style
- Roof** Gable:Front
- Exterior Cladding** Wood: Clapboard
- Foundation** Pier: Brick
- Porch** Verandah
- Windows** Double Hung Sash: 3/1 rectangular
- Chimney** Lateral Exterior
Material: brick
- Additional Notes** -Chimney chopped of at top
-exposed rafter tails
-craftsmen style

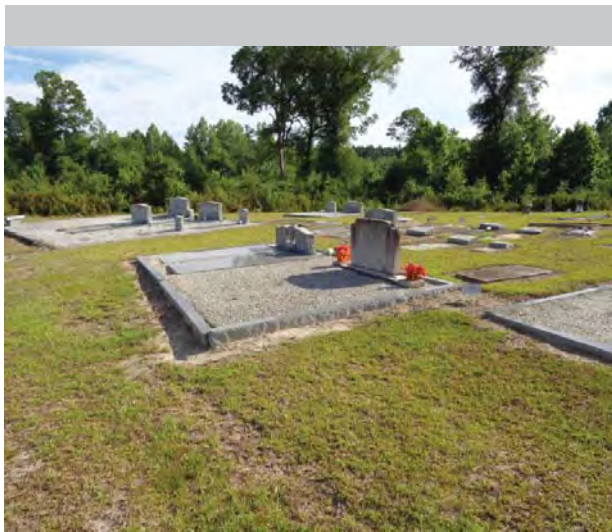
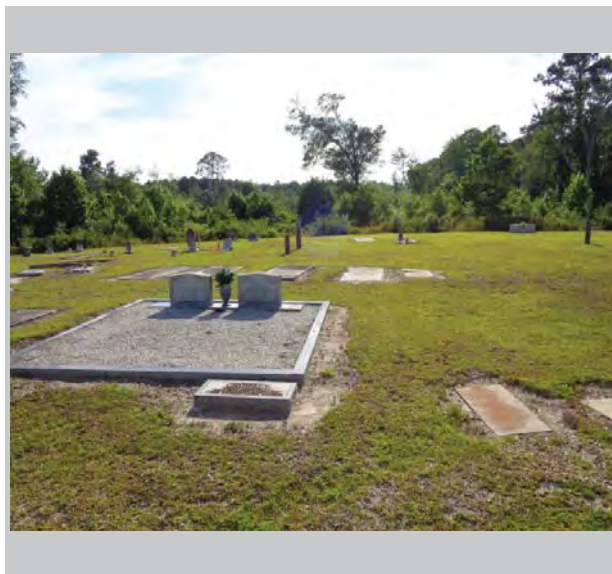
Mercer Cemetery
 NW corner of Copper Lake Road-South Chad Lake Rd
Coordinates: 31.59816, -82.56642

Resource Type Site
Resource Use Funerary: Cemetery
Date of Construction 1900
Common Names Mercer, Taylor, Tanner
≈ Number of Burials 70
Oldest Burial 1900
Burial Description 3 obelisks
 5 family plots

Cemetery Description -Active use
 -Several granite outlined family plots
 -Most are small headstones

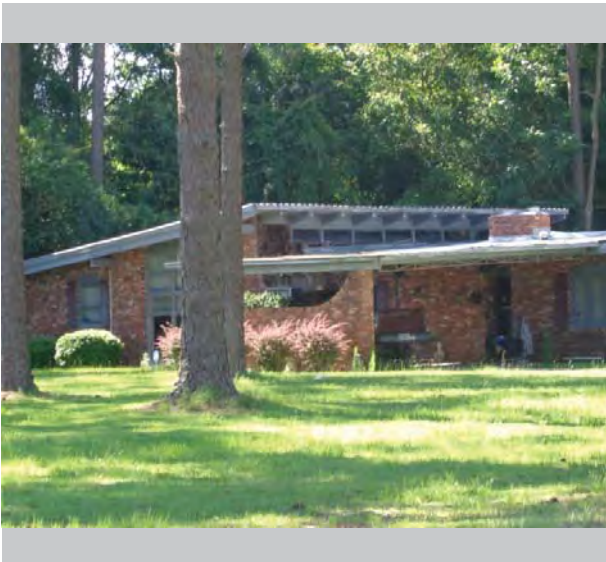
Coordinates: 31.543456, -82.517895

- Resource Type** Building
- Resource Use** Residential: Single Family Dwelling
- Date of Construction** c. 1960
- Building Type** Rambling Ranch
- Structural System** Balloon Frame
- Style** No Academic Style
- Roof** Shed/pent
- Exterior Cladding** Brick
- Foundation** Unknown
- Porch** Porte-Cochere
- Windows** Fixed: Single Pane
- Chimney** Off-center Within Roof Surface: Brick
- Additional Notes** -Eichleresque ranch
-porte-cochere out front
-scalloped brick wall in front

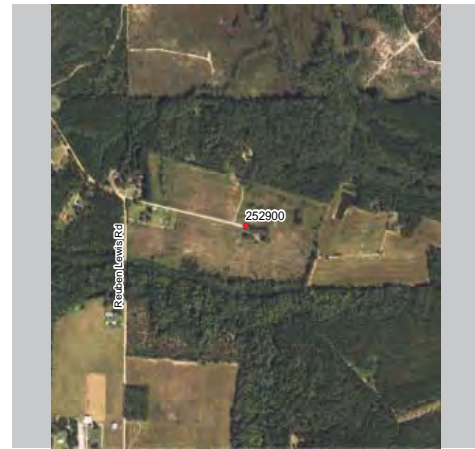
Field ID: BC-62
GNAHRGIS ID: 252900
County: Bacon
Preliminary NR Assessment: May Meet

Patterson Cemetery
 East of Boardwalk Road-State Road 226 intersection

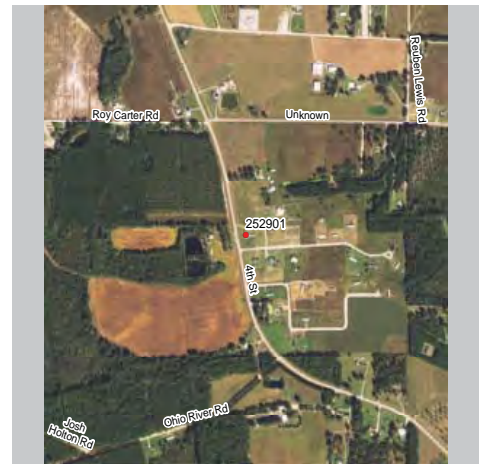
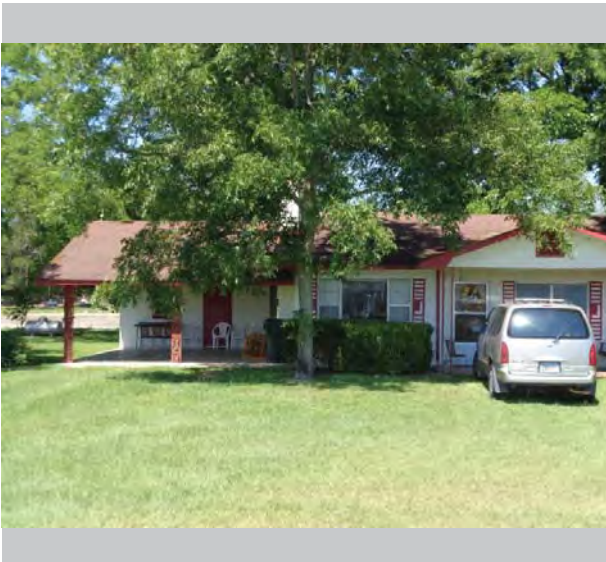
Field ID: BC-63
GNAHRGIS ID: 252901
County: Bacon
Preliminary NR Assessment: May Meet

At intersection of West 4th Street
and Red River Lane

- Resource Type** Building
- Resource Use** Residential: Single Family Dwelling
- Date of Construction** c. 1960
- Building Type** Linear Ranch
- Structural System** Balloon Frame
- Style** No Academic Style
- Roof** Gable:Cross
- Exterior Cladding** Brick
- Foundation** Unknown
- Porch** Verandah
- Windows** Fixed: Single Pane
- Chimney** Off-center, ridgeline: Brick
- Additional Notes** -fixed chicago windows with flanking 2/2 double hung sash windows
-intergrated carport

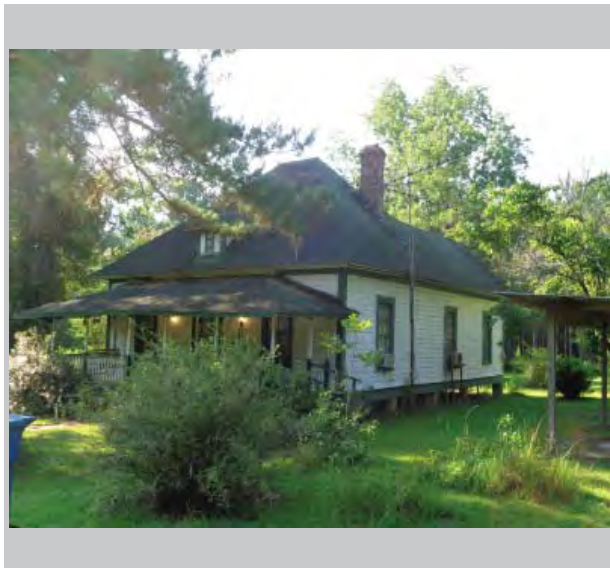
Coordinates: 31.48186, -82.49275

- Resource Type** Building
- Resource Use** Residential: Single Family Dwelling
- Date of Construction** c. 1900
- Building Type** Georgian Cottage
- Structural System** Balloon Frame
- Style** No Academic Style
- Roof** Pyramidal
- Exterior Cladding** Wood: clapboard
- Foundation** Brick: Pier
- Porch** Verandah
- Windows** Double-hung sash, 2/2, rectangular
- Chimney** Off-center, within roof surface: Brick
- Additional Notes** -one chimney on right side, and a corbelled chimney on the back
-vent dormer on front of roof

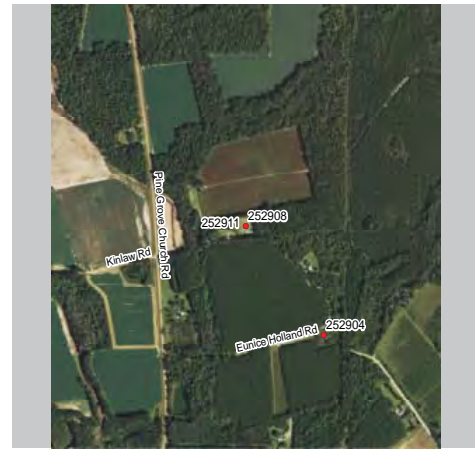
Field ID: BC-66
GNAHRGIS ID: 252908
County: Bacon
Preliminary NR Assessment: May Meet

Pine Grove Cemetery
 At Pinegrove Road-Timber Trail intersection
