Historic Resources Survey Report

Bacon County, Georgia

June 2016

The University of Georgia
College of Environment and Design
Center for Community Design & Preservation
Historic Resources Survey Report
Bacon County, Georgia 2016

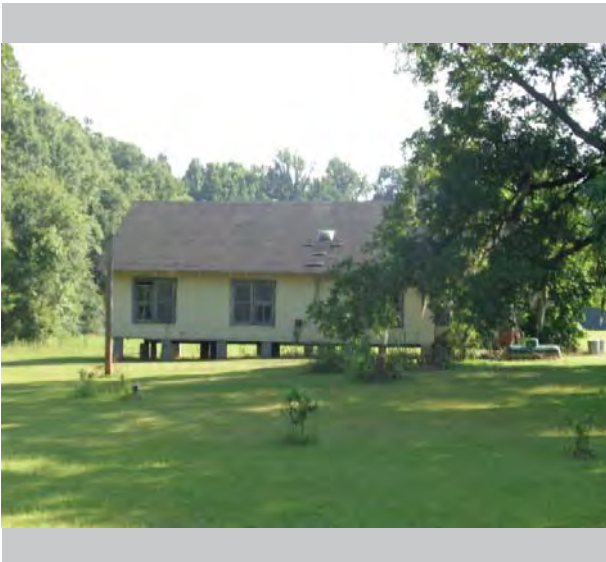
Southeast of Pinegrove Road-Pine View Road intersection

- Resource Type** Building
- Resource Use** Residential: Single Family Dwelling
- Date of Construction** c. 1920
- Building Type** Bungalow: Front Gable
- Structural System** Balloon Frame
- Style** No Academic Style
- Roof** Gable: Front
- Exterior Cladding** Wood: weatherboard
- Foundation** CMU: Pier
- Porch** Portico
- Windows** Double-hung sash, 2/2, rectangular
- Chimney** No chimney observed
- Additional Notes** - battered wood columns on brick piers
-house was possibly moved or raised

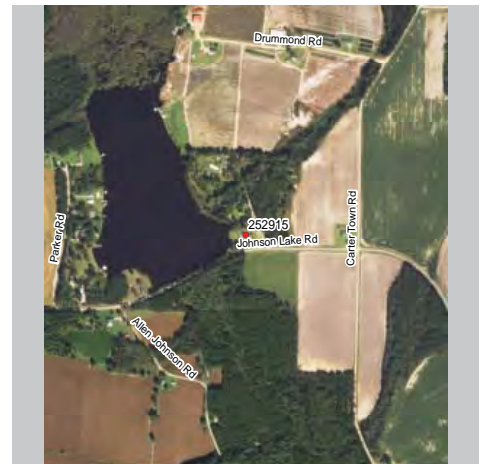
Field ID: BC-71
GNAHRGIS ID: 252915
County: Bacon
Preliminary NR Assessment: May Meet

West of Johnson Lake Road-Sunflower Lane intersection

- Resource Type** Building
- Resource Use** Residential: Single Family Dwelling
- Date of Construction** c. 1960
- Building Type** Linear Ranch
- Structural System** Balloon Frame
- Style** No Academic Style
- Roof** Hip
- Exterior Cladding** Brick: Veneer
- Foundation** Concrete Slab
- Porch** recessed
- Windows** Double-hung sash, 4/4, rectangular
- Chimney** No chimney observed
- Additional Notes** -2 car carport on the the right side with added garage doors
-added carport on left side

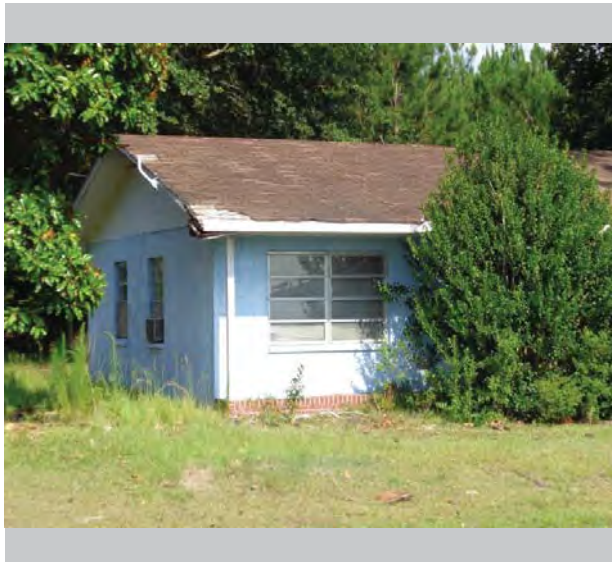
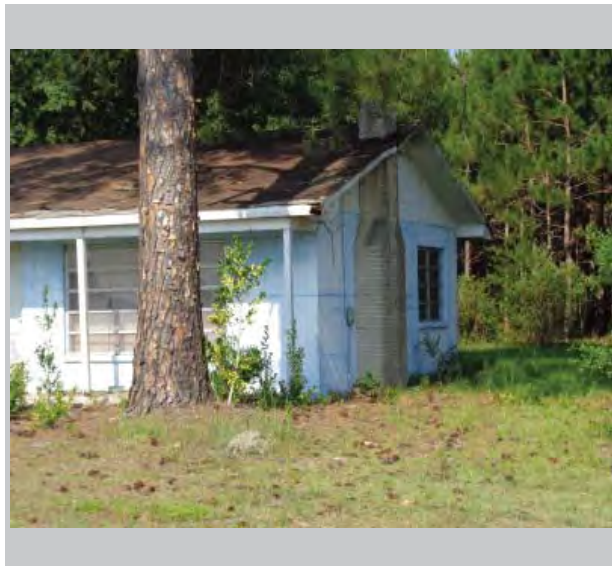
Coordinates: 31.54316, -82.37076

- Resource Type** Building
- Resource Use** Residential: Single Family Dwelling
- Date of Construction** c. 1950
- Building Type** Linear Ranch
- Structural System** Balloon Frame
- Style** No Academic Style
- Roof** Gable: Side
- Exterior Cladding** CMU Block
- Foundation** Unknown
- Porch** Verandah
- Windows** Jalousie, single pane, rectangular
- Chimney** Side - exterior: Brick
- Additional Notes** -concrete block appears to be painted blue
 -paired jalousie windows
 -5 wood porch supports

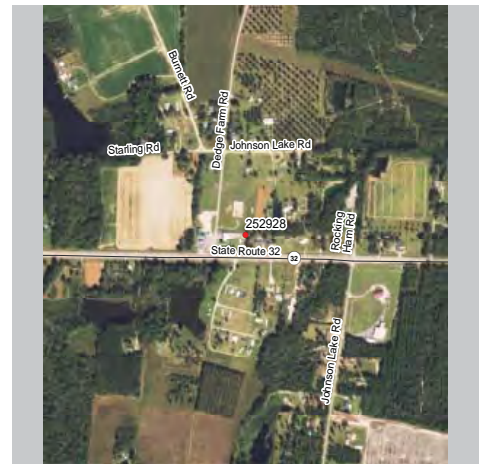
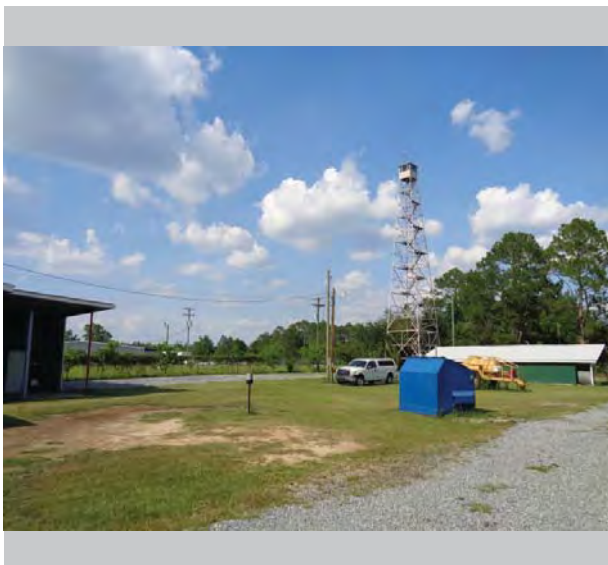
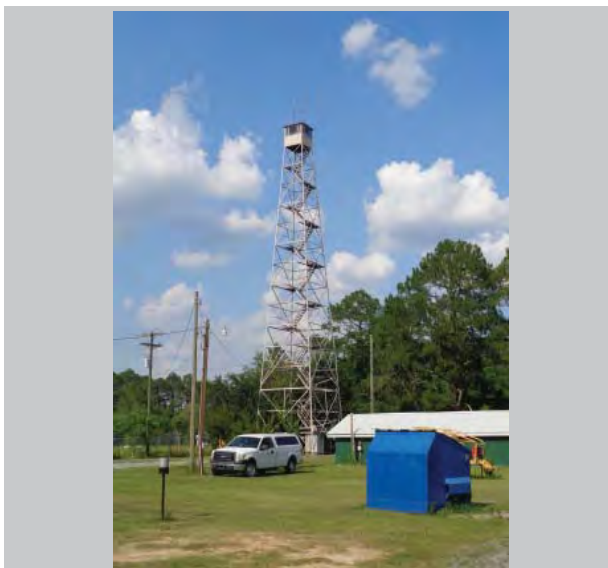
Field ID: BC-75
GNAHRGIS ID: 252928
County: Bacon
Preliminary NR Assessment: May Meet

124-132 Dedge Farm Road

Resource Type Structure

Resource Use Government: Public Works

Foundation Steel Supports

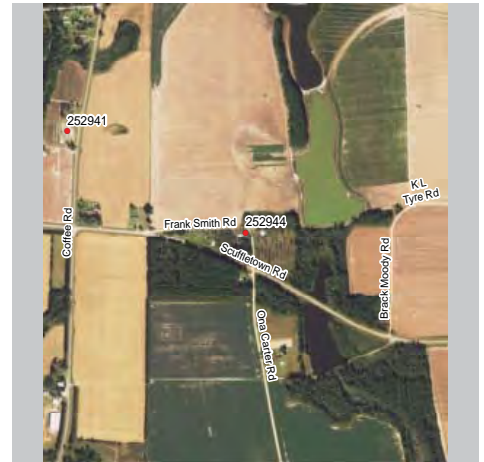
Field ID: BC-77
GNAHRGIS ID: 252944
County: Bacon
Preliminary NR Assessment: May Meet

- Resource Type** Building
- Resource Use** Residential: Single Family Dwelling
- Date of Construction** c.1920
- Building Type** Bungalow: front gable
- Structural System** Balloon Frame
- Style** No Academic Style
- Roof** Gable:Front
- Exterior Cladding** Board-and-batten: vertical board
- Foundation** Pier:Brick
- Porch** Portico
- Windows** Double Hung Sash: 6/6 rectangular
- Chimney** No chimney observed
- Additional Notes** -craftsman battered wood columns on brick piers
-looks to have been a general store

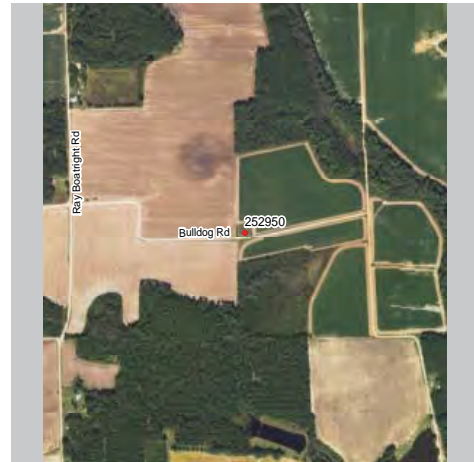
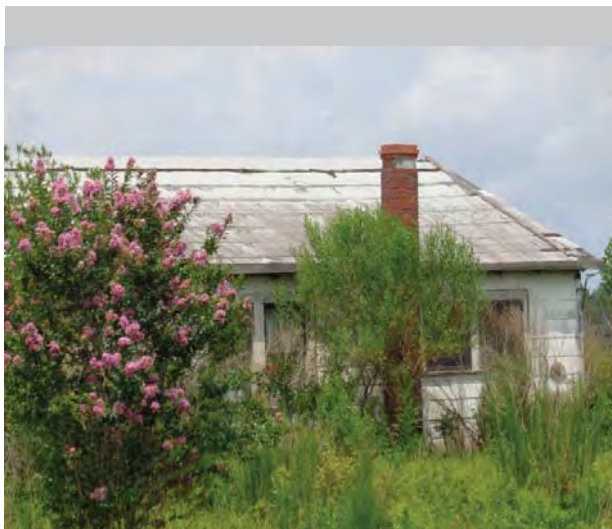
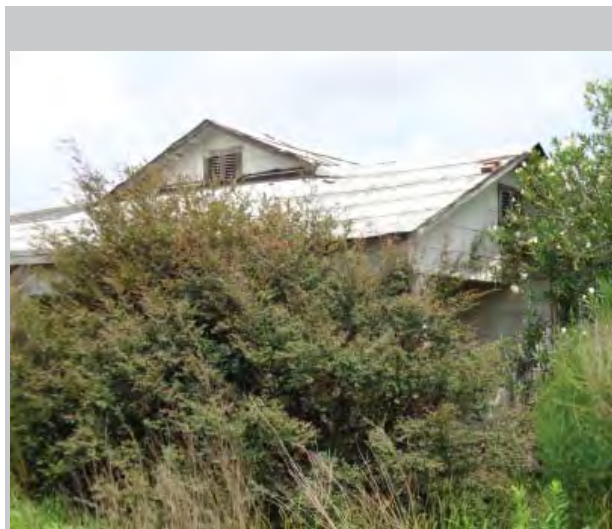
Field ID: BC-80
GNAHRGIS ID: 252950
County: Bacon
Preliminary NR Assessment: May Meet

Additional Notes -heavily obscured by vegetation
-several replacement windows

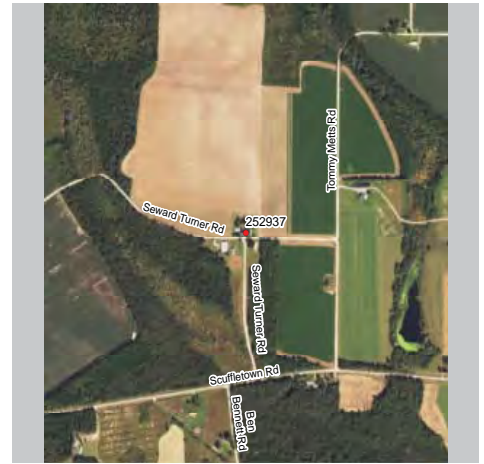
Field ID: BC-83
GNAHRGIS ID: 252937
County: Bacon
Preliminary NR Assessment: Appears to Meet

- Resource Type** Building
- Resource Use** Residential: Single Family Dwelling
- Date of Construction** c.1920
- Building Type** Georgian House
- Structural System** Balloon Frame
- Style** Colonial Revival
- Roof** Gable:Side
- Exterior Cladding** Wood: Weatherboard
- Foundation** Unknown
- Porch** Verandah
- Windows** Double Hung Sash: 6/6 rectangular
- Chimney** No chimney observed
- Additional Notes** -main wing 5 window bays across
-simple square wood columns

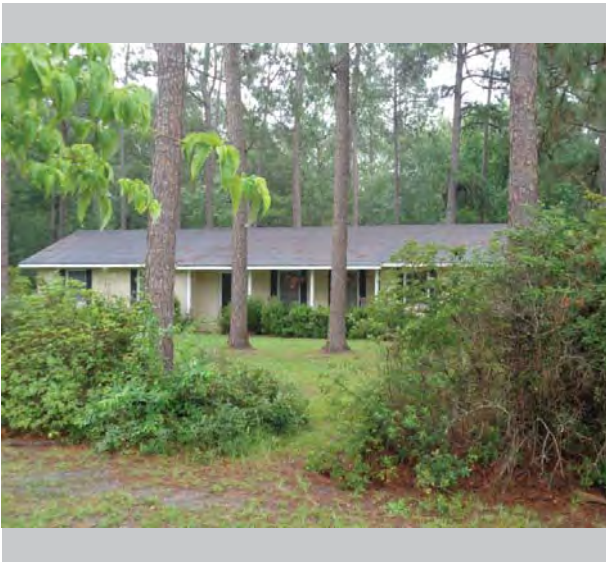
At Brown Thrasher Road-Highway 203
intersection

- Resource Type** Building
- Resource Use** Residential: Single Family Dwelling
- Date of Construction** c.1970
- Building Type** Linear Ranch
- Structural System** Balloon Frame
- Style** No academic style
- Roof** Gable:Side
- Exterior Cladding** Brick: Veneer
- Foundation** Unknown
- Porch** Verandah
- Windows** Double Hung Sash: 6/6 rectangular
- Chimney** No chimney Observed
- Additional Notes** -tan brick exterior
-integrated carport on the right side

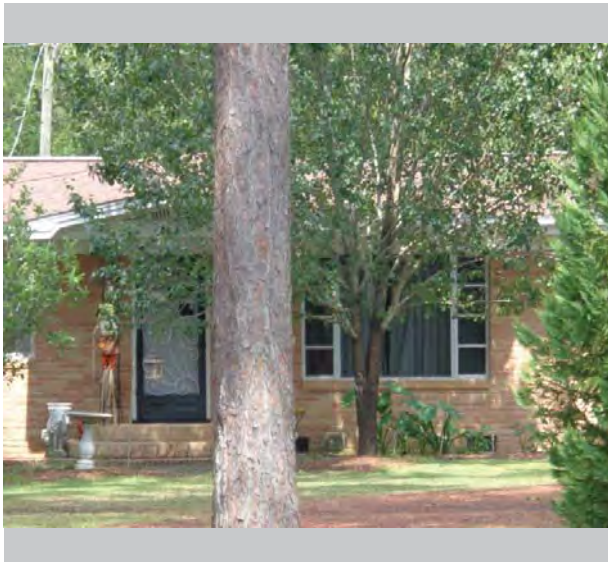
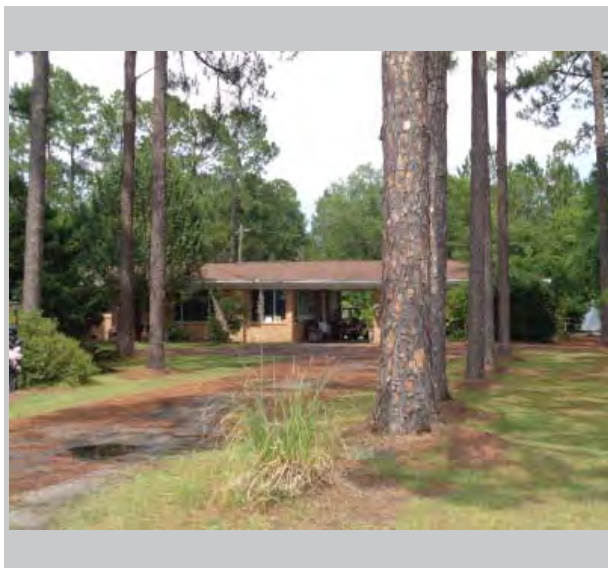
Coordinates: 31.50865, -82.36270

- Resource Type** Building
- Resource Use** Residential: Single Family Dwelling
- Date of Construction** c.1970
- Building Type** Linear Ranch
- Structural System** Balloon Frame
- Style** No academic style
- Roof** Gable:Side
- Exterior Cladding** Brick: Veneer
- Foundation** Unknown
- Porch** Stoop
- Windows** Vertical Jalousie
- Chimney** No chimney Observed
- Additional Notes** -ironwork porch supports
-3 vertical sets of jalousie windows
-double attached carport

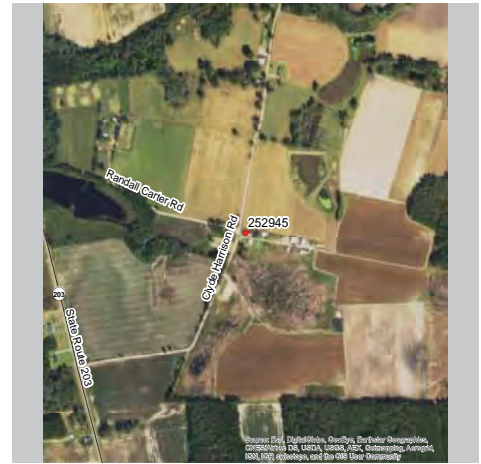
Field ID: BC-89
GNAHRGIS ID: 252945
County: Bacon
Preliminary NR Assessment: May Meet

- Resource Type** Building
- Resource Use** Residential: Single Family Dwelling
- Date of Construction** c.1930
- Building Type** Bungalow: side gable
- Structural System** Balloon Frame
- Style** No academic style
- Roof** Gable:Cross
- Exterior Cladding** Synthetics: Asbestos
- Foundation** Concrete: continuous
- Porch** Verandah
- Windows** Double hung sash, 4/4, rectangular
- Chimney** No chimney Observed
- Additional Notes** -some windows are screened or replaced
-vent in the front gable
-rafter tails are exposed

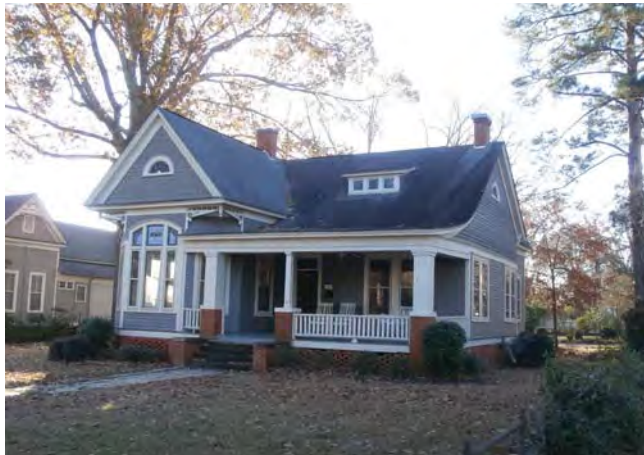
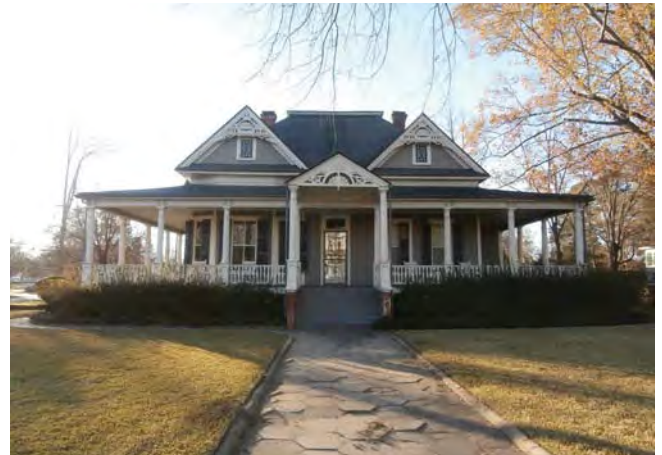
Folk Victorian 1870-1920

Folk Victorian houses were built across Georgia in very large numbers. They were simple house forms, or house types, with Victorian-era decorative detailing such as jigsaw woodworks including brackets, spindlework and gingerbread trim. This detailing generally was taken from the elaborate styles, such as Queen Anne or Italianate, that were popular during the mid to late 19th century. Features were borrowed and added onto such places as porches and roof gables. This provided some hint of stylistic detailing on what was otherwise an unadorned traditional house form. This style is actually more a way of decorating a house than a precise stylistic category; however, the Folk Victorian house is so widespread that it demands a name.

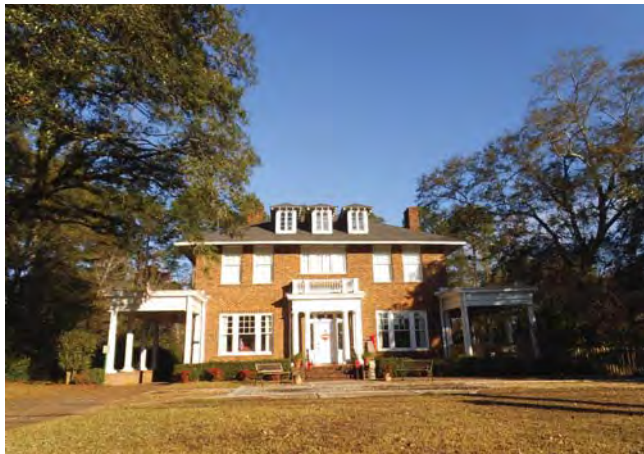
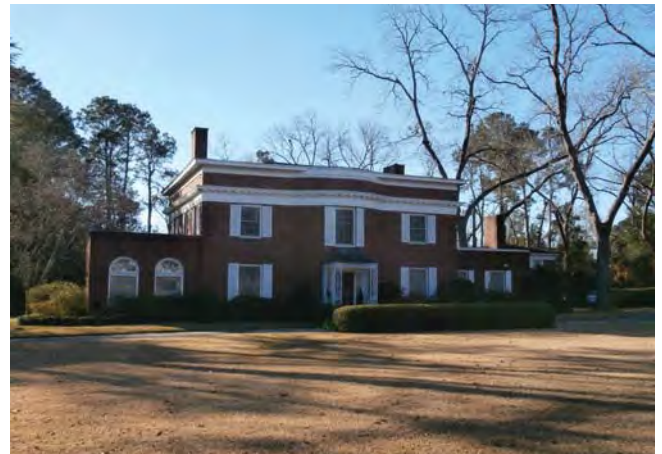
Colonial Revival 1890-1955

Most Colonial Revival houses are symmetrical. A central entranceway is elaborated with a pediment supported by pilasters or columns. The use of broken pediments, fanlights and sidelights is common. Classical cornices with dentils or modillions are usually present. These features tend to be larger than original colonial details. The roof may be hipped or side-gabled with dormers. Windows have double-hung sashes, usually with six-over-six or nine-over-nine panes and may be paired. Walls are of masonry, masonry-veneer or wood.

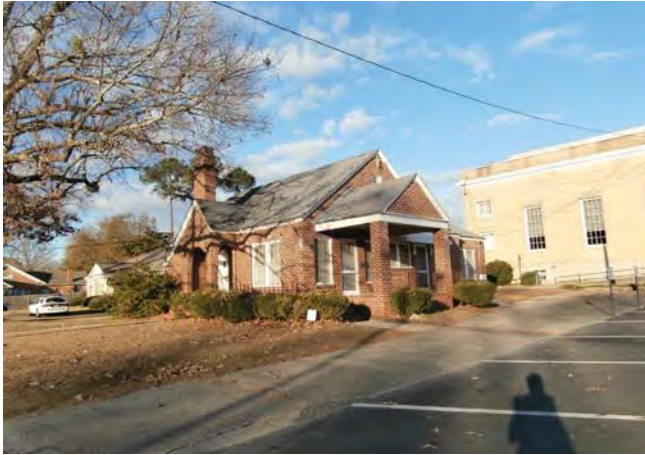
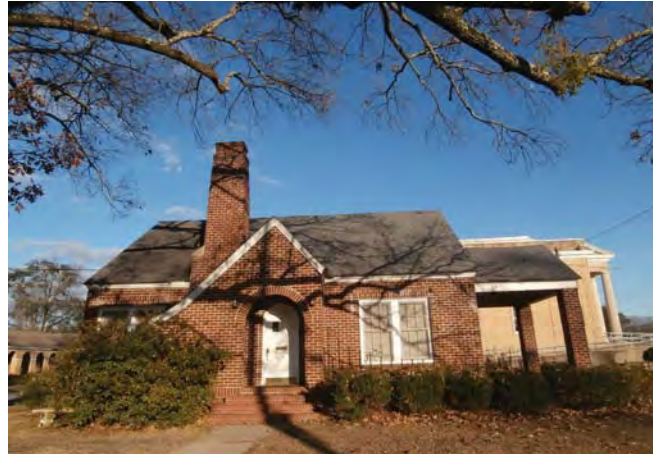
English Vernacular Revival 1900-1940

Characteristics of English Vernacular Revival houses are a steeply pitched gabled roof with dominant front-facing gable and decorative half-timbering in the gables. Almost all have masonry walls. Most are masonry-veneered, a recently developed technique for applying a thin layer of masonry to a wall. Some houses have patterned brickwork, while others may be completely stuccoed. Often a variety of materials are used, such as brick walls with stone trim, wood half-timbering, and stuccoed gables. Massive masonry chimneys with decorative tops are common. Windows are generally tall and narrow, grouped together, multi-paned, and casements rather than double-hung. Some openings, particularly the entrance, may be emphasized by a round arch. Houses of this style are generally asymmetrical.

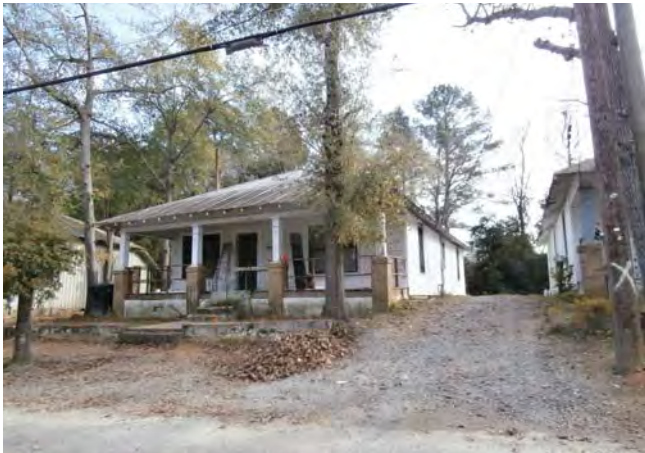
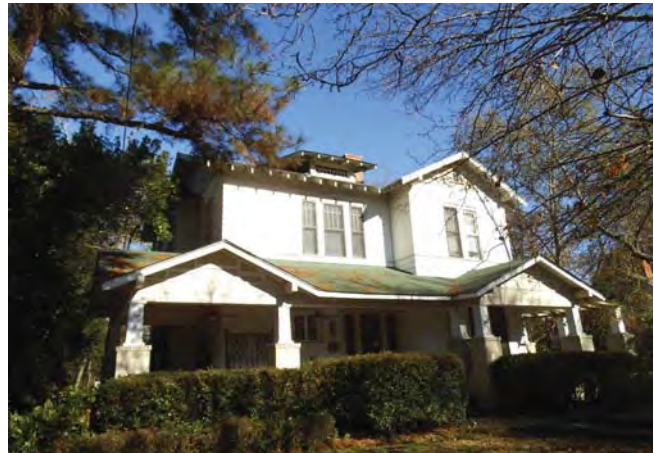
Craftsman 1910-1930

The Craftsman house uses a wide variety of materials both for its structure and decorative detailing. It has a low-pitched roof that is usually gabled but may also be hipped, giving a generally horizontal effect. The widely overhanging eaves are open with exposed rafters. Large gables have decorative brackets or braces at the eaves and may be covered with half-timbering. Roof dormers are sometimes found. Walls are most often wood but may also be covered with shingles or a masonry veneer of stone or brick. Porches have short square columns set on heavy masonry piers extending to the ground. Windows may have a multi-paned sash over a large one-pane sash. Craftsman houses are most often asymmetrical with a generally open and functional plan.

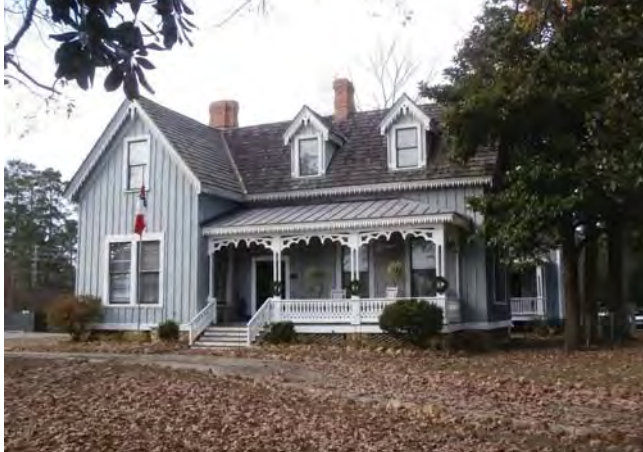
Gothic Revival 1850-1890

Gothic Revival houses typically have steeply pitched gabled roofs with both front-and side-facing gables. Decoratively sawn bargeboards are commonly found along the eaves. Window and door openings often have either pointed arched tops or heavily molded or pointed hoods. Porches are usually supported by slender posts with sawn woodwork forming flattened arches or brackets. Some houses have vertical board-and-batten siding. This style emphasized picturesqueness, verticality, and varied use of materials.

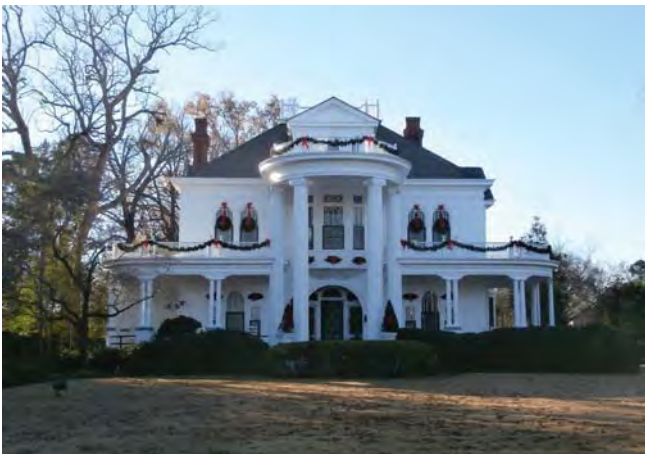
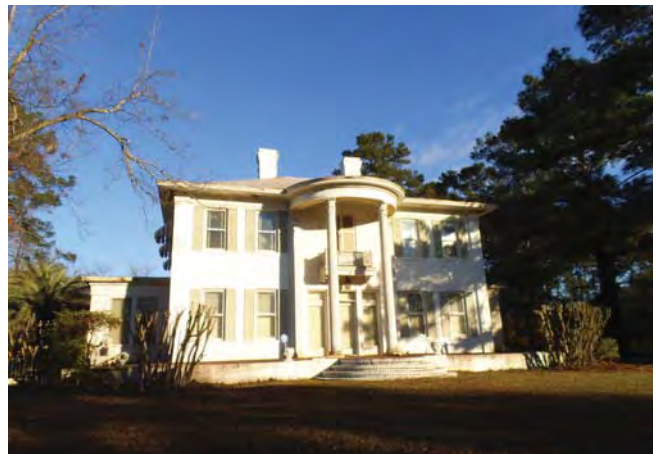
Neoclassical Revival 1895-1940

The most common feature of the Neoclassical Revival style is a dominant full-height front portico with classical columns. The portico may be at the entry or may cover the full facade; it may have a triangular pediment or be part of the overall roof. A full-height entry portico is often coupled with a one-story full-facade porch. The facade is more or less symmetrical, and the central entrance, surrounded with pilasters and columns, is elaborated with fanlights, sidelights, and transoms. There is almost always a classical cornice with dentils or modillions. The roof is usually low-pitched and hipped and may have a balustrade. A porte-cochere and side porches supported by columns are common.

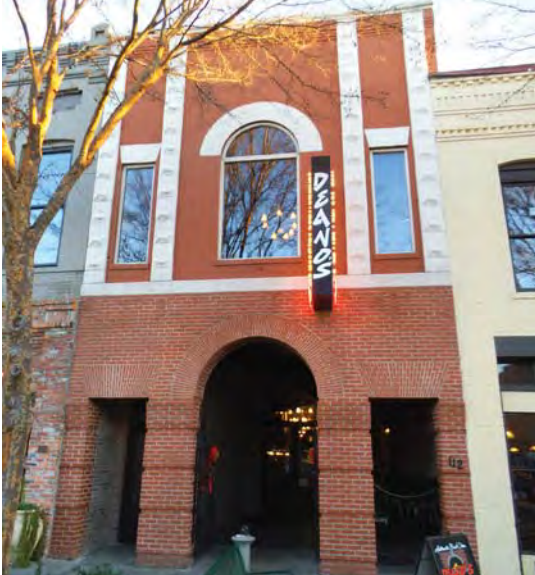
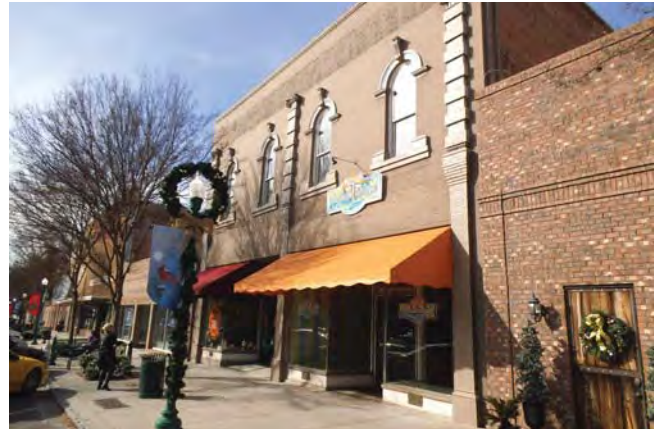
Italianate 1840-1885

Italianate houses are generally asymmetrical with an L-shaped or other irregularly shaped plan and gabled roof. Distinguishing features are the widely overhanging eaves with decorative brackets that emphasize the cornice. Typically tall narrow windows with large two-over-two or one-over-one panes are often paired, arched, and topped with elaborate hoods. Bay windows are also common. Italianate style residential architecture faded out during the 1880s; however, many Italianate style commercial blocks were constructed until the 1890s. The flat topped blocks with brackets and decorative window moldings were two or more stories tall and featured large storefront windows. Brackets beneath eaves are the most distinguishing characteristic of the Italianate commercial block.

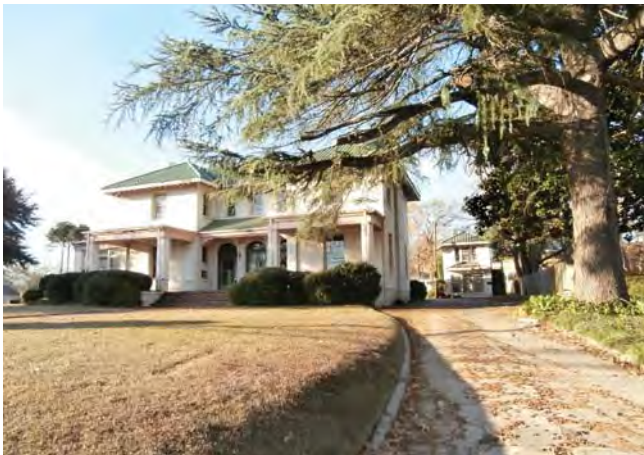
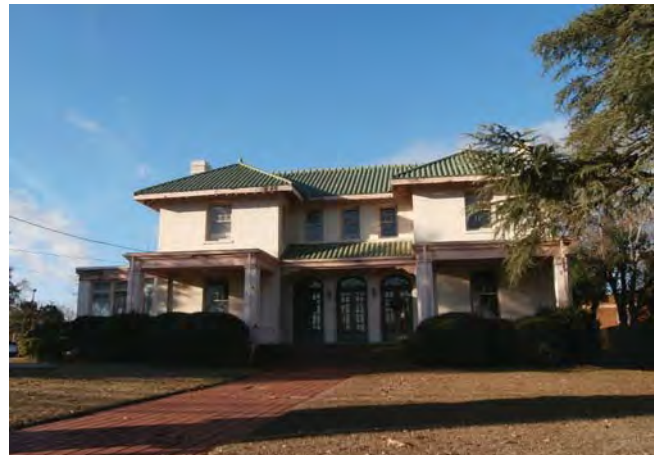
Mediterranean Revival 1890-1910

A Mediterranean Revival house has smooth stuccoed or masonry walls and is usually asymmetrical. The roof is covered with clay tile, is low-pitched, and may be either hipped or gabled. Houses following the Spanish tradition will have little or no eave overhang, while those following the Italian influence will have widely overhanging eaves with exposed rafters. Recessed and arcaded loggias, or open porches, are common. Windows are generally arched and may be grouped together. Sometimes columns and pilasters are used to elaborate openings.

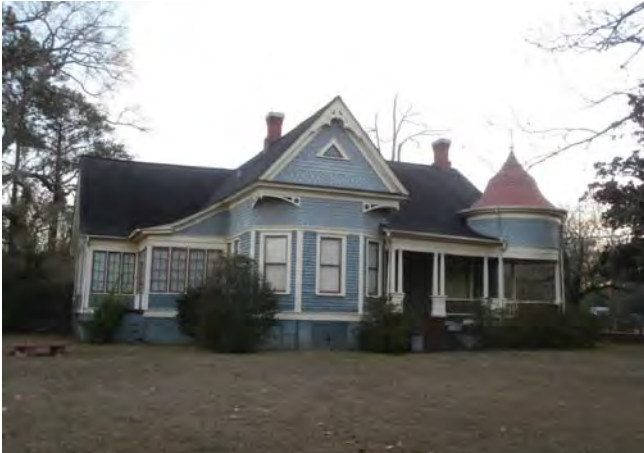
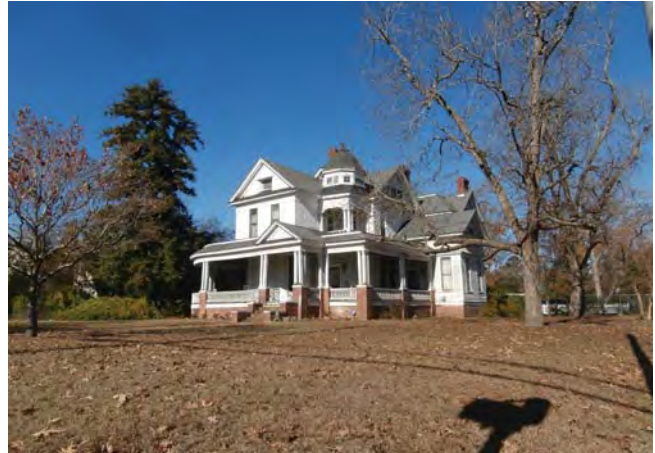
Queen Anne 1880-1915

A Queen Anne style house is asymmetrical with complex roof and wall shapes. It displays a variety of textures, materials, and detailing. The asymmetrical shape results from a floor plan that is open and flowing. The roof is often steeply pitched and hipped with both front-and side-facing, or cross, gables. Wall surfaces avoid a smooth appearance through the use of projecting bays and materials such as patterned shingles that provide texture. The porch is usually asymmetrical and often wraps around two sides of the house. It is supported with slender turned posts and often decorated with sawn brackets and spindlework friezes. Roof gables may also be decorated with sawn ornamentation or spindlework and covered with patterned shingles. There are often prominent and elaborate brick chimneys with patterned and corbeled brickwork. A round or multi-sided tower may be found at a corner.

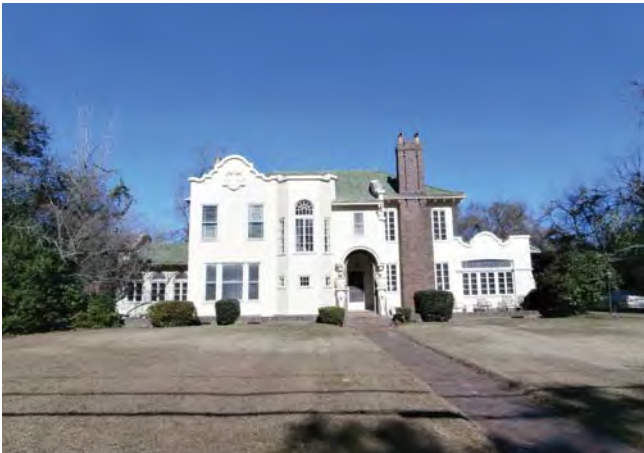
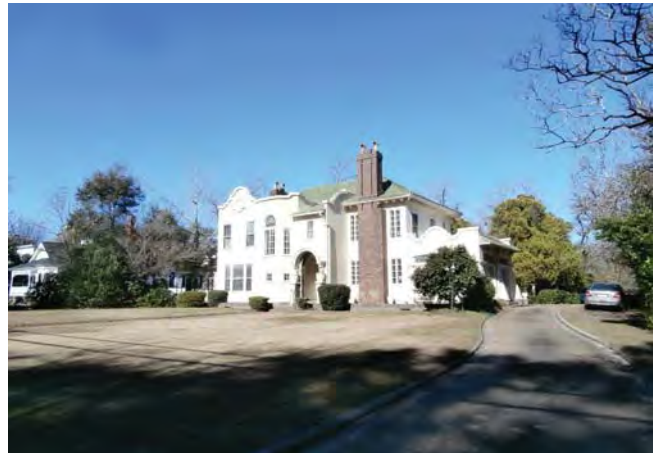
Spanish Colonial Revival 1900-1940

A Spanish Colonial Revival house has a clay tile roof that is usually gabled with little eave overhang. Walls are of smooth stucco. Arched openings and arcaded loggias, or open porches, are common. Windows are generally casement and grouped together. The roof may be elaborated with curvilinear gables or parapets from the mission tradition. Exposed roof beams may protrude from the walls to emphasize construction methods.
