Historic Resources Survey Report

Brantley County, Georgia

July 2016

The University of Georgia
College of Environment and Design
Center for Community Design & Preservation
Historic Resources Survey Report
Brantley County, Georgia 2016

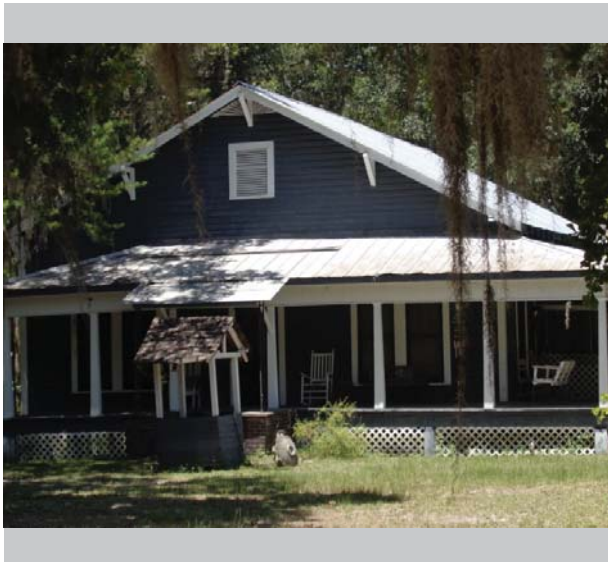
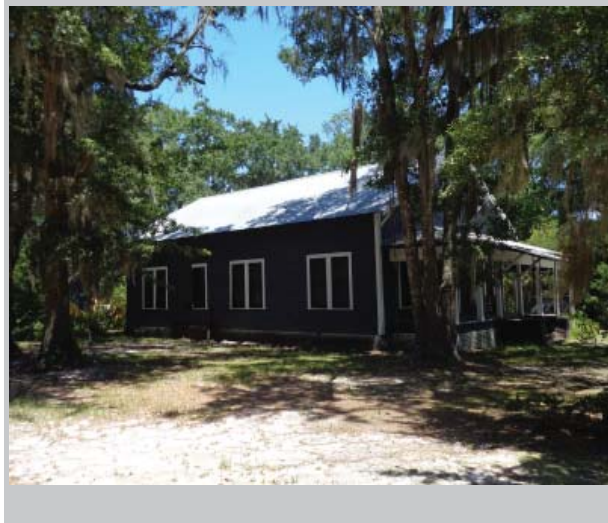
391 Wire Road

- Resource Type** Building
- Resource Use** Residential: Single Family Dwelling
- Date of Construction** c. 1920
- Building Type** Bungalow: Front Gable
- Structural System** Balloon Frame
- Style** No Academic Style
- Roof** Gable: Front
- Exterior Cladding** Wood: Clapboard
- Foundation** Pier with Infill: Concrete
- Porch** Wrap-Around
- Windows** Double Hung Sash: 3/1, Rectangle
- Chimney** No Chimney Observed
- Additional Notes** Possible right side alteration
Lattice infill foundation
Original windows

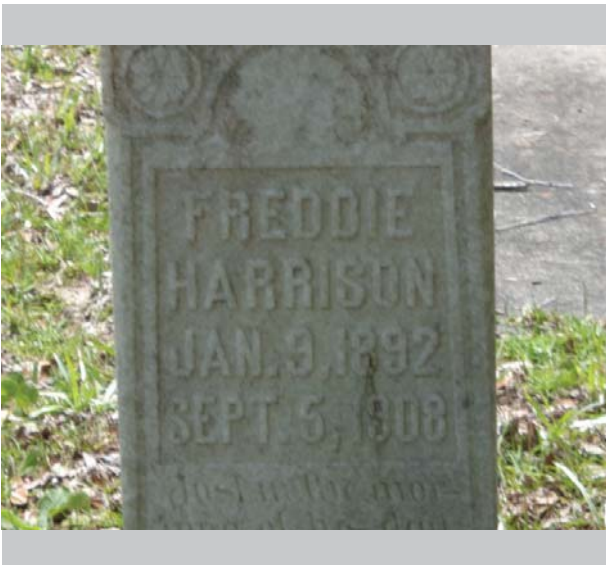
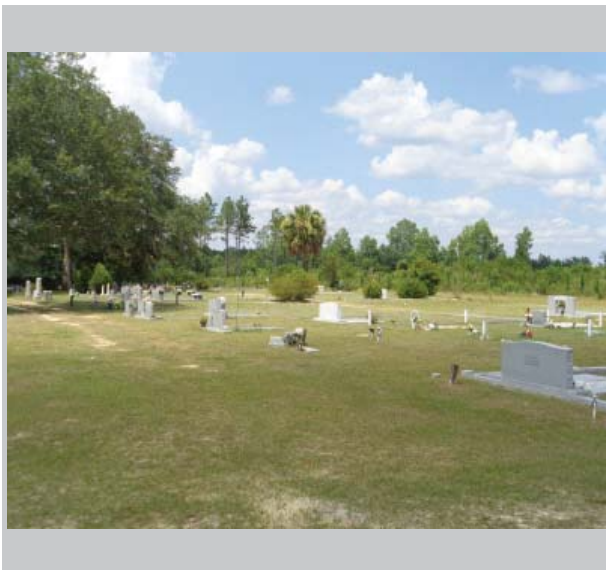
Mount Olive Cemetery
NW of Mt. Olive Rd and Post Rd Intersection

Oldest Burial 1908

Burial Description CSA

Cemetery Description Three obelisks
Granite outlined family plots

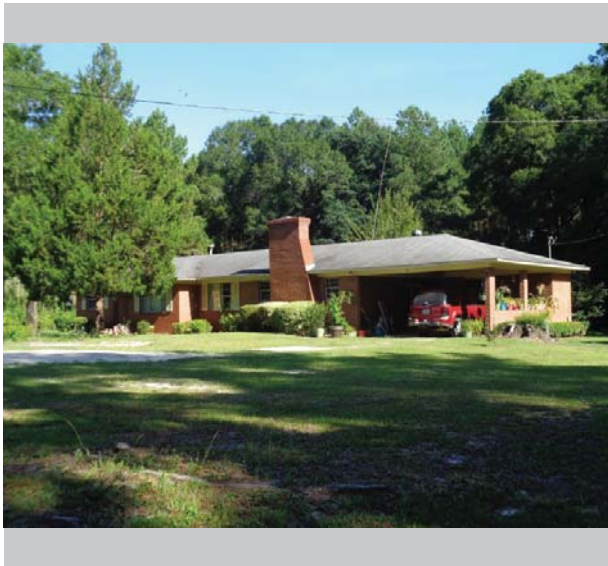
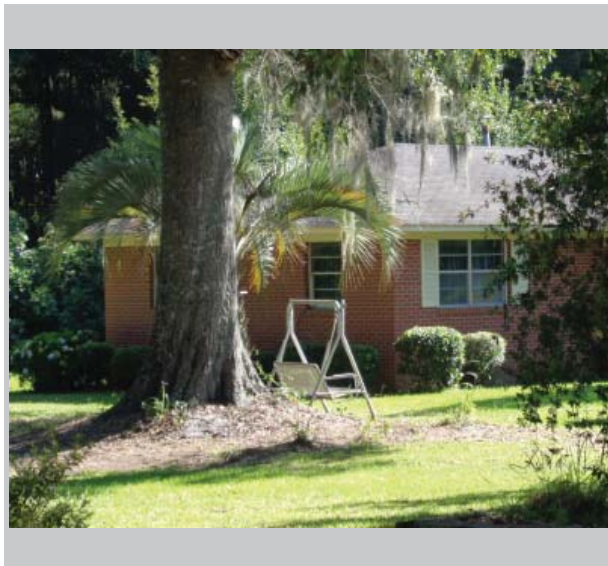
Coordinates: 31.34472, -81.97176

- Resource Type** Building
- Resource Use** Domestic: Single Family Dwelling
- Date of Construction** c. 1960
- Building Type** Ranch
- Structural System** Balloon Frame
- Style** No Academic Style
- Roof** Hip
- Exterior Cladding** Brick: Common
- Foundation** Unknown
- Porch** Stoop
- Windows** Double Hung Sash: 2/2, Rectangle
- Chimney** Lateral Exterior: Brick
- Additional Notes** Pronounced tapered chimney on front facade
Chicago window
Wrought iron on stoop

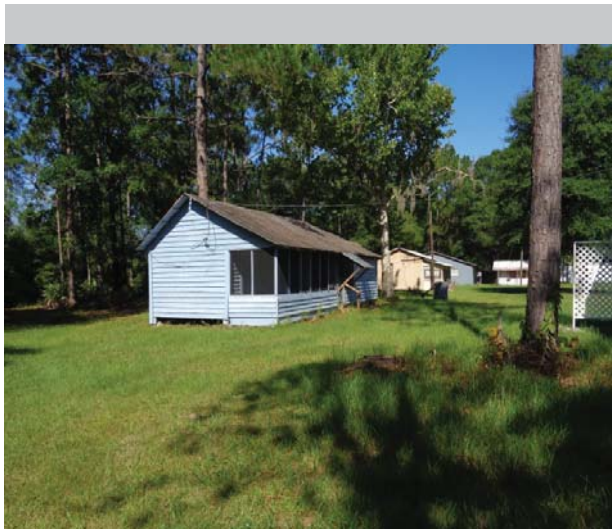
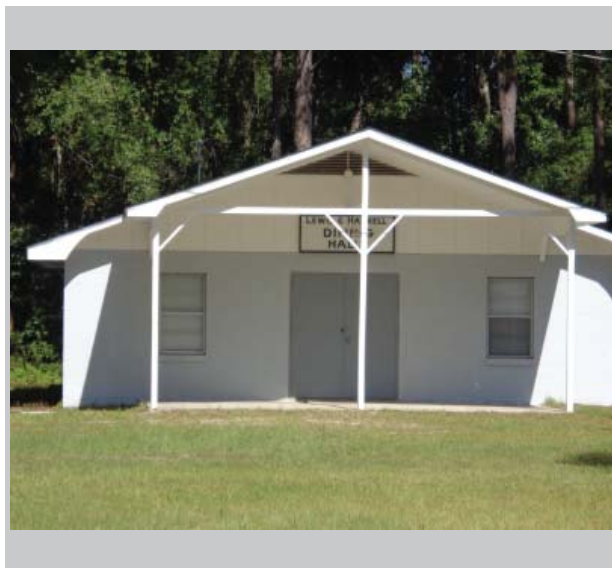
Hortense Wesleyan Camp Meeting
200-698 Tabernacle Road

Resource Use Religious: Campground

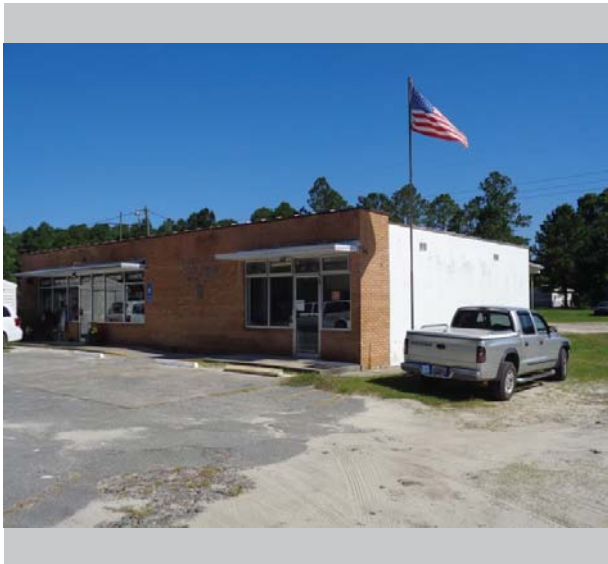
Coordinates: 31.33660, -81.95586

- Resource Type** Building
- Resource Use** Post Office, Retail Store
- Date of Construction** c. 1968
- Building Type** Commercial Storefront
- Structural System** Balloon Frame
- Style** No Academic Style
- Roof** Shed/Pent
- Exterior Cladding** Brick: Common
- Foundation** Unknown
- Porch** Stoop
- Windows** Fixed: 1/1, Rectangle
- Chimney** No chimney observed
- Additional Notes** Mid-century modern
Brick facade
Small porch at each entrance

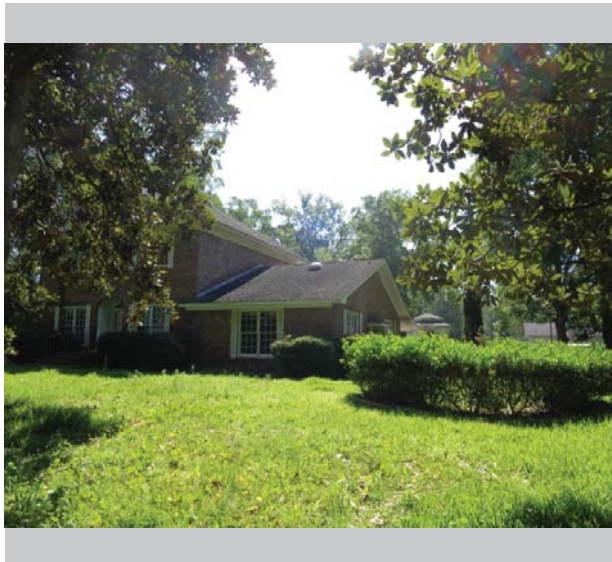
Coordinates: 31.33733, -81.95390

- Resource Type** Building
- Resource Use** Domestic: Single Family Dwelling
- Date of Construction** c. 1920
- Building Type** American Foursquare
- Structural System** Balloon Frame
- Style** No Academic Style
- Roof** Pyramidal
- Exterior Cladding** Brick: Common
- Foundation** Unknown
- Porch** Recessed
- Windows** Double Hung Sash: 6/6, Rectangle
- Chimney** No chimney observed
- Additional Notes** Side additions
Sidelights, fanlight on main entry door
Arched recessed entry

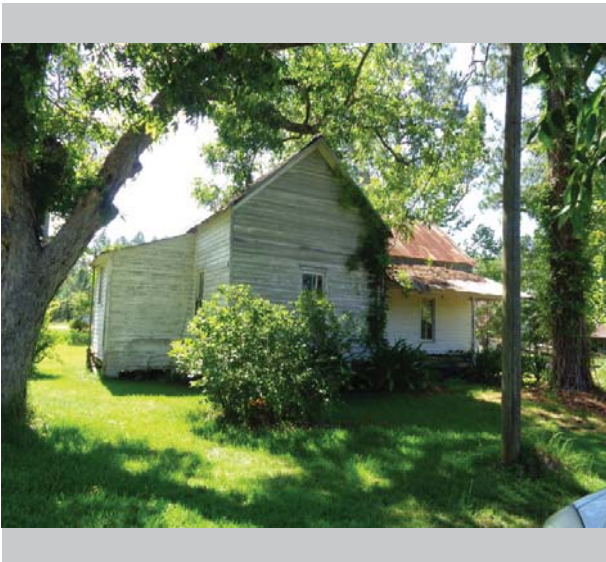
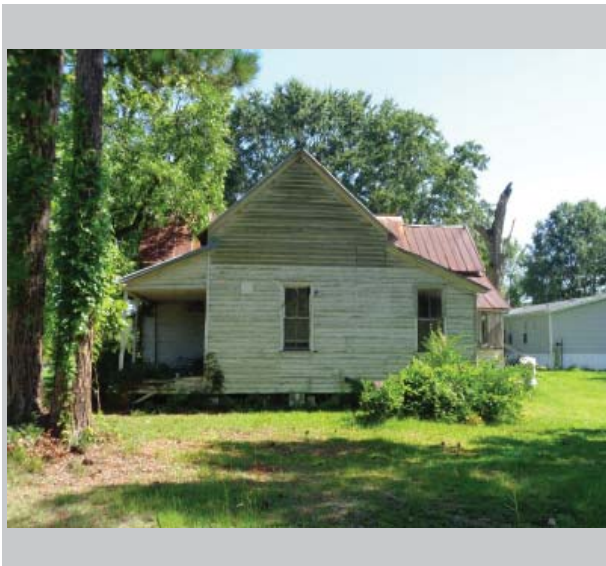
Coordinates: 31.33834, -81.95023

- Resource Type** Building
- Resource Use** Domestic: Single Family Dwelling
- Date of Construction** c. 1900
- Building Type** Gabled Ell Cottage
- Structural System** Balloon Frame
- Style** No Academic Style
- Roof** Gable: Multi
- Exterior Cladding** Wood: Clapboard
- Foundation** Pier: Brick
- Porch** Verandah
- Windows** Double Hung Sash: 2/2, Rectangle
- Chimney** No chimney observed
- Additional Notes** Original windows
Turned wood porch supports
Historic addition on left

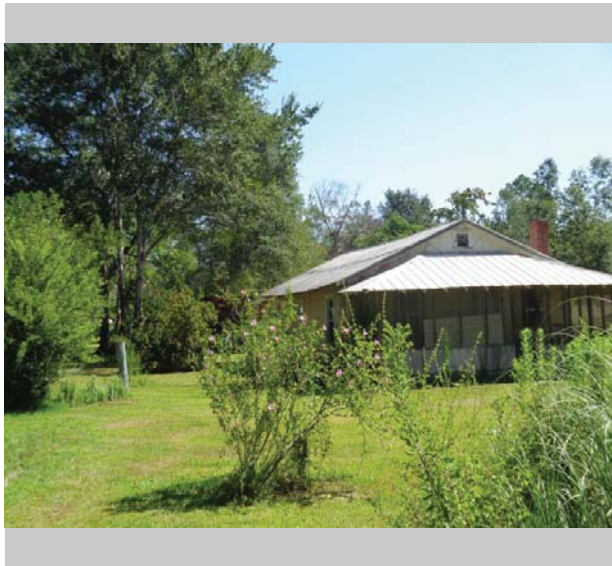
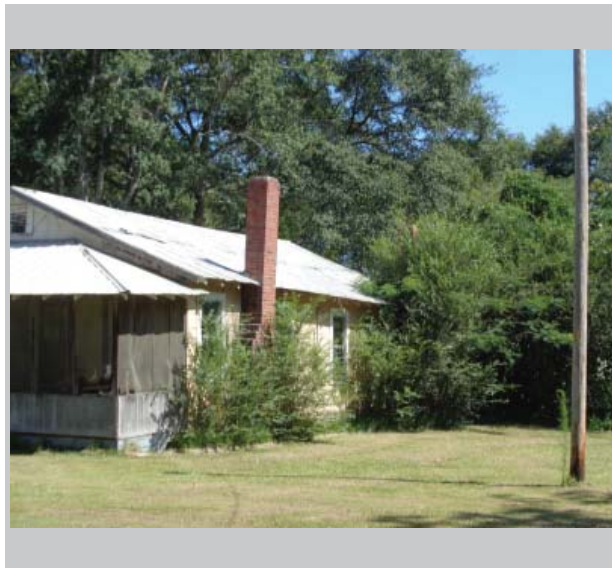
Intersection of State Rd 139 and
Old Hortense Road

Additional Notes Vent in front gable
Foundation covered
Screened porch
Screened windows

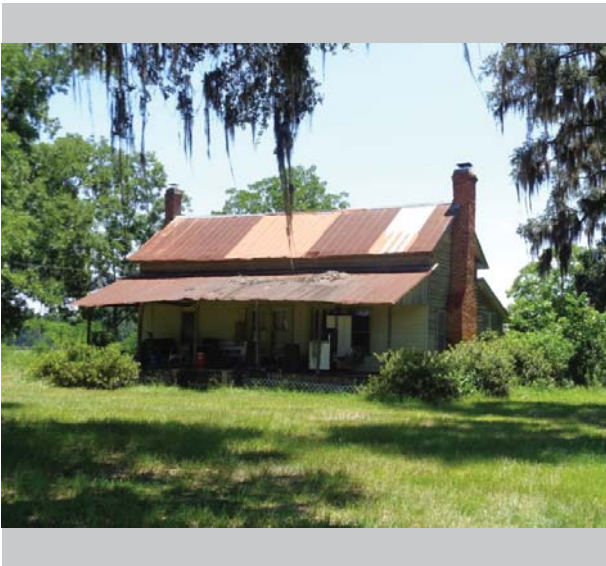
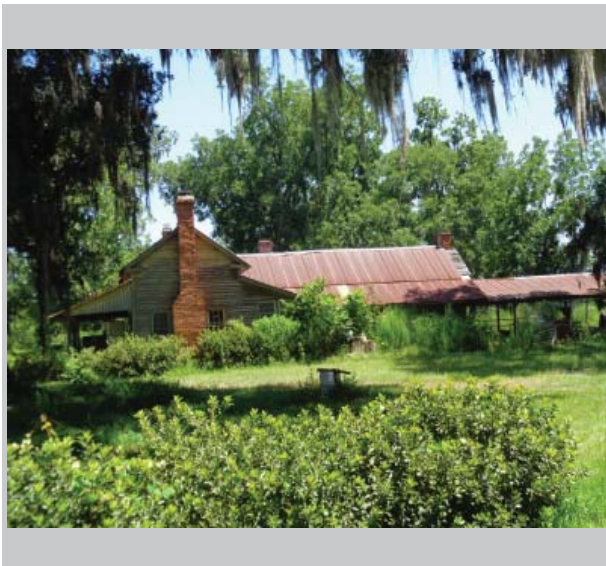
Coordinates: 31.30485, -81.99253

Resource Type Building
Resource Use Residential: Single Family Dwelling
Date of Construction c. 1900
Building Type Extended Hall Parlor
Structural System Balloon Frame
Style No Academic Style
Roof Gable: Side
Exterior Cladding Wood: Weatherboard
Foundation Unknown
Porch Verandah
Windows Double Hung Sash: 3/1, Rectangle
Chimney Gable-End Exterior, Lateral Interior: Brick
Additional Notes Historic addition
Windows original
New siding on porch facade

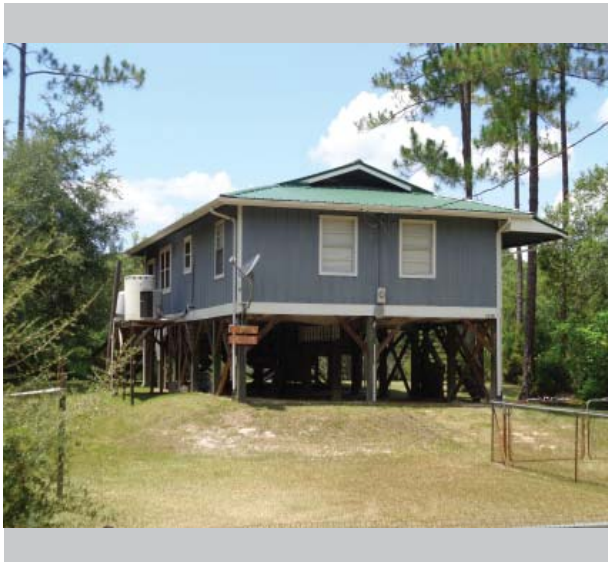
Coordinates: 31.2397, -81.86929

- Resource Type** Building
- Resource Use** Residential: Single Family Dwelling
- Date of Construction** 1960
- Building Type** Ranch
- Structural System** Balloon Frame
- Style** No Academic Style
- Roof** Gable:Side
- Exterior Cladding** Wood: Vertical Board
- Foundation** Pier: Wood
- Porch** Verandah
- Windows** Double Hung Sash: 6/6, Rectangular
- Chimney** No Chimney Observed
- Additional Notes** Hip on gable roof. Linear ranch on stilts. Part of community stilted. Vacation homes.

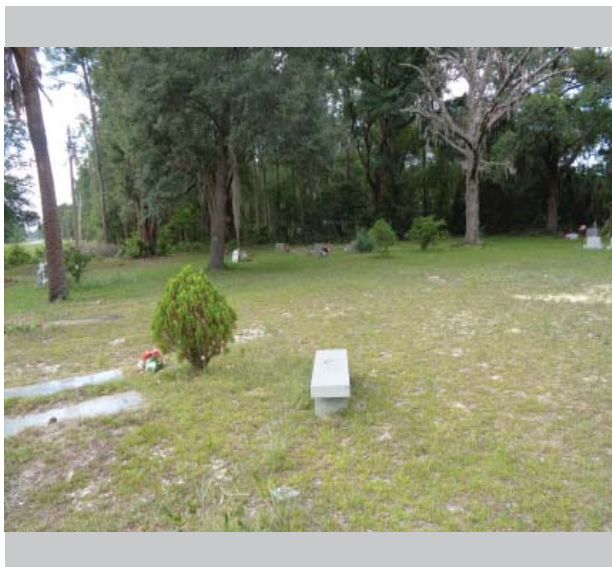
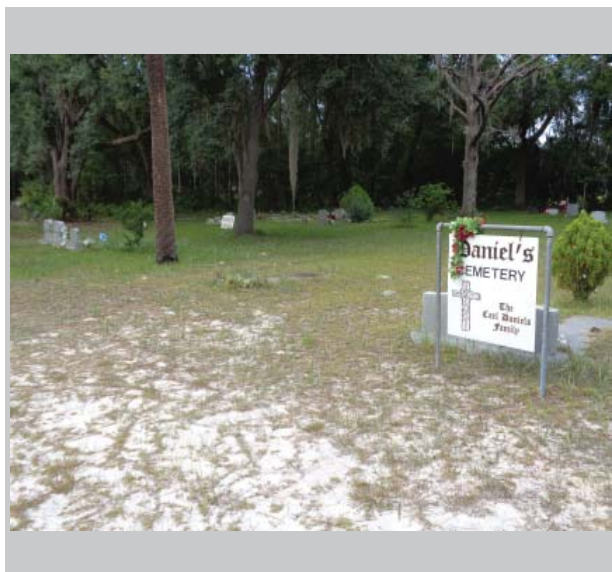
Daniel's Cemetery
 514 Georgia 10

Resource Type Site

Resource Use Funerary: Cemetery

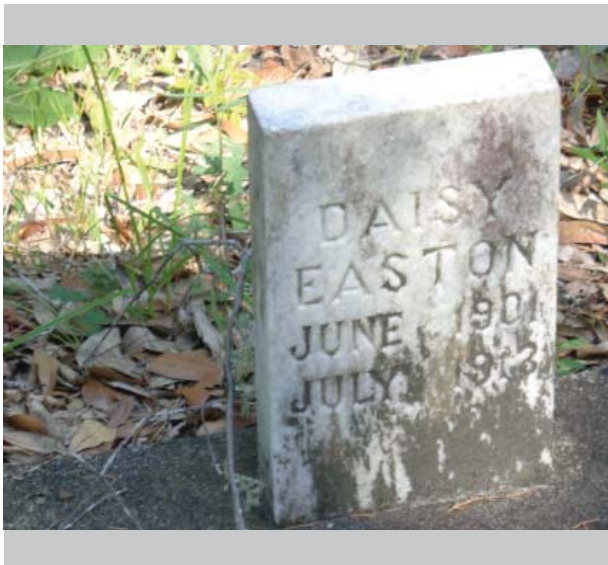
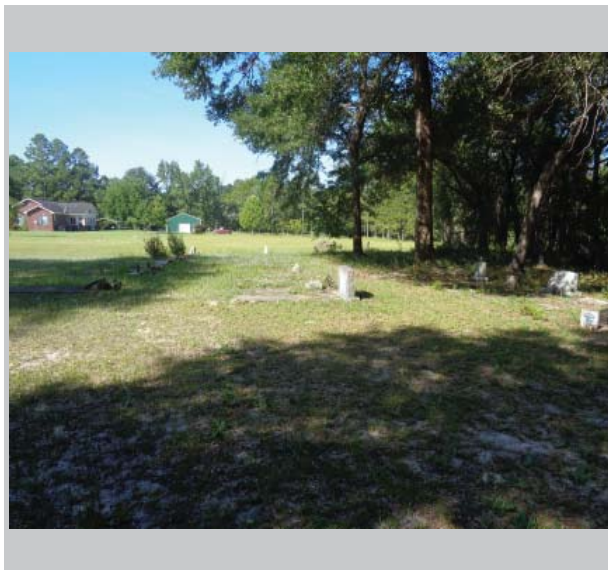
Sand Hill Cemetery
2027 Old State Route 259

Resource Type Site

Resource Use Funerary: Cemetery

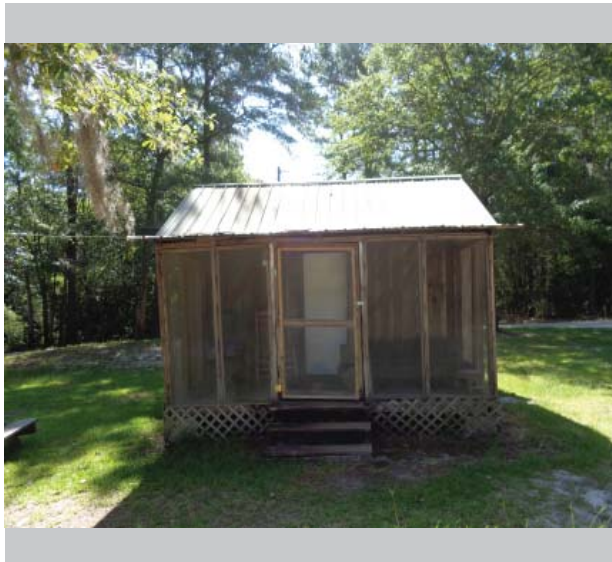
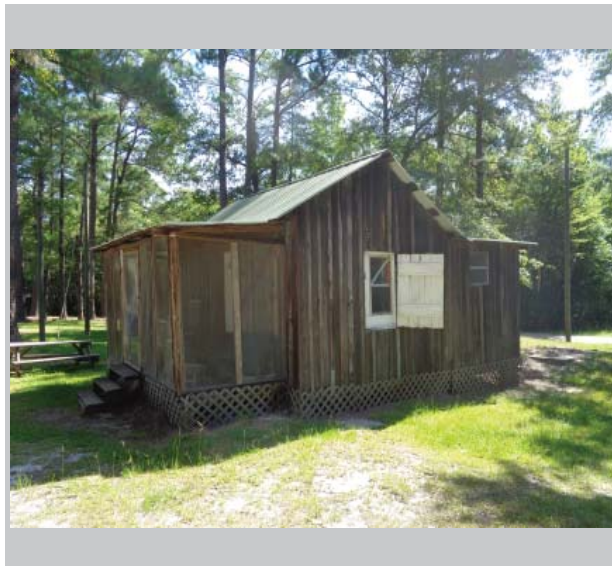
5 Red Cohen Road

Resource Type Building

Resource Use Residential: Single Family Dwelling

Foundation Pier: Concrete

Chimney No Chimney Observed

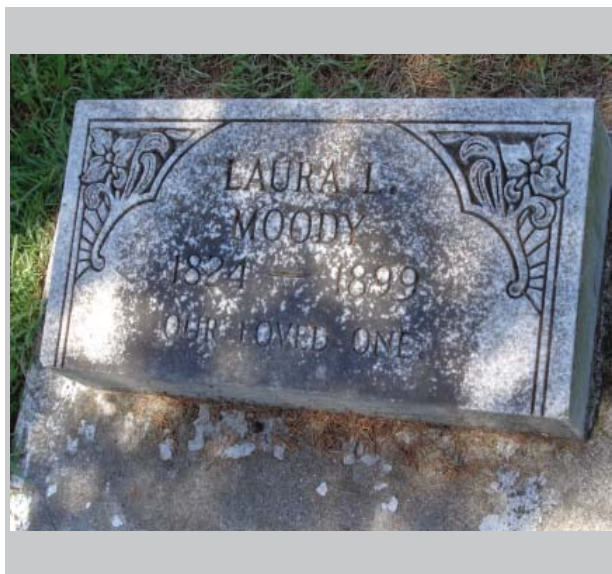
Lewis Cemetery
Near 12847 Raybon Road West

Resource Type Site

Resource Use Funerary: Cemetery

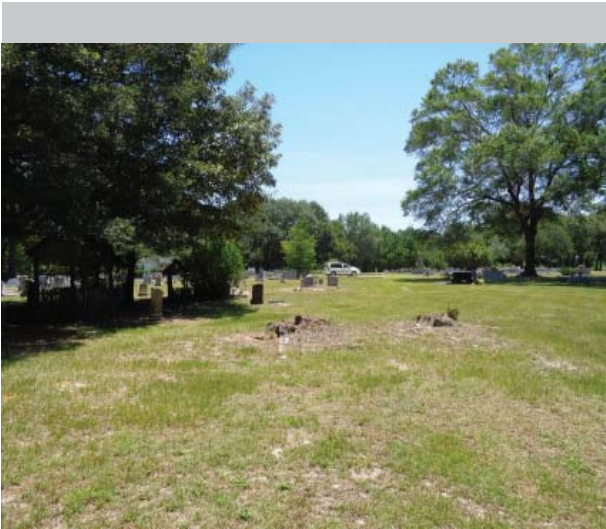
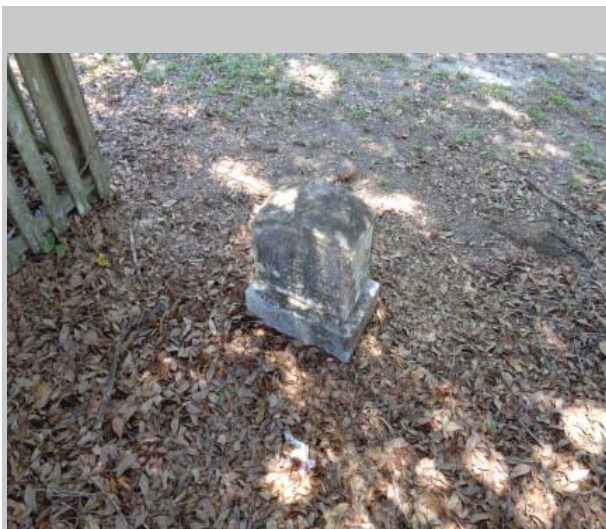
Bethlehem Cemetery
Near 4813 Bachlott Church Road

Resource Type Site

Resource Use Funerary: Cemetery

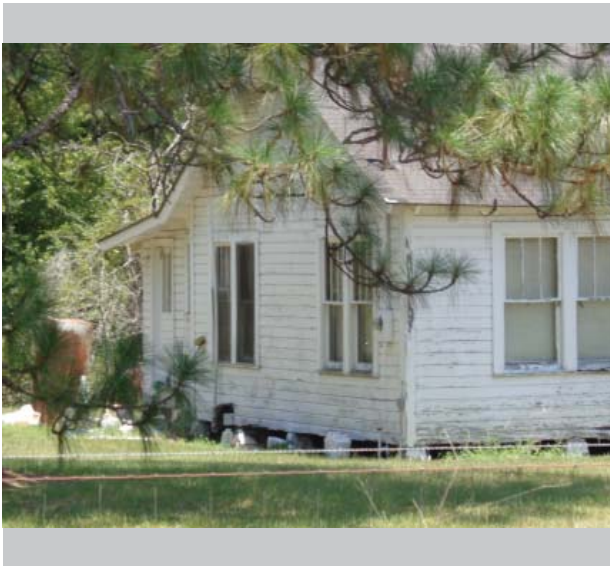
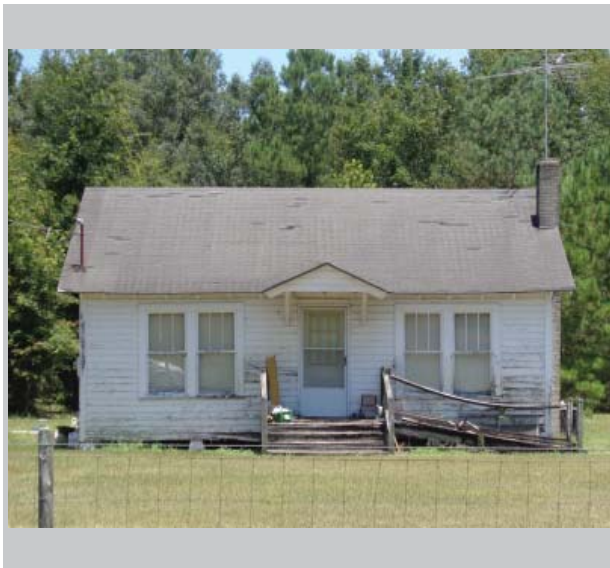
527 County Road 79

Resource Type Building

Resource Use Residential: Single Family Dwelling

Foundation Pier: Concrete

Additional Notes Craftsman: 2 paired 3/1 windows either side of door. Exposed rafters. Poured concrete found.

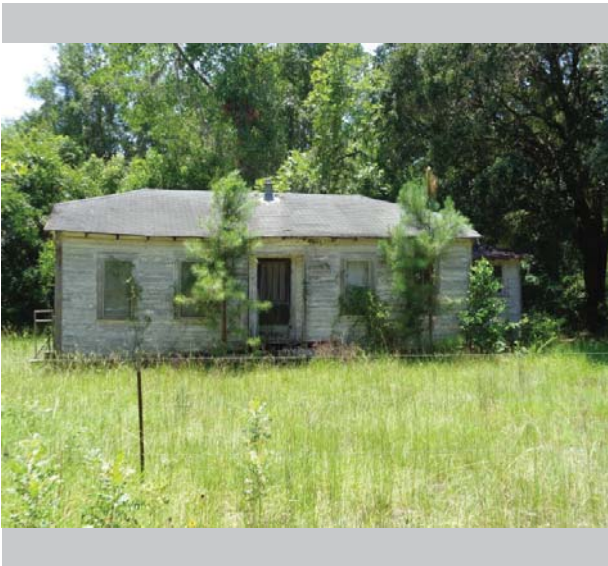
Coordinates: 31.11927, -81.94805

- Resource Type** Building
- Resource Use** Vacant
- Date of Construction** 1920
- Building Type** Bungalow: Side Gable
- Structural System** Balloon Frame
- Style** Craftsman
- Roof** Gable:Side
- Exterior Cladding** Wood: Weatherboard
- Foundation** Unknown
- Porch** Stoop
- Windows** Double Hung Sash: 2/2, Rectangular
- Chimney** No Chimney Observed
- Additional Notes** Craftsman style doors and windows. Central chimney pot. Side hip on gable. Collapsing addition on R.

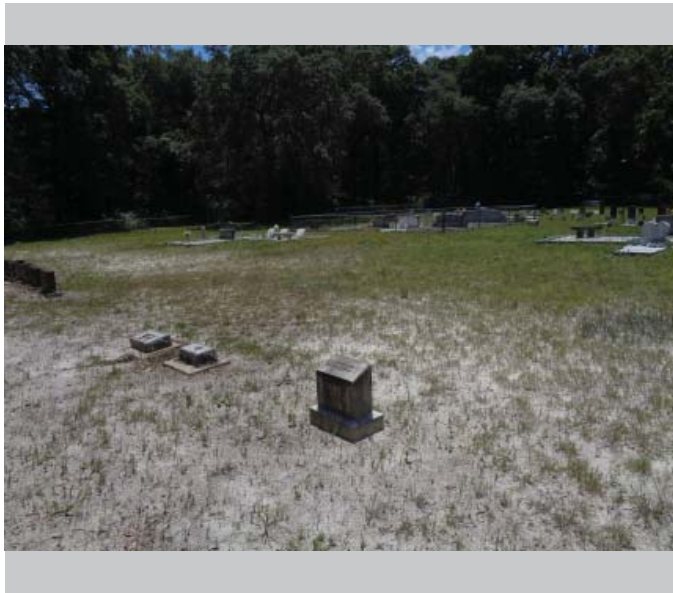
Coordinates: 31.08898,-81.1

Cemetery Description Active Use. Sever
marked with sticl
Outlined family p
Ledger stones. Cl
fence surroundin
cemetery.

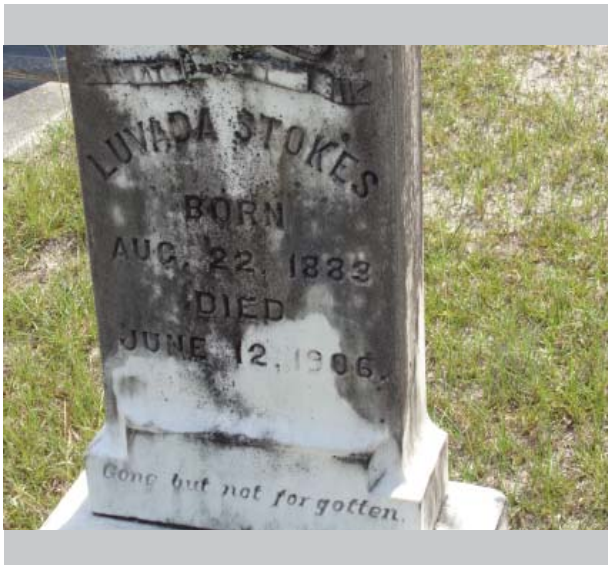
Oak Grove Cemetery
10925 Raybon Road West

Resource Type Site

Resource Use Funerary: Cemetery

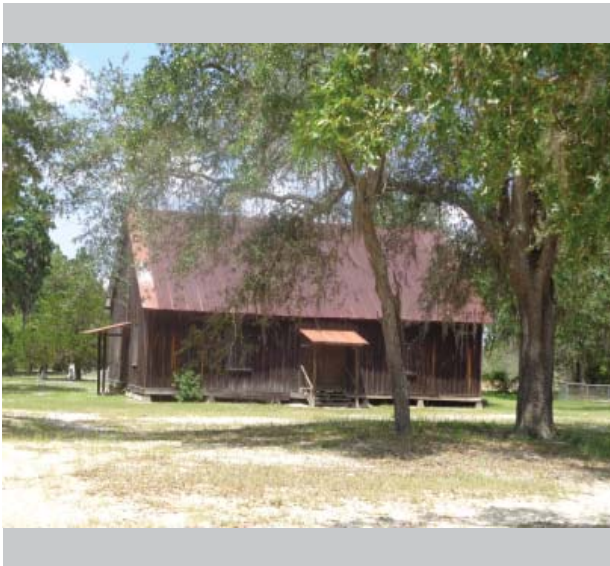
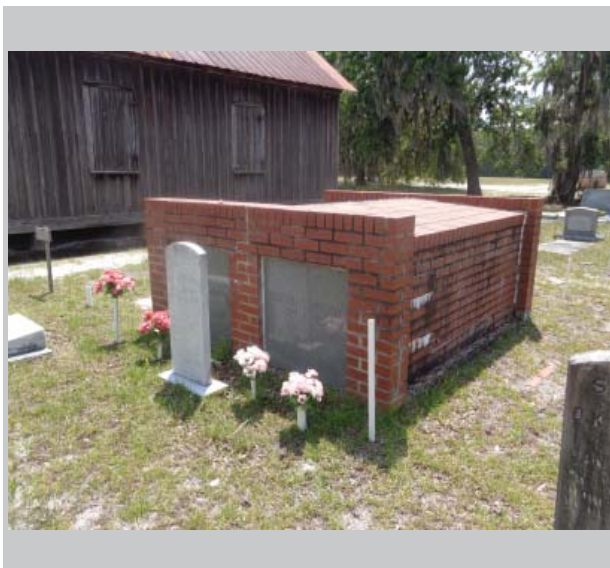
Smyrna Church
Smyrna Church Rd, 150 yds N of Gilman Rd
Coordinates: 31.238918, -81.889426

Resource Type Building

Resource Use Religious: Church

Foundation Pier: Concrete

Chimney No Chimney Observed

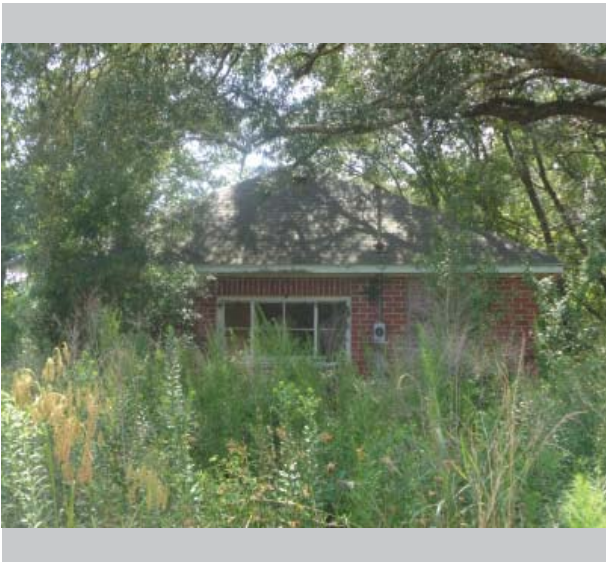
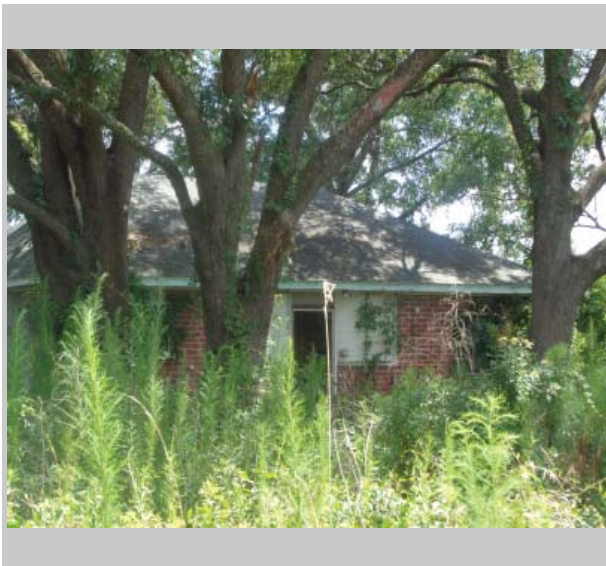
Coordinates: 31.214767, -81.902529

- Resource Type** Building
- Resource Use** Residential: Single Family Dwelling
- Date of Construction** 1950
- Building Type** Unknown
- Structural System** Balloon Frame
- Style** No Academic Style
- Roof** Hip
- Exterior Cladding** Wood: Brick
- Foundation** Unknown
- Porch** Recessed
- Windows** Double Hung Sash: 2/2, Rectangular. 4/4 Fixed.
- Chimney** No Chimney Observed
- Additional Notes** Obscured by vegetation. Different colored brick sections on side and porch. Fixed window on R.

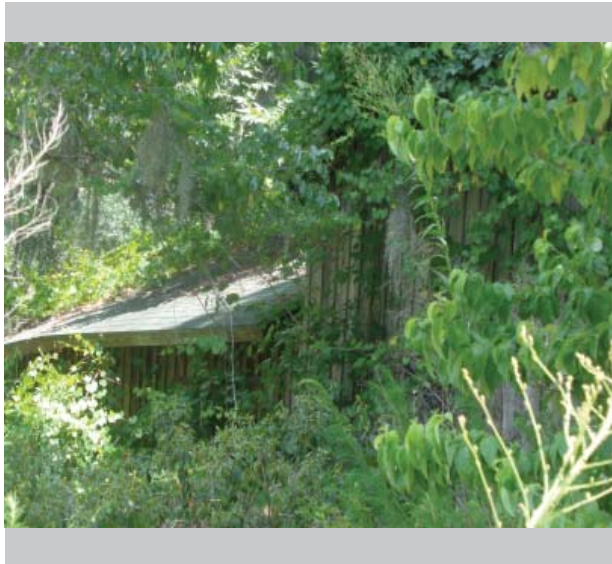
838 Smyrna Church Road

Resource Type Building

Resource Use Residential: Single Family Dwelling

Foundation Pier: Concrete

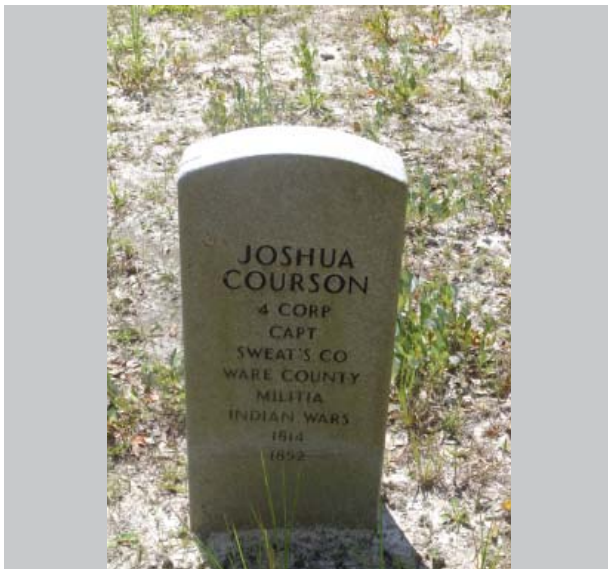
Knox Cemetery
On Knox Cemetery Rd, .5 mi E of Knox Rd
Coordinates: 31.154479, -81.903479

Resource Type Site

Resource Use Funerary: Cemetery

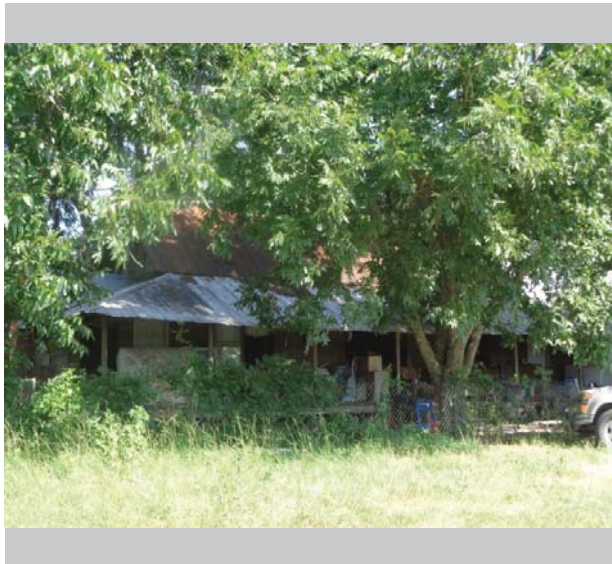
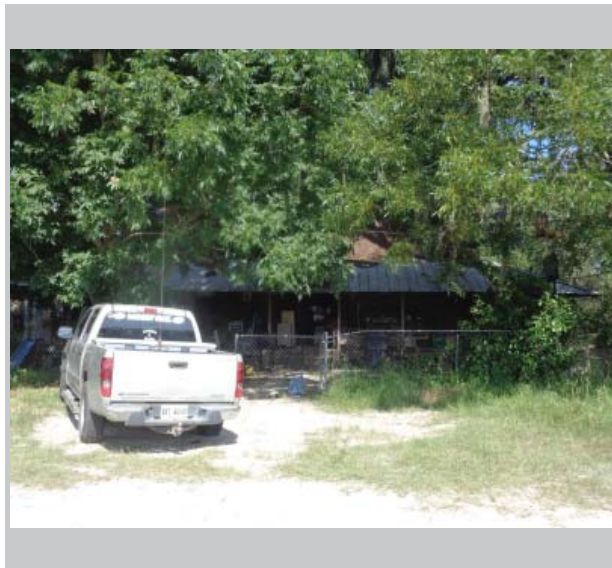
528 White Ford road

Resource Type Building

Resource Use Residential: Single Family Dwelling

Foundation Unknown

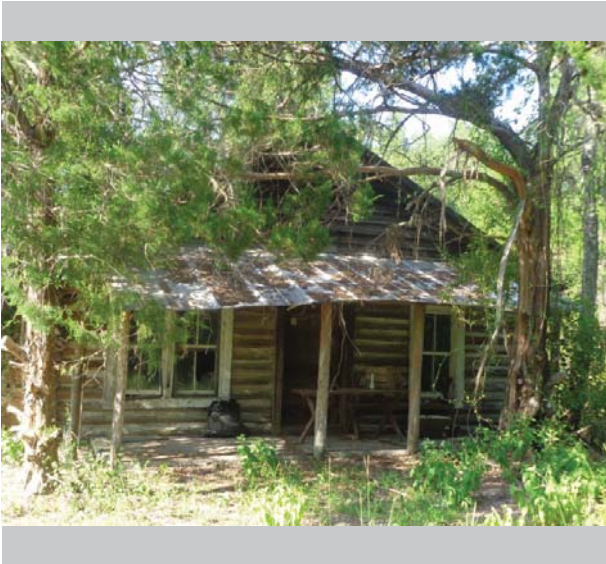
Coordinates:

- Resource Type** Building
- Resource Use** Vacant
- Date of Construction** 1910
- Building Type** Central Hallway
- Structural System** Balloon Frame
- Style** No Academic Style
- Roof** Gable:front
- Exterior Cladding** Wood: log
- Foundation** Unknown
- Porch** Verandah
- Windows** Double Hung Sash: 2/2
- Chimney** Ridgeline, center: Brick
- Additional Notes** Log construction with original chinking
Possible rear addition

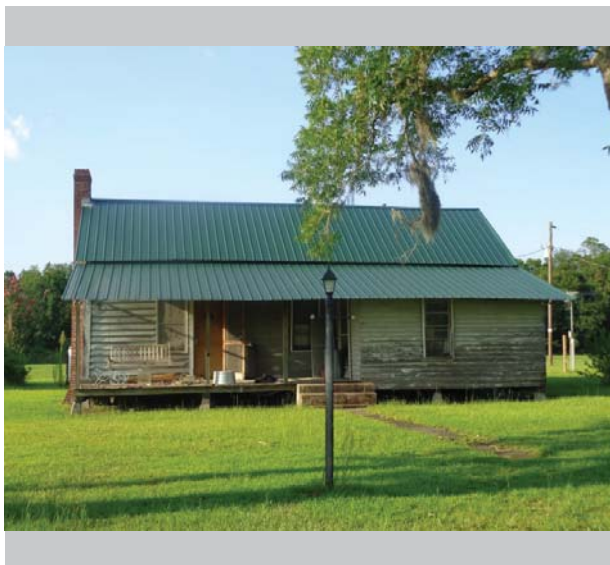
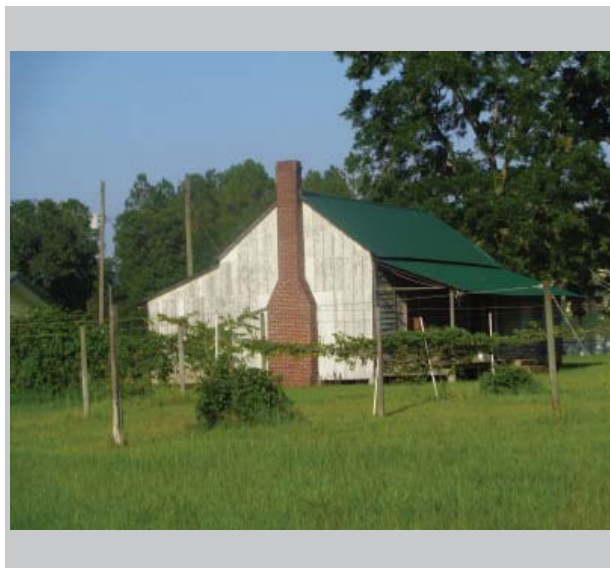
Cecil Herrin Loop approx 380 yards from Ern Rd.

Resource Type Building

Resource Use residential: Single Family Dwelling

Foundation Pier: brick

Additional Notes Right side porch enclosure
Replacement materials

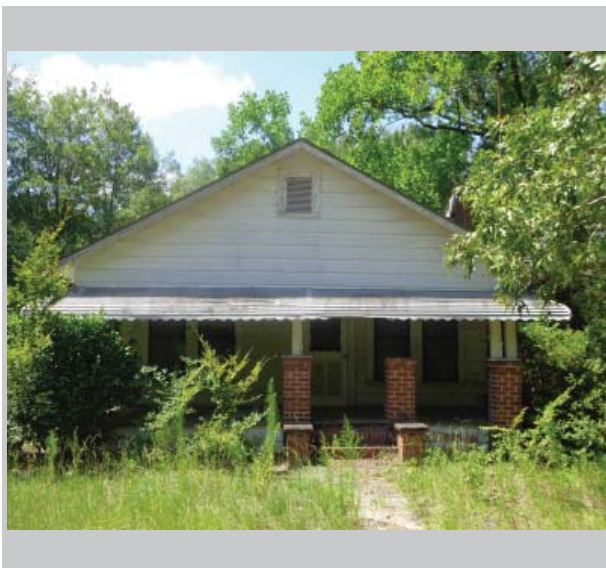
Coordinates: 31.195832, -82.218113

- Resource Type** Building
- Resource Use** Residential: Single Family Dwelling
- Date of Construction** 1940
- Building Type** Bungalow: Front gable
- Structural System** Balloon Frame
- Style** No Academic Style
- Roof** Gable: Front
- Exterior Cladding** Wood: Weatherboard
- Foundation** Unknown
- Porch** Verandah
- Windows** Double Hung Sash: 4/1, Rectangular
- Chimney** Lateral Exterior: Brick
- Additional Notes** Alum. siding around foundation and in gable. Mid century awnings. Missing porch supports.

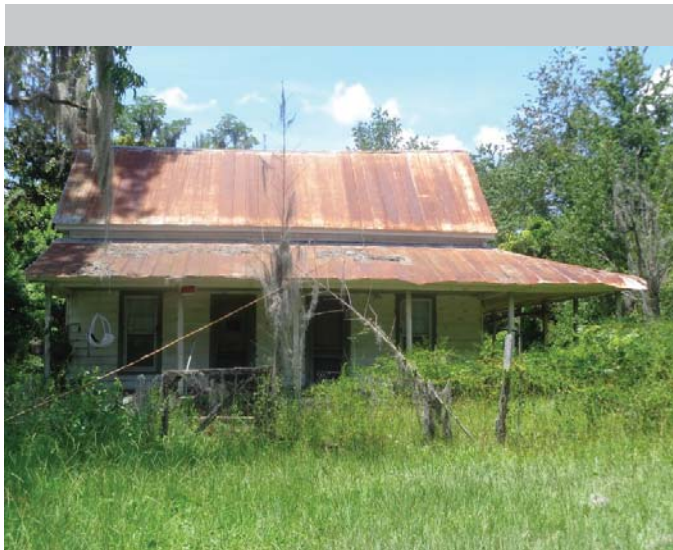
Coordinates: 31.15122, -81.

- Resource Type** Building
- Resource Use** Vacant
- Date of Construction** 1920
- Building Type** Double Pen
- Structural System** Balloon Frame
- Style** No Academic Sty
- Roof** Gable:Side
- Exterior Cladding** Wood: Weatherb
- Foundation** Unknown
- Porch** Wrap Around
- Windows** Double Hung Sas Rectangular
- Chimney** Gable End Exteri
- Additional Notes** Wrap around por
historic addition.
doors > windows

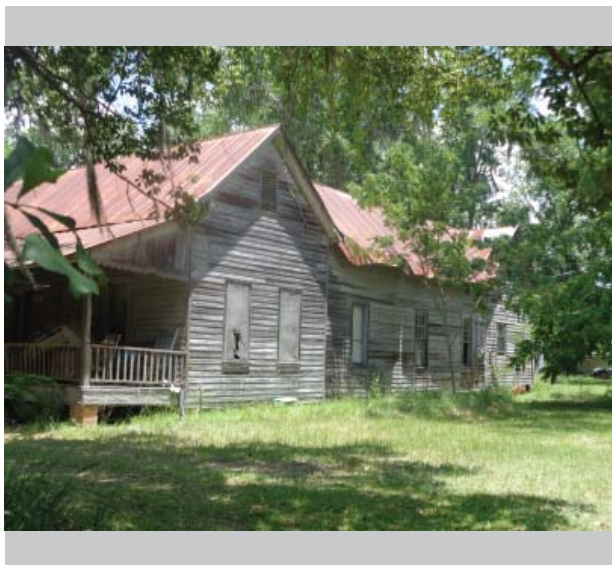
7545 Hoke Circle / Caney Bay

Resource Type Building

Resource Use Residential: Single Family Dwelling

Foundation Pier with Infill:Brick

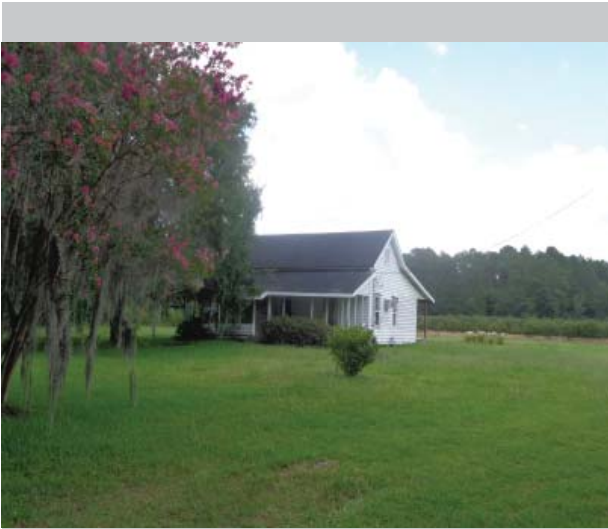
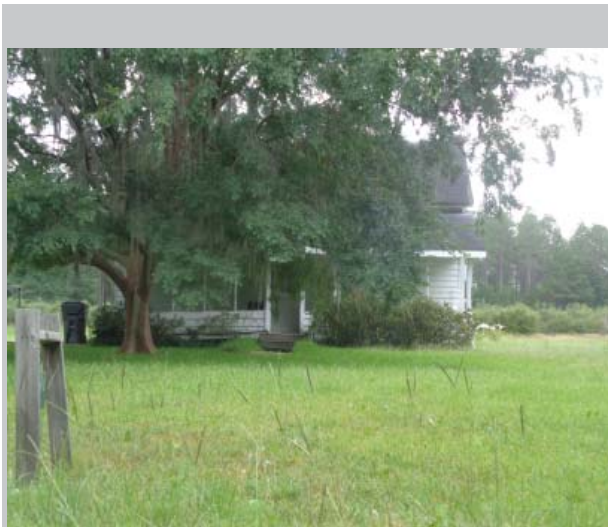
Coordinates: 31.18797, -82.00645

- Resource Type** Building
- Resource Use** Residential: Single Family Dwelling
- Date of Construction** 1910
- Building Type** Central Hallway
- Structural System** Balloon Frame
- Style** No Academic Style
- Roof** Gable:Side
- Exterior Cladding** Wood: Weatherboard
- Foundation** Unknown
- Porch** Verandah
- Windows** Unknown
- Chimney** No Chimney Observed
- Additional Notes** Carport addition.
Materials replaced.
Windows can't be seen because of vegetation.

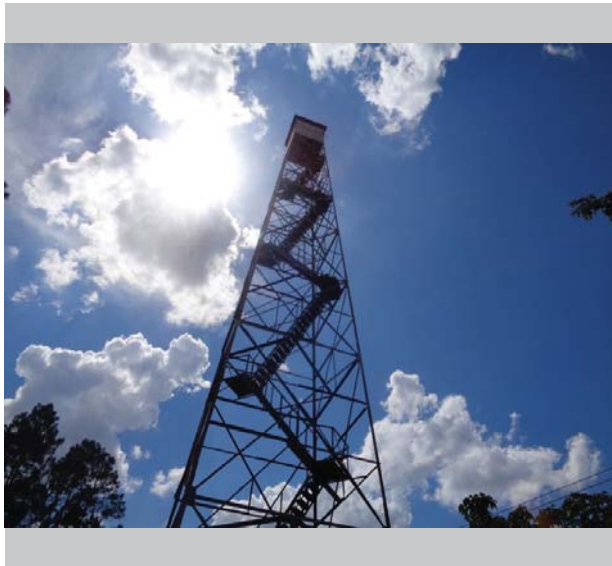
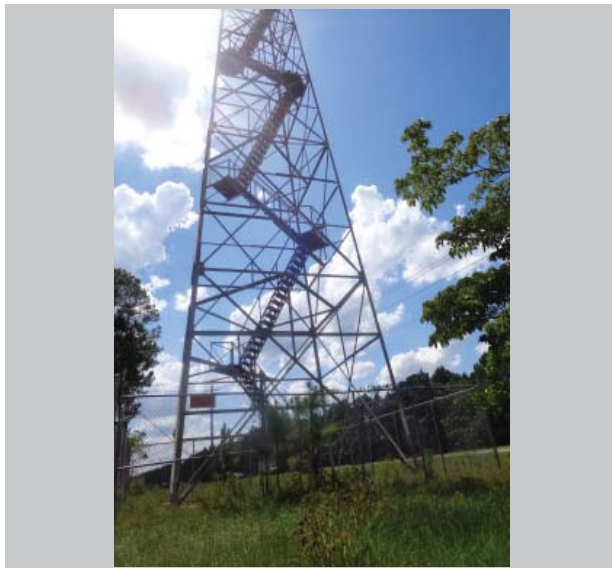
Fire Tower
On HWY 82, .5 mi W of Silas Harris Rd
Coordinates: 31.189393, -82.080005

Resource Type Structure

Resource Use Fire Tower

Foundation N/A

Chimney No Chimney Observed

Additional Notes Lookout fire tower. Chain link fence surrounding. Metal appears to be rusting. Off HWY 82.

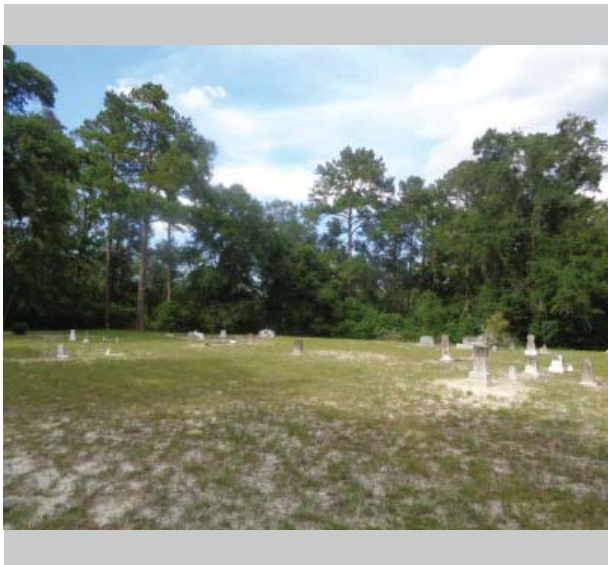
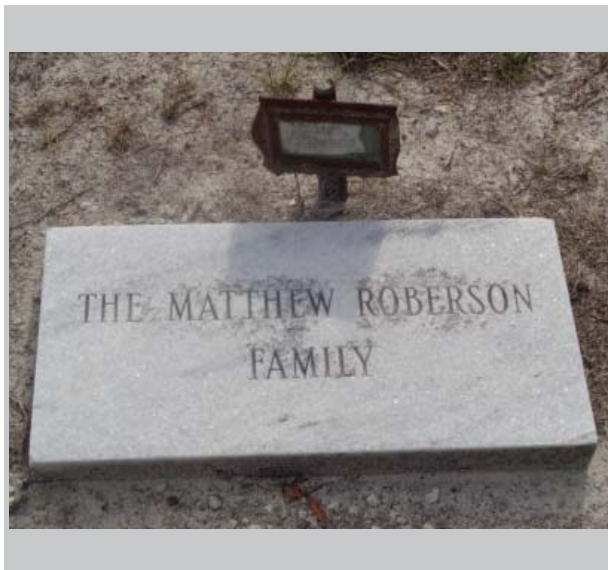
Moore Cemetery
Unmarked rd off Saddle Club Rd

Resource Type Site

Resource Use Funerary: Cemetery

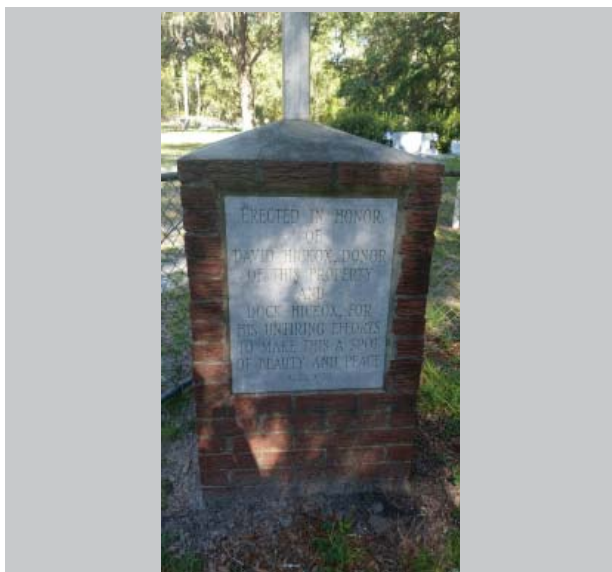
Thrift Cemetery
 Creek Drive, ~.5 N of Mars Hill Rd

Resource Type Site

Resource Use Funerary: Cemetery

Date of Construction 1919

Common Names Hickox, Cox

≈ Number of Burials 40

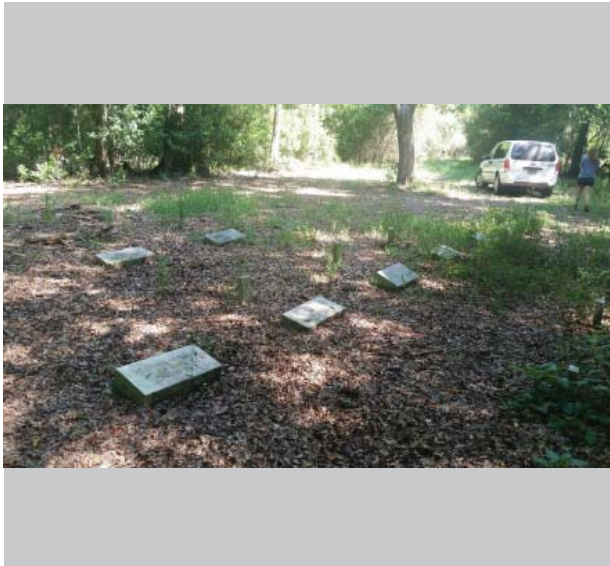
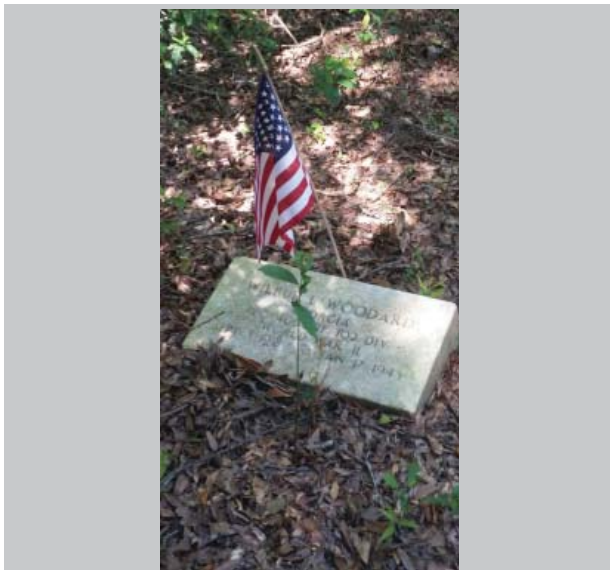
Martin Cemetery
Deadend of Red Trail, south of Bay Rd
Coordinates: 31.166101, -82.146991

Resource Type Site
Resource Use Funerary: Cemetery
Date of Construction 1905
Common Names Martin, Woodard, Wainwright
≈ Number of Burials 13
Oldest Burial 1905
Burial Description WWII
Cemetery Description No longer active use. Overgrown road leading to small circular field surrounded by natural forest. All flat granite headstone, uniform and in rows. Shade trees, slightly overgrown. Some stones without dates.

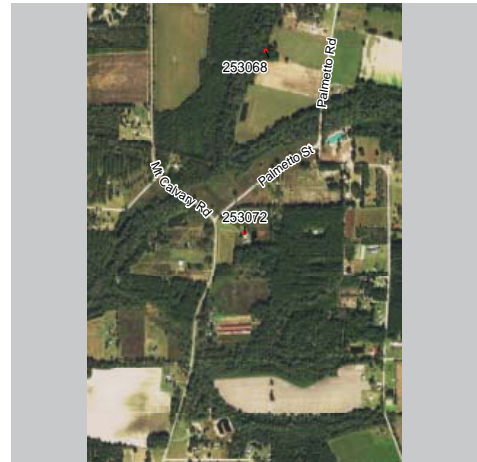
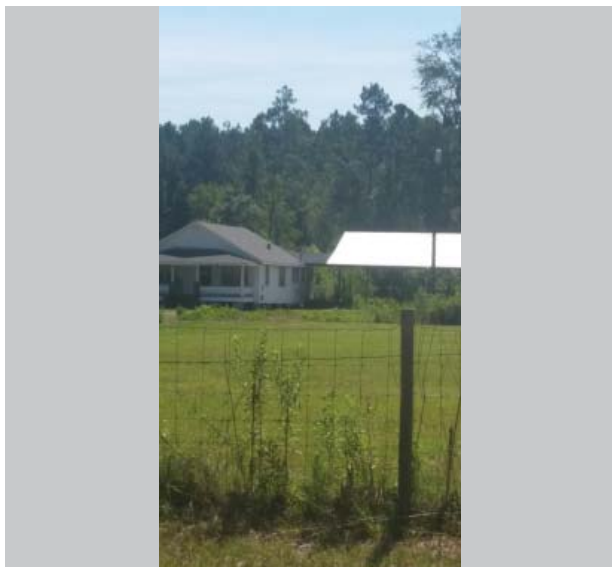
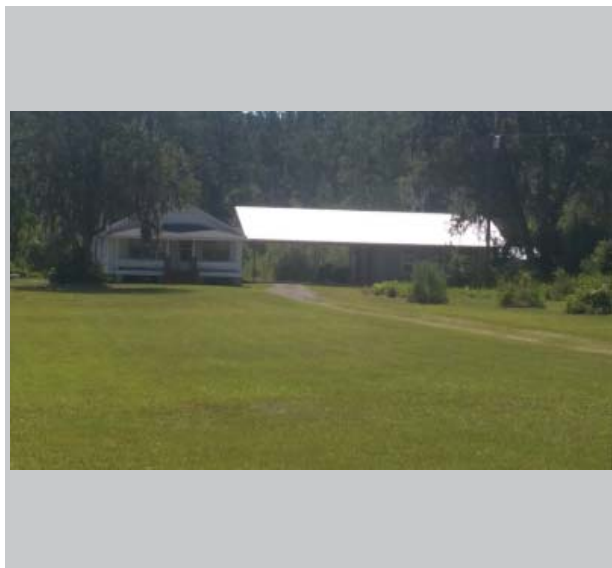
Field ID: BT-48
GNAHRGIS ID: 253072
County: Brantley
Preliminary NR Assessment: May Meet

Resource Type Building

Resource Use Residential: Single Family Dwelling

Foundation Pier: Concrete

Chimney No Chimney Observed

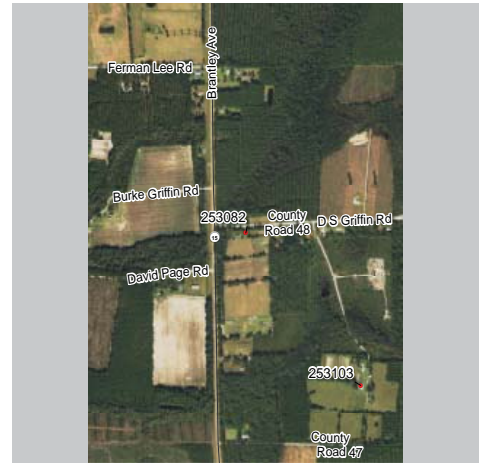
Field ID: BT-49
GNAHRGIS ID: 253082
County: Brantley
Preliminary NR Assessment: May Meet

- Resource Type** Building
- Resource Use** Secondary structure: outbuilding
- Date of Construction** 1900
- Building Type** Single Pen
- Structural System** Balloon Frame
- Style** No Academic Style
- Roof** Gable:Side
- Exterior Cladding** Wood: Vertical Board
- Foundation** Pier: Concrete block
- Porch** Verandah
- Windows** Double Hung Sash: 2/2
- Chimney** N/A
- Additional Notes**
