Historic Resources Survey Report

Brantley County, Georgia

July 2016

The University of Georgia
College of Environment and Design
Center for Community Design & Preservation
Historic Resources Survey Report
Brantley County, Georgia 2016

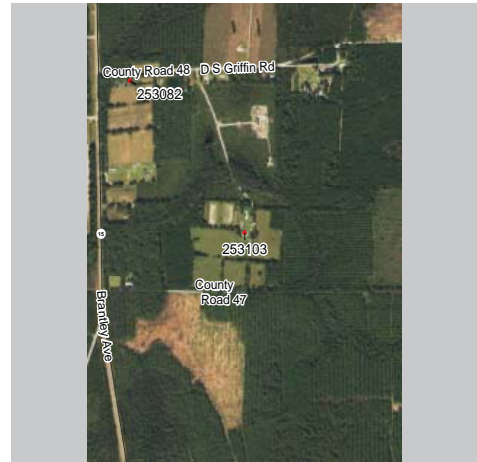
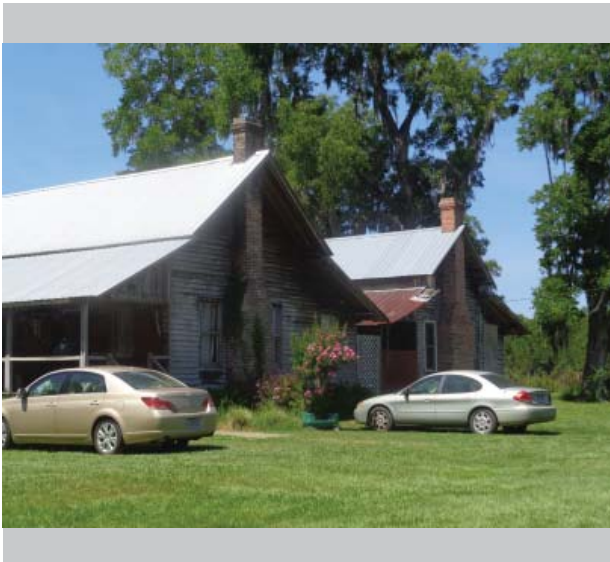
Field ID: BT-50
GNAHRGIS ID: 253103
County: Brantley
Preliminary NR Assessment: May Meet

Resource Type Building

Resource Use Residential: Single Family Dwelling

Foundation Pier: Concrete

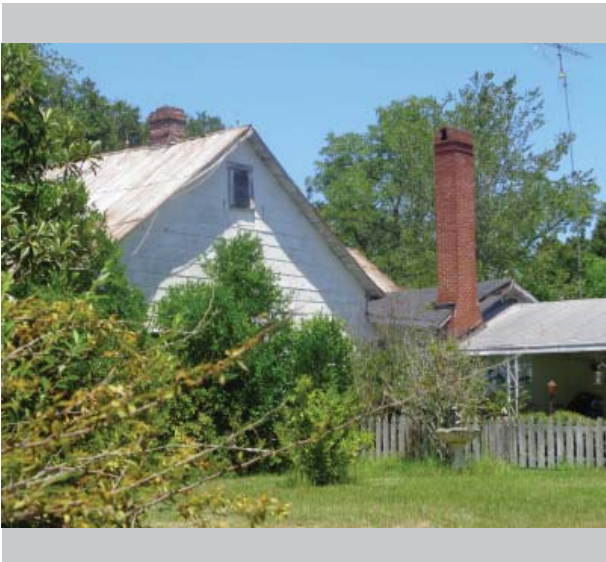
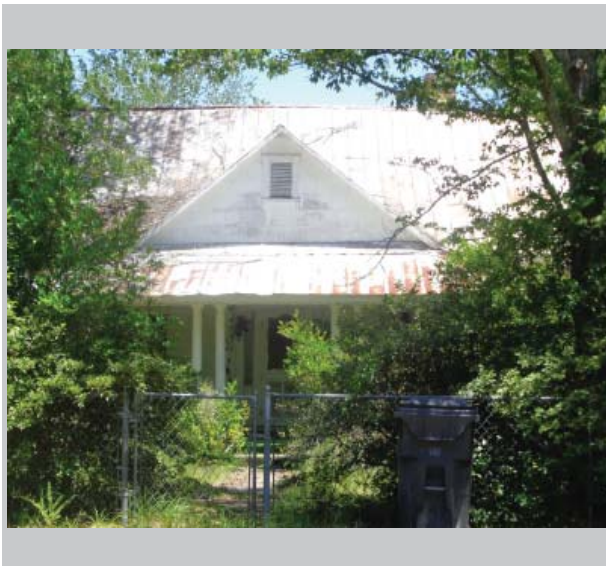
Coordinates: 31.15730, -82.172405

- Resource Type** Building
- Resource Use** Residential: Single Family Dwelling
- Date of Construction** 1910
- Building Type** Georgian Cottage
- Structural System** Balloon Frame
- Style** No Academic Style
- Roof** Gable: Multi
- Exterior Cladding** Synthetic: Asbestos
- Foundation** Unknown
- Porch** Verandah
- Windows** Double Hung Sash: 2/2, Rectangular
- Chimney** Off-center Ridgeline & Gable End Exterior: Brick
- Additional Notes** Obscured by veg. Rect vent in front and side gable. Decorative wood supports on porch.

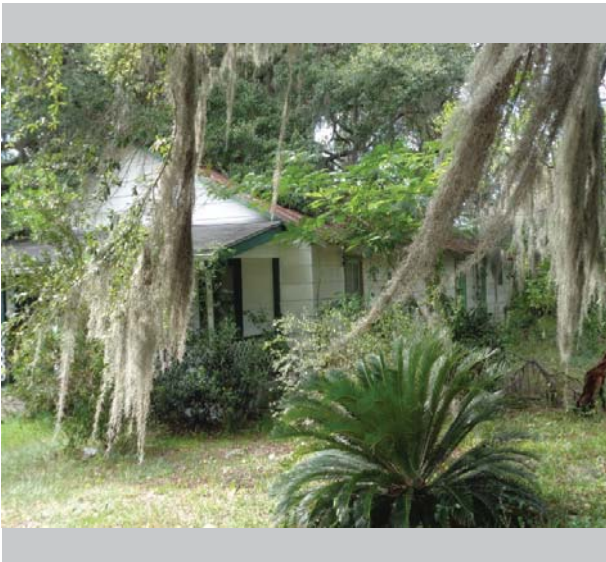
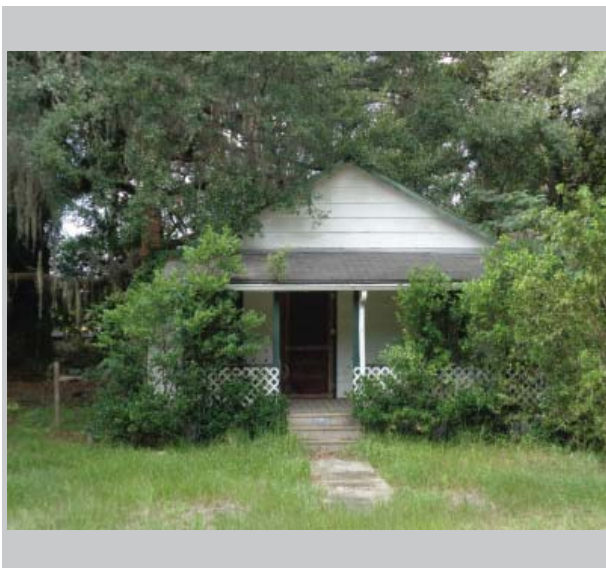
442 Willis Road

Resource Type Building

Resource Use Residential: Single Family Dwelling

Foundation Unknown

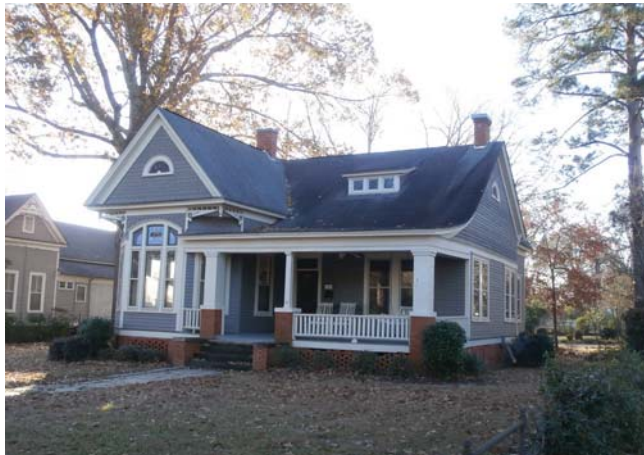
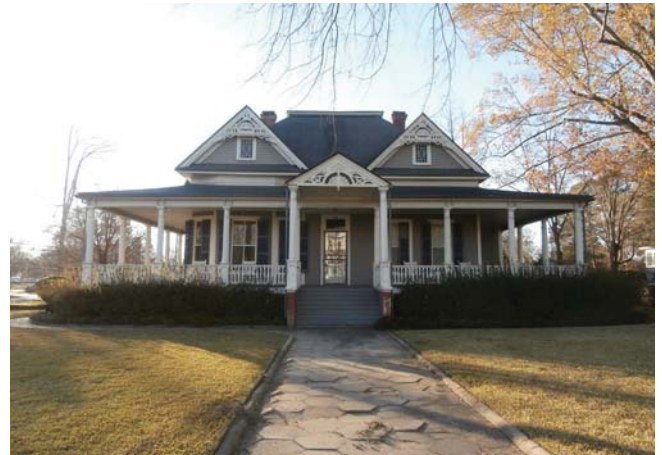
Folk Victorian 1870-1920

Folk Victorian houses were built across Georgia in very large numbers. They were simple house forms, or house types, with Victorian-era decorative detailing such as jigsaw woodworks including brackets, spindlework and gingerbread trim. This detailing generally was taken from the elaborate styles, such as Queen Anne or Italianate, that were popular during the mid to late 19th century. Features were borrowed and added onto such places as porches and roof gables. This provided some hint of stylistic detailing on what was otherwise an unadorned traditional house form. This style is actually more a way of decorating a house than a precise stylistic category; however, the Folk Victorian house is so widespread that it demands a name.

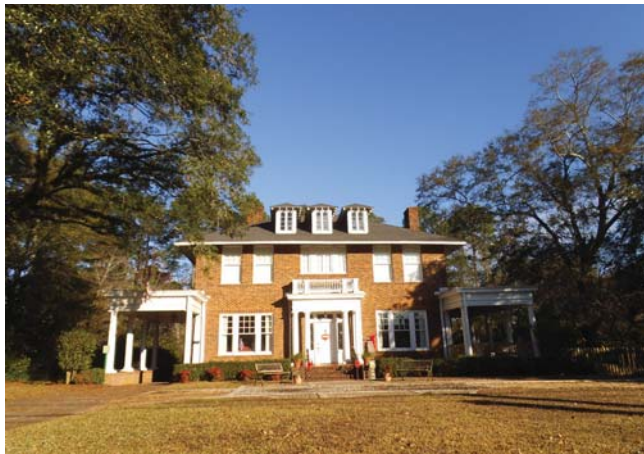
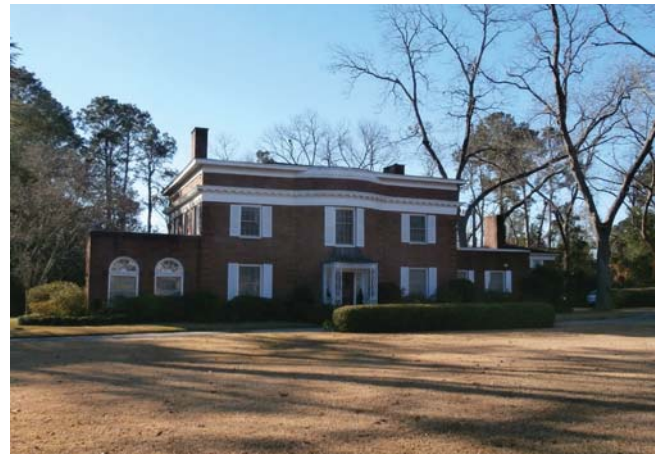
Colonial Revival 1890-1955

Most Colonial Revival houses are symmetrical. A central entranceway is elaborated with a pediment supported by pilasters or columns. The use of broken pediments, fanlights and sidelights is common. Classical cornices with dentils or modillions are usually present. These features tend to be larger than original colonial details. The roof may be hipped or side-gabled with dormers. Windows have double-hung sashes, usually with six-over-six or nine-over-nine panes and may be paired. Walls are of masonry, masonry-veneer or wood.

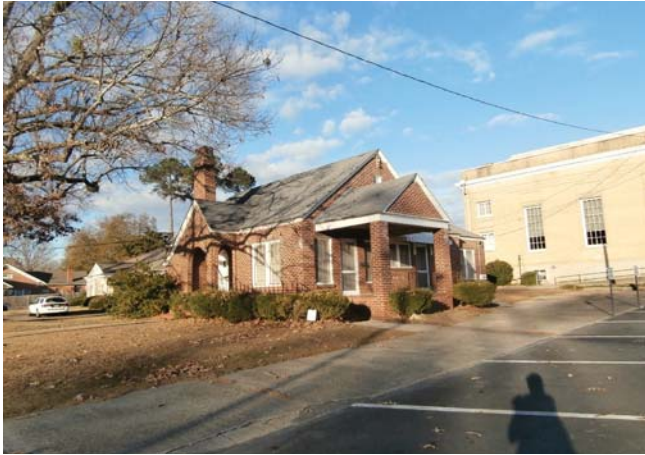
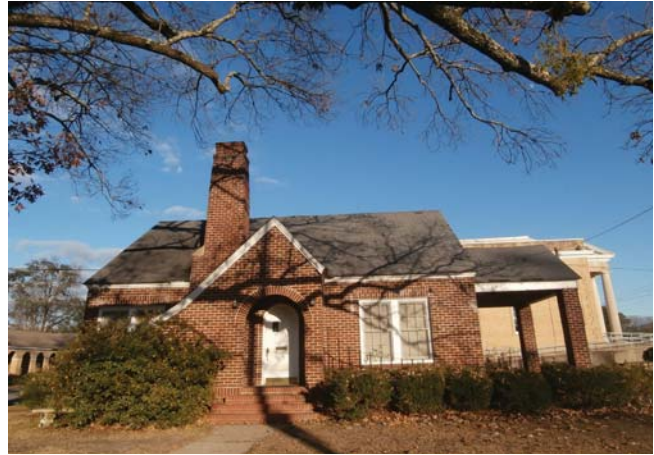
English Vernacular Revival 1900-1940

Characteristics of English Vernacular Revival houses are a steeply pitched gabled roof with dominant front-facing gable and decorative half-timbering in the gables. Almost all have masonry walls. Most are masonry-veneered, a recently developed technique for applying a thin layer of masonry to a wall. Some houses have patterned brickwork, while others may be completely stuccoed. Often a variety of materials are used, such as brick walls with stone trim, wood half-timbering, and stuccoed gables. Massive masonry chimneys with decorative tops are common. Windows are generally tall and narrow, grouped together, multi-paned, and casements rather than double-hung. Some openings, particularly the entrance, may be emphasized by a round arch. Houses of this style are generally asymmetrical.

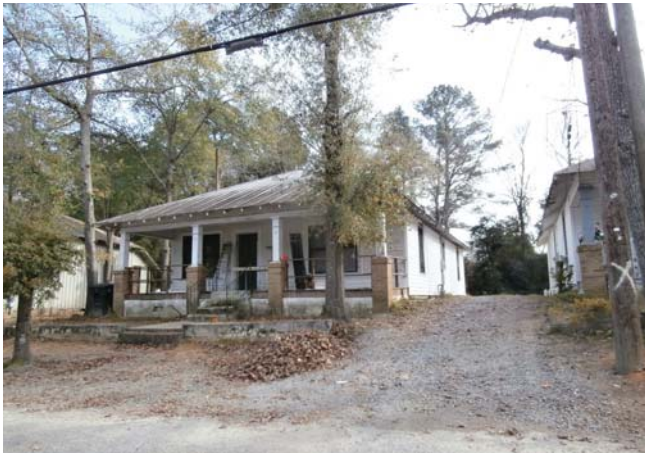
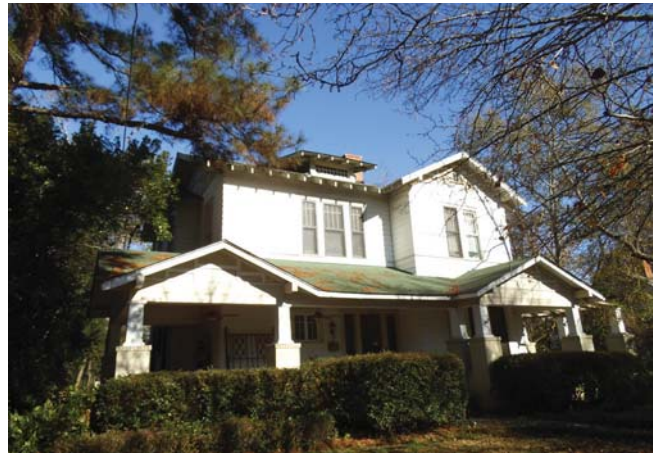
Craftsman 1910-1930

The Craftsman house uses a wide variety of materials both for its structure and decorative detailing. It has a low-pitched roof that is usually gabled but may also be hipped, giving a generally horizontal effect. The widely overhanging eaves are open with exposed rafters. Large gables have decorative brackets or braces at the eaves and may be covered with half-timbering. Roof dormers are sometimes found. Walls are most often wood but may also be covered with shingles or a masonry veneer of stone or brick. Porches have short square columns set on heavy masonry piers extending to the ground. Windows may have a multi-paned sash over a large one-pane sash. Craftsman houses are most often asymmetrical with a generally open and functional plan.

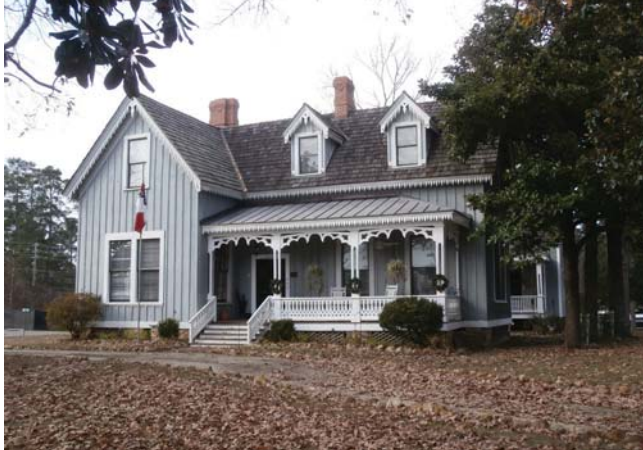
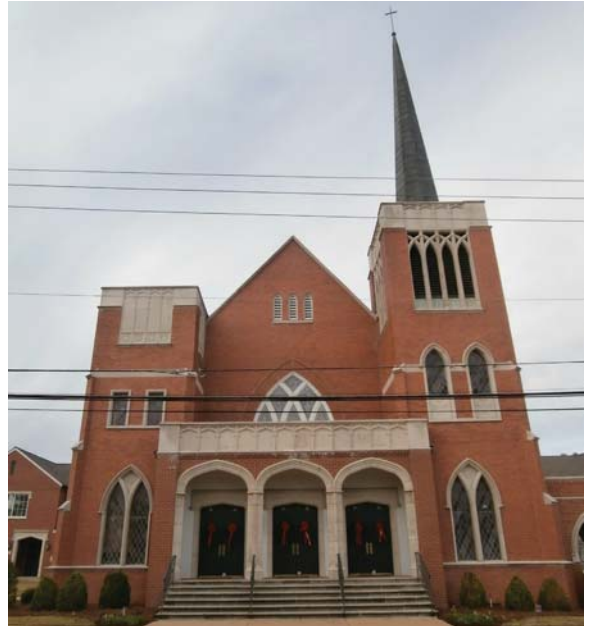
Gothic Revival 1850-1890

Gothic Revival houses typically have steeply pitched gabled roofs with both front-and side-facing gables. Decoratively sawn bargeboards are commonly found along the eaves. Window and door openings often have either pointed arched tops or heavily molded or pointed hoods. Porches are usually supported by slender posts with sawn woodwork forming flattened arches or brackets. Some houses have vertical board-and-batten siding. This style emphasized picturesqueness, verticality, and varied use of materials.

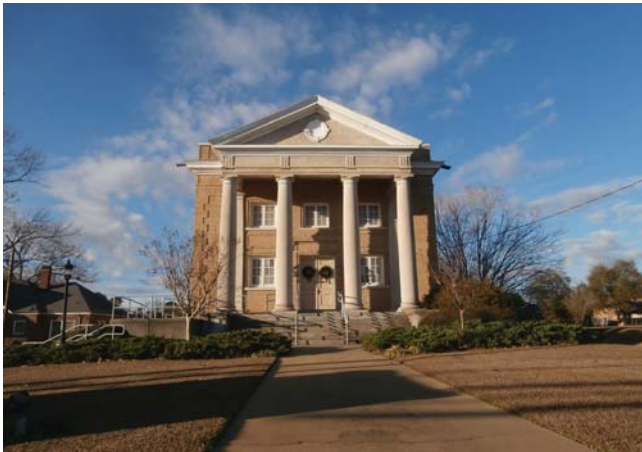
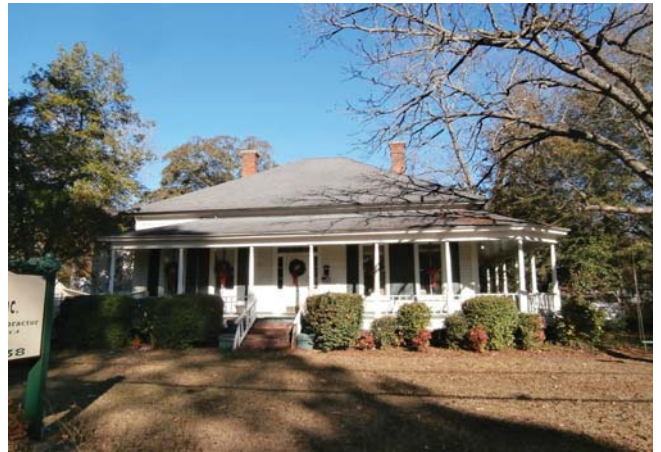
Greek Revival 1825-1860

The Greek Revival style is characterized by details such as prominent columns, pilasters, and wide plain entablatures that encircle a house. Proportions are large and heavy. A symmetrical, rectangular block has a symmetrical front facade with a central entrance. An elaborate door surround contains a rectangular transom, sidelights and pilasters. A typical expression of the Greek Revival in Georgia is a low-pitched, hipped roof supported by columns to form a full-width porch. Porticoes with triangular pediments are also found. Vernacular interpretations with simplified details, such as square rather than round columns, are common. Double-hung windows generally have six-over-six panes.

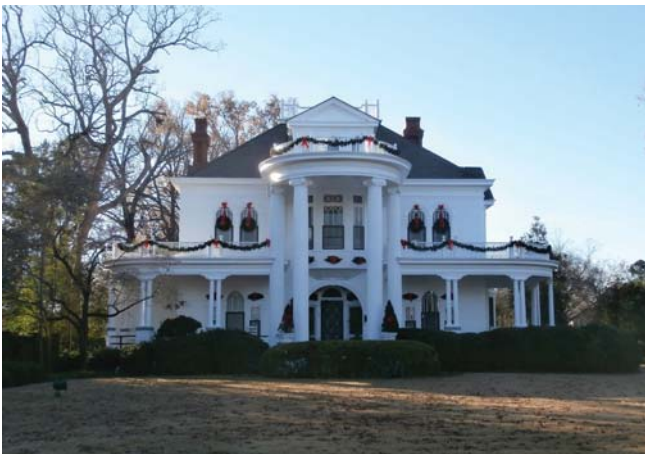
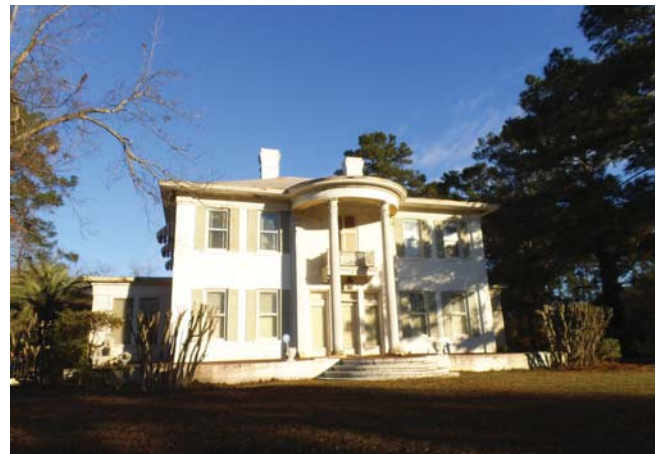
Neoclassical Revival 1895-1940

The most common feature of the Neoclassical Revival style is a dominant full-height front portico with classical columns. The portico may be at the entry or may cover the full facade; it may have a triangular pediment or be part of the overall roof. A full-height entry portico is often coupled with a one-story full-facade porch. The facade is more or less symmetrical, and the central entrance, surrounded with pilasters and columns, is elaborated with fanlights, sidelights, and transoms. There is almost always a classical cornice with dentils or modillions. The roof is usually low-pitched and hipped and may have a balustrade. A porte-cochere and side porches supported by columns are common.

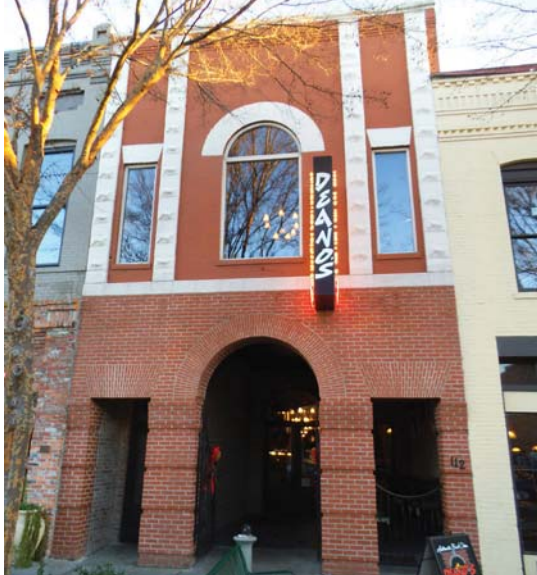
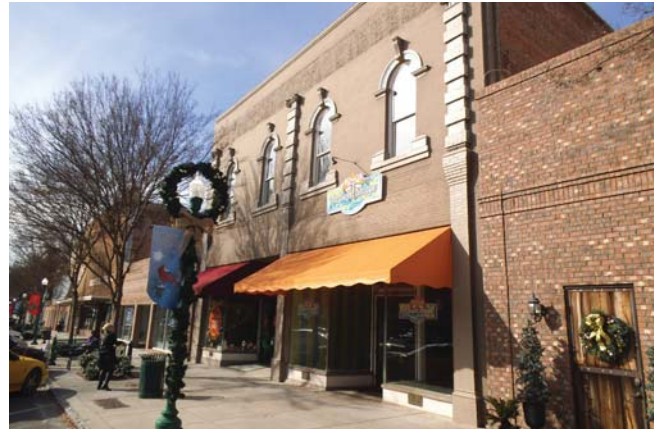
Italianate 1840-1885

Italianate houses are generally asymmetrical with an L-shaped or other irregularly shaped plan and gabled roof. Distinguishing features are the widely overhanging eaves with decorative brackets that emphasize the cornice. Typically tall narrow windows with large two-over-two or one-over-one panes are often paired, arched, and topped with elaborate hoods. Bay windows are also common. Italianate style residential architecture faded out during the 1880s; however, many Italianate style commercial blocks were constructed until the 1890s. The flat topped blocks with brackets and decorative window moldings were two or more stories tall and featured large storefront windows. Brackets beneath eaves are the most distinguishing characteristic of the Italianate commercial block.

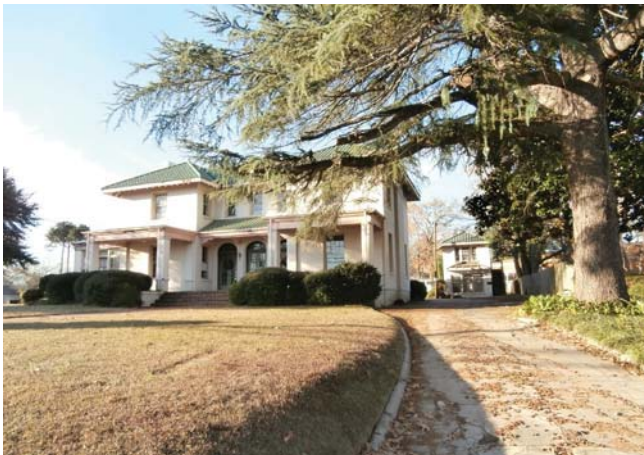
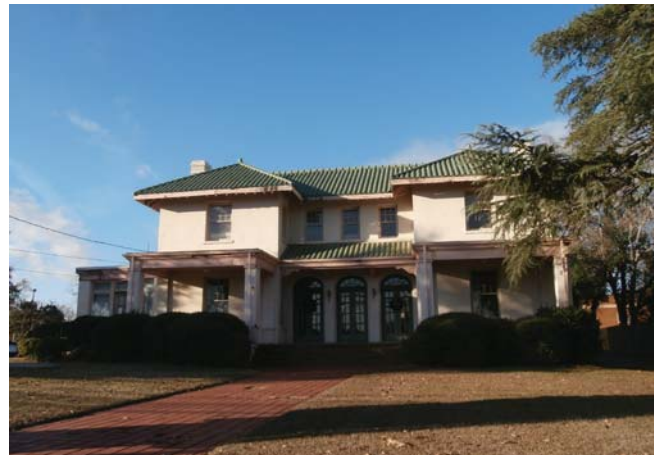
Mediterranean Revival 1890-1910

A Mediterranean Revival house has smooth stuccoed or masonry walls and is usually asymmetrical. The roof is covered with clay tile, is low-pitched, and may be either hipped or gabled. Houses following the Spanish tradition will have little or no eave overhang, while those following the Italian influence will have widely overhanging eaves with exposed rafters. Recessed and arcaded loggias, or open porches, are common. Windows are generally arched and may be grouped together. Sometimes columns and pilasters are used to elaborate openings.

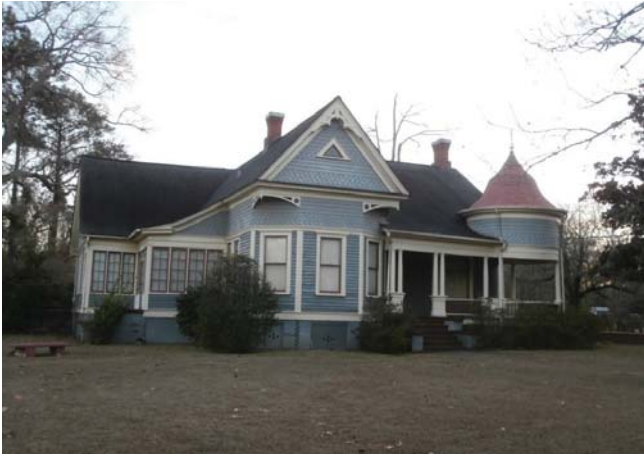
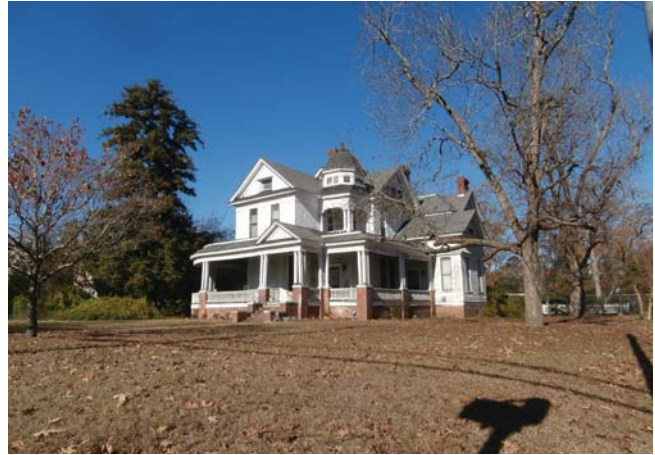
Queen Anne 1880-1915

A Queen Anne style house is asymmetrical with complex roof and wall shapes. It displays a variety of textures, materials, and detailing. The asymmetrical shape results from a floor plan that is open and flowing. The roof is often steeply pitched and hipped with both front-and side-facing, or cross, gables. Wall surfaces avoid a smooth appearance through the use of projecting bays and materials such as patterned shingles that provide texture. The porch is usually asymmetrical and often wraps around two sides of the house. It is supported with slender turned posts and often decorated with sawn brackets and spindlework friezes. Roof gables may also be decorated with sawn ornamentation or spindlework and covered with patterned shingles. There are often prominent and elaborate brick chimneys with patterned and corbeled brickwork. A round or multi-sided tower may be found at a corner.

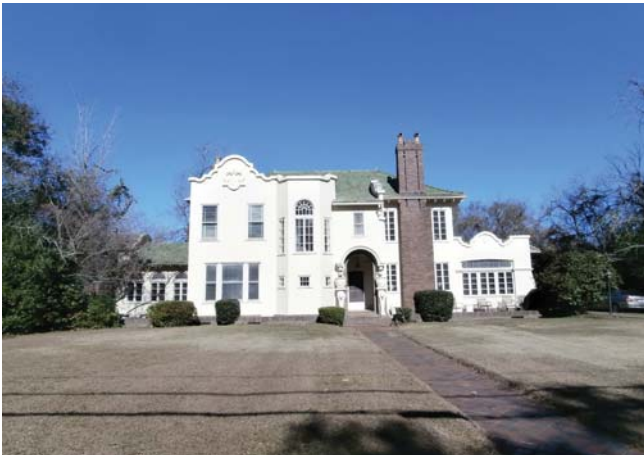
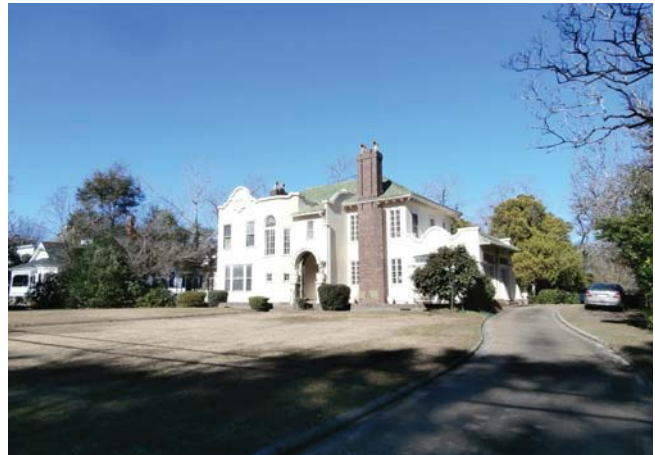
Spanish Colonial Revival 1900-1940

A Spanish Colonial Revival house has a clay tile roof that is usually gabled with little eave overhang. Walls are of smooth stucco. Arched openings and arcaded loggias, or open porches, are common. Windows are generally casement and grouped together. The roof may be elaborated with curvilinear gables or parapets from the mission tradition. Exposed roof beams may protrude from the walls to emphasize construction methods.
