# Historic Resources Survey Report Butts County, Georgia

July 2015

The University of Georgia College of Environment and Design Center for Community Design & Preservation Historic Resources Survey Report Butts County, Georgia 2015

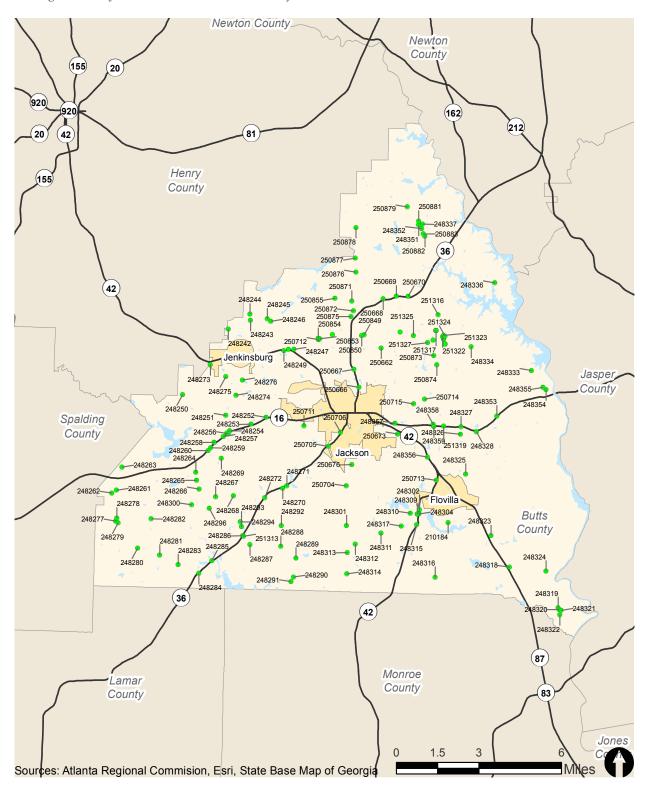
Figure 2. Identified Historic Resources in Butts County

A total of 142 historic resources that meet and maintain a minimum level of age, architectural integrity, and historic significance were identified in unincorporated Butts County. These resources are primarily buildings, with 118 resources remaining county wide. Of the built resources, the two most represented house types are the New South Cottage (37 resources, 31.4 % of total) and the Central Hallway Cottage (17 resources, 14.4 % of total). The Gable Ell Cottage and the Georgian Cottage both had an adequate representation, with 13 and 12 extant resources respectively.

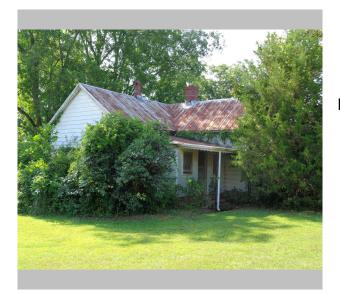
Field ID: BT-1
GNAHRGIS ID: 248242
County: Butts

309 Burg Rd

Resource Type Building

Foundation Unknown

Replacement siding

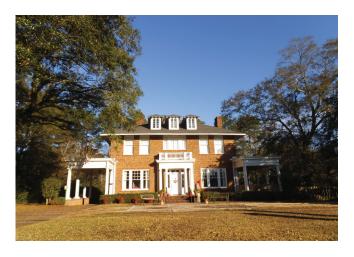
#### Colonial Revival 1890-1955

Most Colonial Revival houses are symmetrical. A central entranceway is elaborated with a pediment supported by pilasters or columns. The use of broken pediments, fanlights and sidelights is common. Classical cornices with dentils or modillions are usually present. These features tend to be larger than original colonial details. The roof may be hipped or side-gabled with dormers. Windows have double-hung sashes, usually with six-over-six or nine-over-nine panes and may be paired. Walls are of masonry, masonry-veneer or wood.

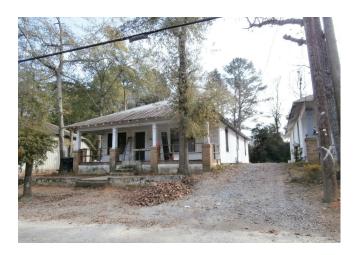
#### Craftsman 1910-1930

The Craftsman house uses a wide variety of materials both for its structure and decorative detailing. It has a low-pitched roof that is usually gabled but may also be hipped, giving a generally horizontal effect. The widely overhanging eaves are open with exposed rafters. Large gables have decorative brackets or braces at the eaves and may be covered with half-timbering. Roof dormers are sometimes found. Walls are most often wood but may also be covered with shingles or a masonry veneer of stone or brick. Porches have short square columns set on heavy masonry piers extending to the ground. Windows may have a multi-paned sash over a large one-pane sash. Craftsman houses are most often asymmetrical with a generally open and functional plan.

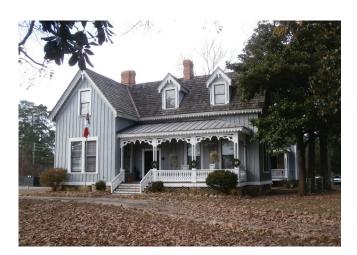
#### Gothic Revival 1850-1890

Gothic Revival houses typically have steeply pitched gabled roofs with both front-and side-facing gables. Decoratively sawn bargeboards are commonly found along the eaves. Window and door openings often have either pointed arched tops or heavily molded or pointed hoods. Porches are usually supported by slender posts with sawn woodwork forming

flattened arches or brackets. Some houses have vertical board-and-batten siding. This style emphasized picturesqueness, verticality, and varied use of materials.

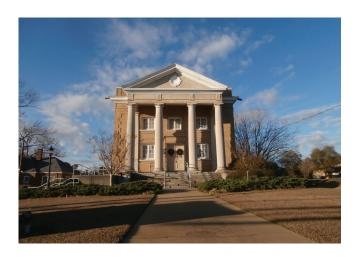
#### Greek Revival 1825-1860

The Greek Revival style is characterized by details such as prominent columns, pilasters, and wide plain entablatures that encircle a house. Proportions are large and heavy. A symmetrical, rectangular block has a symmetrical front facade with a central entrance. An elaborate door surround contains a rectangular transom, sidelights and pilasters. A typical expression of the Greek Revival in Georgia is a low-pitched, hipped roof supported by columns to form a full-width porch. Porticoes with triangular pediments are also found. Vernacular interpretations with simplified details, such as square rather than round columns, are common. Double-hung windows generally have six-over-six panes.
