# City of Dublin

## Historic Resource Survey Report

December 2013

Report Prepared By:  
Center for Community Design and Preservation at the University of Georgia  
<http://www.ced.uga.edu/psd>  
225 W Broad Street  
Athens, Georgia 30602

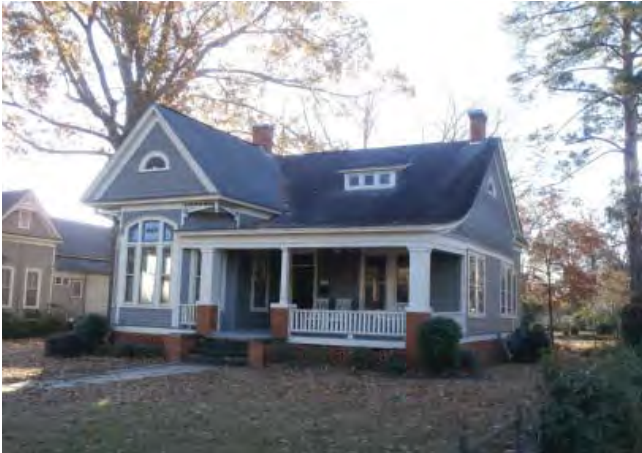
Figure 15. Folk Victorian Example

Folk Victorian houses were built across Georgia in very large numbers. They were simple house forms, or house types, with Victorian-era decorative detailing such as jigsaw woodworks including brackets, spindlework and gingerbread trim. This detailing generally was taken from the elaborate styles, such as Queen Anne or Italianate, that were popular during the mid to late 19th century. Features were borrowed and added onto such places as porches and roof gables. This provided some hint of stylistic detailing on what was otherwise an unadorned traditional house form. This style is actually more a way of decorating a house than a precise stylistic category; however, the Folk Victorian house is so widespread that it demands a name.

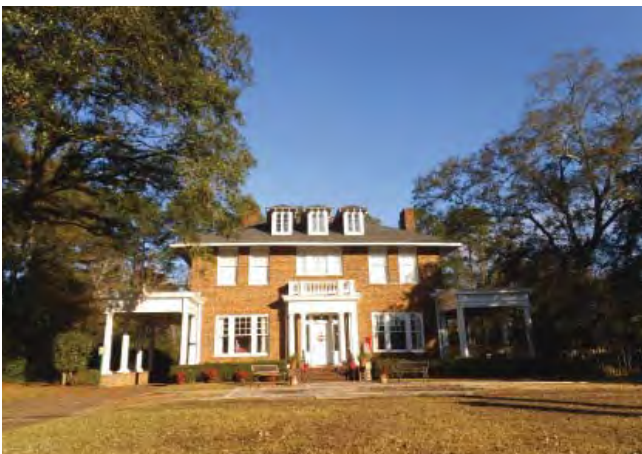
Figure 17. Colonial Revival Example

Most Colonial Revival houses are symmetrical. A central entranceway is elaborated with a pediment supported by pilasters or columns. The use of broken pediments, fanlights and sidelights is common. Classical cornices with dentils or modillions are usually present. These features tend to be larger than original colonial details. The roof may be hipped or side-gabled with dormers. Windows have double-hung sashes, usually with six-over-six or nine-over-nine panes and may be paired. Walls are of masonry, masonry-veneer or wood.

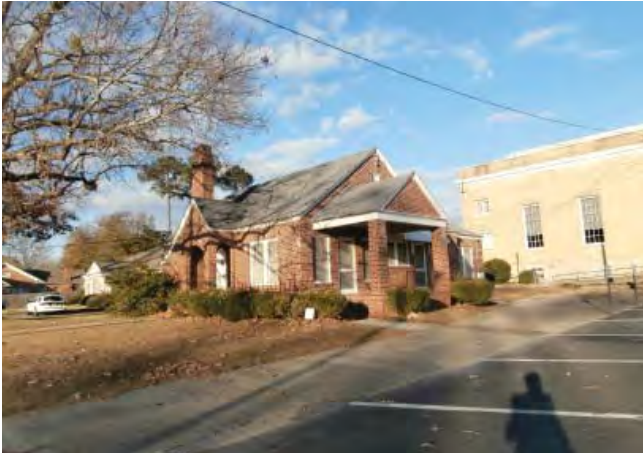
Figure 19. English Vernacular Revival Example

Characteristics of English Vernacular Revival houses are a steeply pitched gabled roof with dominant front-facing gable and decorative half-timbering in the gables. Almost all have masonry walls. Most are masonry-veneered, a recently developed technique for applying a thin layer of masonry to a wall. Some houses have patterned brickwork, while others may be completely stuccoed. Often a variety of materials are used, such as brick walls with stone trim, wood half-timbering, and stuccoed gables. Massive masonry chimneys with decorative tops are common. Windows are generally tall and narrow, grouped together, multi-paned, and casements rather than double-hung. Some openings, particularly the entrance, may be emphasized by a round arch. Houses of this style are generally asymmetrical.

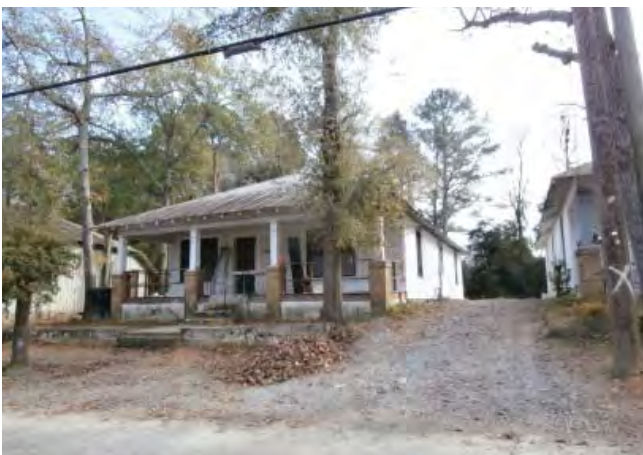
Figure 21. Craftsman Example

The Craftsman house uses a wide variety of materials both for its structure and decorative detailing. It has a low-pitched roof that is usually gabled but may also be hipped, giving a generally horizontal effect. The widely overhanging eaves are open with exposed rafters. Large gables have decorative brackets or braces at the eaves and may be covered with half-timbering. Roof dormers are sometimes found. Walls are most often wood but may also be covered with shingles or a masonry veneer of stone or brick. Porches have short square columns set on heavy masonry piers extending to the ground. Windows may have a multi-paned sash over a large one-pane sash. Craftsman houses are most often asymmetrical with a generally open and functional plan.

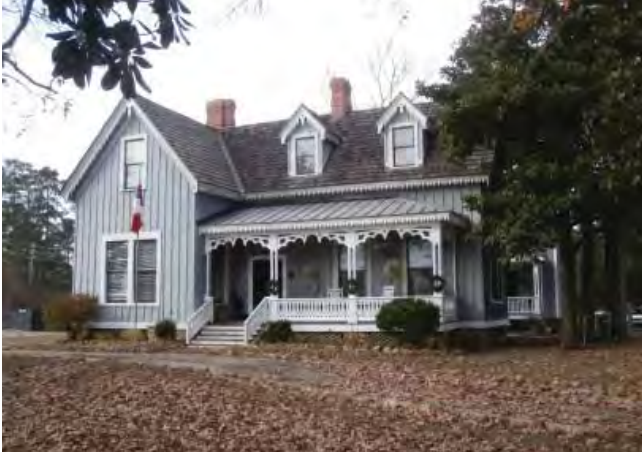
Figure 23. Gothic Revival Example

Gothic Revival houses typically have steeply pitched gabled roofs with both front-and side-facing gables. Decoratively sawn bargeboards are commonly found along the eaves. Window and door openings often have either pointed arched tops or heavily molded or pointed hoods. Porches are usually supported by slender posts with sawn woodwork forming flattened arches or brackets. Some houses have vertical board-and-batten siding. This style emphasized picturesqueness, verticality, and varied use of materials.

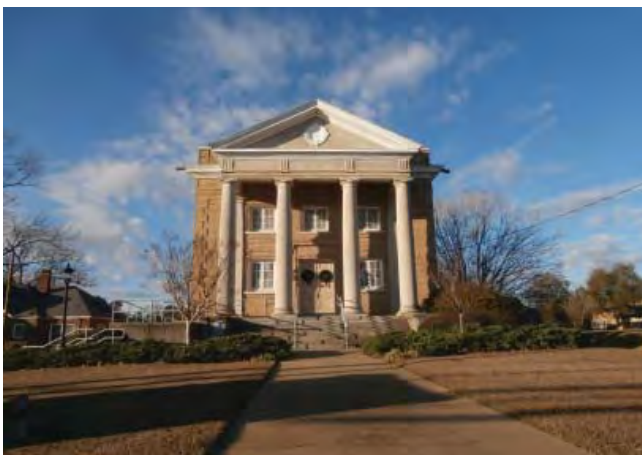
Figure 25. Greek Revival Example

The Greek Revival style is characterized by details such as prominent columns, pilasters, and wide plain entablatures that encircle a house. Proportions are large and heavy. A symmetrical, rectangular block has a symmetrical front facade with a central entrance. An elaborate door surround contains a rectangular transom, sidelights and pilasters. A typical expression of the Greek Revival in Georgia is a low-pitched, hipped roof supported by columns to form a full-width porch. Porticoes with triangular pediments are also found. Vernacular interpretations with simplified details, such as square rather than round columns, are common. Double-hung windows generally have six-over-six panes.

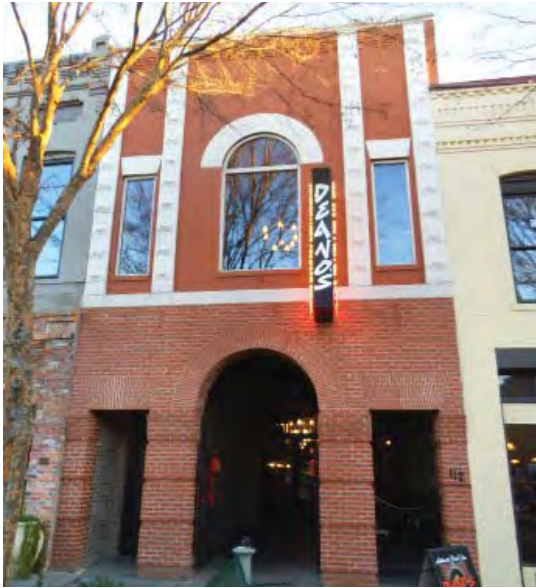
Figure 27. Italianate Example

Italianate houses are generally asymmetrical with an L-shaped or other irregularly shaped plan and gabled roof. Distinguishing features are the widely overhanging eaves with decorative brackets that emphasize the cornice. Typically tall narrow windows with large two-over-two or one-over-one panes are often paired, arched, and topped with elaborate hoods. Bay windows are also common. Italianate style residential architecture faded out during the 1880s; however,

many Italianate style commercial blocks were constructed until the 1890s. The flat topped blocks with brackets and decorative window moldings were two or more stories tall and featured large storefront windows. Brackets beneath eaves are the most distinguishing characteristic of the Italianate commercial block.

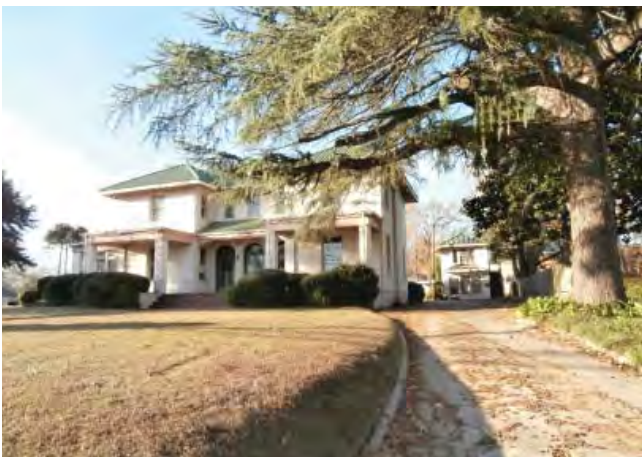
Figure 29. Mediterranean Revival Example

A Mediterranean Revival house has smooth stuccoed or masonry walls and is usually asymmetrical. The roof is covered with clay tile, is low-pitched, and may be either hipped or gabled. Houses following the Spanish tradition will have little or no eave overhang, while those following the Italian influence will have widely overhanging eaves with exposed rafters. Recessed and arcaded loggias, or open porches, are common. Windows are generally arched and may be grouped together. Sometimes columns and pilasters are used to elaborate openings.

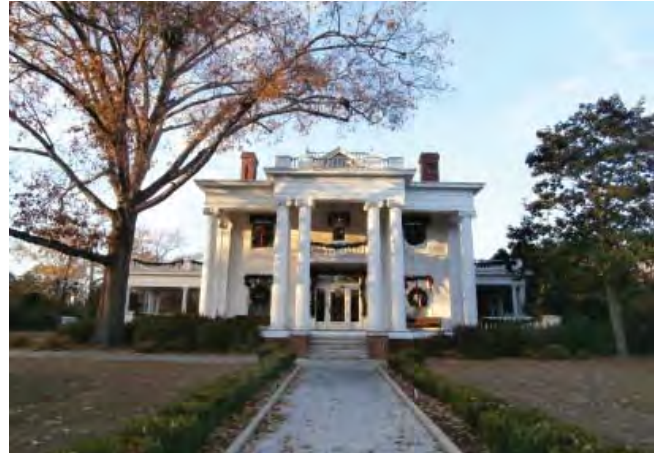
Figure 32. Neoclassical Revival Example

The most common feature of the Neoclassical Revival style is a dominant full-height front portico with classical columns. The portico may be at the entry or may cover the full facade; it may have a triangular pediment or be part of the overall roof. A full-height entry portico is often coupled with a one-story full-facade porch. The facade is more or less symmetrical, and the central entrance, surrounded with pilasters and columns, is elaborated with fanlights, sidelights, and transoms. There is almost always a classical cornice with dentils or modillions. The roof is usually low-pitched and hipped and may have a balustrade. A porte-cochere and side porches supported by columns are common.

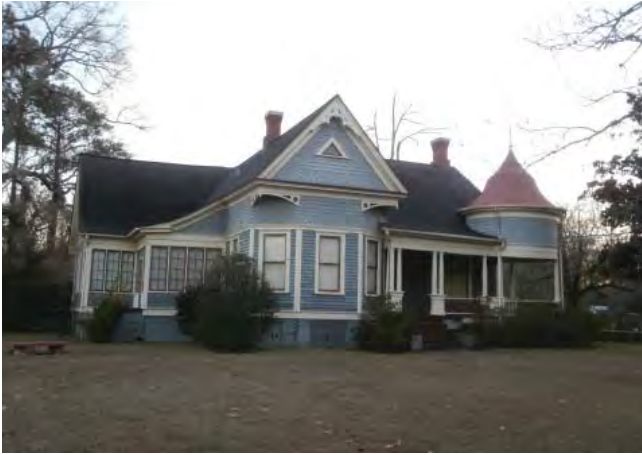
Figure 35. Queen Anne Example

A Queen Anne style house is asymmetrical with complex roof and wall shapes. It displays a variety of textures, materials, and detailing. The asymmetrical shape results from a floor plan that is open and flowing. The roof is often steeply pitched and hipped with both front-and side-facing, or cross, gables. Wall surfaces avoid a smooth appearance through the use of projecting bays and materials such as patterned shingles that provide texture. The porch is usually asymmetrical and often wraps around two sides of the house. It is supported with slender turned posts and often decorated with sawn brackets and spindlework friezes. Roof gables may also be decorated with sawn ornamentation or spindlework and covered with patterned shingles. There are often prominent and elaborate brick chimneys with patterned and corbeled brickwork. A round or multi-sided tower may be found at a corner.

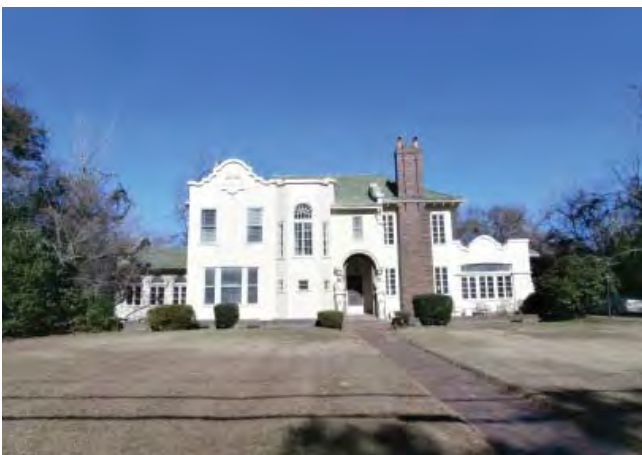
Figure 37. Spanish Colonial Revival Example

A Spanish Colonial Revival house has a clay tile roof that is usually gabled with little eave overhang. Walls are of smooth stucco. Arched openings and arcaded loggias, or open porches, are common. Windows are generally casement and grouped together. The roof may be elaborated with curvilinear gables or parapets from the mission tradition. Exposed roof beams may protrude from the walls to emphasize construction methods.

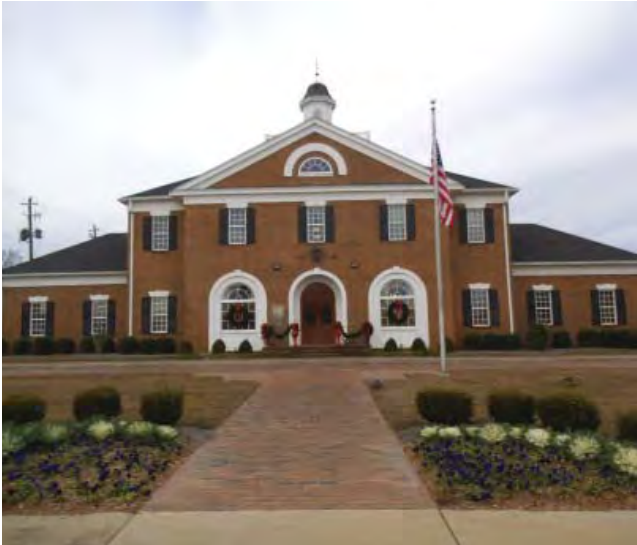
Figure 41. Example of Contemporary Structure with Historic Detailing

Many of the contemporary infill buildings lack an academic style and often borrow historic architectural detailing from "High styles," most often elements of Colonial Revival (or 'Traditionalism'), or Greek Revival. Details can include fanlights, emphasis on symmetry, flat arches, and columns. These structures are noncontributing to the district, but do not detract from the overall architectural unity.

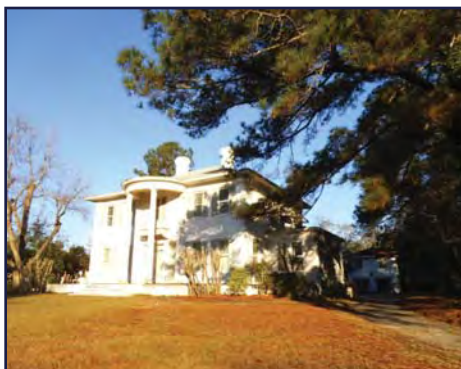
Roof Material: Asphalt (composition) shingle  
Roof Type: Hip

Foundation Materials: Brick  
Foundation Type: Continuous

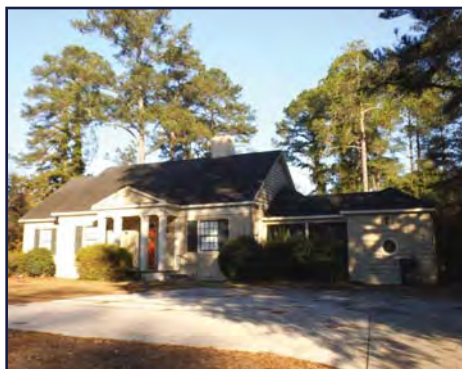
Roof Material: Asphalt roll  
Roof Type: Gable-Side-oriented

Foundation Materials: Brick  
Foundation Type: Continuous

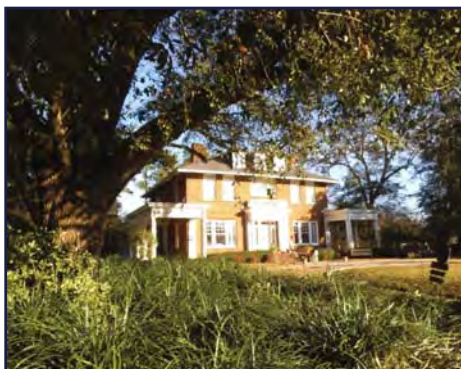
Roof Material: Asphalt (composition) shingle  
Roof Type: Hip

Foundation Materials: Unknown/obscured  
Foundation Type: N/A

Three lit tripartite dormers with exposed rafter tails  
Two tripartite windows on first floor, one on second floor  
stoop with three Doric columns on either side supporting  
plain entablature  
Balustrade on porch and porte cochere roofs  
Brick steps  
Leaded glass transom and side lights  
Doric columns support porte cochere  
Foundation plantings  
Solidier course above first story windows  
Low wall boarders side walk

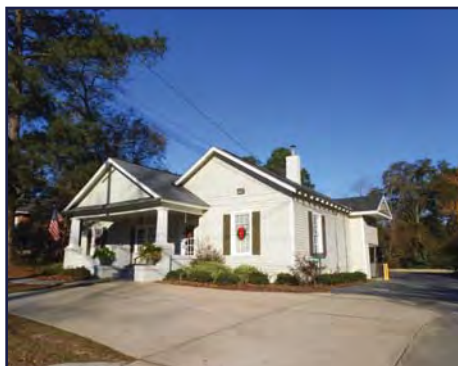
Roof Material: Asphalt (composition) shingle  
Roof Type: Gable-Cross gable

Foundation Materials: Brick  
Foundation Type: Continuous

Paired windows next to door  
15 fixed glass pane door  
Square piers support square porch columns  
Brick business sign in yard  
Foundation plantings  
Side addition  
Electric light fixture on porch  
Exposed rafter tails under roof eaves  
Low walls flank cement porch steps

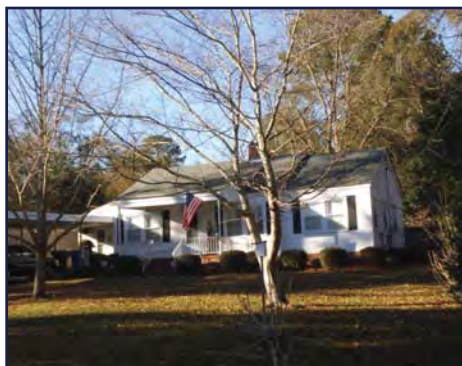
Roof Material: Asphalt (composition) shingle  
Roof Type: Gable-Side-oriented

Foundation Materials: Brick  
Foundation Type: Continuous

Three sets of paired windows  
Metal banister for porch  
Square porch supports  
Foundation plantings  
Plantings along driveway  
Simple corbelled chimney  
Side addition  
Carport addition

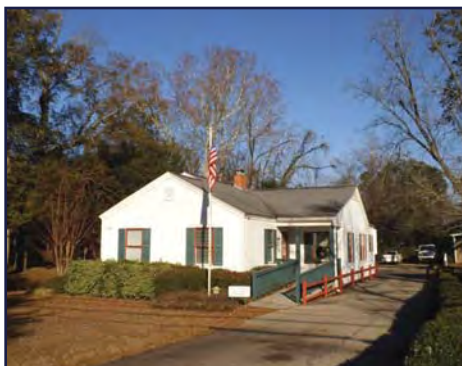
### Supporting Document 2

Roof Material: Asphalt (composition) shingle  
Roof Type: Gable-Cross gable

Foundation Materials: Concrete (poured)  
Foundation Type: Continuous

Ada ramp with banister  
Square porch supports  
Shutters  
Circle attic vent  
Short fence along side of building  
State farm business sign in yard  
Flag pole  
Foundation plantings

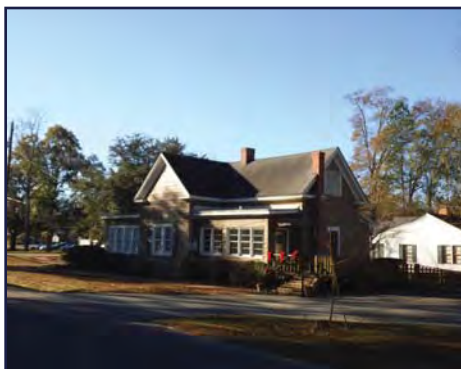
### Supporting Document 2

Roof Material: Asphalt (composition) shingle  
Roof Type: Gable-Multi-gable

Foundation Materials: Brick  
Foundation Type: Continuous

Paired windows left of door  
Tripartite grouping on right shutters  
Paneled front door  
Enclosed rear addition  
Overhanging eaves  
Brick steps to stoop with low brick walls  
Foundation plantings  
Parking lot on side  
Enclosed porch on rear addition with casement windows

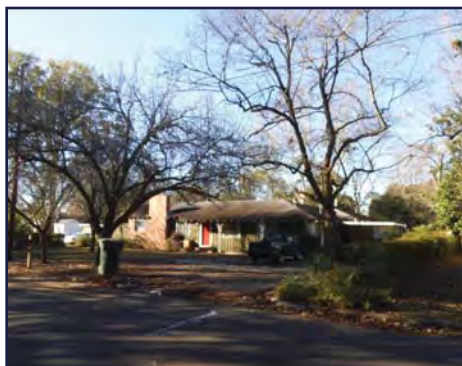
### Supporting Document 2

Roof Material: Asphalt (composition) shingle  
Roof Type: Hip

Foundation Materials: Brick  
Foundation Type: Continuous

Foundation plantings exposed  
Rafter tails  
Metal scrool porch supports  
Windows replaced  
Rear addition  
Carport addition  
Large overhanging eaves  
Pronounced front chimney  
Variation in fenestration

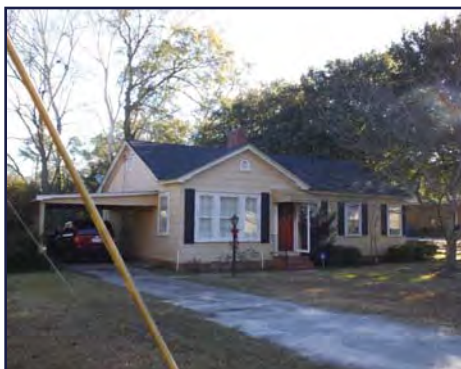
### Supporting Document 2

Roof Material: Asphalt (composition) shingle  
Roof Type: Gable-Cross gable

Foundation Materials: Brick  
Foundation Type: Continuous

Brick stairs to stoop  
Carport added  
Shutters  
Chicago window in front gable  
Scattered shrubs  
Picket fence  
Lamp post  
Pentagonal roof vent  
White window surrounds  
Metal stair rail door  
Six fixed panes with three wood panels below  
Wood detailing at end of gable  
Faca board  
Midcentury awning

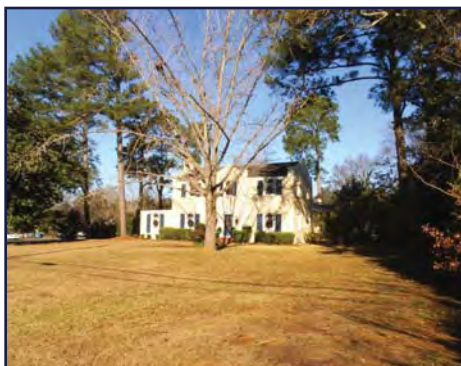
### Supporting Document 2

Roof Material: Asphalt (composition) shingle  
Roof Type: Hip

Foundation Materials: Brick  
Foundation Type: Continuous

Jack arches over windows  
Side flat roof addition  
6/6 window centered on second floor  
Fan light over door  
Quions on center portion  
Mission style roof  
Parapet in center and on ends  
Brick steps  
Brick yard sign mimics roof profile  
Foundation plantings

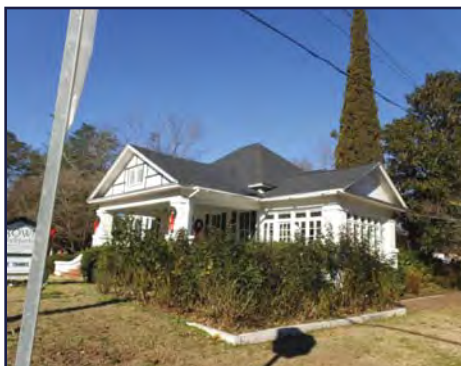
### Supporting Document 2

Roof Material: Asphalt (composition) shingle  
Roof Type: Hip

Foundation Materials: Unknown/obscured  
Foundation Type: N/A

Hexagonal pavers  
Brick retaining wall borders side walk  
Large square piers with square porch supports  
Craftsman style rectangular window in front gable  
Foundation plantings  
Transom over door  
Large side addition with casement windows  
Overhanging eave  
Gable wing extends from central hip massing  
Pronounced gable to porch portico with half timbering detail

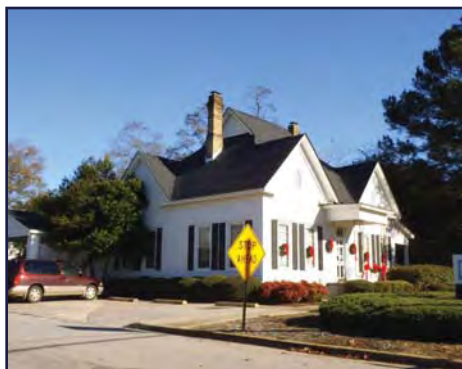
### Supporting Document 2

Roof Material: Asphalt (composition) shingle  
Roof Type: Gable-Multi-gable

Foundation Materials: Brick  
Foundation Type: Continuous

High pitched roof with multiple gables  
Pointed arch/ pentagonal vents  
Scrolling iron porch supports and railing  
Brick steps to porch  
Cement walkway  
Shutters  
Corbelled chimney transom over six fixed pane door  
Foundation plantings  
Scroll patterned brackets supporting lintel and fluted  
plasters on either side of door

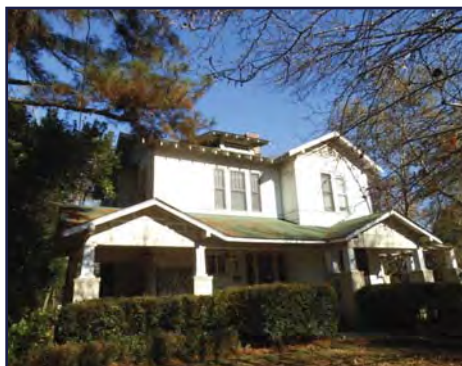
### Supporting Document 2

Roof Material: Asphalt (composition) shingle  
Roof Type: Gable-Multi-gable

Foundation Materials: Unknown/obscured  
Foundation Type: N/A

Clerestory window in dormer  
Sidelights flank door  
Large square piers with battered columns supporting porch roof  
Overhanging eaves with exposed rafter tails  
Decorative half timbering in gables  
Rectangle window in second story gable  
Hexagonal pavers in front walk  
Lined with plantings  
Foundation plantings  
Rear addition

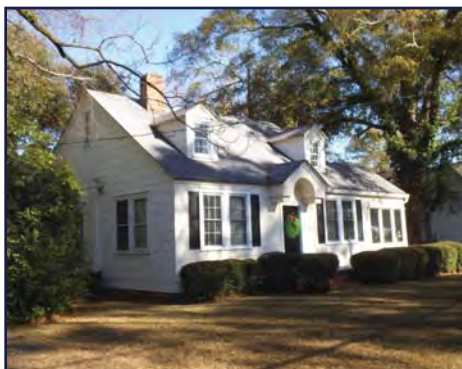
### Supporting Document 2

Roof Material: Asphalt roll  
Roof Type: Gable-Side-oriented

Foundation Materials: Brick  
Foundation Type: Continuous

Foundation plantings  
Sun porch side addition  
Paired windows on either side of door with shutters  
Wood business sign in front yard  
Two dormers with 6/6 windows  
Fanlight in door  
Brick steps  
Hood over stoop has arch cut out

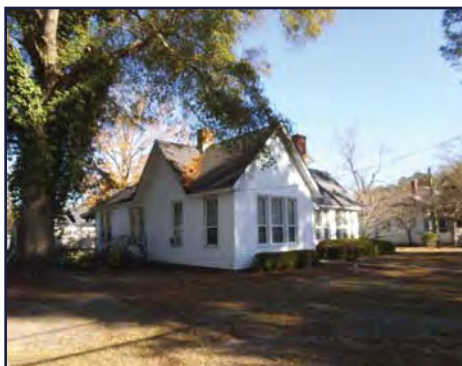
### Supporting Document 2

Roof Material: Asphalt roll  
Roof Type: Gable- Multi-gable

Foundation Materials: Brick  
Foundation Type: Continuous

Patterned cement walk with edging  
Lateral chimney with relief arch detail  
Gable dormer detail on ridgeline  
Stoop roof square supports  
Arch detail in stoop roof  
Metal fence connected to porch support  
Two tripartite window groupings  
Foundation plantings  
Side carport added  
Flemish eave over entry  
Exterior material replacement

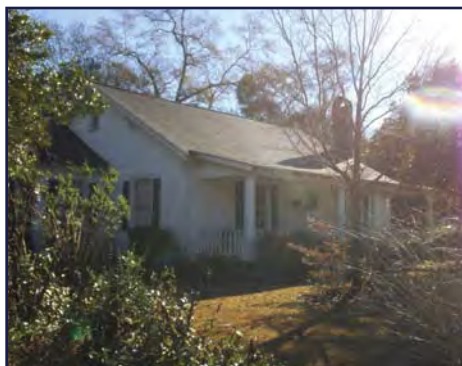
### Supporting Document 2

Roof Material: Asphalt roll  
Roof Type: Gable- Side-oriented

Foundation Materials: Brick  
Foundation Type: Continuous

Doric columns on brick bases support porch  
Exposed rafter tails  
Brackets in side gables  
Shutters  
Arched brick cover  
Crape myrtles in front yard  
Octagonal pavers  
Marble step leads to porch side addition  
Planting beds lined with rocks

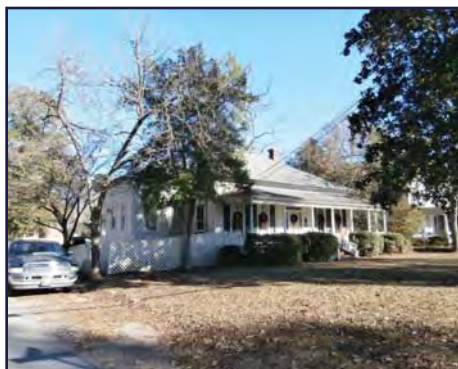
### Supporting Document 2

Roof Material: Asphalt (composition) shingle  
Roof Type: Hip

Foundation Materials: Brick  
Foundation Type: Continuous

Side addition  
Turned wood porch railing  
Doric column porch supports  
Scroll detail brackets under eaves  
Corbelled chimneys  
Sidelights and transom  
Foundation plantings  
Brick steps up to porch  
Wood railing with turned wood detail  
Door has arched paneling  
Shutters  
Ada ramp with lattice

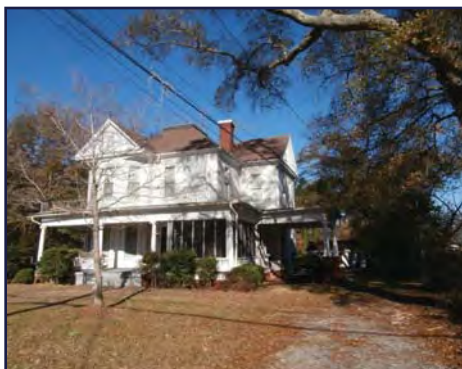
### Supporting Document 2

Roof Material: Asphalt (composition) shingle  
Roof Type: Truncated hip/deck-on-hip

Foundation Materials: Brick  
Foundation Type: Pier/Post with Infill-Brick

Door single fixed pane with bottom panel with transome  
Bay shaped first and second floor protrusions  
Ionic smooth column porch supports (same on porte cochre)  
Turned banisters  
Concrete steps with low brick wall, topped with concrete  
Half of porch screened in entablature above columns with  
dentil detail  
Corbled chimney  
Metal railing on porch and porte cochre roof  
Low wall along sidewalk with large square corner posts  
Walkway  
Octagonal powers with cement lip  
Foundation plantings  
Hedges on right and left of property

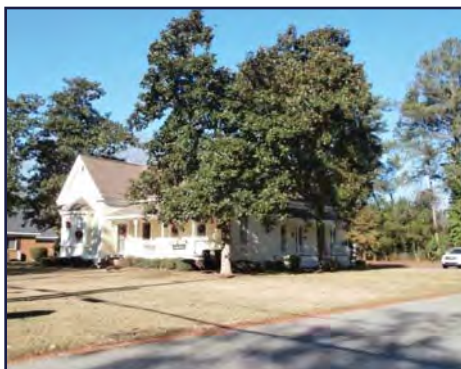
### Supporting Document 2

Roof Material: Asphalt (composition) shingle  
Roof Type: Gable-Cross gable

Foundation Materials: Brick  
Foundation Type: Continuous

Bay window in Gabled Ell  
Center window is 2/2, sides are 1/1  
Conical roof above floor-to-ceiling windows on verandah  
Detailed border around door with large glass pane turned  
wood porch railing  
Folk Victorian scrolling  
Gingerbread detailing in eaves  
Turned wood column porch supports with scroll detail  
capitals  
Brick steps to porch  
Pentagonal vent in front gable  
Vertical board under bay window  
Overhanging eaves  
Rear addition  
Pronounced eave returns on Gable Ell

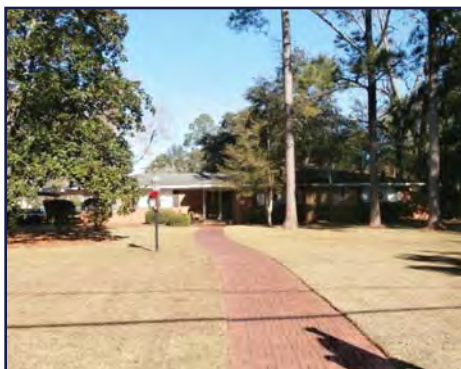
### Supporting Document 2

Roof Material: Asphalt (composition) shingle  
Roof Type: Hip

Foundation Materials: Unknown/obscured  
Foundation Type: Unknown/obscured

Jalousie windows on either side of door and on right  
Stone used for stoop to right side of front door and on  
portion of right side of house where casement windows is  
-Shutters on jalousie windows  
Large fixed pane sidelight to left of door  
Enclosed carport with large fixed pane windows  
New carport attached on left  
Foundation plantings  
Curvilinear brick path from side walk to door  
Large pines in yard  
Metal carport supports on brick bases  
Pierced brick wall in carport  
Variation in fenestration

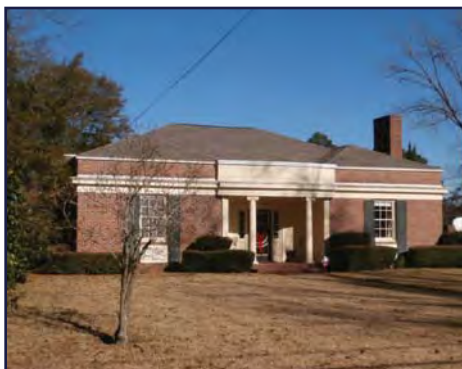
### Supporting Document 2

Roof Material: Asphalt (composition) shingle  
Roof Type: Hip

Foundation Materials: Brick  
Foundation Type: Continuous

Shutters, wood panels below windows  
Cornice runs along facade above windows  
Smooth Ionic columns support porch sidelights  
Three fixed panes above wood panels  
Foundation plantings  
Hedge on right of property, shrubs on left brick  
Wall to right of house  
Rear additions  
Freeze above cornice above door with wood panels

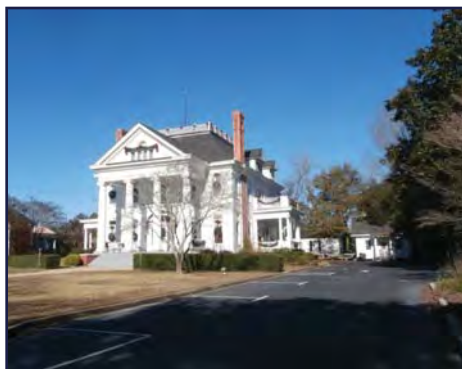
### Supporting Document 2

Roof Material: Asphalt (composition) shingle  
Roof Type: Truncated hip/deck-on-hip

Foundation Materials: Unknown/obscured  
Foundation Type: N/A

Two stories fluted ionic columns support porch also pilasters  
on house under porch roof and on corners of house  
Brick steps up to porch  
Stained glass windows in door, sidelights, and transom  
(fanlight)  
Transom widows over first story windows  
Stained glass windows and fanlight in front gable  
Corbelled chimneys  
Widows walk with turned wood balusters  
Porte cohere with Doric column supports on brick bases  
Balcony with turned wood baluster acts as roof for verandah  
below with Doric columns and turned wood balustrade  
Entablature with dentals over front door  
Dentils under all eaves  
Paired windows in center of second story  
Entablatures over all windows  
Hexagonal pavers fro front walk this cement curbs  
Foundation planting and hedges  
Granite bases for porch columns  
Overhanging eaves  
Rear addition and exterior stair addition

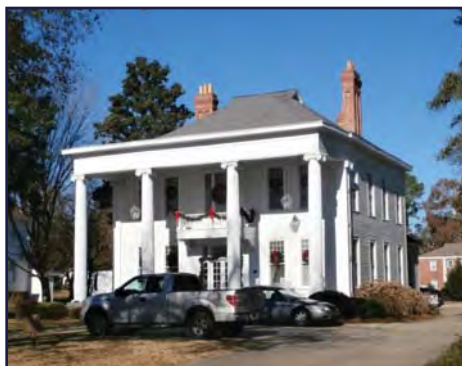
### Supporting Document 2

Roof Material: Asphalt (composition) shingle  
Roof Type: Truncated hip/deck-on-hip

Foundation Materials: Unknown/obscured  
Foundation Type: N/A

Ionic columns support entablature with dentils  
Ionic paneled pilasters on corners  
Transom, sidelights, and corners windows with roman  
pattern  
Corbelled paneled chimneys  
Foundation plantings, planting beds on right and left of lot  
Second floor balcony supported by ogee brackets, it has a  
paneled base, turned balusters, square paneled end posts  
Second story center windows tripartite window group  
Decorative cornice above door with dentils

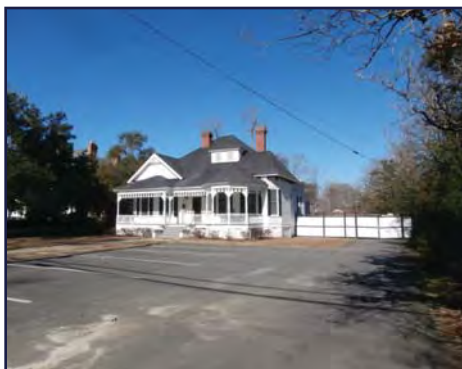
### Supporting Document 2

Roof Material: Asphalt (composition) shingle  
Roof Type: Complex

Foundation Materials: Brick  
Foundation Type: Pier/Post with Infill-Brick

Hexagonal pavers and brick pavers  
Brick steps to porch  
Turned wood porch railing  
Turned wood porch supports with scroll, folk Victorian  
detailing at tops and eaves  
Paneled front door  
Shutters on windows  
Fish scale shingles in front gables  
Side bay windows  
Lattice wood work in front gable  
Two rectangular attic vents  
Corbelled chimney  
Brackets under overhanging eaves  
Rear additions  
Brackets between door and roof line part of entablature  
Brick lattice work in porch foundation

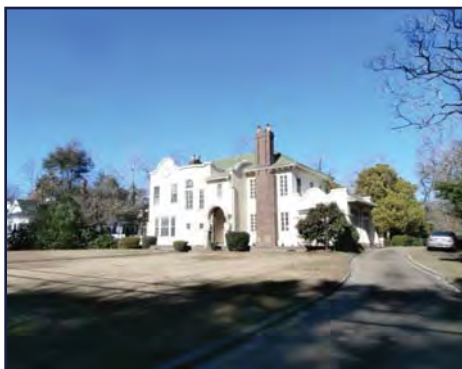
### Supporting Document 2

Roof Material: Clay (terra-cotta) tile  
Roof Type: Hip

Foundation Materials: Brick  
Foundation Type: Continuous

Ogee Spanish style parapet wall at roof line  
Chimney pots on chimney  
Brackets under overhanging eaves  
Circular detail over door in arched recessed entrance with  
scroll work  
Designs in ogees  
Second story bay windows, arched windows at top of bay  
Side addition with stained glass windows above casements,  
left are individual arches on right are long arch over  
casement windows  
Brick patio area on front with brick lined planting beds  
Diamond shaped brick create walk front sidewalk to door  
with brick piers marking it on side walk  
Corbelled chimneys  
Foundation plantings  
Planter/ pots, lion head stone work under scroll detail flank  
door opening  
Paired casement windows on left addition triplicate on right  
Garage in rear with matching style  
Carved casement pavers mark yard edges and driveway  
Arch over entrance place on brick bases

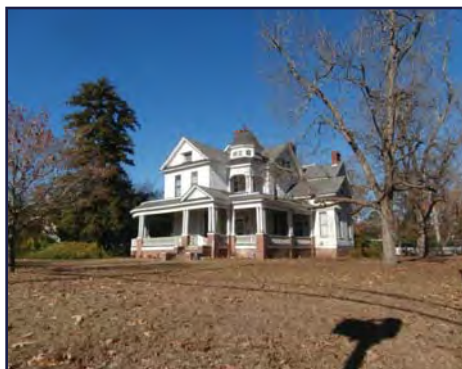
### Supporting Document 2

Roof Material: Asphalt (composition) shingle  
Roof Type: Complex

Foundation Materials: Brick  
Foundation Type: Continuous

Paired square porch supports on brick bases  
Brick stepped wall with concrete sill line concrete steps  
Doors single fixed pane with paneled bottom  
Bay bump out on first floor  
First floor weather board second and third story shingles  
Second story balcony same paired supports as porch and decorative brackets  
Third floor dome with two windows and two square attic vents and terracotta decorative top  
Main gable window with wood jack arch and buffered sides  
Corbelled and paneled chimneys  
Clipped gable in center of roof  
All windows wood surrounds  
Hexagonal pavers with cement curbing  
Trees flank sidewalk  
Large pine left of yard  
Bell capped turret

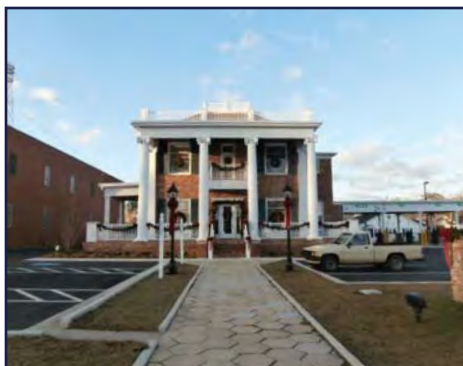
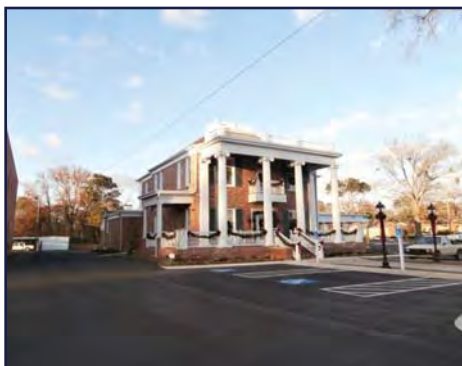
Ionic fluted columns support full entablature, for porch porte  
cochere and verandah  
Ionic pilasters with paneling detail on corners  
Balcony, porte cochere roof and veranda roof has turned  
balusters and square corner posts  
Glass door with transom leads to balcony  
Front door single light glass door with transom and sidelight  
dentil detail above  
Chimneys corbelled with panel detail  
Widows walk  
Palladian window on third story with dentil detail and  
pilasters  
Dentil detail above windows  
Balcony has large ogee bracket supports

Resource id: 244927  
Resource Type: Building  
Coordinate System: GCS\_WGS\_1984  
X: 32.538318  
Y: -82.912749

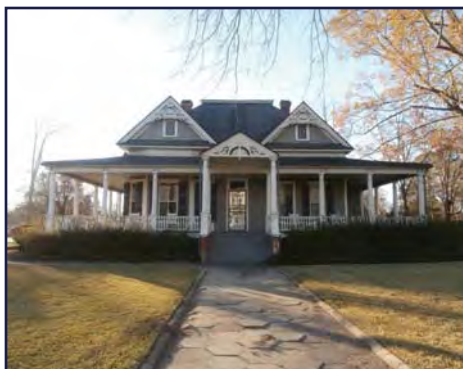
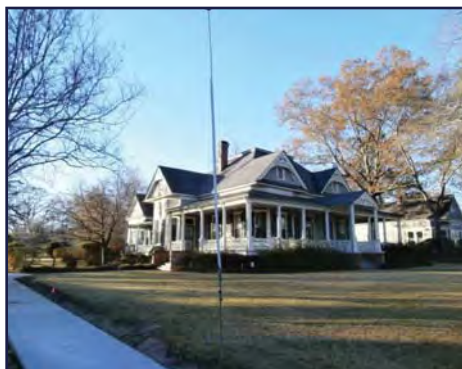
Rear and side additions  
Variety of fish scale shingle siding in eaves and on conical roof  
Paired Doric columns porch supports  
On wood bases  
Turned wood porch railing  
Brackets under eaves with scroll and star pattern  
Corbelled chimneys  
Large 1/1 windows on veranda has stained glass boarder on top sash  
Transom over door  
Door is paneled with a pane of glass in top half  
Dentil detailing  
Scroll detail in top of front gable  
Triangular vent in front gable  
Brick steps up to porch  
Fixed windows on side addition  
One story turret with bell cap

Resource id: 244571  
Resource Type: Building  
Coordinate System: GCS\_WGS\_1984  
X: 32.53738  
Y: -82.914012

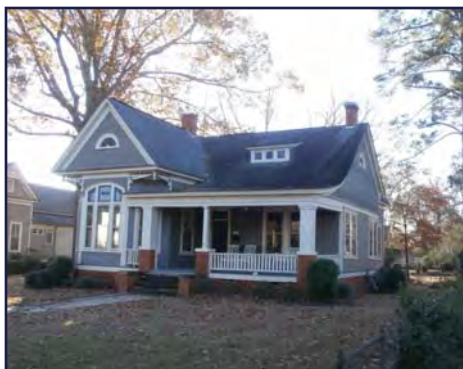
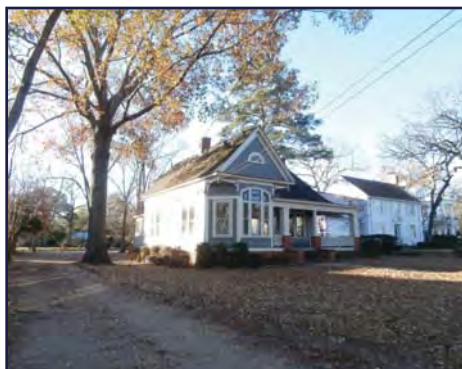
Turned wood porch railing  
Fluted Doric porch supports  
Fish scale in gables  
Stained glass windows in gables  
Shutters  
Scrolling decorative wood in pediment over stairs matches  
details in both front gables  
Transom over door  
Corbelled chimneys

Resource id: 244572  
Resource Type: Building  
Coordinate System: GCS\_WGS\_1984  
X: 32.537412  
Y: -82.91434

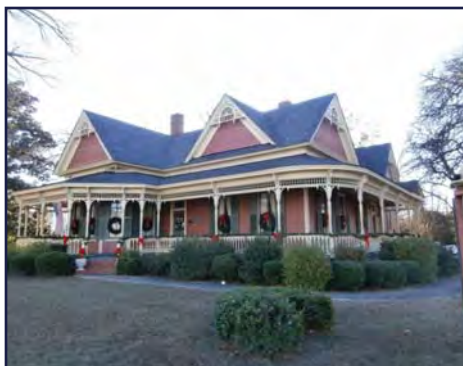
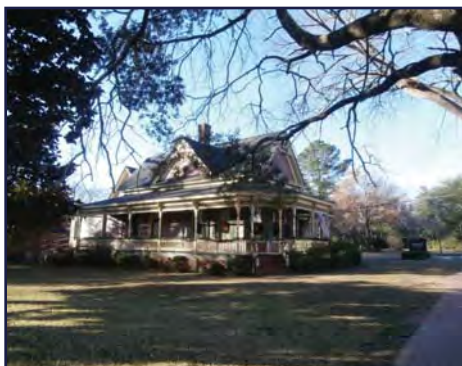
Windows: sidelights are large single panes; palladian windows with rectangular panes with star pattern mullions and center window arched with two arches inside; arched windows paired on second floor; 3 arched windows in attic  
Two story Ionic columns on verandah in center over door  
Smaller Doric columns around rest of porch  
Metal railing on verandah with wood on balconies  
diamond pattern glass front door with transom  
large bay window on second floor in center  
scroll work above Doric capitals on verandah. Also on brick bases  
Pilasters on attic balcony  
dentils in entablature  
Recessed entry under Syrian arch  
Corbelled chimneys  
gable over attic balcony door  
overhanging eaves  
widows walk on top with turned wood railing

Resource id: 244633  
Resource Type: Building  
Coordinate System: GCS\_WGS\_1984  
X: 32.537217  
Y: -82.915536

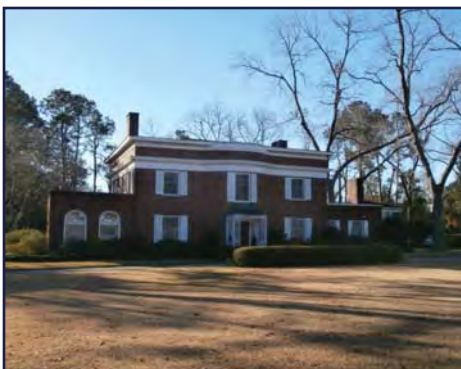
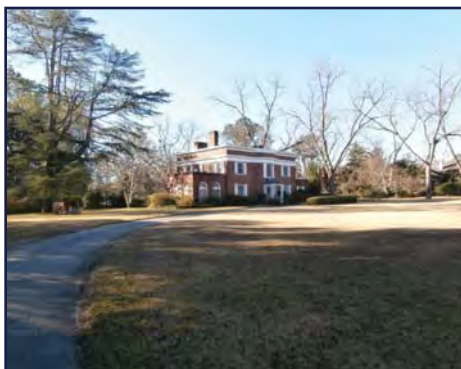
Simple fluted Doric columns support pediment  
Shutters  
Side lights with 3 panes fixed glass  
Side addition  
Ivy on first story  
Metal railings flank stairs  
Foundation plantings  
Property boarded by hedge on right  
Lamp post in yard  
Setback about 40 feet

Resource id: 244635  
Resource Type: Building  
Coordinate System: GCS\_WGS\_1984  
X: 32.536787  
Y: -82.916636

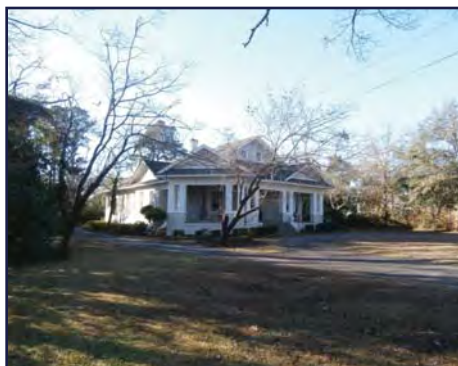
### Supporting Document 2

Stucco in gables  
Main gable with square attic vent, flanked by two windows  
Square brick paired porch supports on brick bases  
Doors have 15 fixed glass panes with transoms  
Concrete stairs lead to porch  
Foundation plantings  
Planting beds border right and left of property  
Lamp post in yard  
Setback about 30 ft  
Cement window sills  
Chicago style window pairings  
Square brick post at corners of lot  
Alterations to porch, creates two jutting gables supported by paired columns on brick piers

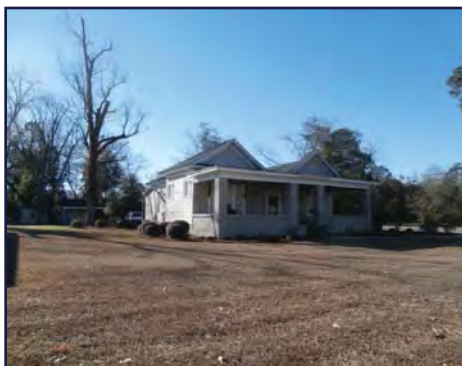
### Supporting Document 2

Foundation plantings  
Stucco on porch; covers foundation and porch supports  
Vinyl on sides; fish scale shingles in two front gables  
Brick steps up to porch with metal railing  
Rear Addition  
Door with Circular glass pane in center  
Craftsman detailing above front door  
Front porch alterations approximately at mid-century

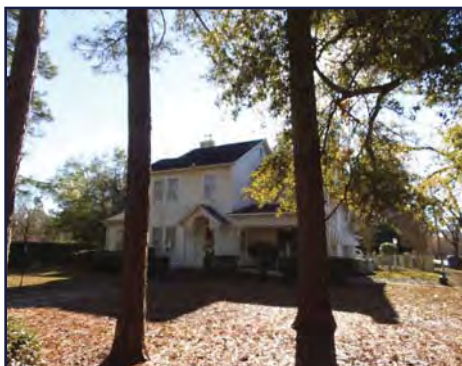
### Supporting Document 2

Two large side additions  
Scrolling metal porch supports and railings  
Mid-century awnings on side windows  
12 Glass panes in door with fanlight  
2 Front doors; second is in right side addition  
Right side addition is two stories. Brick verandah here  
Brick steps to original front door  
Paired single hung sash windows  
Overhanging eaves - integrity issues - serious alterations

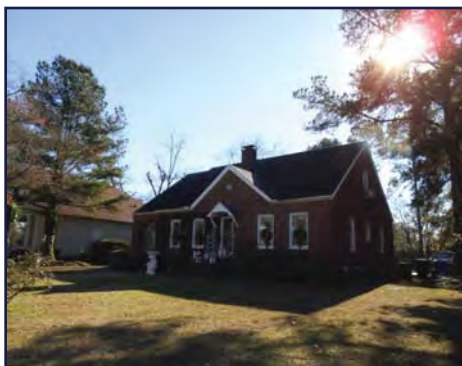
### Supporting Document 2

Circular attic vent in gable  
Gable hood for stoop with bracket supports  
Brick steps for stoop and side porch  
Side porch metal grate for opening  
Side porch with two arched openings and brick support for roof line  
Front door replaced  
Foundation planting beds and hedges  
Lamp post in yard  
Asphalt drive  
rowlock and sailor course jack arches above windows  
West beds have ivy and large pine tree

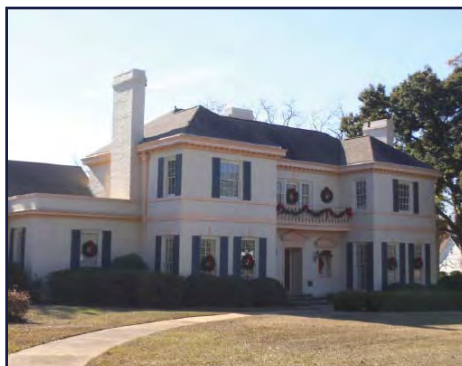
### Supporting Document 2

Chamber of Commerce  
Large integrated garage addition on left facade  
Overhanging eaves -Side additions  
Pyramidal roof over 2 front wings  
Corbelled chimneys  
Balcony with turned wood railing  
Triangular pediment over door, semicircular pediments over windows on either side  
Glass pane balcony door  
Large courtyard/fountain in rear of building, in front of conference center

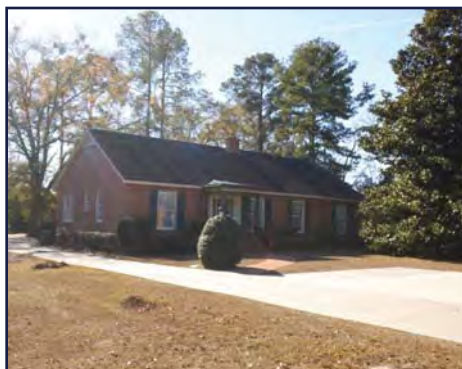
### Supporting Document 2

Law in front paved over for parking  
Scrolling organic metal porch supports and railing  
Ornate metal roof over door  
Side addition  
Brick walk to door from driveway  
Sidelights  
Vinyl around door  
Brick steps

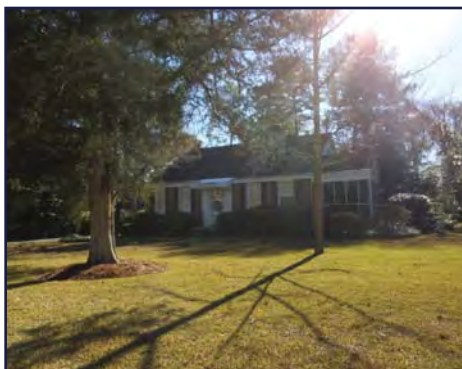
### Supporting Document 2

Aluminum hood over stoop, metal railings  
Brick steps with concrete tops  
Screened inside porch addition  
Vertical board surrounds front door  
Door has three fixed panes of glass  
Asphalt driveway  
City brick sidewalk with planting strip  
Foundation planting beds with hedges  
Hedgerow on east lot border

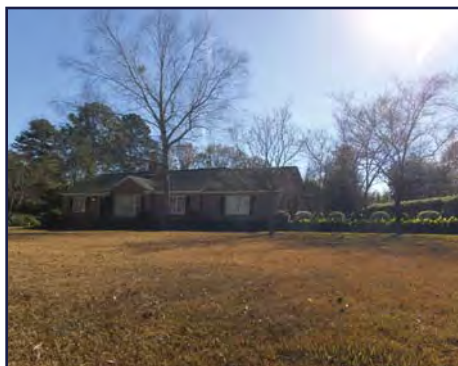
### Supporting Document 2

Foundation plantings  
Front gable over large Chicago style window; 4/4 on either side of large 10/10 fixed window  
Brick steps up to porch  
Metal porch railing  
flat arches, soldier course over windows  
2/4 paneled door  
Paired double-hung sash windows

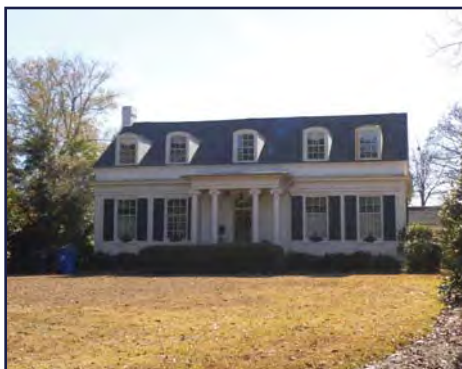
### Supporting Document 2

6/9 windows on first story, 6/6 in dormers with arched tops  
Ionic columns on porch  
transom over door  
Multiple rear additions  
Shutters on first story windows  
Dentils in eave of porch roof  
Foundation plantings  
Designed planting bed in front yard  
Large, overhanging entablature separates the floors  
corbelled chimney

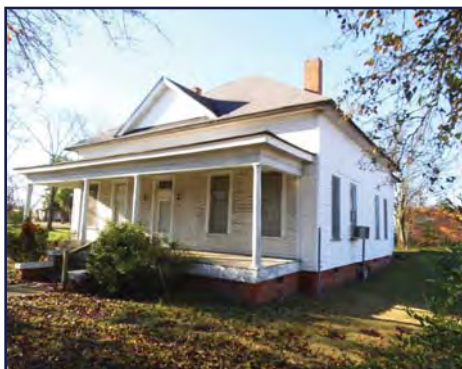
### Supporting Document 2

Rear gable addition  
Vinyl siding in front gablet and sides  
Doric column porch supports  
Brick foundation to porch  
Full length single light transom  
Large, single light in entry door with inset square wood detailing

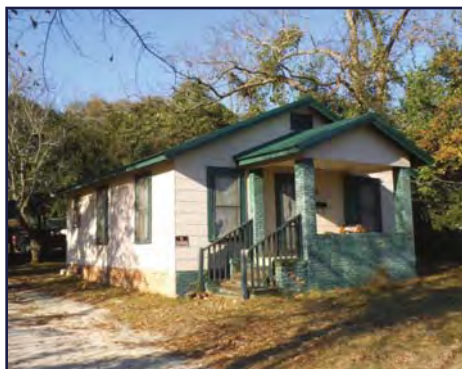
### Supporting Document 2

Horizontally oriented vent in front of gable  
Exposed rafter tails under house and portico gables  
Engaged brick columns on front side  
Portico has solid brick infill serving as ballustrade  
Brick soldier course at original portico foundation  
Vertical Brick vents along portico foundation

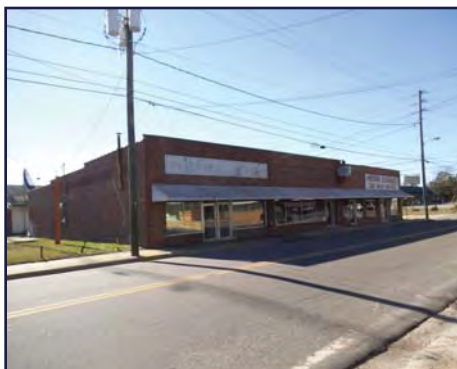
### Supporting Document 2

Original storefront has incorporated all storefronts on parcel  
Expansive aluminum awning  
Midcentury alteration in windows  
Double glass entry door  
Full singlelight transom above entry  
brick sills to window  
Protruding brick square detailing, creates area for signage  
Partially battlemented parapet  
Midcentury alley midcentury alley enclosed between  
cleaners and bottling plant  
Single parcel encompasses three storefronts

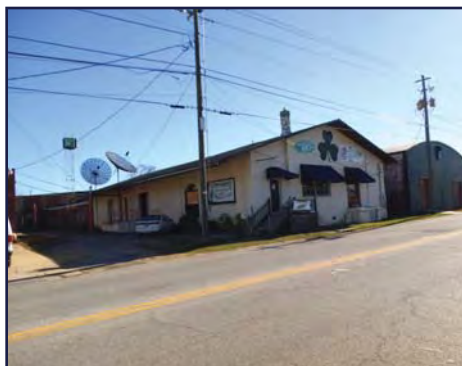
### Supporting Document 2

Multiple alterations to historic fabric: enclosure of original entry, bricked-in windows, alteration to historic windows during late 20th century  
Polychromatic painted brick chimney  
Attached alleyway  
Open exposed basement area

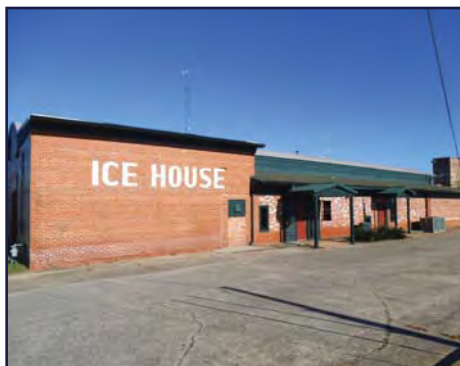
### Supporting Document 2

Side shed addition (late 20th Century)  
Now commercial office  
Historic vaulted warehouse with bricked-in original entry door and windows  
Bricked round arches around original windows and entry  
Five course American bond

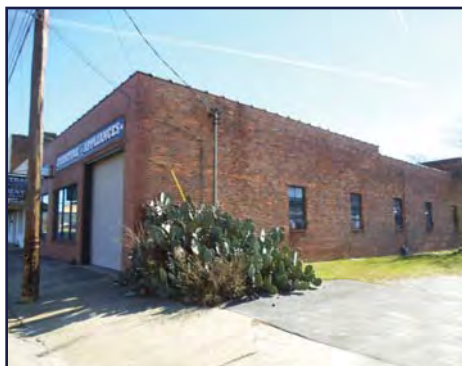
### Supporting Document 2

Late 20th century alterations:  
storefront entry and fixed commercial windows  
replaced warehouse door  
Tripartite fixed store windows  
Protruding brick lining above windows for signage  
Soldier course brick sills

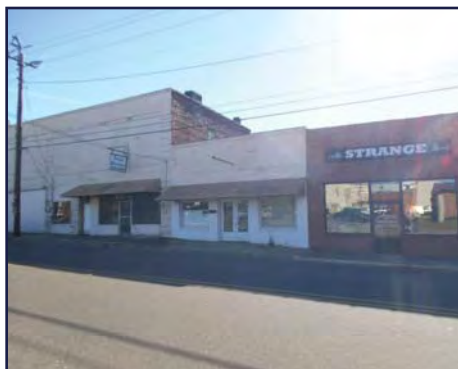
### Supporting Document 2

Pattern brick detailing above storefront windows  
Glass block above store windows (3x9)  
Midcentury aluminum awning  
Brick sill on storefront windows

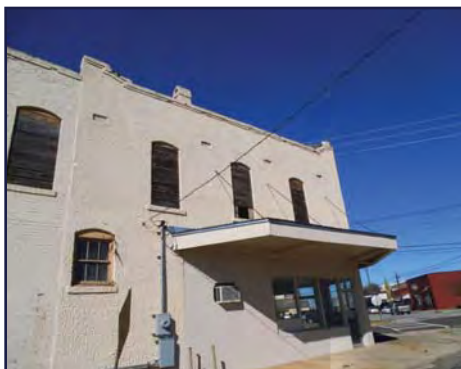
### Supporting Document 2

Singular large commercial structure subsequently broken into multiple commercial retail  
Primary historic structure  
Situates on lot diagonally  
Transverses parcel in southeast direction  
Stucco on second story  
Multiple windows on second story boarded over  
Corbelled brick detailing on front diagonal facade  
Pentagonal inset at apex of second story  
Battlemented parapet  
Southwest facade has multiple bricked windows  
Evidence of historic entries and loading areas  
Multiple chimneys along ridgeline, no evidence on exterior  
Paired three panel oak door under four pane tansom, all with brick sills

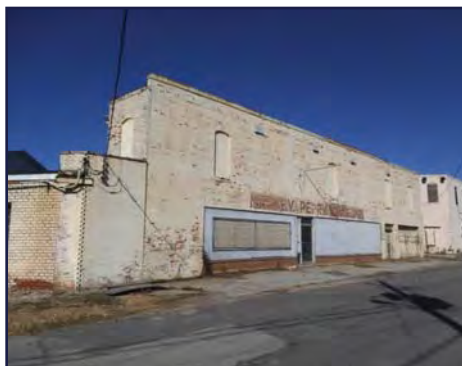
### Supporting Document 2

Midcentury enclosure of storefront with synthetic siding  
Brick/wood infill on second story windows  
Brick sills, rounded arches in windows  
Dovetailed brick placement on diagonal corners  
Vertical board warehouse doors  
Three tiered set back brick at roof crest

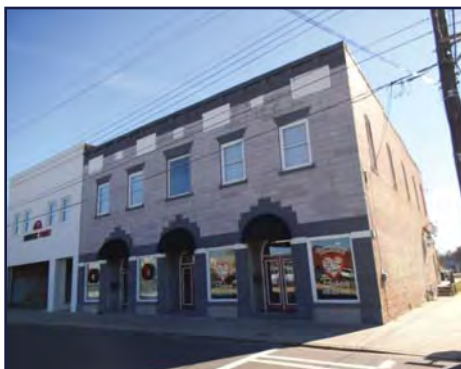
### Supporting Document 2

Brick structure with concrete facade  
Flat arches with diagonally-placed voussoirs above second story windows  
Granite/sandstone sill above second story windows  
Scroll patterned stamped concrete course along roofline and first floor lintels  
Printed pattern on stamped decorated concrete frieze  
Voussoirs above three pronounced recessed entryways

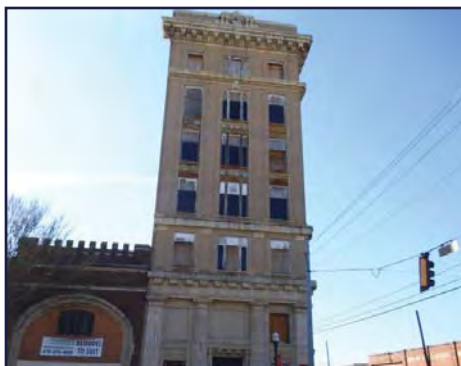
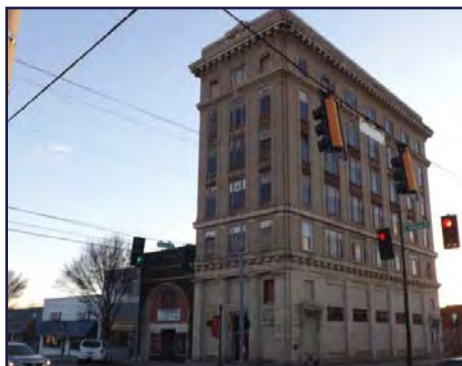
High style Colonial Revival skyscraper  
Full entablature around entry doors  
Granite base entry with dentils and scrolled details  
Brackets under frieze and unbroken pediment with circular detail  
1.5 story engaged columns with doric order and carved concrete detailing  
Columns have concave scalloped design (12 sections)  
Boarded fixed windows, each with concrete scored voussoirs  
In architrave: "first national bank", with vertical triglyphs  
Floors 2-6: repetitive and symmetrical tripartite - single flanked by two small fixed windows  
Top floor: repeated motif of tripartite with two flanking fixed dentils and bracketed wall overhanging eaves  
1.5 story flat-headed pilasters  
3-5 brick pilasters on corners
