# City of Dublin

## Historic Resource Survey Report

December 2013

Report Prepared By:  
Center for Community Design and Preservation at the University of Georgia  
<http://www.ced.uga.edu/psd>  
225 W Broad Street  
Athens, Georgia 30602

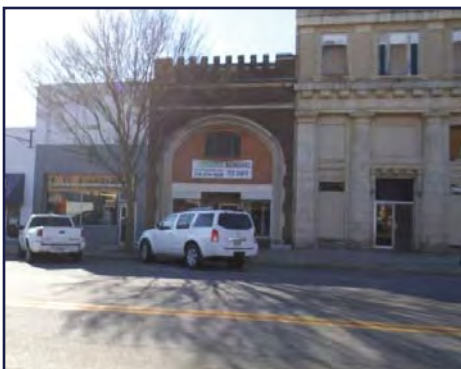
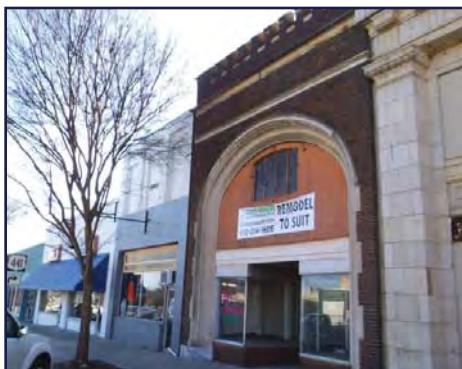
First floor: store front windows recessed  
Entry flanked by sidelights  
Original tile entry floor, extant with greek key detailing  
Large 1.5 Story Richardsonian arch  
Sandstone scored brick foundation to store front windows with soldier course sills  
Vertical board in second story of arch with convex ribbon window in center  
Second floor has crenulated parapet

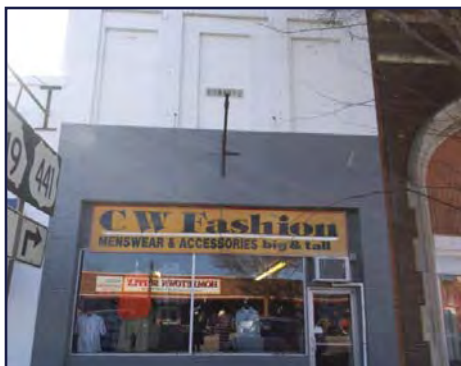
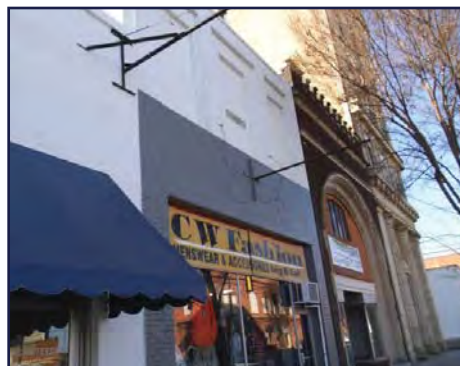
Store front windows have mid-19th century or later alterations  
Continuous brick sill under store front windows  
Second story recessed windows  
Bricked in flat arches still evident

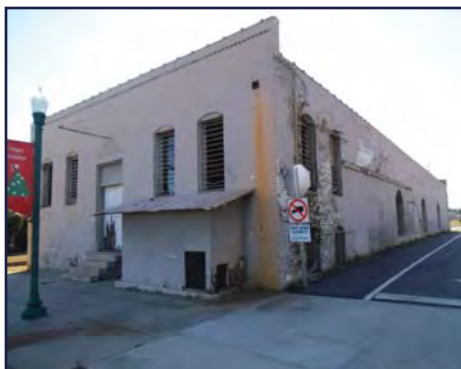
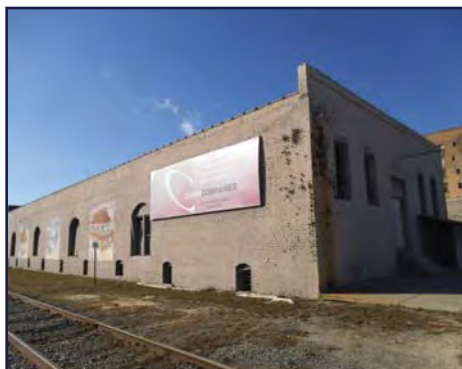
Recessed single pane windows on side facade  
Recessed entry door  
Most windows missing, one extant is fixed  
Some frames of double hung sash windows in front flat arch  
Frieze above entry door  
Diagonally-coursed brick detailing along roof lines  
Partially submerged basement

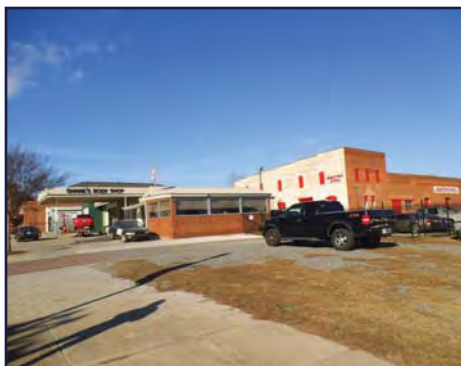
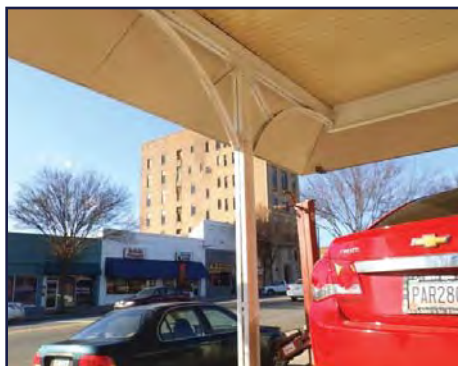
Original service station  
Alterations on flanking portions in last 10 years (side shed  
and gabled additions)  
Large fixed paired windows in front  
Vertical board on service entry  
Metal supports with original rivets

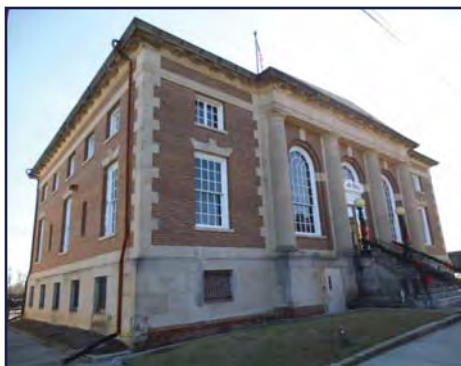
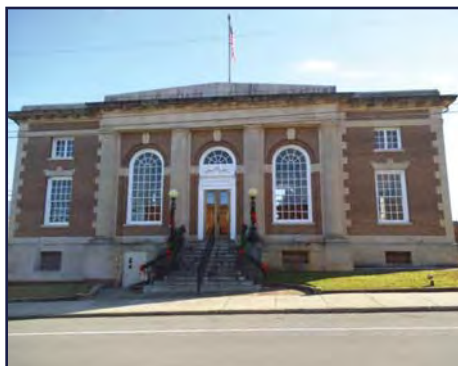
Sandstone sills to all windows  
Raised basement  
Bricked-in windows on English basement  
Large concrete blocks above continuous brick foundation  
Ornate granite entry stairs  
Molded concrete curved railings  
Double front door, single light  
Full entablature with chippenidale pediment with scrolls and dentils  
Pronounced arches above entry doors carved sandstone  
Keystone in all large arches  
1.5 engaged Doric sandstone columns  
Flat sandstone arches with pronounced keystone above doublehung sashes  
Large sandstone quoins in each facade section  
Sandstone running course beneath fanlight on middle front third of facade  
Sandstone triglyph in frieze

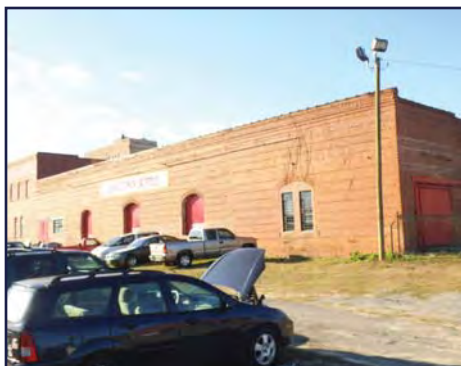
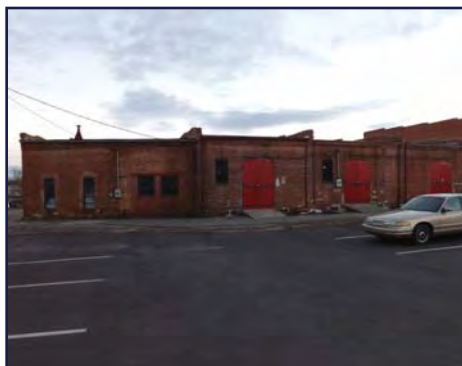
Original outbuilding/storage for multiple light industrial surrounding structures  
Round arches over doors and windows  
Dovetail brick detailing at diagonal corners  
Parapet separates individual storage facilities  
Concrete inclined plane ramps to double door storage facilities  
Single section has been altered with bricks and flat window additions  
Two story main structure has corbeled brick detailing along roofline  
Windows in primary structure are enclosed

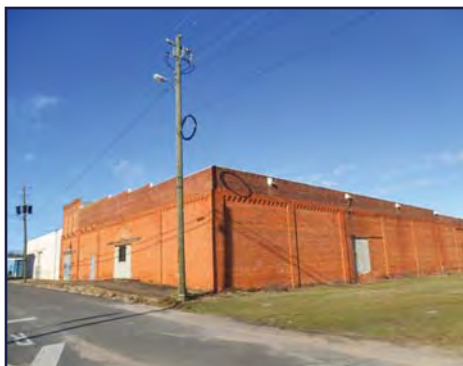
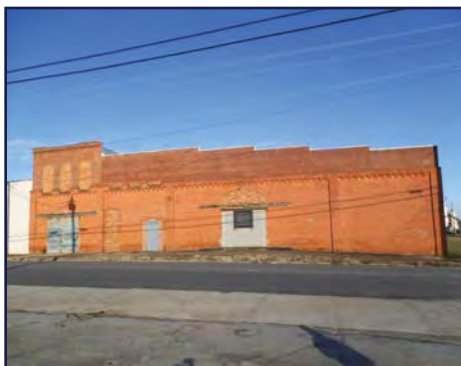
Corbelled brick detailing at top of first story and along second story roof eave  
All windows and doors bricked in  
Largest secondary access has concrete block infill  
Five engaged columns  
Roofline descends gradually from left to right facade, stepped by four courses every 20 feet  
Six course american bond brick

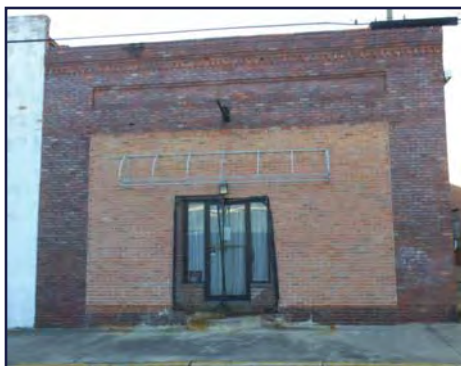
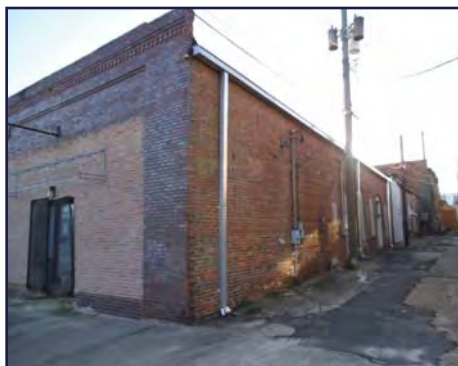
Entire original store facade bricked in  
Protruding brick detailing along cornice  
Recessed portion above bricked in facade ghosted  
Bricked in windows on alley way facade  
Single pane entry door with flanking sidelights

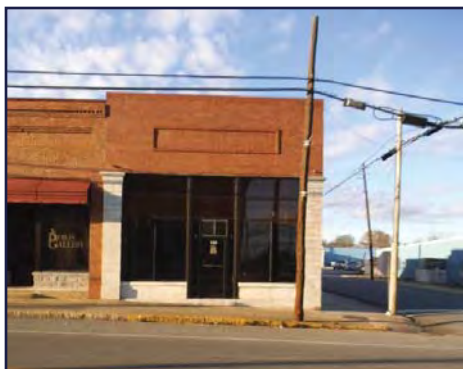
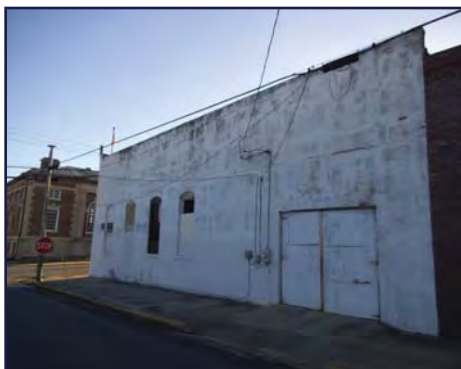
Historic protruding brick detailing above windows  
Late 20th century remodel of front facade  
Granite curbs  
Two engaged one story granite columns with regular coursed granite stone

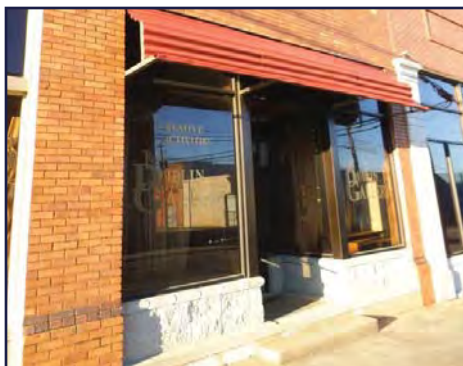
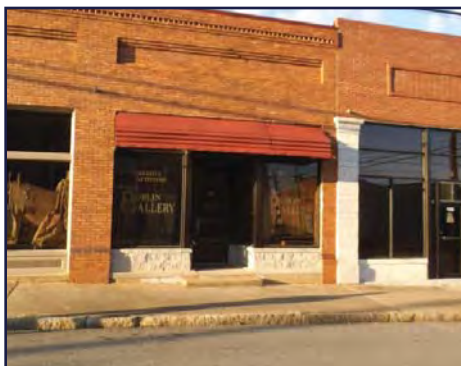
Recessed entry flanked by single pane shop windows  
Remodeled late 20th century  
Inset brick design on upper portion of front facade  
Diagonally coursed brick along roof top

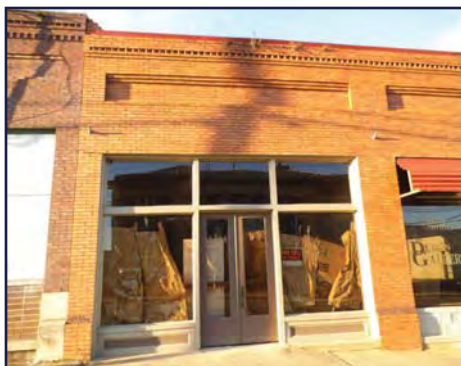
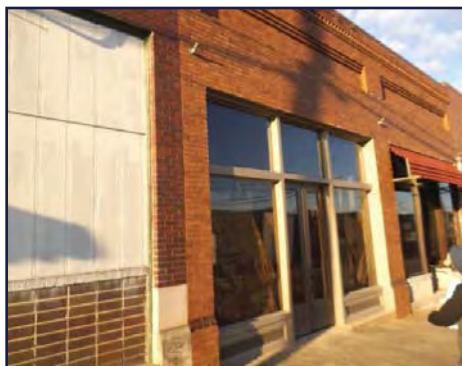
Diagonally coursed brick detailing below roofline  
Recessed brick detailing above fixed single pane windows on front facade  
Granite curbs

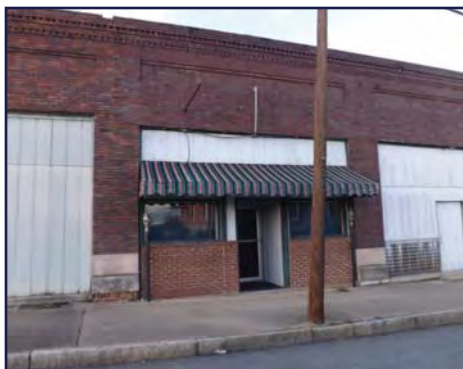
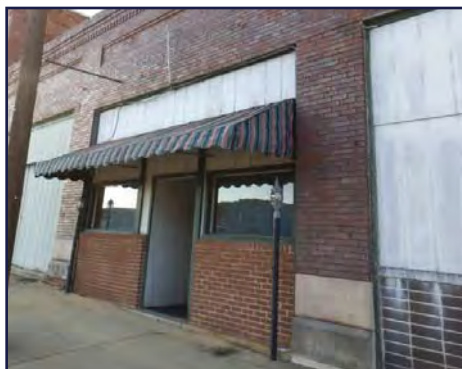
Solid granite along foundation  
Original frontage enclosed by brick and plywood vertical board  
Recessed brick detailing above fixed single pane windows on front facade  
Protruding brick detailing under roofline  
Diagonally coursed brick detailing along roofline  
Granite curbs

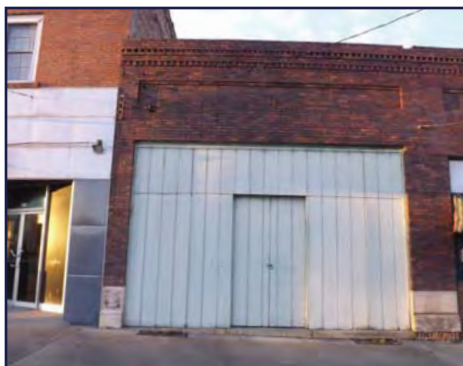
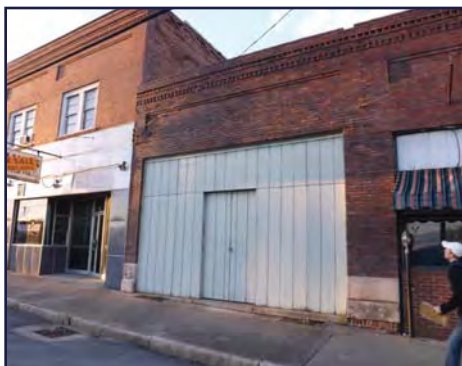
Diagonal brick detailing and dentiles along roof lines  
Recessed brick detail above original entryway  
Vertical board replacement siding  
Granite curbs  
20th century replacements

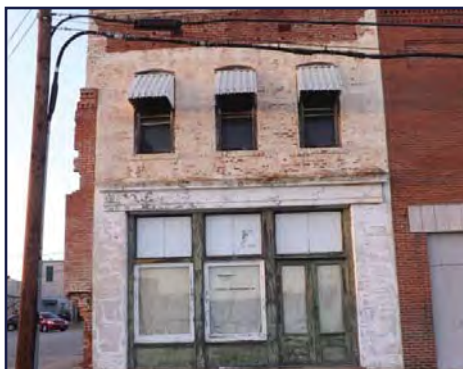
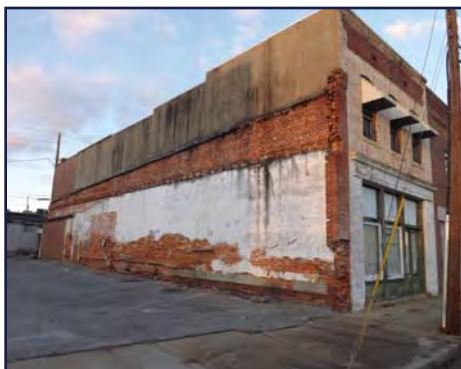
Much of original fabric extant  
Granite step along foundation  
Corbelled brick entablature at roofline  
Paired large fixed glass storefront windows  
Double entry door has two vertically orientated lights  
Three large paired fixed lights above store windows \and entry door  
Midcentury aluminum awnings on second floor windows

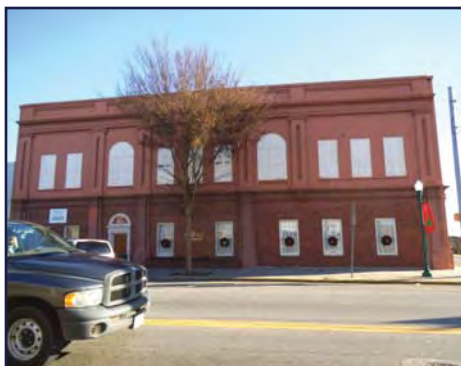
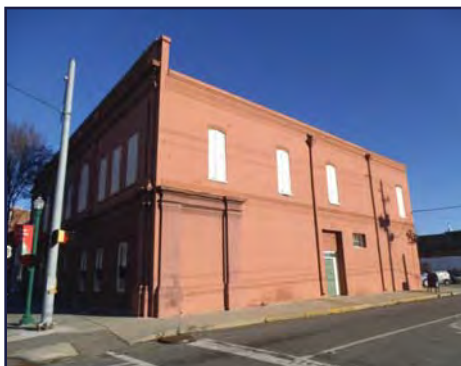
First and second floor- dhs windows, second story covered over by shutters  
Doric pilasters with dentils on first floor  
Pronounced Ionic columns on second floor  
Full entablature runs across first floor facade, repeats on second floor  
Full tabernacle frame on entry door  
Rounded brick arch over fanlight  
Second story has large fixed windows with rounded brick fanlight  
Three course corbelled brick detailing with inset detailing  
Rusticated stone runs across lintel

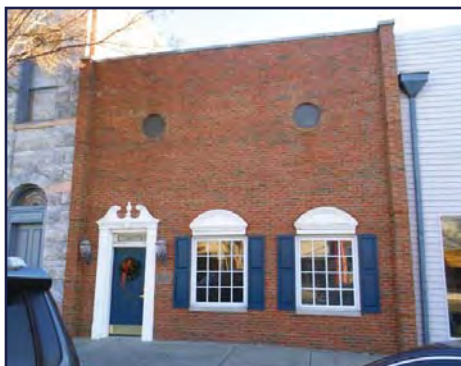
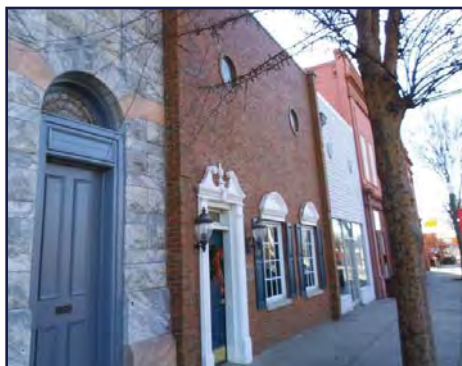
Poured concrete border along roofline  
Chippendale pediment door frame  
Single light transom  
Fixed windows are replacement  
Gothic revival detailing in second story  
Circular window  
Exterior colonial revival details, altered later

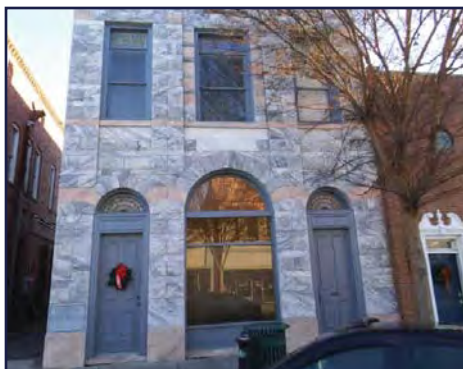
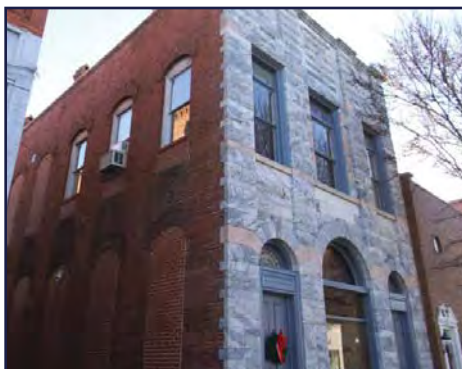
Continuous pink granite foundation  
Rusticated large granite block exterior materials in regular  
coursed pattern  
Pronounced fixed window in center of first story facade,  
with single light, rounded arch transom  
Peacock feather patterned stained glass fanlights above both  
entry doors  
Solid granite voussoirs above entry doors  
Solid granite sills on all second floor windows  
Stained glass transoms in queen anne pattern above second  
story windows  
Solid rusticated granite flat arches above second story  
windows  
Two story granite pilasters

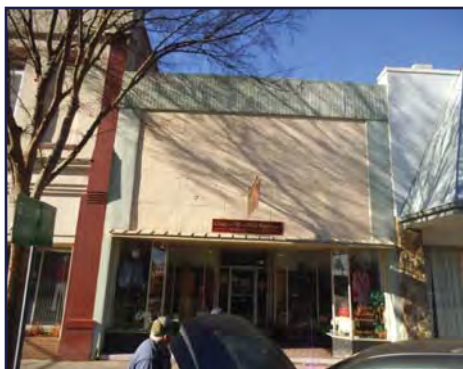
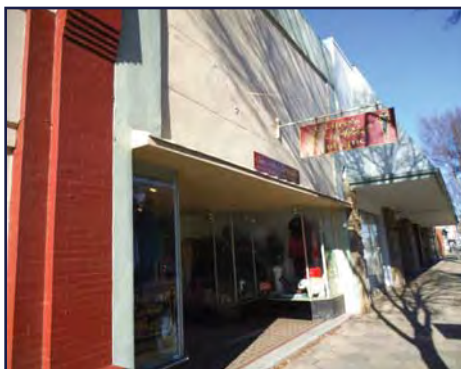
Midcentury alterations to original store front windows:  
recessed vertical expanses of glass  
Elaborately patterned tile floor to entry  
Solid granite block along foundation  
Coursed concreted poured over original exterior materials  
Vertical wood slats along roofline

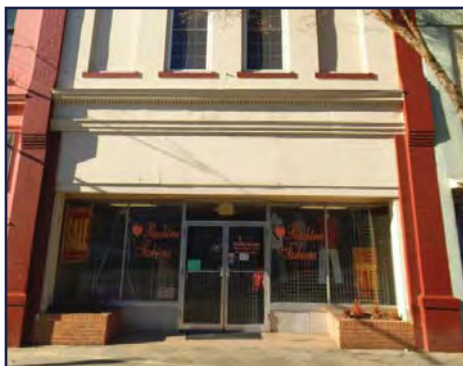
First floor midcentury alterations  
Brick planters flanking entry  
Recessed entry with geometrically patterned floor  
Plywood above recessed entry over original facade  
Dentils at apex of first floor  
Second story replaced windows  
Flat arched replacement windows with solid brick sills  
Granite curb  
Two story brick pilasters at facade ends  
Recessed corbelled brick detailing below roofline

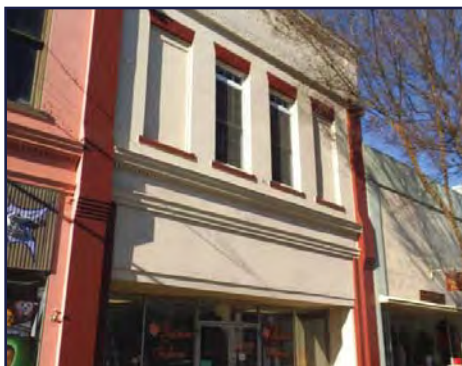
### Supporting Document 2

### ROOF TYPE AND MATERIAL

Roof Material: Unknown  
Roof Type: Flat

Foundation Materials: Brick  
Foundation Type: Continuous

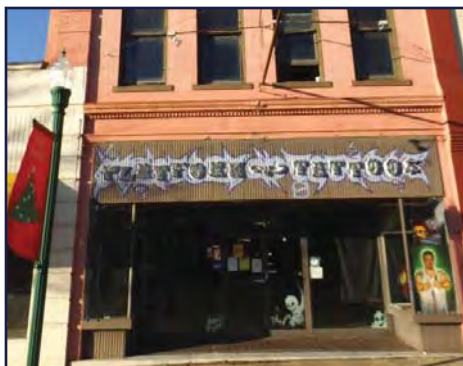
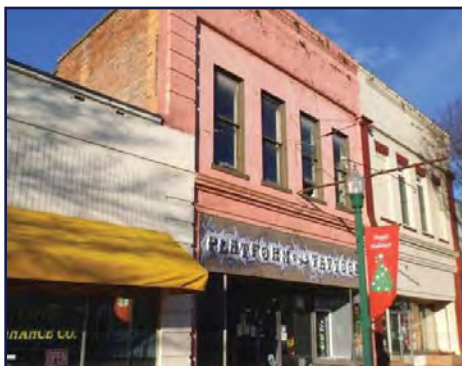
### Supporting Document 1

Roof Material: Unknown  
Roof Type: Flat

Foundation Materials: Unknown/obscured  
Foundation Type: N/A

Midcentury alterations: large fixed single pane shop windows on first floor, recessed entryway with aluminum frame  
Recessed entryway has patterned geometric tile flooring  
Dentils at apex of first floor  
Two story brick coins on left facade  
Flat arches above second story replacement windows  
Two coursed brick corbelling  
Granite curbs

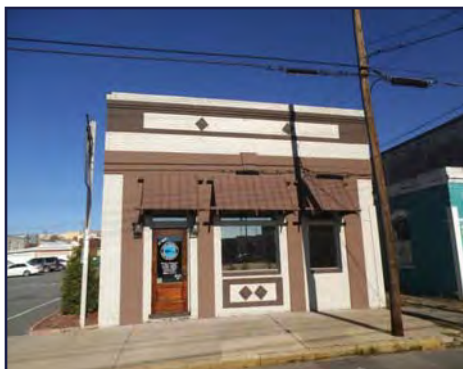
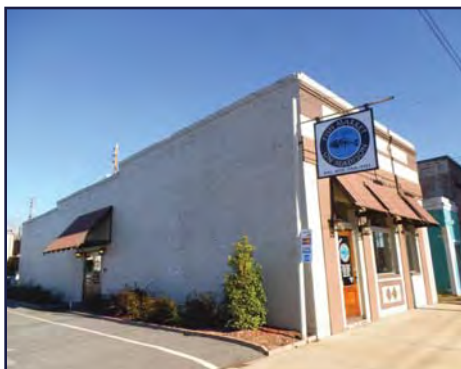
### Supporting Document 1

Roof Material: Unknown  
Roof Type: Flat

Foundation Materials: Brick  
Foundation Type: Continuous

Originally electronics store  
20th century awning addition and lighting flanking entry  
Three course corbelled brick detailing on roofline  
Pattern brick detailing below fixed windows and along  
roofline  
Textured concrete over brick facade with pronounced key  
stone  
Five course american bond  
Large single light above entry door

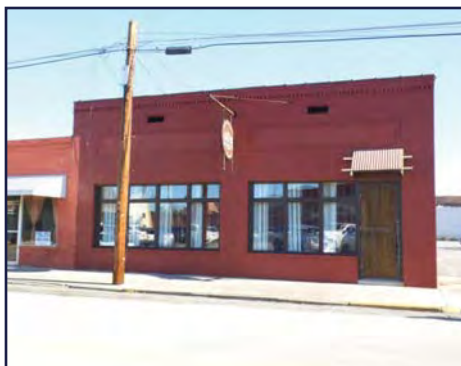
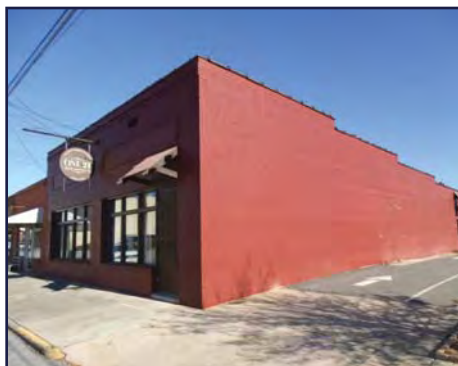
### Supporting Document 1

Roof Material: Unknown  
Roof Type: Flat

Foundation Materials: Brick  
Foundation Type: Continuous

Midcentury renovations: fixed single pane window replacements  
Side and front of building have five course american bond  
Diagonally coursed brick detailing along roofline  
Two rectangular vents with protruding brick sills,  
symmetrically arranged on front facade above fixed windows  
Protruding brick detailing over both ribbon windows

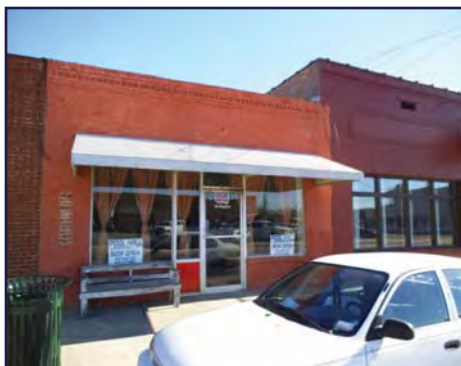
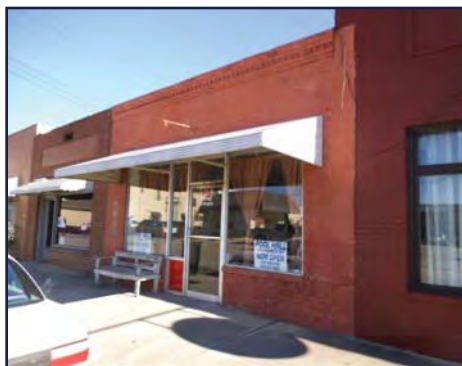
### Supporting Document 1

Roof Material: Unknown  
Roof Type: Flat

Foundation Materials: Brick  
Foundation Type: Continuous

Four course brick detailing  
Large fixed single pane windows with brick sills flanking  
entryway  
20th century awning addition over entry and ribbon  
windows

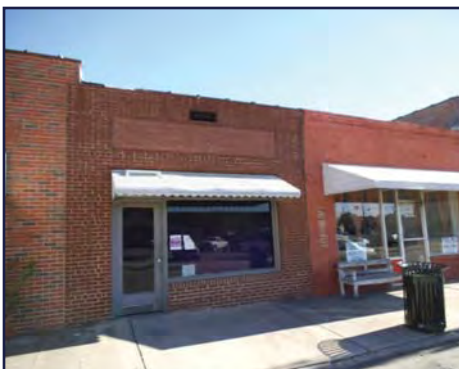
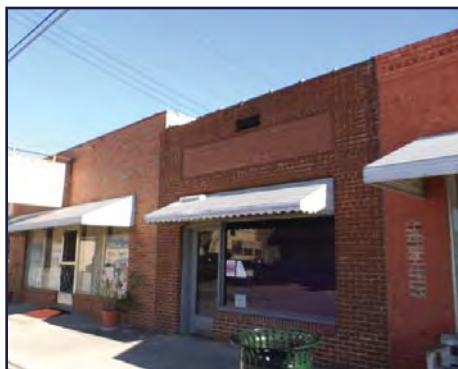
### Supporting Document 1

Roof Material: Unknown  
Roof Type: Flat

Foundation Materials: Brick  
Foundation Type: Continuous

Brick sills under store windows  
Full transom with two lights  
Scored brick exterior  
Inset rectangular brick section under roof line

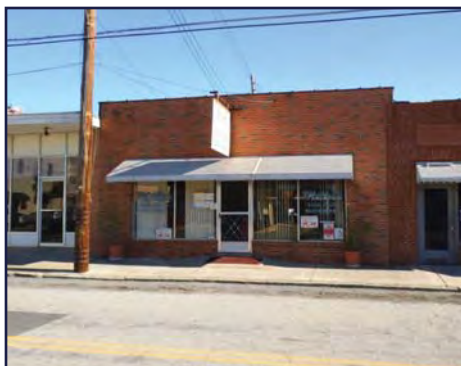
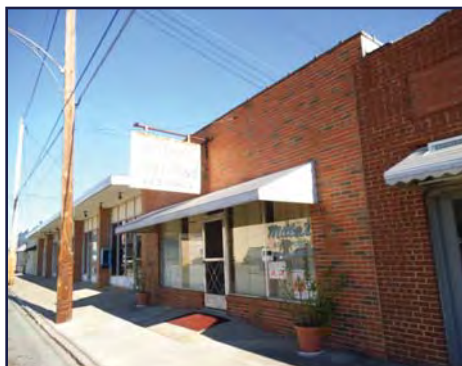
### Supporting Document 1

Roof Material: Unknown  
Roof Type: Flat

Foundation Materials: Brick  
Foundation Type: Continuous

Midcentury alterations to storefront windows  
Brick sills under large fixed windows  
Single light transom above door  
Midcentury aluminum awning

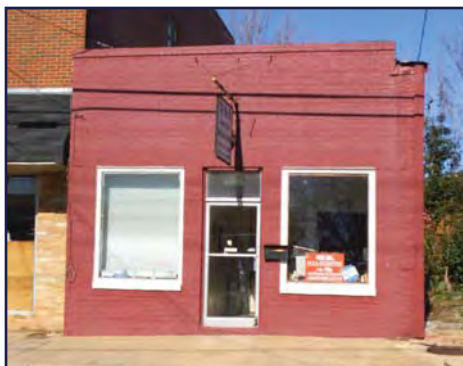
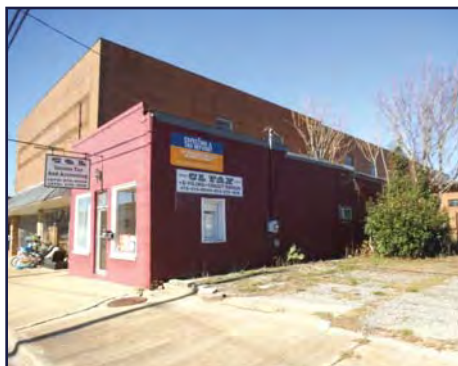
### Supporting Document 1

Roof Material: Unknown  
Roof Type: Flat

Foundation Materials: Brick  
Foundation Type: Continuous

Soldier course above entry door  
Fixed windows  
Single light transom above entry door  
Granite sill to entry door  
Five course american bond brick facade

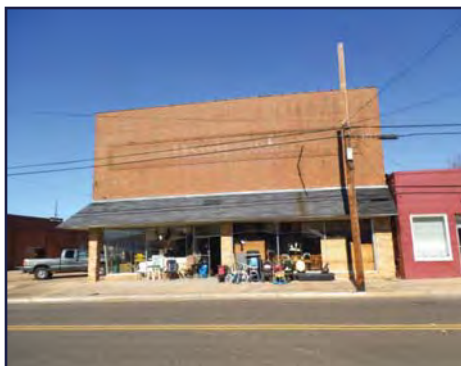
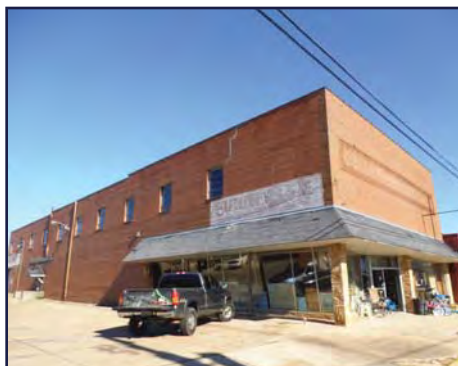
### Supporting Document 1

Roof Material: Unknown  
Roof Type: Flat

Foundation Materials: Brick  
Foundation Type: Continuous

Midcentury alterations: ribbon windows running front facade  
Second story: scored brick with rectilinear, protruding patterned detailing (basketweave)  
Irregularly coursed sandstone  
Hipped roof extending towards street  
Left front facade: hipped roof supported by irregularly coursed sandstone pillar

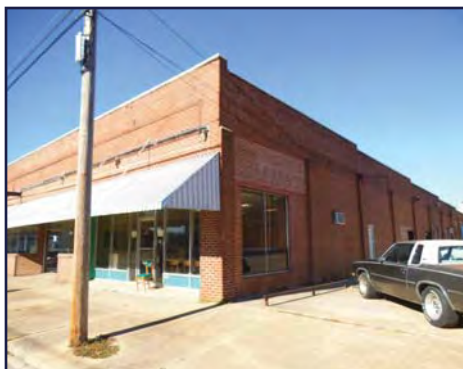
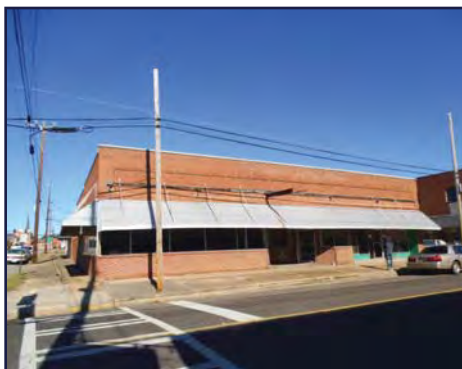
### Supporting Document 1

Roof Material: Unknown  
Roof Type: Flat

Foundation Materials: Brick  
Foundation Type: Continuous

Dovetail detailing on diagonal walls  
Multiple commercial block with two individual properties  
Left store currently vacant  
Right store retail space  
Scored brick facade on both storefronts  
Midcentury aluminum awning additions  
Aluminum frames on all windows  
Decorated glass blocks on left facade above entry door and below ribbon windows  
Horizontally-oriented protruding brick detailing along entire front facade

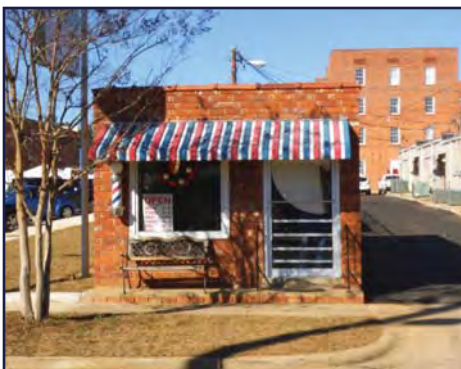
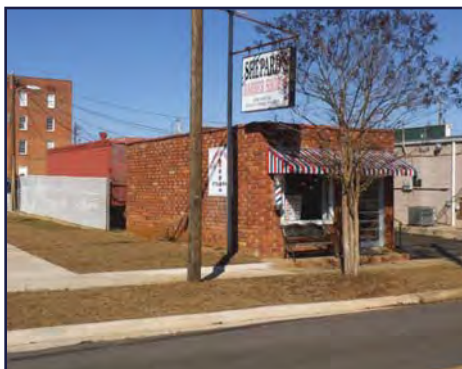
### Supporting Document 1

Roof Material: Unknown  
Roof Type: Flat

Foundation Materials: Brick  
Foundation Type: Continuous

Large bricks comprise running bond  
Midcentury aluminum awning  
Fenced portion of back parcel  
Large fixed store front window  
Brick patio across front facade  
Minimal alterations  
Current use: barber shop

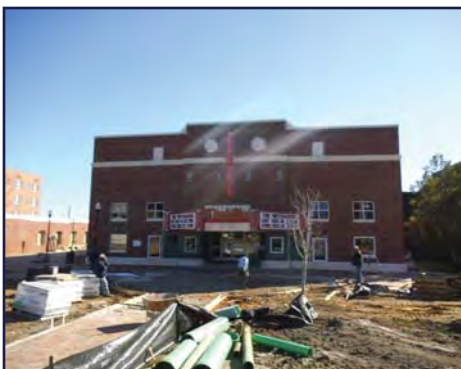
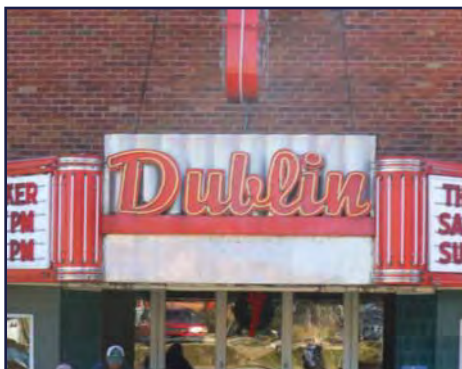
### Supporting Document 1

Roof Material: Unknown  
Roof Type: Flat

Foundation Materials: Brick  
Foundation Type: Continuous

Six course American bond on side front facade  
Midcentury renovations (fixed windows and brick)  
Original first story windows replaced and bricked in (arches evident)  
Second story windows: four pane with flat arch sills and flat brick four course corbelled brick detail 2/3 up front facade  
Upper third front facade has two infilled fixed windows with flat arches and two circular windows outlined in brick decorative concrete course at roof apex

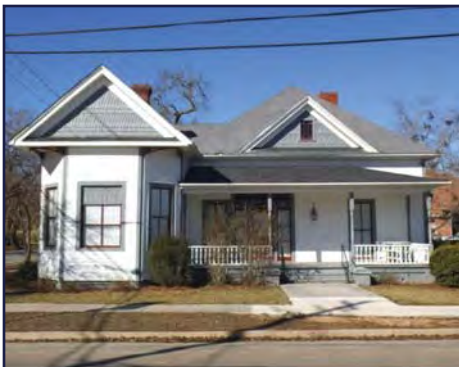
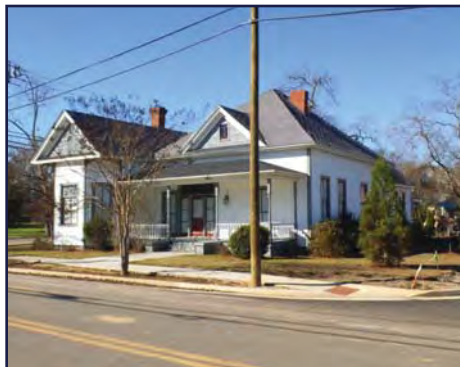
### Supporting Document 1

Roof Material: Asphalt (composition) shingle  
Roof Type: Hip

Foundation Materials: Brick  
Foundation Type: Pier/Post with Infill-Brick

Brick pier with brick infill  
Gable ell plan with hipped main section bay on ell  
Queen Anne drop shingles/scalloped shingles in front gable and gablet  
Vertically oriented fixed windows in front gablet  
Stained glass turned wood porch supports corbelled chimney on ell  
Three pane sidelights with full three pane transom  
Stamped concrete stairs to porch  
Rear gable addition  
Single light entry door  
Turned balustrade  
Star detailed brackets under roof eave on ell

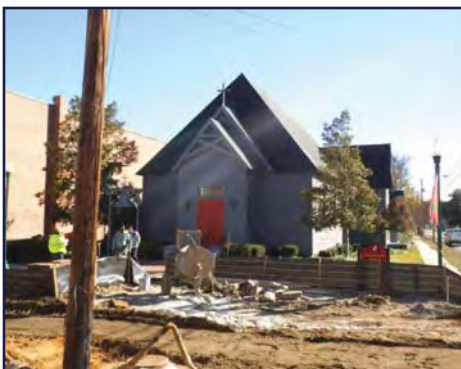
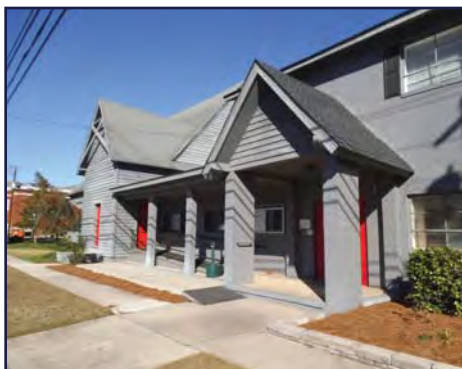
### Supporting Document 1

Roof Material: Asphalt (composition) shingle  
Roof Type: Hip

Foundation Materials: Brick  
Foundation Type: Pier/Post with Infill-Brick

No windows on front facade  
Fixed stained glass on side  
Steeply pitched hip roof  
Two small double front gable projections off front with cross beam details  
Large integrated rear addition (school)  
Two story midcentury brick front gable, painted to match church  
Etched glass transom above double church doors \ Integrated side gable addition fronts church street (historic)

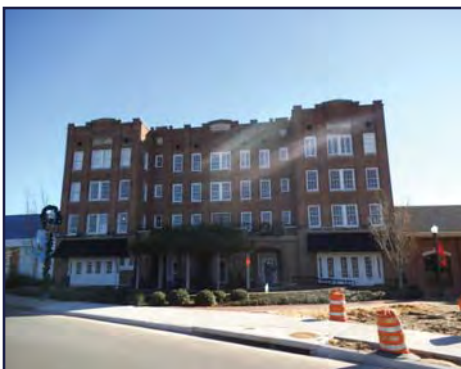
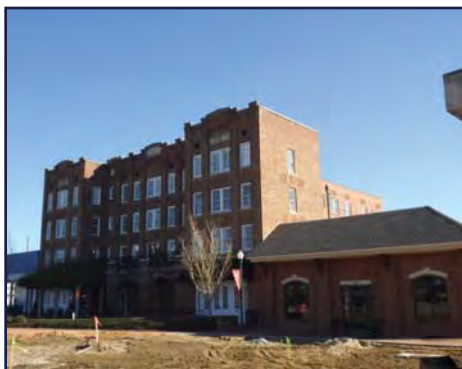
### Supporting Document 1

Roof Material: Unknown  
Roof Type: Flat

Foundation Materials: Brick  
Foundation Type: Continuous

Renovated three years ago for condominiums  
Original brick facade with midcentury window replacements  
First floor: three 24-pane entry doors on front facade, each  
each with four-pane sidelights and six-pane rectangular  
transom light  
Recessed entry with stamped concrete walkway between  
entry doors and ogee arches  
Second floor: patio is center of front facade with ornately-  
detailed iron bannister and slate facade detail running length  
of patio  
15-pane double doors are exit to balcony  
Cast concrete sills and pilaster footings on projecting wings  
Floors 2-4: basketweave brick detail in between 6/6 double  
hung sash windows  
Four story brick pilasters separate 13 bays floors  
Floors 4-5: concrete course battlement along roofline  
Detailed iron cap between brick pilasters  
Projecting wings on cast concrete detail under six protruding  
brick detail pointed arches ("egyptian revival") between

projecting wings  
Cast concrete shield detail on left and right of recession  
Concrete plaque centered on front facade above six  
protruding corbelled pointed brick arches ("Hotel Fred  
Roberts, 1926")

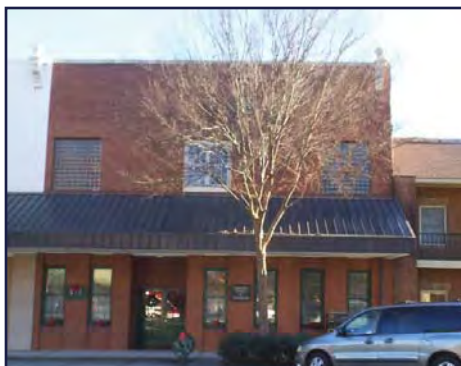
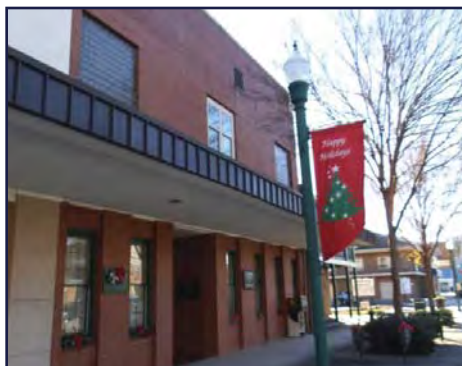
### Supporting Document 1

Roof Material: Unknown  
Roof Type: Flat

Foundation Materials: Brick  
Foundation Type: Continuous

Originally built in 1898  
Second story added in 1912  
Remodeled and enlarged in 1944  
Renovated again 1985  
First floor - midcentury renovation to brick facade  
Six bays divide brick pilasters  
Recessed brick entry way with decorative tile flooring 45  
degree brick sills below 9/9 windows  
Large triangular concrete /aluminum awning spans building  
and divides first and second floors  
Second floor- decorative cast concrete sconce on ends  
6/6 windows centered on facade with decorative glass tiles on  
left and right wings  
Square vent centered in front facade below roofline  
Capped concrete course

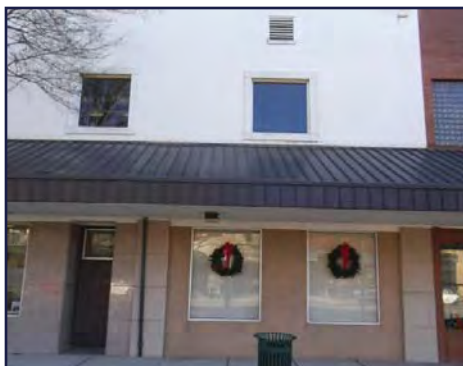
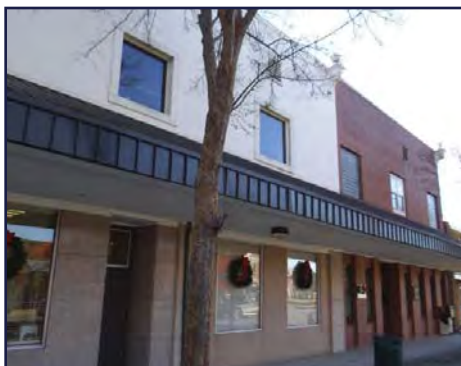
### Supporting Document 1

Roof Material: Unknown  
Roof Type: Flat

Foundation Materials: Brick  
Foundation Type: Continuous

Middle section of large multiple retail commercial block  
Large fixed store windows with aluminum frames  
Square vent on second story  
Decorative sconces at roofline

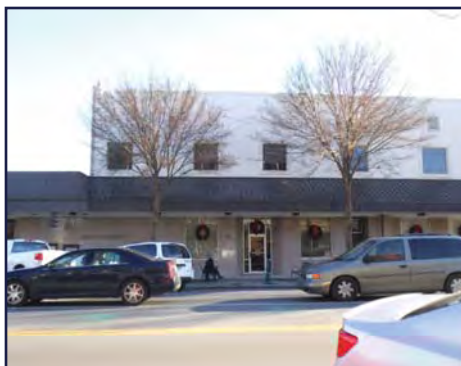
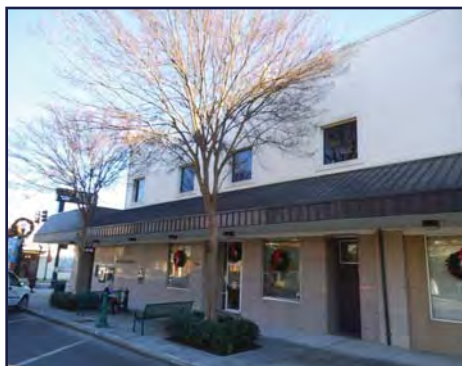
### Supporting Document 1

Roof Material: Unknown  
Roof Type: Flat

Foundation Materials: Brick  
Foundation Type: Continuous

Third section of a multi-retail commercial block that encompasses the majority of the northside "200" block on West Jackson Street  
Major alterations (full replacements) of first floor exterior materials, now encased in granite sheeting (2x2' blocks)  
Alterations to entry doors include single light entry door with full sidelights and square transom  
Aluminum frames to store windows  
Historic frames to second story windows  
Decorative sconces on roofline  
Brick exterior on second floor

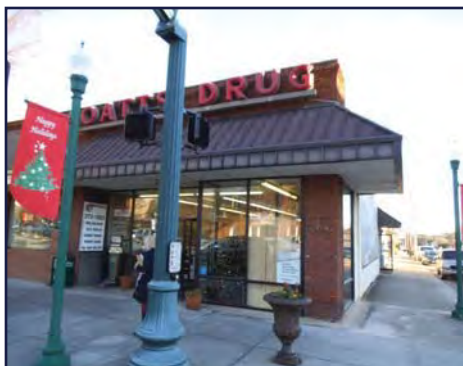
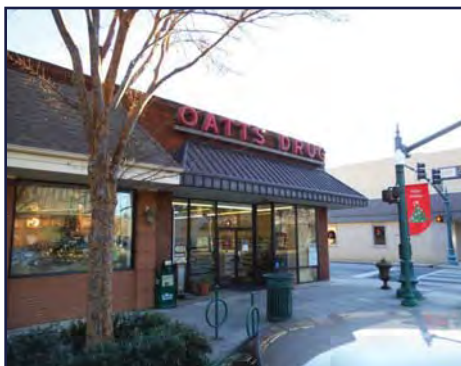
### Supporting Document 1

Roof Material: Unknown  
Roof Type: Flat

Foundation Materials: Brick  
Foundation Type: Continuous

Double entry doors with single pane transom  
Recessed entry surrounded by store front windows  
Hard etched rusticated brick  
Exterior large mural on right facade  
Poured concrete entry  
Late addition plastic hipped roof awning

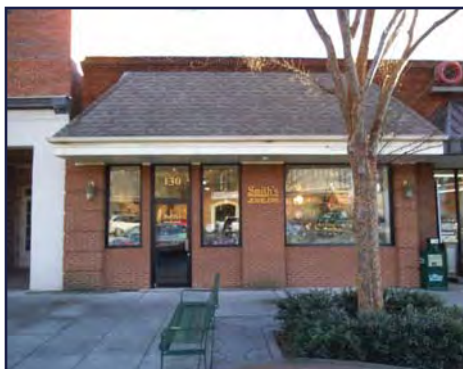
### Supporting Document 1

Foundation Materials: Brick  
Foundation Type: Continuous

Midcentury renovations: front brick facades and fixed windows  
Main entry door flanked by rectangular fixed windows  
Brick coins on left and right side of facades  
Rusticated brick below roofline and above hipped roof awning

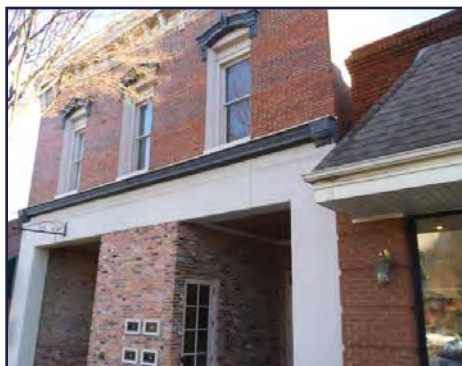
### Supporting Document 2

Italianate details on second floor: hood with keystone and triglyphs over windows, pronounced brackets under eaves, and sconces on roofline  
Late 20th century alterations to first floor (now has deeply recessed entry with common bond polychromatic brick)  
Five course American bond on second story  
Large smooth concrete detailing on first floor  
Current use: vacant and office space  
Fixed windows on first floor  
Eight light entry door with single pane transom

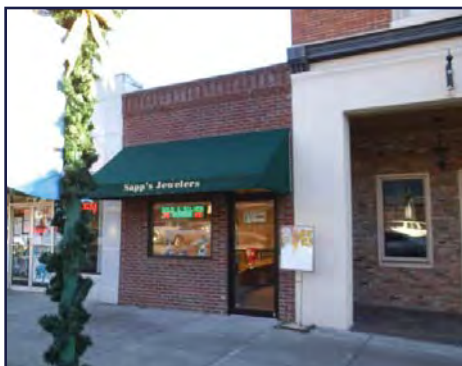
### Supporting Document 2

Midcentury alterations to store windows and entry door  
Single pane transom above single pane entry door  
Sailor course brick window sill  
Decorative alternating sailor soldier course along roofline

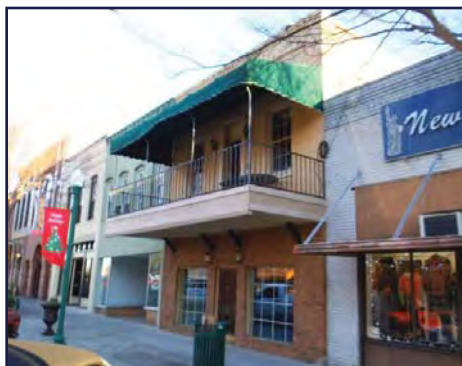
### Supporting Document 2

First floor: late 20th century renovations to brick facade and windows  
Main entry door flanked by large fixed single pane windows  
Second floor: 20th century wood and aluminum balcony extension with iron bannister  
Late 20th century fabric awning covering patio  
Patio entryway centered on facade and flanked by 6/6 double hung sash windows  
Three course corbelled brick detailing along roofline

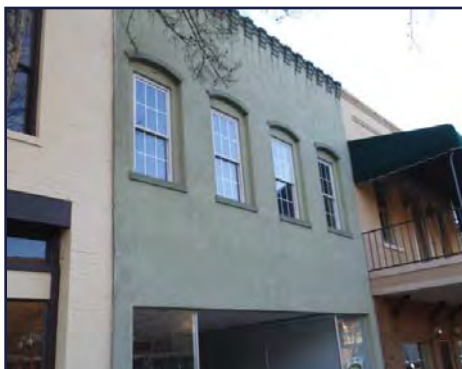
### Supporting Document 2

Recessed entryway altered during midcentury  
Full expanse of storefront now glass display cases  
Single pane entry door with single pane transom  
Recessed windows (double hung sash) on second story, with rounded arch surrounds  
Corbelled brick detailing at roofline  
Italianate detailing removed, covered with stucco  
Random coursed mosaic tiles to entry floor

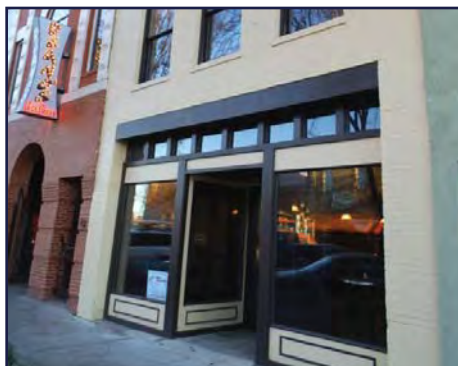
### Supporting Document 2

Micentury renovations to facade  
Recessed entry door flanked by large fixed single pane windows  
Eight pane transom spanning building  
Front facade rectilinear  
Detailed wood protrusions below ribbon windows  
Renovated second floor with 1/1 double hung sash windows within historic brick arch and sill detailing  
Brick dentils along roofline  
Alternating sailor/soldier course brick detail below dentils  
Diagonal brick detail between four course brick detail, above bricked arches

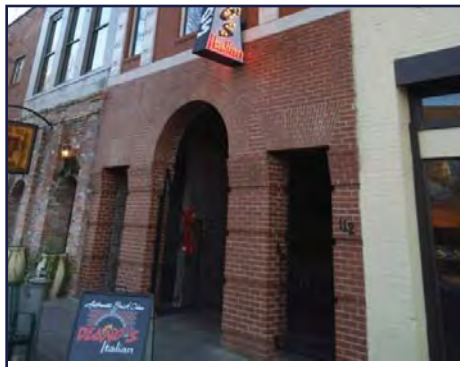
### Supporting Document 2

Heavily altered first floor - recessed entry off original facade, removed windows and original door  
Round arch above door and flat arches above windows still extant  
Replaced windows on second floor  
Flat arched fixed windows flank central round arched window, all with brick arches  
Alternating rusticated concrete masonry units  
Smooth concrete block vertical details on top third of facade  
Three course corbelled brick detailing along roofline  
Slate floor to recessed entry

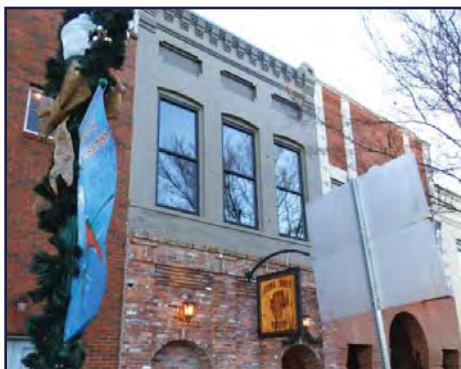
### Supporting Document 2

Sailor course brick along foundation  
Soldier course above sailor  
Blind round arch with brick key stone above recessed brick arches  
Round arch entry leads to recessed round arch entry door with single light and single light rounded arch transom  
One story brick pilasters on first floor  
Double hung sash windows on second floor with round brick arches  
Three recessed decorative brick sections above windows  
Corbelled six course brick dentils along roof line  
Square decorative brick caps on roof line

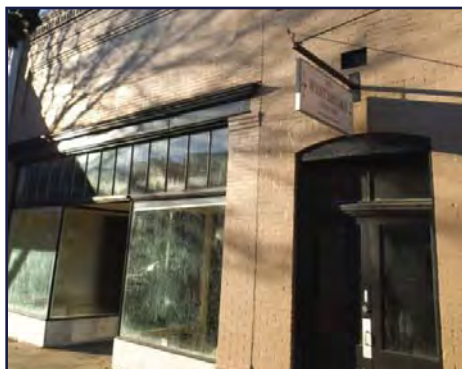
### Supporting Document 2

Alterations to historic storefront  
Large fixed display windows lead to recessed double entry  
door, both with single light 14 light transom across entire  
facade on entry  
Recessed rectangular brick section above transom  
Diagonally coursed decorative brick detailing at roofline  
Brick dentils and three course corbelled brick detail along  
roofline

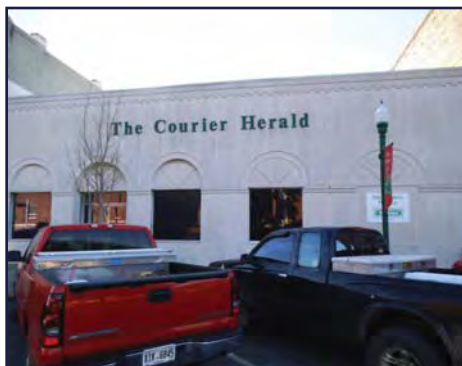
### Supporting Document 2

Large commercial block with three individual storefronts  
Solid granite foundation along facade, brick on sides  
Midcentury alterations to original storefronts: left portion  
recessed with two large fixed glass panes and solid transom,  
recessed entry with single pane door  
Pronounced colonial revival pediment in front center facade  
with scrolled brackets and dentils  
Five course corbelled brick water table  
Right facade- large fixed windows, recessed double entry  
door with single pane transom, aluminum sheeting on  
corners  
Solid granite course across facade under second story  
windows  
Corbelled brick detailing  
Diagonal course brick across entry facade  
Stamped decorative concrete in entablature  
Brackets with acanthus leaf detailing  
Most alterations on right portion

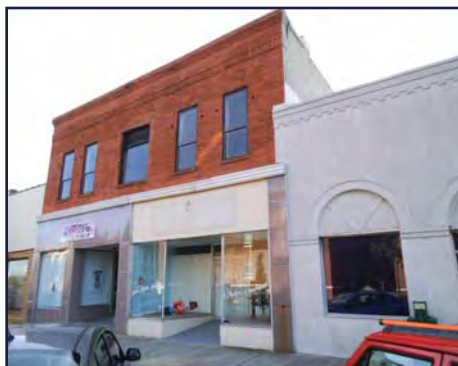
### Supporting Document 2

Two businesses within same original structure first floor:  
Left facade: midcentury renovations- recessed double entry  
door flanked by large fixed single pane windows  
Right facade: two separate entryways (to first and second  
floor), recessed entry, synthetic plastic facade  
Second floor: large fixed single pane window on center,  
flanked by two 1/1 dhs windows on either side  
with brick sills  
Four course corbelled brick detail along roofline  
Alternating soldier course detail below

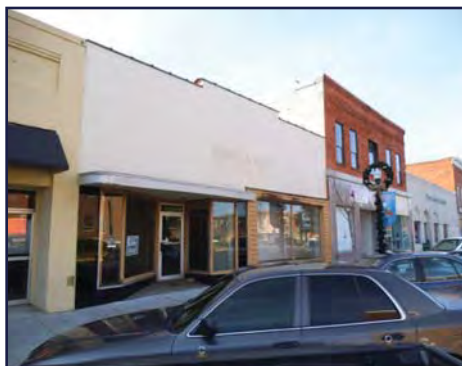
### Supporting Document 2

Original multiple commercial converted to single right facade, enclosed with shiplap and display windows (late 20th century)  
Left facade late twentieth century alterations, diagonally recessed display window, single pane entry door, single light transom curvilinear art deco aluminum awning about left facade entry

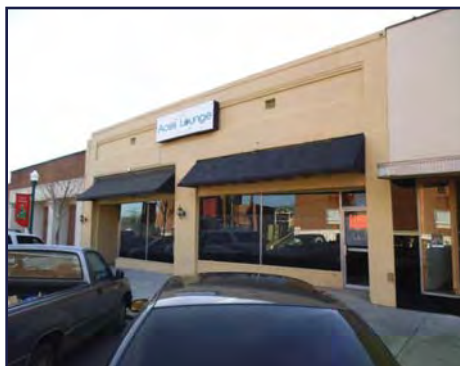
### Supporting Document 2

Two entry doors on opposite facade ends  
First floor midcentury renovations: large fixed single pane windows span facade  
Bisected concrete pillar  
Right facade - side entry recess with painted brick veneer detailing under windows  
Left facade - random coursed painted stack stone facade in recessed entry and under windows  
Midcentury synthetic awning addition above ribbon windows  
Two course brick detail within rectilinear brick recession spanning entirety of facade  
Two square solid iron vents centered above each awning

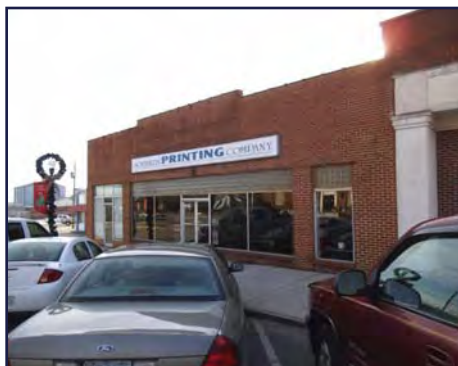
### Supporting Document 2

One continuous block, one business within two storefronts  
Midcentury store windows with glass block transom above  
display windows and double entry door  
Single pane transom above both entry doors  
Scored brick exterior  
Smaller storefront has brick veneer at foundation  
Rectangular recessed brick section above glass blocks

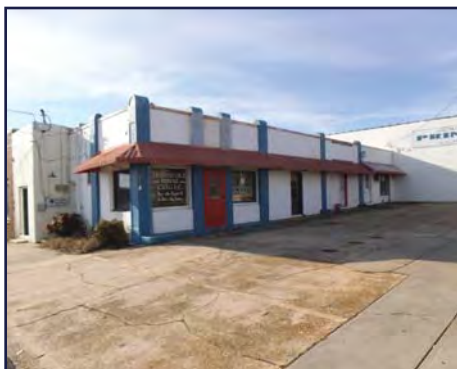
### Supporting Document 2

Three businesses on one parcel all midcentury aluminum awning additions  
Right facade - concrete block facade, replacement door with large fixed single pane windows  
Middle facade- brick and concrete block, single door on right side, single pane window with brick sill  
Left facade- door centered between concrete pilasters flanked by single pane windows  
All buildings divided by detailed concrete pilasters  
Parking lot in front of parcel with approximately 7 spaces

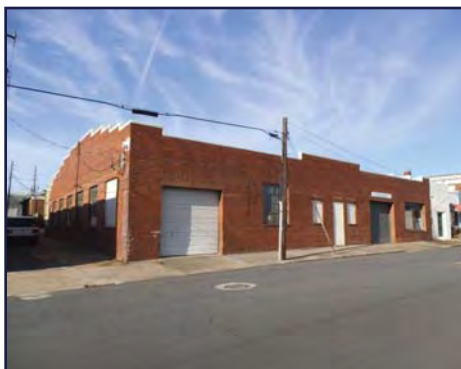
### Supporting Document 2

Two bays of rolling warehouse doors, aluminum and plastic  
Two boarded windows and entry door  
Fixed 5x4 window with privacy glass  
Large painted fixed window with brick sill

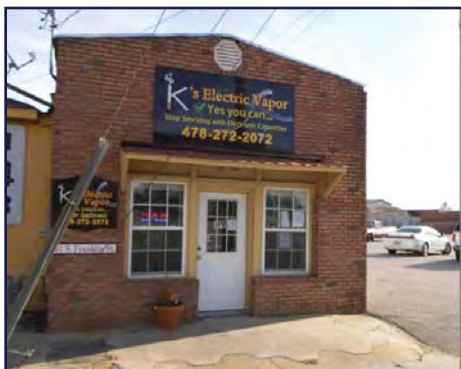
### Supporting Document 2

Octagonal vent in front gable  
Brick veneer on front facade with concrete blocks on sides  
Wooden awning with metal roof  
Slightly recessed windows and door, late 20th century alterations  
Party wall with automotive center

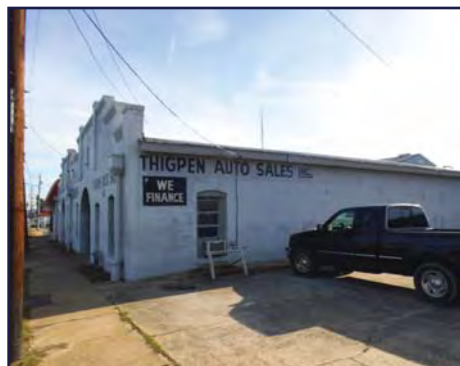
### Supporting Document 2

Arched doorways with metal framing  
Bricked in round arched windows on first floor  
Replacement door and window on right facade  
Pronounced battlemented parapet  
Corbelled brick pilasters on second floor  
Round arch attic vents  
Five course corbelled detailing along roofline

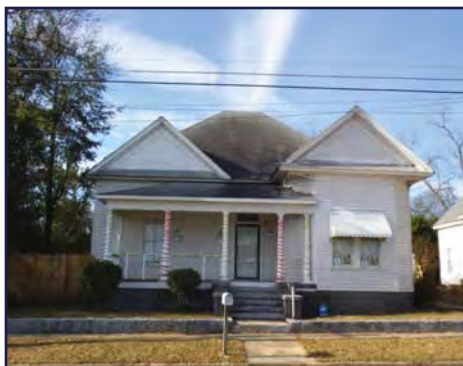
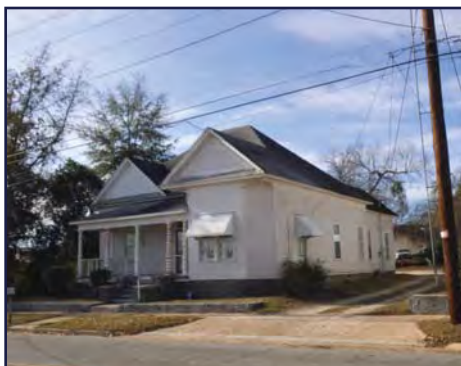
### Supporting Document 1

Paired double-hung sash windows on projecting ell  
Midcentury aluminum awnings  
Scored concrete retaining wall and porch steps  
Engaged Doric columns on front facade  
Single light transom  
Arts and Crafts door with nine panes  
Wood floor to porch drop shingles (triangular and  
scalloped) in front eaves  
Dentils under gable eaves  
Rear shed addition
