# City of Dublin

## Historic Resource Survey Report

December 2013

Report Prepared By:  
Center for Community Design and Preservation at the University of Georgia  
<http://www.ced.uga.edu/psd>  
225 W Broad Street  
Athens, Georgia 30602

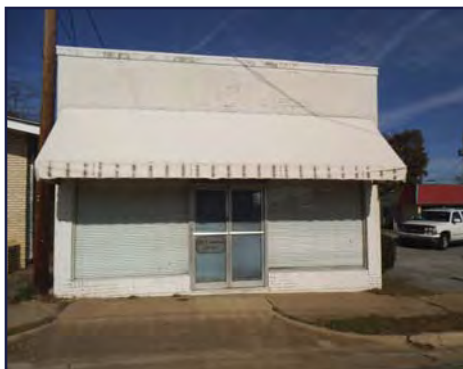
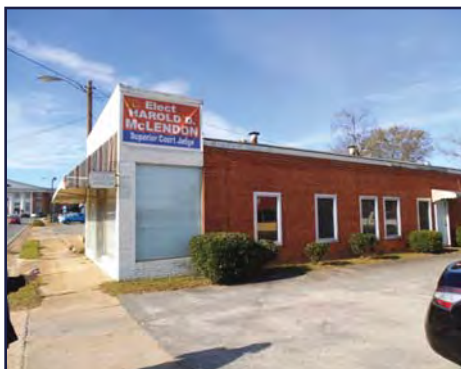
### Supporting Document 1

False front  
Large fixed display windows on front facade and sides of front addition  
Double entry doors with single pane light & single light full width transom  
Late 20th century fabric awning

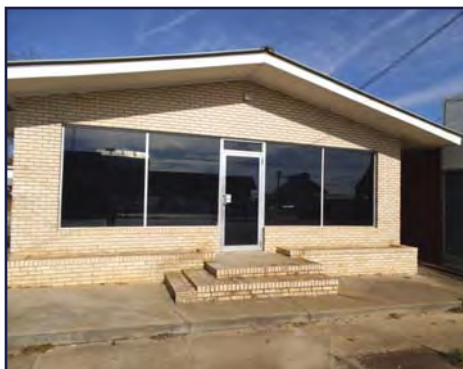
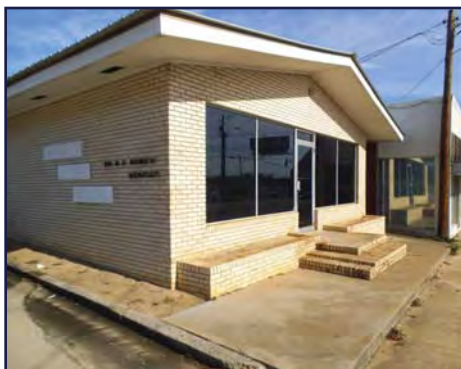
### Supporting Document 1

Stained brick facade and entry steps  
Main entry door centered, flanked by two fixed single pane windows on either side with two brick planters  
Brick sills under windows  
Gable extends three feet beyond bridge  
Side facade - three casement windows (12 panes total with three pane transom light)

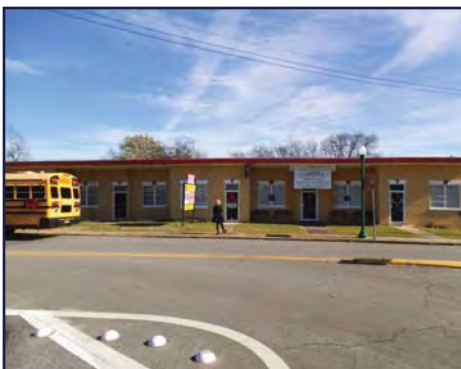
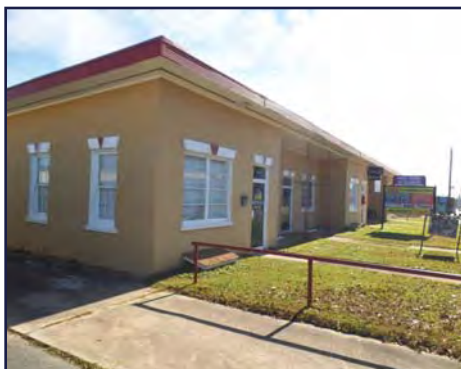
### Supporting Document 1

Paired jalousie windows  
Five businesses in one strip structure  
All entry doors one single light and single light transom  
Flat concrete arches above all bays with pronounced keystone  
Art Deco geometric pattern  
Metal porch supports  
Approximately 10 feet of lawn in front  
Brick floor to recessed porch

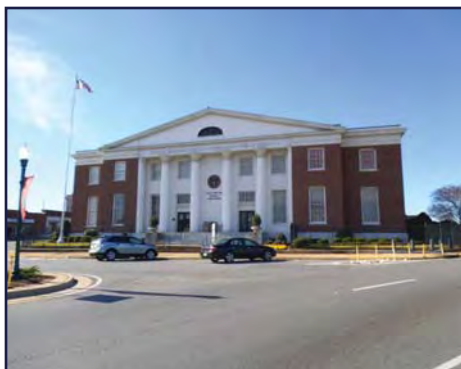
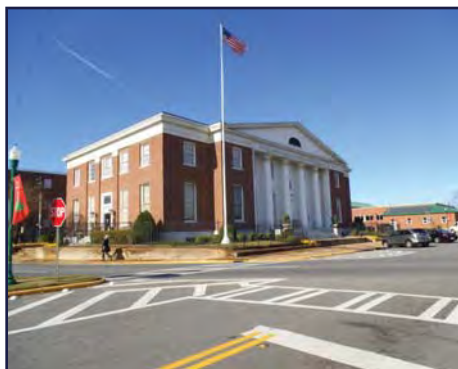
### Supporting Document 1

Federal building and US Courthouse of Dublin  
Two story courthouse columns with acanthus leaf details  
Solid granite block steps  
Solid granite raised basement  
Paired double doors with single light fixed transom over both  
double entry doors, eight lights  
Textured concrete on recessed facade, common bond brick  
on flanking wings  
Fanlight with iron scrolled details in front gable  
Solid granite lintel above columns  
Two panel wood transom above entry doors with greek key  
details  
Dentils in entablature and under gable eave  
All windows on brick facade have flat brick arches

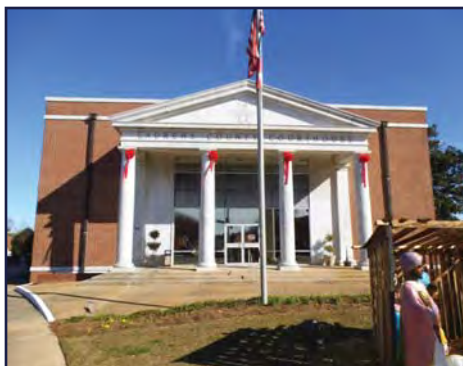
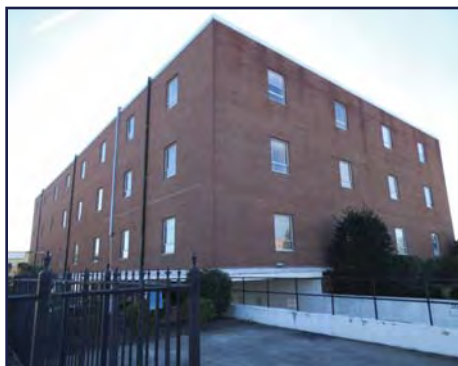
### Supporting Document 1

Front facade: midcentury renovations- centered glass double door entry flanked by two fixed single pane windows with aluminum trim  
Second floor: large five pane transom Doric granite columns and pilasters (3 sections)  
Running granite course and table across facade  
Poured concrete entry steps  
Rear side annex addition (2.5 Stories) with ADA entry and central protruding overhang

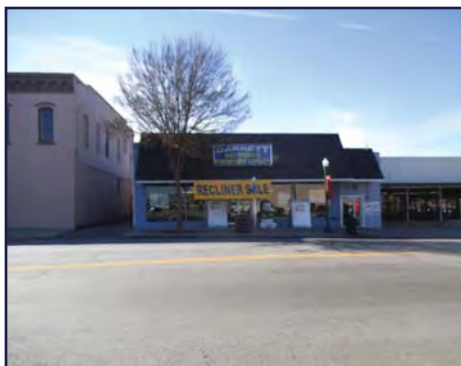
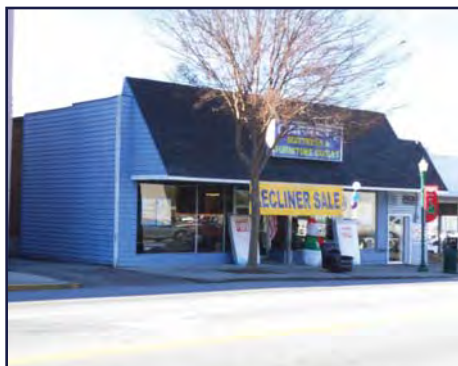
### Supporting Document 1

Midcentury alterations: ribbon display windows with aluminum frames, added clapboards  
Steeply pitched shed roof transcends roofline (serves as awning (asphalt shingle)  
Rear and sides of building brick and common bond (extant material)  
Adjacent to small hamburger restaurant

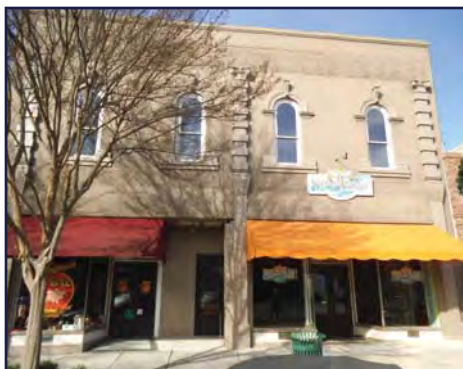
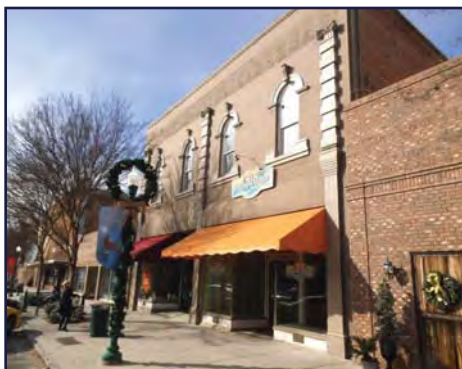
### Supporting Document 1

High style Italianate commercial structure  
Four double-hung sash windows on second floor, all with rounded Italianate arches  
Doric pilasters under round brick arch with scrolled metal keystones  
Two story pilampsets, corbelled (nine course) at first floor apex and continues with brick under Ionic capital  
First floor alterations to both storefronts  
109 W Jackson Street: left portion enclosed by display glass, recessed diagonally towards double entry doors with single light and single light transoms  
Additional frontage bricked with additional door and single light transom  
107 W Jackson Street: retains much of historic character  
Replacement shop windows, but original shape  
Double doors with vertical single light and large square transom

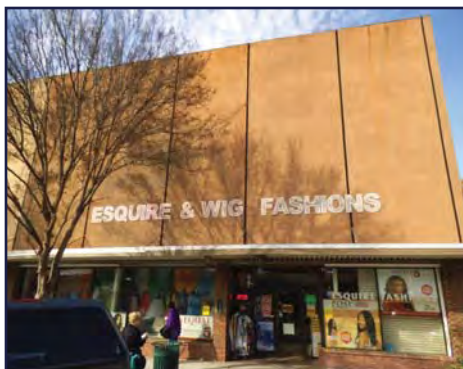
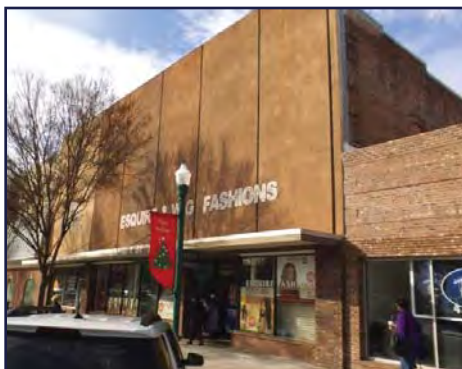
### Supporting Document 1

Site of former JC Penney  
Ribbon windows across first floor- aluminum frames and brick sills  
Brick along foundation  
1960s/70s alteration of textured concrete on second story  
Tiled entry floor  
Altered doorway with single transom and double doors

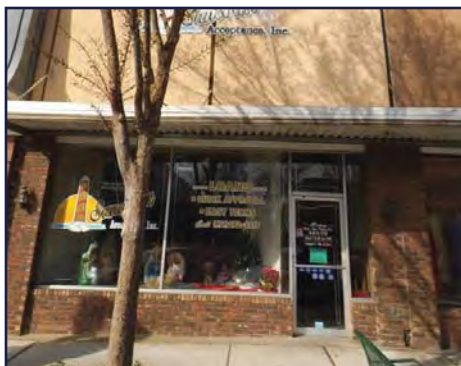
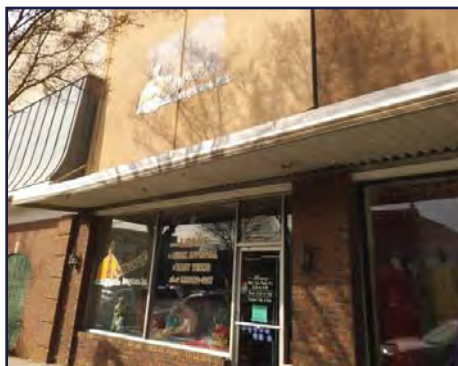
### Supporting Document 1

Second story has 1960/70 exterior material alterations  
Textured concrete over brick, flat midcentury awnings  
Paired flat display windows with aluminum frames  
Single entry door with single light transom and one side light  
Common bond brick exterior on first floor

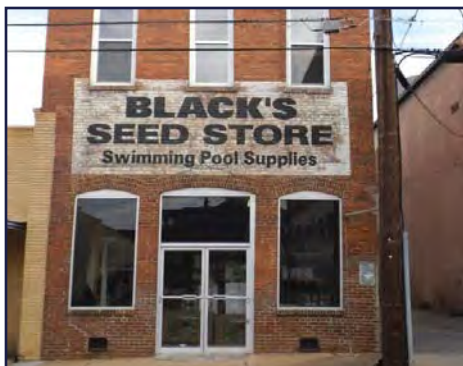
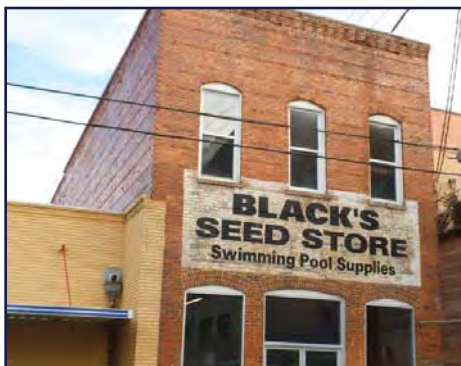
### Supporting Document 1

All windows replaced  
Double front door, with transom rounded arches over all  
bays with three course rowlock detail and rowlock sills on  
windows  
Five course corbelled brick detail at roof line  
Decorative iron vents at foundation  
Painted business sign: "Black's Seed Store"

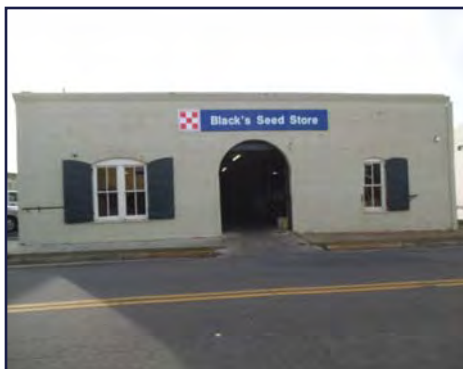
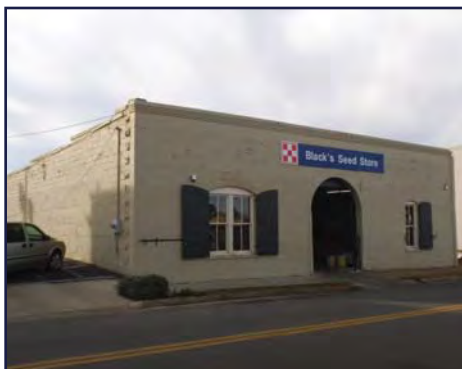
### Supporting Document 1

1.5 story arch as main entryway, with three course horizontal brick detail  
Paired double-hung sash bays on left facade, with two course brick arch banding and brick sill  
Wood shutters covered in tin  
Right facade - single double-hung sashes with wood and tin shutters and brick sill with two course banding  
Five course brick detail along roofline

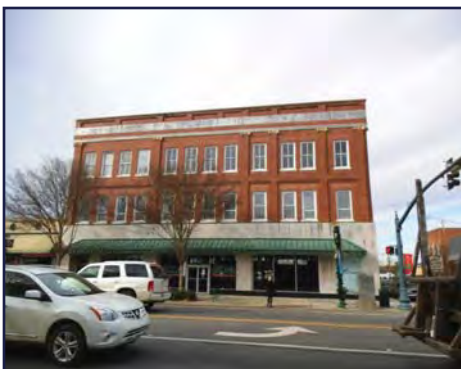
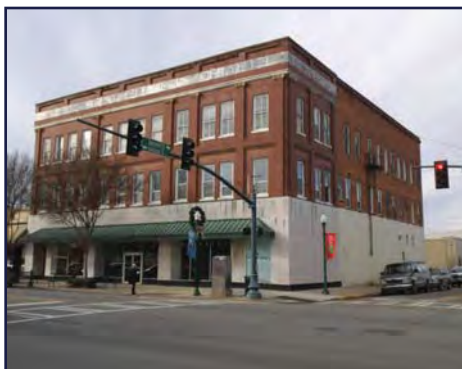
### Supporting Document 1

Recessed brick rectangles along roofline  
Decorative granite panels  
Six two-story Ionic pilasters separating bays  
Twelve bays on second and third floors  
Flat brick arches on all windows (second and third floors)  
Three course brick corbelling above second story  
Solid granite sills on all windows  
First floor: major alterations- replaced storefront with display  
ribbon windows and aluminum frames  
Single pane double entry door with single light transom  
Granite panels  
Covered historic brick

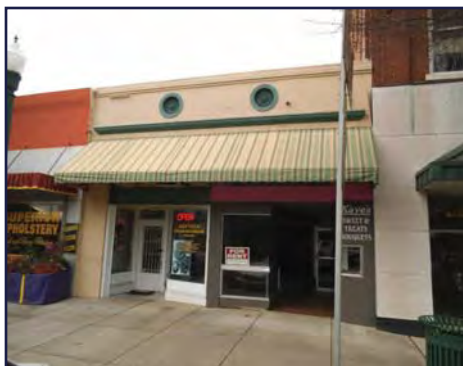
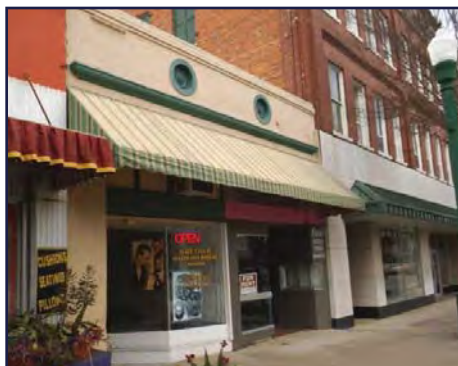
### Supporting Document 1

Two buildings in same structure  
Midcentury renovations to both  
Right facade: recessed entry with fixed single pane windows and glass block detail  
Left facade: recessed entry with fixed single pane windows  
Block wood detail above eave  
Midcentury fabric awning spans facade length  
Cast scalloped concrete detail above awning brickline  
Circular detail below roofline  
Three course brick detail along roofline

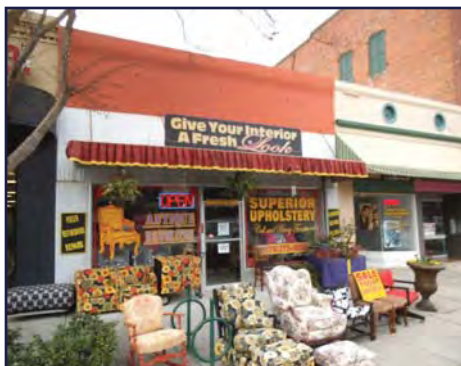
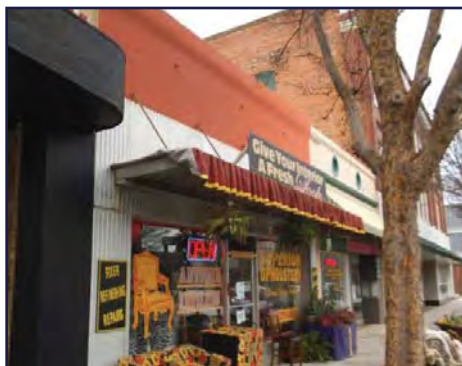
### Supporting Document 1

Stucco on upper third of facade  
Aluminum siding tacked on front lower portion  
Replaced fixed store windows with aluminum frames and no transom

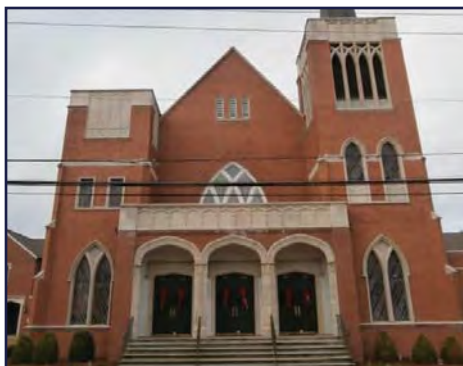
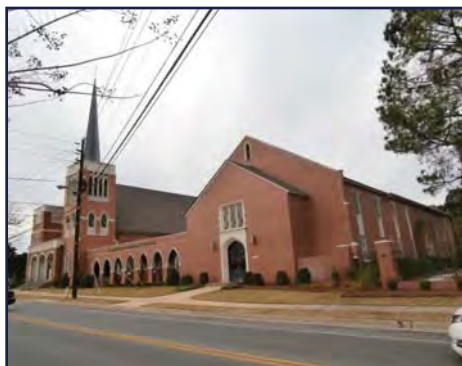
### Supporting Document 1

Multiple additions to create U-shaped floor plan: offices, chapel, education building  
Pointed arch with stained glass windows  
Bisecting arches in main window and under steeple  
One tower has bell tower with 4 pointed arch vents on all sides  
Recessed entry with 3 pointed arches and 3 double doors (also shaped as pointed arches)  
Concrete steps with metal quatrefoil railing  
3 pointed arch vents in gable  
Scroll design across top of recessed entry and at top of both towers  
Foundation plantings  
Arcade connects to education building which creates an enclosed courtyard inside U-shape  
Paired stained glass windows along sides and in towers. Each with different patterns  
2 towers were front additions. Can tell from brick pointing along side of sanctuary and age of bricks  
Granite window sills  
Steeple on top of bell tower  
Twisted cord brick design around stained glass windows on side  
Storm windows in front of sanctuary stained glass

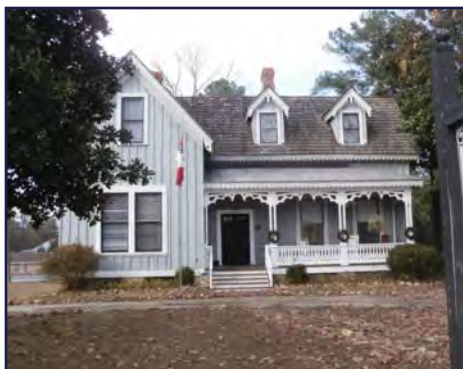
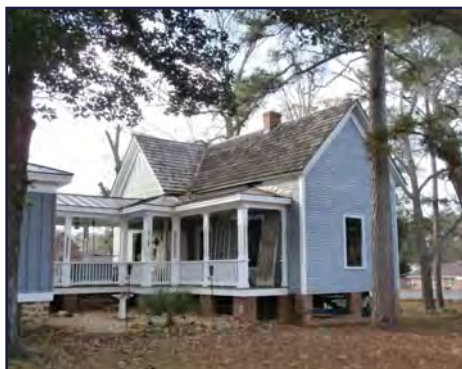
### Supporting Document 1

Stone lined beds, drive, lot, walks (brick path)  
Foundation plantings, large magnolias in yard, holly, pine  
Saw tooth wood detailing along roof lines, porch roof line and dormer roof lines  
Four dormers (2 side, 2 front)  
Wood cutout, stencil rail for porch and steps  
Paired porch supports with wood cut out detail cornice  
Wood steps  
Corbelled chimneys  
House behind gabled ell originally was kitchen, built in 1900.  
Connected by covered walk, similar stylistically as main house but more simplified  
Pointed arch attic vent  
Cutout porch supports with square baluster and balustrade

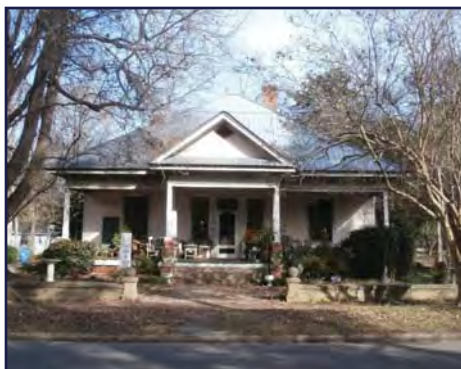
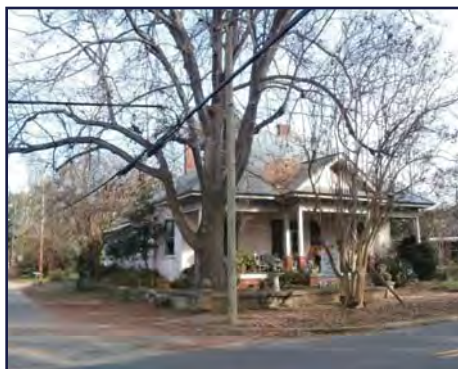
### Supporting Document 1

Foundation plantings  
Cement wall around front of lot with decorative end post with sphere on top  
Brick bases for square porch supports below cornice  
Diamond vent in gable  
Corbeled chimneys  
Low brick wall with cement tops border cement steps to porch  
Chain-link fence on right of lot

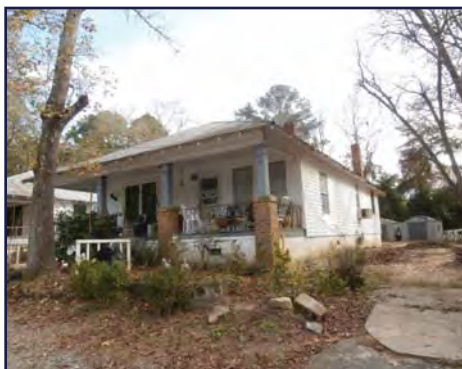
### Supporting Document 2

Roof Material: Steel/steel alloy-Standing seam  
Roof Type: Hip

Foundation Materials: Brick  
Foundation Type: Pier/Post with Infill-Concrete(block)

Location: Front  
Height: 1 story  
Width/Length: Full  
Roof Type: Shed/pent  
Porch Type: Verandah  
Foundation Material: N/A

Square wood porch supports on brick base  
Wood and scroll metal porch railing  
Rear addition  
Overhanging eaves with dentils and exposed rafter tails  
Concrete steps to porch  
Craftsman three light door  
Paired double hung sash windows

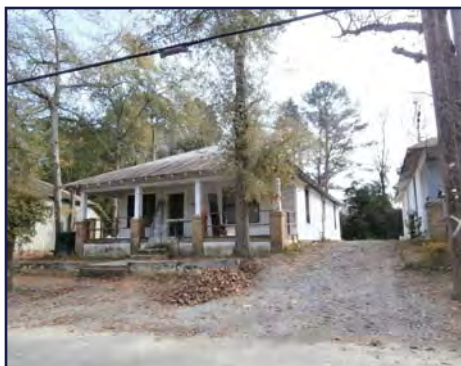
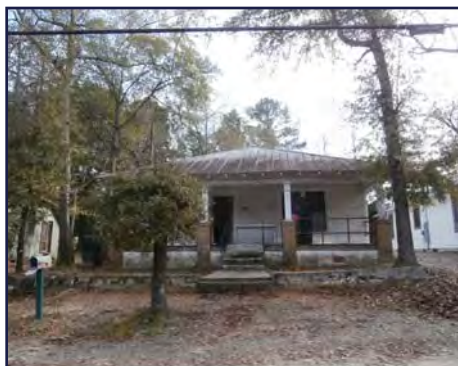
### Supporting Document 1

Roof Material: Steel/steel alloy-Standing seam  
Roof Type: Hip

Foundation Materials: Brick  
Foundation Type: Pier/Post with Infill-Concrete (block)

Exposed rafter tails  
Brick bases for square porch supports  
Wood window surrounds  
Concrete steps with metal railing  
Concrete landing before steps  
Setback ~15  
Scattered trees  
Concrete retaining wall  
Overhanging porch eaves  
Paired windows

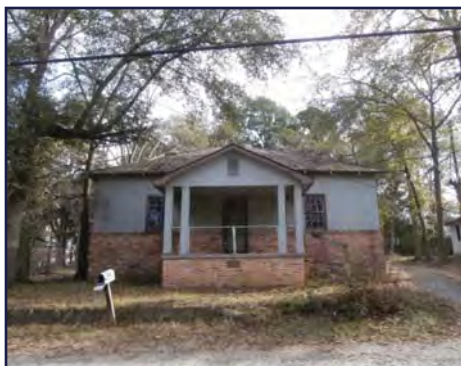
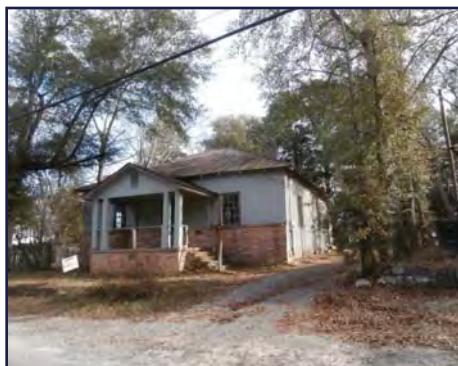
### Supporting Document 1

Roof Material: Steel/steel alloy-Standing seam  
Roof Type: Hip

Foundation Materials: Unknown/obscured  
Foundation Type: N/A

Location: Front  
Height: 1 story  
Width/Length: Partial  
Roof Type: Gable  
Porch Type: Portico  
Foundation Material: N/A

Brick veneer on lower half of front facade  
Screen door  
Rectangle vent in gable  
Over hanging eaves with dentils and exposed rafter tails  
Rear addition  
Paired square wood porch supports at corners  
Steps on side of porch  
Six glass lights in door  
Brick steps and foundation to portico

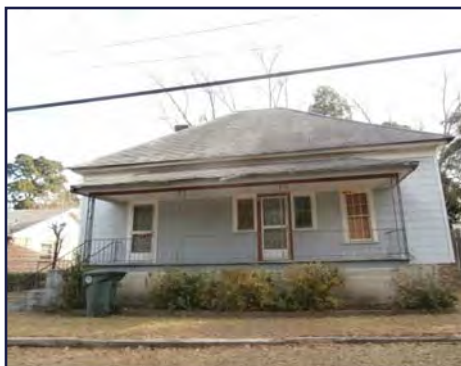
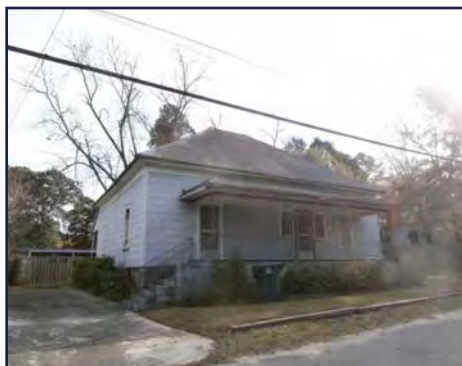
### Supporting Document 1

Roof Material: Asphalt (composition) shingle  
Roof Type: Hip

Foundation Materials: Brick  
Foundation Type: Pier/Post with Infill-Concrete(block)

Location: Front  
Height: 1 story  
Width/Length: Partial  
Roof Type: Half-Hip  
Porch Type: Verandah  
Foundation Material: N/A

Scroll porch supports metal railing on porch and stairs  
Cement stairs  
Foundation plantings  
Chain-link fence on right of lot  
Wood gate and wood fence in front  
Three vertical fixed panes above panels of doors  
4/4 windows flank right door  
Rail road ties border street  
Major interior alteration read on front facade  
Window replacement, door added  
Rear shed addition

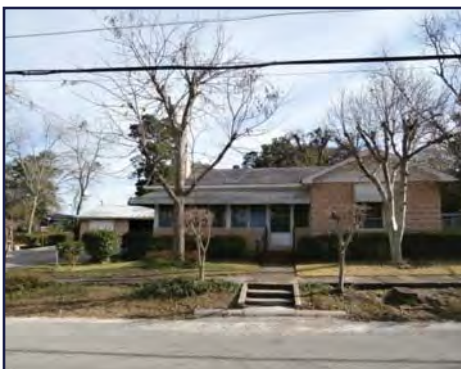
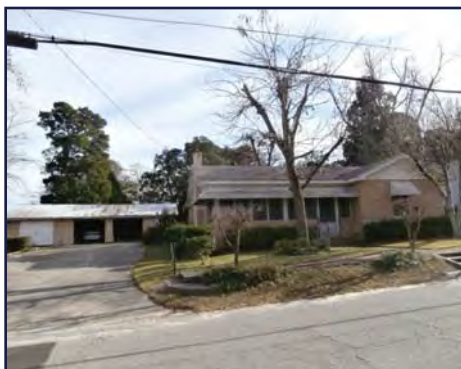
### Supporting Document 1

Location: Front  
Height: 1 story  
Width/Length: Partial  
Roof Type: Gable  
Porch Type: Sunporch  
Foundation Material: N/A

Enclosed porch  
Porch with row of jalousie windows  
Midcentury awnings over windows  
Rear shed addition  
Foundation plantings  
Vinyl in gables metal stair railing  
Concrete steps lead to street  
Cement driveway and garage

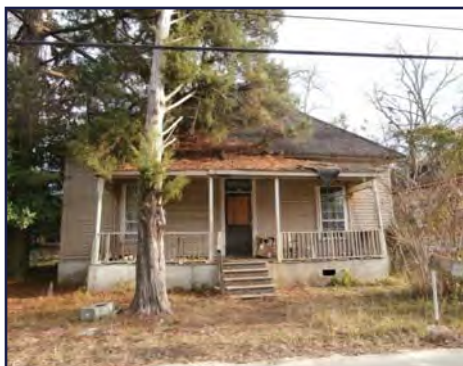
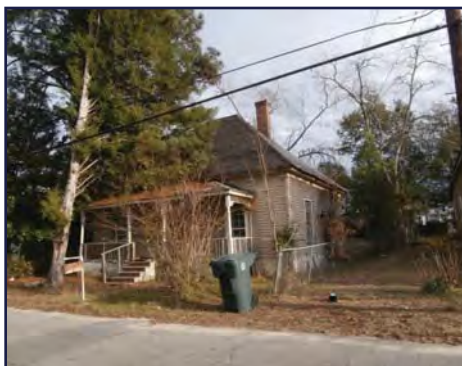
### Supporting Document 1

Roof Material: Asphalt (composition) shingle  
Roof Type: Hip

Foundation Materials: Unknown/obscured  
Foundation Type: N/A

Location: Front  
Height: 1 story  
Width/Length: Partial  
Roof Type: Half-Hip  
Porch Type: Verandah  
Foundation Material: N/A

Corbelled chimney  
Cement steps  
Foundation covered with stucco  
Four turned porch supports -Cornice wood detailing with turned wood (on sides but not on front)  
Square post baluster and banister  
Transom  
Chain link fence on right side tree line on left  
Large cedar in front  
Setback ~10ft

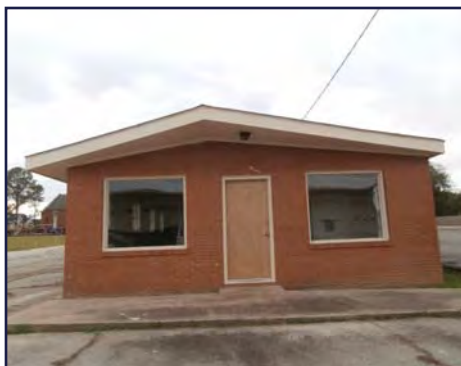
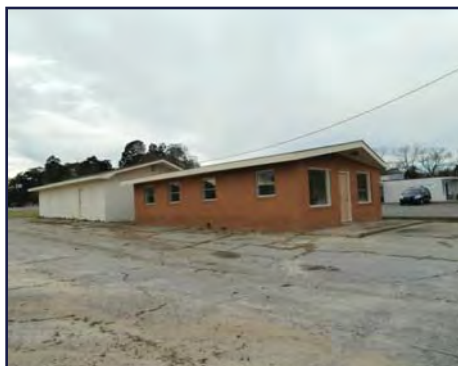
### Supporting Document 1

Roof Material: Asphalt (composition) shingle  
Roof Type: Gable-Front-oriented

Foundation Materials: Concrete (poured)  
Foundation Type: Slab

Location: Front  
Height: 1 story  
Width/Length: Full  
Roof Type: Shed/pent  
Porch Type: Stoop  
Foundation Material: N/A

Cement pad in front for landing  
Asphalt to left and right for parking  
Asymmetric gable roof line over hangs  
Right side has grass strip  
Attached back building (gabled wood shingle doorway with step and window)  
Off center eichler pitch to roof

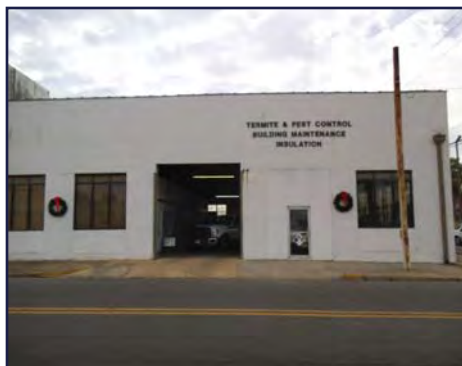
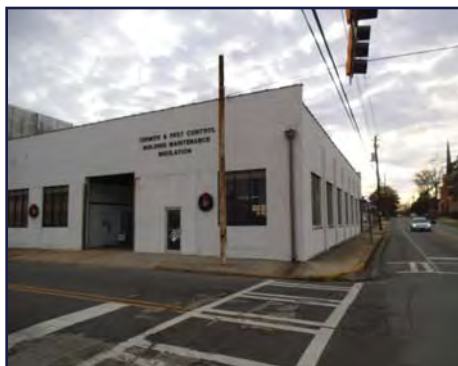
### Supporting Document 1

Location: N/A  
Height: N/A  
Width/Length: N/A  
Roof Type: N/A  
Porch Type: N/A  
Foundation Material: N/A

Replacement windows and wood panels  
Original openings surrounding current door  
Wood panel infill brick buttriss detail on sides  
Side windows have brick rowlock sills

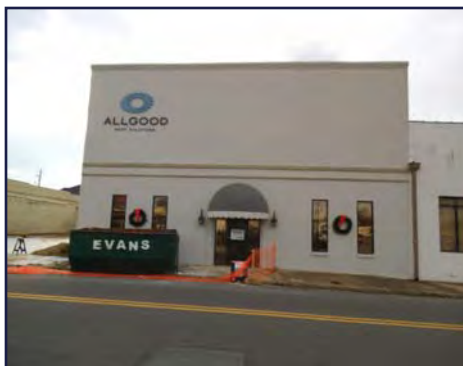
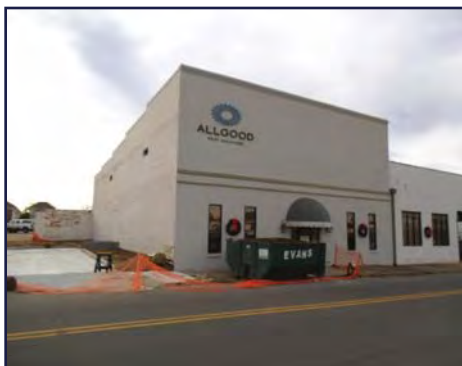
### Supporting Document 1

Roof Material: Unknown  
Roof Type: Flat

Foundation Materials: Brick  
Foundation Type: Continuous

Front facade stuccoed over  
Sidelights  
Canvas awing  
Band detail at top of first story  
Five course brick detail(cornice corbelling) along roof line  
Along side-four windows filled in

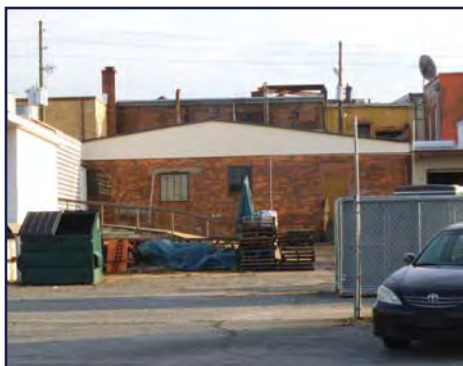
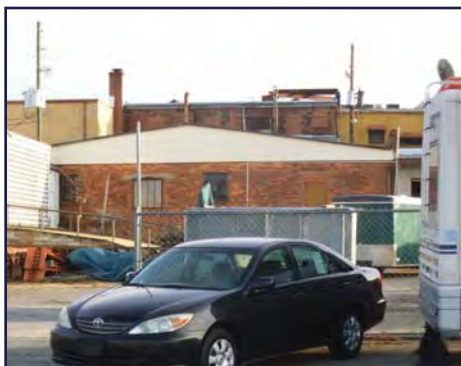
### Supporting Document 1

Roof Material: Unknown  
Roof Type: Gable -Front-oriented

Foundation Materials: Unknown/obscured  
Foundation Type: N/A

Original central entryway  
Filled in new entry with brick infill  
Original fixed 18-pane window with brick sills  
Vinyl in front gable  
Concrete steps to entryway

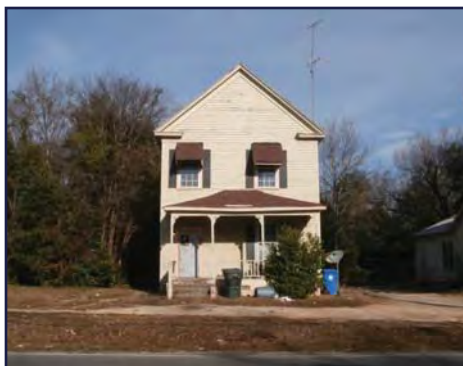
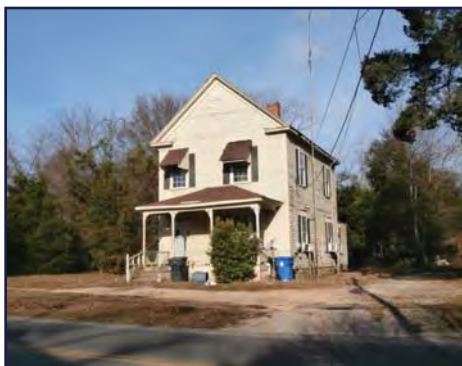
### Supporting Document 1

Roof Material: Asphalt (composition) shingle  
Roof Type: Gable - Front-oriented

Foundation Materials: Brick  
Foundation Type: Continuous

Folk Victorian scroll details at tops of square wood porch supports  
Awnings over second floor windows with shingling  
Windows replaced  
Concrete steps to porch  
Overhanging eave  
Shutters on windows  
Wood porch railing  
Rear addition

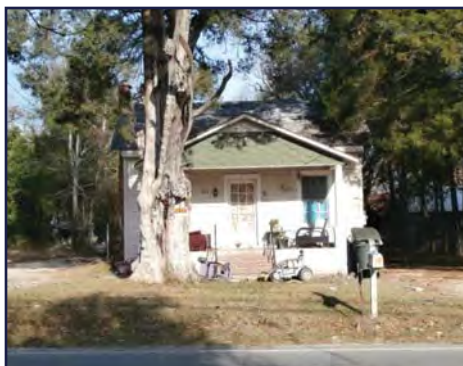
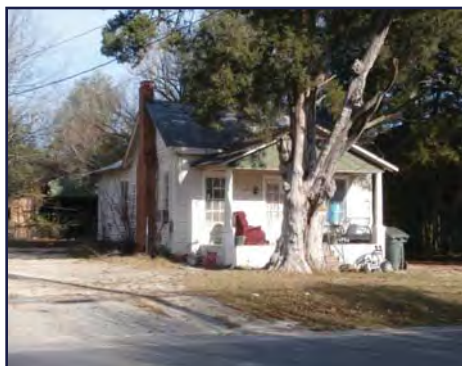
### Supporting Document 1

Roof Material: Asphalt (composition) shingle  
Roof Type: Gable - Cross gable

Foundation Materials: Brick  
Foundation Type: Continuous

Honeycomb asphalt in gable  
Triangular vent in gable  
Fixed pane door with 3x5 panes  
Column porch supports on brick bases  
Large cedar in front yard

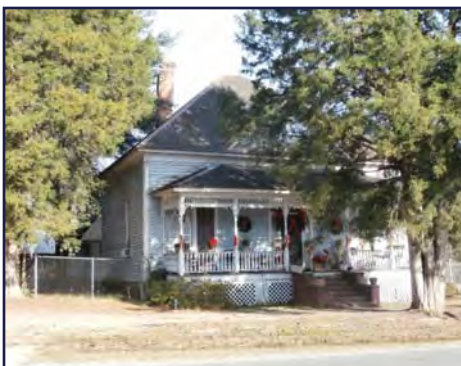
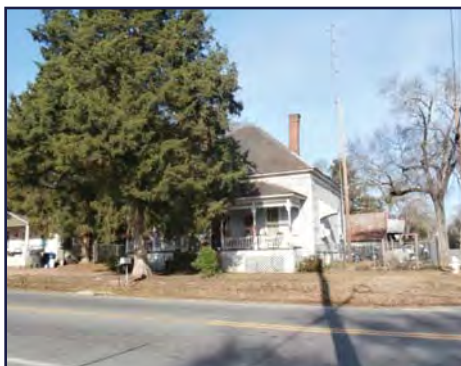
### Supporting Document 1

Roof Material: Asphalt (composition) shingle  
Roof Type: Pyramidal

Foundation Materials: Brick  
Foundation Type: Pier/Post (no infill)

Large cedar planted  
centered on house  
Turned wood and scroll details under eaves of porch  
Turned wood porch supports and railing  
Brick steps to porch  
Sidelights and transom  
Mid-century modern awnings over side windows  
Diamond shaped vent in front gable with fish scaling

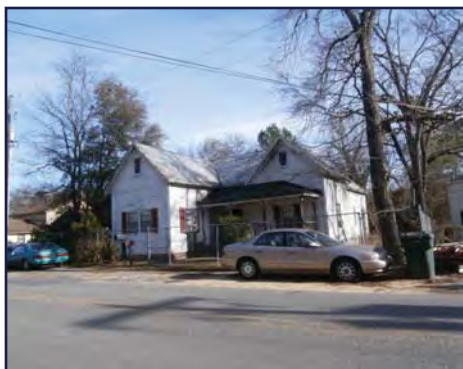
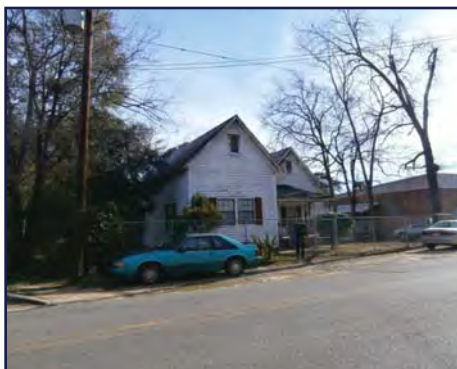
### Supporting Document 1

Roof Material: Steel/steel alloy (tin) - Pressed sheet  
Roof Type: Gable - Front Oriented

Foundation Materials: Brick  
Foundation Type: Pier/Post with Infill

Square wood porch supports with Folk Victorian scroll detail  
Rectangular vents in front gables  
Wood porch railing  
Surrounded by chain link fence  
Paired double  
hung sash windows in ell  
Shutters on windows  
Large rear addition  
Door into ell on side, next to front door  
Overhanging eaves

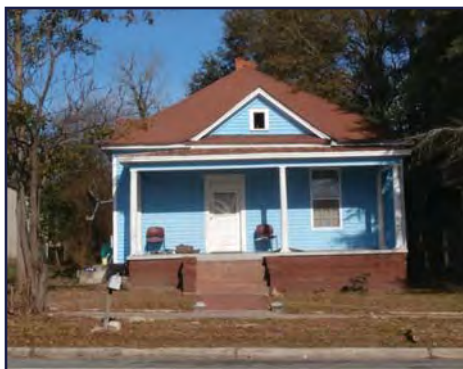
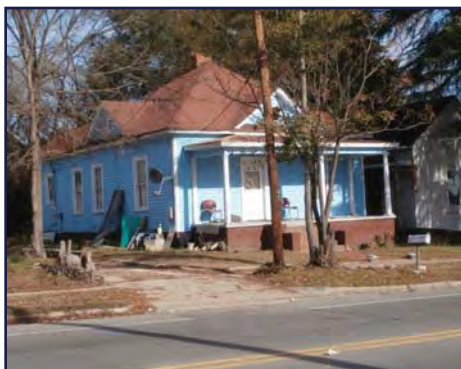
### Supporting Document 1

Roof Material: Steel/steel alloy (tin) - Standing seam  
Roof Type: Hip

Foundation Materials: Brick  
Foundation Type: Pier/Post with Infill

Rectangular vent or window in front gable. Broken, so unsure  
Fluted Doric column porch supports; engaged on facade  
1 glass pane in paneled door  
Brick steps and path to porch  
Chimney falling  
Replaced windows  
Rear gable addition  
Textured concrete foundation

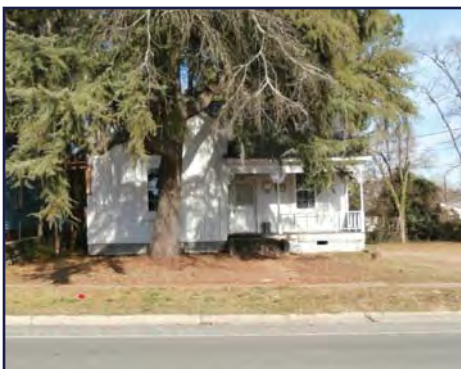
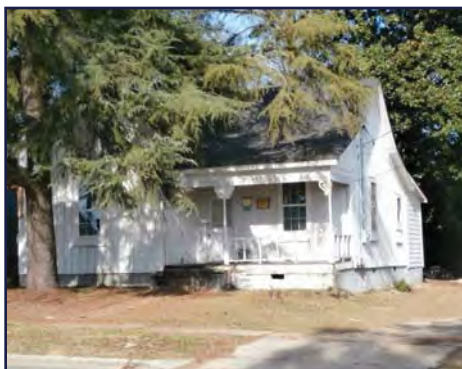
### Supporting Document 1

Roof Material: Asphalt (composition) shingle  
Roof Type: Gable - Cross gable

Foundation Materials: Brick  
Foundation Type: Pier/Post with Infill

Turned wood porch supports with decorative brackets  
Square balusters  
Concrete steps to porch  
Door has one fixed pane above paneling  
Rear addition with vinyl  
Large cedar planted in yard  
Rusticated concrete masonry unit wall on left of property  
Windows replaced  
Wood window surrounds

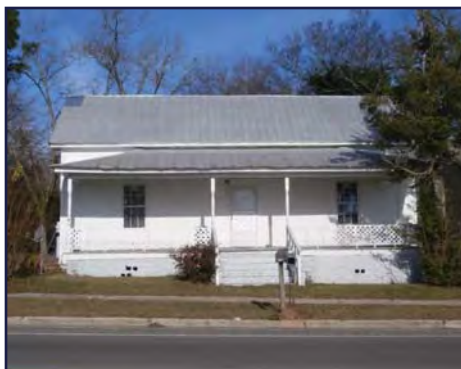
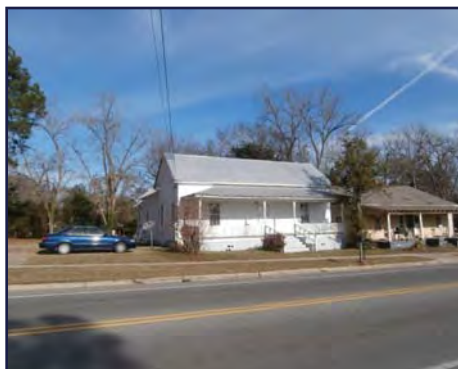
### Supporting Document 1

Roof Material: Steel/steel alloy (tin) - Standing seam, Pressed  
Roof Type: Gable - Side-oriented

Foundation Materials: Unknown/obscured  
Foundation Type: Unknown/obscured

Asbestos siding on front, wood on sides  
Large rear gabled addition with chimney  
Turned wood porch supports  
Foundation obscured by stucco  
Brick steps up to porch with wood railing  
Wood lattice porch railing  
Corbelled chimney  
Pressed sheet roof on original structure, standing seam on  
porch and addition  
Glass and scroll metal door

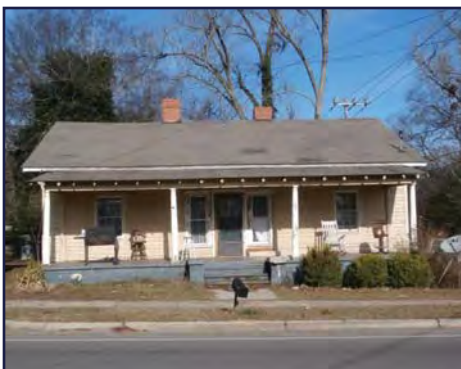
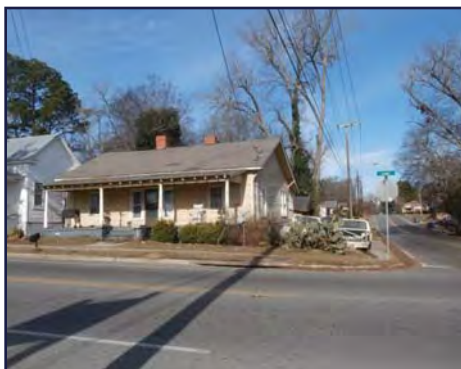
### Supporting Document 1

Roof Material: Asphalt (composition) shingle  
Roof Type: Gable - Side-oriented

Foundation Materials: Concrete (poured)  
Foundation Type: Continuous

Foundation plantings  
Exposed rafter tails  
Smooth columns support porch roof  
Rear addition  
Low concrete masonry unit walls flank stairs to porch  
Set back about 5 feet  
Brackets on corner

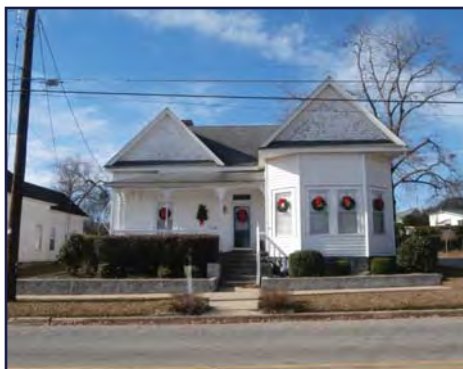
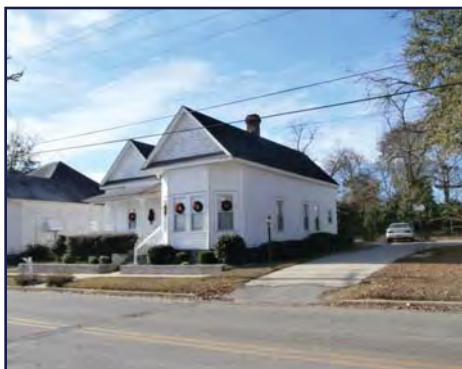
### Supporting Document 1

Roof Material: Asphalt (composition) shingle  
Roof Type: Gable - Multi-gable

Foundation Materials: Unknown/obscured  
Foundation Type: Unknown/obscured

Shingles in gable  
Turned wood porch supports, square balusters, wood carved capitals  
Concrete steps with wood handrail and square balusters  
Foundation plantings in raised beds  
Transom  
Corbelled chimney  
Lamp post in yard  
Chain link fence on right side of lot and behind with shrubs around  
Bay on gable ell  
Scrolled brackets on porch supports

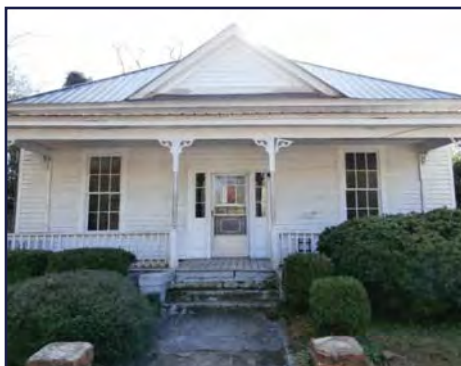
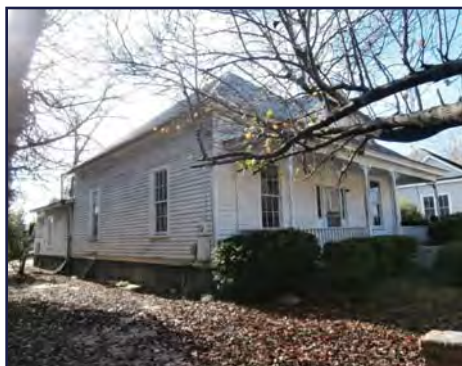
### Supporting Document 1

Roof Material: Steel/steel alloy (tin) - Standing seam  
Roof Type: Pyramidal

Foundation Materials: Unknown/obscured  
Foundation Type: Unknown/obscured

Scalloped shingles in gable  
Turned porch supports  
Carved wood capitals  
Square post balusters  
Sidelights  
3 fixed panes in door above panel  
Side bay  
Foundation plantings  
Low cement wall in front of property with brick end posts  
Property bordered with wood fence on left and bushes on  
right  
Rear addition

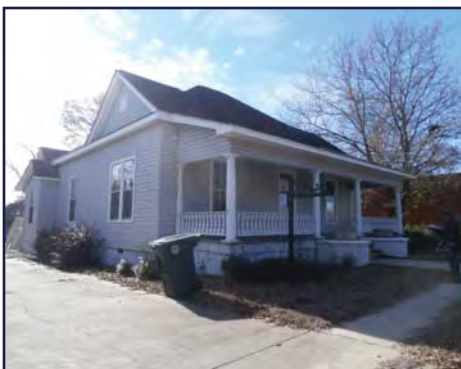
### Supporting Document 1

Foundation Materials: Brick  
Foundation Type: Continuous

Turned wood porch railing  
Tuscan column porch supports  
Transom over door  
Concrete steps with brick up to porch  
Foundation plantings  
Rear gable additions  
Overhanging eaves  
Engaged column porch supports against front  
Rectangular vent in side gable  
Replacement siding and windows  
Former business  
metal hanging sign post with scroll detail still in yard  
Large parking area in rear  
Glass pane in top half of paneled door with ornate door knob  
Electric lights on porch

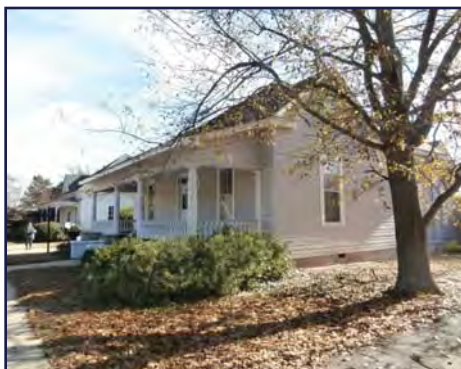
### Supporting Document 2

Roof Material: Asphalt (composition) shingle  
Roof Type: Complex

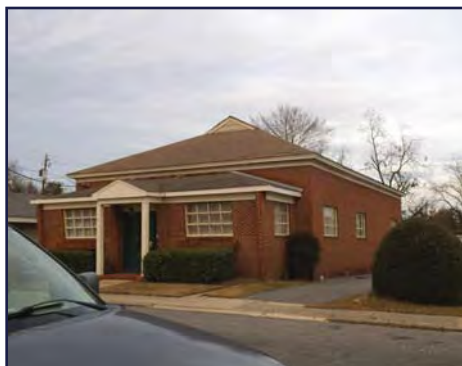
### Supporting Document 2

Roof Material: Asphalt (composition) shingle  
Roof Type: Hip

Foundation Materials: Brick  
Foundation Type: Continuous

Original verandah enclosed in brick with added fixed windows  
Small portico extends from enclosed verandah  
Single light in door with side lights  
Front verandah recesses towards foundation  
Brick steps to porch

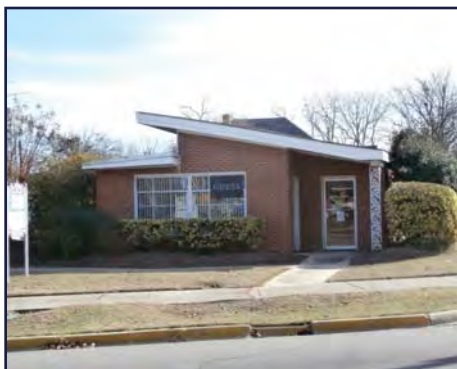
### Supporting Document 2

Roof Material: N/A  
Roof Type: Shed/Pent

Foundation Materials: Brick  
Foundation Type: Continuous

Foundation plantings, parking lot on left  
Organic metal porch supports  
Tree and crape myrtle along right side  
Two plate glass door  
Left side hedge and crape myrtles and tree  
Break in roof line with windows, now covered with hvac unit

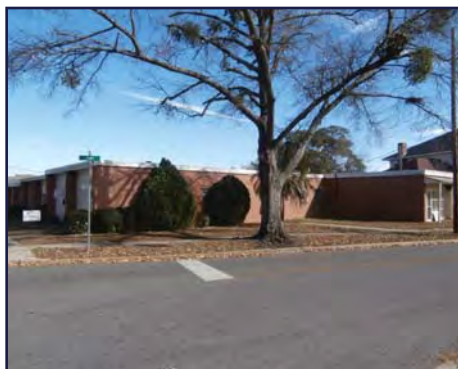
### Supporting Document 2

Roof Material: N/A  
Roof Type: Flat

Foundation Materials: Concrete (poured)  
Foundation Type: Continuous

Retail development with multiple offices  
One office has large fixed 4by 3 window  
Brick pilasters separate individual office spaces  
Additions added over years  
Transoms and sidelights  
Single glass pane doors  
End units have vinyl fronts

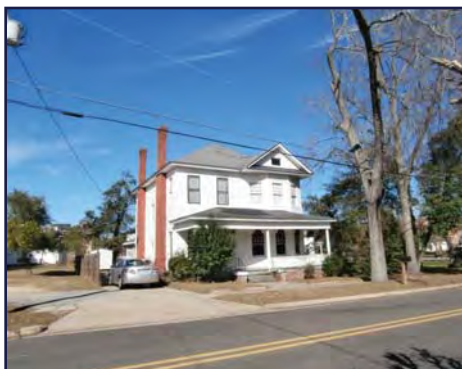
### Supporting Document 2

Roof Material: Asphalt (composition) shingle  
Roof Type: Gable-on-hip

Foundation Materials: Brick  
Foundation Type: Continuous

Gabled ell is bay on both floors  
Corbelled chimneys  
12/1 windows in ell on both floors  
Rear addition  
Fixed single pane window in gable  
Fluted Doric column porch supports

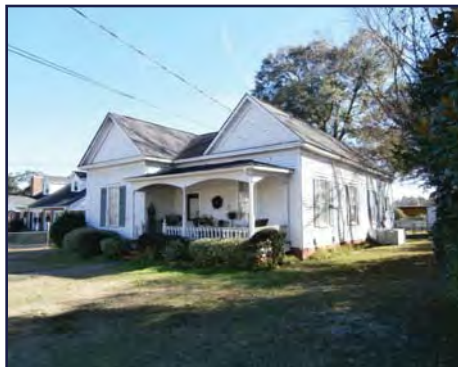
### Supporting Document 2

Roof Material: Asphalt (composition) shingle  
Roof Type: Gable - Cross gable

Foundation Materials: Brick  
Foundation Type: Pier/Post with Infill

Turned porch supports, balusters, and newel post  
Arched wood cornice on porch foundation plantings  
Chain link fence band and left side of lot  
Shutters  
Set back about 15  
Brick steps to porch  
Door fixed pane glass above bands  
Drive is brick strips wood window surrounds

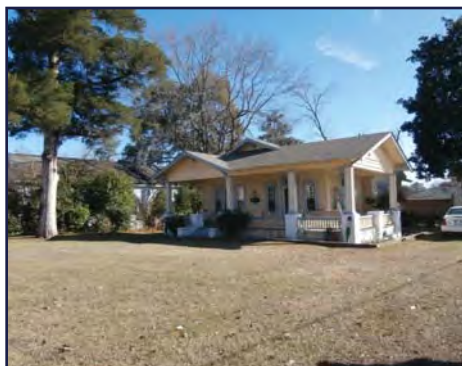
### Supporting Document 2

Roof Material: Asphalt (composition) shingle  
Roof Type: Gable - Cross gable

Foundation Materials: Unknown/obscured  
Foundation Type: Unknown/obscured

shingle in gables  
Over hanging eaves with detail  
Transom over door  
Large rear door  
Large rear addition  
Wood porch railing  
Chicago window  
Wrap around porch  
Square wood porch supports  
Brackets in gable

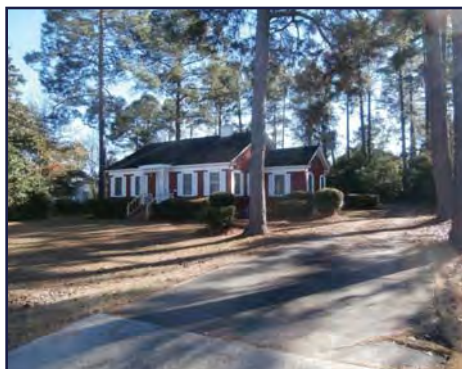
### Supporting Document 2

Roof Material: Asphalt (composition) shingle  
Roof Type: Gable - Side-oriented

Foundation Materials: Brick  
Foundation Type: Continuous

Foundation plantings  
Brick steps up to porch  
Cross-braced wood porch supports and railing  
Side addition  
Shutters

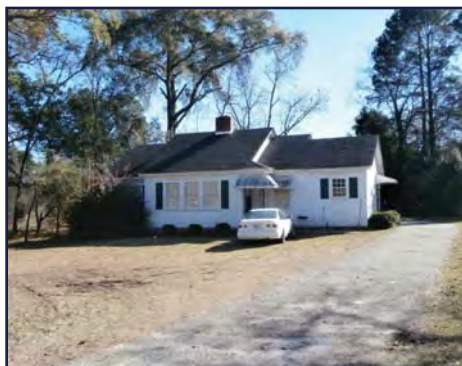
### Supporting Document 2

Roof Material: Asphalt (composition) shingle  
Roof Type: Gable - Side-oriented

Foundation Materials: Brick  
Foundation Type: Continuous

Aluminum mid century awnings  
Shutters  
Scroll porch railing and supports  
Foundation plantings

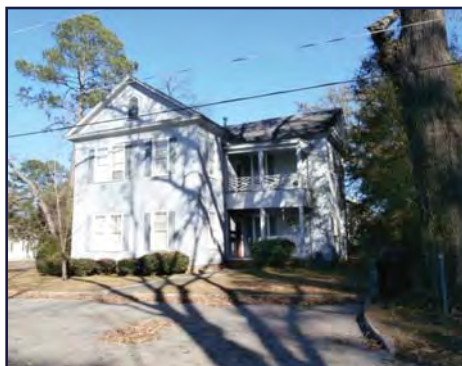
### Supporting Document 2

Roof Material: Asphalt (composition) shingle  
Roof Type: Gable - Cross gable

Foundation Materials: Brick  
Foundation Type: Continuous

Paired double-hung sash windows  
Shutters on windows  
Wood railing for verandah and balcony with herringbone  
pattern  
pentagonal vent in gable  
fishscale shingles in gable

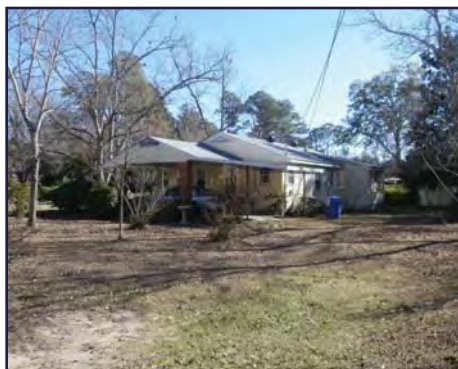
### Supporting Document 2

Roof Material: Asphalt (composition) shingle  
Roof Type: Gable - Side-oriented

Foundation Materials: Brick  
Foundation Type: Continuous

Metal scroll porch supports  
Shutters  
Tripartite windows  
Mid century 3 vertical pane door  
Brick supports for integrated carport  
Foundation plantings  
Hedgerow on left side of lot  
Multiple adolescent trees

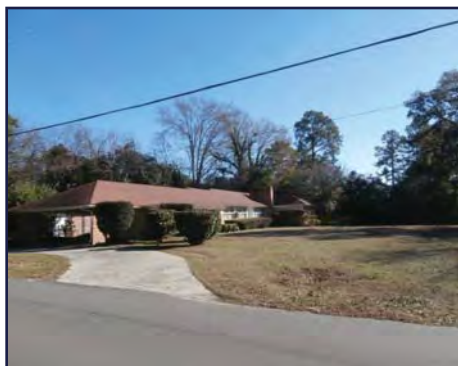
### Supporting Document 2

Roof Material: Asphalt (composition) shingle  
Roof Type: Hip, Pyramidal

Foundation Materials: Unknown/obscured  
Foundation Type: Unknown/obscured

Large 1/1/1 windows on facade  
Mid-century modern door details: 3 circles inside squares  
Some windows under eaves  
Integrated carport  
Foundation plantings  
Ivy on carport wall  
Pyramidal roof over right wing  
Variation in fenestration, use of natural materials on exterior  
High style ranch

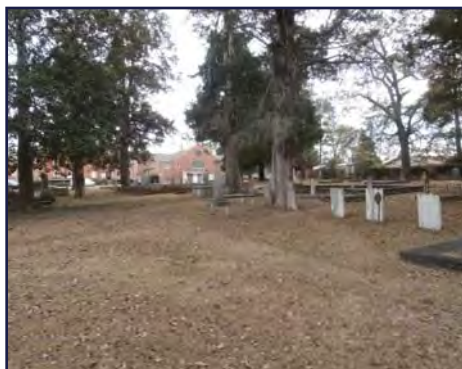
### Supporting Document 2

Veterans: Confederate States of America Army,  
Revolutionary War, Indian Wars  
Mason  
approximately 200 graves  
Iron gate and fence - Broken tomb stones  
Cement, brick ledger stones  
Cement and brick lined family plots  
Magnolias, cedars and boxwoods line path  
Stepped brick entrances (2) Chain link fence on north, east,  
and west sides  
Raised stone grave

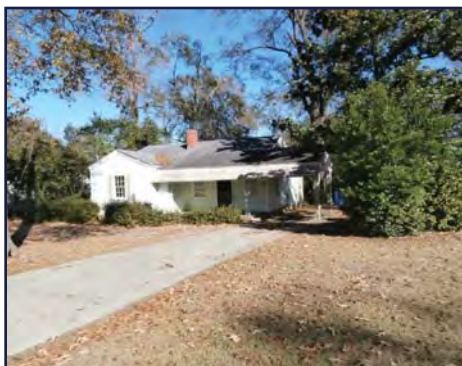
### Supporting Document 2

Roof Material: Asphalt (composition) shingle  
Roof Type: Gable - Cross gable

Foundation Materials: Brick  
Foundation Type: Continuous

Shutters on window in ell  
Metal porch supports with scroll and star pattern. used for carport too  
Mid-century modern awning over porch and carport integrated carport

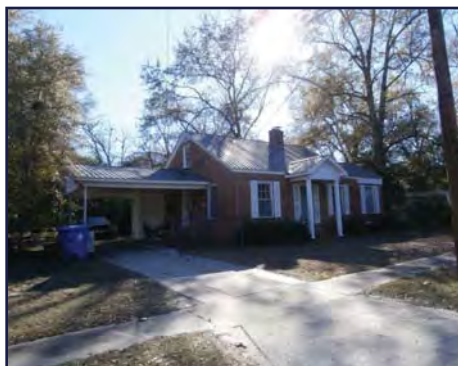
### Supporting Document 2

Roof Material: Steel/steel alloy (tin) - Pressed sheet  
Roof Type: Gable - Side-oriented

Foundation Materials: Brick  
Foundation Type: Continuous

Integrated carport addition  
Gabled porch roof with square porch supports  
Shutters  
6 fixed panes in door with paneling below  
Rounded porch steps made of brick  
Foundation plantings  
Carport with brick bases with metal supports  
Nice example of American small house

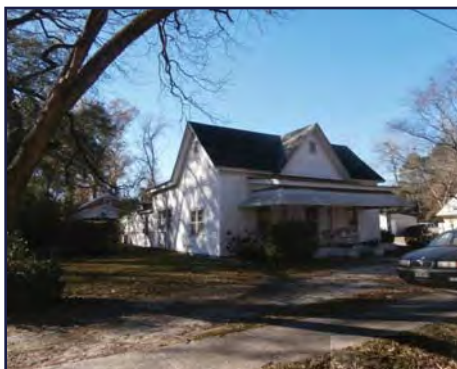
### Supporting Document 2

Roof Material: Asphalt (composition) shingle  
Roof Type: Gable -Cross gable

Foundation Materials: Brick  
Foundation Type: Continuous

Concrete Masonry Unit planting beds at foundation  
Rectangular vents in gables  
Rear additions: one is a garage  
Scrolling metal porch supports  
Mid century awning over verandah  
Glass, metal door with scroll detail

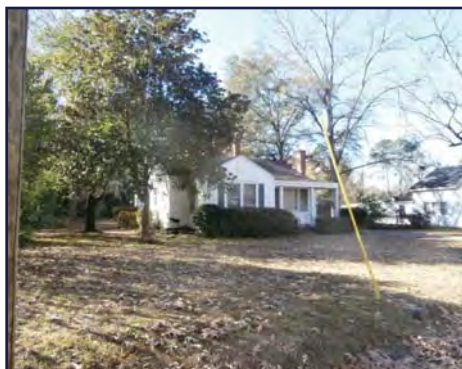
### Supporting Document 2

Roof Material: Asphalt (composition) shingle  
Roof Type: Gable-Cross gable

Foundation Materials: Brick  
Foundation Type: Continuous

Chicago window with double-hung sash on either side of fixed window  
Paired double-hung sash windows  
Square aluminum porch supports  
Glass door in front of door  
Metal railing for steps and porch  
Slightly corbelled chimney  
Rectangular vent in front gable  
Rear carport addition

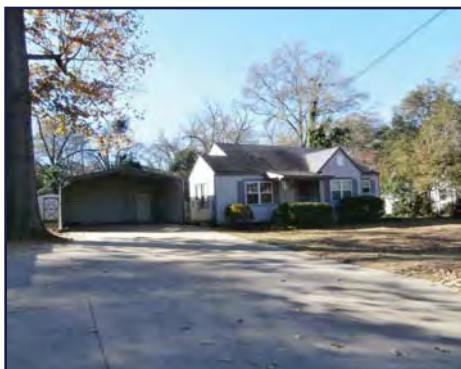
### Supporting Document 2

Roof Material: Asphalt (composition) shingle  
Roof Type: Gable - Side-oriented

Foundation Materials: Brick  
Foundation Type: Continuous

Metal scroll porch supports  
Shutters  
2 groups of paired windows  
Rectangular attic vent  
Foundation plantings  
Brushline on right side of lot  
Set back: 20 feet  
Large oak tree  
Metal carport

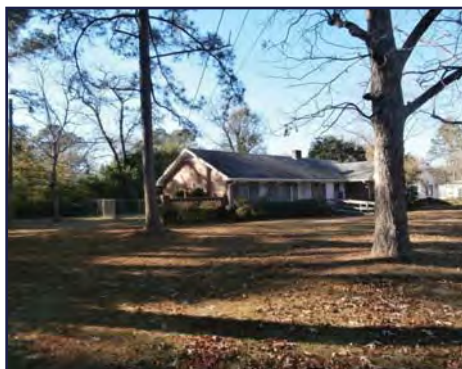
### Supporting Document 2

Roof Material: Asphalt (composition) shingle  
Roof Type: Gable - Cross gable

Foundation Materials: Unknown/obscured  
Foundation Type: Unknown/obscured

Shutters on windows  
Vinyl on enclosed carport  
Side addition to enclosed carport addition  
Scrolling metal railing on stairs to porch  
Pierced brick fence  
Sidelights  
Wooden ramp to porch
