# City of Dublin

## Historic Resource Survey Report

December 2013

Report Prepared By:  
Center for Community Design and Preservation at the University of Georgia  
<http://www.ced.uga.edu/psd>  
225 W Broad Street  
Athens, Georgia 30602

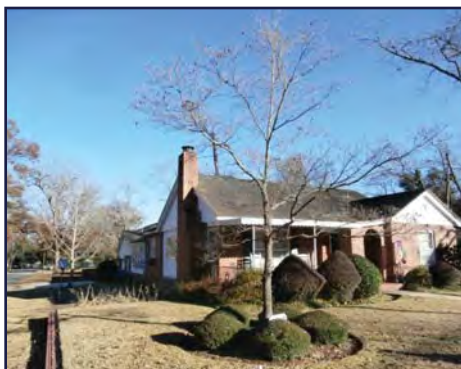
### Supporting Document 2

Roof Material: Asphalt (composition) shingle  
Roof Type: Gable - Cross gable

Foundation Materials: Unknown/obscured  
Foundation Type: Unknown/obscured

Arched opening onto porch  
Circle vent in gable  
Shutters on windows  
Mid-century modern awning on porch  
Round metal porch supports  
Metal porch railing  
Foundation plantings  
Brick planting beds and terraces  
Rear addition  
Slight Flemish eave over entry

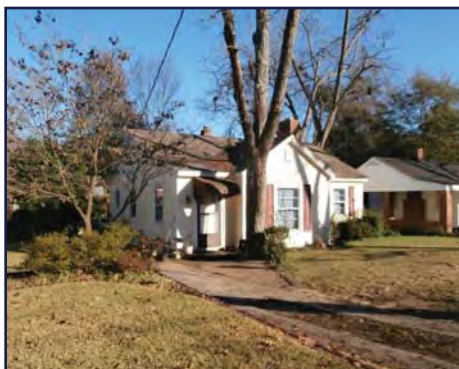
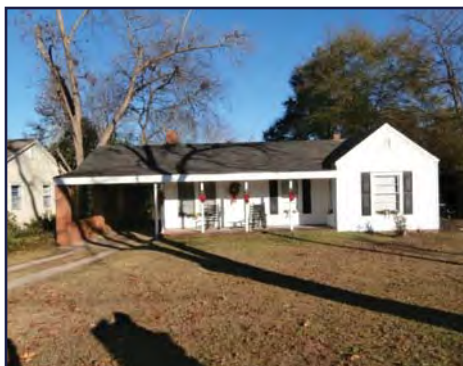
Roof Material: Asphalt (composition) shingle  
Roof Type: Gable - Cross gable

Foundation Materials: Concrete (poured)  
Foundation Type: Continuous

Rectangular attic vent  
Mid-century aluminum awning  
Foundation plantings  
3 large trees in yard  
half circle brick pad for porch landing  
brick retaining wall on left side of lot  
Planting bed on right side of lot  
2/2 double hung sash windows have horizontal muntins only

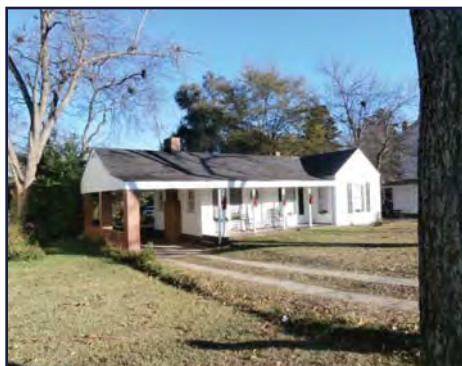
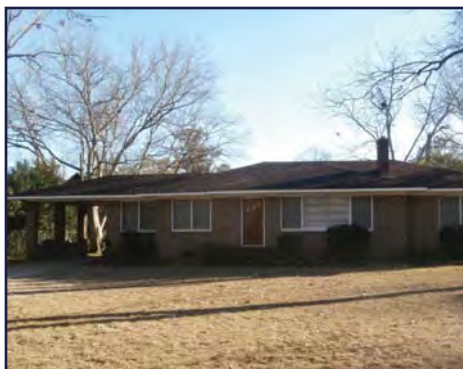
Roof Material: Asphalt (composition) shingle  
Roof Type: Gable - Cross gable

Foundation Materials: Brick  
Foundation Type: Continuous

Half courtyard ranch  
Fanlight in door  
Shutters on windows  
Square wood porch supports  
Rectangular vent in gable  
Carport attached with large square brick supports connected by low brick wall

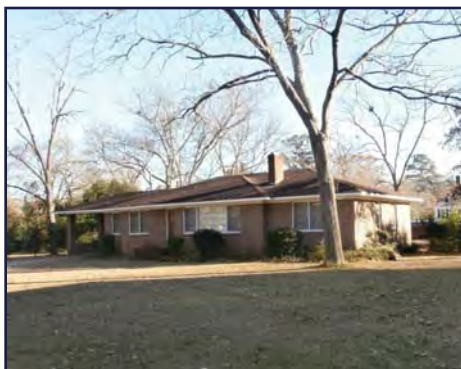
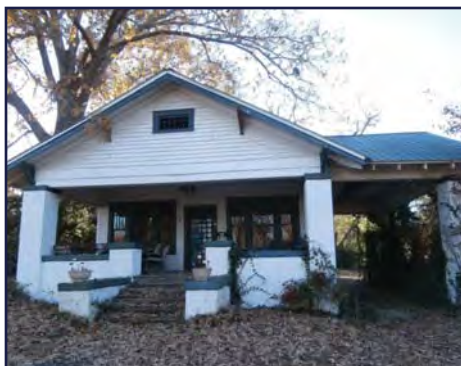
Roof Material: Asphalt (composition) shingle  
Roof Type: Hip

Foundation Materials: Unknown/obscured  
Foundation Type: Unknown/obscured

Paired single hung sash windows  
Chicago window  
Mid century door with rectangular glass panes  
Attached carport  
Curved brick steps  
Metal stair railing  
Square brick carport supports connected by low brick wall  
Foundation plantings  
Great example of ranch house in Georgia

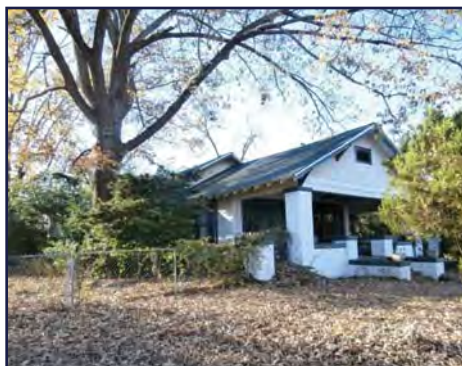
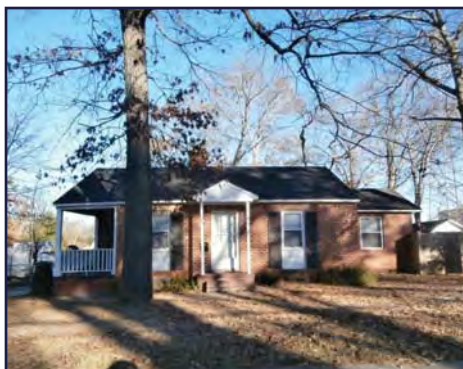
Roof Material: Steel/steel alloy (tin) - Standing seam  
Roof Type: Gable - Front-oriented

Foundation Materials: Brick  
Foundation Type: Pier/Post (no infill)

Large square, stucco porch supports on corner  
Rectangular window in gable  
Brackets in eaves  
4x10 glass pane door  
Craftsman style windows  
Concrete steps up to porch  
Concrete walk from sidewalk to porch  
Attached carport  
Large stucco, square carport supports  
Overhanging eaves  
Foundation plantings  
Large side yard with chainlink fence  
Rear addition

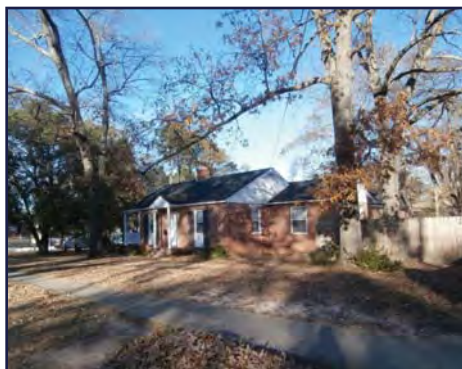
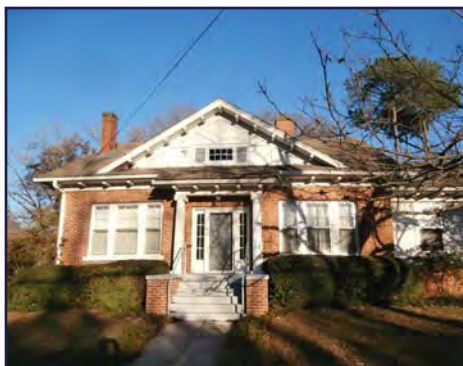
Roof Material: Asphalt (composition) shingle  
Roof Type: Gable - Side-oriented

Foundation Materials: Brick  
Foundation Type: Continuous

Shutters  
Paneling under windows in main body  
Cement jack arches above main house windows  
Rowlock sills under windows  
Brick steps for stoop, square porch supports  
Weatherboard in gable  
Rowlock course along water table in main house  
Side porch with square supports and balusters  
Brick lined drive - Foundation plantings  
One large oak tree

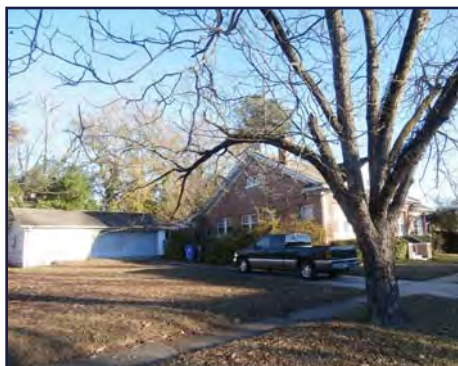
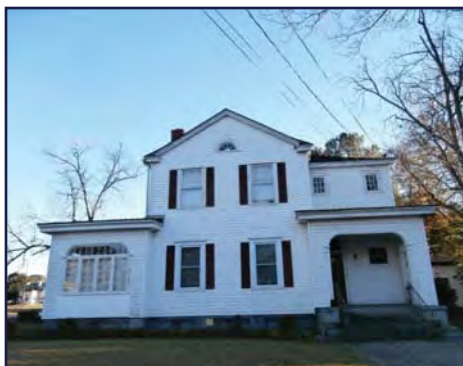
Roof Material: Asphalt (composition) shingle  
Roof Type: Gable - Cross gable

Foundation Materials: Unknown/obscured  
Foundation Type: Unknown/obscured

4/2 window in front gable with rectangular vents on both sides  
2 Chicago windows  
Side addition: enclosed carport  
Overhanging eaves with brackets  
Ionic columns, fluted, porch supports  
Craftsman detailing in gable  
Sidelights  
Jack arches over Chicago windows and doors  
Vinyl on side addition  
Foundation plantings  
Concrete walk from sidewalk to door  
Brick steps  
Tripartite window  
half timbering in gable, decorative

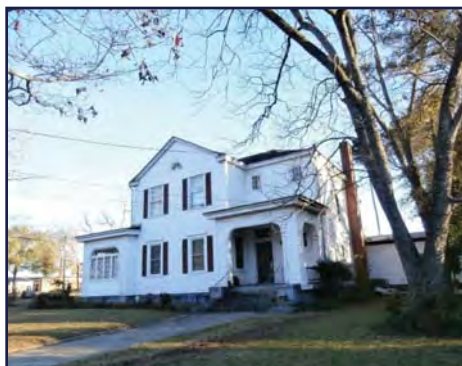
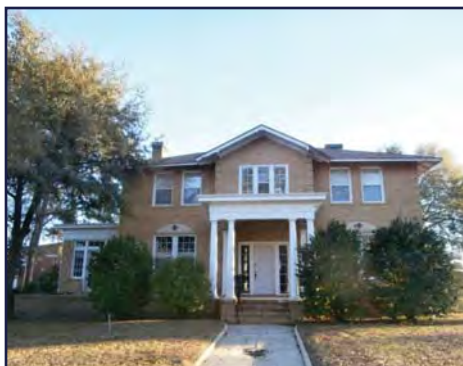
Roof Material: Asphalt (composition) shingle  
Roof Type: Complex

Foundation Materials: Brick  
Foundation Type: Pier/Post with Infill

Marching curves of recessed entry on windows for left side addition in windows  
Shutters on windows  
2/4 glass pane door  
Concrete steps to porch  
Fanlight in gable with keystone  
Transom over door  
Brick lattice work in foundation  
Electric light at end of driveway  
Square wooden porch supports at ends of arched entry  
Rear addition

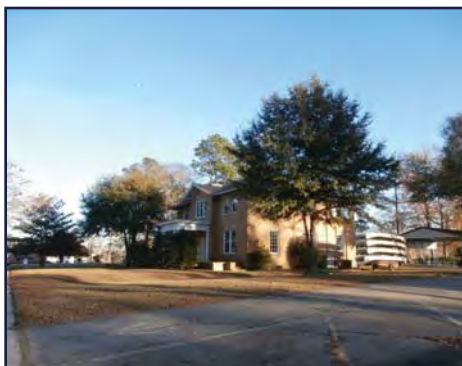
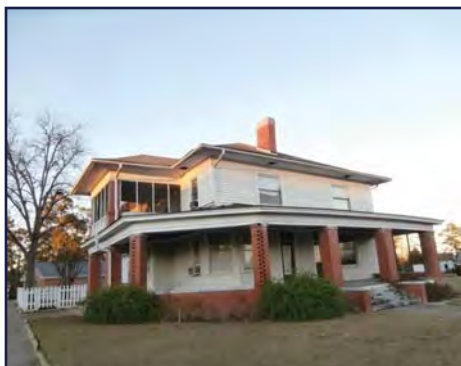
Roof Material: Asphalt (composition) shingle  
Roof Type: Hip

Foundation Materials: Brick  
Foundation Type: Continuous

Foundation plantings  
Quoins on corners  
2 sets of paired windows on first floor with rowlock sills and arches with rowlock basid with soldier course above windows. Stucco in the middle with diamond center detail.  
Decorative rafter tails  
Gable bracket  
3 grouped windows on second story above sidelights  
Smooth Tuscan columns for porch supports; paired Square pilasters behind  
Brick steps with low brick walls  
Brick porch continues beyond entry shed roof  
Side addition with two fixed pane windows: 3x4 with 1x3 transom with glass door with 1x3 transom  
Rowlock course under addition windows as sill  
Large entablature to roof line mimics porch roof line  
2 large shrubs frame entrance  
Other scattered trees

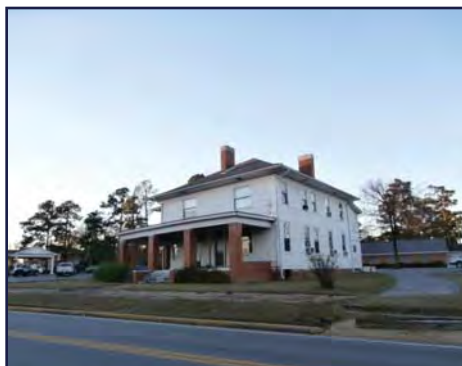
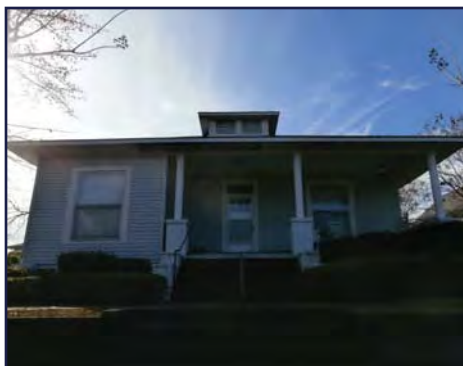
Roof Material: Asphalt (composition) shingle  
Roof Type: Pyramidal

Foundation Materials: Brick  
Foundation Type: Pier/Post with Infill

Large square brick porch supports  
Bay window/area on left side  
Rear addition  
Transom over both doors  
Brick steps  
Angled, interlocking brick supports at corners  
balcony screened in  
Brick lattice infill

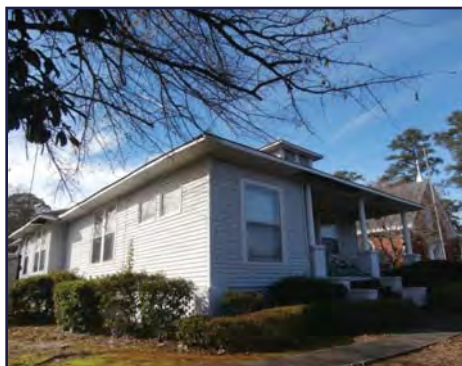
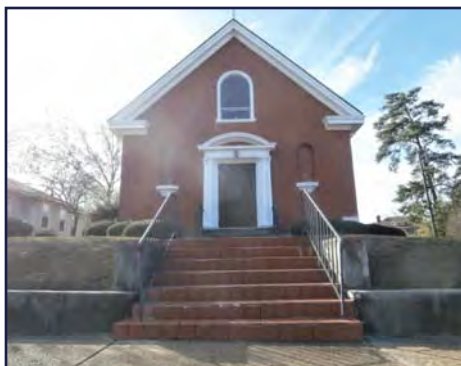
Roof Material: Asphalt (composition) shingle  
Roof Type: Hip

Foundation Materials: Brick  
Foundation Type: Pier/Post with Infill

Shed domer with 2 rectangular vents  
Transom over door  
3 vertical panes of glass above panels for door  
Brick bases for fluted columns that support porch  
Concrete steps lead to porch  
Exposed rafter tails, but covered with vinyl  
Stepped brick walls beside stairs  
Foundation plantings  
Large lot to left of house: empty  
Concrete steps with metal railing in center, leads from sidewalk to house level. Another set heads from street to sidewalk  
Large magnolia tree in yard

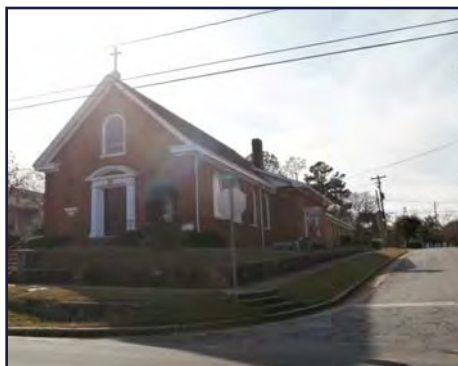
Roof Material: Asphalt (composition) shingle  
Roof Type: Gable - Front-oriented

Foundation Materials: Concrete (poured)  
Foundation Type: Continuous

Flemish bond  
2 arched niches on facade  
Double wooden door  
Terra cotta tile stairs from sidewalk and path to door  
Arched single hung sash window in gable  
Arched pediment over door  
Door has Doric engaged columns on either side  
Rear additions  
Cross on roof  
Foundation plantings  
Cornerstone with date written  
Metal railing for stairs

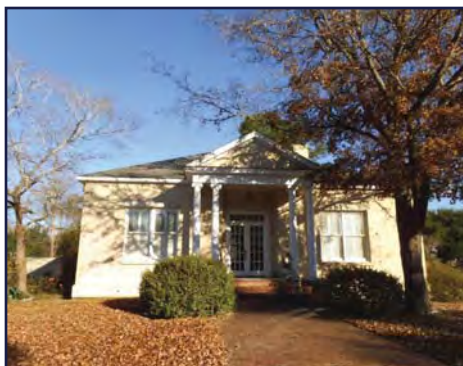
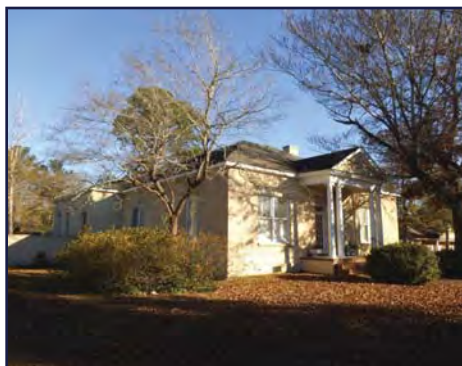
Roof Material: Asphalt (composition) shingle  
Roof Type: Hip

Foundation Materials: Unknown/obscured  
Foundation Type: N/A

Brick walkway  
Transom window  
15 glass panes in door  
Double front door  
Paired windows on either side of door  
Paired Ionic columns on porch portico  
Large rear addition  
Brick steps to porch  
Jack arches over windows and doors  
Foundation plantings  
Electric light on porch  
Pierced brick wall next to garage  
Stucco wall around back yard  
Replacement entry doors

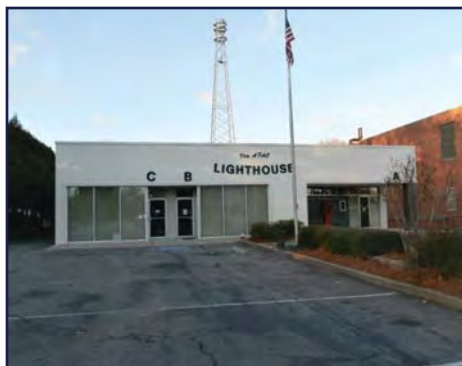
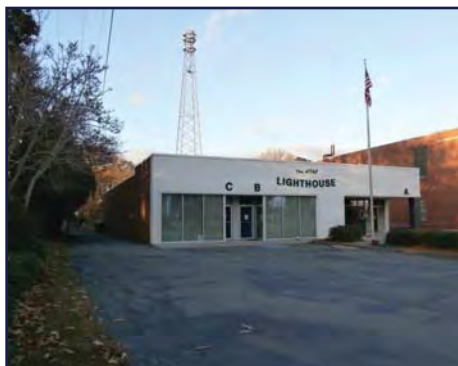
Location: Front corner  
Height: 2 story  
Width/Length: Partial  
Roof Type: Flat  
Porch Type: Recessed  
Floor: N/A

Foundation Materials: Concrete (poured)  
Foundation Type: Continuous

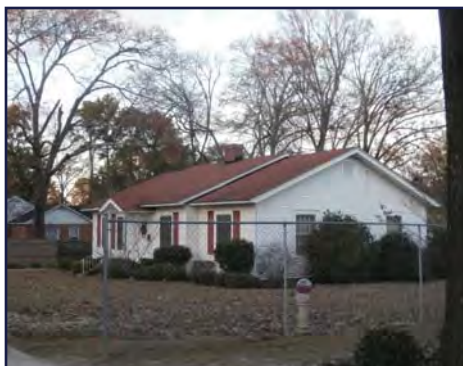
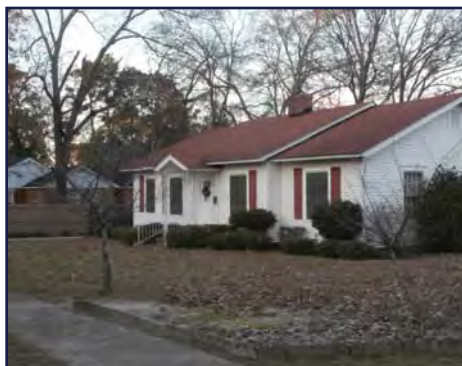
Roof Material: Asphalt (composition) shingle  
Roof Type: Gable- Side-oriented

Foundation Materials: Brick  
Foundation Type: Continuous

Midcentury modern detail in door  
Brick steps to stoop  
Metal scrolled porch supports and railing  
Foundation planting  
Shutters on windows  
Side additions  
Concrete pavers in front yard  
Cement walkway

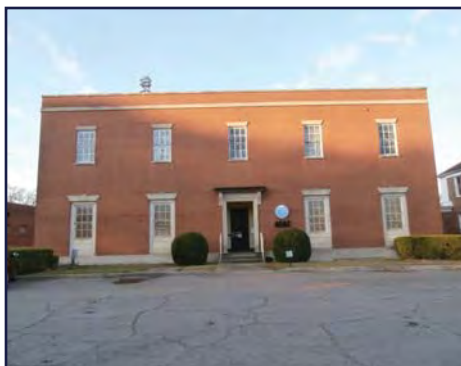
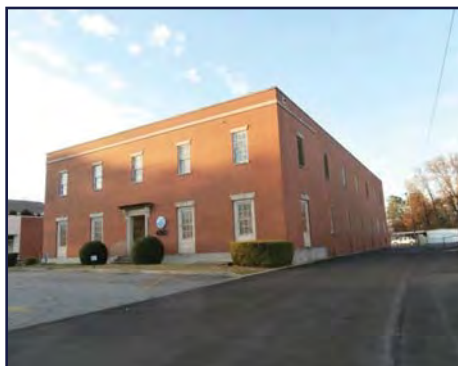
Roof Material: Unknown  
Roof Type: Flat

Foundation Materials: Concrete (poured)  
Foundation Type: Continuous

Concrete strip along roofline  
Jack arches above windows on second story plane, on first story have keystone and panel detail below  
Recessed opening with concrete surround  
Brackets support entrance cornice  
Concrete steps with metal railing  
Parking lot in front  
Sparse foundation plantings

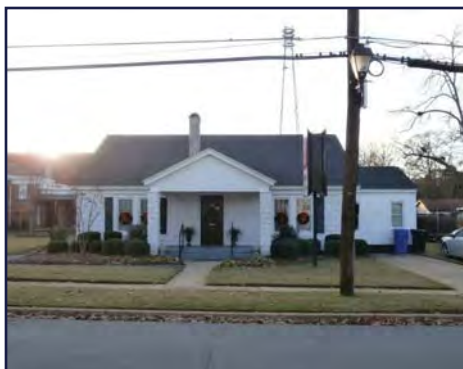
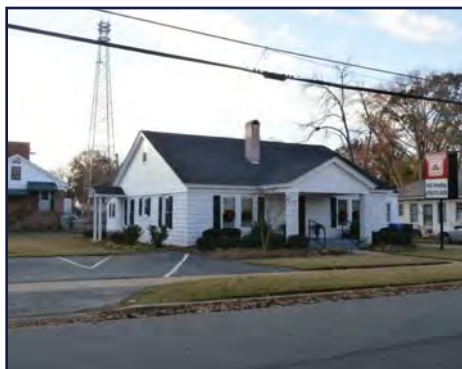
Roof Material: Asphalt (composition) shingle  
Roof Type: Gable-Side-oriented

Foundation Materials: Concrete (poured)  
Foundation Type: Continuous

Vinyl in front gable and on side addition  
Square porch supports  
Metal railing on steps  
Shutters on exterior of paired windows  
Side addition  
Foundation plantings  
Dentils under eaves  
Chimney with arched top

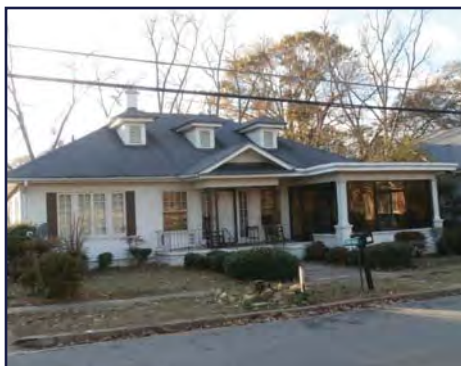
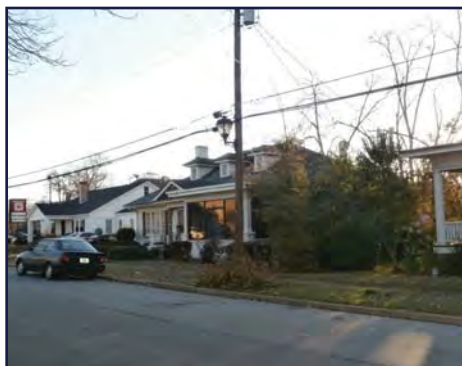
Roof Material: Asphalt (composition) shingle  
Roof Type: Hip

Foundation Materials: Concrete (poured)  
Foundation Type: Continuous

Enclosed front porch addition  
3 dormers with rectangle vents  
Metal porch supports and guard rail  
Shutters  
Gabled portico  
Sidelights 2x5  
Chicago window replaced with 2 paired 2x5  
Chimney coming out as dormer  
Enclosed porch supports have stucco base and square porch supports

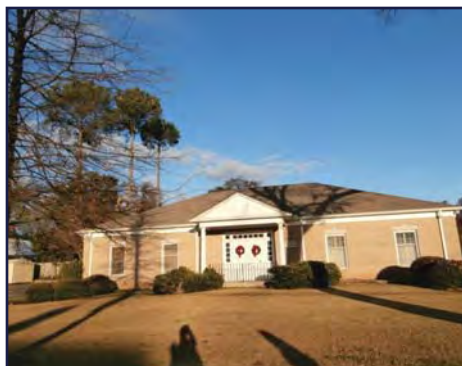
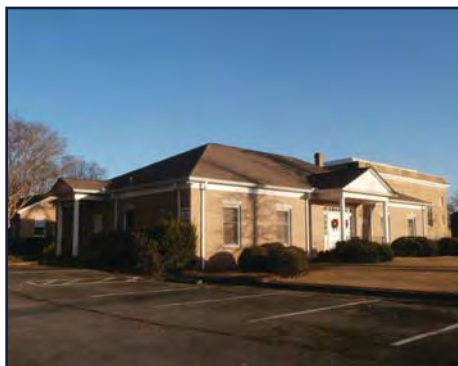
Roof Material: Asphalt (composition) shingle  
Roof Type: Hip

Foundation Materials: Concrete (poured)  
Foundation Type: Continuous

Christian life center part of Henry Memorial Church  
Tuscan columns porch supports Jack arches above windows  
Sidelights and transom over double front door  
Foundation plantings  
Ramps on either side up to portico with metal railing

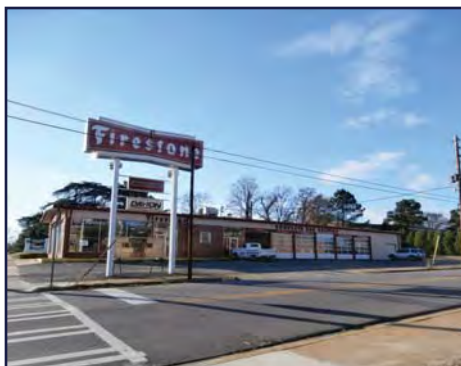
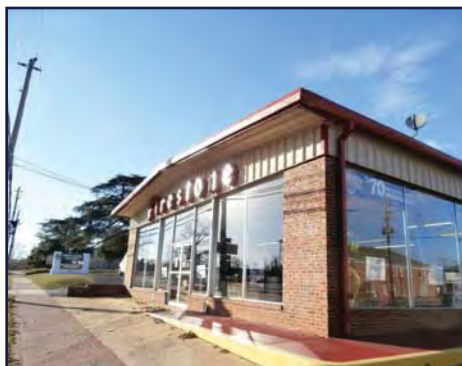
Roof Material: Steel/steel alloy-Corrugated sheet  
Roof Type: Gable-Front-oriented

Foundation Materials: Concrete (poured)  
Foundation Type: Continuous

Fixed pane windows of various sizes make up store front  
Glass double doors with side lights and transom  
Three rooms deep additions  
Low pitched gable front

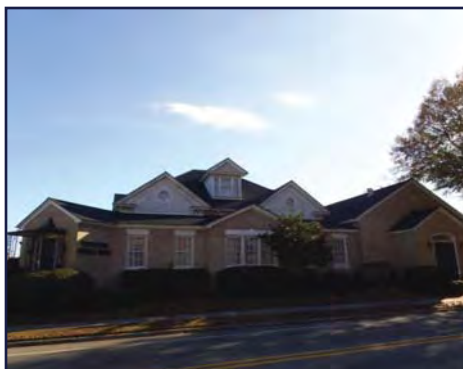
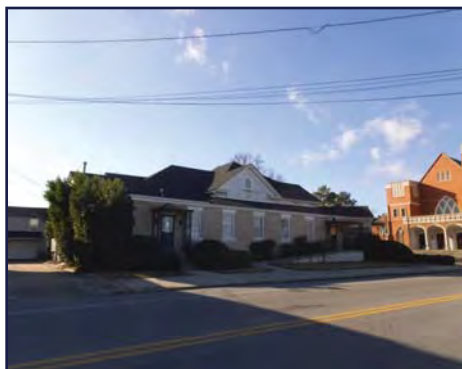
Roof Material: Asphalt (composition) shingle  
Roof Type: Complex

Foundation Materials: Brick  
Foundation Type: Continuous

Original structure encased in addition  
Circle window in gables  
Tripartite window in dormer  
Multiple entrances  
Foundation plantings  
Jack arches above addition windows

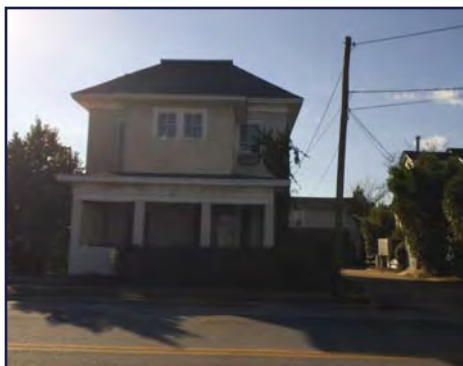
Foundation Materials: Unknown/obscured  
Foundation Type: N/A

Transom over door  
Shutters  
Large two story addition clad in vinyl  
Brick wall and porch supports  
Foundation plantings  
Driveway to garage  
3-4 car garage with second story with rusticated cmu, scroll banister, porch supports, exposed rafter tails, and three 6/6 windows

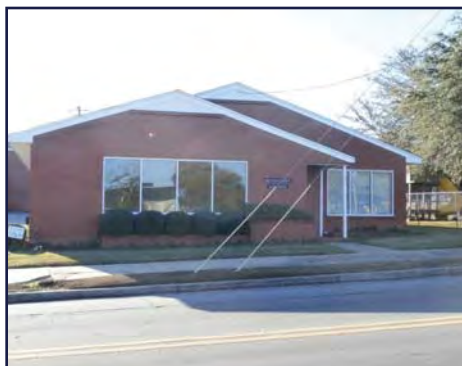
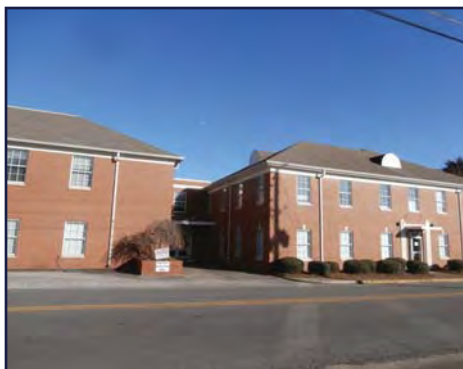
Built in planter with foundation plantings  
Square porch supports  
Small portion of gable was vinyl siding  
Playground adjacent  
Foundation planting strips alongside of building

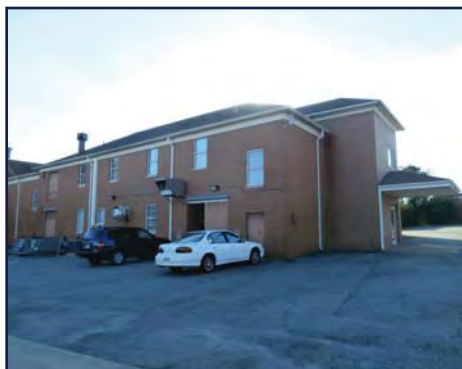
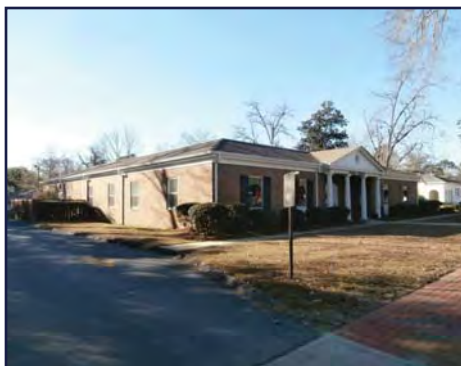
Large multi addition building  
Windows have concrete sills  
Multiple entrances  
Foundation plantings  
Glass hyphen connect one addition  
Large planter on side  
One addition has solidier course above first story windows  
Other building has solidier course and keystone detail above first story windows  
Another entrance has concrete pilasters with pointed tops and door has transom and sidelights  
Half-moon dormer vents on roof  
Main entrance has large brick and concrete wall with decorative concrete medallions inserted into the wall and a metal gate leading to a court yard  
Gabled bay with round windows in peak  
Window with bracketed arch and quoining  
Door way has bracketed arch and quoins, transom, sidelights, concrete steps with low brick walls

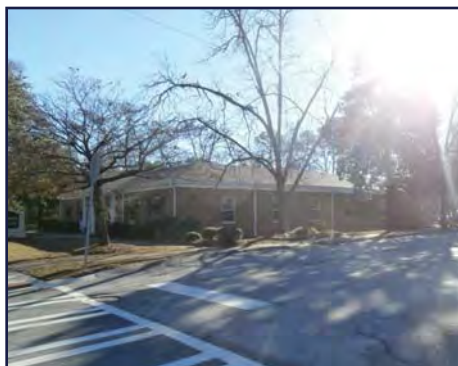
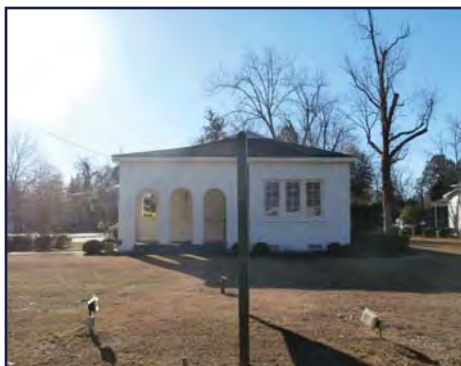
Recessed entry  
Fluted Doric columns  
Broken pediment over glass paned front door  
12 panes in front door  
Circular vent in gable over door  
Shutters on windows  
Pilasters, fluted, on either side of door

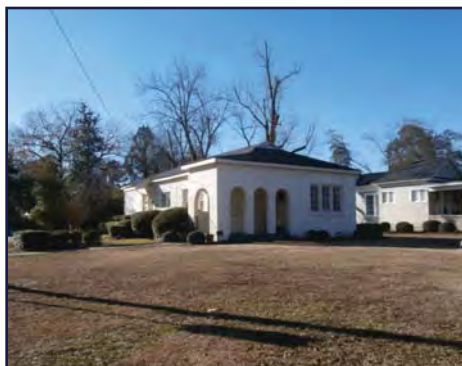
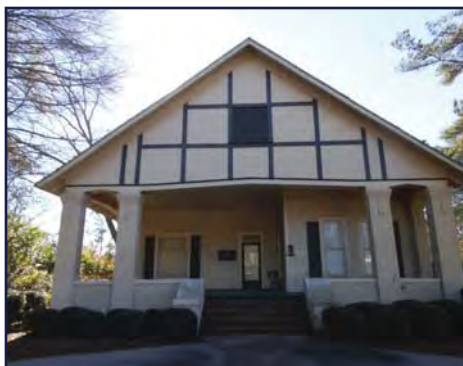
Group of 3 paired windows with stuccoed sill, other window opening covered with plywood has concrete sill  
3 arched openings to porch  
Triangular roof vent at gable  
Side arched entrance to porch with metal hand railing  
Arch window on back porch wall  
Foundation plinths  
Metal guard rail to front door step  
Yard sign  
Used to be a lateral exterior chimney on right side, but no longer  
Setback about 20 feet

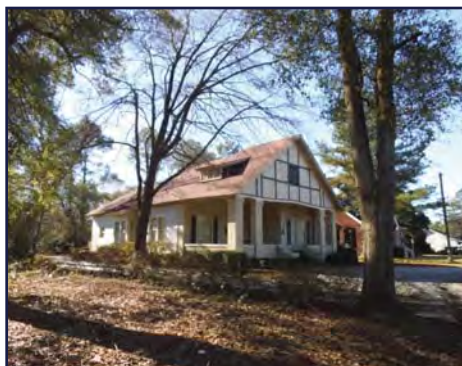
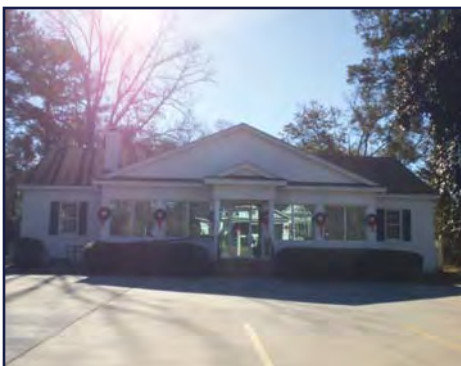
Transom over door  
Appears to have originally been a gabled ell cottage.  
Multiple material replacements/additions c. 1920-  
1925 have turned it into a front gable bungalow  
Craftsman details in front gable and transom  
windows  
Large Rectangular vent in Gable  
Brick Steps  
Square brick corbelled porch supports  
Single glass pane door  
Foundation plantings  
Overhanging eaves  
Attic vents on both sides  
Large 1/1 window to left of door  
Shutters on exterior sides of windows  
Paired Single hung sash windows in gabled-ell

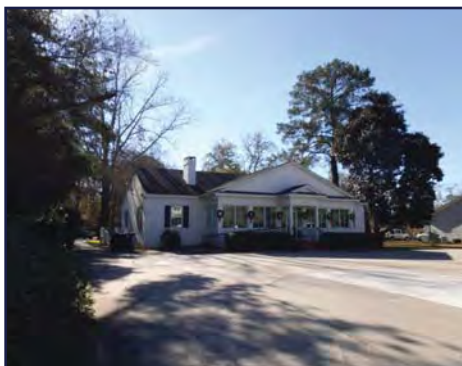
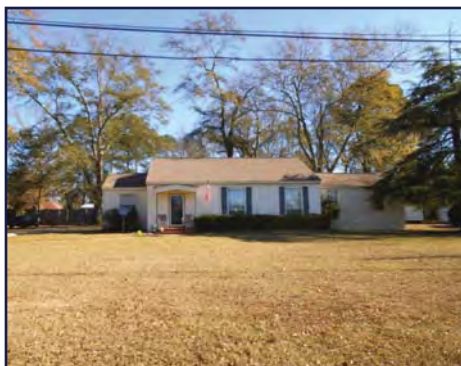
Large front gable addition with large fixed pane glass windows (enclosed verandah)  
Sidelight and transom over front door  
Single glass pane  
Parking lot in front  
Shutters on single hung sash windows  
Brick piers between fixed windows  
Front gable with gablet over front door  
Brick steps and ramp up to door with metal railing

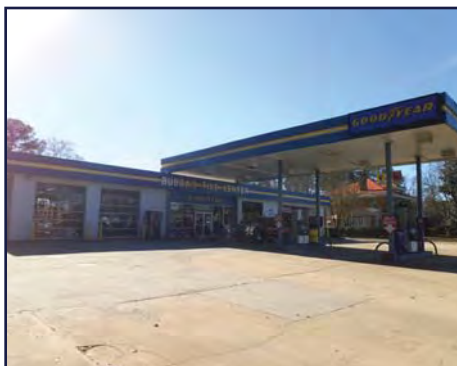
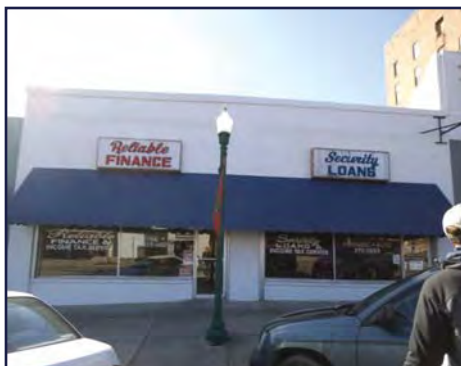
Gas station and tire center  
Garage/repair areas on either side of center single  
room retail area with glass paned garage doors  
Gas pumps and parking in front

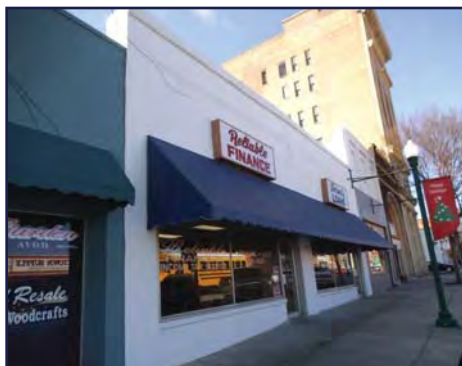
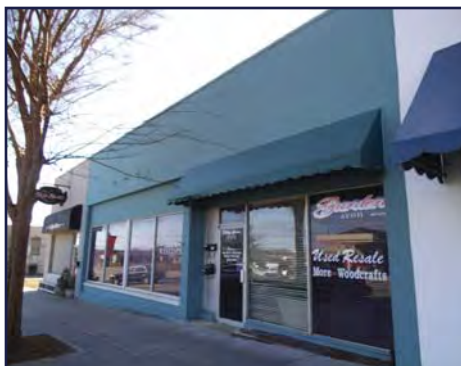
Two individual buildings on one parcel  
Individual buildings asymmetrical  
Storefront symmetrical  
Midcentury alteration to storefront  
windows and entry door  
All historic facade features behind stucco  
1.5 story depression evident of past brick detailing  
Vertical board under awnings

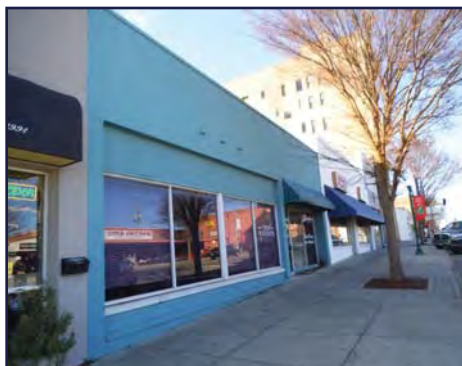
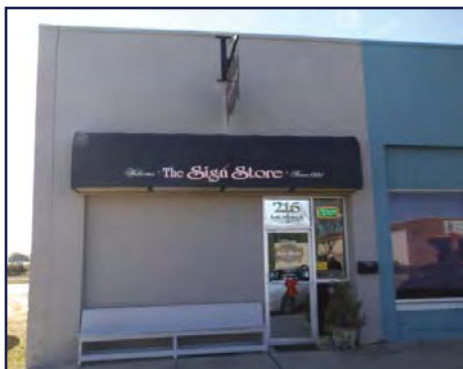
Two original historic structures, now combined on one parcel  
Midcentury alterations to storefront  
Scored brick and terracotta tile (6x6") facade  
Painted terracotta tiles above large fixed ribbon windows  
Single light transom over entry door  
Setback: 20ft

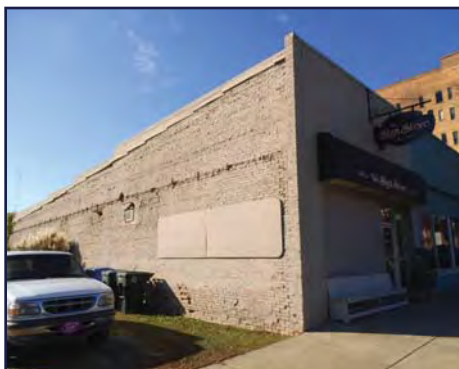
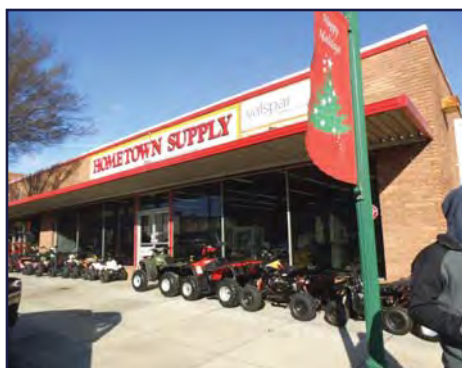
Original recessed storefront bricked over with rusticated brick  
Midcentury alterations to entry door and fixed windows

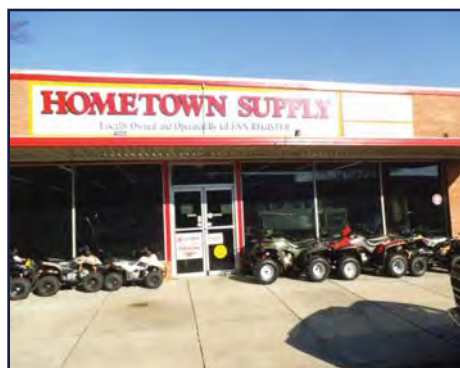
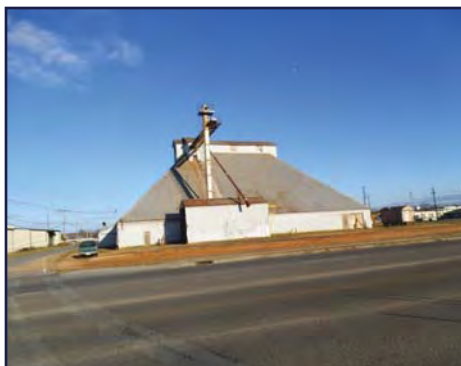
Two structures on same parcel  
Large fixed tripartite windows on right, fixed single  
pane windows on left  
Single pane lit transom on both facades  
Wood and aluminum awnings transverse entirety of  
facade  
Integrated side shed addition  
Setback: 20ft

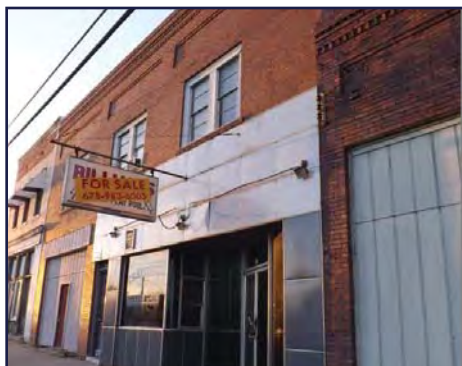
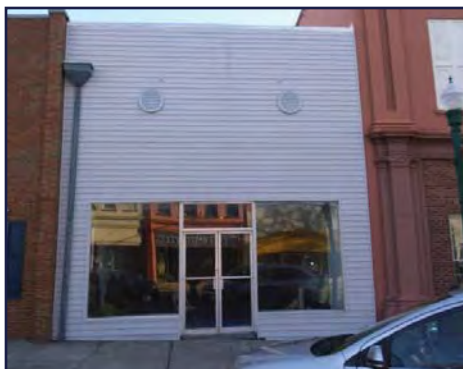
Paired 2/2 double hung sash upper story windows  
Replacement of original storefront windows with reflective glass  
Brick on lower portion of facade replaced by particle board with resin coating  
Recessed rectangular brick pattern in upper third of facade  
Brick dentils  
Diagonally coursed brick detailing along roofline  
Three store fronts integrated on one parcel  
Granite curbs  
Setback: 15 ft

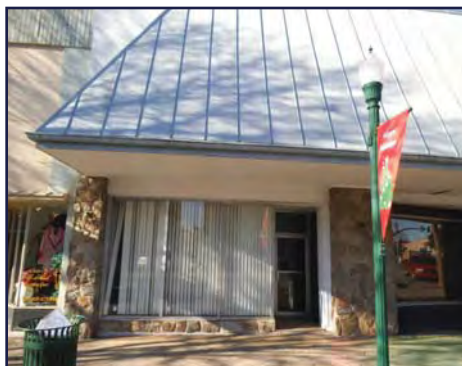
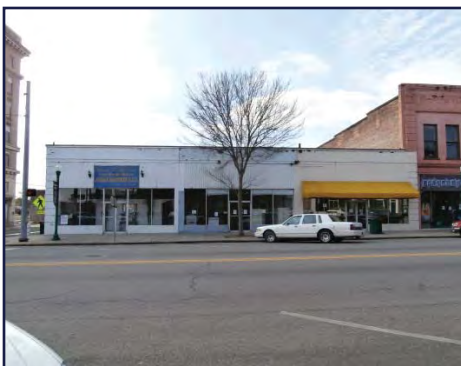
Midcentury additions: fixed single pane ribbon windows, recessed entry door  
Running granite block foundation  
Two coursed stone columns flanking entry door and fixed windows on facade  
Two stories - second story integrated hip roof, projecting off original facade  
Stucco over original facade material

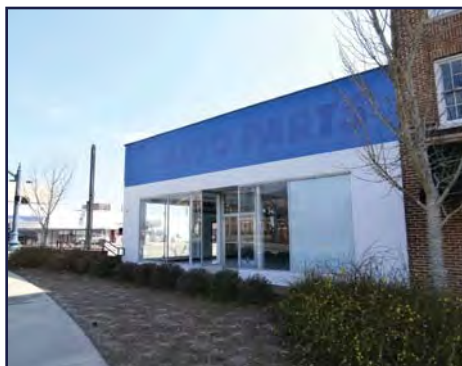
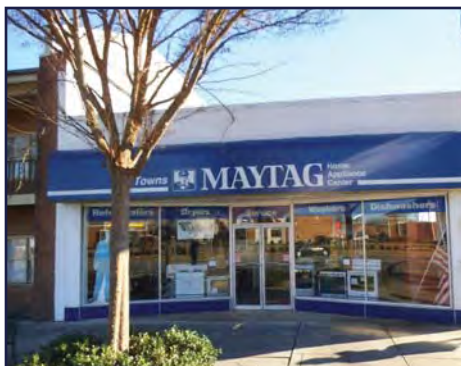
Vacant storefront on corner of Bellevue Ave and Monroe St  
Large ribbon windows with glass recessed entryway and full light double entry doors  
Front facade has smoothed concrete exterior materials(south left facade is concrete masonry units)  
Brick pavers on front sidewalk  
Located adjacent to seven story historic hotel and near City Hall

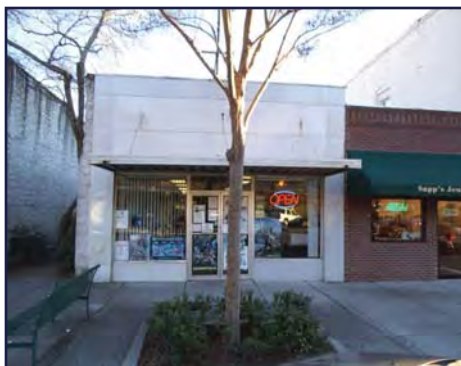
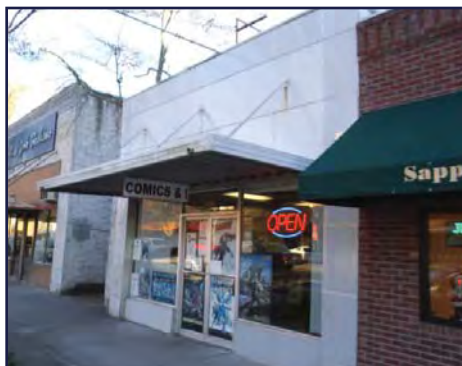
Midcentury single retail establishment  
Full width floor to ceiling shop windows across front  
facade  
Slightly recessed entry door  
Poured concrete entry area  
Original extant material covered by synthetic siding  
Setback- 25ft

Roof Material: Steel/steel alloy-Standing seam  
Roof Type: Hip

Foundation Materials: Unknown/obscured  
Foundation Type: N/A

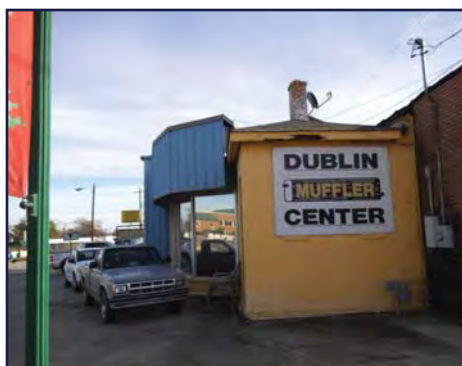
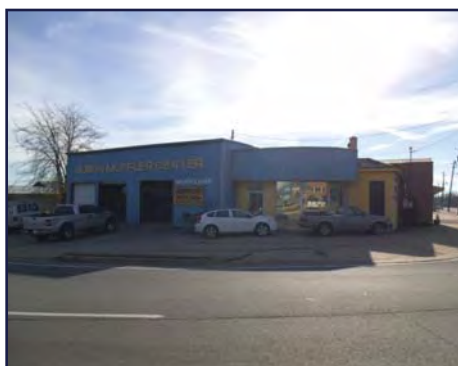
Original facade bricked in, added elements of Colonial Revival  
Concrete door surround with pronounced keystone  
Flat arches over windows with pronounced keystone  
Aluminum frames around windows and entry recessed  
One story integrated concrete piers under concrete entablature  
Brick sills under windows  
Brick header water table  
Setback: 15ft

Roof Material: Steel/steel alloy; Unknown  
Roof Type: Standing seam; Flat

Foundation Materials: Brick  
Foundation Type: Continuous

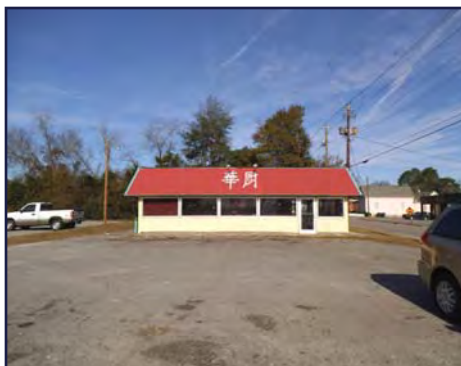
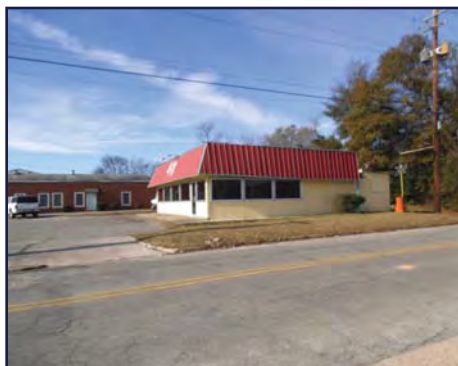
Historic facade covered with aluminum siding  
Midcentury renovations- fixed single pane windows to right  
of main entry door  
Three large bay doors on left facade

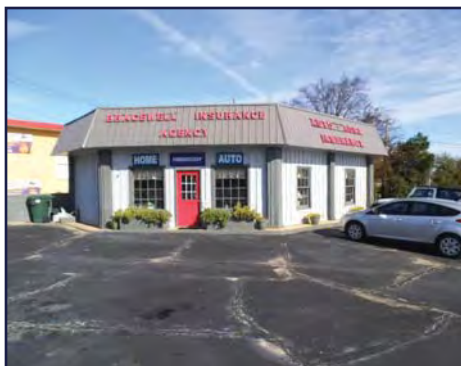
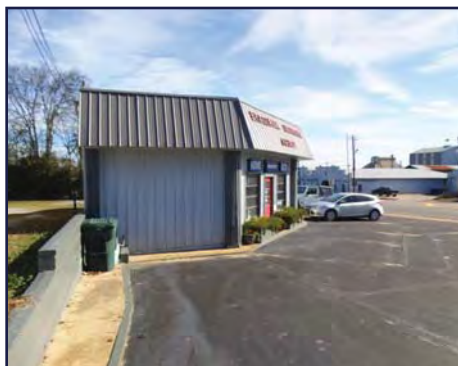
Paired flat fixed windows  
Single light commercial entry door  
Wooden ram and steps to entry  
Flat awning integrated into roof  
Pink slate stone exterior with concrete mortar  
Approximately 20 parking spaces in front  
Single story single retail adjacent  
Few trees remain

Roof Material: Aluminum  
Roof Type: Mansard

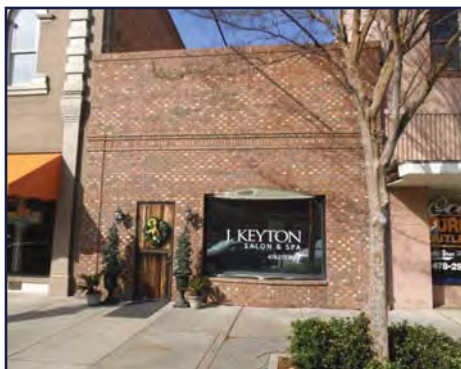
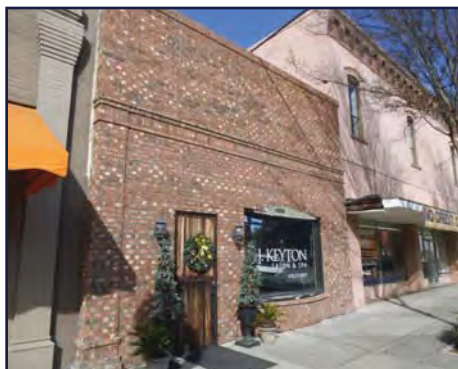
Three facades affronting East Jackson Street  
Right facade: divided in two by detailed wood pilaster with 6/6 double-hung sashes in middle of each division  
Middle facade: centered entry door flanked by 16 pane fixed windows and framed by detailed wood pilasters  
Symmetrical planting beds at entry  
Left facade: entirely covered in vertical board  
Seven space parking lot on front of parcel

Roof Material: Unknown  
Roof Type: Flat

Foundation Materials: Brick  
Foundation Type: Continuous

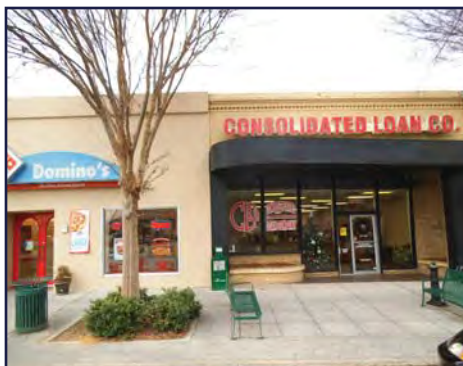
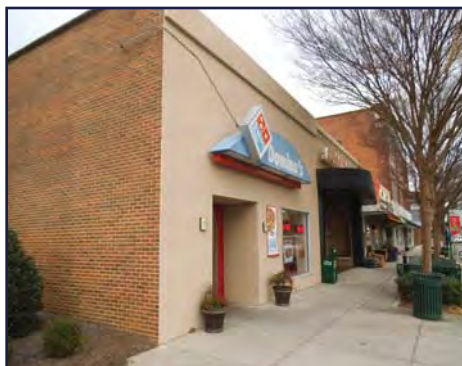
Large fixed single pane window with curved bay setting in facade with brick sills  
Late 20th century rusticated brick facade, wooden door, and bay window replacements  
One story corbelled brick pilasters frame structure and connect at one story, three course brick detailing

Roof Material: Unknown  
Roof Type: Flat

Foundation Materials: Brick  
Foundation Type: Continuous

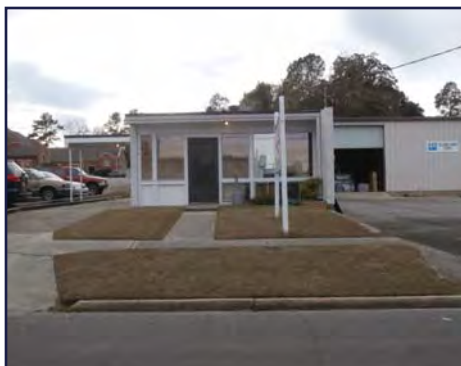
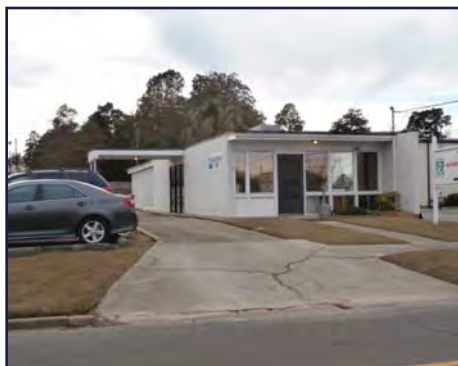
One replacement window  
Foundation plantings  
Brick steps up to door  
Nine glass panes in door  
Screen and scroll metal door  
Side addition  
Brick water table

Roof Material: Unknown  
Roof Type: Flat

Foundation Materials: Concrete (poured)  
Foundation Type: Continuous

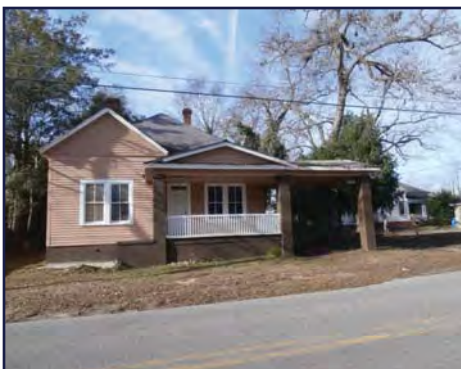
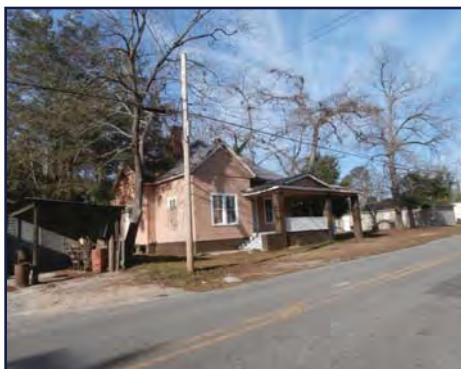
Square porch supports  
Weatherboard in gable  
Closed square attic vent  
Double paneled front doors, 2 more sets of double paneled  
doors, one set of plywood double doors, and one single metal  
door  
Two shed side additions  
Parking lot in front  
Right side: shed roof added to side of building  
Porch has concrete masonry unit infill with brick piers  
Patterned asphalt panel doors

Roof Material: Asphalt (composition) shingle  
Roof Type: Pyramidal, Gable - Front Oriented

Foundation Materials: Brick  
Foundation Type: Pier/Post (no infill)

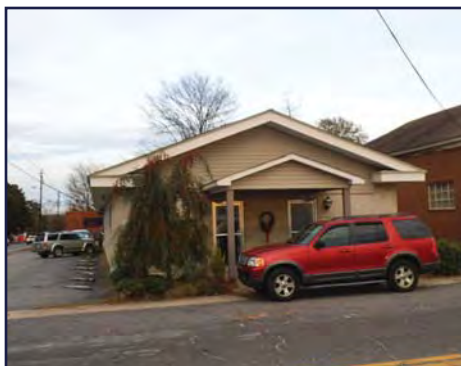
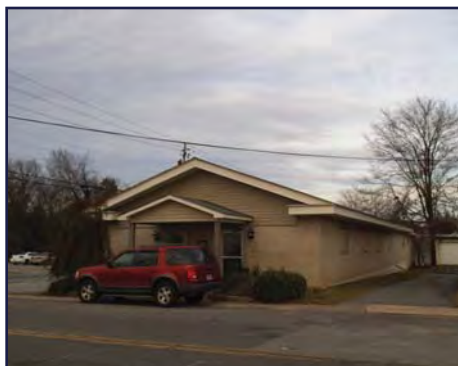
Brick pad for step  
Rear addition  
5 foot set back  
Shutters  
Bars over windows  
Foundation plantings  
Rowlock course near the off line and soldier course  
at roof line  
Parking lot to right  
Side addition

Roof Material: Asphalt (composition) shingle  
Roof Type: Gable-Front-oriented

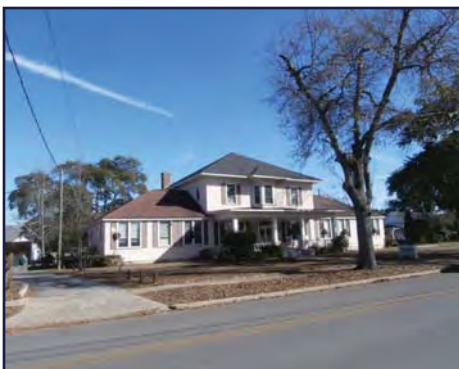
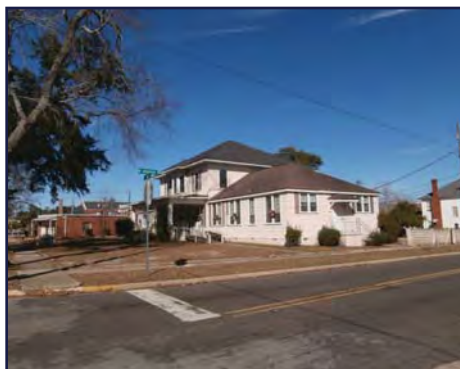
Two entry doors at front  
Small projecting portico off front facade  
One story projected eaves  
Minimal plantings

Roof Material: Asphalt (composition) shingle  
Roof Type: Hip

Foundation Materials: Concrete (block)  
Foundation Type: Continuous

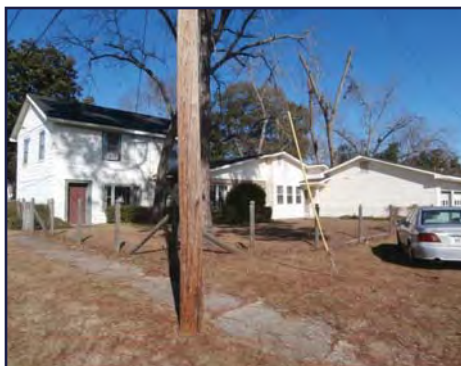
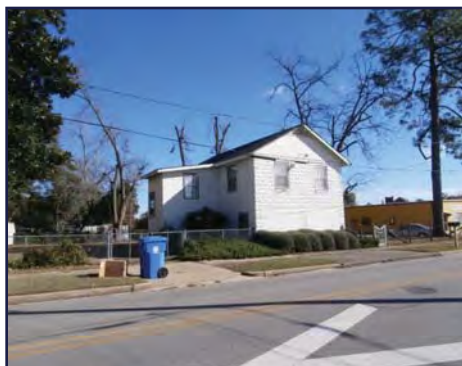
-Foundation plantings  
Bay window in second story  
Cement porch support bases, square porch supports  
Square banister and balustrades  
ADA ramp addition  
Shutters  
Transom, double 3x5 fixed pane doors  
Parking lot in rear  
Five groups of paired windows  
Two Chicago windows  
Wood window surrounds  
Major alteration  
two large side additions and replacement windows

Roof Material: Asphalt (composition) shingle  
Roof Type: Gable - Cross gable

Foundation Materials: Concrete (block)  
Foundation Type: Continuous

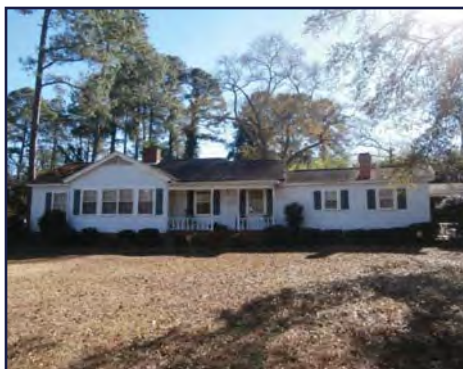
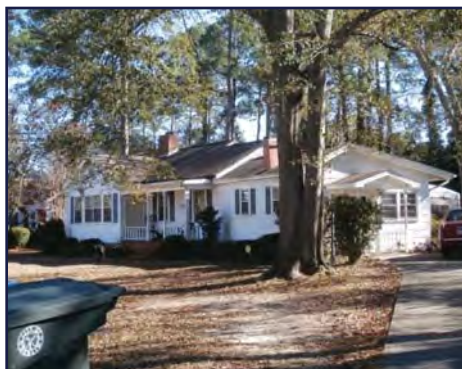
Two front additions  
Two front doors  
Chicago style window  
Fenced yard  
Foundation plantings  
Mature trees  
Paired windows  
Stoop with shed roof and square porch supports  
Attached garage

Roof Material: Asphalt (composition) shingle  
Roof Type: Gable - Cross gable

Foundation Materials: Brick  
Foundation Type: Continuous

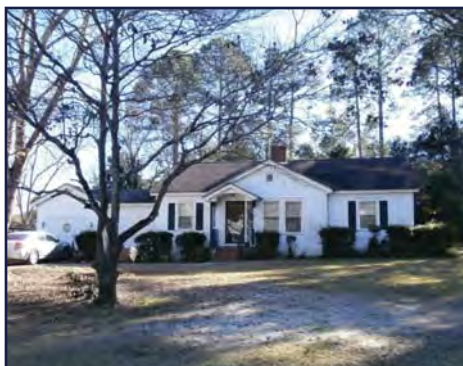
Triangular vent in front gable  
Turned wood porch supports and railing  
Shutters on windows  
4 windows grouped under front gable  
Large side gable addition

Foundation Materials: Brick  
Foundation Type: Pier/Post with Infill

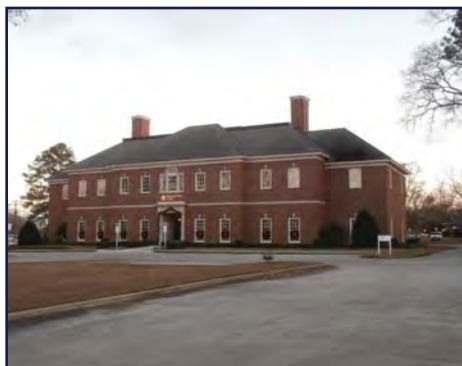
### Supporting Document 2

Entrance flanked by ionic pilasters frieze has triglyphs and cornice  
Transom over door  
Quoins on corners of building  
Jack arches with cement keystone above windows  
Foundation plantings  
Scattered oak trees  
Palladian window above entrance in second story  
Cement story dividing line  
Brick retaining wall

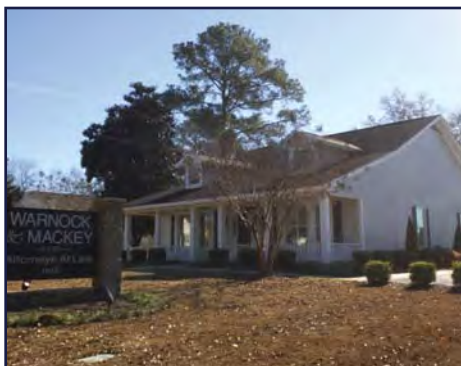
### Supporting Document 2

Two dormers with 6/6 windows that are gabled with gambrel arch with fascia board detail  
Arched leaded glass transom and leaded glass sidelights  
Square porch supports with banister  
Shutters  
Designed bedground structure with shrubs and decorative glass  
Concrete walkway  
Brick sidewalk in front with street trees in planting strip  
Busines sign in yard  
2 crape myrtles  
Two bay windows flank front door  
Parking lot on west side of the building

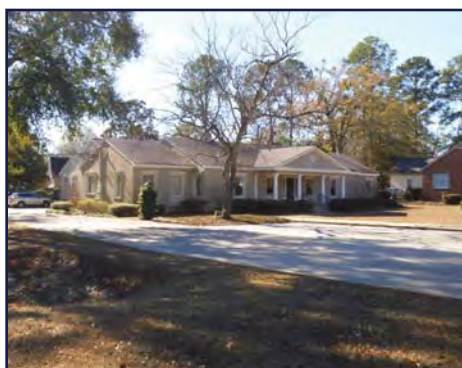
### Supporting Document 2

Porch with Ionic column porch supports  
Jack arch detail above windows and panel detail below  
Door has leaded glass sidelights and a jack arch above the door  
Circular vent in front gable  
Cement stairs lead to porch with metal railing  
Business sign in yard  
Foundation planting beds, other beds in yard  
Parking lot, driveway, and sidewalk are concrete  
Street trees in planting strip by brick city sidewalk  
Large rear auxiliary building/addition

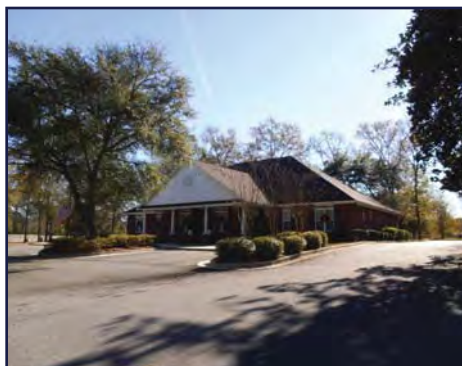
### Supporting Document 2

Front door with transom and side lights  
All windows have transom  
Doric columns support portico with exaggerated  
dentil detailing  
Business sign in yard  
Planting beds in driveway and parking lot

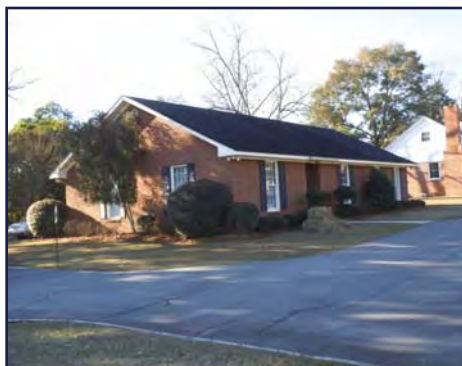
### Supporting Document 2

Turn of the 21st Century Medical Complex  
Neo-Colonial Revival  
Recessed Entry Doorway  
Holly Foundation Plantings  
Non-Contributing Structure
