# City of Dublin

## Historic Resource Survey Report

December 2013

Report Prepared By:  
Center for Community Design and Preservation at the University of Georgia  
<http://www.ced.uga.edu/psd>  
225 W Broad Street  
Athens, Georgia 30602

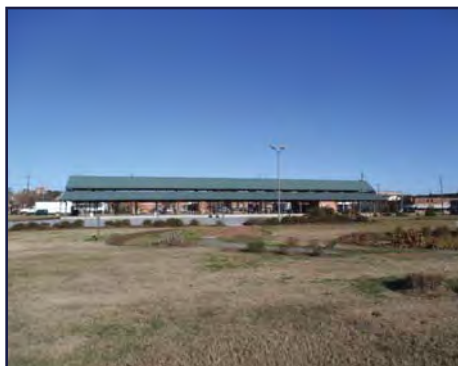
### Supporting Document 2

150 ft outdoor civic pavilion  
Resembling historic train depot  
Large lot with expansive turf  
Enclosed section for facilities and maintenance  
Facilitated walks  
Exposed beams under pavillion roof with large  
exposed trusses

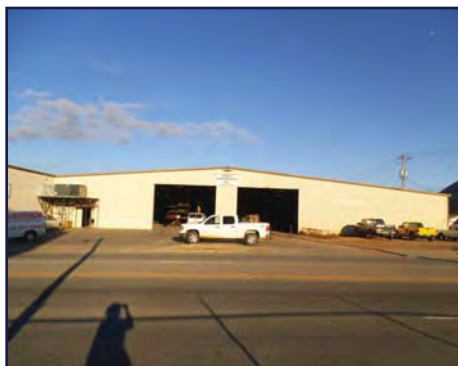
### Supporting Document 2

Large two bay, front gabled storage facility  
Approximate dimensions: 200 x 350 feet  
Three bay flat roof addition  
Side shed addition  
Setback: 50ft

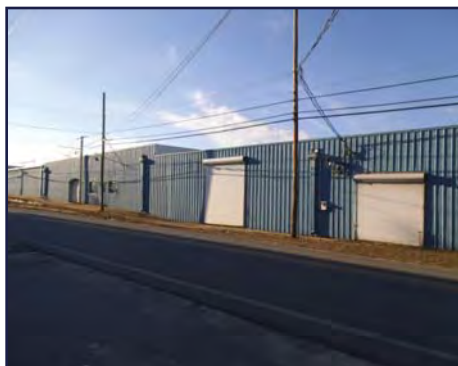
### Supporting Document 2

Historical structure clad in 21st century vertical aluminum siding  
Large multiple bays and points of entry spans city block  
Concrete sidewalks  
Old rail tracks run parallel to parcel  
Setback: 20ft

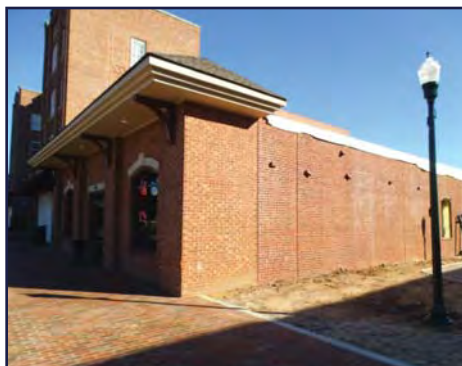
### Supporting Document 2

Recently built single retail structure integrated into historic Roberts Building  
Fixed round arched windows with concrete rounded arches  
Two-light entry door has side lights, transom, and flat concrete arch  
Large brackets support wide overhanging eaves

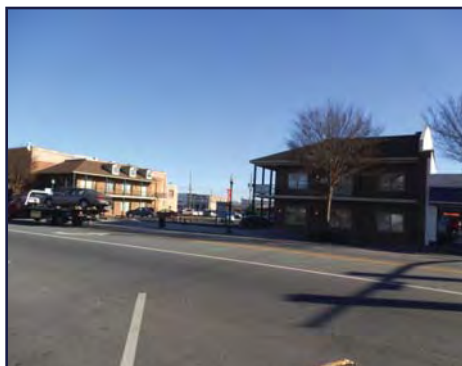
### Supporting Document 2

Two buildings bisected by parking lot on same parcel  
Asphalt parking lot with approximately 30 parking spaces  
Planters as buffers between sidewalk and lot  
Both buildings have 1/1 double hung sash windows on second floor and 6/6 on second floor  
Flat brick arches above bays and entryways on both floors  
Brick sills  
Three gables within roofline, facing parking lot on each building  
Setback - 20ft

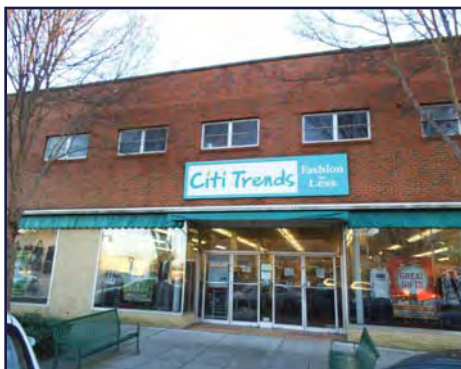
### Supporting Document 2

Historic corner store with scored brick and yellow brick facade replacement  
Two recessed entryways one diagonally-facing road intersection, one fronting West Jackson Street (with midcentury aluminum awnings)  
Tile detailing on entryway floors  
Second floor scored brick facade  
2/2 windows above scored brick sills on both street facing facades

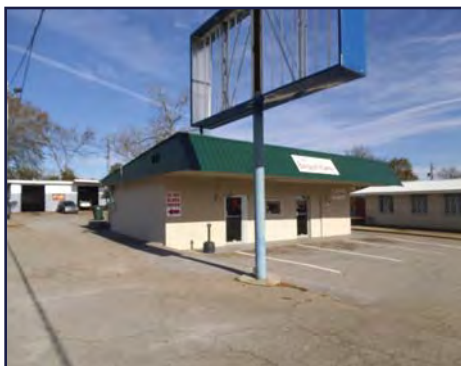
### Supporting Document 2

Late 20th century concrete block single retail facility  
Two single pane entry doors  
Vinyl on center front facade between doors  
Single fixed windows with vinyl frame  
Mansard roof tapers in back  
Four parking spaces  
Large vacant lot adjacent  
Setback- 30 feet

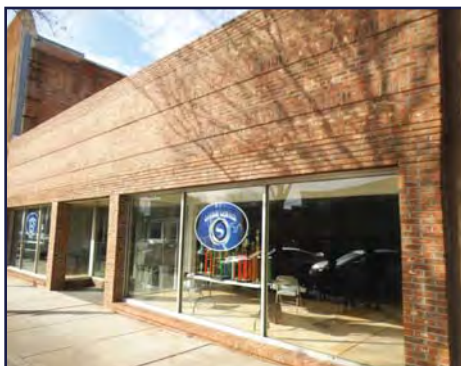
### Supporting Document 2

Late 20th century facade renovations: rusticated brick, aluminum trim around fixed ribbon windows spanning facade, double glass entry doors  
Four evenly spaced brick pillars  
Brick sills under ribbon windows  
Seven course brick detailing above ribbon windows and six course brick detailing along roofline  
Doubly vertical brick protrusion details between course details  
Recessed entryway

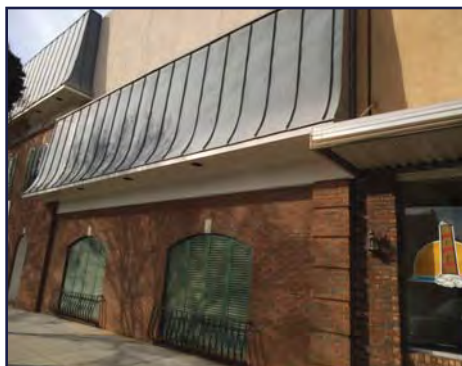
### Supporting Document 2

Former store  
Two bays with brick arch and key stone detail with shutters  
and decorative iron work  
Second story faux-mancered roof with standing seam roofing  
Third story textured concrete quoins on corner

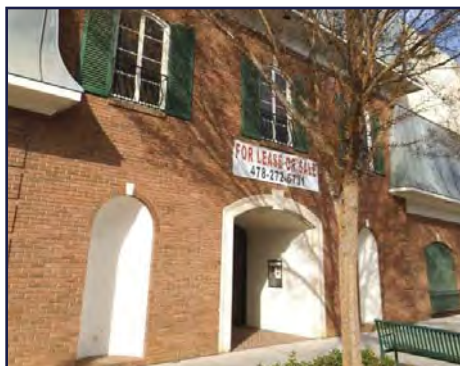
### Supporting Document 2

Commercial block that has integrated three historic buildings into one- includes three separate parcels  
Large arched entry (cast concrete) with concrete key stone  
Leads to recessed entry with single light entry door with rounded transom and side lights  
Blind recessed arches on either side of entry-interior is textured concrete  
Rowlock course for arches and concrete key stones above current and enclosed windows  
Iron gate detail on seconds story windows and shutters  
Quoin detailing on corners  
Rowlock window sills

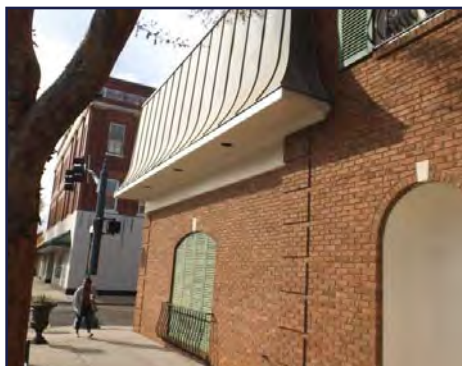
### Supporting Document 2

Former store, now incorporated with two other buildings  
One bay quoin detail  
Arched opening with shutters and iron detail  
Opening arch has rowlock course and cement key stone  
Faux-mancared roof detail

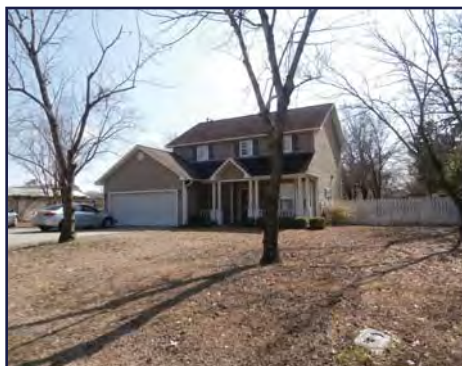
### Supporting Document 2

Roof Material: Asphalt (composition) shingle  
Roof Type: Gable-Side-oriented

Foundation Materials: Concrete (poured)  
Foundation Type: Continuous

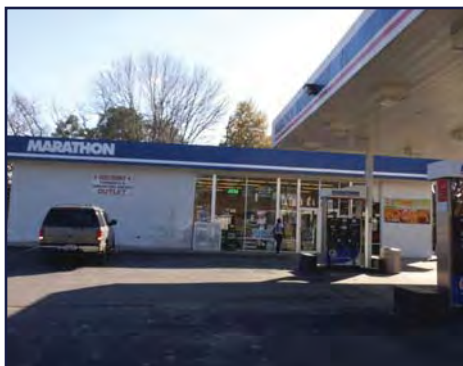
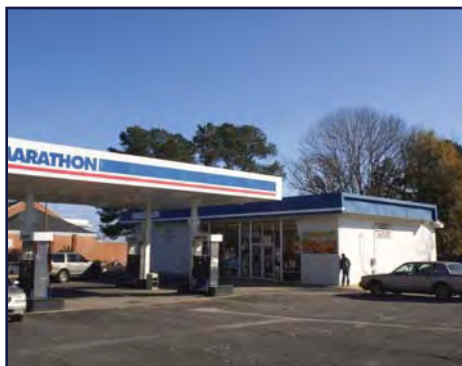
### Supporting Document 1

Roof Material: Unknown (Insufficient information)  
Roof Type: Flat

Foundation Materials: Concrete (poured)  
Foundation Type: Slab

Outbuildings: Non-historic Outbuildings observed  
Outbuilding observed: Gas station pumps and awning

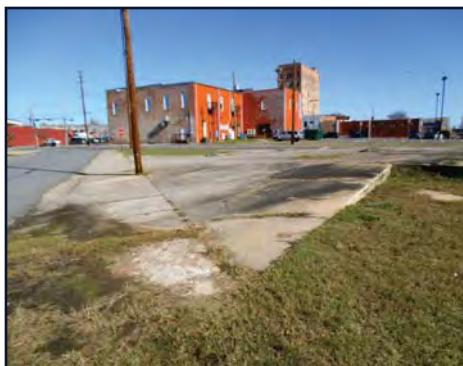
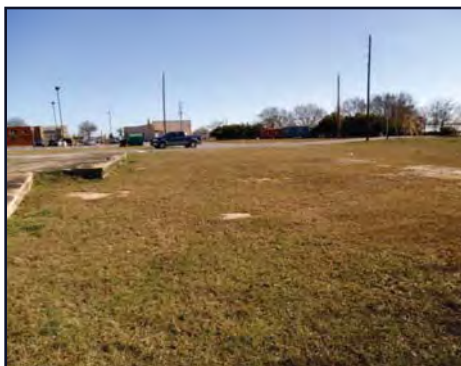
Gravel and Turf parking lot  
Cactus planting  
Adjacent to modern cleaners and historic bottling  
plant  
Setback 12ft

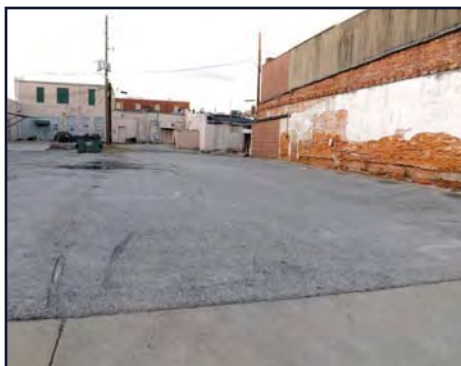
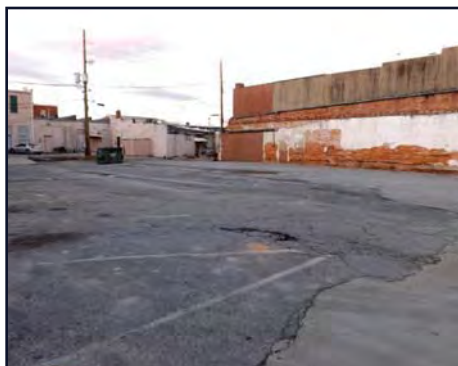
Asphalt parking lot adjacent to train tracks

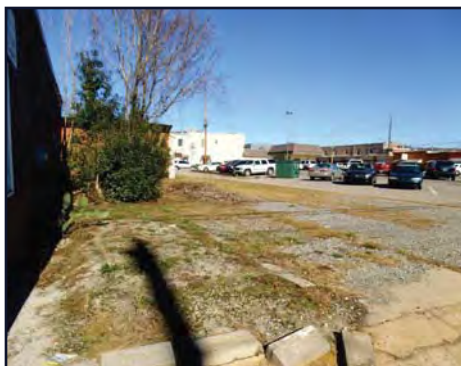
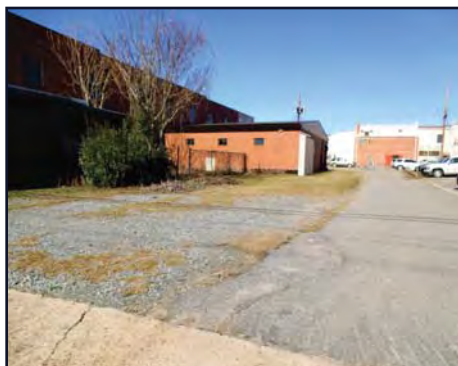
Single parcel broken into two large parking lots  
Approximately 200 ft by 200 ft  
Approximately 40 spaces  
20 foot setback from main intersection  
Surrounded primarily by 1 to 2-story commercial structures

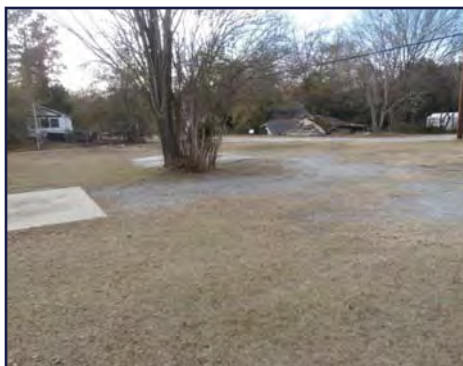
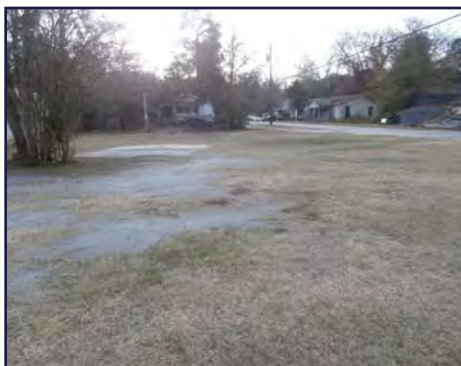
Parking lot for First Baptist church  
Business office on one side and apartment complex  
at rear and residence on other side across the street  
from bank  
Setback ~ 25feet

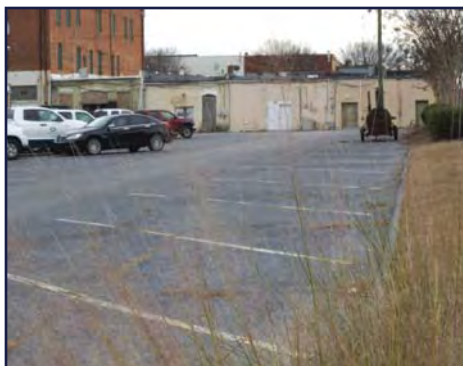
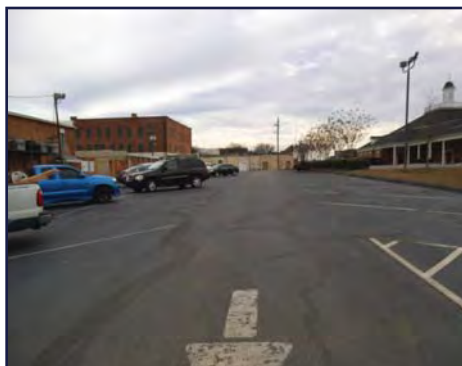
Parking lot behind first united Methodist church  
Between church and cemetery  
About 75 spots  
About 50 feet by 100 feet

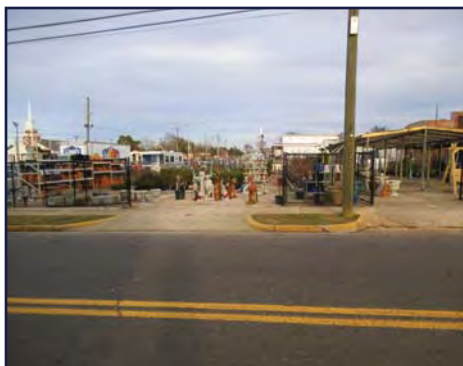
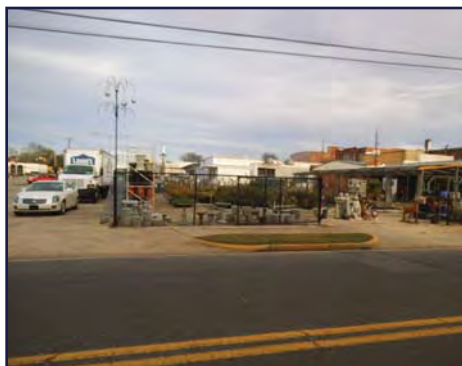
Attached to lot 274, 275, & 276  
Plant display  
Approximately 10x800 feet  
Setback: 10 feet

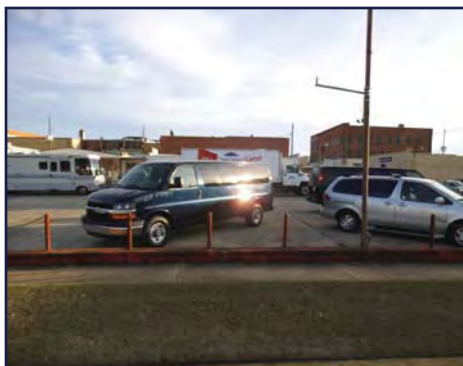
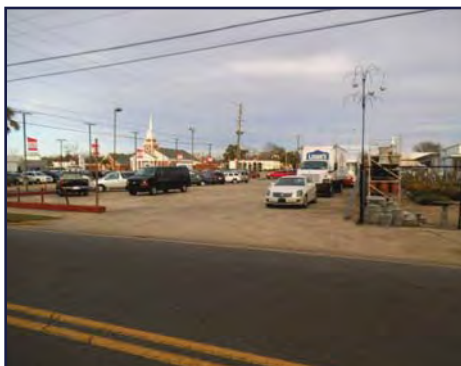
Parking lot  
Approximately 300x300 feet with 15 spaces  
Setback: 15 feet

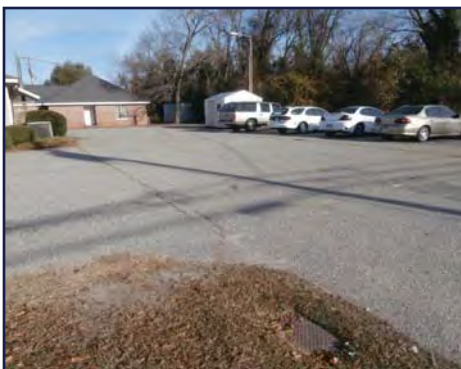
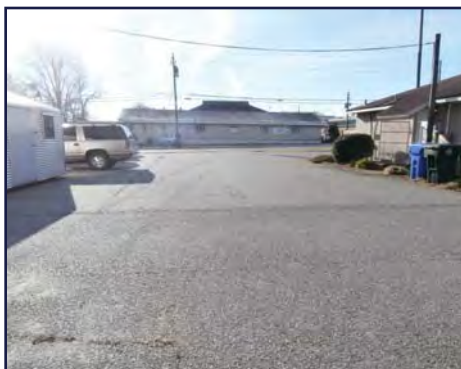
Parking lot with set back of 10 feet  
Surrounding set back about 10 feet  
50 feet by 50 feet lot  
Parking spaces on east side  
Aluminum shed in lot  
15 parking spaces

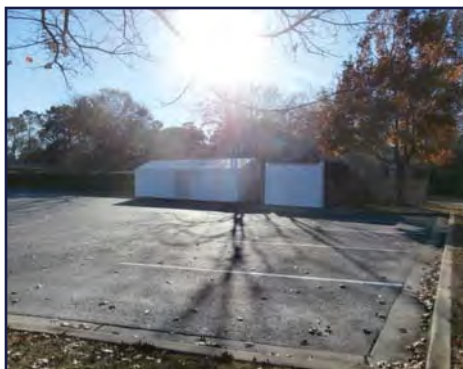
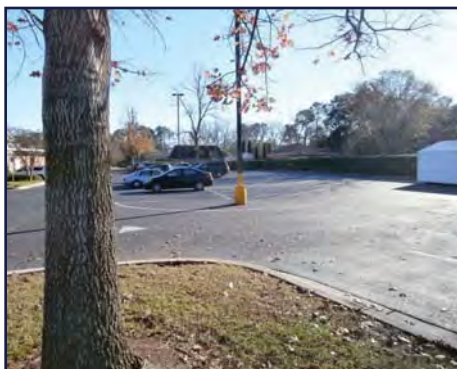
Parking lot for public library  
Metal storage shed  
approximately 20 parking spots  
Set back about 20 feet

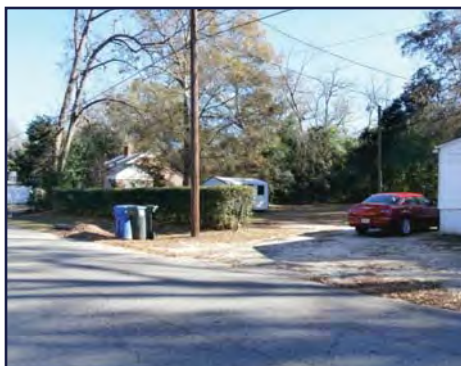
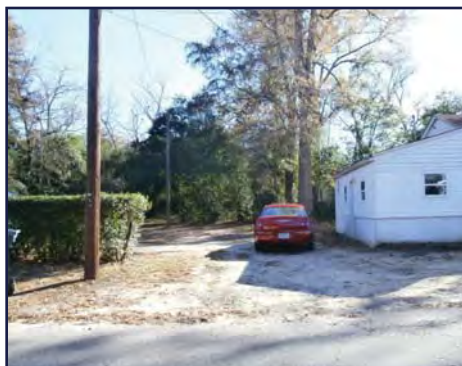
North edge has hedgerow  
Storage shed is gabled  
Large trees  
Utility poll with lamp located in yard as well  
Set back: 0 feet  
Used as a yard for the house next door
