# Historic Resources Survey Report

City of Johns Creek, Georgia  
September 2012

The University of Georgia  
College of Environment + Design  
Center for Community Design & Preservation  
Historic Resources Survey Report  
City of Johns Creek, Georgia

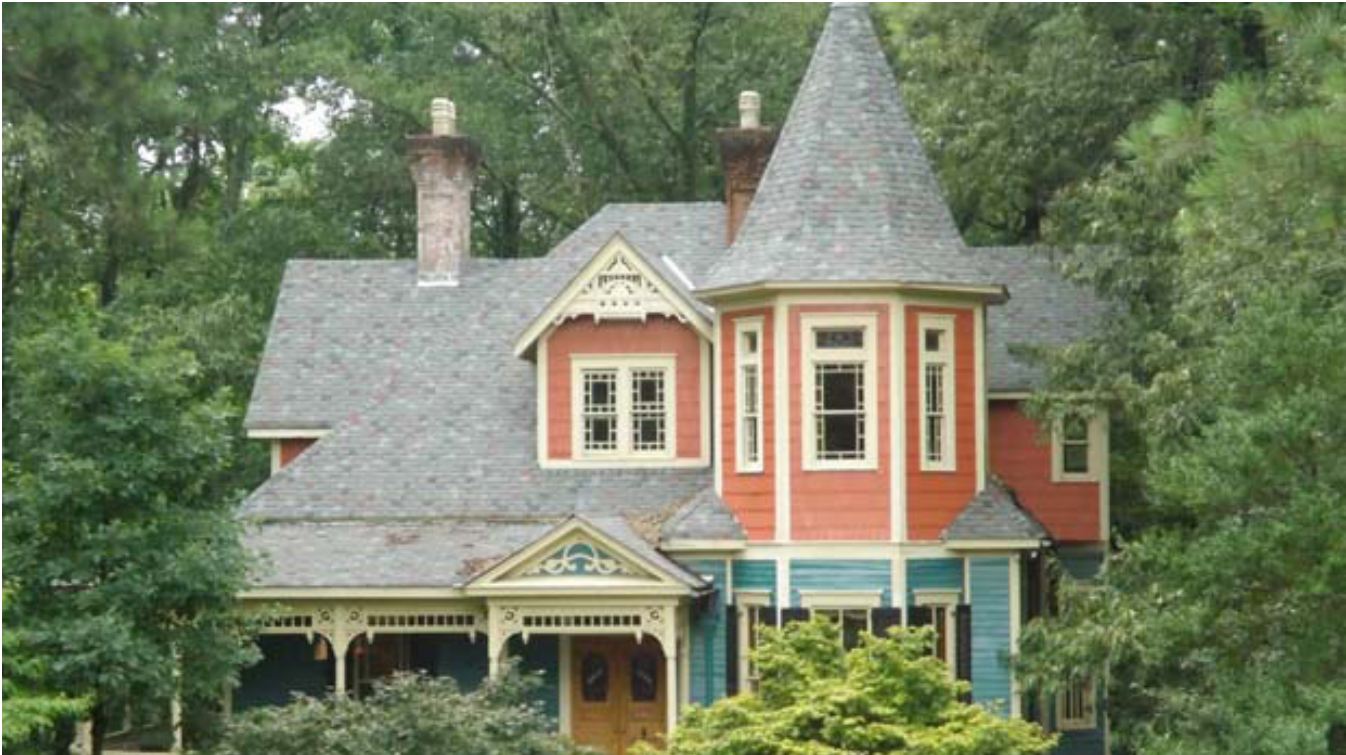
Figure 4. Example of Contemporary Structure with Historic Detailing

Rapid development at the end of the 20th century greatly altered the historic landscape of the Johns Creek area. Current developments are primarily single family homes located within subdivisions, or mixed use communities. A number of contemporary structures were noted within city limits that contain qualities of historic architectural detailing. However, the extant rural Ranch Houses, Queen Anne cottages and Craftsman Bungalows better exemplify the history and rural context of Johns Creek.

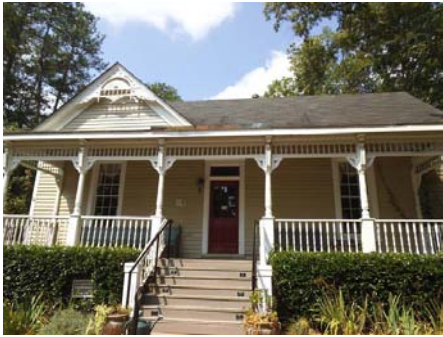
### Autrey Mill Nature Preserve and Heritage Center

Resource FU-CoJC-01, the Summerour Farmhouse, is located at 10281 Autrey Mill Rd and is part of the Autrey Mill Nature Preserve and Heritage Center. It was identified in the 1996 GA Historic Resources Survey.

Built circa 1882, the one-story Georgian cottage is currently used as an educational facility. The asymmetric front façade has a full-width verandah with Folk Victorian detailing, and the entry door has a full-width lit transom. The entire exterior is clad with weatherboard siding, and the cottage retains its historic 9/9 double hung sash windows. The well-maintained yard plantings obscure the foundation, and no chimney was observed. This structure has multiple rear shed additions that do not adversely affect the historically preserved front façade.

Resource FU-CoJC-01 was evaluated under Criterion C for architecture and design and is recommended **not eligible** for the listing in the National Register of Historic Places. These resources maintain good integrity in location, but the changes to the historic landscape setting is so altered that they are unable to convey a sense of historic workmanship or feeling and aesthetic of the period of construction.

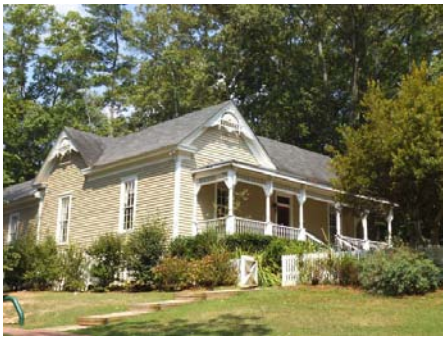
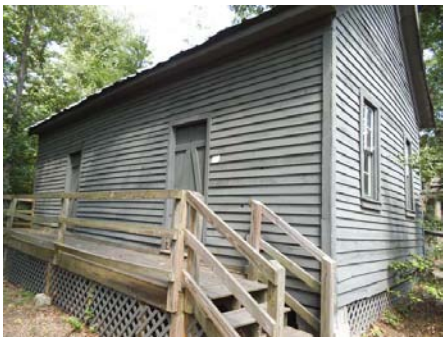
A circa 1880 tenant house outbuilding is located adjacent to the primary structure. The side gabled double pen has a partial verandah porch, 4/4 double hung sash windows, and a standing seam metal roof. The exterior is clad in historic weatherboard which has been painted a pale blue at the time of this survey. The date of construction of the tenant house and the primary residence was taken from information gathered at the Autrey Mill Heritage Center.

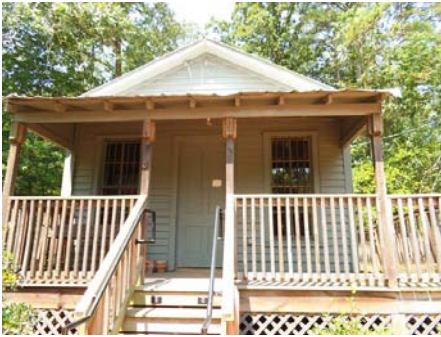
### Green Family Store

Resource FU-CoJC-02, The Green Family Store is located at 10281 Autrey Mill Road, and is a contributing resource to the Autrey Mill Nature Preserve and Heritage Center. This structure was not documented in the 1996 GA Historic Resources Survey.

Resource FU-CoJC-02 was evaluated under Criterion A for commerce and Criterion C for architecture and is recommended **not eligible** for listing in the National Register. This resource lacks integrity in location, setting, and feeling because it has been moved from its original location, and its current setting is not comparable to its historic landscape or use. This resource retains integrity in design and materials. Due to its association with the Autrey Mill Heritage Center and educational practices, this structure is no longer able to convey its association with commerce and is unable to convey the feeling and aesthetic of its period of construction and historic landscape.

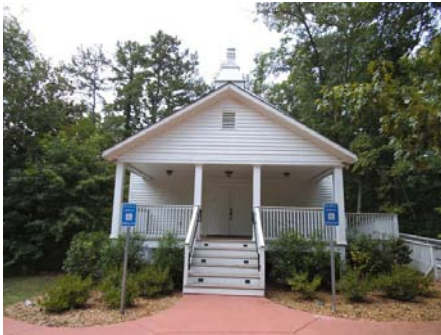
### Warsaw Church

Resource FU-CoJC-03 is located at 10281 Autrey Mill Rd and is a component of the Autrey Mill Nature Preserve and Heritage Center. This structure was not documented in the 1996 GA Historic Resources Survey.

This circa 1860s single-front gable church is clad with weatherboard and rests on a continuous concrete masonry block foundation. The structure has an asphalt shingle roof and unique geometric patterned double hung sash windows, and contains a rectangular vent in the front facing portico gable. No chimney was observed at the time of this survey.

Warsaw Church is **not eligible** for individual listing in the National Register of Historic Places. This structure was evaluated under Criterion C for significance in architecture and design. Information gathered from the Autrey Mill Nature Preserve and Heritage Center indicates the structure was moved from its original site on Medlock Bridge Road to its current location in 2004. The new setting of the church and its current use as an educational facility do not adequately represent its historic nature or historic landscape. The structure retains integrity in materials and design, but lacks integrity in location, setting, workmanship, and feeling. It is not known whether the structure is associated with an important person or event.

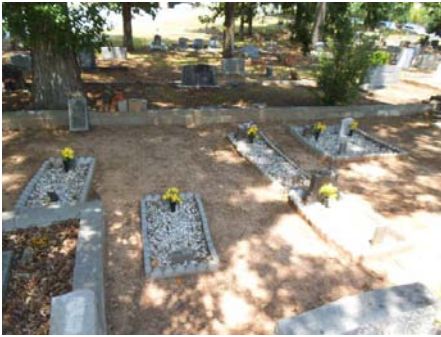
## Pleasant Hill Baptist Church Cemetery

**Resource FU-CoJC-04 The Pleasant Hill Baptist Church Cemetery is located at 3605 Jones Bridge Way, along the heavily trafficked intersection of Jones Bridge Way and Old Alabama Road. This resource was documented in the 1996 GA Historic Resources Survey.**

The Pleasant Hill Baptist Church Cemetery contains approximately 200 burial sites. The oldest observed marker dates to 1873; however, many uncarved natural stone markers exist which indicate a burial date of the early to mid-19th century. The site also includes a number of hand etches stone markers. Unique funerary markings were documented indicating World War Two veterans, Woodsman of the World, Free Masons, Order of the Eastern Star, and International Order of Odd Fellows. The site contains family plots which are outlined with varying material such as poured concrete, brick, or seamed granite. Approximately twelve graves of children are dated to the late 19th century and are located in a grouping. The site has well-maintained turf and mature trees. Common surnames include: Boise, Gibson, Thomason, Jones, and Young.

FU-CoJC-04 was evaluated under Criterion C for design and Criterion D for information potential and is recommended **not eligible** for listing in the National Register. This resource maintains integrity in location and setting, but is an active site and has compromised integrity in design, materials, workmanship, and feeling. A cemetery cannot be eligible for design values if it no longer conveys its historic appearance because of the introduction of new grave markers. It is unknown if this resource is associated with an important person or event. This resource cannot be related to a particular time period or cultural group and therefore lacks a historic context to be nominated under Criterion D.

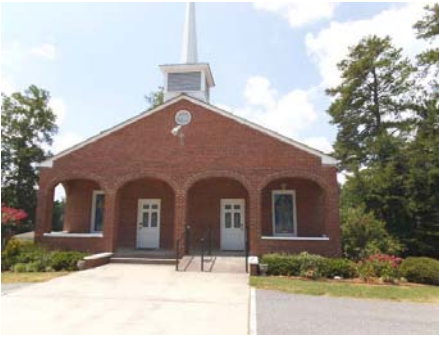
### Pleasant Hill Baptist Church

Resource FU-CoJC-05, the Pleasant Hill Baptist Church, is located at 3605 Jones Bridge Way. This resource was surveyed in the 1996 GA Historic Resources Survey.

This 1954 symmetric front gable church has two four-pane lit entry doors recessed from a full width one-and-a-half story verandah with arched entries. The two fixed stained glass windows flank both entry doors on the front façade. The square steeple has horizontally orientated vents above a pronounced circular vent in the front facing building gable. A brick chimney is located along the ridgeline of the asphalt shingled roof, and the entire structure rests on a continuous foundation of concrete masonry units. The structure has one rear shed addition.

Resource FU-CoJC-05 is recommended **not eligible** for listing in the National Register. Resource FU-CoJC-05 was evaluated under Criterion C for significance in the areas of architecture and design. The church building corresponds to a type identified as important to Georgia's architectural history; however, alterations to the structure negatively impact its integrity of design, materials, workmanship, and feeling. The building is unable to convey the aesthetics or feeling of its period of significance or a sense of historic workmanship given the exterior alterations. The structure retains good integrity in location and setting, and is not known to be associated with any important person or event.

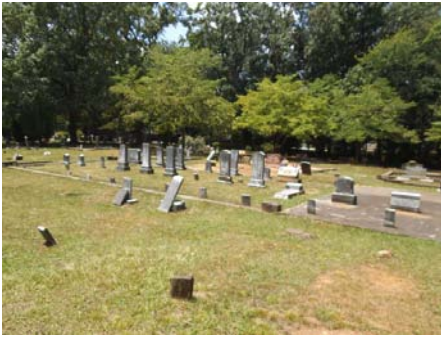
### Mt. Pisgah Church Cemetery

Resource FU-CoJC-06, the Mt. Pisgah Church Cemetery, is located 9820 Nesbit Ferry Road, south of the intersection with Old Alabama Road. This site was surveyed in the 1996 GA Historic Resources Survey.

The oldest observed marker in this picturesque cemetery dates to 1870. There are approximately 300 burials burial sites with twenty or more unmarked gravesites. The design is mostly scattered markers with few outlined family plots, and several contemporary markers. Several fraternal associations are presented through funerary marking including Freemasons, International Order of Odd Fellows, Woodman of the World, and Society of the Eastern Star. Several veterans of World War I and World War II are also present. The landscape includes old white oaks and red oaks as well as several plantings indicative of cemeteries: Crape Myrtles, Nandinas, Camillias, Boxwoods, and Cedars. Noted common family surnames were: Scott, Morris, Nesbits, Eison, Benson, and Thomason.

Resource FU-CoJC-06 was evaluated under Criterion C for design and landscape architecture and Criterion D for information potential and is recommended **not eligible** for listing. This resource maintains its historic location and setting. The site lacks integrity in design, materials, workmanship and feeling because of the incorporation of new grave markers. This resource cannot be related to a particular time period or cultural group and therefore lacks a historic context to be nominated under Criterion D. The site is unable to convey its historic aesthetics and is not known to be associated with any significant person or event.

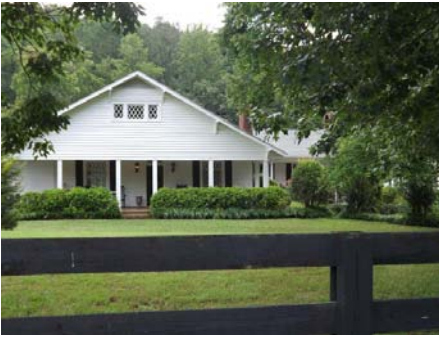
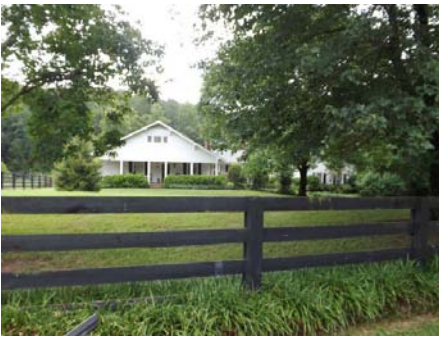
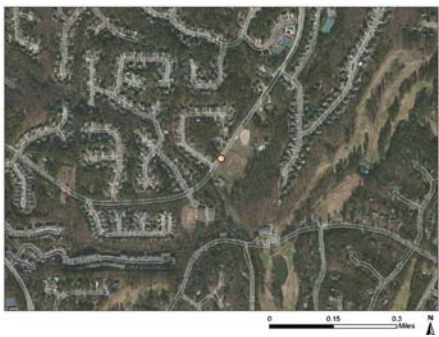
### Intersection of Brumbelow Road and Crossing Way

**FU-CoJC-07 is located at the intersection of Brumbelow Road and Brumbelow Crossing Way. This resource was documented in the 1996 GA Historic Resources Survey.**

Resource FU-CoJC-07 is a circa 1924 Front Gable Bungalow in the Craftsman style. The structure was built as a single family residence, which is its current primary use. The symmetric façade supports wide overhanging eaves with knee braces, and contains a tripartite diamond patterned fixed window. A single brick chimney is located off-center within the asphalt shingled roof. Two large single-hung sash windows have a diamond pattern in the upper sash, which mirrors the transom above the entry door. The entire weatherboard clad façade is recessed from square post porch supports which create a full width verandah. The structure has a far set back from Brumbelow Road, and is located on a partially wooded lot.

Resource FU-CoJC-07 is recommended **eligible** for listing in the National Register under Criterion C for its significance in architecture. Resource-FU-COJC-07 represents a type identified in *Georgia's Living Places* as significant to Georgia's architectural history, and the house retains the integrity to convey this significance. FU-CoJC-07 has been determined to retain its historic location, design, setting, materials, workmanship and feeling. The house has not been altered; the building contains its historic materials and remains in its original location. The house is able to convey a sense of historic workmanship and aesthetics because of its unaltered state. There are no known associations between this resource and any important person or event. The non-historic secondary dwelling and pump house located on the site should not be considered for nomination.

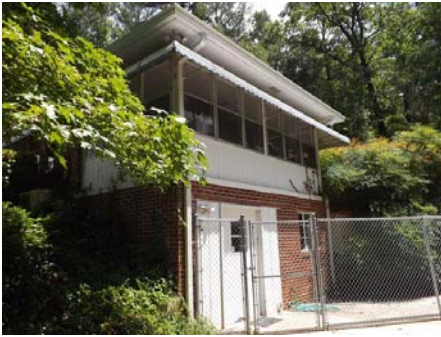
### 10155 Haynes Bridge Road

Resource FU-CoJC-08 is located at 10155 Haynes Bridge Road and currently serves as the Lafferty Animal Clinic. This structure was not included in the 1996 GA Historic Resources Survey.

This circa 1953 linear Ranch house was constructed as a single family dwelling and was converted into a veterinary office in the late 1990s. The asymmetric façade is encased in brick veneer and is beneath an asphalt shingle roof with a large off-center brick chimney. The 2/2 paired double hung sash windows have horizontal muntins, and are located on the front façade by the central Chicago window. All windows on the front façade have typical mid-century aluminum awnings. A continuous concrete masonry unit foundation supports the structure which is integrated into the sloping topography. This resource retains its original mid-century three horizontally orientated lit entry door. A full width verandah is located on the right façade and is enclosed by glass; the current occupant indicated it was altered in the 1960s.

Resource FU-CoJC-08 was evaluated under Criterion C for significance in architecture, but is recommended **not eligible** for listing in the National Register. Although identified as a type significant to Georgia's architectural history, this Ranch house is unable to convey its historic significance due to non-historic alterations. The structure maintains integrity in location and setting, but lacks integrity in design, materials, workmanship, and feeling. The current occupant claims that the alterations to the verandah on the right façade occurred in the 1960s; these alterations may gain historic significance in time and contribute to the overall integrity of the resource. FU-CoJC-08 is not known to be associated with any important person or event.

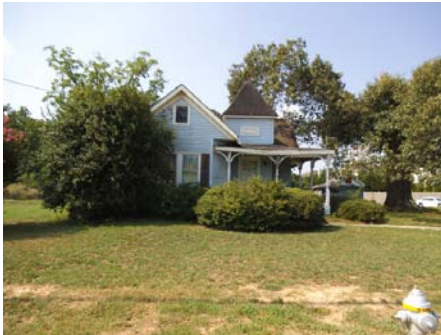
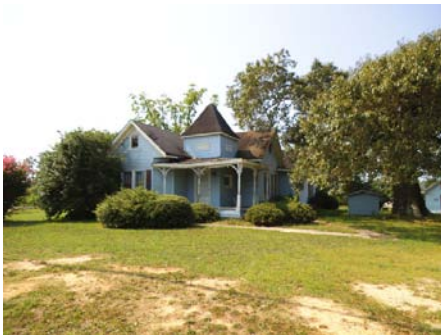
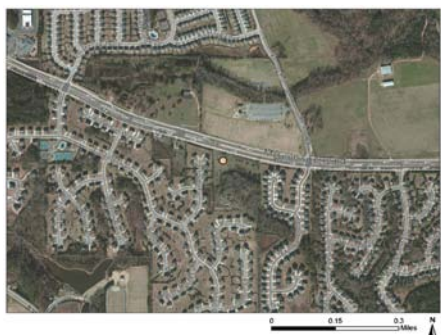
### 8139 McGinnis Ferry Rd

**Resource FU-CoJC-09 is located at 8139 McGinnis Ferry Rd. This resource was not identified in the 1996 GA Historic Resources Manual.**

This circa 1907 single family dwelling is an asymmetrical Queen Anne Cottage with a pronounced central turret containing a horizontally orientated rectangular vent. The complex asphalt shingle roof has a central hip with protruding gable sections in all directions. An exterior single brick chimney is located on a rear gable end. Folk Victorian detailing is evident on the partial width front verandah supported by turned post porch supports with ornately carved brackets. The single pane lit entry door is located beneath the main turret, adjacent to paired 6/6 double hung sash windows. The primary façade has a single fixed window in the front facing gable. Located on the site are two historic outbuildings; one well house, and one storage shed, both potentially built in the 1930s.

Resource FU-CoJC-09 was evaluated under Criterion C for significance in architecture and is recommended **eligible** for listing in the National Register. This resource has been identified as a type significant to Georgia's architectural history and retains the integrity to convey this significance. Resource FU-CoJC-09 has been determined to retain its integrity in location, design, setting, materials, workmanship, and feeling. The house and outbuildings remain in their original locations, and the setting of the site has not been altered. The house retains its historic design and materials and is able to convey a sense of historic workmanship through its architectural detailing which possess the feeling and aesthetic of its period of significance. There is no known association between this resource and any important person or event. Extant outbuildings appear historic and should be considered along with the primary structure in any potential listing.

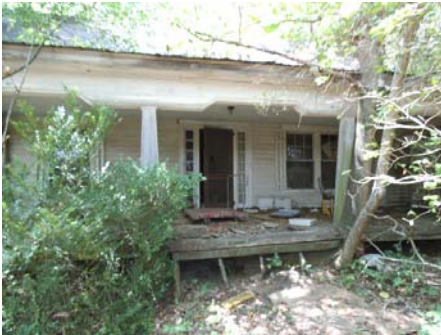
### Adjacent to 7781 McGinnis Ferry Road

Resource FU-CoJC-10 is located adjacent to 7781 McGinnis Ferry Road. This resource was documented in the 1996 GA Historic Resources Survey.

This circa 1880 Georgian Cottage was originally built as a single family home but is currently vacant. The façade is clad with historic weatherboard and supports paired 6/6 double hung sash windows. The entry door is flanked by seven pane sidelights on a full width single-story verandah, which rests on a stone pier foundation. The side-gabled roof is comprised of standing seam metal, and supports multiple stuccoed masonry chimneys. The structure has undergone a number of historic alterations, many in the 1930s including: Craftsman style battered column porch supports, and multiple rear additions.

Resource FU-CoJC-10 was evaluated under Criterion C for significance in architecture and is recommended **eligible** for listing in the National Register. This structure remains in its original location and has been identified as a type significant to Georgia's architectural history. FU-CoJC-10 retains integrity in setting, and although it is in poor physical condition, it maintains integrity in feeling, design, and materials. The additions to the rear of the structure contribute to the overall design integrity and architectural evolution of the resource. It is unknown whether this resource is associated with an important person or event.

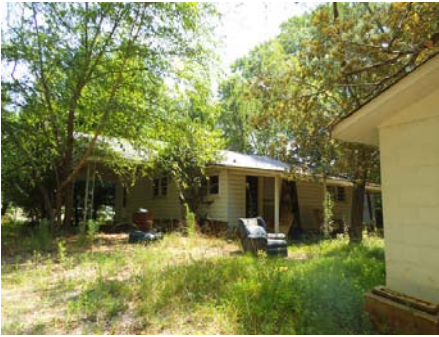
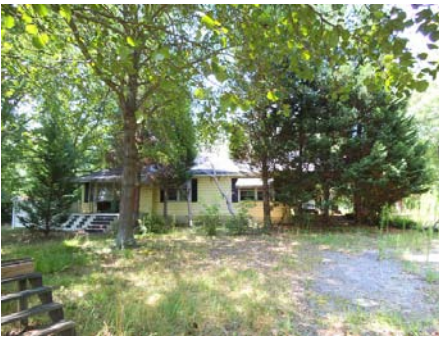
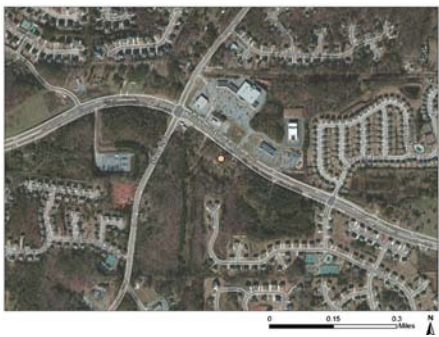
### 7785 McGinnis Ferry Road

This circa 1955 structure is an asymmetric linear Ranch house with no academic style. A partial width veranda is located on the left portion of the front façade and is supported by decorative metal supports. The façade has paired 2/2 double hung sash windows with horizontal muntins, covered by mid-century aluminum awnings. A mid-century two pane lit entry door is located atop polychromatic concrete stairs which contribute to the overall continuous concrete foundation. The roof is hipped with asphalt shingles, and contains no chimney. Vinyl siding with shiplap detailing serves as the exterior material.

Resource FU-CoJC-11 was evaluated under Criterion C for significance in architecture and is recommended **not eligible** for listing in the National Register. This resource retains its original historic location, and the setting remains partially wooded. FU-CoJC-11 lacks integrity in design, materials, workmanship, feeling, or association. The design and materials of the house have been altered by the application of vinyl siding. The design and material change prevent this resource from conveying a sense of historic workmanship, and lacks the feeling and aesthetics of the period of construction. There are no known associations between this resource and any important person or event.

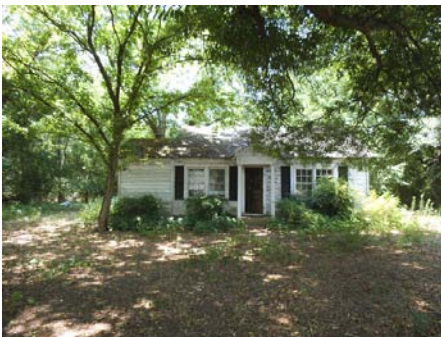
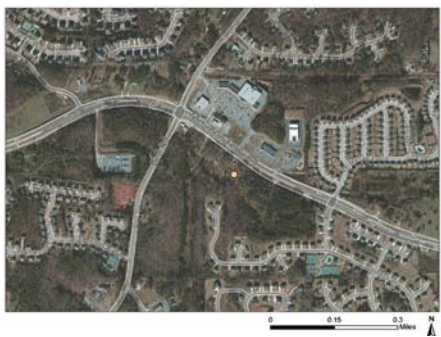
This American Small House, constructed circa 1945, is a single family residential dwelling that is currently vacant. The asphalt shingle, side gable roof is flanked by metal chimneys. Elements of Craftsman style are apparent in the exposed rafter tails in the roof eaves. The front portico spans the width of the door, has wood box column supports, concrete stoop, and front gable roof. The windows are predominantly flat headed, rectangular, double hung sash with a 6/6 pattern. There is a single fixed pane hexagonal window on the rear of the house. The house appears to have two non-historic additions: one located on the rear, and one on the right facade. An historic well house and shed are present near the rear addition of the house. The landscape setting is characterized as informal/picturesque with large mature trees, ornamental shrubs, designed drives and a large hibiscus tree.

Resource FU-CoJC-12 was evaluated under Criterion C for significance in architecture and is recommended **not eligible** for listing on the National Register. The resource retains integrity in location and setting; however, multiple non-historic alterations affect its integrity of materials and design. The prominent addition to the right façade prevents this resource from conveying a sense of historic workmanship and lacks the feeling or aesthetic of the period of construction. There is no known association between this resource and any important person or event.

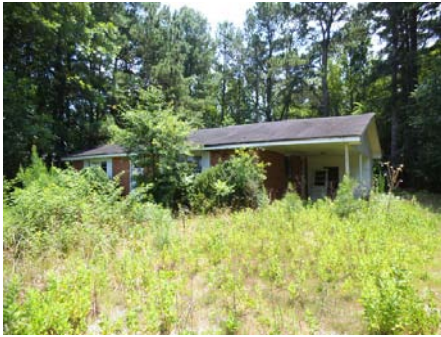
### McGinnis Ferry Road at the corner of Blackstone Way

This circa 1965 Ranch house is a single family residential dwelling that is currently vacant. The building has an asphalt shingle, side gable roof, with no apparent chimney. The exterior cladding is brick veneer in a running bond which sits atop a concrete foundation. The windows are flat-headed double hung sash, with a 2/2 pattern. There is a soldier course of bricks under the overhanging roof eaves, and decorative ironwork over all windows. The Ranch House has single entry stoop and an integrated carport. The original mid-century inset fanlight door is extant. The yardscape is casual, and there are pine and sweet gum trees present. The surrounding area is characterized as a mixed use suburban area.

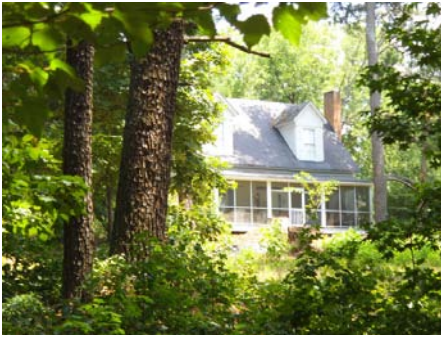
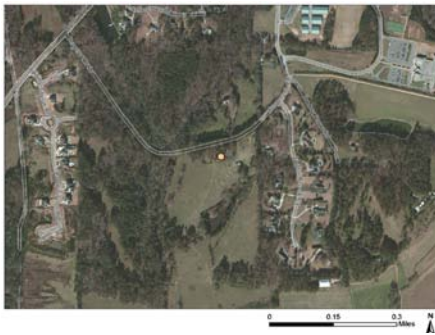
### 10660 Rogers Circle Road

FU-CoJC-14 is a circa 1840 Central Hallway Cottage with a symmetrical façade. The structure has a side gable roof comprised of asphalt shingle. There are two lit front gable dormers, and two gable end brick chimneys. The windows are flat, double-hung sash with a 6/6 pattern. A full width front verandah has been enclosed with screens, and covers the Greek Revival entry door with transom and sidelights. Two historic outbuildings are located on the property; a livestock barn, and an implement shed. The landscape setting is picturesque and contains agriculture fields where designed fences delineate several field systems. The house was part of the former crossroads community of Shakerag, and now exists in a suburban, residential area of Johns Creek.

Resource FU-CoJC-14 was evaluated under Criterion A for association with agriculture and Criterion C for significance in architecture and design and is recommended **eligible** for listing in the National Register. This resource is noted as a type significant to Georgia's architectural history. The house maintains its original location and setting, within active agricultural field systems. FU-CoJC-14 has minimal changes in materials; those which have been altered, such as the screened verandah, can be reversed. This resource accurately depicts the historic workmanship and feeling of the period of construction. This structure is known to have an association with William Rogers, one of the twenty signers of the Treaty of New Echota in 1835.

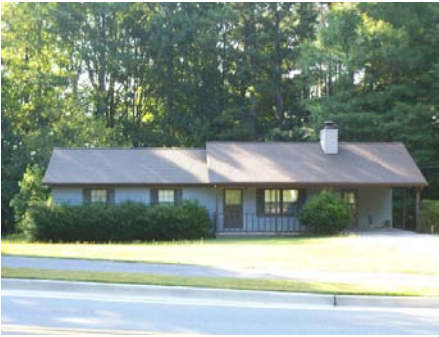
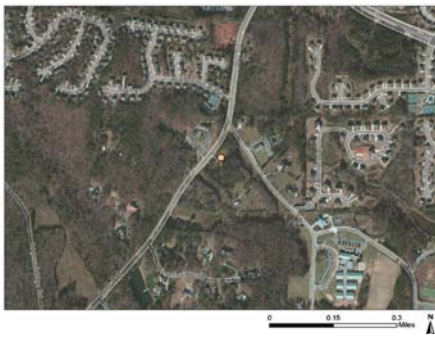
### 10985 Bell Road

This mid-1960s Ranch House is an asymmetrical structure with a stepped side gable roof. The roof material is comprised of asphalt shingle and a non-fire chimney is located off-center on the ridgeline. A one-story verandah is located on the front façade; it is a partial width porch comprised of wood and concrete. The flat-headed windows are double hung with a 6/6 pattern and are rectangular. The landscape is characterized as casual with a designed drive. The house is located in a mixed use suburban area.

FU-CoJC-15 was evaluated under Criterion C for significance in architecture and is recommended **eligible** for listing in the National Register., if the minimum age requirement is met. The structure maintains its original location and setting, and retains good integrity of original materials and design. The retention of mid-century features accurately depicts the feeling of the period of construction and showcases the historic workmanship of the era. The exact date of construction of this resource is unknown; when it has surpassed 50 years in age it can be considered eligible for nomination.

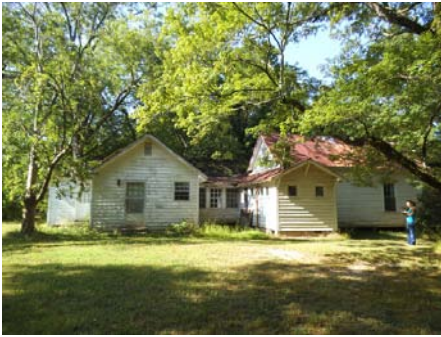
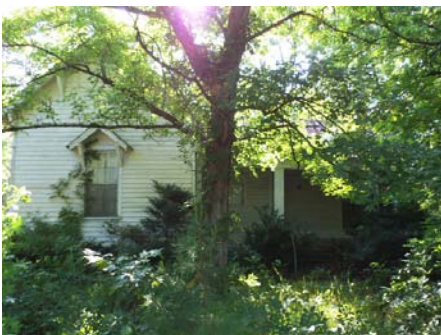
### 10935 Bell Road

FU-CoJC-16 is circa 1850s single family residence which is currently vacant. The Gabled Ell Cottage incorporates stylistic elements from both Colonial Revival and Craftsman styles. The façade of the house is asymmetrical and the multi-gable roof is comprised of a combination of asphalt shingle, standing seam metal and corrugated sheet metal. The foundation is multi-material, primarily stone and concrete piers. A number of additions have occurred on the rear of the structure; however, dates for these alterations are not available. A verandah is located on the front façade spanning half width and has a shed roof. There are several historic outbuildings on the property: including a barn and a well house and an implement shed. The landscape setting is classified as informal, with many mature trees: black walnut, apple, pear, post oak, hemlock, Southern sugar maple, and beech. Also on the property are boxwoods, variegated canicum and wisteria.

Resource FU-CoJC-16 was evaluated under Criterion C for significance in architecture and is recommended **eligible** for listing in the National register. This house type and corresponding architectural styles are identified as significant to Georgia's architectural history. The resource maintains its original location; however, the overgrowth of the site adversely affects the integrity of setting. Rear additions do not diminish the integrity of design or materials, as they appear over 50 years of age and contribute to the architectural evolution of the resource. There is no known association between Resource FU-CoJC-16 and any significant event or person.

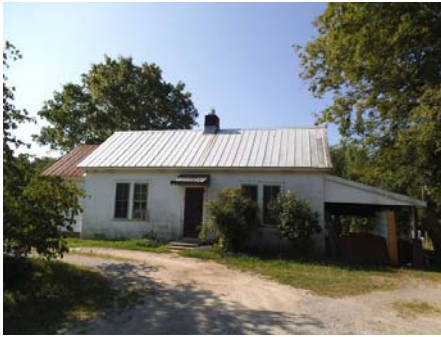
### 10960 Rogers Circle

This one-story circa 1915 Saddle Bag Cottage has an asymmetrical façade which includes a mid-century integrated one vehicle carport. Paired, flat-headed double-hung sash windows with a 4/4 pattern are located on the front façade. The side gable roof is comprised of standing seam metal and has a brick chimney along the center ridgeline of the roof. The front stoop is comprised of concrete and has a small attached hood roof. The exterior material of the structure is a combination of original weatherboard and replacement vinyl siding. The structure has multiple rear additions, but the dates of construction are undetermined. The landscape setting is informal and includes agricultural fields and natural woods. The house is located in a heavily developed, suburban area of Johns Creek.

Resource FU-CoJC-17 was evaluated under Criterion C for architecture and is recommended **not eligible** for listing in the National Register. This resource maintains its historic location and has fair integrity in setting. Multiple alterations in exterior materials and additions adversely affect the resources integrity of design and materials; a large integrated carport changes the overall footprint of the structure, and vinyl siding is not an appropriate historic material. FU-CoJC-17 is unable to convey a sense of historic workmanship and does not express the feeling of the era of construction. It is unknown if this resource has any association with any important person or event.

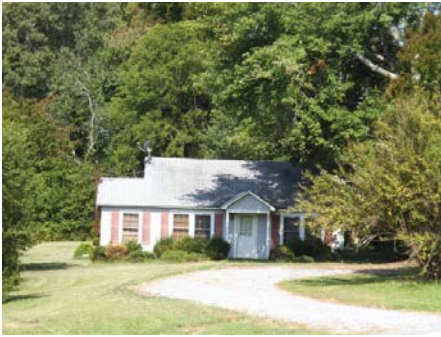
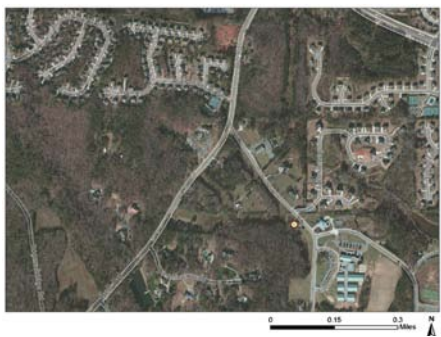
### 10950 Rogers Circle

This circa 1948 American Small House is a single family dwelling with an asymmetrical façade and asphalt shingle side gable roof. The portico on the façade is partial width, spanning the width of the front entry door and a pronounced gable. The exterior material is vinyl siding and no chimney was observed. The windows are flat, double hung sash with a 6/6 pattern, and one set of paired windows is located adjacent to the 9 pane lit entry door. An implement shed was documented and is located behind the house. The landscape setting is informal and contains agricultural fields and forests. The surrounding environment is suburban with both historic and non-historic resources.

Resource FU-CoJC-18 was evaluated under Criterion C for design and significance to architecture and is recommended **not eligible** for listing in the National Register. Although this house type has been identified as significant to Georgia's architectural history, this resource does not retain the integrity to express this significance. The structure retains its historic location and setting, but has poor integrity in design and materials. The inclusion of vinyl siding as the exterior cladding precludes this resource from expressing historic workmanship or the feeling of the period of construction. It is unknown whether this resource is associated with an important person or event.

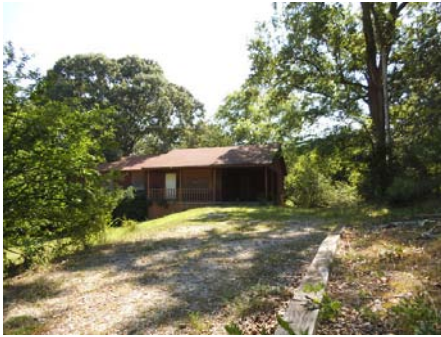
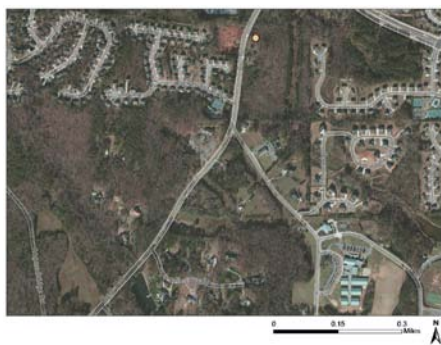
### 11245 Bell Road

This circa 1955 Ranch house is a single family dwelling that is currently vacant. The asymmetrical structure has a side gable asphalt shingle roof and no chimney. The exterior material is weatherboard and the foundation is a combination of concrete block and stucco. All windows on the front façade are obscured by boards. The landscape is characterized as informal with contouring and natural woods present. The surrounding environment is suburban and contains a mixture of old and new structures.

FU-CoJC-19 was evaluated under Criterion C for significance in architecture and design and is recommended **eligible** for listing in the National Register. The Ranch House has been identified as significant to Georgia's architectural history, and this resource maintains its original location and setting. FU-COJC 19 exhibits excellent integrity in its design and materials; through these components the resource expresses the feeling and aesthetic of the period of construction and displays historic workmanship. There is no known association between this resource and any important person or event.

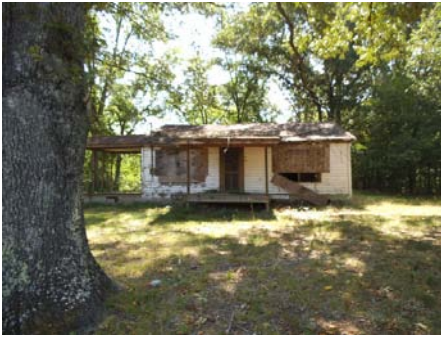
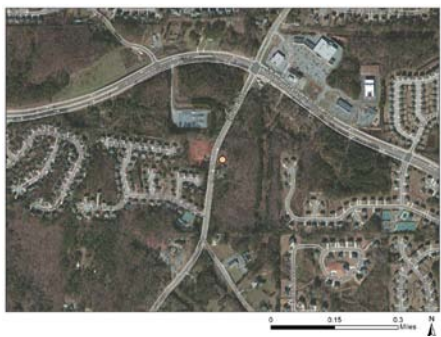
### 11247 Bell Road

Resource FU-CoJC-20 is a single family, Central Hallway dwelling, built circa 1955, which is currently vacant. The asymmetrical structure is side gabled with an asphalt shingle roof, and no visible chimney was observed. The windows of the weatherboard cladded structure are obscured. A large multi-gabled addition extends from the rear and is composed of multiple materials. A single entry door is centrally located within the partial width verandah; a partial width verandah also extends from the left façade. The resource setting has few planted hydrangeas and is sited within a wooded lot. The lot is located in a suburban area comprised of mixed old and new resources.

Resource FU-CoJC-20 was evaluated under criterion C for architecture and is recommended **not eligible** for listing in the National Register. This resource maintains its historic location and setting and is recognized as a type significant to Georgia's architectural history. The large addition to the rear of the structure does not adequately represent the historic design or materials, and does not express the historic workmanship or feeling and aesthetics of the period of construction. There is no known association between FU-CoJC-20 and any important person or event.

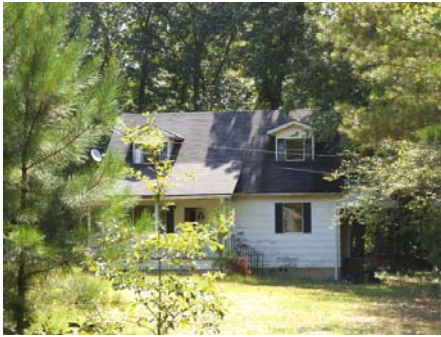
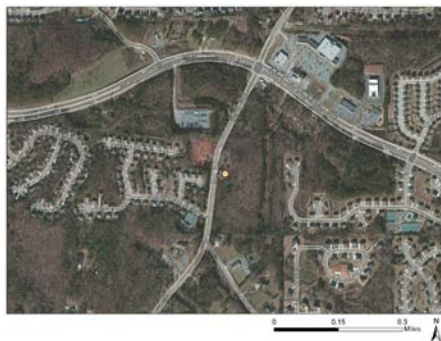
### 11263 Sheltonville Alpha Road

Resource FU-CoJC-21 is a single family, Side Gable Bungalow, constructed circa 1960, that is currently vacant. The asymmetrical structure is clad in asbestos siding and has an asphalt shingle roof with no visible chimney. There are two lit dormers in the upper half story. The partial width front verandah has a shed roof with a Flemish eave, and a side stair with metal balustrades. The single entry door has an inset fanlight. A port-cochere extends from the right façade. The observed windows are 1/1 double hung sash, and a large Chicago window is present. The structure is sited within a wooded lot, surrounded by chain link fencing. The resource is located in a suburban area with mixed old and new resources.

Resource FU-CoJC-21 was evaluated under Criterion C for significance in architecture and design and is recommended **not eligible** for listing in the National Register. The structure maintains its historic location but lacks integrity in setting due to extreme overgrowth of vegetation and surrounding developments. The alteration of exterior cladding to asbestos siding adversely affects the original material and design of the structure. This resource is unable to express the feeling and aesthetics of the period of construction, and does not exhibit historic workmanship. There is no known association between this resource and any important person or event.

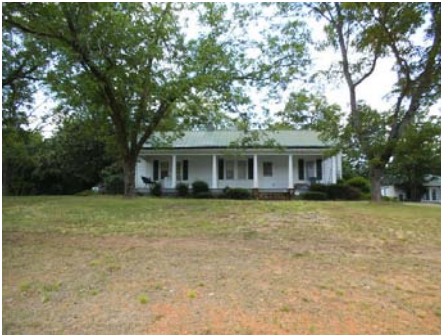
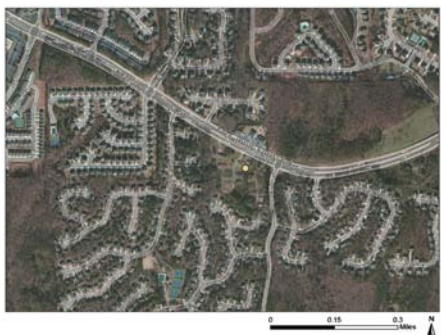
### 7315 McGinnis Ferry Road

Resource FU-CoJC-22 is an asymmetrical, single family Extended Hall-parlor dwelling, built circa 1875. The structure is side gabled with a standing seam metal roof, and has two stuccoed masonry chimneys located on the exterior gable end and off center along the roof's ridgeline. The façade's exterior material has been replaced and is currently clad in vinyl siding. There is a single entry door located under the shed roof of the full width verandah. The porch supports are non-decorative tapered columns. Double hung sash windows with 3/1 and 3/3 patterns are located on the front façade. A large non-historic, rear addition was documented. The structure is sited within a wooded lot, which also contains an implement shed. The lot is located in a suburban area with mixed old and new resources.

Resource FU-CoJC 22 was evaluated under Criterion C for significance in architecture and is recommended **not eligible** for listing in the National Register. This structure has undergone replacements in exterior materials, large rear additions, and is unable to convey the historic workmanship or design of the period of construction. Although this type is significant to Georgia's architectural history, FU-CoJC-22 does not adequately embody the historic feeling. There is no known association between this resource and any important person or event.

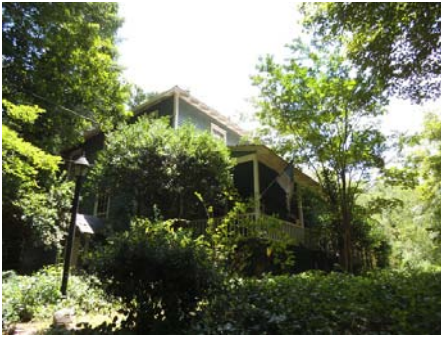
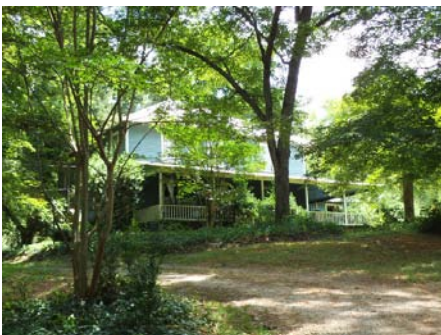
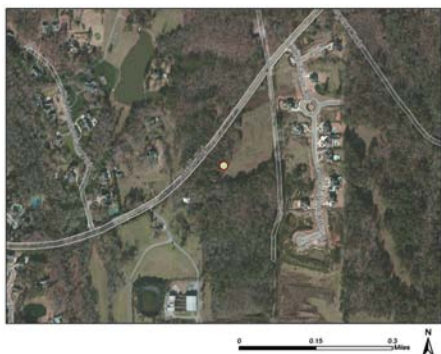
### 7355 Bell Road

The two-story Georgian House circa 1804 is a single family dwelling with a symmetrical façade and multiple roof types including: rear gable, hip, and pyramid. The entire roof is comprised of corrugated sheet metal and a brick chimney was documented off-center within the roof surface. The exterior material is wood weatherboard, and the foundation is comprised of continuous brick. Verandahs are located on the front and side facades of the house; both are one-story, full width, made of wood, and have shed roofs. The windows documented are flat-headed double hung sash with a 6/6 pattern. The house has some Craftsman stylistic elements such as exposed rafter tails along the overhanging roof and porch eaves. There is a large 1.5-story gable rear addition as well as an implement shed documented on the property. The landscape setting is picturesque and includes some agricultural fields and natural woods. The majority of the house is largely obscured due to the vegetation.

Resource FU-CoJC-24 is recommended **not eligible** for listing in the National Register. Resource FU-CoJC-24 was evaluated under Criterion C for significance in architecture, and although identified as a house type significance to Georgia's architectural history, this resource lacks the integrity to convey this significance. The house remains at its historic construction site, but the building lacks integrity in its setting and historic landscape features. Resource FU-CoJC-24 lacks integrity of design, materials, workmanship, feeling, or association. The large, 1.5 story addition to the property prevents this resource from conveying a sense of historic workmanship, and the structure lacks the feeling and aesthetics of the period of construction. Although the ownership history of this house is known, it is not known to be associated with any significant person or event.

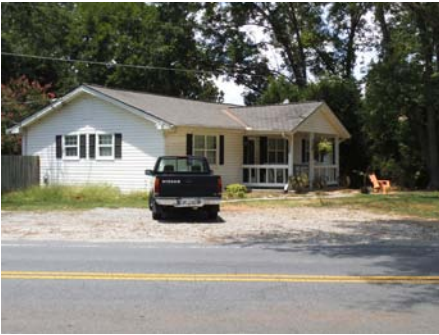
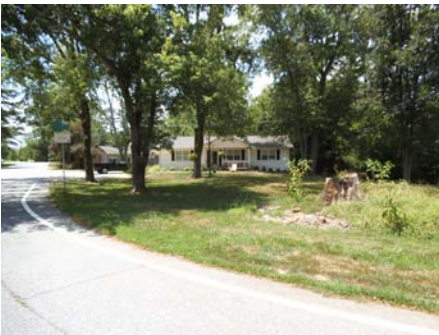
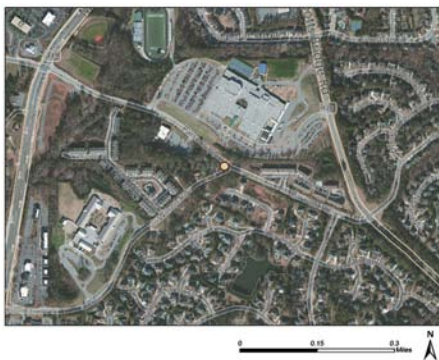
### 10500 Wilson Road

This 1960s era Ranch House has an asymmetrical façade and cross gable roof comprised of asphalt shingles. No chimney was observed and a one-story partial width front portico supported by wood piers was documented. Flat headed double hung sash windows are located on the front and side facades; a set of paired double hung sash windows are located on the front façade. The exterior cladding is non-historic replacement vinyl siding. The landscape setting is informal and includes designed fences; an implement shed was documented on the property. This structure is located in a suburban area of Johns Creek with the surrounded by resources by both historic and non-historic resources.

Resource FU-CoJC-25 is recommended **not eligible** for listing in the National Register. This resource was evaluated under Criterion C for significance in architecture, but lacks the integrity necessary to convey this significance. The building remains at its historic site and retains integrity in its residential setting. This resource lacks integrity of design materials and feeling due to the replacement of the historic brick exterior with vinyl synthetics. Brick or natural stone exteriors have been identified as an integral component to the integrity of the mid-century Ranch House. The changes to the exterior preclude Resource FU-CoJC-25 from displaying the aesthetics or workmanship of the era of construction. There are no known associations between this resource and any important event or person.

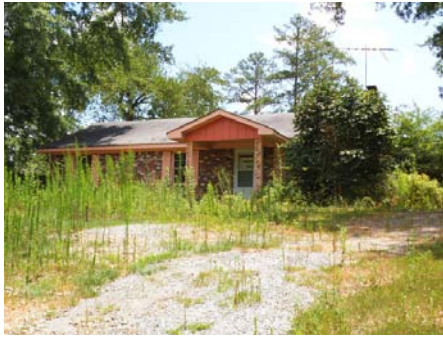
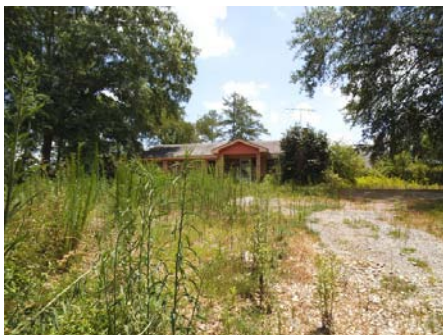
### 6265 Wilson Road

Resource FU-CoJC-26 is recommended **eligible** for listing in the National Register. This resource was evaluated under Criterion C for significance in architecture and design and retains the integrity to express this significance. The structure remains on its historic construction site and has minimal alterations to its historic landscape setting. Key materials of the Ranch House type remains extant including the polychromatic brick, horizontally oriented windows, and original entry door, which allow the structure to represent this historic workmanship and feeling and aesthetic of the period of significance. There is no known association between Resource FU-CoJC-26 and any person or event.

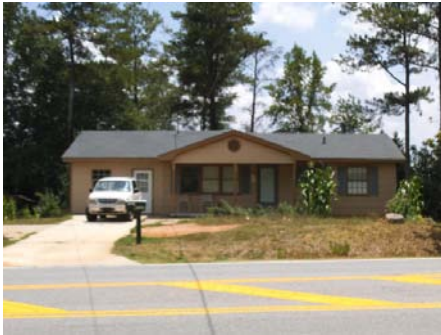
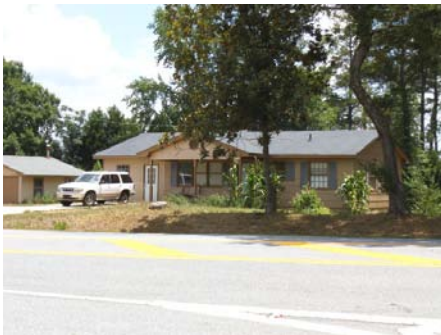
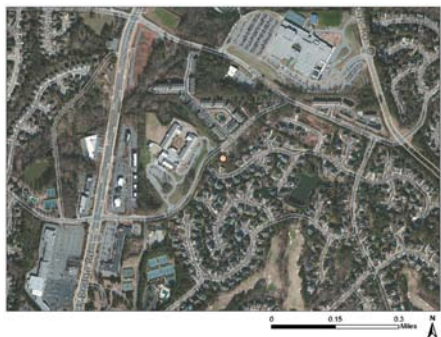
### 6215 Wilson Road

This asymmetrical Ranch house was built circa 1958 and has a cross gable roof composed of asphalt shingles and does not contain a chimney. Vertical board, novelty siding, and Masonite siding make up the exterior materials on the structure, and a wood portico with a front gable roof is situated on the front façade. The portico has spindlework porch supports. An original carport on the left side of the house has been enclosed. A tripartite window is located on the front façade; the remainder of the windows are flat headed double hung sash with 4/4, 1/1, 8/8, 6/6 patterns. A garage and implement shed were documented behind the structure. A casual landscape setting surrounds the Ranch House which is located in a suburban area of Johns Creek. The surrounding resources are historic and non-historic.

Resource FU-CoJC-27 is recommended **not eligible** for listing in the National Register and was evaluated under Criterion C for significance in architecture. Although this type has been identified as significant to Georgia's architectural history, the structure lacks the integrity to express this significance. Resource FU-CoJC-27 remains in its historic location and has undergone few changes to its historic landscape setting. This resource has had multiple material changes, including two which are integral to the Ranch House type; removal of original exterior materials and enclosure of the original carport. These alterations prevent FU-CoJC-27 from displaying historic workmanship or the feeling or aesthetics of the period of construction. There are no known associations between this resource and any important person or event.

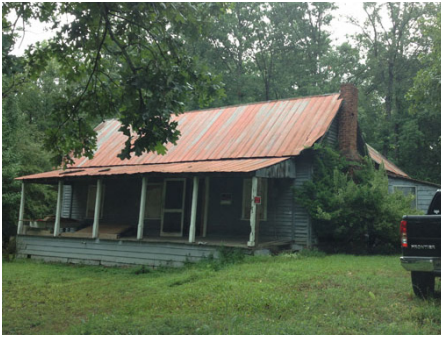
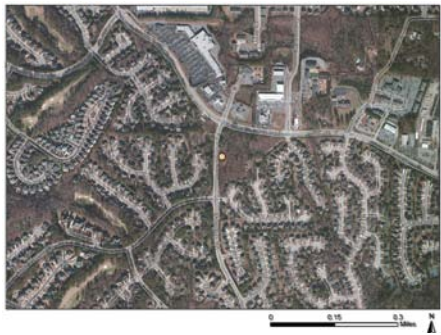
### 12745 Douglas Road

This circa 1880s asymmetrical Hall-parlor has a side gable roof composed of standing seam metal with one gable end, exterior brick chimney. The exterior is clad with weatherboard siding and has a stone pier foundation. A full width verandah is located on the front façade and is comprised of wood with a shed roof. The windows on the structure are boarded and a shed addition exists on the side of the house. The landscape setting is casual and includes natural woods. The house is located in a suburban area of Johns Creek and the majority of the resources surrounding the house are younger than fifty years old.

Resource FU-CoJC-28 was evaluated under Criterion C for significance in architecture and is recommended **not eligible** for listing in the National Register. This resource was identified as significant to Georgia's architectural history but does not retain the integrity to convey this significance. Resource FU-CoJC-28 remains in its historic location and has undergone few changes in its historic landscape setting. This resource lacks integrity in materials and design due to the large shed addition on the side of the structure. This major alteration interrupts this resource's ability to express historic workmanship and the feeling and aesthetics of the period of construction. There is no known association between this resource and any important person or event.

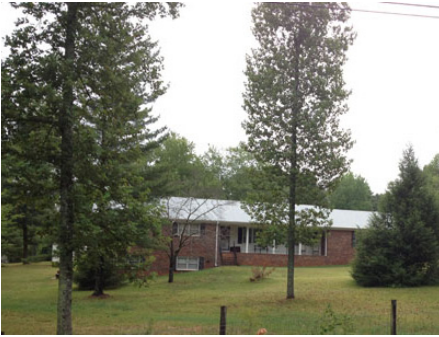
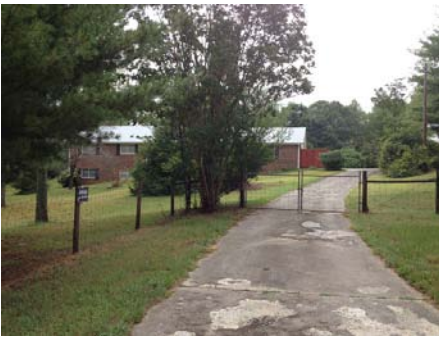
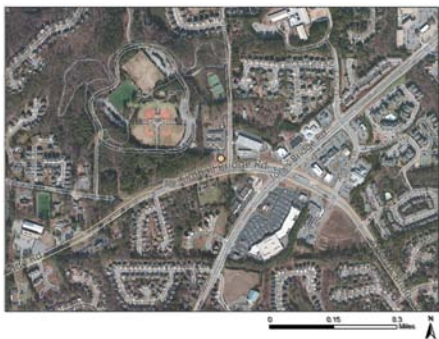
### 11705 Fox Road

This late 1960s, asymmetrical Ranch house has a side gable roof comprised of asphalt shingles with no evident chimney. The exterior materials are common bond brick and vinyl siding and the foundation is composed of concrete with brick veneer. Two Chicago windows are located on the porch, partial width recessed porch; and the remainder of the windows are flat headed double hung sash with a 6/6 pattern. Several outbuildings were documented on the property including a barn, implement shed, and a secondary dwelling. The view of the house is obstructed by large trees and shrubs, and the landscape setting is casual. The house is located in a suburban area of Johns Creek and the majority of surrounding resources are younger than fifty years old.

Resource FU-CoJC-29 is recommended **not eligible** for listing in the National Register. This resource was evaluated under Criterion C in the area of architecture. Although the house type represents a type that has been identified as important to Georgia’s architectural history, Resource FU-CoJC-29 lacks the character defining features to serve as a good or representative example, and has experience alterations to original historic materials. The house remains at its historic construction site, and retains elements of its historic setting. This resource is unable to express the feeling or aesthetic of the period of construction, or historic workmanship through use of synthetic siding. There is no known association between this structure and any important figure or event.

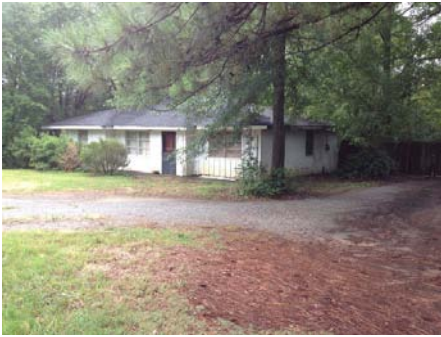
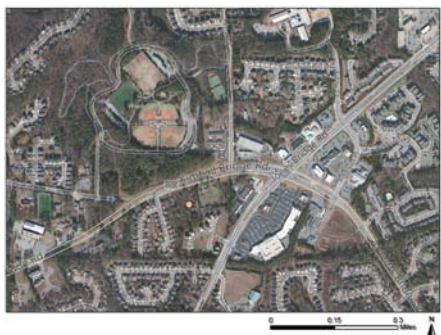
### 4935 Kimball Bridge Road

Resource FU-CoJC-30 is a single family Ranch house circa 1955. The concrete foundation supports an asymmetrical structure of painted brick veneer and vertical board. A single off center replacement entry door rests above a stepless stoop. A single jalousie window is located on the left portion of the front façade, adjacent to two sets of paired jalousie windows. The hipped asphalt-shingled roof has a single brick chimney off-center along the ridgeline. This resource is located in a suburban area with mixed old and new structures, on a heavily wooded lot.

Resource FU-CoJC-30 was evaluated under Criterion C for significance to architecture and is recommended **not eligible** for listing in the National Register. Resource FU-CoJC-30 retains its original construction site and has undergone alterations to its exterior materials, most notably the painted brick veneer. *The Ranch House in Georgia*.<sup>1</sup> denotes a natural brick exterior as an integral component to the integrity of a brick Ranch; therefore, this resource is unable to convey historic design, materials, workmanship, or feeling. There is no known association between Resource FU-CoJC-30 and any significant event or person.
