# Historic Resources Survey Report

City of Johns Creek, Georgia  
September 2012

The University of Georgia  
College of Environment + Design  
Center for Community Design & Preservation  
Historic Resources Survey Report  
City of Johns Creek, Georgia

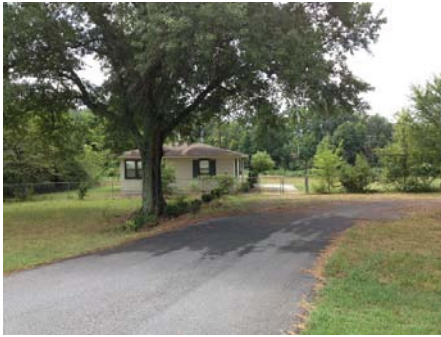
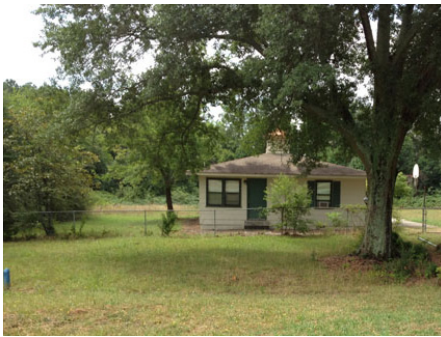
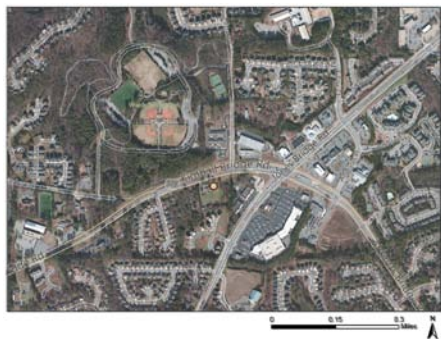
### 5035 Kimball Bridge Road

Resource FU-CoJC-31 is recommended **not eligible** for listing in the National Register and was evaluated under Criterion C for architecture and design. Although this type is recognized as significant to the architectural history of Georgia, this structure does not retain enough integrity to convey this significance. FU-CoJC-31 is located on its historic construction site and has undergone few changes to its landscape setting. The structure is unable to express integrity in design and materials due to the multiple exterior alterations made to the exterior materials. These alterations preclude FU-CoJC-31 from expressing the feelings and aesthetics of the period of construction, and the sense of historic workmanship. There is no known association between this resource and any significant person or event.

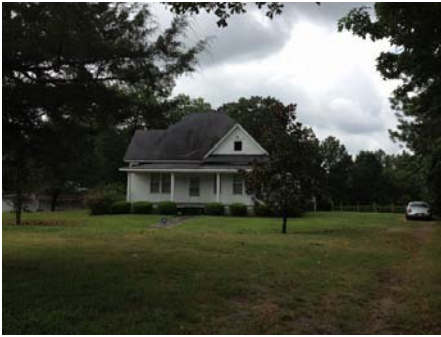
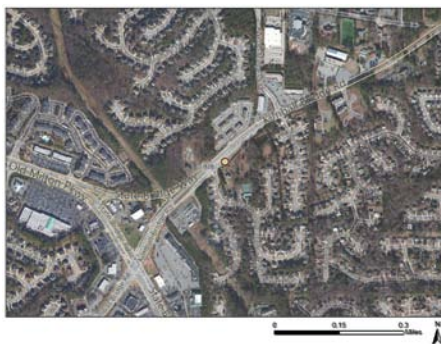
### 4505 Kimball Bridge Road

Resource FU-CoJC-32 is a classic example circa 1900 Queen Anne rural cottage. The asphalt roof is complex, and no chimney is visible. A large vertically oriented vent is located in the front facing gable. The asymmetrical structure is clad with weatherboard and has a single front entry door. Rectangular single pane fixed windows, paired rectangular 1/1 double hung sash windows, and a bay window were documented on the resource. The full width porch has a shed roof, and a concrete block foundation. Several historic use outbuildings were on the property among apple, pear, fig, magnolia, and muscadine plantings. The entire site is bounded by natural woods and agricultural fields.

Resource FU-CoJC-32 is recommended **eligible** for listing on the National Register under Criterion C for its significance in architecture. Resource FU-CoJC-32 represents a type identified in Georgia's Living Places as significant to Georgia's architectural history and the house retains the integrity to convey this significance. The structure has not been altered; the building retains its historic materials, and is able to convey a sense of historic workmanship through its unaltered design. The structure conveys the aesthetics of its period of construction because of its unaltered state. There are no known associations between this resource and any important events or person.

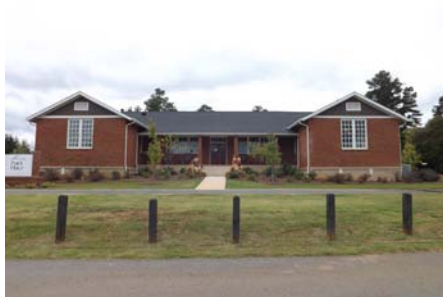
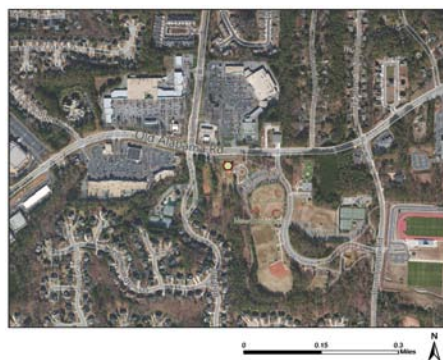
### NewTown School

Resource FU-CoJC-33 was evaluated under Criterion C for architecture and design and recommended **eligible** for listing in the National Register of Historic Places. This resource remains at its historic location and maintains excellent integrity in design, materials and workmanship. FU-CoJC-33 has undergone alterations to its historic landscape setting; however, the alterations do not adversely affect the historic feeling of the school. It is unknown whether this resource is associated with an important event or person.

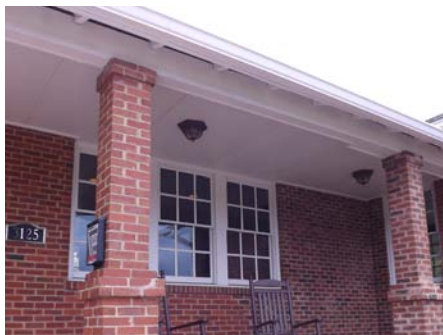
Resource Fu-CoJC-33 is an H-shaped school building circa 1929. This symmetrical school house has a recessed front porch with large brick post porch supports and double door entry with a 6 pane lit transom. Tripartite 6/6 DHS windows are located on both sides of the building and horizontally oriented vents are within both gable wings. The picturesque landscape includes designed planting beds, designed drives, and walks. An extensive renovation of the building began approximately in 2010 and the facility is now named 'Park Place at NewTown School' and is a center for active senior adults. The 1929 schoolhouse is listed on the National Register of Historic Places.

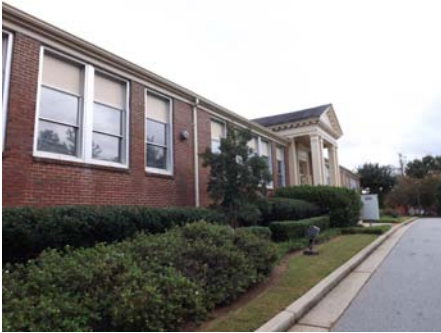
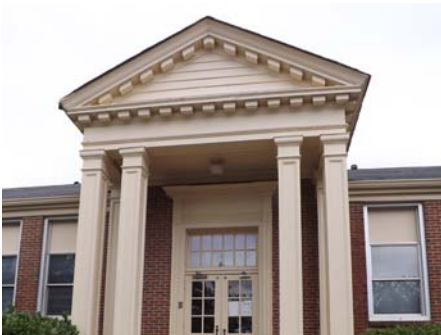
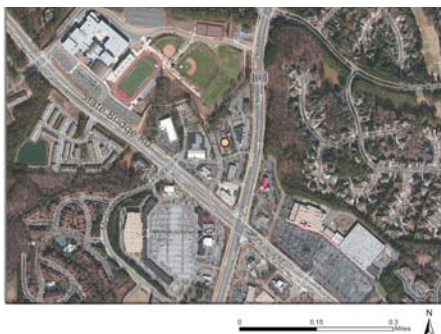
### Warsaw School

Resource FU-CoJC-34 is three-part school house circa 1932-1933. This symmetrical school house has a Colonial Revival front entry portico with double doors and transom light. There are triple hung sash windows spanning both sides of the façade with the top sash painted shut. There is a side entry door with a recessed porch and large brick arch voussoirs with a large sandstone keystone. The side door includes transom and sidelights. There is a 1950s addition on the left of the building; the original name still appears on this addition: Annette Medlock Verner Cafetorium. Classes were held at the Warsaw School from 1933-1980 and the building is currently used as an office building. According to a chronology plaque found inside the building, a major renovation was done in 1953; based on the footprint and architectural detailing of the addition, it is believed the construction was completed during this period. This building has been well maintained, and exists in a busy commercial area and business park.

FU-CoJC-34 is recommended **eligible** for listing in the National Register of Historic Places. This resource was evaluated under Criterion C for architecture. Although the historic landscape of this resource is greatly altered, the structure maintains its original location. The mid-century addition furthers the evolution of the property, and contributes to the workmanship, design, materials and feeling of the resource. It is unknown whether this resource is associated with any significant individual or event.

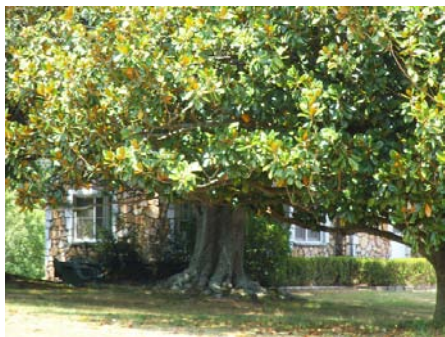
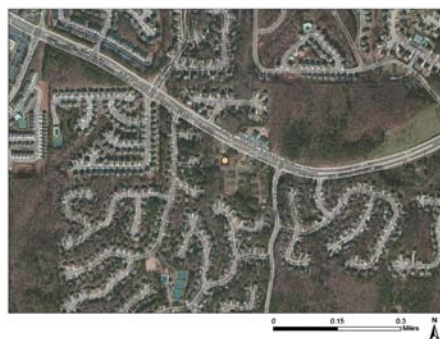
### 7315 McGinnis Ferry Road

Resource FU-CoJC-35 is a single family, Tudor style English Cottage circa 1925. This asymmetrical structure is cross gabled with asphalt shingles. There is a lateral exterior chimney on the front façade, and an exterior gable-end chimney, both comprised of fieldstone. The entire façade is clad with fieldstone, as is the full width verandah on the left façade. The corners of the structure have quoins of large white fieldstone. The foundation is a stone veneer. Tripartite and single 8/8 double hung sash windows are on the front facade. A large carport is integrated on the right façade. There are unknown use outbuildings behind the structure located before the natural woods boundary.

Resource FU-CoJC-35 is recommended **not eligible** for listing in the National Register and was evaluated under Criterion C for architecture and design. Resource FU-CoJC-35 is located at its historic construction site and has undergone few changes in its historic landscape setting. The resource lacks integrity in design, workmanship, materials, and feeling due to the non-historic integrated three-car garage on the right façade. This major alteration prevents Resource FU-CoJC-35 from accurately conveying the feeling and aesthetics of the period of construction. There is no known association between this resource and any significant figure or event.

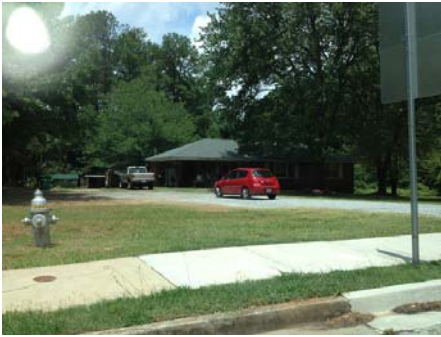
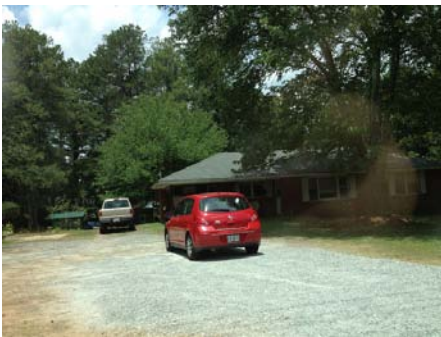
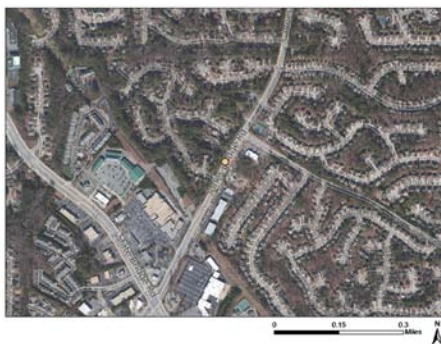
### 11160 Jones Bridge Road

This building is a single family Ranch house constructed circa, 1955. This asymmetrical brick structure with brick foundation has an asphalt shingle hipped roof and no chimney. The front façade contains a single front door, 6/1 paired double hung sash windows and a large Chicago window. There is an integrated carport on the left façade. This resource is located in a mixed old and new residential neighborhood.

Resource FU-CoJC-36 is recommended **not eligible** for listing in the National Register. This resource was evaluated under Criterion C for architecture and design and, although identified as a contributing type to Georgia's architectural history, FU-CoJC-36 is not a quality representation of the type. The resource remains on its historic construction site and maintains a minimum of integrity in its historic landscape setting. FU-CoJC-36 lacks integrity in design, materials, and workmanship because key components which are representative of the mid-century Ranch type are not present, including a chimney and multiple window variations. This particular example of the Ranch House type does not express the feeling or aesthetics of the period of construction. There is no known association between this resource and any significant person or event.

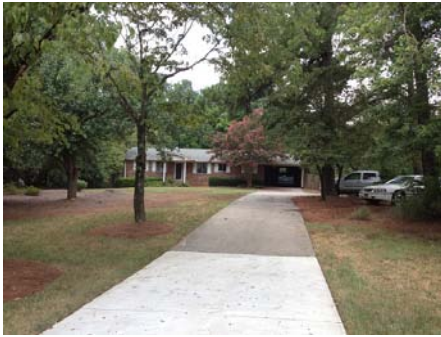
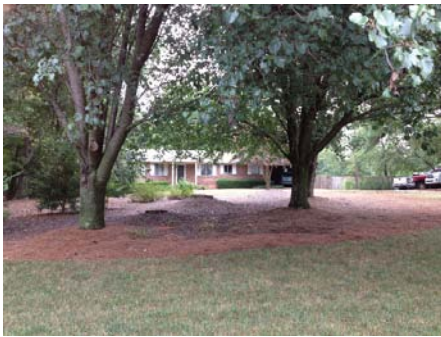
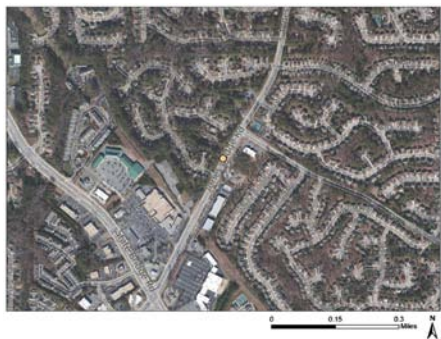
### 11100 Jones Bridge Road

Resource FU-CoJC-37 is a side gabled, polychromatic brick Ranch House with a continuous brick foundation. This circa 1955 asymmetrical structure has a partial width front portico with a gable roof. The façade contains a single front door and paired single hung sash windows. The roof has asphalt shingles, and no visible chimney was observed. An original carport is integrated into the right façade of the structure. Designed fencing and a designed drive were observed in the informal landscape of the site.

Resource FU-CoJC-37 was evaluated under Criterion C for architecture and design and is recommended **eligible** for listing in the National Register. This resource remains in its original location and maintains good integrity in its historic landscape setting. Resource FU-CoJC-37 is an excellent example of this significant house type in Georgia, and displays excellent integrity in design, materials, workmanship, and feeling. This resource contains several elements which are vital to the integrity of the Ranch House type. There is no known association between this resource and any important person or event.

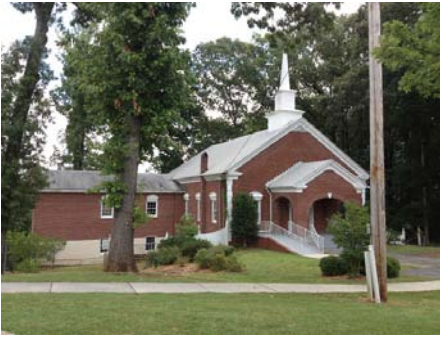
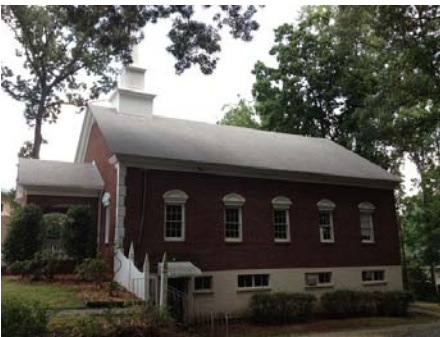
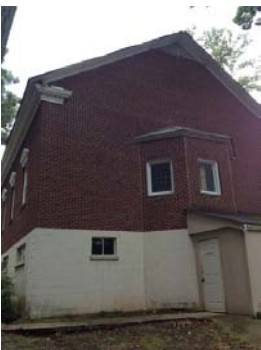
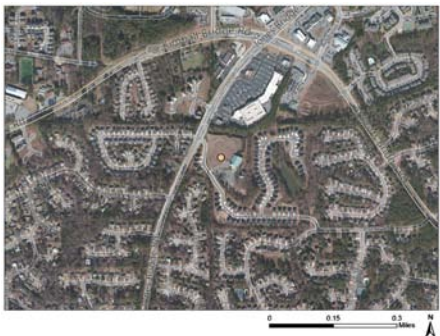
### Clear Springs Missionary Baptist Church

Resource FU-CoJC-38 is a front-gabled, Colonial revival style church built circa 1940. The landscape setting is set in a suburban area of mixed old and new development. The resource has designed planting beds and designed walks. The brick and concrete block structure has white quoins on the facade corners, and a concrete block foundation. It is symmetrical, two storied, with a full entablature on the gable eave; the entry portico has large rounded brick voussoir arches with a granite keystone. A large square steeple with rectangular vents sits upon .0. on the asphalt shingle roof. 6/6 double hung sash windows have hooded eyebrow arches, and are located on the front façade, flanking the portico of the building. A large addition has been added to the rear of the building. A non-historic storage shed is also located on the lot.

Resource FU-CoJC-38 is recommended **not eligible** for listing in the National Register. Resource FU-CoJC-05 was evaluated under Criterion C for significance in the areas of architecture and design. The church building corresponds to a type identified as important to Georgia's architectural history; however, alterations to the structure negatively impact its integrity of design, materials, workmanship, and feeling. The building is unable to convey the aesthetics or feeling of its period of significance or a sense of historic workmanship given the exterior alterations, most notably a large side gable addition. The structure retains good integrity in location and setting, and is not known to be associated with any important person or event.

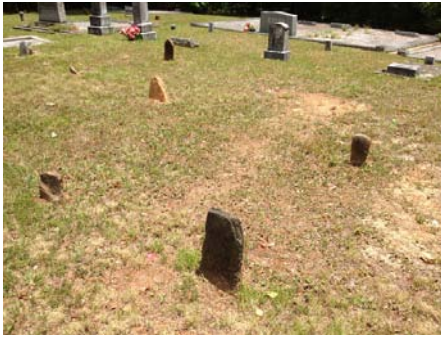
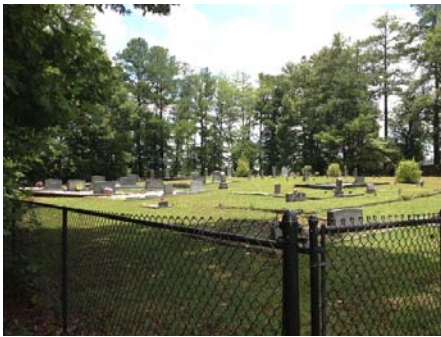
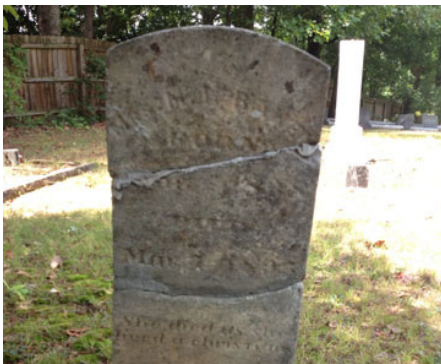
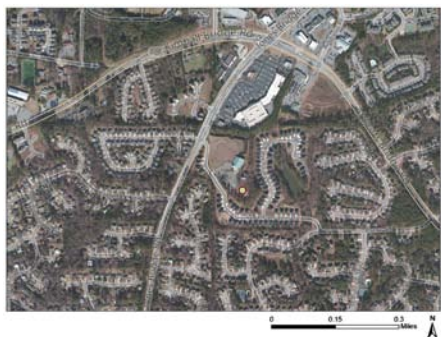
### Clear Springs Missionary Baptist Church Cemetery

Resource FU-CoJC-39 is a picturesque historic cemetery associated with Clear Springs Missionary Baptist Church. The cemetery is fenced and located at the edge of a naturally wooded forest. There are approximately 100 graves including both marked and marked stones. The grounds of the cemetery are well maintained, as are the individual grave, which is evidenced by repointed and repaired stones. The family surnames observed varied greatly, but included Rogers and Gibbons. Markers for veterans of World War II and the fraternal order, Woodmen of the World were also observed. The oldest marked gravestone located was from 1885, and the cemetery appears to be active.

Resource FU-CoJC-39 is recommended **not eligible** for listing in the National Register and was evaluated under Criterion C for design and landscape architecture and Criterion D for information potential. Resource FU-CoJC-39 is unable to convey a sense of historic workmanship and feeling or aesthetic of the period of construction because it is an active cemetery with a number of non-historic markers. This resource maintains good integrity in location and setting. The inclusion of contemporary markers negatively affects the integrity of the historic landscape design and materials. This resource cannot be related to a particular time period or cultural group and therefore lacks a historic context to be nominated under Criterion D. There is no known association between this resource and any important person or event.

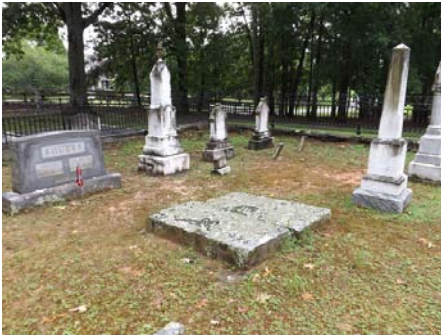
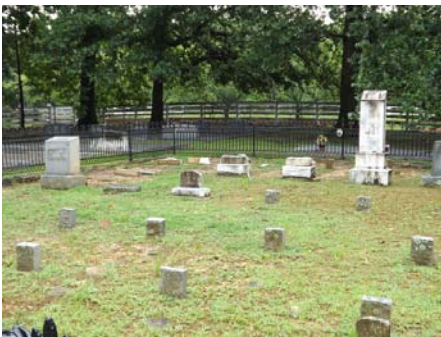
### Rogers-Bell Cemetery

Resource FU-CoJC-40 is a picturesque historic cemetery which dates it to 1839. The site is surrounded by an ironwork fence with an iron and stone entry gate. Both the grounds and the individual graves are well maintained. There are approximately 150 graves, both marked and unmarked granite stones. Large family plots were observed outlined with iron fences or granite stone. Common surnames observed include: Rogers, Bell, and Lowe. Funerary markings indicated Confederate, World War II and Vietnam veterans were present. The oldest grave observed was dated 1839, the most recent was 2012, indicating active use.

Resource FU-CoJC-40 is recommended **not eligible** for listing in the National Register, and was evaluated under Criterion C for design and landscape architecture and Criterion D for information potential. Resource FU-CoJC-40 is a small family cemetery which is currently active. The small size of the cemetery is directly affected by the introduction of contemporary markers; which impacts the integrity of design, materials, workmanship and feeling. The resource remains in its historic location, and due to adjacent suburban development, has experienced loss of integrity in setting. This resource does not express the feeling and aesthetics of its period of construction. There is no known association between this site and any significant event or individual. This resource cannot be related to a particular time period or cultural group and therefore lacks a historic context to be nominated under Criterion D.

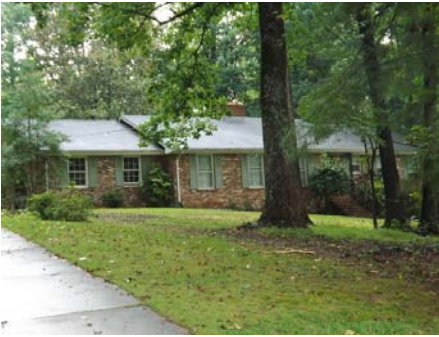
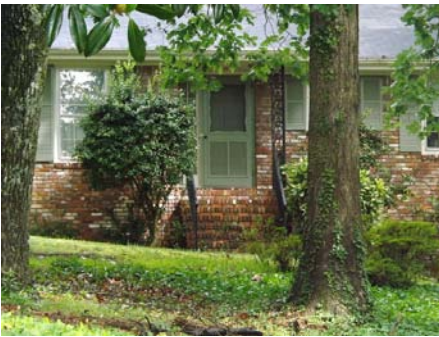
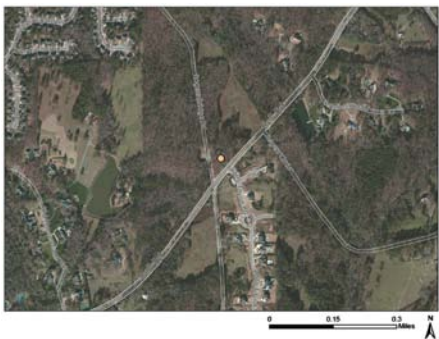
### 7480 Bell Road

**FU-CoJC-41 is located at 7480 Bell Road. This resource was not documented in the 1996 Georgia Historic Resources Survey.**

Resource FU-CoJC-41 is a single family, Ranch style house built circa 1965. It is set back from Bell Road within a partially wooded lot and is integrated into the topography. This asymmetrical brick structure has a continuous brick foundation and is side gabled. The asphalt shingle roof contains one large brick chimney at the center ridgeline with paired chimney pots. There are rectangular 6/6 double hung sash windows with a soldier course at the window seals. The brick stairs leading up to the front recessed entry porch are framed by a scrolled ironwork railing.

Resource FU-CoJC-41 was evaluated under Criterion C for significance in architecture and design and is recommended **not eligible** for listing in the National Register. Resource FU-CoJC-41 is located on its historic construction location and retains integrity of siting. The resource is exemplary of late mid-century Ranch Houses, and may not meet the minimum age requirement for listing. Although this resource maintains integrity in design and materials, it lacks key components integral to the mid-century Ranch House as a type. There is no known association between this resource and any significant event or person.

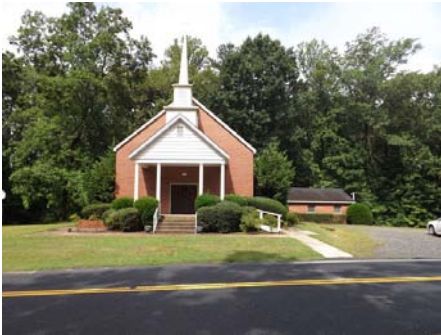
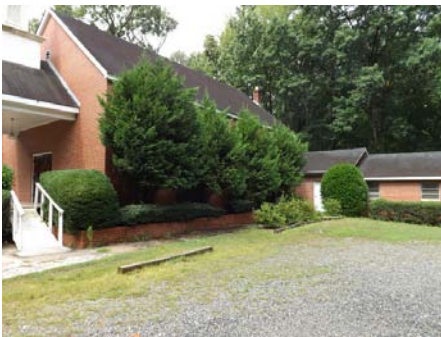
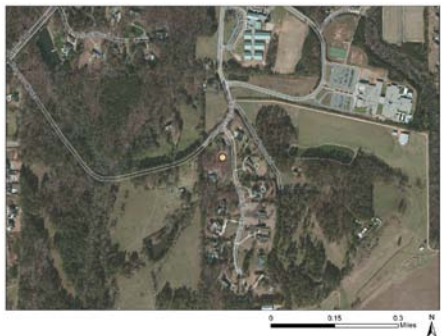
### Mt. Zion Methodist Church

FU-CoJC-42 is the resource known as Mount Zion Methodist Church and is located at 10795 Rogers Bridge Road. This resource was documented in the 1996 Georgia Historic Resources Survey.

Resource FU-CoJC-42 is a front gabled brick church constructed in 1894, as indicated on the cornerstone, with a concrete and brick foundation. There are two side additions from a 1960 remodel; the 1960s additions may meet the minimum age criteria to be considered historic. The original one and a half story structure is symmetrical. The front façade contains a Tuscan-columned portico with a vertically oriented vent located under the overhanging eave. The portico has a far-sided rectangular steeple, and spans half the width of the façade. The centrally located double entry doors have inset panels with carved decorative scrolls. The structure's roof has asphalt shingles and a gable-end brick chimney. No windows are evident on the front façade; both lateral facades contain 9/9 double hung sash rectangular windows.

Resource FU-CoJC-42 is recommended **not eligible** for listing in the National Register and was evaluated under Criterion C for architecture and design. This resource retains integrity in location and setting. The front gable church type has been identified as significant to Georgia's architectural history; however, it does not retain the integrity of materials and design, feeling or association to adequately express this significance. Although the additions to the side of the resource date to the 1960s, they greatly alter the historic design and materials. There is no known association between this resource and any significant event or person.

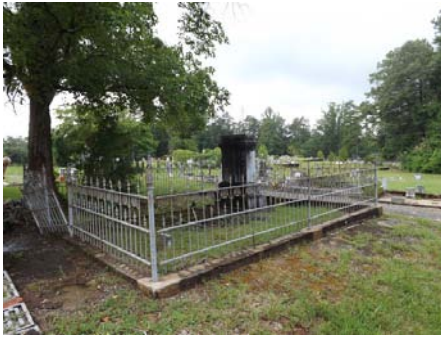
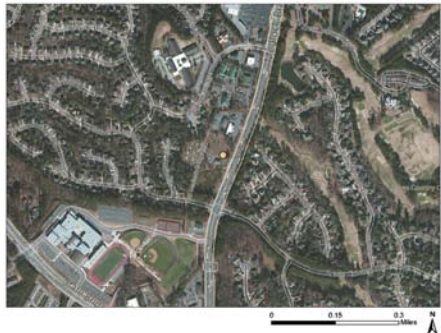
### Warsaw Cemetery

**FU-CoJC-43, Warsaw Cemetery is located approximately at 10529 Medlock Bridge Road. This resource was documented in the 1996 Georgia Historic Resources Survey.**

Resource FU-CoJC-43 is a historic cemetery once associated with a Warsaw Church, which was moved in 2004. There are varying degrees of maintenance that have been done to the individual graves within the cemetery. There are both individual graves and family plots within the sprawling layout. Markers consist of various materials, including brick, granite, and poured concrete. Various veteran and fraternity groups are represented and include: WWI, WWII, confederate veteran, the Iraq War, the Korean War, Masons, and the Woodsmen of the World. Common observed surnames are Findley, Medlock, Gilstrap, Dispain, Latham, Smith, Nunn, Graham, Nunnally, and Brimbelow. There are approximately 300 graves, both marked and unmarked. Funerary plantings such as yucca, iris, boxwood, dogwood, and red cedar were observed. Recent graves were noted, indicating an active cemetery; the oldest marker documented dates to 1868.

Resource FU-CoJC-43 was evaluated under Criterion C for design and landscape architecture and Criterion D for information potential and is recommended **not eligible** for listing. This resource maintains its historic location however has experienced changes in its historic landscape setting by the expansion of Medlock Bridge Road. This is an active cemetery; the inclusion of new grave markers negatively affects the site's ability to convey the workmanship and aesthetics of its historic era. Contemporary markers also affect the integrity of the design and materials of the site. This resource cannot be related to a particular time period or cultural group and therefore lacks a historic context to be nominated under Criterion D.

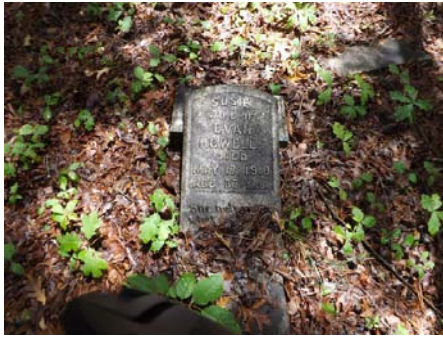
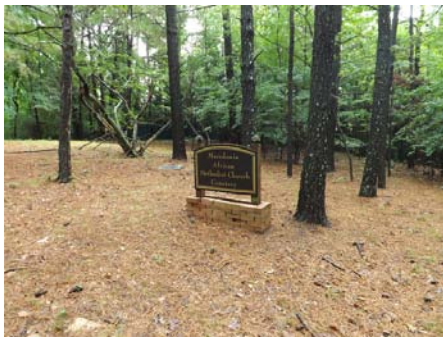
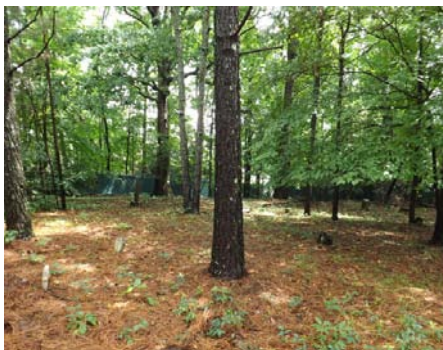
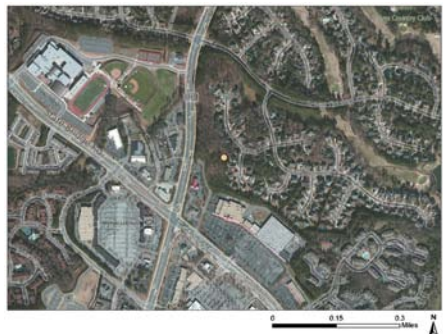
### Macedonia African Methodist Cemetery

**FU-CoJC-44 the Macedonia African Methodist Church Cemetery, and is located at approximately 9735 Medlock Bridge Road. This resource was documented in the 1996 Georgia Historic Resources Survey.**

Resource FU-CoJC-44 is a historic cemetery once associated with the Macedonia African Methodist Church, no longer extant at this location. The cemetery is only accessible from the adjacent parking lot located at 9735 Medlock Bridge Road. There are approximately 50 graves on site, with many uncarved stone markers. Common documented surnames include: Baker, Riley, Ousley, and Hanely. The oldest grave dates to 1893, and the cemetery is not currently in use. Many headstones are in a state of disrepair and horizontal. The secluded location is overgrown and forested, and contains household debris. The original Macedonia African American Methodist Church cement sign still stands at the cemetery entrance.

Resource FU-CoJC-44 is recommended **eligible** for listing in the National Register. The property possesses significance under Criterion A for its association with African-American ethnic heritage. The property is representative of the growth of independent African-American religious institution at the turn of the 20th century. Additionally, this property was evaluated under Criterion C for design and landscape architecture; and it exhibits design features that were common in African-American cemeteries at the time. This resource also fulfills Criterion D for information potential because it derives its significance from its associative and design qualities. FU-CoJC-44 retains integrity of location, design, setting, materials, workmanship, feeling, and association. The cemetery remains at its historic site although the church is no longer present. The design of the cemetery remains largely unaltered; however, basic maintenance is needed to improve its current condition.

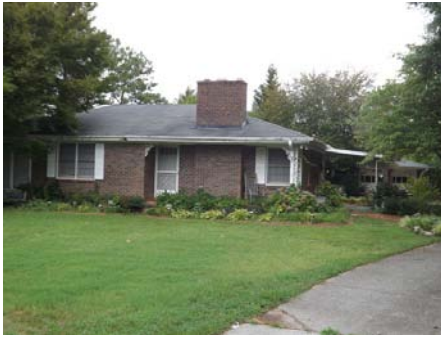
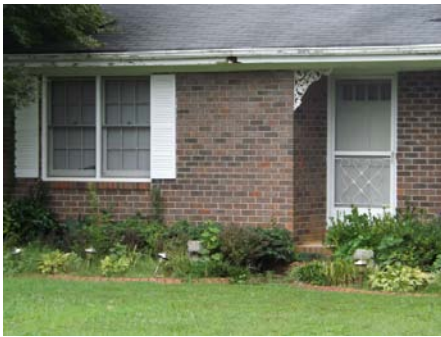
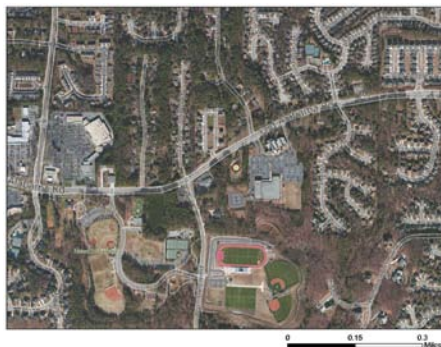
### 3340 Old Alabama Road

**FU-CoJC-45 is located at 3340 Old Alabama Road. The resource was not included in the 1996 Georgia Historic Resources Survey.**

Resource FU-CoJC-45 is a single family Ranch house with a two car hipped roof garage outbuilding on site. The circa 1960 house is an asymmetrical structure with brick veneer, and likely has a brick foundation which is obscured by planting beds. The front door has four vertical lights along the lintel and is located within a partial width recessed front porch. Scrolled metal brackets are located along the recessed porch eaves, and mirror the design of the metal porch supports. Windows are 6/6 double hung sash, with one pair set on the front of the facade. The hipped roof has asphalt shingles and a prominent brick chimney located off-center within the roof surface.

Resource FU-CoJC-45 was evaluated under Criterion C for architecture and design and is recommended **eligible** for listing in the National Register. This resource is located on its historic construction site and has undergone few changes to its landscape setting. This resource also maintains good integrity in design and materials. FU-CoJC-45 retains excellent integrity of materials and maintains a number of architectural details which are exemplary of the Ranch House type, including: a lit entry door, metal porch details, and a recessed porch. These elements accurately portray the feeling and aesthetics of the period of construction. This resource is not known to be associated with any important person or event.

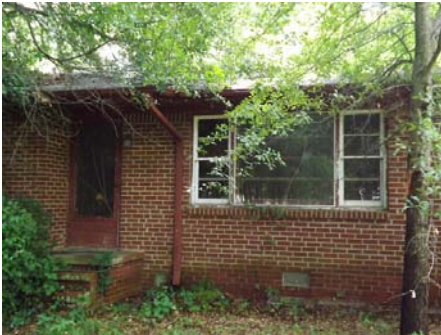
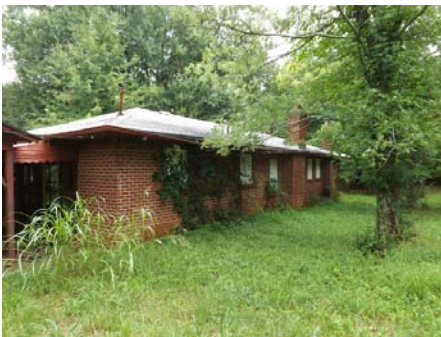
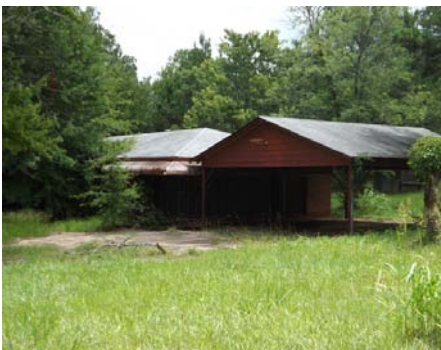
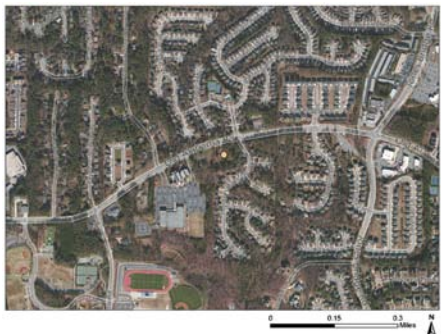
### 3455 Old Alabama Road

**FU-CoJC-46 is located at 3455 Old Alabama Road. The resource was not included in the 1996 Georgia Historic Resources Survey.**

Resource FU-CoJC-46 is a single family Ranch house built circa 1960 which is currently vacant. This asymmetrical brick structure has a continuous brick foundation and is capped by a hipped roof comprised of asphalt shingles. A mid-century aluminum covers the enclosed carport on the front right facade. A brick chimney is located on the rear of the structure. Paired 2/2 double hung sash windows with horizontal muntins are on the front façade adjacent to a full Chicago window. The original entry door is located within the recessed porch. This resource is sited within a naturally wooded area; the site also contains a mid-century well house and free standing carport.

Resource FU-CoJC-46 is recommended **eligible** for listing in the National Register and was evaluated under Criterion C for architecture and design. This resource has excellent integrity in location, setting, design, materials, workmanship, and feeling. There are minimal changes to the exterior or historic landscape; Resource FU-CoJC-46 retains architectural elements that are significant to the ranch house type including, horizontally orientated windows, brick exterior, and mid-century awnings. This resource successfully conveys the feeling and aesthetic of the period of construction, and is not associated with any important person or event.

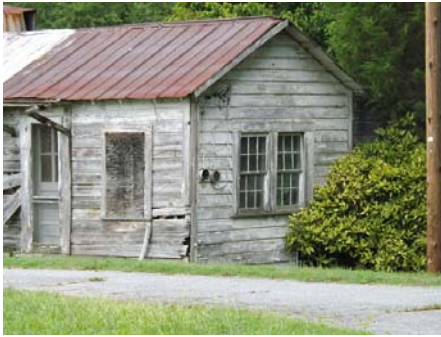
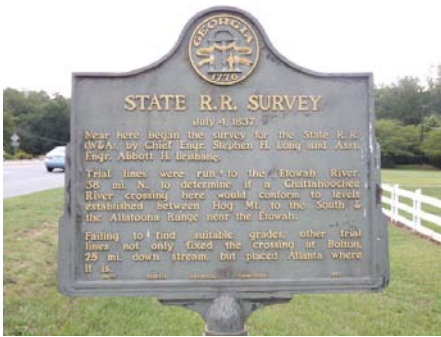
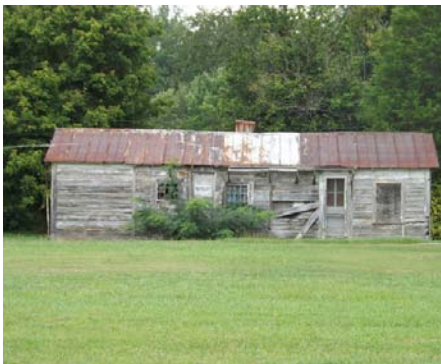
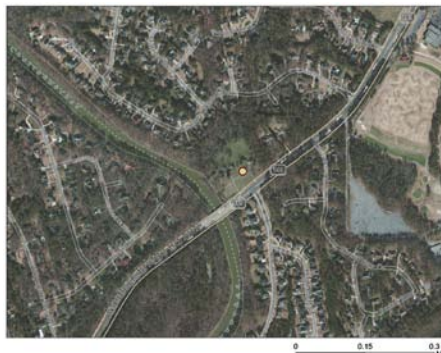
### 9110 Medlock Bridge Road

FU-CoJC-47 is located at 9110 Medlock Bridge Road. The resource was not included in the 1996 Georgia Historic Resources Survey.

Resource FU-CoCJ-47 is a weatherboard Hall-parlor house constructed circa 1910. The single family dwelling is currently vacant and historically served as both a family home as well as a general store. No porch currently exists, but remnants of a formal covering are evident. The side-gabled asymmetrical structure has a single four-pane lit entry door. The windows are 6/6 double hung sash. The standing-seam metal roof contains a center ridgeline chimney with a metal enclosure. Craftsman detailing is expressed through the exposed rafter tails in the wide overhanging eaves. A significant rear addition is also documented.

Resource Fu-CoJC-47 was evaluated under Criterion C for architecture and design and is recommended **not eligible** for listing in the National Register. This resource remains in on its historic construction site and maintains good integrity in landscape setting. FU-CoJC-47 lacks integrity in design, materials, workmanship, and feeling, due to the large rear addition. The significant alteration to the structure alters its overall footprint which prohibits FU-CoJC-47 from accurately representing the aesthetics from the period of construction. There is no known association between this resource and any important person or event.

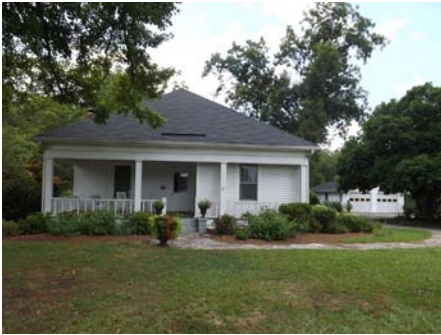
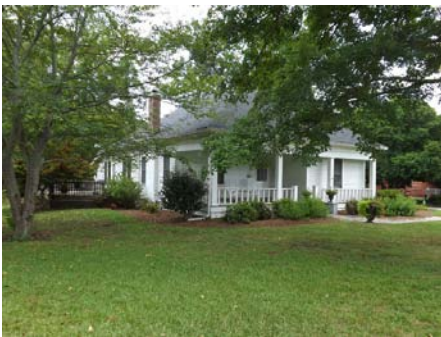
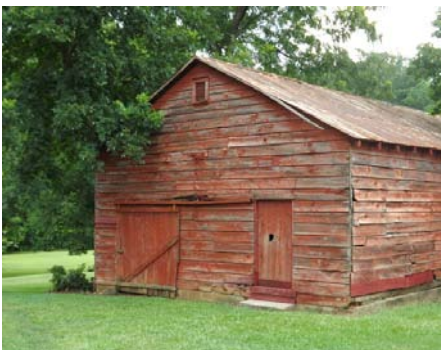
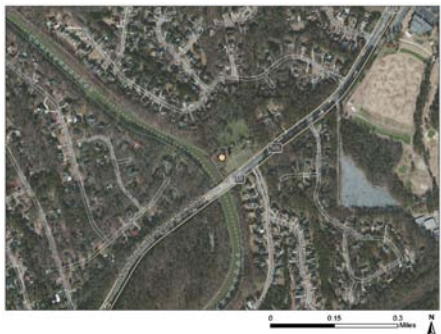
### 9110 Medlock Bridge Road

**FU-CoJC-48 is located at 9110 Medlock Bridge Road. The resource was included in the 1996 Georgia Historic Resources Survey.**

Resource FU-CoJC-48 is a single family New South Cottage circa 1923 with Craftsman elements. The asymmetrical weatherboard structure has a hipped asphalt shingled roof with an off-center brick chimney. There is a full width verandah with exposed rafter tails on the front of the structure. The structure's front façade has a single front door. Windows are rectangular 4/1 double hung sashed. The picturesque yard has designed fencing and planting beds. Also on the site are a barn, a well house, and a garage.

Resource FU-CoJC-48 is recommended **not eligible** for listing in the National Register and was evaluated under Criteria C for architecture and design. This resource maintains good integrity in location and setting; many historic outbuildings are located on the site. The current occupant indicated that the front right portion of the verandah was enclosed in the 1980s. This significant alteration negatively affects the resources ability to convey historic workmanship, design, materials, and feeling. There is no known association between this resource and any significant event or individual.
