Historic Resources Survey Report

Pierce County, Georgia

July 2016

The University of Georgia
College of Environment and Design
Center for Community Design & Preservation
Historic Resources Survey Report
Pierce County, Georgia 2016

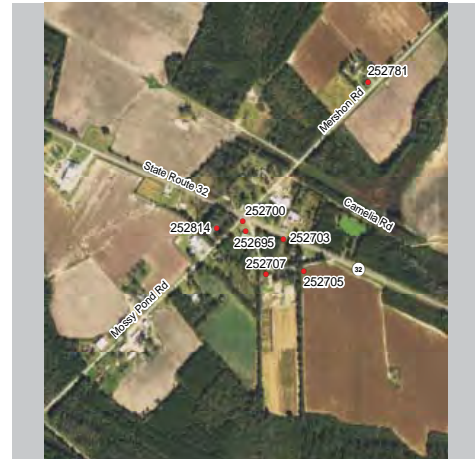
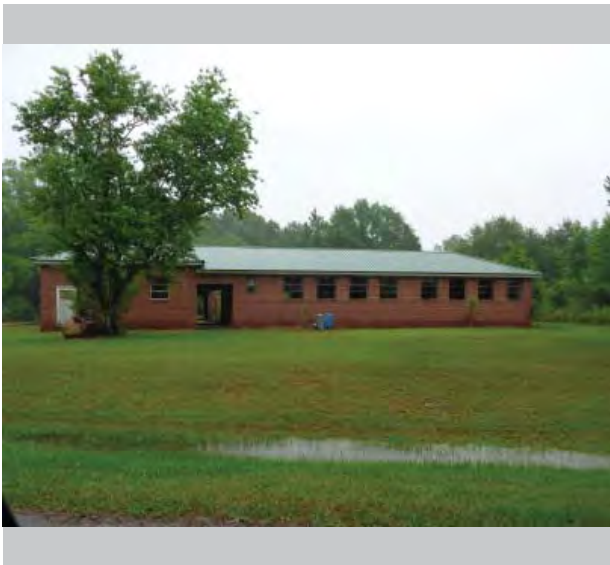
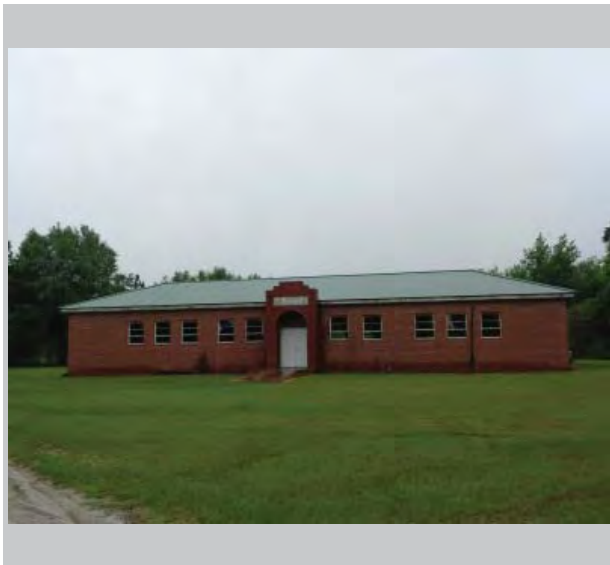
Field ID: PR-1
GNAHRGIS ID: 252695
County: Pierce
Preliminary NR Assessment: May Meet

Mershon School
 Intersection of HWY 32 & Mershon Rd
Coordinates: 31.46361, -82.25712

Additional Notes Front entry with archway
 Stepped pattern on entry
 Large addition
 Windows missing

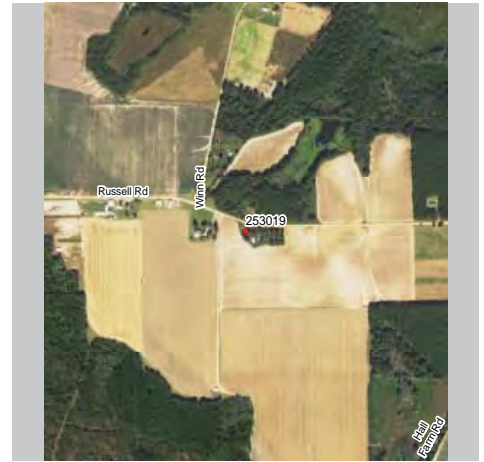
Field ID: PR-110
GNAHRGIS ID: 253019
County: Pierce
Preliminary NR Assessment: May Meet

- Resource Type** Building
- Resource Use** Domestic: Single Family Dwelling
- Date of Construction** 1900
- Building Type** Central Hallway
- Structural System** Balloon Frame
- Style** No Academic Style
- Roof** Gable: Side
- Exterior Cladding** Wood: Clapboard
- Foundation** Unknown
- Porch** Verandah
- Windows** Double Hung Sash: 2/2. Rectangular.
- Chimney** Gable-End Exterior: Brick
- Additional Notes** Fish scale shingle roof
Obscured by vegetation
Chimney on the left
No visible additions

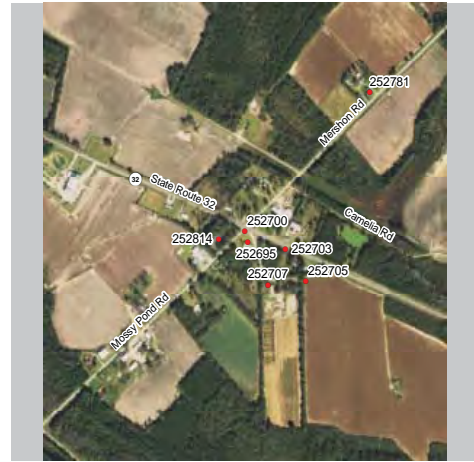
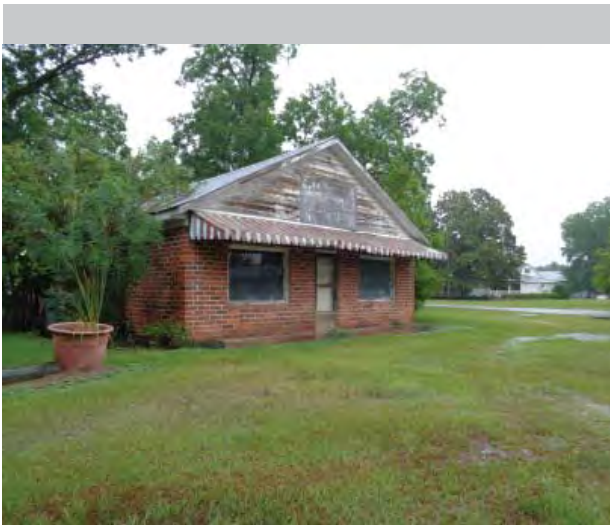
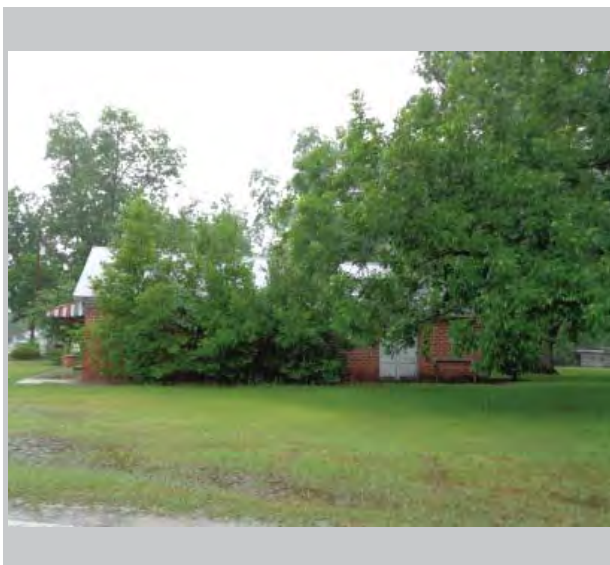
Field ID: PR-2
GNAHRGIS ID: 252700
County: Pierce
Preliminary NR Assessment: May Meet

Intersection HWY 32 & Mershon Rd

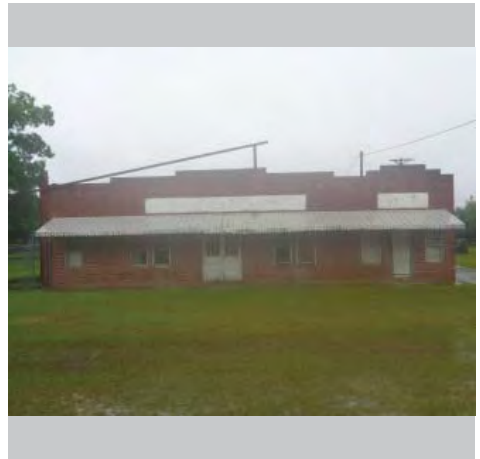
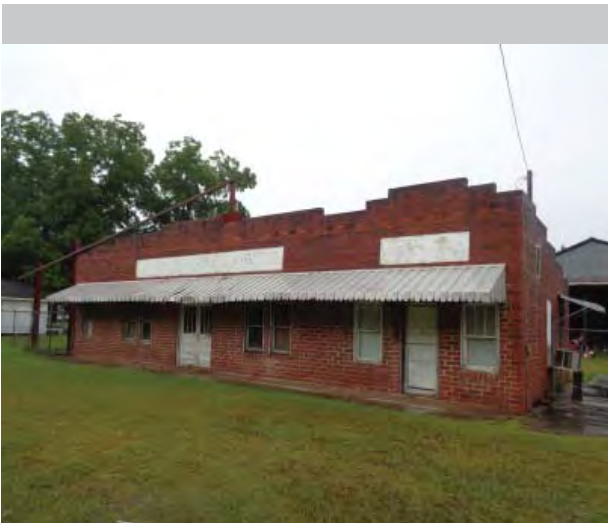
Field ID: PR-3
GNAHRGIS ID: 252703
County: Pierce
Preliminary NR Assessment: May Meet

- Resource Type** Building
- Resource Use** Commercial: Multiple
- Date of Construction** ca. 1925
- Building Type** Unknown
- Structural System** Brick Bearing
- Style** Elements: Craftsman
- Roof** Unknown
- Exterior Cladding** Brick
- Foundation** Unknown
- Porch** N/A
- Windows** Double Hung Sash: 3/1
- Chimney** No Chimney Observed
- Additional Notes** 2 commercial storefronts
Stepped roof pattern
Mid-century aluminum awning

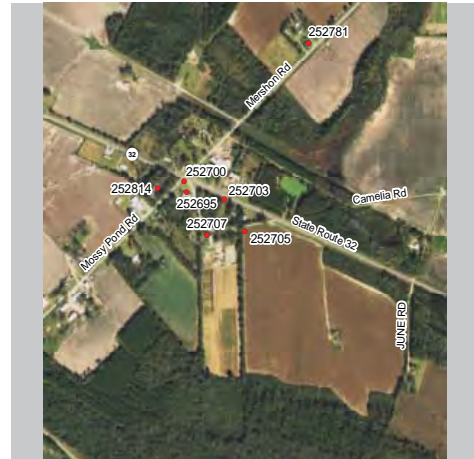
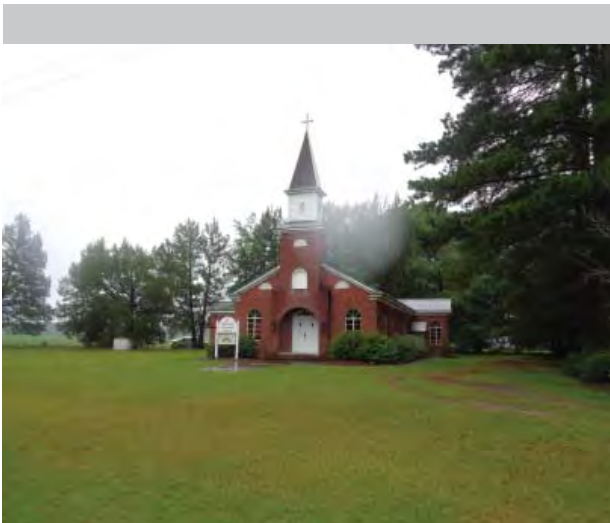
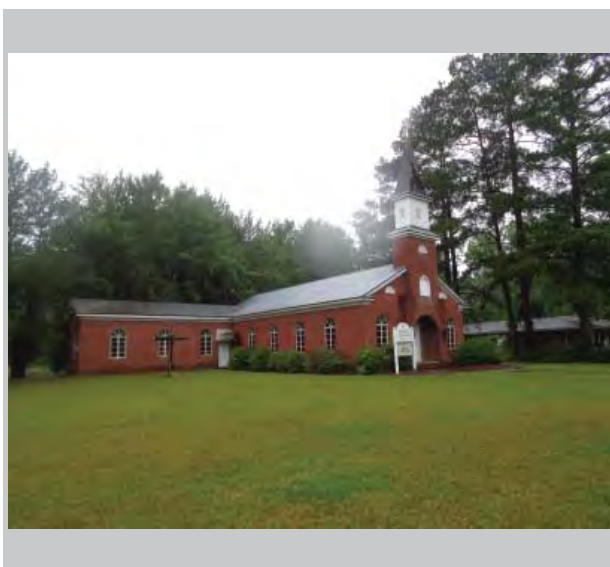
Field ID: PR-4
GNAHRGIS ID: 252705
County: Pierce
Preliminary NR Assessment: Does not meet

Additional Notes Recessed arch entry
 Large rear addition
 Rounded arch vents
 Stained glass windows

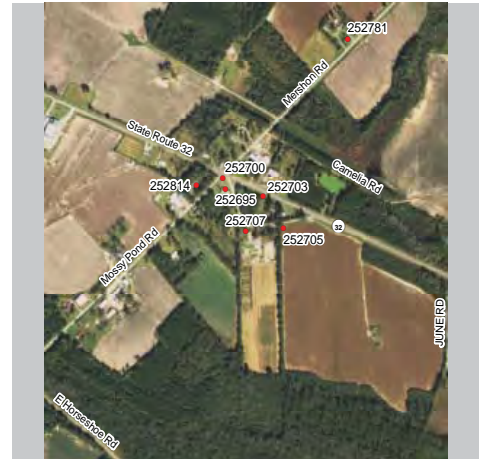
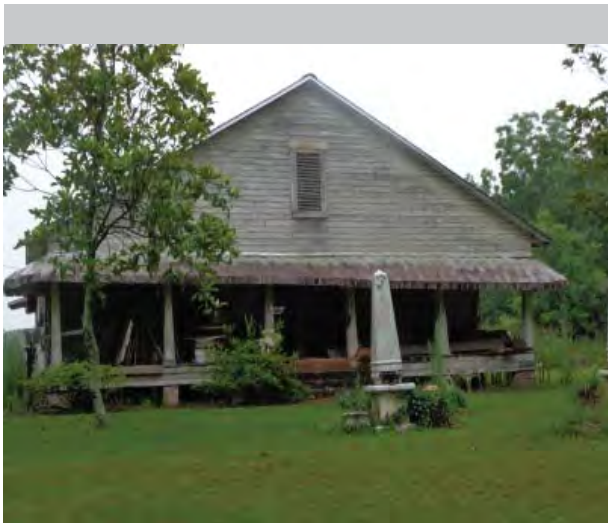
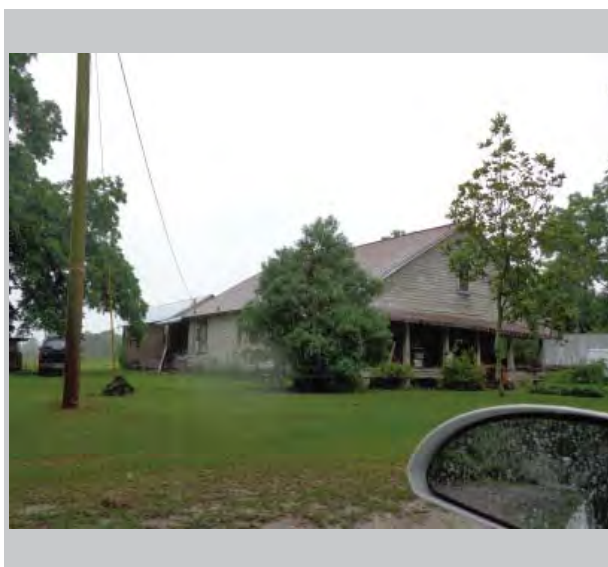
Field ID: PR-5
GNAHRGIS ID: 252707
County: Pierce
Preliminary NR Assessment: May Meet

Foundation Pier: Brick

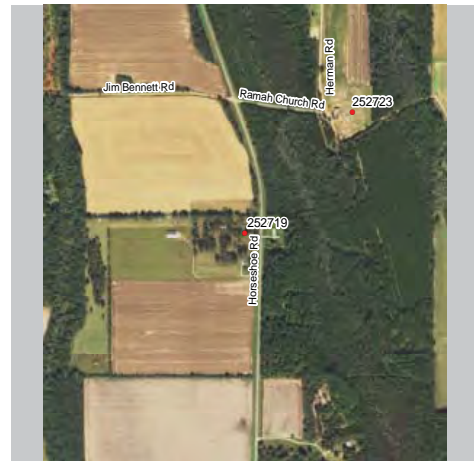
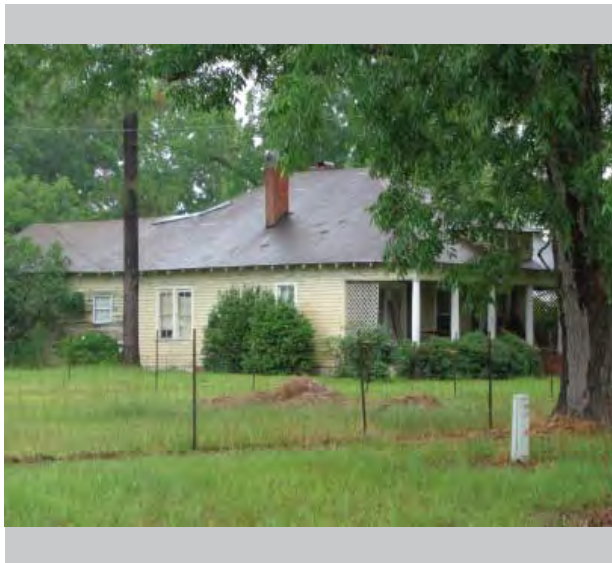
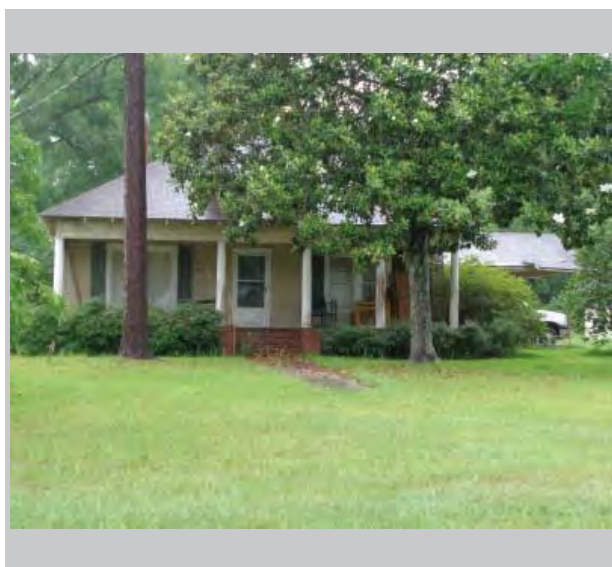
Field ID: PR-6
GNAHRGIS ID: 252719
County: Pierce
**Preliminary NR
Assessment:** Does not meet

Foundation Continuous: Concrete

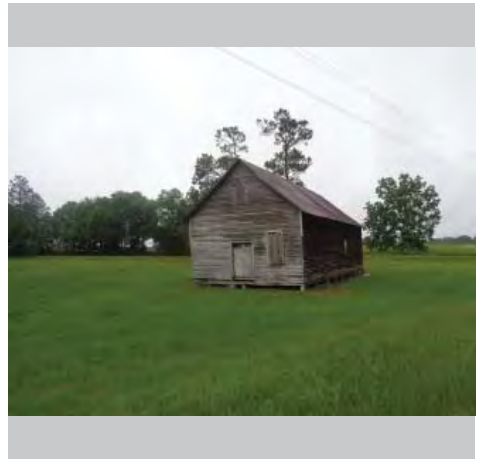
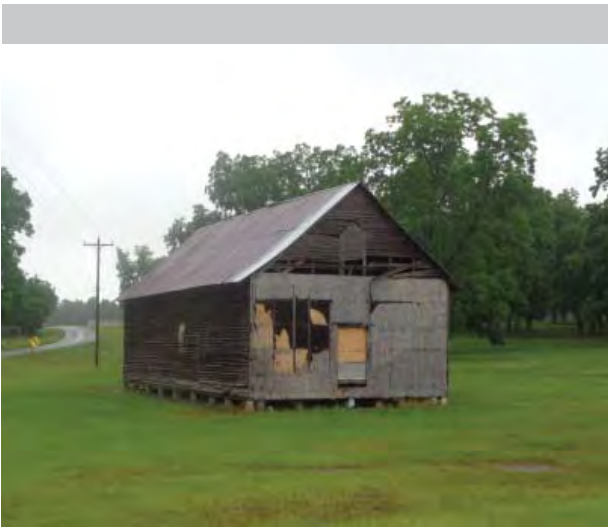
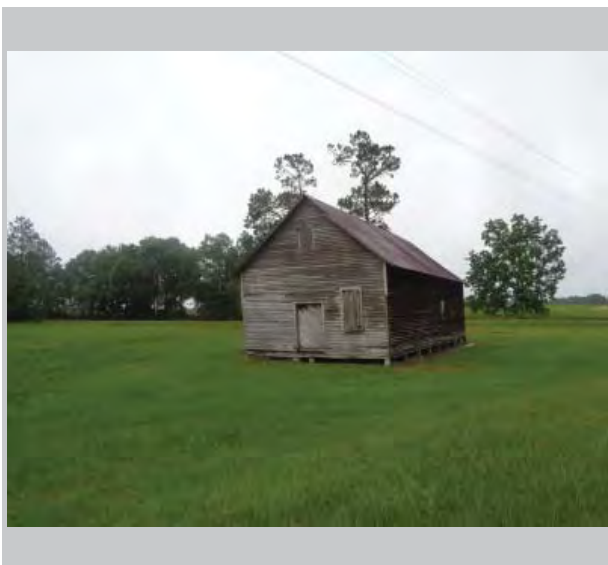
Field ID: PR-7
GNAHRGIS ID: 252720
County: Pierce
Preliminary NR Assessment: Appears to Meet

Foundation Pier: Concrete

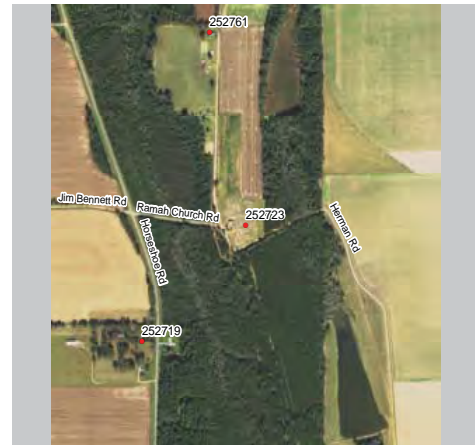
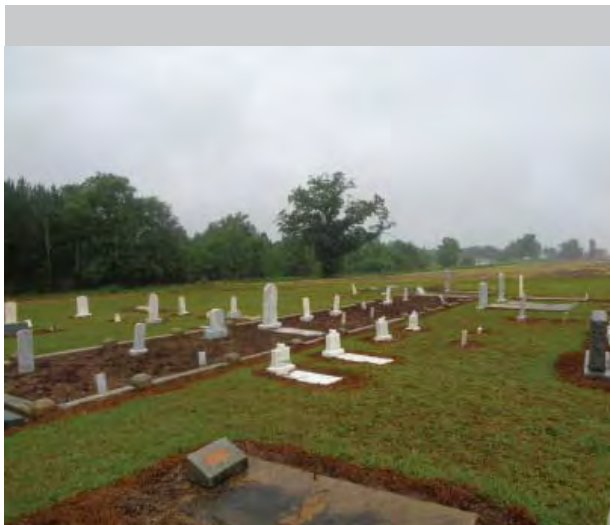
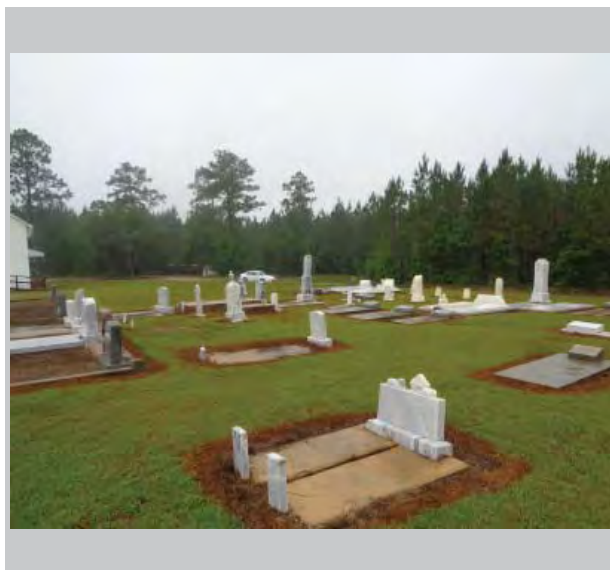
Field ID: PR-8
GNAHRGIS ID: 252723
County: Pierce
Preliminary NR Assessment: Does not meet

Ramah Baptist Church Cemetery
 intersection of Herman Road Ramah & Ramah Church

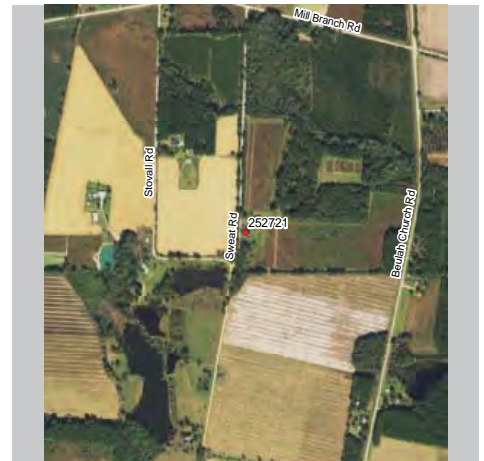
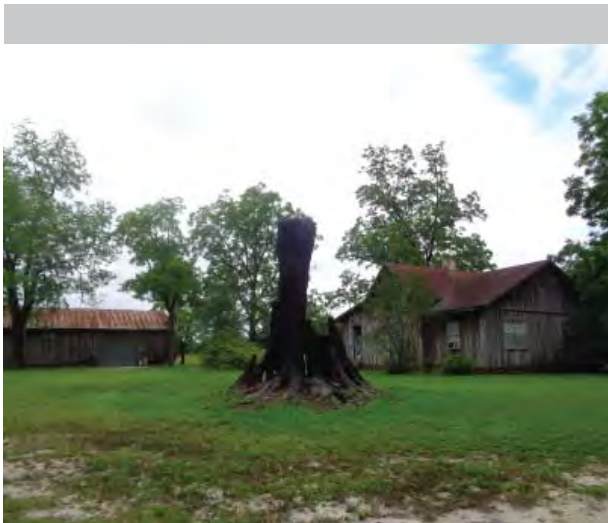
Field ID: PR-9
GNAHRGIS ID: 252721
County: Pierce
Preliminary NR Assessment: Does not meet

- Resource Type** Building
- Resource Use** Domestic: Single Dwelling
- Date of Construction** ca. 1900
- Building Type** Unknown
- Structural System** Balloon Frame
- Style** No Academic Style
- Roof** Gable: Multi
- Exterior Cladding** Board-and-Batten: Vertical Board
- Foundation** Continuous: Brick
- Porch** Portico, Stoop
- Windows** Double Hung Sash: 6/6
- Chimney** Center: Brick
- Additional Notes** Not an academic type
Unpainted exterior
Two significant outbuildings on the parcel

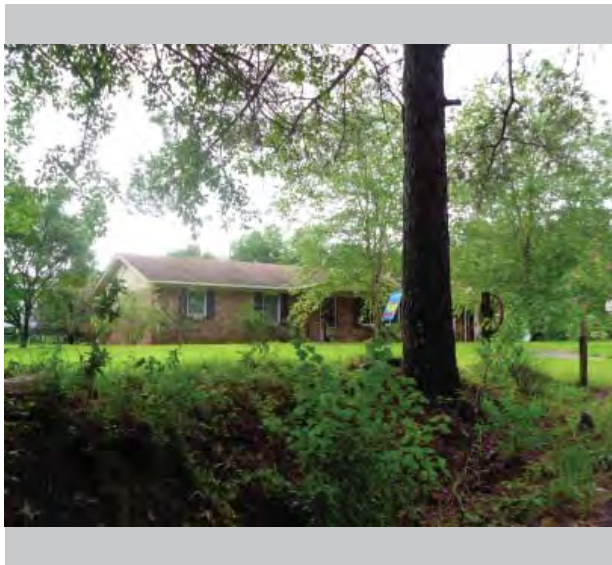
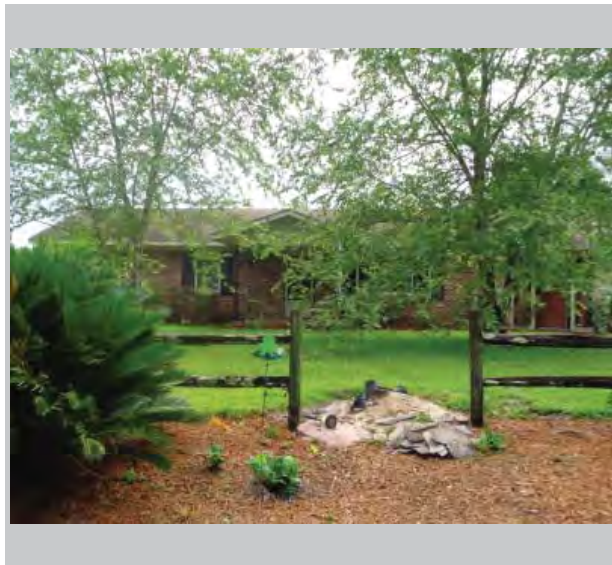
Coordinates: 31.41185, -82.38513

Resource Type Building
Resource Use Domestic: Single Dwelling
Date of Construction ca. 1964
Building Type Ranch
Structural System Brick Bearing
Style No Academic Style
Roof Gable: Multi
Exterior Cladding Brick, Wood: Weatherboard
Foundation Unknown
Porch Portico
Windows Double Hung Sash: 1/1
Chimney No Chimney Observed

Additional Notes Polychromatic red brick
 Replacement windows
 Vertical wood siding on gables and side

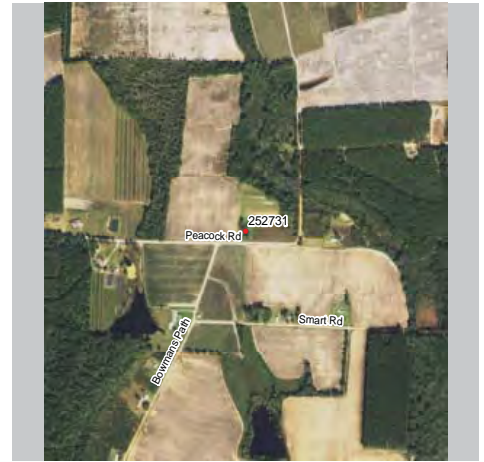
734 Peacock Road

- Resource Type** Building
- Resource Use** Domestic: Single Dwelling
- Date of Construction** ca. 1935
- Building Type** Bungalow: Cross Gable
- Structural System** Balloon Frame
- Style** Elements: Craftsman
- Roof** Gable: Multi
- Exterior Cladding** Prism Synthetics: Asbestos Siding
- Foundation** Pier: Concrete
- Porch** Verandah
- Windows** Double Hung Sash: 2/2
- Chimney** No Chimney Observed
- Additional Notes** Paired double hung sash windows
Craftsman three light door
Exposed rafter tails

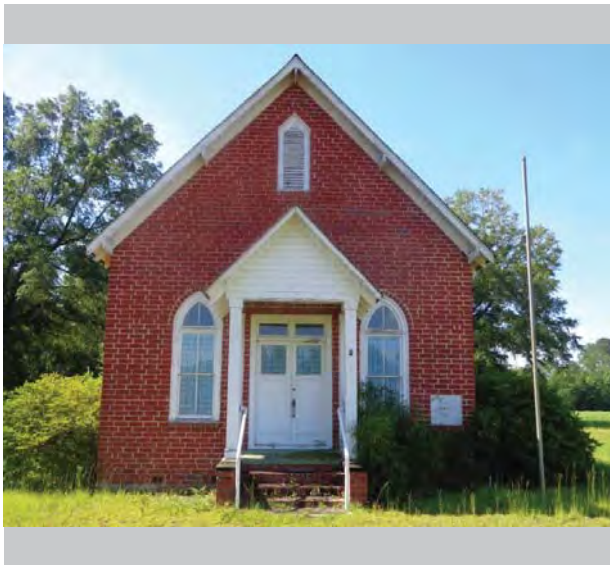
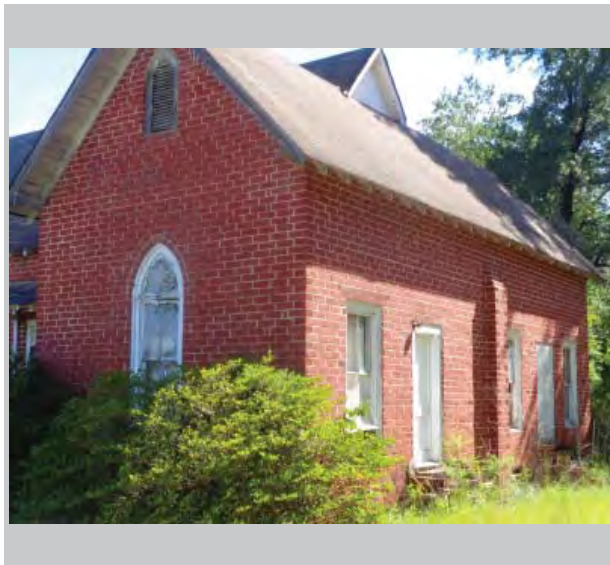
Church of Christ / Raulerson Church
Trudie Road between Oliver Rd & Lynn Rd
Coordinates: -82.041517, 31.298549

- Resource Type** Building
- Resource Use** Religious: Church
- Date of Construction** 1945
- Building Type** Front Gable Church
- Structural System** Balloon Frame
- Style** No Academic Style
- Roof** Gable: Front
- Exterior Cladding** Brick
- Foundation** Pier: Brick
- Porch** Portico
- Windows** Fixed: Pointed arch, 2/2/2
- Chimney** No Chimney Observed
- Additional Notes** "T" shape, possible back addition. Exposed rafters, arched windows. Stepped brick detail on sides/rear.

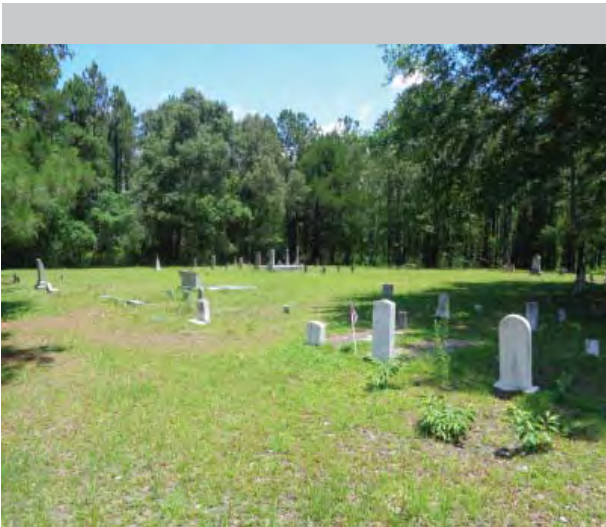
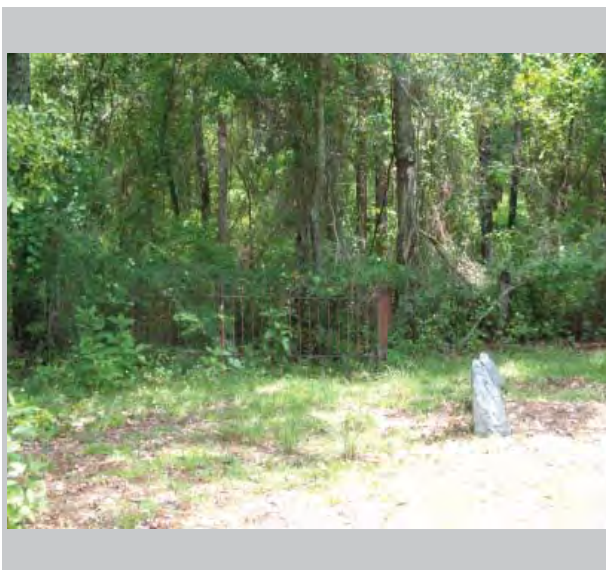
Old Alma Rd between Lee Drive & Jacks Rd

Cemetery Description Iron fencing outlined family plot
Few raised brick ledger stones
Mostly random plots
Some broken headstones
Fair condition
Active use

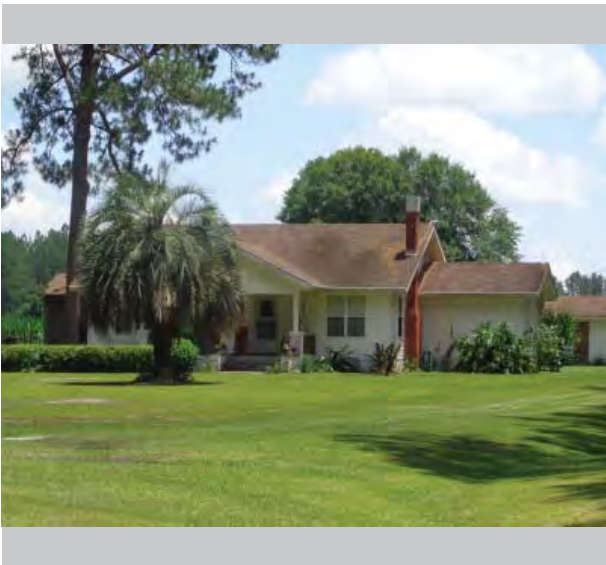
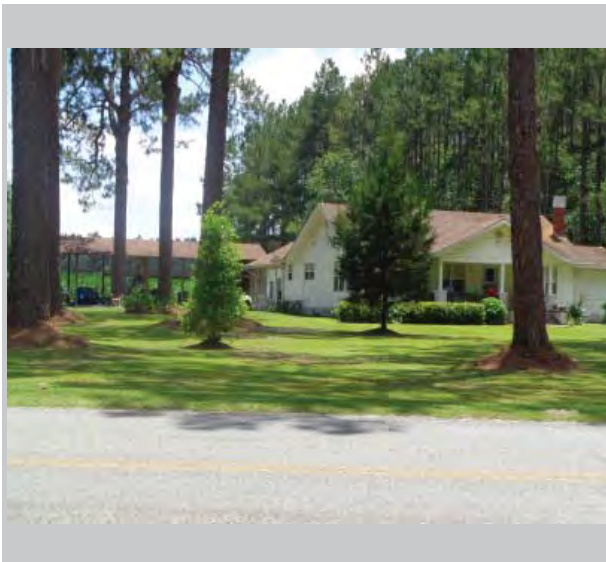
Old Alma Road, approx 3 m from Blackshear

Additional Notes Paired windows
Multiple material replacements and side additions

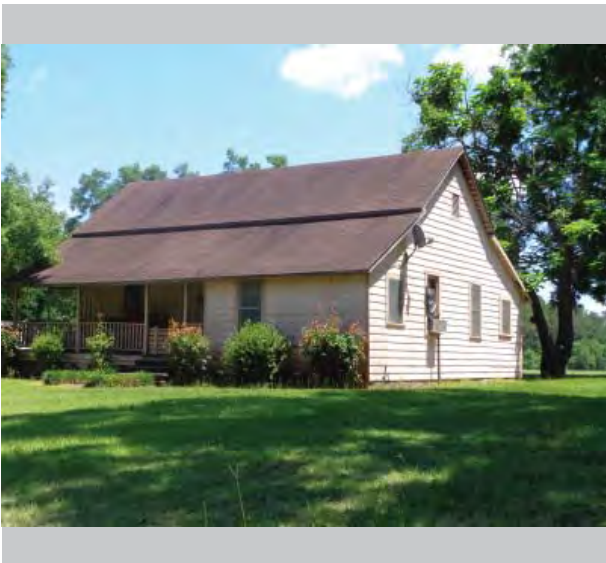
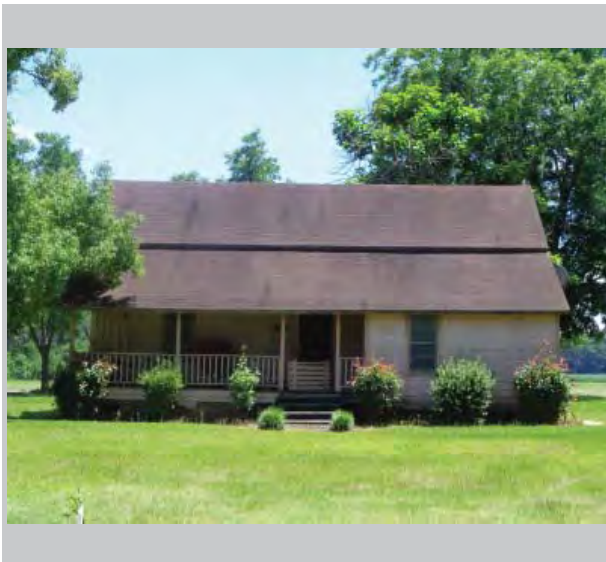
End of Lee Drive off Radio Station Road

Additional Notes Enclosed portion of right verandah, 2 additions
Replacement windows and siding

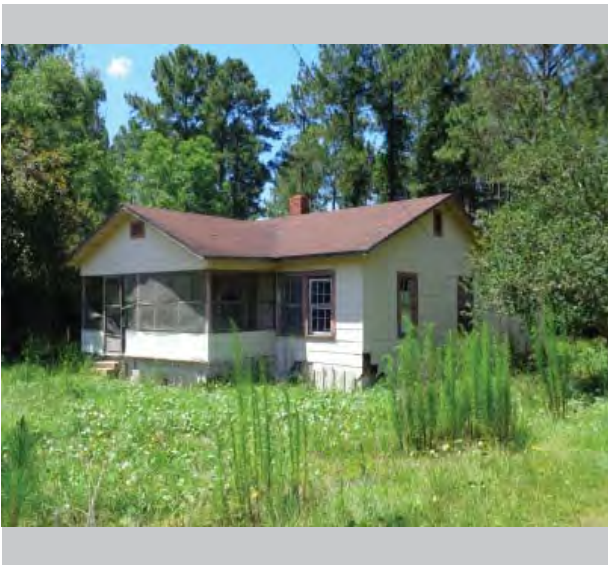
Coordinates: 31.42241, -82.36457

- Resource Type** Building
- Resource Use** Domestic: Single Dwelling
- Date of Construction** ca. 1945
- Building Type** Bungalow: Cross Gable
- Structural System** Balloon Frame
- Style** No Academic Style
- Roof** Gable: Multi
- Exterior Cladding** Prism Synthetics: Masonite Siding
- Foundation** Pier: Concrete
- Porch** Verandah
- Windows** Double Hung Sash: 6/6
- Chimney** Center: Brick
- Additional Notes** Multiple rear additions
Porch is walled and screened
Questionable condition

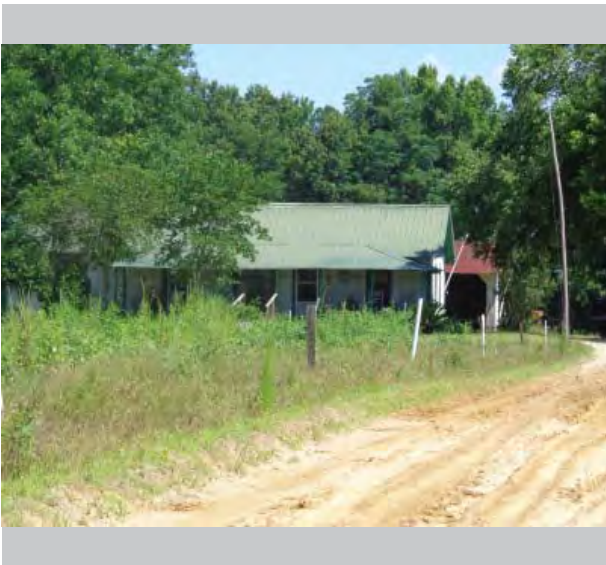
- Resource Type** Building
- Resource Use** Domestic: Single Dwelling
- Date of Construction** ca. 1930
- Building Type** Unknown
- Structural System** Balloon Frame
- Style** No Academic Style
- Roof** Gable: Side
- Exterior Cladding** Wood: Weatherboard
- Foundation** Unknown
- Porch** Verandah
- Windows** Unknown
- Chimney** No Chimney Observed
- Additional Notes** Set far off public right of way; difficult to survey
Appears to have multiple material replacements

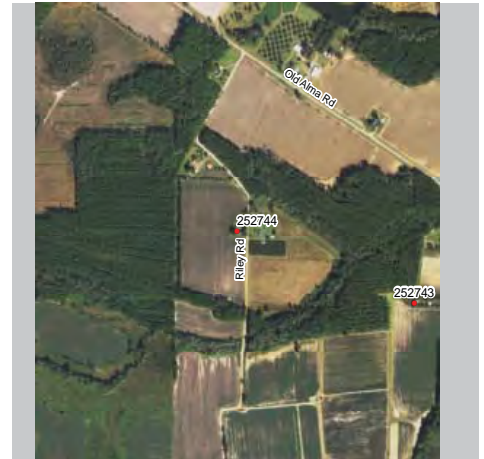
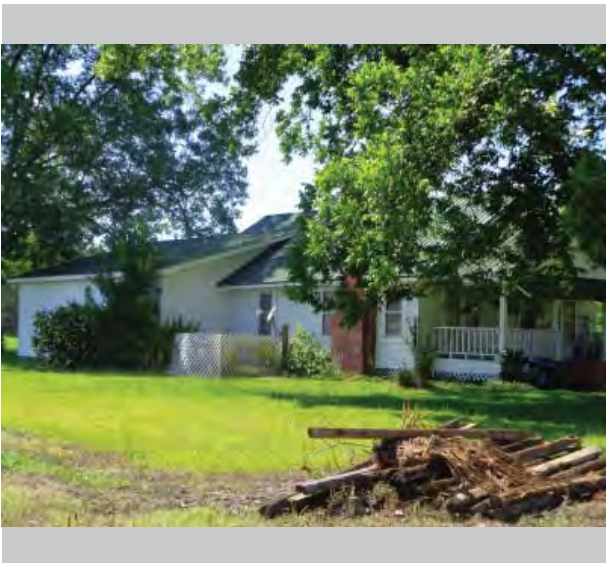
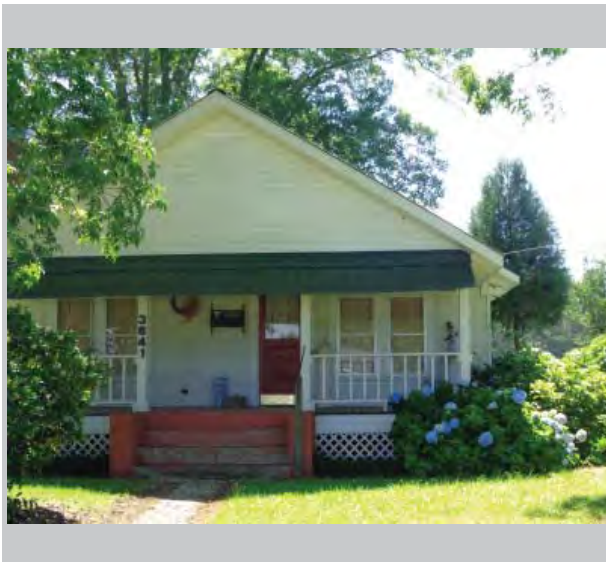
Field ID: PR-27
GNAHRGIS ID: 252744
County: Pierce
Preliminary NR Assessment: Does not meet

- Resource Type** Building
- Resource Use** Domestic: Single Dwelling
- Date of Construction** ca. 1930
- Building Type** Bungalow: Front Gable
- Structural System** Balloon Frame
- Style** No Academic Style
- Roof** Gable: Multi
- Exterior Cladding** Prism Synthetics: Vinyl Siding
- Foundation** Unknown
- Porch** Verandah
- Windows** Double Hung Sash: 1/1
- Chimney** Gable End Exterior, Lateral Exterior: Brick
- Additional Notes** Large light to entry door
Large addition in rear
Multiple material replacements

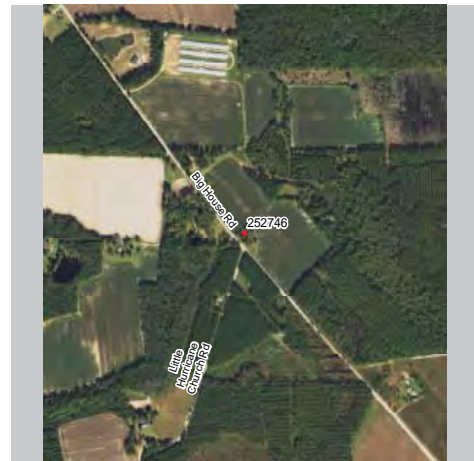
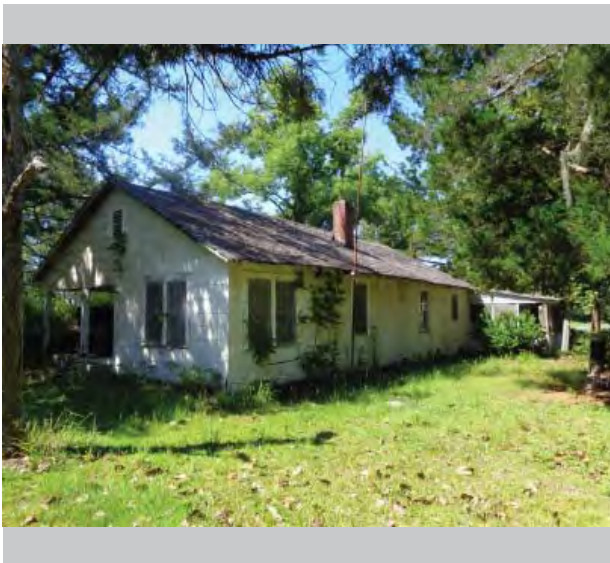
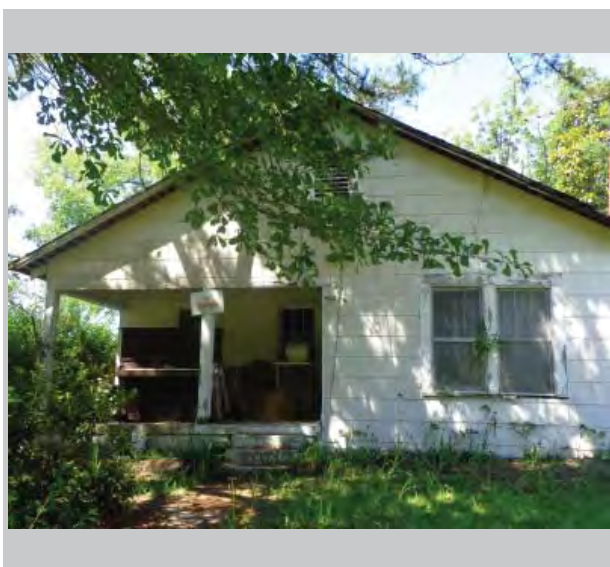
Field ID: PR-28
GNAHRGIS ID: 252746
County: Pierce
**Preliminary NR
Assessment:** Does not meet

Foundation Continuous: Concrete

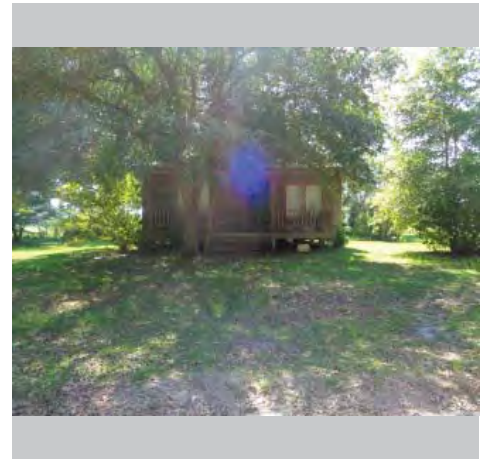
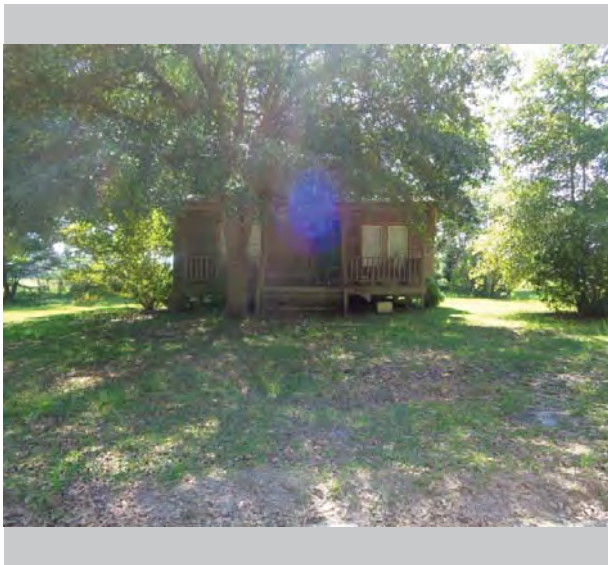
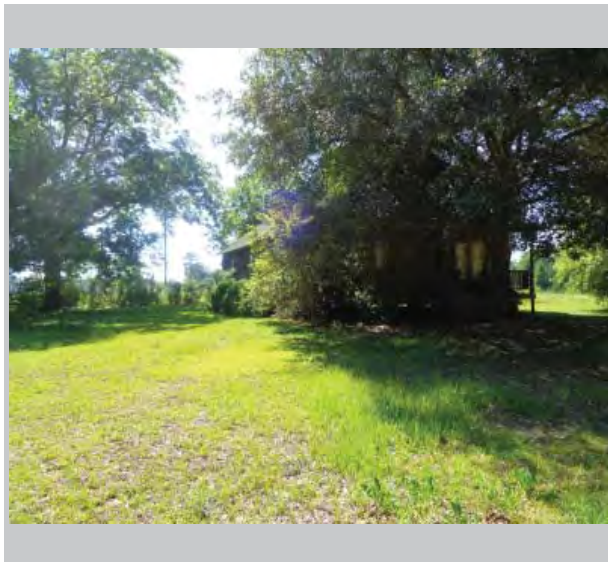
Field ID: PR-29
GNAHRGIS ID: 252749
County: Pierce
Preliminary NR Assessment: Does not meet

Additional Notes Paired double hung sash windows
Replacement materials
Obscured by vegetation

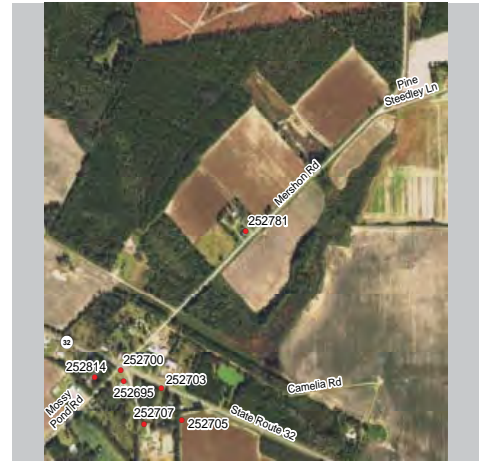
Field ID: PR-31
GNAHRGIS ID: 252781
County: Pierce
Preliminary NR Assessment: May Meet

- Resource Type** Building
- Resource Use** Domestic: Single Dwelling
- Date of Construction** ca. 1900
- Building Type** Unknown
- Structural System** Balloon Frame
- Style** No Academic Style
- Roof** Complex
- Exterior Cladding** Wood: Weatherboard, Drop Siding: Shingles
- Foundation** Pier: Concrete
- Porch** Wrap-Around
- Windows** Double Hung Sash: 12/12
- Chimney** No Chimney Observed
- Additional Notes** Sawtooth shingles in gable
Bay window on side
Corbelled chimney
Unusual type for Georgia

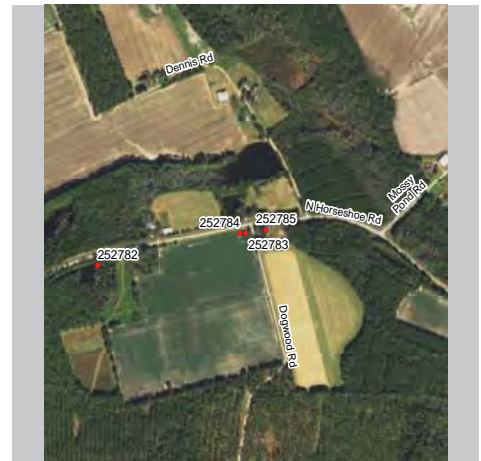
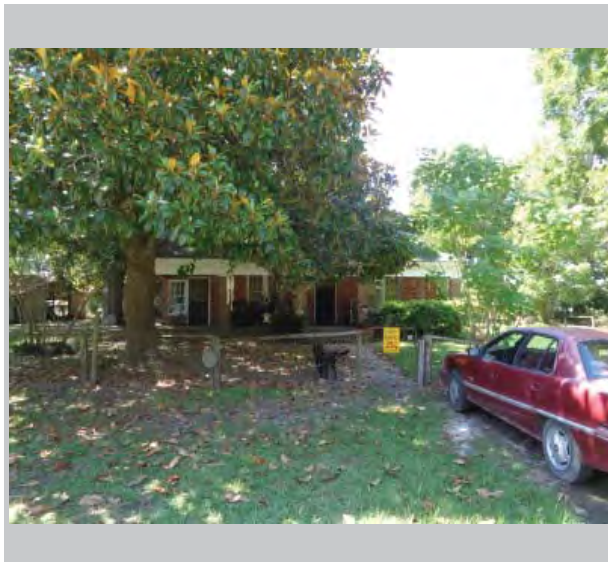
Field ID: PR-33
GNAHRGIS ID: 252783
County: Pierce
Preliminary NR Assessment: Appears to Meet

- Resource Type** Building
- Resource Use** Residential: Single Family Dwelling
- Date of Construction** 1925
- Building Type** Bungalow: Hip
- Structural System** Balloon Frame
- Style** Craftsman
- Roof** Gable: Front
- Exterior Cladding** Brick: Veneer
- Foundation** Unknown
- Porch** Recessed
- Windows** Double Hung Sash: 3/1 Rectangular
- Chimney** Off-center Within Roof: Ridgeline
- Additional Notes** Craftsman style windows (paired).
Two front doors.

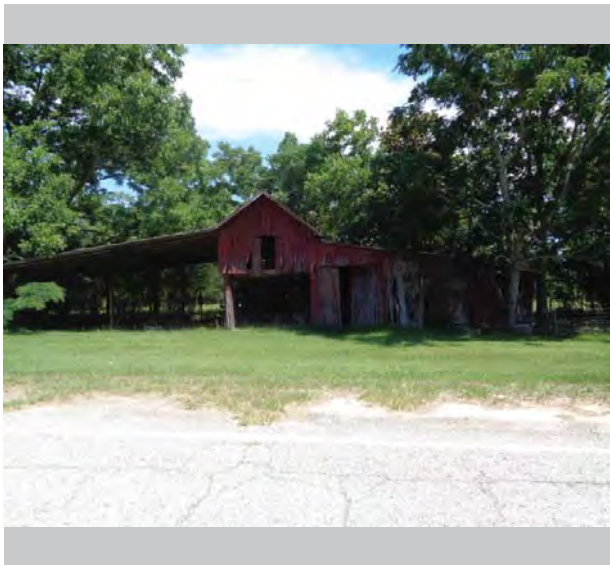
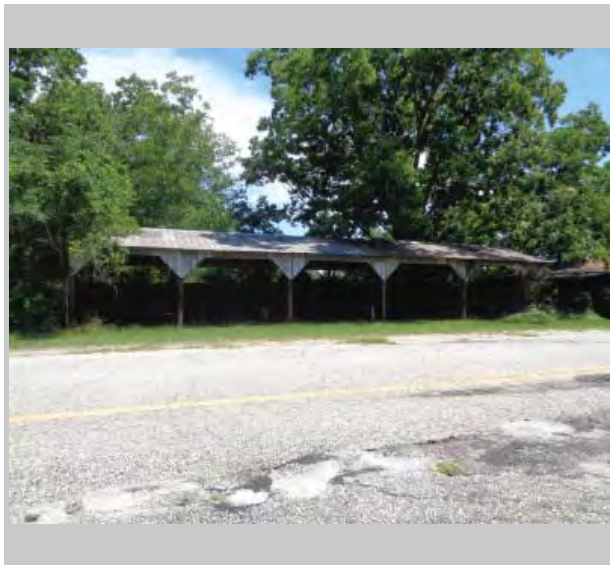
- Resource Type** Site
- Resource Use** Vacant
- Date of Construction** 1910-1920
- Building Type** Unknown
- Structural System** Balloon Frame
- Style** No Academic Style
- Roof** Unknown
- Exterior Cladding** Wood: Weatherboard
- Foundation** Unknown
- Porch** None
- Windows** Unknown
- Chimney** Unknown

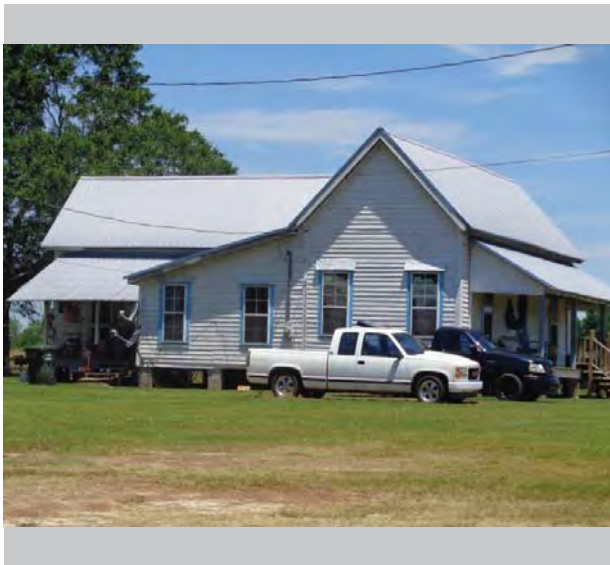
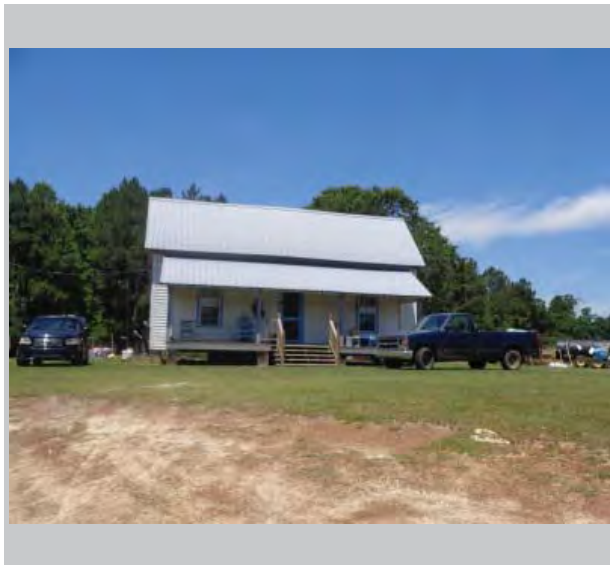
- Resource Type** Building
- Resource Use** Residential: Single Family Dwelling
- Date of Construction** 1910
- Building Type** Central Hallway
- Structural System** Balloon Frame
- Style** No Academic Style
- Roof** Gable:Side
- Exterior Cladding** Wood: Weatherboard
- Foundation** Pier: Concrete Block
- Porch** Verandah
- Windows** Double Hung Sash: 4/4, 6/6, 6/4, 9/6, Rectangular
- Chimney** No Chimney Observed
- Additional Notes** Appears to have addition in back. Historic L shape (1920-1930). Outbuildings raised or moved.

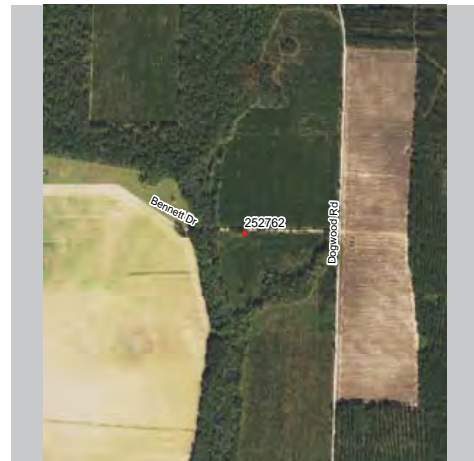
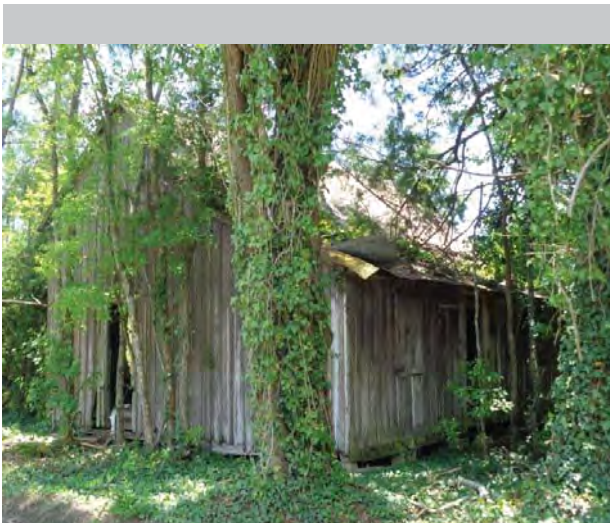
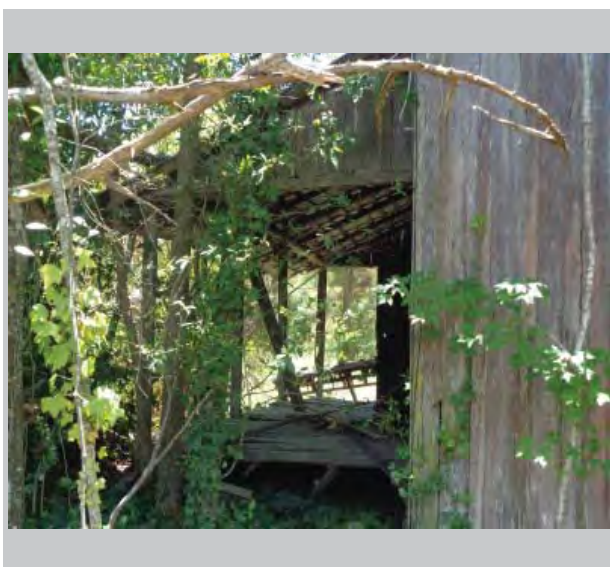
Field ID: PR-40
GNAHRGIS ID: 252762
County: Pierce
**Preliminary NR
Assessment:** May Meet

Additional Notes One doorway without door. Windows covered/missing glass. Historic rearshed addition.

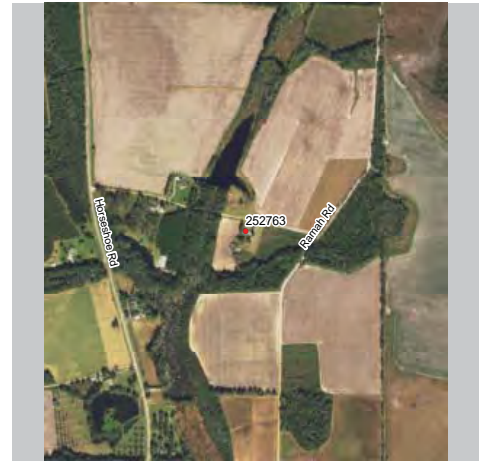
Field ID: PR-41
GNAHRGIS ID: 252763
County: Pierce
Preliminary NR Assessment: Does Not Meet

- Resource Type** Building
- Resource Use** Residential: Single Family Dwelling
- Date of Construction** ca. 1965
- Building Type** Ranch
- Structural System** Balloon Frame
- Style** No Academic Style
- Roof** Gable: Multi
- Exterior Cladding** Brick: Veneer
- Foundation** Pier with Infill: Brick
- Porch** Verandah
- Windows** Fixed: 1/1, Rect. Unknown: 1/1, Rect.
- Chimney** Gable-End, Interior
- Additional Notes** Carport with three walled sides. Fanlight on door. Large side gable addition. Window replacements.

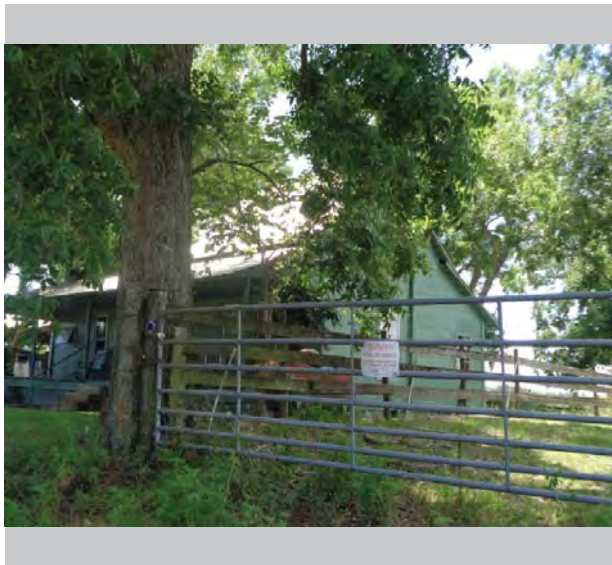
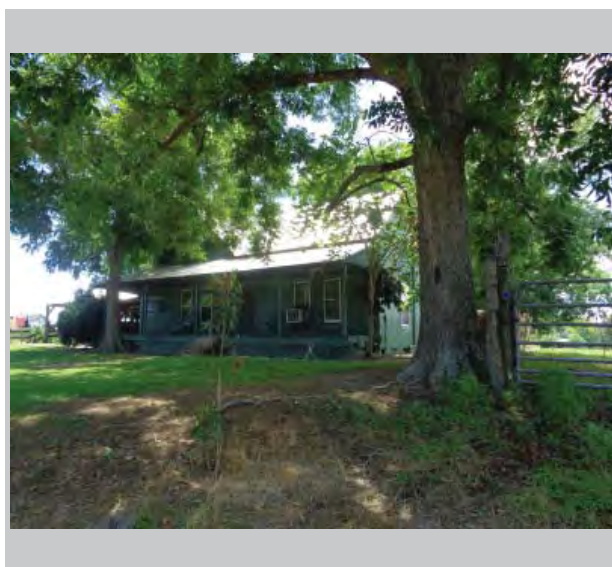
1633 Caney Creek Road

Foundation Continuous: Concrete

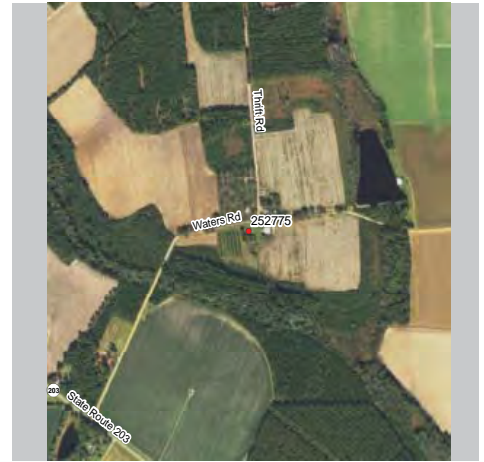
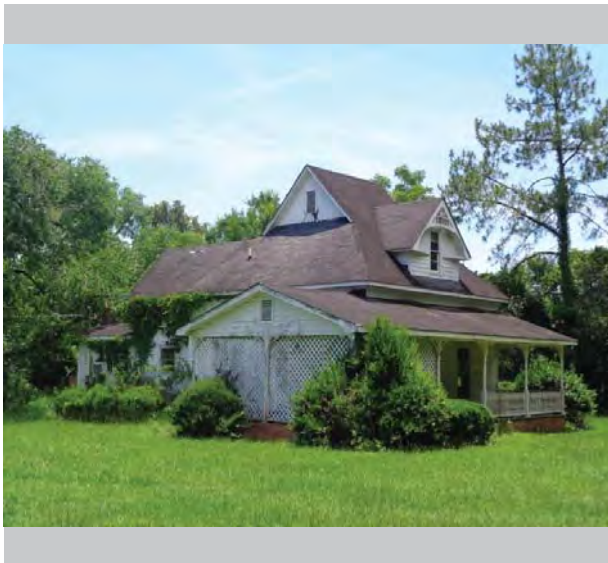
Intersection of Waters Rd and Thrift Rd

- Resource Type** Building
- Resource Use** Residential: Single Family Dwelling
- Date of Construction** 1915
- Building Type** N/A - See Notes
- Structural System** Balloon Frame
- Style** No Academic Style
- Roof** Gable: Complex
- Exterior Cladding** Wood: Weatherboard
- Foundation** Pier with Infill: Brick
- Porch** Verandah
- Windows** Double Hung Sash: 2/2, Rect.
- Chimney** No Chimney Observed
- Additional Notes** Seems to be local variant. Hip on gable. Sawtooth shingles in gable. Spindlework columns.

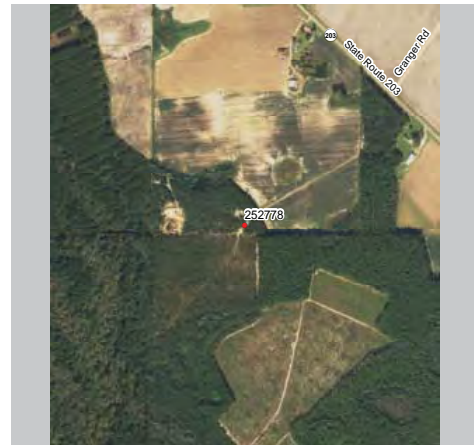
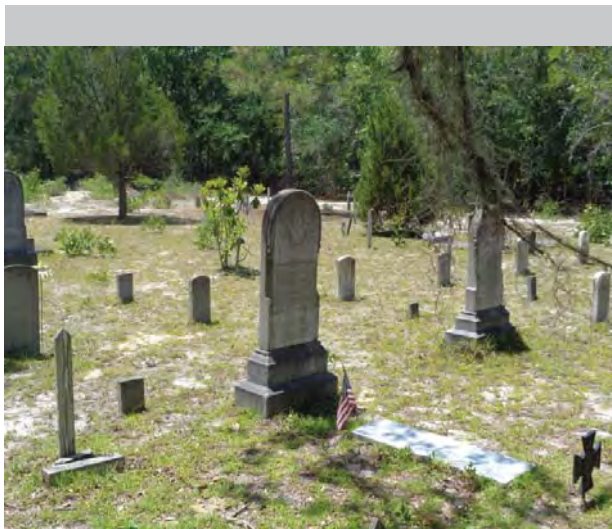
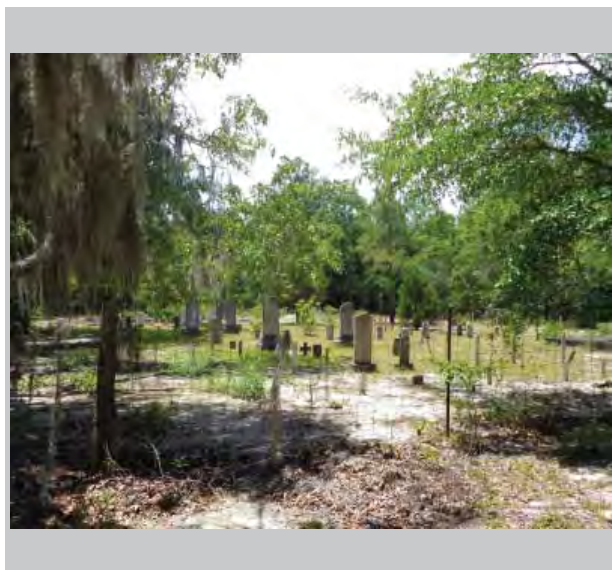
Henderson Cemetery
 Off HWY 203, 1/4 mile on unnamed road.

Resource Type Site

Resource Use Funerary: Cemetery
