Historic Resources Survey Report

Pierce County, Georgia

July 2016

The University of Georgia
College of Environment and Design
Center for Community Design & Preservation
Historic Resources Survey Report
Pierce County, Georgia 2016

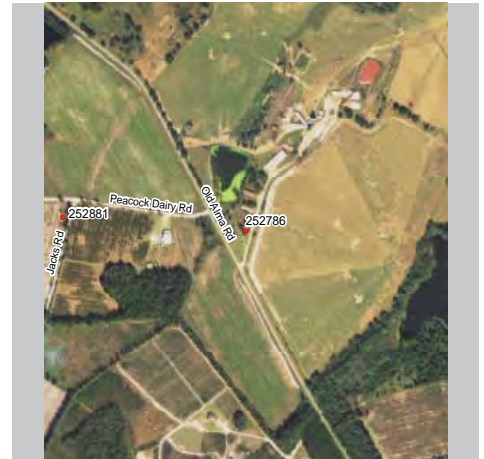
4208 Old Alma Road

- Resource Type** Building
- Resource Use** Residential: Single Family Dwelling
- Date of Construction** 1970
- Building Type** Ranch
- Structural System** Balloon Frame
- Style** No Academic Style
- Roof** Gable: Multi
- Exterior Cladding** Brick: Veneer
- Foundation** Unknown
- Porch** Recessed
- Windows** Double Hung Sash: 4/4, 6/6, 8/8, Rect.
- Chimney** Off-center: Ridgeline
- Additional Notes** "Y" shaped ranch. Wood on gable ends with curved detail over windows. Multiple additions.

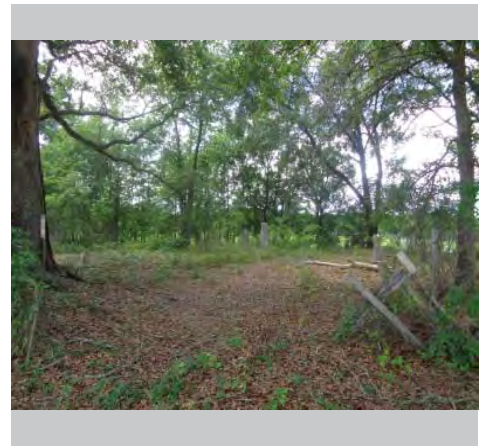
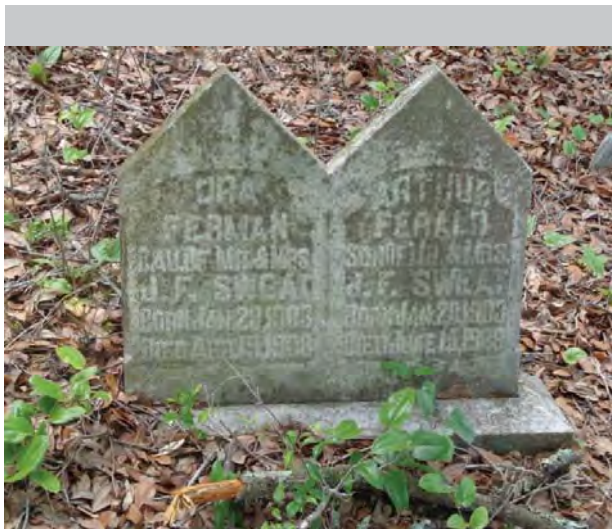
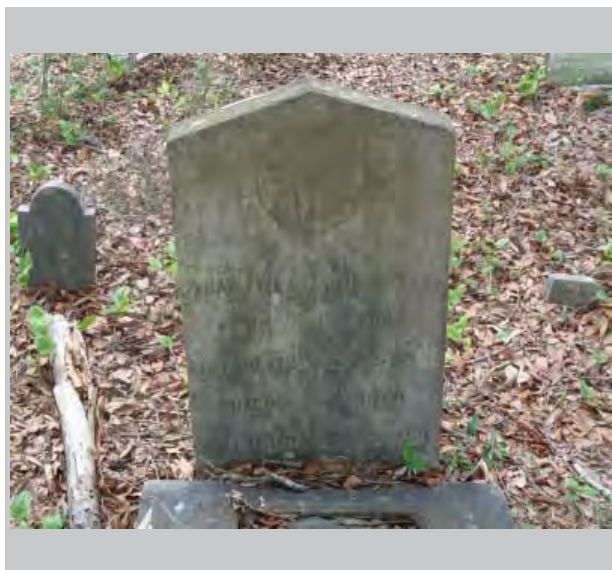
Sweat Cemetery
MeadowWood Loop, between Alicia Rd & HWY 203
Coordinates: 31.36783, -82.29082

Cemetery Description Earliest observed: 1860's. Mostly late 1800's and early 1900's. Random plots, no pattern or grid. Fenced with wood posts and wire. Lots of stones without names, around 25-30 graves. Sweat family.

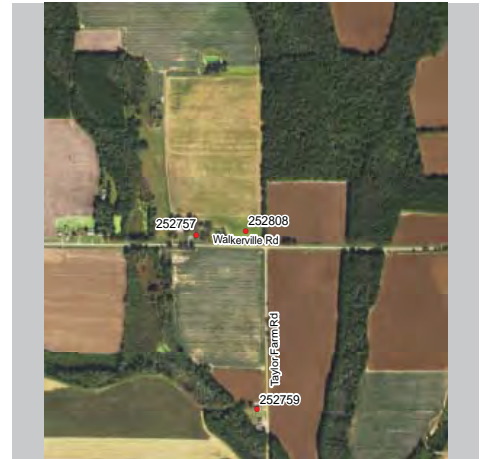
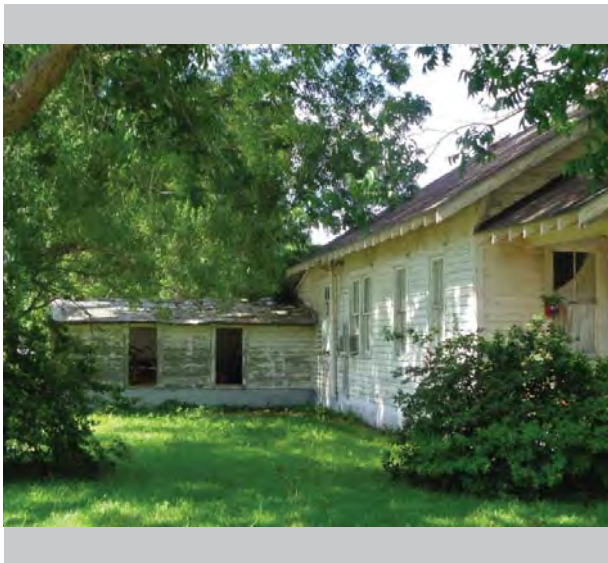
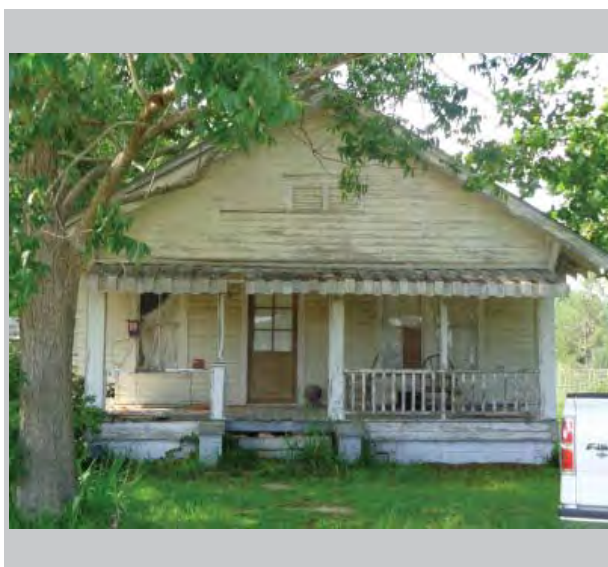
Walkermill Road (Beside PR-36/ID: 252757)

Foundation Pier: Concrete

Additional Notes Built in 1800's, burnt down and rebuilt in 1920's. Off center front door, large roof overhang.

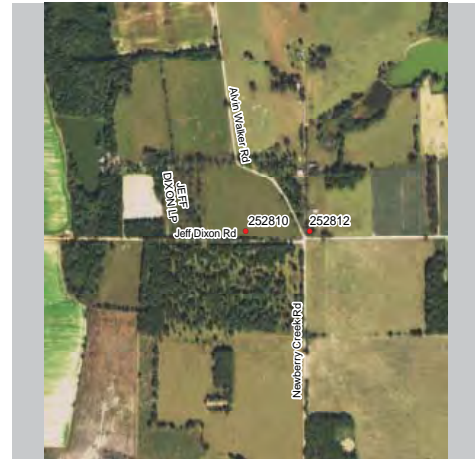
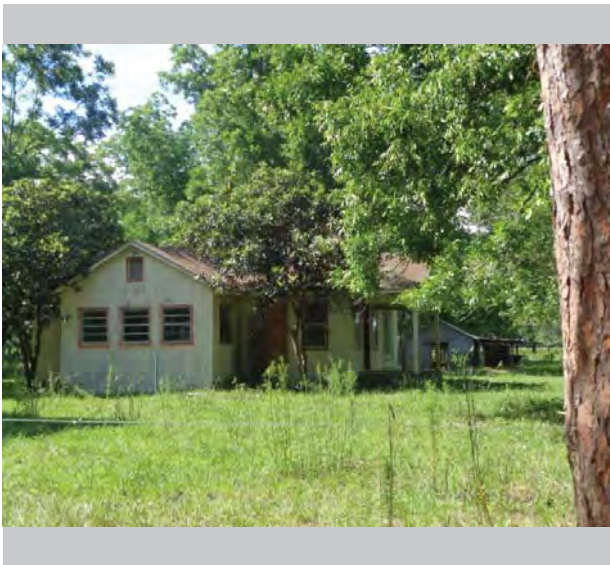
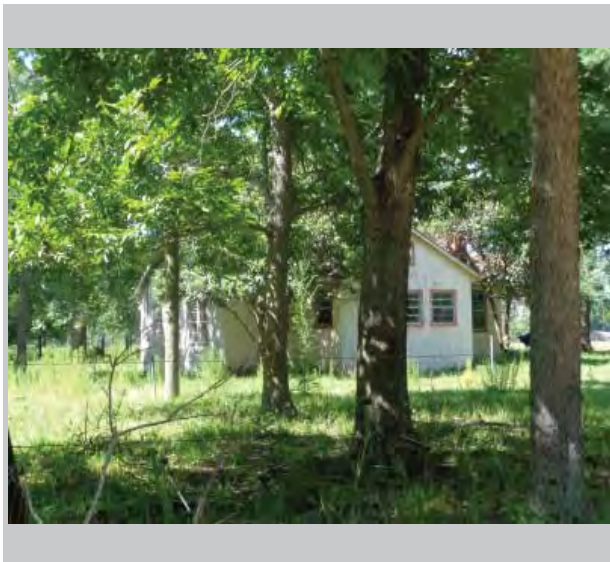
Near intersection of Jeff Dixon Rd & Alvin Walker Rd

Foundation Pier: Concrete Block

Additional Notes Midcentury replacement windows. Original house type unknown.

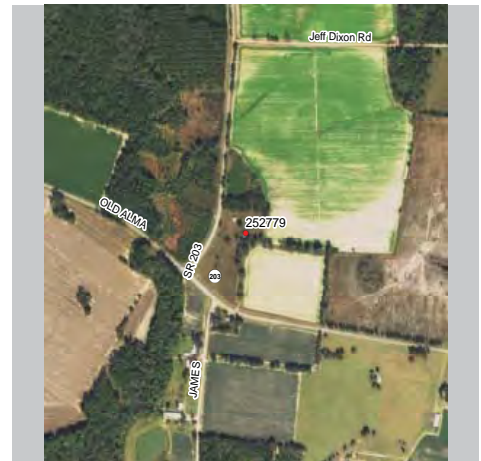
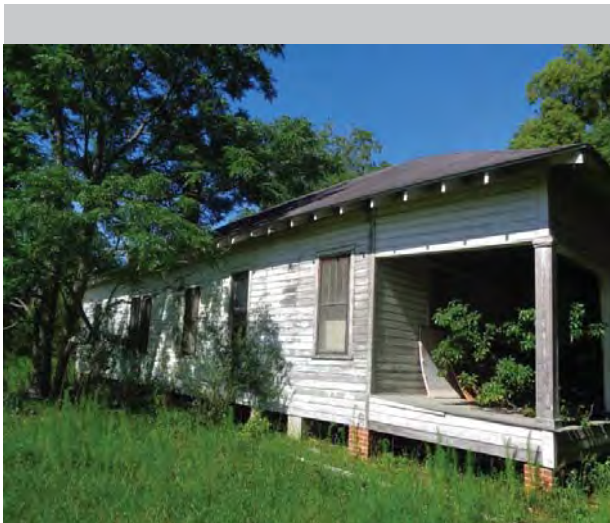
The Dixon House
Intersection between HWY 203 & Old Alma Rd

- Resource Type** Building
- Resource Use** Residential: Single Family Dwelling
- Date of Construction** 1920
- Building Type** Georgian Cottage
- Structural System** Balloon Frame
- Style** Craftsman
- Roof** Hip
- Exterior Cladding** Wood: Weatherboard
- Foundation** Pier with Infill: Brick & Concrete
- Porch** Verandah
- Windows** Double Hung Sash: 1/6, 4/1, 2/2, 1/2.
- Chimney** Off-center within roofline surf. Lateral Exterior.
- Additional Notes** Some condition issues at peak. Two chimneys. Overhanging eaves, screened porch on rear.

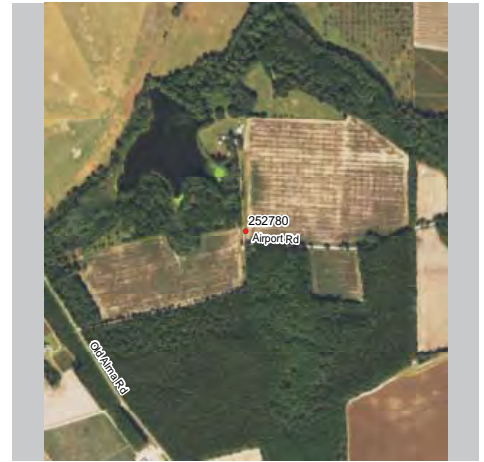
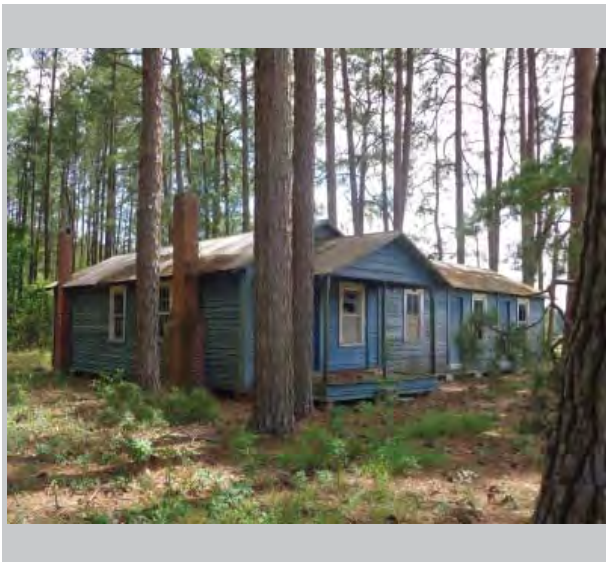
Airport Rd off Old Alma Rd

- Resource Type** Building
- Resource Use** Residential: Single Family Dwelling
- Date of Construction** 1930
- Building Type** No Type
- Structural System** Balloon Frame
- Style** Craftsman
- Roof** Gable:Side
- Exterior Cladding** Wood: Weatherboard
- Foundation** Pier:Brick & Concrete
- Porch** Verandah
- Windows** Double Hung Sash: 2/2, 6/6. Rectangle.
- Chimney** Lateral Exterior: Brick
- Additional Notes** Originally multi-housing, possibly triplex or more. Both chimneys on one side. Craftsman elements.

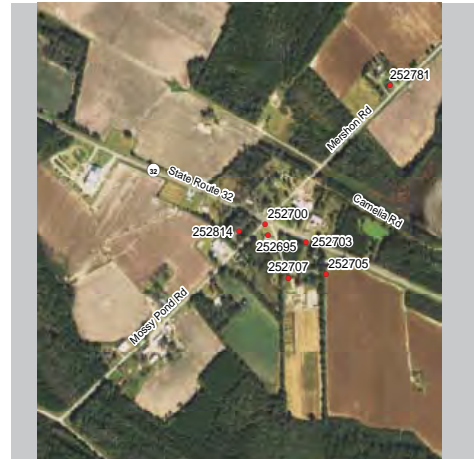
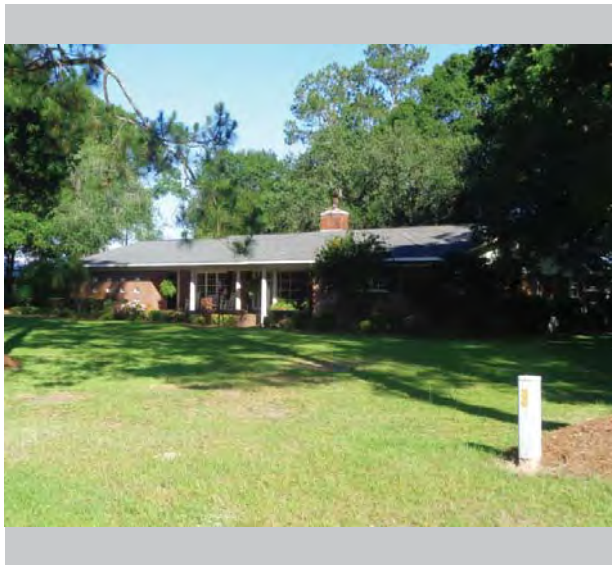
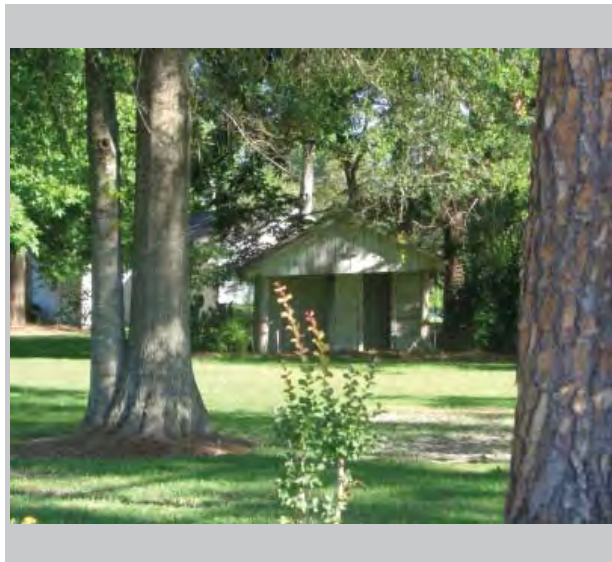
1755 Mershon Road

Foundation Continuous: Brick

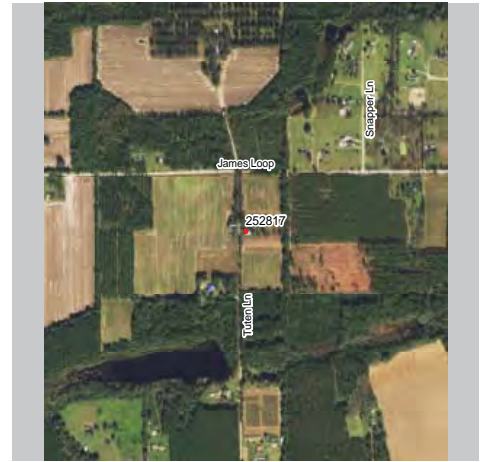
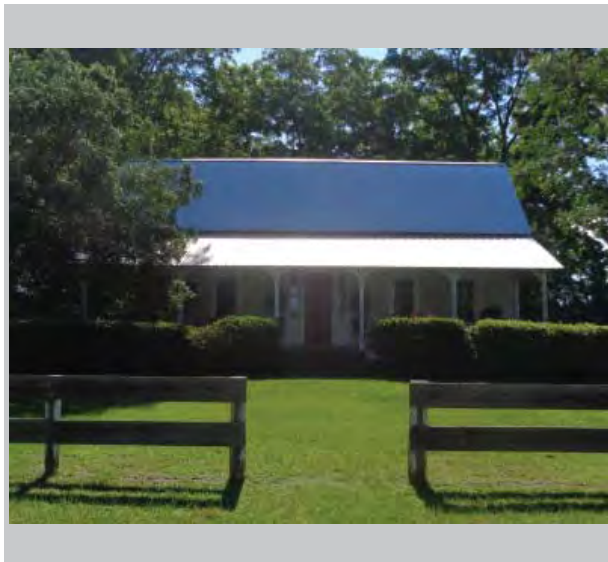
4941 Tuten Lane

- Resource Type** Building
- Resource Use** Residential: Single Family Dwelling
- Date of Construction** 1900
- Building Type** Central Hallway
- Structural System** Balloon Frame
- Style** No Academic Style
- Roof** Gable:Side
- Exterior Cladding** Wood: Weatherboard
Synthetic: Vinyl
- Foundation** Pier: Concrete
- Porch** Verandah
- Windows** Double Hung Sash: 4/4,
Rectangular.
- Chimney** Lateral Exterior: Brick
- Additional Notes** Outbuildings appear to have been housing & barns, all historic. Side lights on front door.

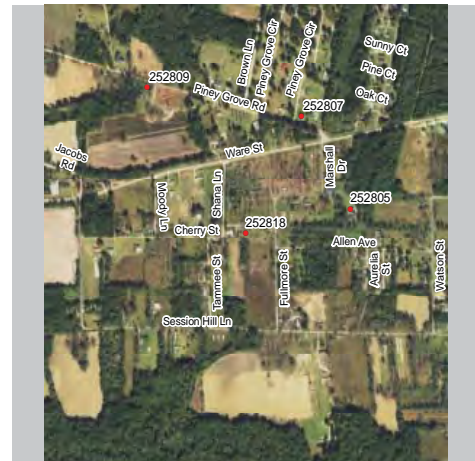
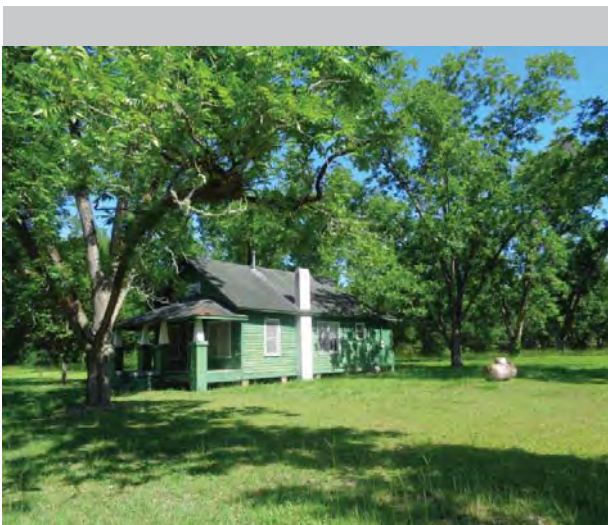
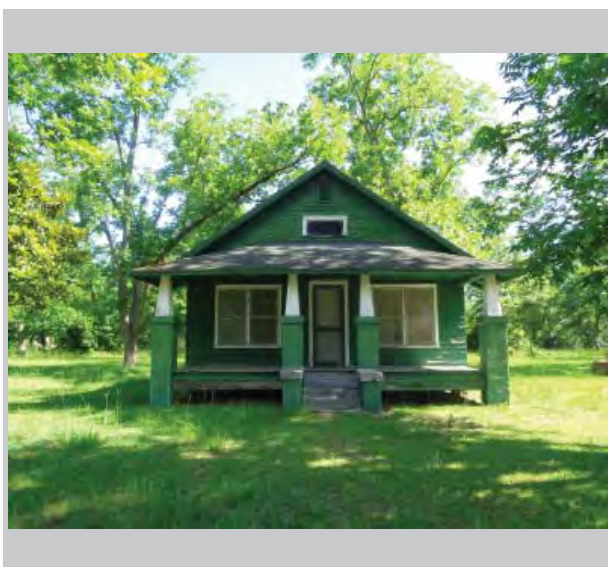
Cherry Street Across from 3113

Foundation Pier: Brick & Concrete

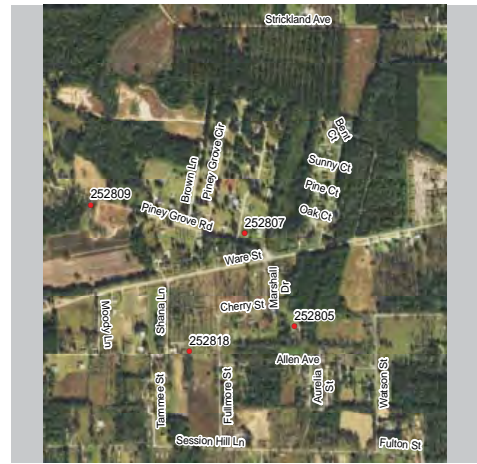
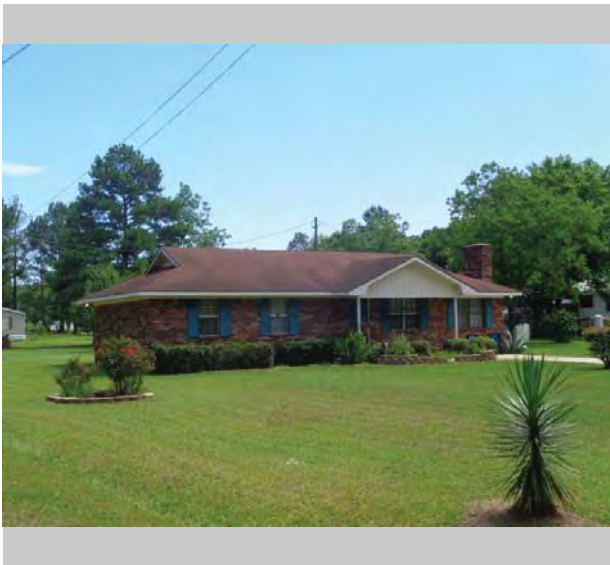
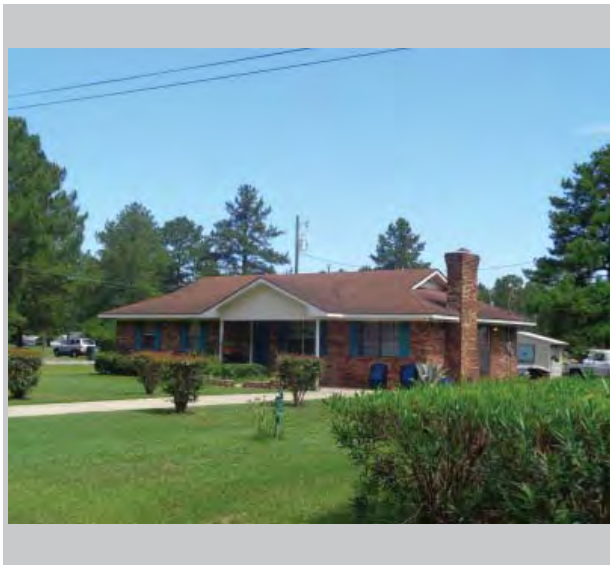
On Piney Grove Road off Ware Street
Coordinates: 31.30109, -82.26348

Foundation Continuous: Brick

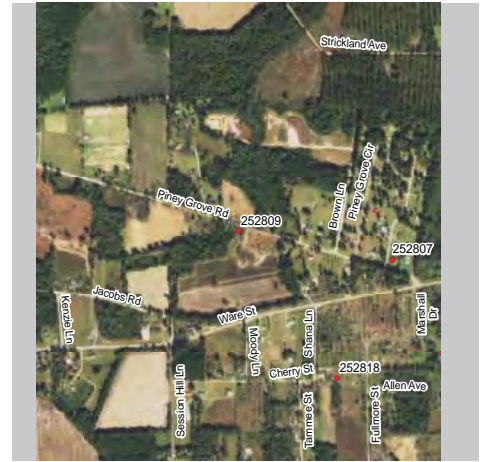
2835 Piney Grove Road

- Resource Type** Building
- Resource Use** Residential: Single Family Dwelling
- Date of Construction** 1920
- Building Type** Bungalow: Front Gable
- Structural System** Balloon Frame
- Style** Craftsman
- Roof** Gable: Front
- Exterior Cladding** Wood: Weatherboard
- Foundation** Pier: Brick & Concrete
- Porch** Verandah
- Windows** Double Hung Sash: 4/1, Rect.
- Chimney** Off Center Within Roof-Surf: Brick
- Additional Notes** Porch foundation is continuous concrete, main house is brick pier. Exposed rafter tails.

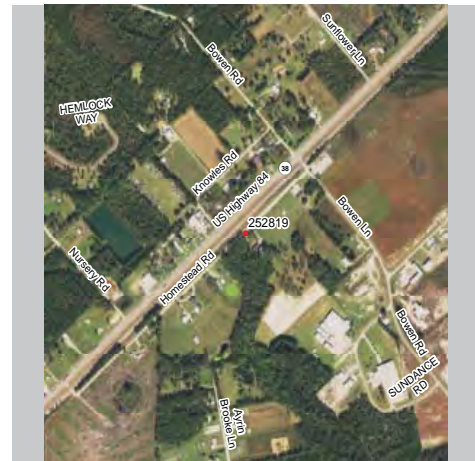
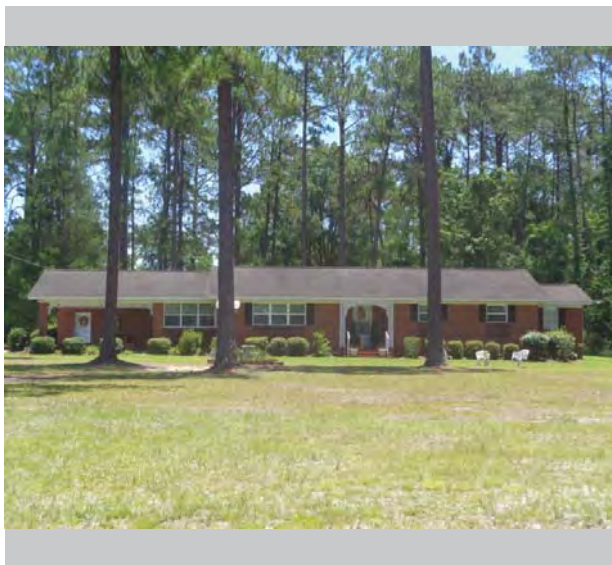
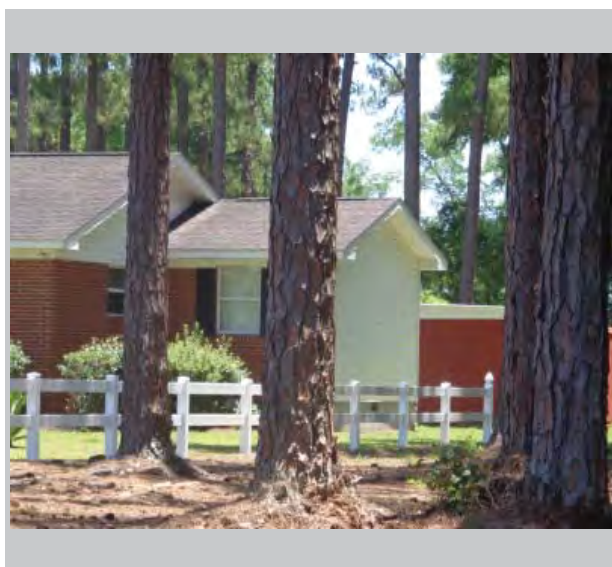
6058 Homestead Road

Foundation Continuous: Brick

Chimney No chimney observed

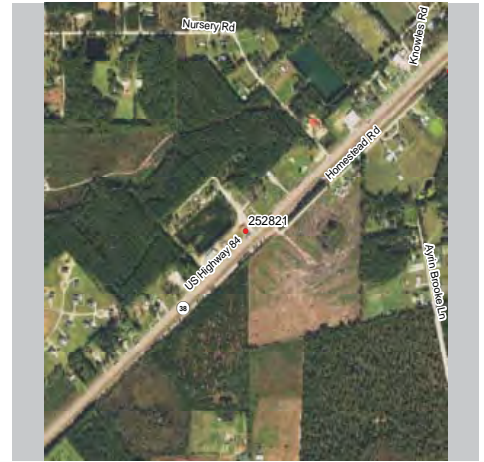
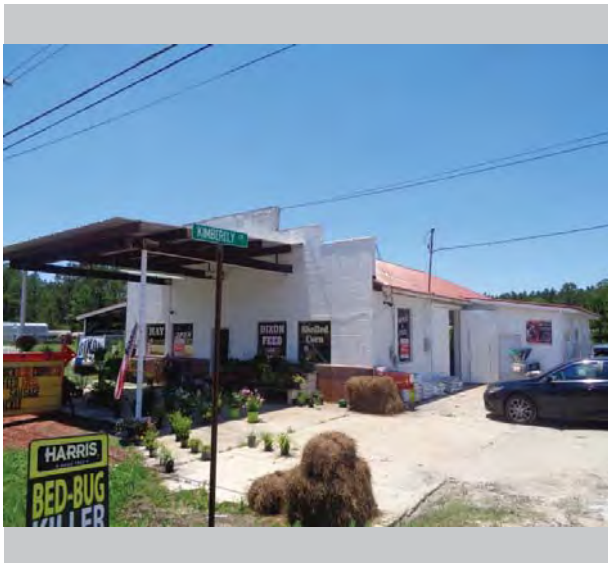
Field ID: PR-59
GNAHRGIS ID: 252821
County: Pierce
Preliminary NR Assessment: May Meet

- Resource Type** Building
- Resource Use** Commercial: single retail
- Date of Construction** 1930
- Building Type** No Known Type
- Structural System** Balloon Frame
- Style** No Academic Style
- Roof** Gable: Front
- Exterior Cladding** Concrete: Concrete Block
- Foundation** Continuous: Concrete Block
- Porch** None
- Windows** Fixed: 1 pane, Square
- Chimney** No Chimney Observed
- Additional Notes** Parapet pattern on front gable (obscuring gable). Garage doors on rear. False front, new windows.

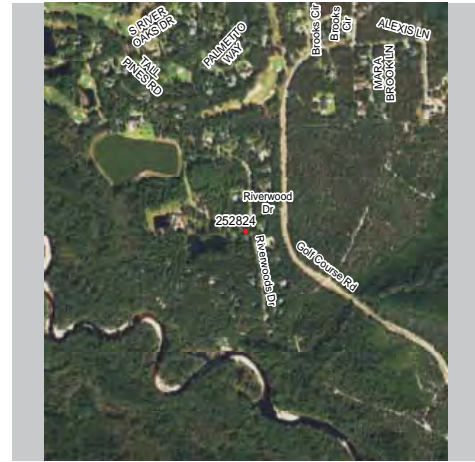
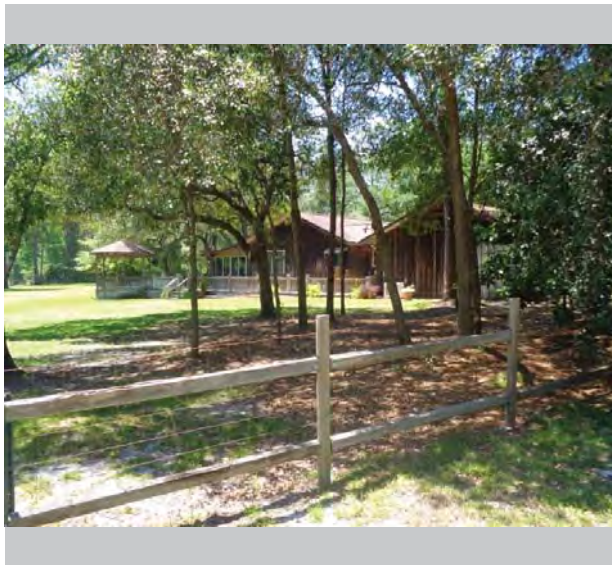
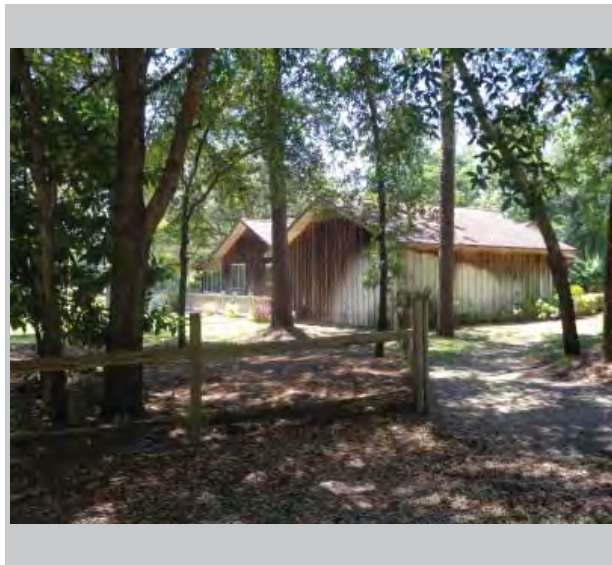
Field ID: PR-60
GNAHRGIS ID: 252824
County: Pierce
Preliminary NR Assessment: Does Not Meet

Additional Notes Rusticated ranch made to look historic.

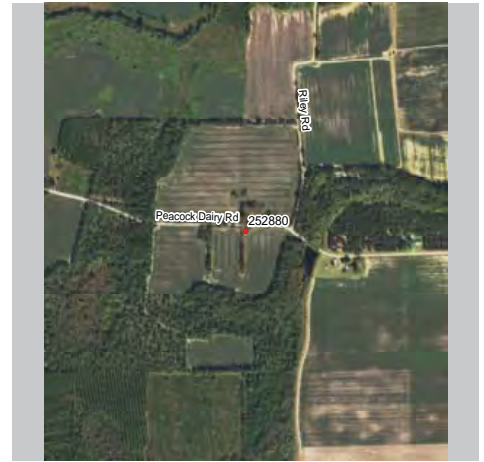
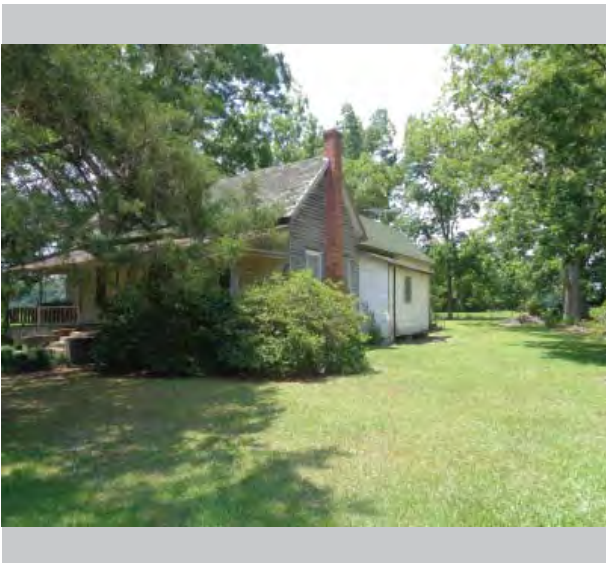
Field ID: PR-61
GNAHRGIS ID: 252880
County: Pierce
Preliminary NR Assessment: May Meet

- Resource Type** Building
- Resource Use** Residential: Single Family Dwelling
- Date of Construction** 1890
- Building Type** Central Hallway
- Structural System** Balloon Frame
- Style** No Academic Style
- Roof** Gable:Side
- Exterior Cladding** Wood: Clapboard
- Foundation** Pier:Brick
- Porch** Verandah
- Windows** Flat: 2/2. Rectangle.
- Chimney** Both Gable Ends: Brick
- Additional Notes** Fish scale shingles. 5 bays across. Central bay = front door. Decorative wood supports on front porch.

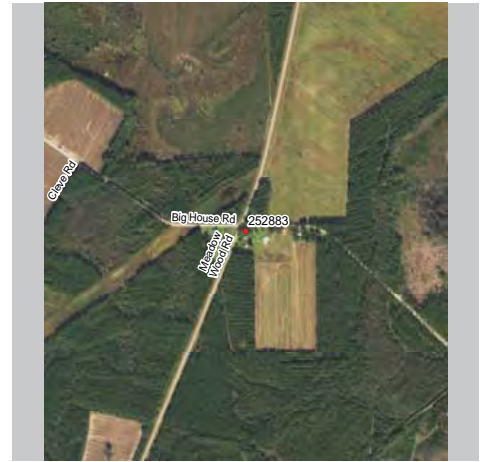
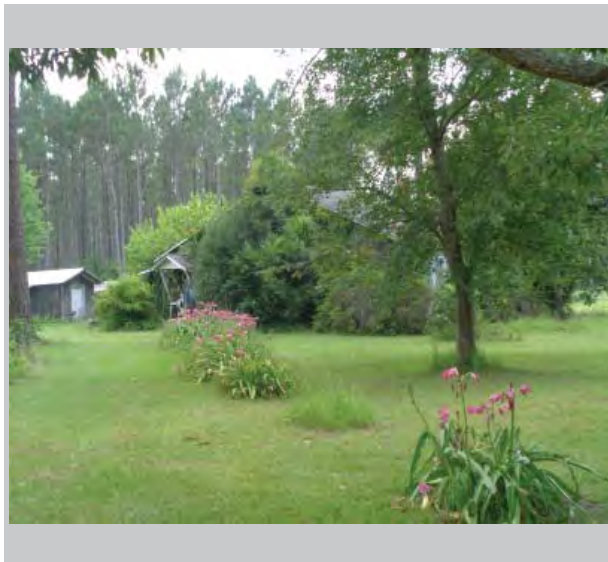
Field ID: PR-63
GNAHRGIS ID: 252883
County: Pierce
Preliminary NR Assessment: Appears to Meet

- Resource Type** Building
- Resource Use** Residential: Single Family Dwelling
- Date of Construction** 1920
- Building Type** Bungalow: Front Gable
- Structural System** Balloon Frame
- Style** No Academic Style
- Roof** Gable: Front
- Exterior Cladding** Drop Siding: Shingles
- Foundation** Unknown
- Porch** Portico
- Windows** Double Hung Sash: 2/2, 6/6. Rectangle.
- Chimney** Gable End Exterior & Off CTR With Roof Surf: Brick
- Additional Notes** 2 front doors with front gables on front. Exposed rafters. Front is covered by vegetation. Side 2 bays.

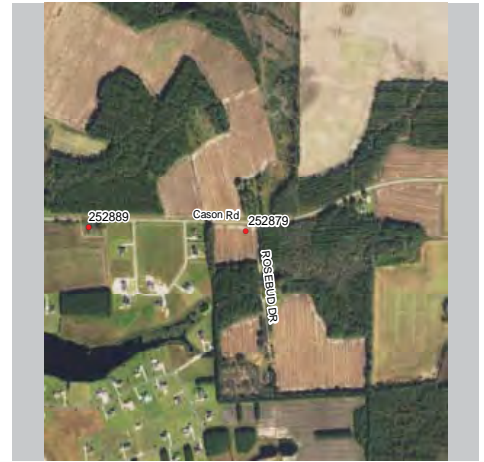
Field ID: PR-65
GNAHRGIS ID: 252879
County: Pierce
Preliminary NR Assessment: Appears to Meet

- Resource Type** Building
- Resource Use** Residential: Single Family Dwelling
- Date of Construction** 193
- Building Type** Bungalow: Front Gable
- Structural System** Balloon Frame
- Style** No Academic Style
- Roof** Gable: Front
- Exterior Cladding** Wood: Weatherboard
- Foundation** Unknown
- Porch** Portico
- Windows** Double Hung Sash: 6/6. Rectangle.
- Chimney** Lateral Exterior: Brick x2 Off CTR With Rood Surf
- Additional Notes** Clipped gable on front. Brick porch steps. Front door at center flanked by pair of DHS 6/6 both sides.

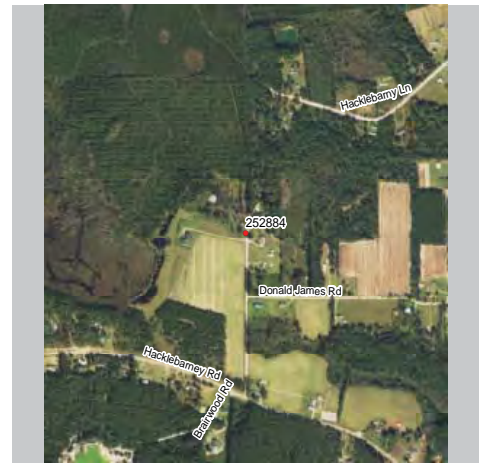
Field ID: PR-67
GNAHRGIS ID: 252884
County: Pierce
Preliminary NR Assessment: May Meet

- Resource Type** Building
- Resource Use** Residential: Single Family Dwelling
- Date of Construction** 1960
- Building Type** Ranch
- Structural System** Balloon Frame
- Style** No Academic Styl
- Roof** Gable:Side
- Exterior Cladding** Brick: Veneer
- Foundation** Pier:Brick
- Porch** Verandah
- Windows** Double Hung Sash: 3/1. Rectangle.
- Chimney** No Chimney Observed
- Additional Notes** Linear ranch, 3 bays across. Left bay 3/1 window. Central portico porch, metal supports.

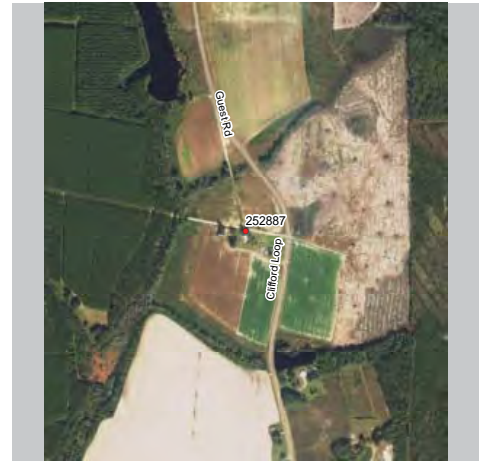
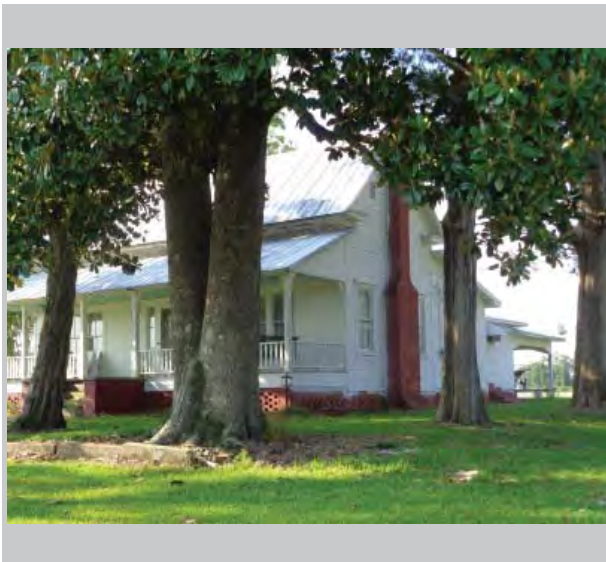
Field ID: PR-69
GNAHRGIS ID: 252887
County: Pierce
Preliminary NR Assessment: Appears to Meet

- Resource Type** Building
- Resource Use** Residential: Single Family Dwelling
- Date of Construction** 1910
- Building Type** Central Hallway
- Structural System** Balloon Frame
- Style** No Academic Style
- Roof** Gable:Side
- Exterior Cladding** Wood: Weatherboard
- Foundation** Pier:Brick
- Porch** Verandah
- Windows** Double Hung Sash: 2/2, 6/6. Rectangle.
- Chimney** Gable Ends: Both sides and rear. 3 chimneys.
- Additional Notes** Sidelights on front door. Rectangular vent in gable. 3 chimneys, 3 bay facade. Detail on porch supports.

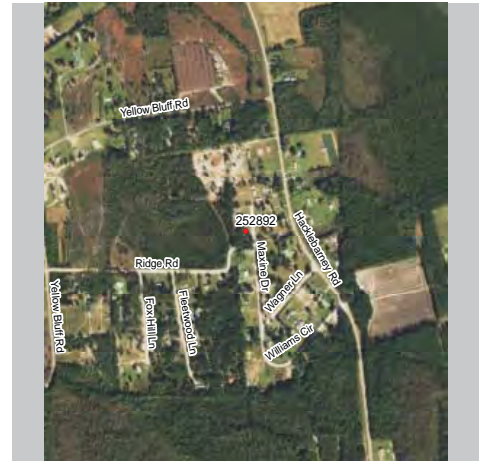
Field ID: PR-71
GNAHRGIS ID: 252892
County: Pierce
Preliminary NR Assessment: May Meet

- Resource Type** Building
- Resource Use** Residential: Single Family Dwelling
- Date of Construction** 1910
- Building Type** Bungalow: Front Gable
- Structural System** Balloon Frame
- Style** Craftsman
- Roof** Hip
- Exterior Cladding** Wood: Weatherboard
- Foundation** Pier: Concrete
- Porch** Verandah
- Windows** Double Hung Sash: 1/1. Rectangle.
- Chimney** No Chimney Observed
- Additional Notes** Asymmetrical Bungalow. 3 bays: both end bays with paired windows. Addition in rear.

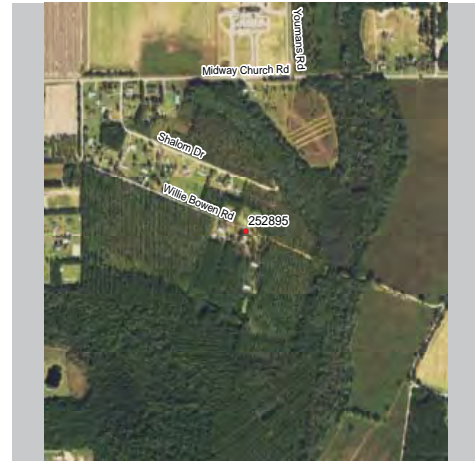
Field ID: PR-72
GNAHRGIS ID: 252895
County: Pierce
Preliminary NR Assessment: May Meet

- Resource Type** Building
- Resource Use** Residential: Single Family Dwelling
- Date of Construction** 1890
- Building Type** I-House: Central Hallway
- Structural System** Balloon Frame
- Style** No Academic Style
- Roof** Gable:Side
- Exterior Cladding** Wood: Weatherboard
- Foundation** Pier:Brick & Concrete
- Porch** Verandah
- Windows** Double Hung Sash: 2/2. Rectangle.
- Chimney** Gable End Exterior: Brick
- Additional Notes** Sidelights on front door. Replacement windows. Multiple additions to back. Different materials used.

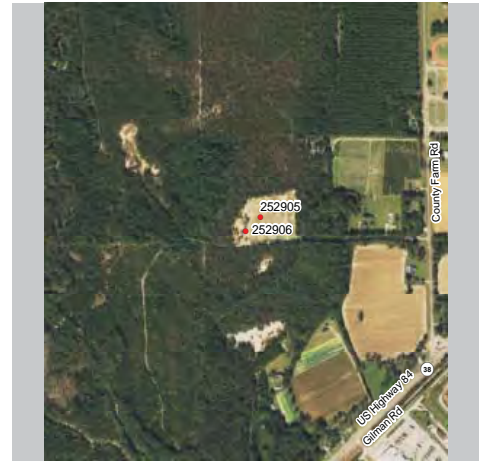
Field ID: PR-75
GNAHRGIS ID: 252906
County: Pierce
Preliminary NR Assessment: May Meet

- Resource Type** Building
- Resource Use** Church
- Date of Construction** 1940
- Building Type** Single Pen: Church
- Structural System** Balloon Frame
- Style** No Academic Style
- Roof** Gable: Front
- Exterior Cladding** Wood: Vertical Board
- Foundation** Pier: Wood & Wood Log
- Porch** Stoop
- Windows** Unknown: Shuttered
- Chimney** No Chimney Observed
- Additional Notes** Restroom outbuilding. Exposed rafters. Rear door with ramp. Log pier and plank foundation.

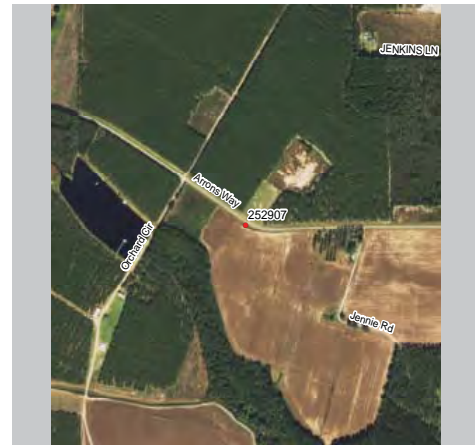
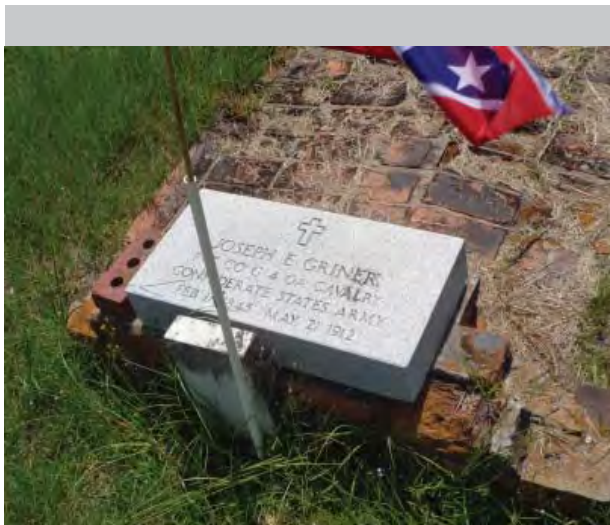
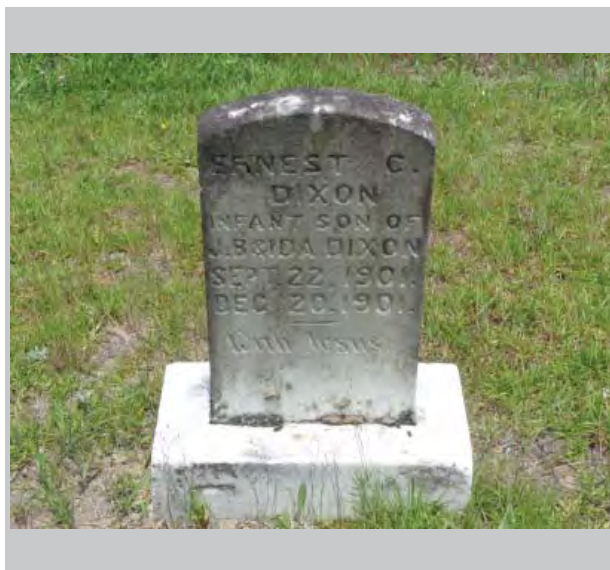
Field ID: PR-76
GNAHRGIS ID: 252907
County: Pierce
Preliminary NR Assessment: Does Not Meet

Cemetery Description Active Use. Largely random plots, but all facing the same direction. Mixed old and new, predominantly old. 1861 earliest observed date, majority below 1930. Surrounded by fencing and timber rows.

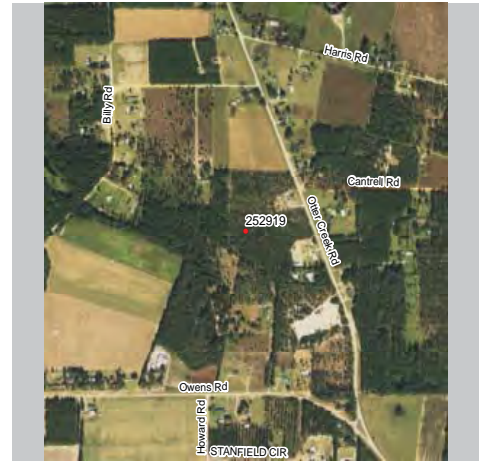
Field ID: PR-77
GNAHRGIS ID: 252919
County: Pierce
Preliminary NR Assessment: May Meet

- Resource Type** Building
- Resource Use** Residential: Single Family Dwelling
- Date of Construction** 1920
- Building Type** Bungalow: Front Gable
- Structural System** Balloon Frame
- Style** Craftsman
- Roof** Gable: Front
- Exterior Cladding** Synthetic: Asbestos Siding
- Foundation** Pier: Brick
- Porch** Verandah
- Windows** Double Hung Sash: 2/2. Rectangle.
- Chimney** Lateral Exterior: Brick
- Additional Notes** Rear addition (vinyl). Rect. vent in front gable. Ceiling fans on porch. 3 pecan, 1 magnolia, 3 cypress yard.

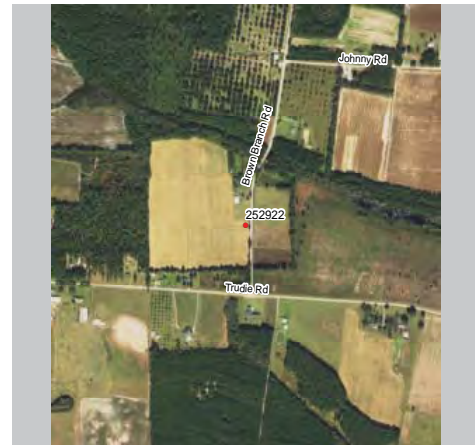
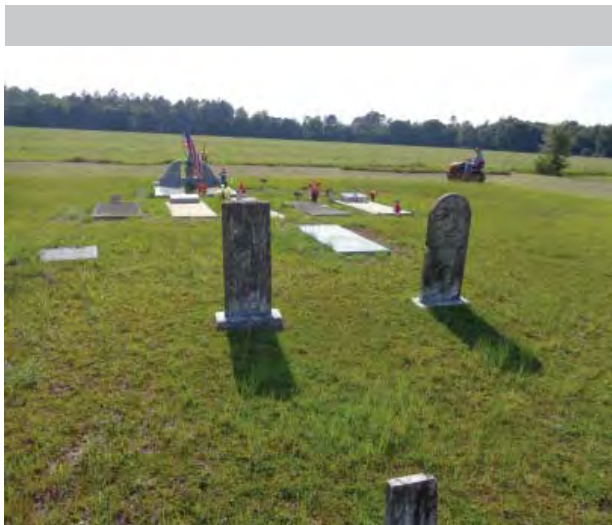
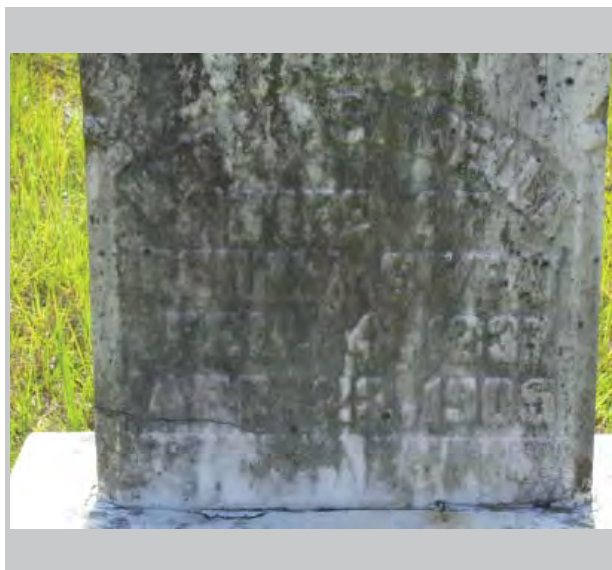
Field ID: PR-78
GNAHRGIS ID: 252922
County: Pierce
Preliminary NR Assessment: May Meet

Smith Cemetery
 Brown Branch Rd, 250 yards from int. w/ Trudie Road
Coordinates: 31.30649, -82.17646

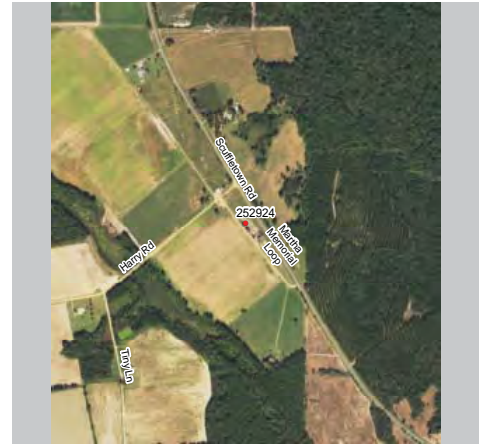
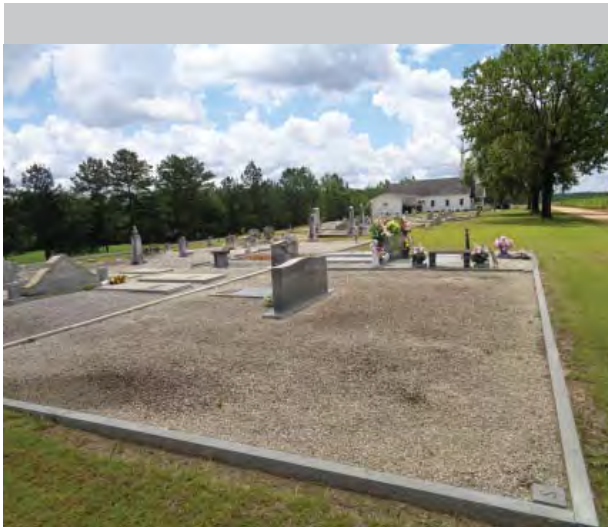
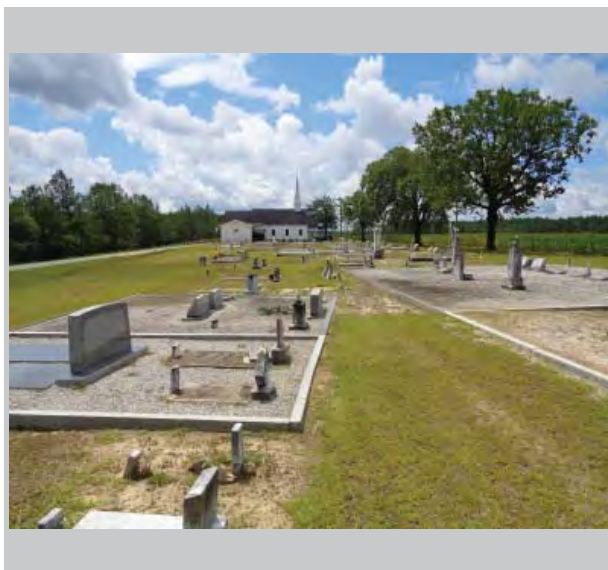
Field ID: PR-79
GNAHRGIS ID: 252924
County: Pierce
Preliminary NR Assessment: Does Not Meet

Martha Memorial Cemetery
Martha Memorial Loop, 80 yards from Harry Rd
Coordinates: 31.515577, -82.227166

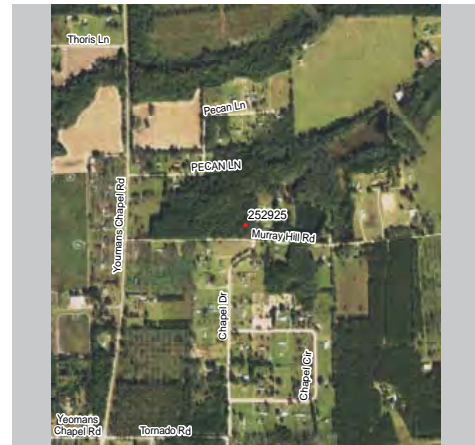
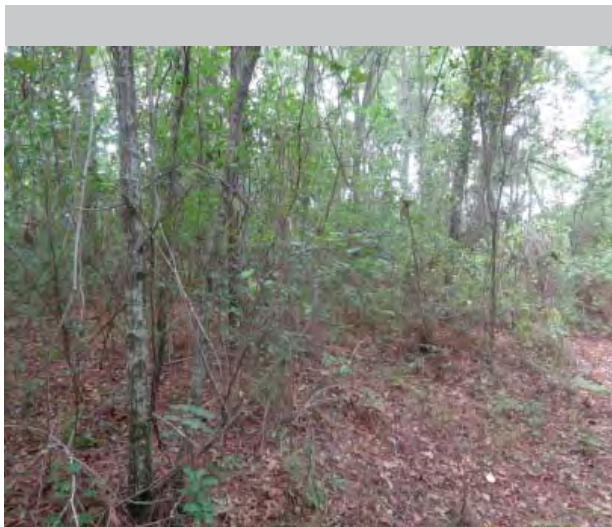
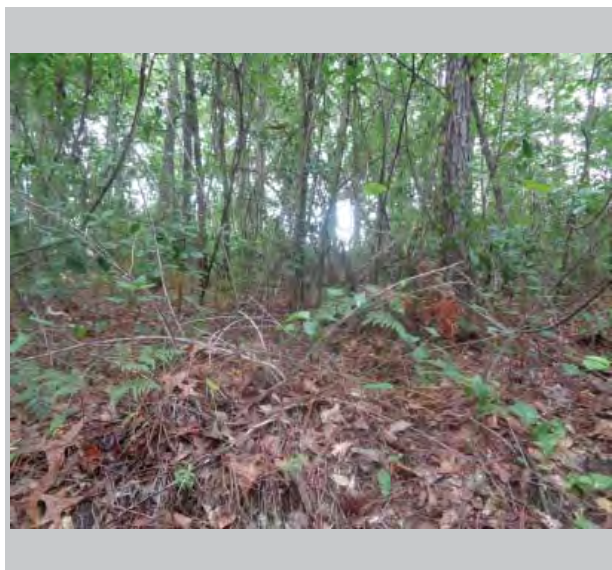
Field ID: PR-80
GNAHRGIS ID: 252925
County: Pierce
Preliminary NR Assessment: May Meet

Ivy Cemetery
 Murray Hill Rd, across from Chapel Drive
Coordinates: 31.279412, -82.244587

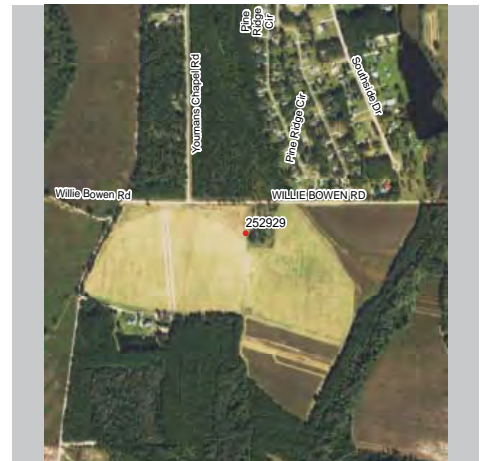
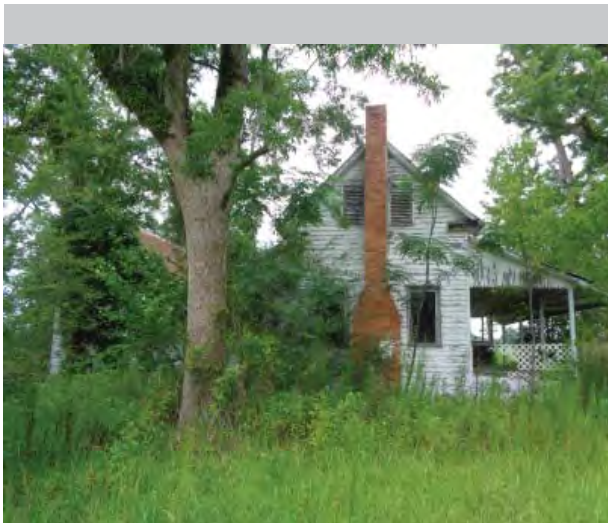
Field ID: PR-81
GNAHRGIS ID: 252929
County: Pierce
Preliminary NR Assessment: Appears to Meet

- Resource Type** Building
- Resource Use** Residential: Single Family Dwelling
- Date of Construction** 1910
- Building Type** 1 House
- Structural System** Balloon Frame
- Style** No Academic Style
- Roof** Gable:Side
- Exterior Cladding** Wood: Weatherboard
- Foundation** Unknown
- Porch** Verandah
- Windows** Unknown
- Chimney** Gable End Exterior: Brick
- Additional Notes** 5 bays on facade, central doorway framed by 2 windows on each side. Historic rear addition.

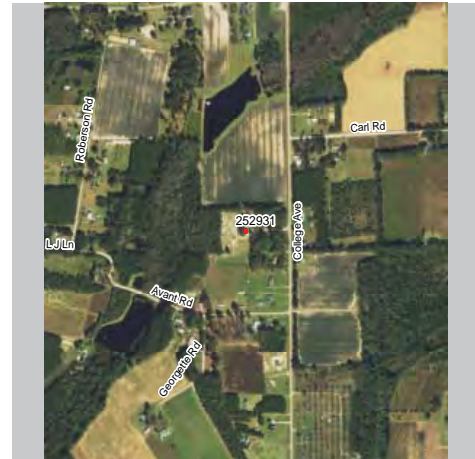
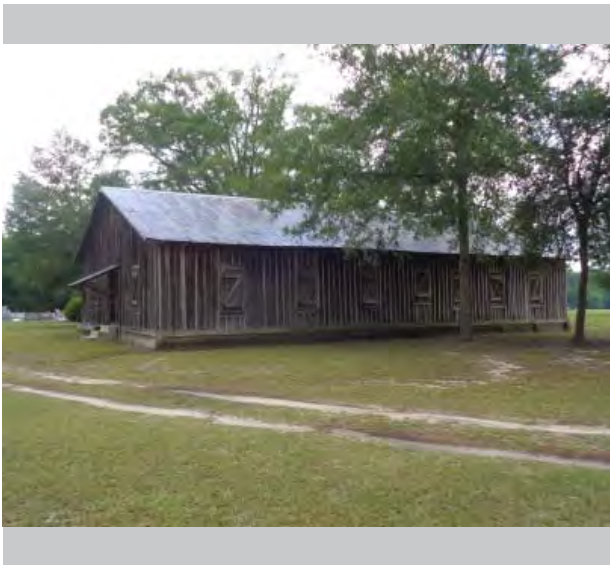
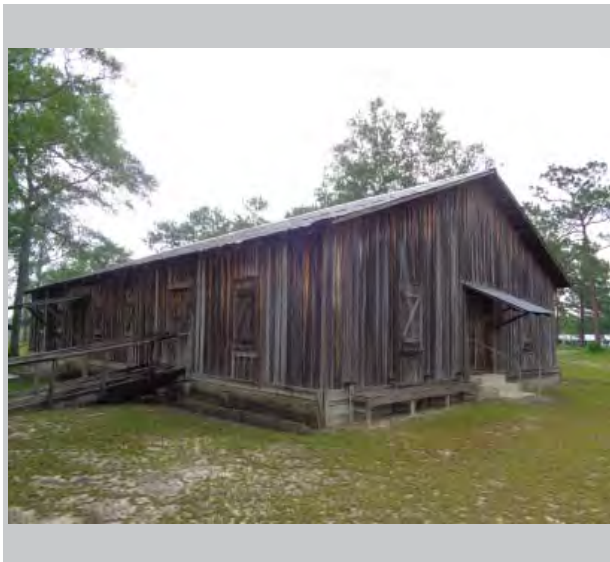
Field ID: PR-82
GNAHRGIS ID: 252931
County: Pierce
Preliminary NR Assessment: May Meet

Enon Church: Old Schlatterville Road, between St. Johns Church Road and Avant Road

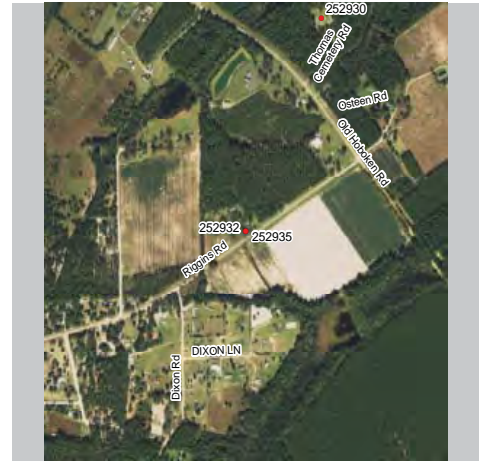
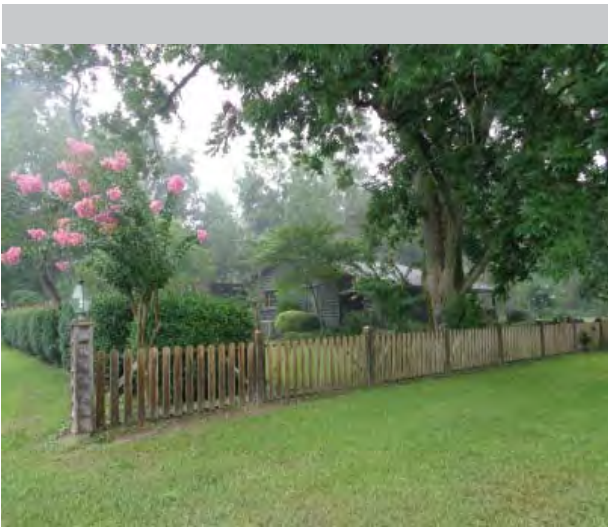
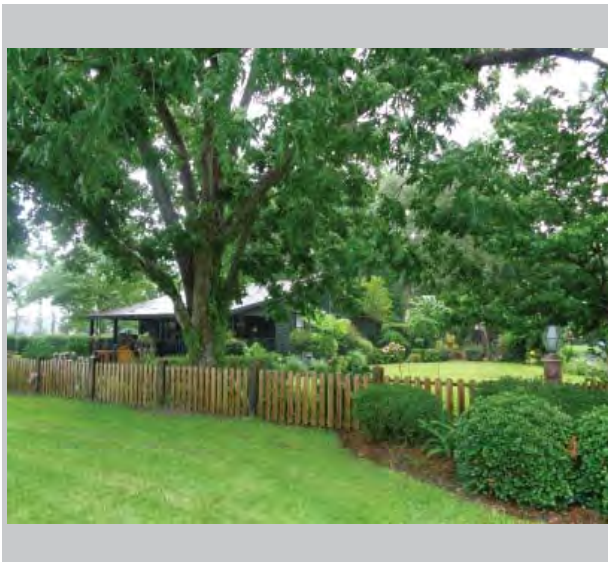
Field ID: PR-83
GNAHRGIS ID: 252932
County: Pierce
Preliminary NR Assessment: May Meet

- Resource Type** Building
- Resource Use** Domestic: Single Dwelling
- Date of Construction** ca. 1940
- Building Type** Bungalow: Side Gable
- Structural System** Balloon Frame
- Style** No Academic Style
- Roof** Gable: Front
- Exterior Cladding** Wood: Weatherboard
- Foundation** Continuous: Wood
- Porch** Verandah
- Windows** Double Hung Sash: 8/4, Rectangle
- Chimney** No Chimney Observed
- Additional Notes** Window replacements
Rear addition
Decorative fencing
Metalwork gate
