Historic Resources Survey Report

Pierce County, Georgia

July 2016

The University of Georgia
College of Environment and Design
Center for Community Design & Preservation
Historic Resources Survey Report
Pierce County, Georgia 2016

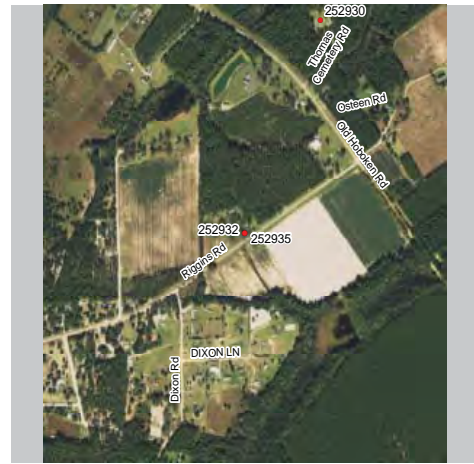
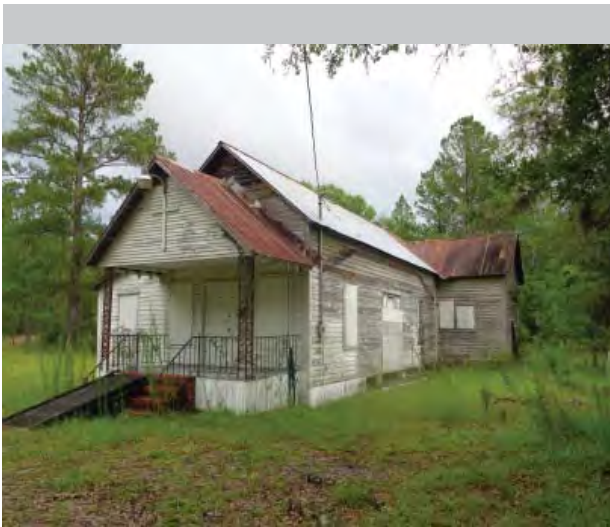
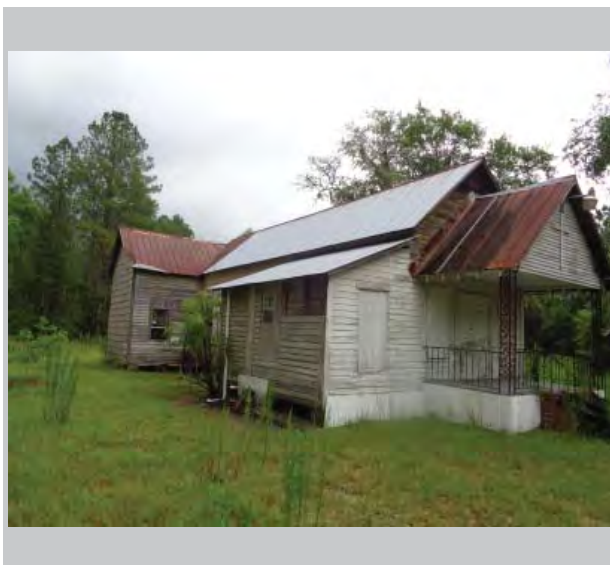
Field ID: PR-84
GNAHRGIS ID: 252935
County: Pierce
Preliminary NR Assessment: May Meet

Additional Notes Replacement materials,
multiple additions
Decorative porch supports
Exposed rafters

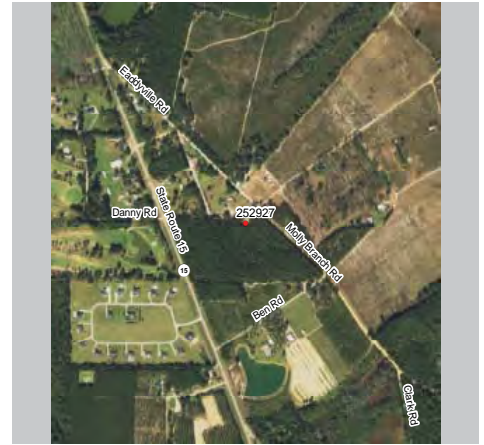
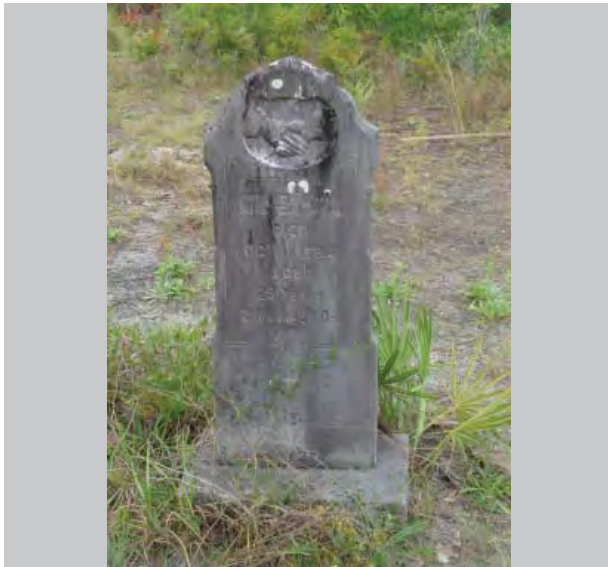
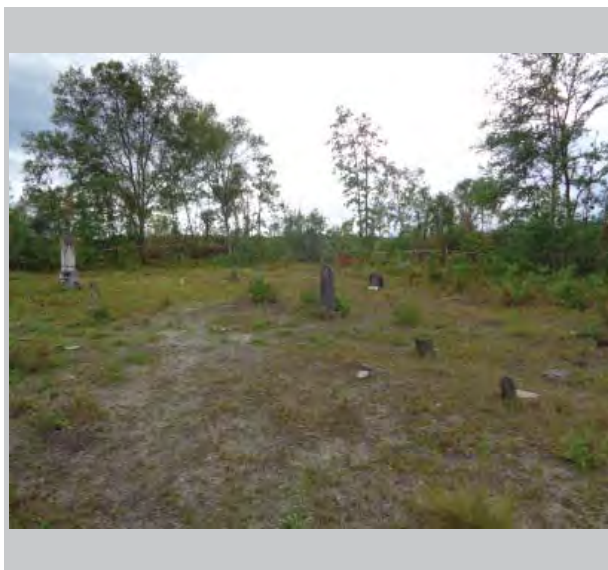
Field ID: PR-85
GNAHRGIS ID: 252927
County: Pierce
Preliminary NR Assessment: May Meet

Cemetery Description Not in use
Upright stones, footstones
Some decorative markers
Poor condition, some markers fallen and broken
Some rows
Taped off

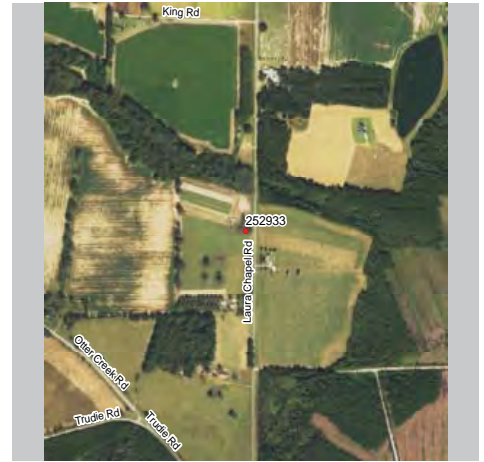
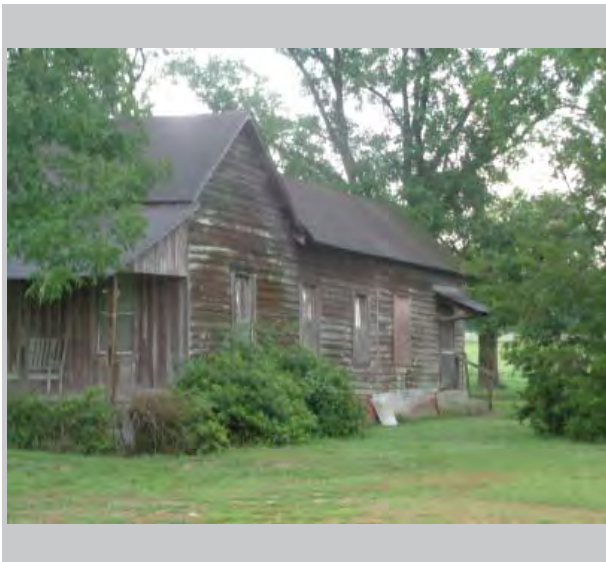
Field ID: PR-87
GNAHRGIS ID: 252933
County: Pierce
Preliminary NR Assessment: May Meet

- Resource Type** Building
- Resource Use** Domestic: Single Dwelling
- Date of Construction** ca. 1900
- Building Type** Hall-Parlor
- Structural System** Balloon Frame
- Style** No Academic Style
- Roof** Gable: Side
- Exterior Cladding** Weatherboard, Vertical Board
- Foundation** Continuous: Concrete
- Porch** Verandah
- Windows** Double Hung Sash: 2/2, 6/6, Rectangle
- Chimney** Gable-End Exterior: Brick
- Additional Notes** Rear addition
Some windows boarded
Exposed rafters
Vertical board on front

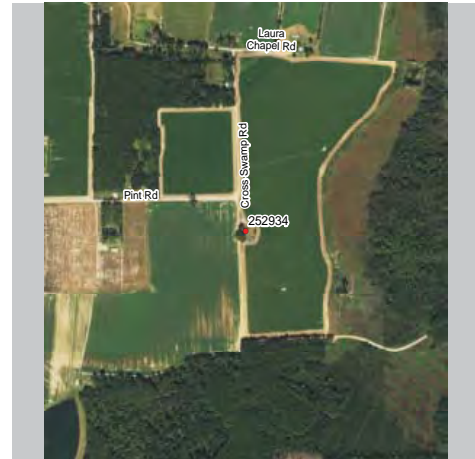
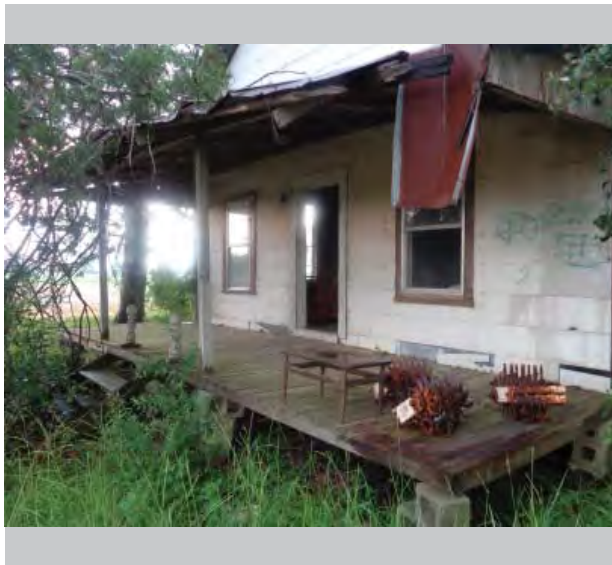
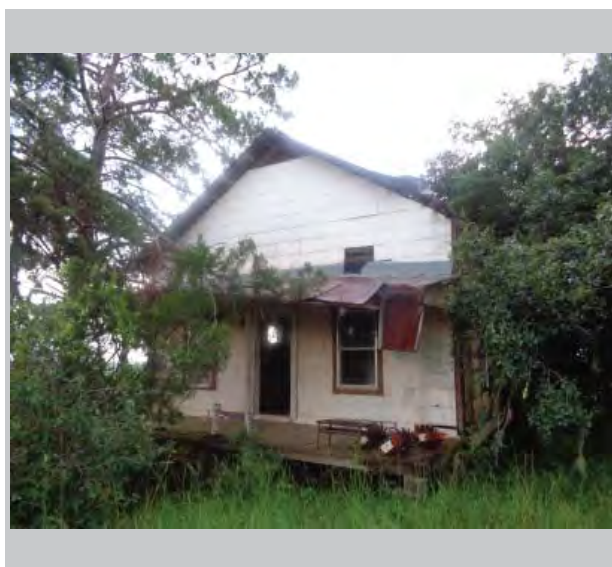
Field ID: PR-88
GNAHRGIS ID: 252934
County: Pierce
Preliminary NR Assessment: Does Not Meet

Additional Notes Exposed rafters
Rear addition
Replacement windows
Poor condition

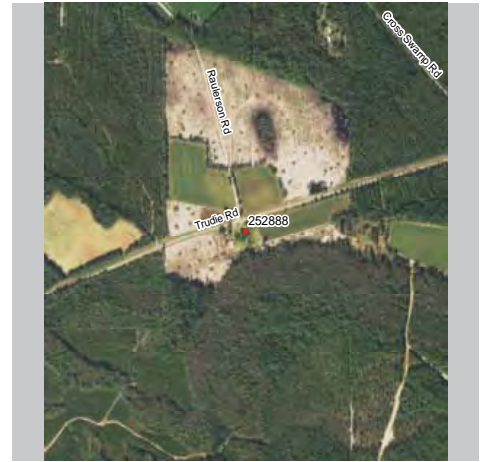
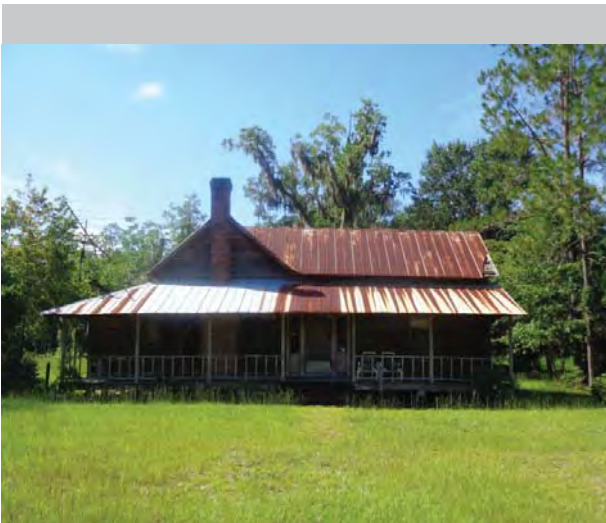
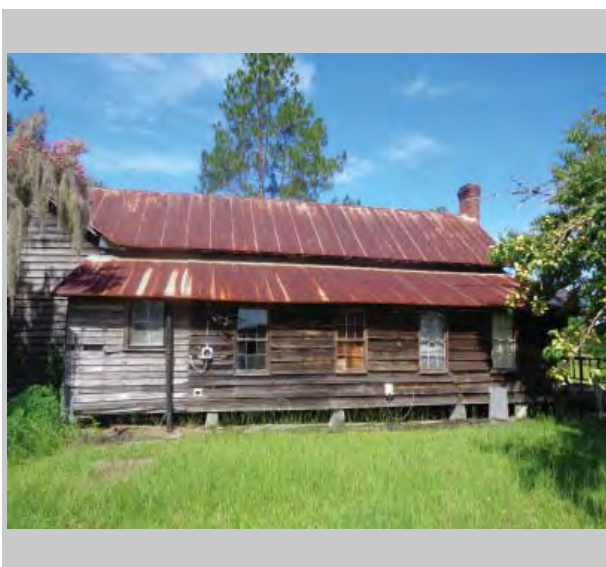
Field ID: PR-89
GNAHRGIS ID: 25288
County: Pierce
Preliminary NR Assessment: Does Not Meet

Additional Notes Multiple additions and material replacements
Corbelled chimney
Sidelights at main entry

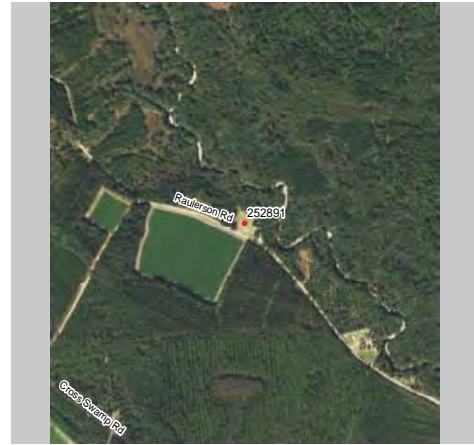
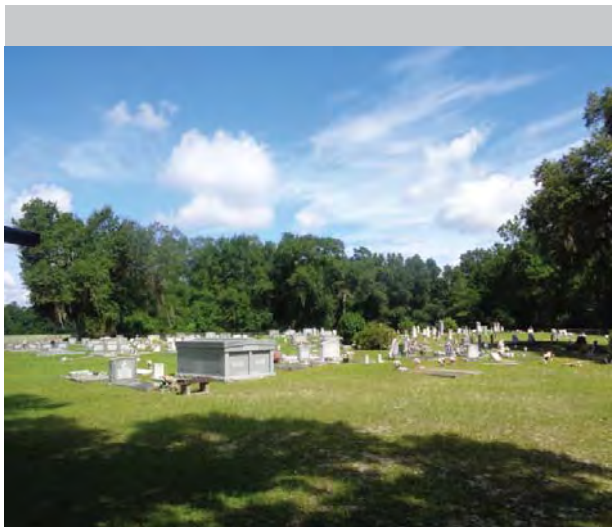
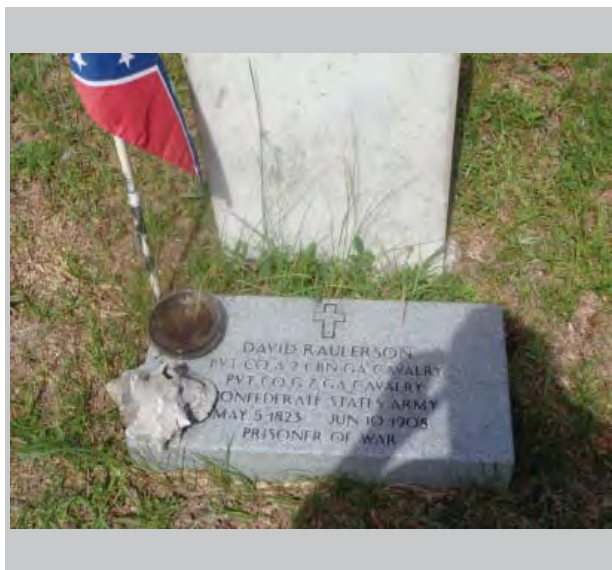
Field ID: PR-90
GNAHRGIS ID: 252891
County: Pierce
Preliminary NR Assessment: Does Not Meet

Cemetery Description Active Use
Some replaced markers
Upright, flat, foot stones
Chain link fence surrounds
Newly constructed brick shelter
1 large shade tree, several shrubs
Enclosed family plots
1 mausoleum

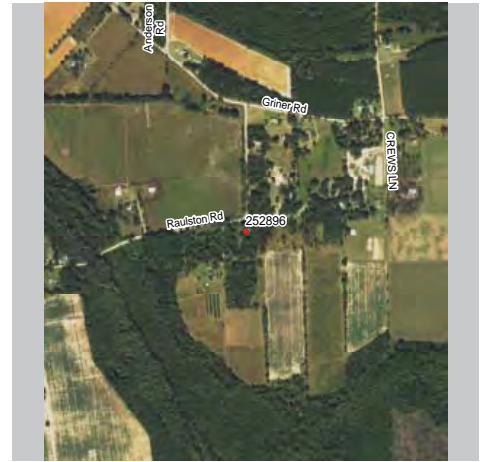
Field ID: PR-91
GNAHRGIS ID: 252896
County: Pierce
Preliminary NR Assessment: May Meet

- Resource Type** Building
- Resource Use** Domestic: Single Dwelling
- Date of Construction** ca. 1910
- Building Type** Central Hallway
- Structural System** Balloon Frame
- Style** No Academic Style
- Roof** Gable: Cross
- Exterior Cladding** Wood: Weatherboard
- Foundation** Pier with Infill: Brick
- Porch** Verandah
- Windows** Double Hung Sash: 4/4, Rectangle
- Chimney** Both Gable Ends: Brick
- Additional Notes** Large rear addition
Some windows boarded, replaced
Wood porch supports

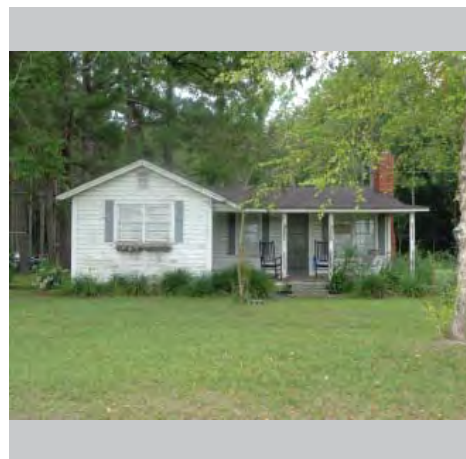
Field ID: PR-92
GNAHRGIS ID: 252897
County: Pierce
Preliminary NR Assessment: May Meet

Additional Notes Addition in rear.
Replacement windows.
Replacement materials on exterior. 3 pane door.

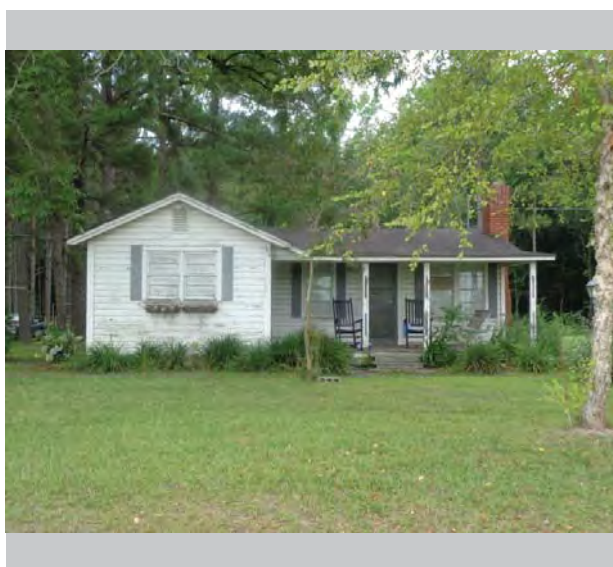
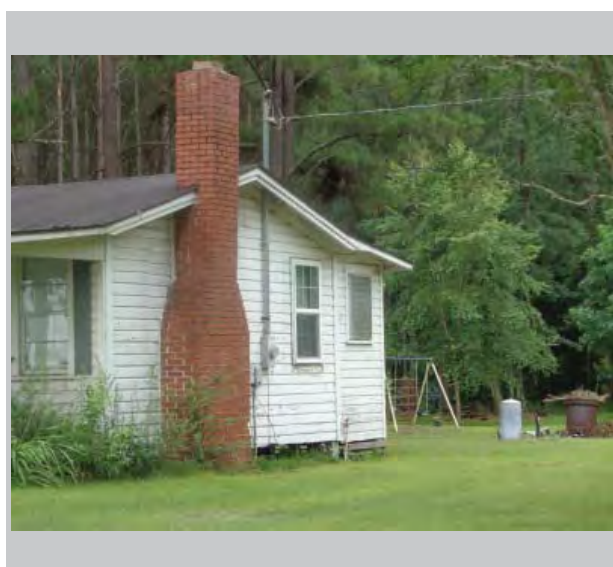
6513 Claude Road

Foundation Pier: Concrete

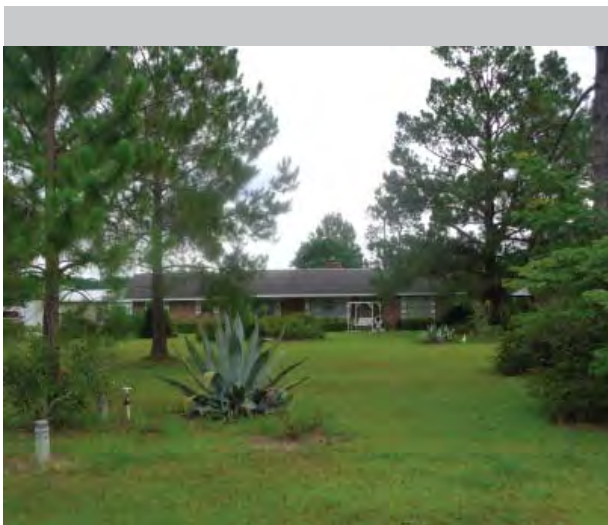
7326 Scenic Drive

- Resource Type** Building
- Resource Use** Residential: Single Family Dwelling
- Date of Construction** 1975
- Building Type** Ranch
- Structural System** Balloon Frame
- Style** No Academic Style
- Roof** Gable:Side
- Exterior Cladding** Brick: Veneer
- Foundation** Continuous: Brick
- Porch** Recessed
- Windows** Double Hung Sash & Flat: 2/2, 6/6. Rectangle & SQ
- Chimney** No Chimney Observed
- Additional Notes** Polychromatic brick. Decorative shutters. Linear ranch. Walled in carport, landscaped.

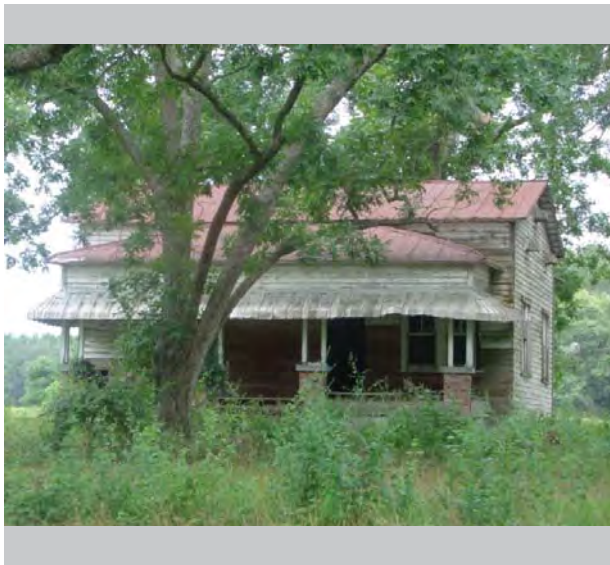
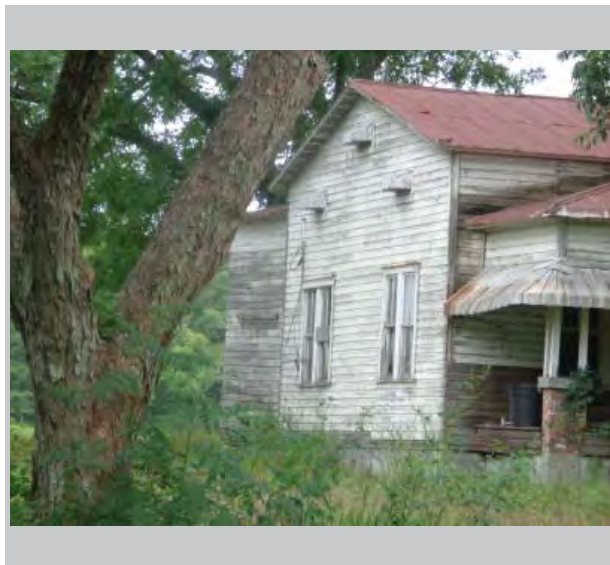
Scenic Drive between Stage Coach Dr & HWY 82

Foundation Pier: Concrete

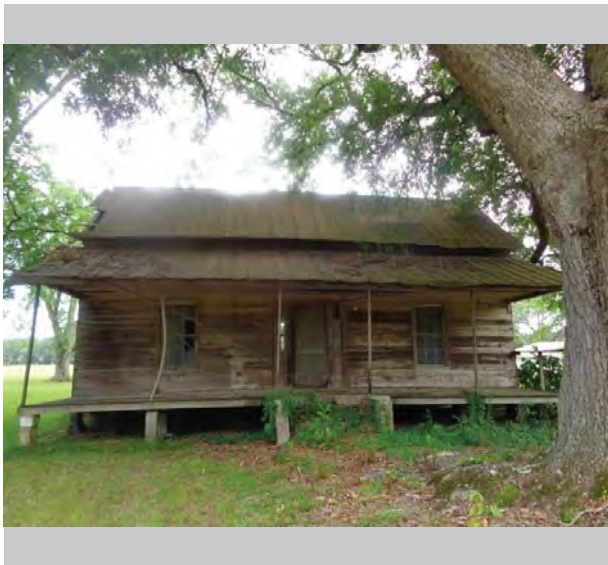
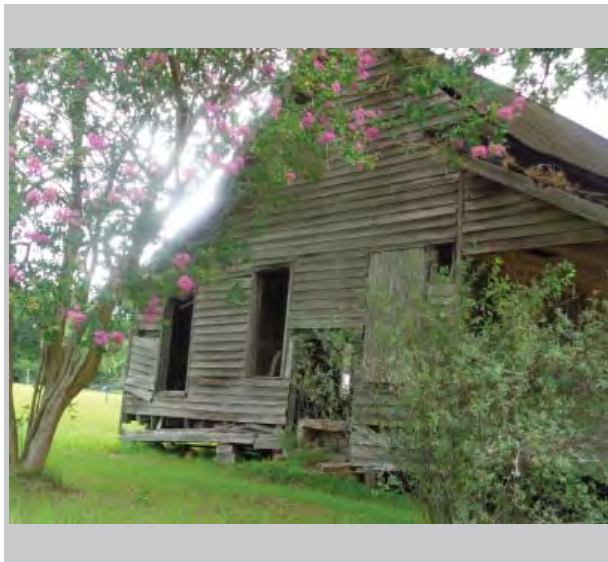
Intersection of Chris Tyre Rd & Shellie Trail (West)

Foundation Pier: Concrete

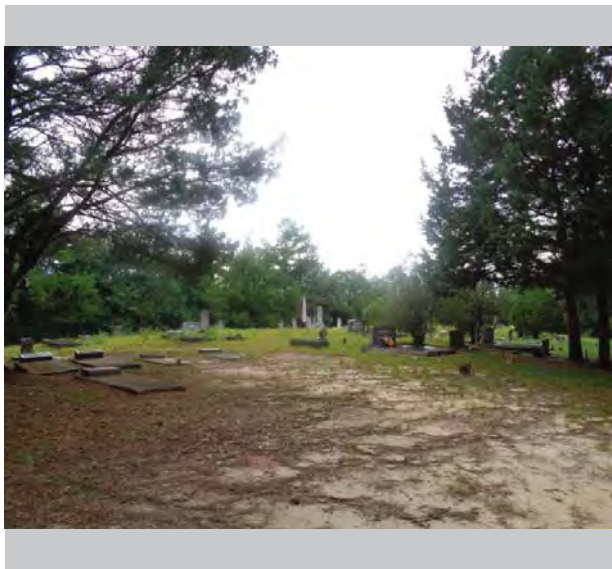
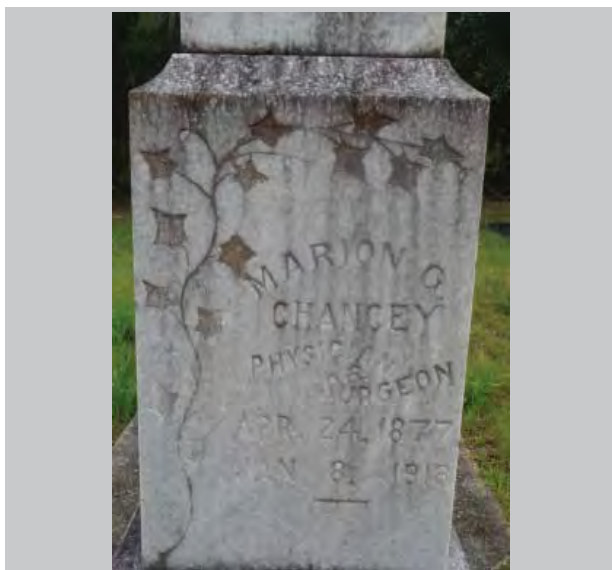
Clay Hill Cemetery
End of Foster Cemetery Rd to the left
Coordinates: 31.470234, -82.115650

Resource Type Site

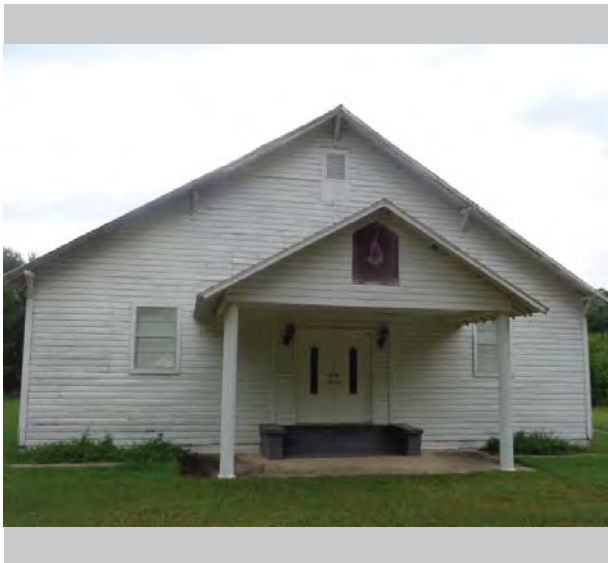
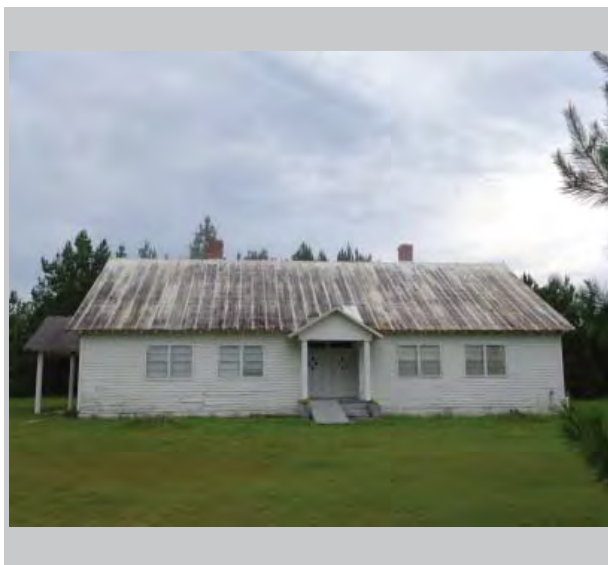
World Wide Deliverance Church
Mill Creek Road, 200 yards South of Chancey Road

Foundation Continuous: Brick

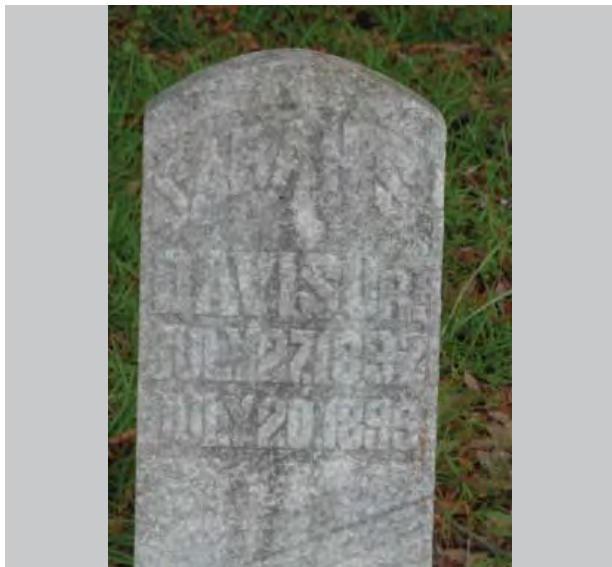
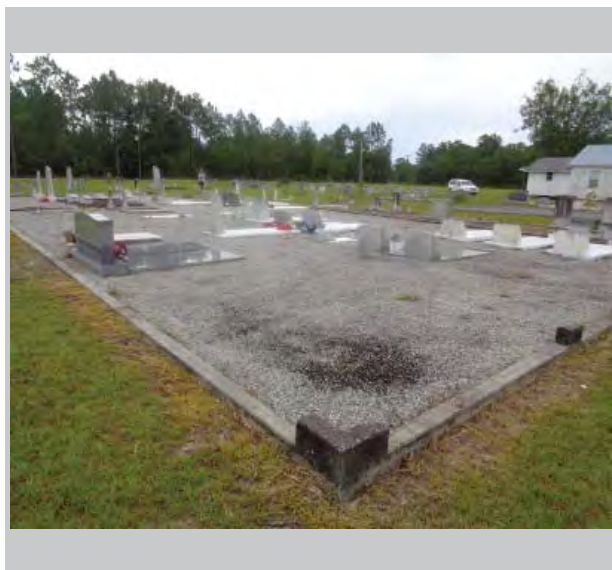
Resource Type Site
Resource Use Funerary: Cemetery
Date of Construction ca. 1899
Common Names Davis, Aspinwall, Dixon
≈ Number of Burials Unknown
Oldest Burial 1899
Burial Description CSA

Cemetery Description Active use
 Non-contributing church
 Planned rows
 Field surrounded by forest
 Maintained
 Outlined family plots
 Upright and flat markers
 Granite, brick, metal
 Some replaced, broken

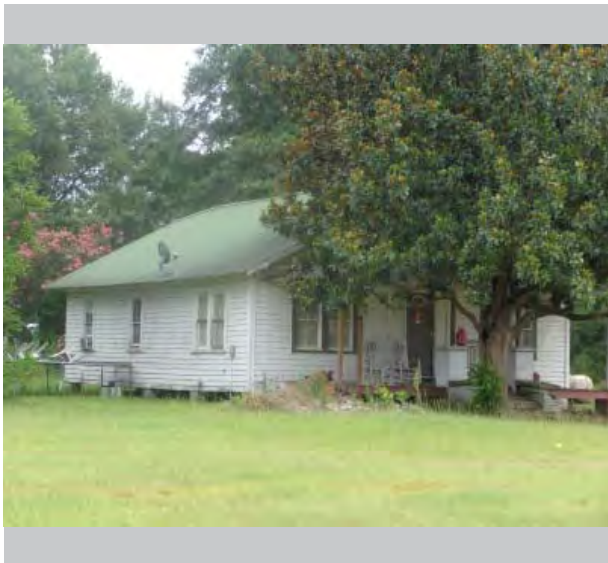
7683 Highway 82

- Resource Type** Building
- Resource Use** Domestic: Single Dwelling
- Date of Construction** ca. 1930
- Building Type** Bungalow: Front Gable
- Structural System** Balloon Frame
- Style** No Academic Style
- Roof** Gable: Front
- Exterior Cladding** Prism Synthetics: Vinyl Siding
- Foundation** Pier: Brick
- Porch** Verandah
- Windows** Double Hung Sash: 2/2, Rectangle
- Chimney** No Chimney Observed
- Additional Notes** Exposed rafters
Brick porch piers
Sidelights around door
Replacement materials

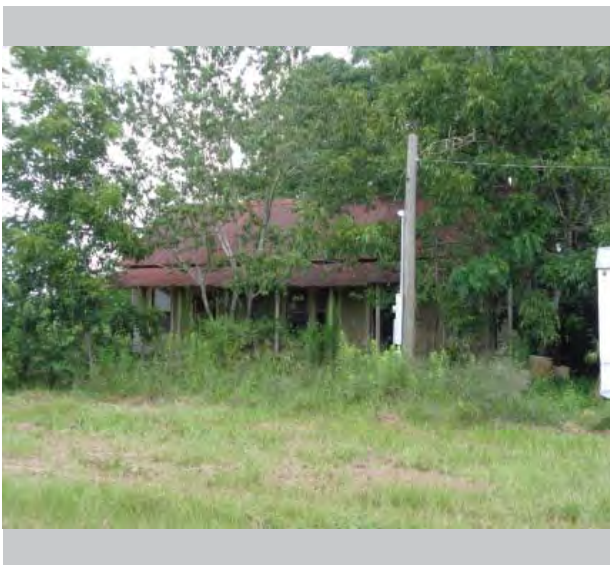
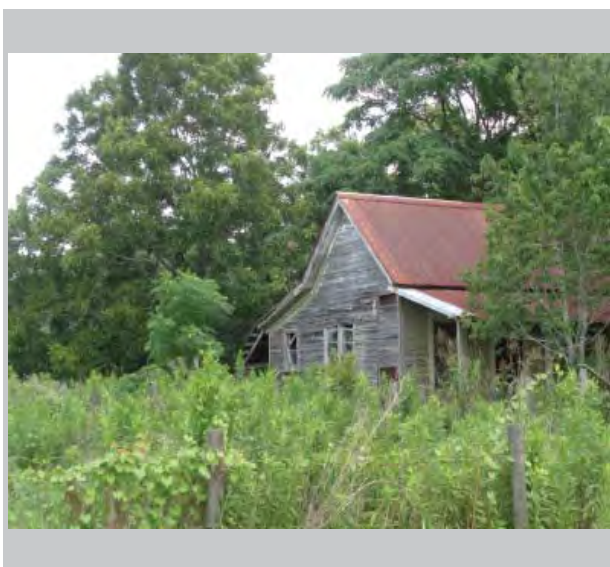
on Russell Road,
200 yards South of Crump Road

Additional Notes Obscured by vegetation
Facade altered
Windows replaced,
missing

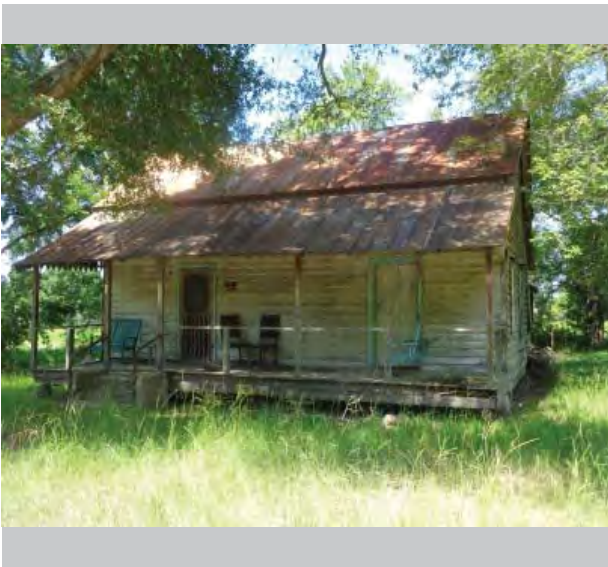
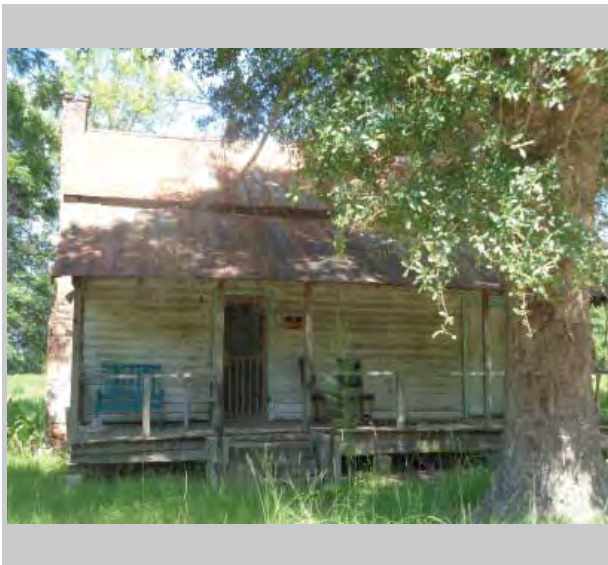
- Resource Type** Building
- Resource Use** Residential: Single Family Dwelling
- Date of Construction** 1900
- Building Type** Hall-parlor
- Structural System** Balloon Frame
- Style** Double Pen
- Roof** Gable:Side
- Exterior Cladding** Wood: Weatherboard
- Foundation** Pier:Wood & Concrete
- Porch** Verandah
- Windows** Double Hung Sash: 2/2, 4/4. Rectangle.
- Chimney** Lateral Exterior: Brick
- Additional Notes** 2 bay on front facade. 2 main entry doors. "Eagle's Nest" Restarant across street in outbuilding.

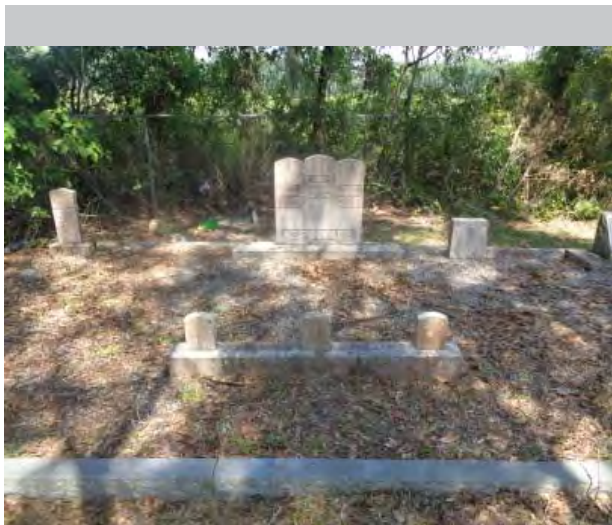
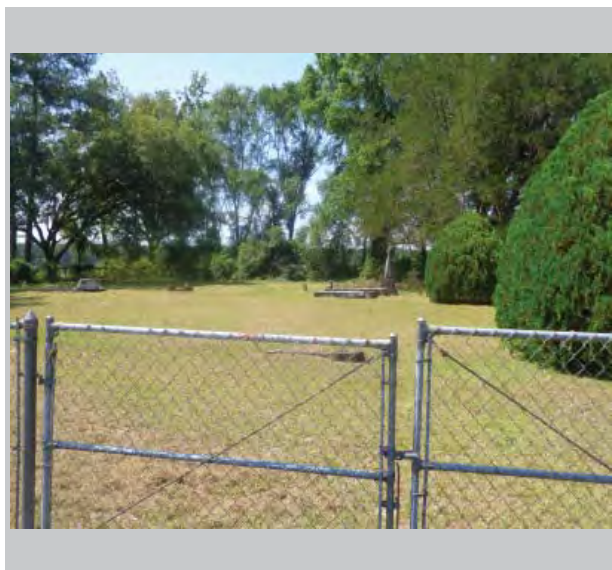
Aspinwall Cemetery
 End of unnamed rd, 550 yds from Tyre Cemetery Rd
Coordinates: 31.464284, -82.147987

Resource Type Site
Resource Use Funerary: Cemetery
Date of Construction 1880
Common Names Aspinwall
≈ Number of Burials 30
Oldest Burial 1880
Burial Description Woodsmen of America

Cemetery Description Not active use.
 Family cemetery.
 Maintained.
 Shrubs, shade trees.
 Chain link fence surrounding.
 Some flat stones among headstones.
 Remnants of possible arch/entryway.

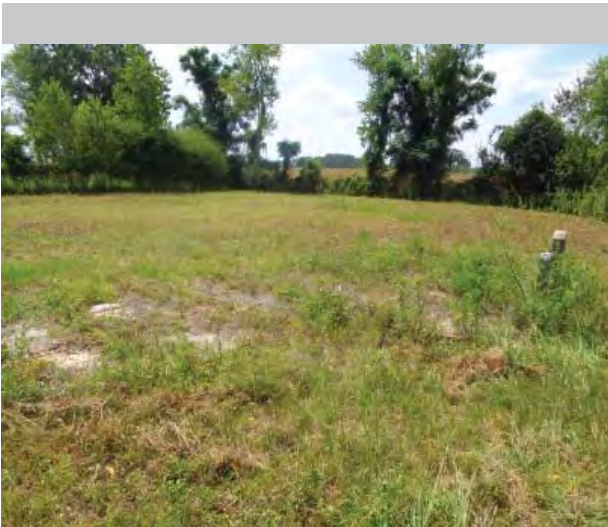
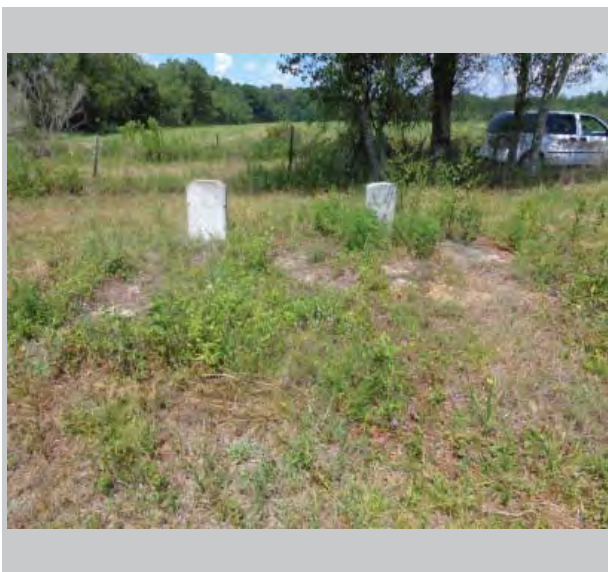
Old Tyre Cemetery
End of Tyre Cemetery Road

Resource Type Site

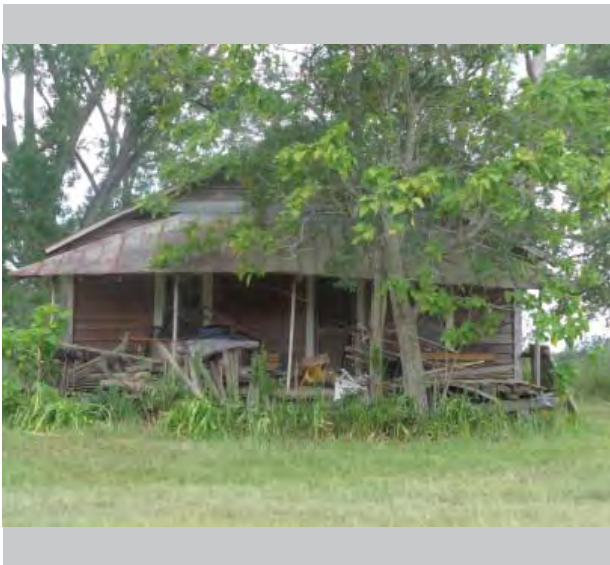
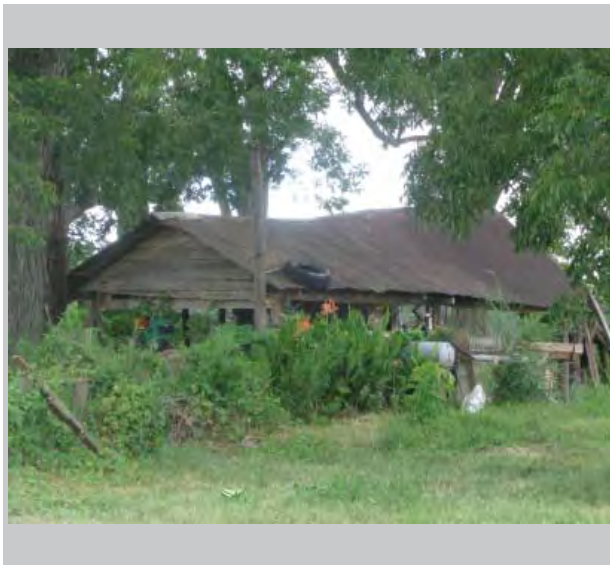
Resource Type Building
Resource Use Residential: Single Family Dwelling
Date of Construction 1920
Building Type Bungalow: Front Gable
Structural System Balloon Frame
Style No Academic Style
Roof Gable: Front
Exterior Cladding Wood: Weatherboard
Foundation Pier: Brick
Porch Verandah
Windows Double Hung Sash: 6/1, 4/4. Rectangle.
Chimney No Chimney Observed
Additional Notes Corrugated sheet over windows. Veg. obscures foundation. Rear door. Exposed rafters.

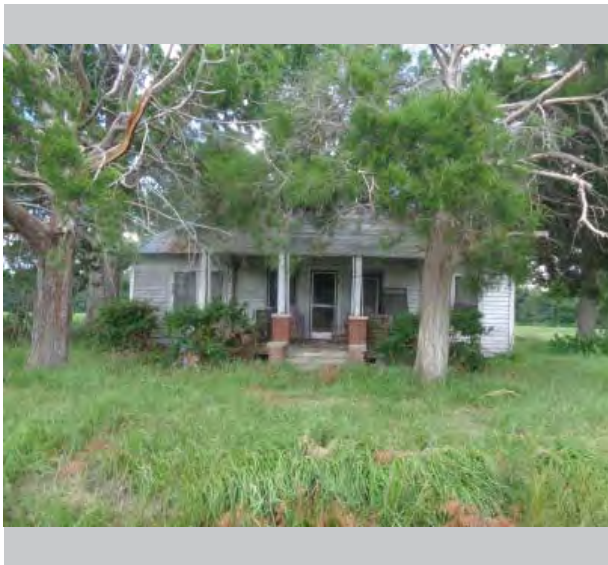
- Resource Type** Building
- Resource Use** Residential: Single Family Dwelling
- Date of Construction** 1930
- Building Type** Bungalow: Hip
- Structural System** Balloon Frame
- Style** Craftsman
- Roof** Hip
- Exterior Cladding** Wood: Weatherboard
- Foundation** Pier: Concrete
- Porch** Portico
- Windows** Double Hung Sash: 2/2. Rectangle.
- Chimney** Center: Brick
- Additional Notes** Some windows boarded. Brick piers with battered wood columns. Central doorway, 5 bays.

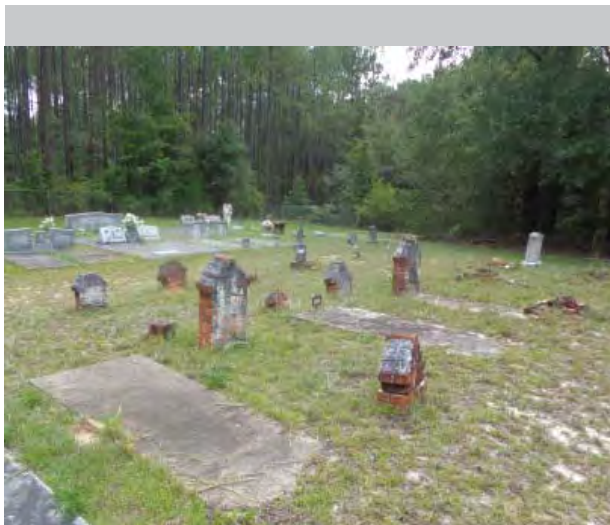
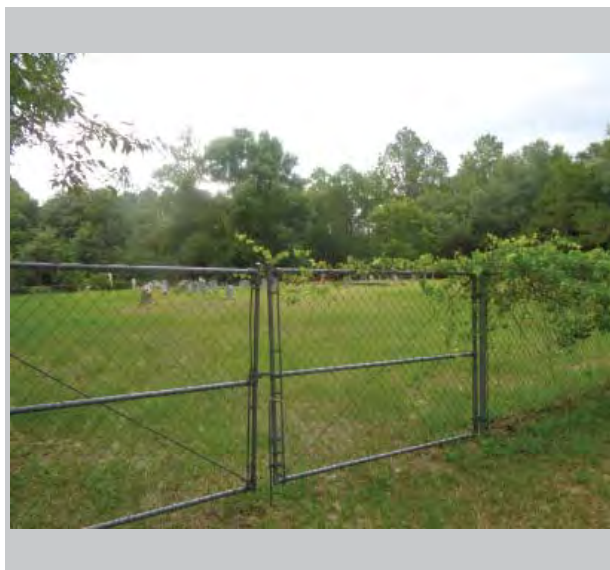
Bird Cemetery
 Unmarked rd N of Honeysuckle Ln, .6 mi from 121.
Coordinates: 31.472240, -82.195794

Cemetery Description Active use. Surrounded by chain link fence, located down unmarked grass road. 70%-75% "old" graves. Trinkets, shells, statues, ect left at graves. Brick piles/markers with no writing. Some outlined plots. Some broken headstones.

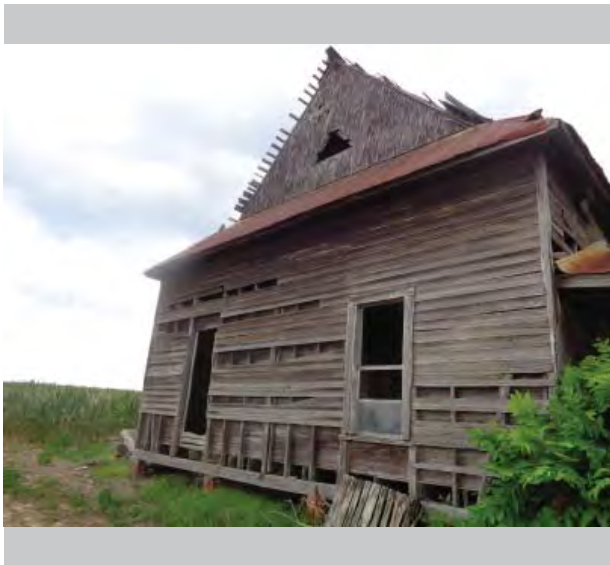
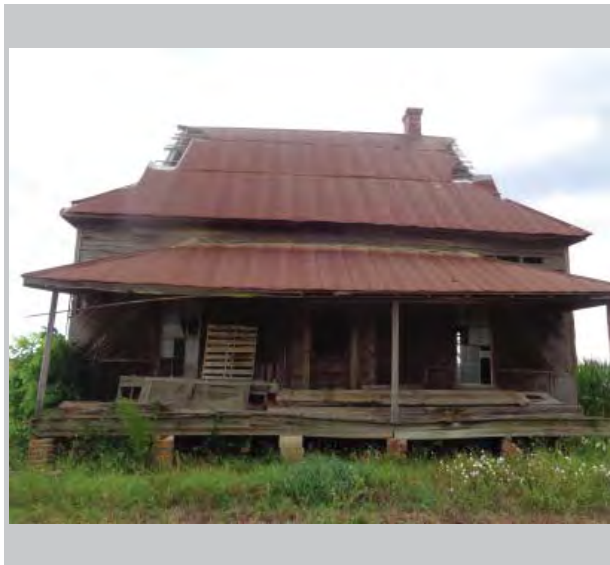
- Resource Type** Building
- Resource Use** Residential: Single Family Dwelling
- Date of Construction** 1910
- Building Type** Georgian Cottage
- Structural System** Balloon Frame
- Style** No Academic Style
- Roof** Gable-On-Hip
- Exterior Cladding** Wood: Weatherboard
- Foundation** Pier: Brick, Concrete Block
- Porch** Verandah
- Windows** Double Hung Sash: 6/6. Rectangle.
- Chimney** Gable-End Interior: Brick
- Additional Notes** Replacement siding
Sawtooth shingles
Corbelled chimney
Collapsed rear porch

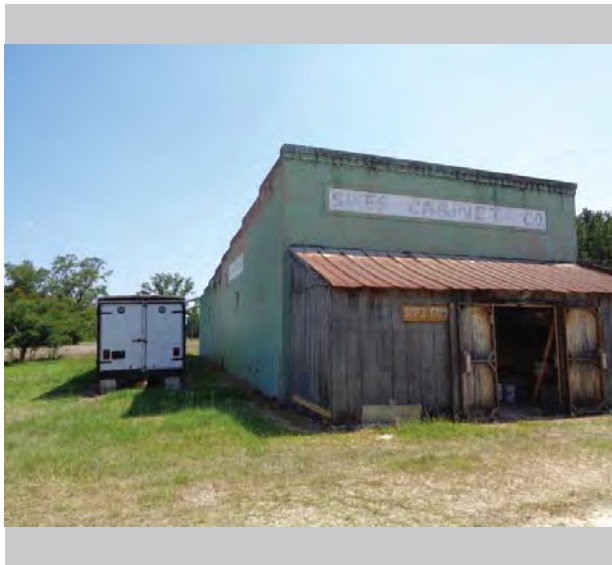
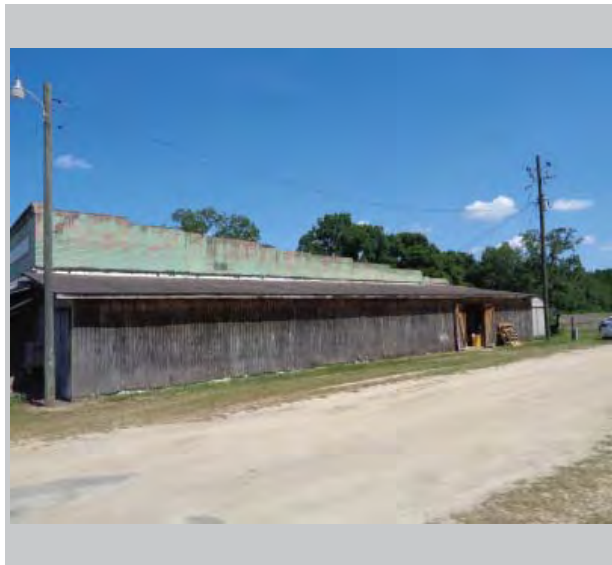
- Resource Type** Building
- Resource Use** Commercial: Retail store/shop
- Date of Construction** 1940
- Building Type** Commercial: Single Retail
- Structural System** Brick Bearing
- Style** No Academic Style
- Roof** Unknown
- Exterior Cladding** Brick: Common Bond
- Foundation** Unknown
- Porch** No Porch
- Windows** Unknown
- Chimney** No Chimney Observed
- Additional Notes** Wooden additions on front and right side
Original structure mostly intact

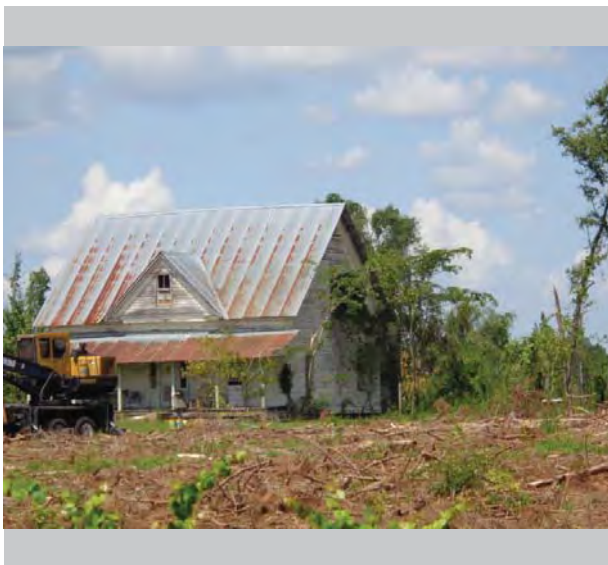
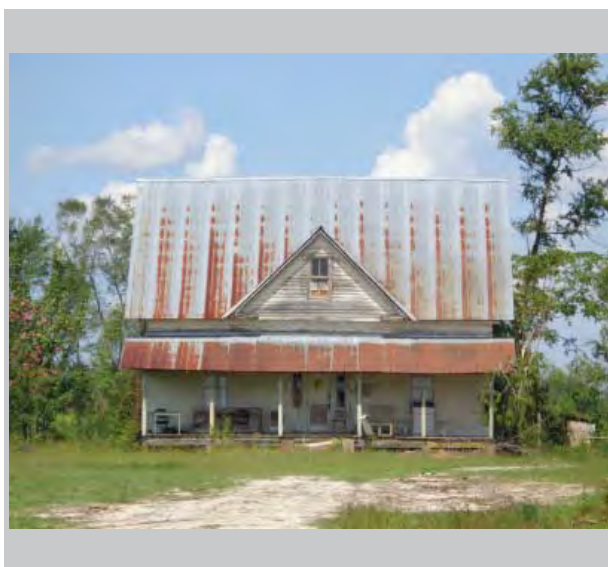
- Resource Type** Building
- Resource Use** Domestic: Single Family Dwelling
- Date of Construction** 1900
- Building Type** Plantation Plain
- Structural System** Balloon Frame
- Style** No Academic Style
- Roof** Gable: Cross
- Exterior Cladding** Wood: Clapboard
- Foundation** Pier: Brick
- Porch** Verandah
- Windows** Double Hung Sash: 2/2. Rectangular.
- Chimney** No Chimney Observed
- Additional Notes** Mostly original materials
Steeply pitched roof
Sidelights
Window in front gablet

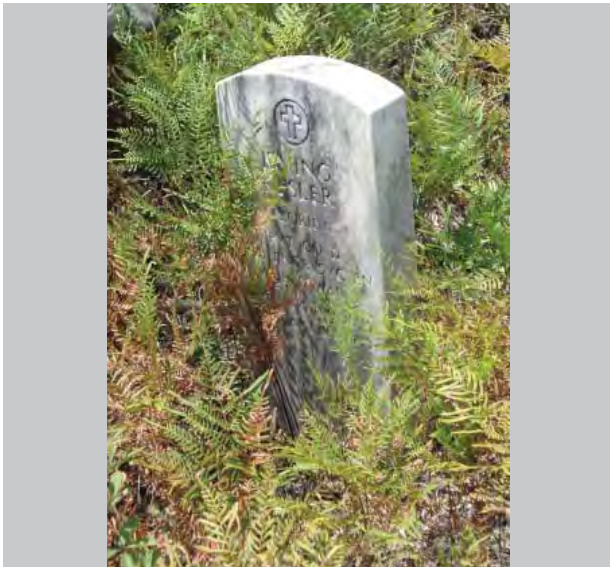
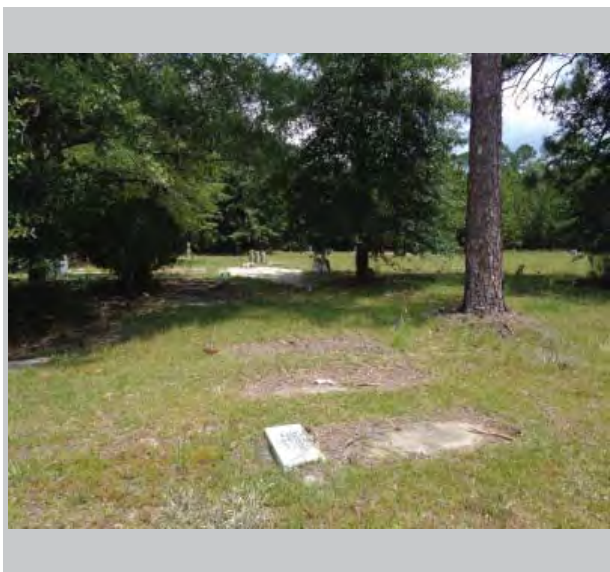
Pine Road, 360 yards East of Mershon Road
Coordinates: 31.47258, -82.24462

Resource Type Site
Resource Use Funerary: Cemetery
Date of Construction 1956
Common Names Kysler, Fuller
≈ Number of Burials 50
Oldest Burial 1956
Burial Description N/A

Cemetery Description Active use
 Spread out graves
 Not well maintained
 Granite ledger stones
 Outlined family plots
 Mostly new

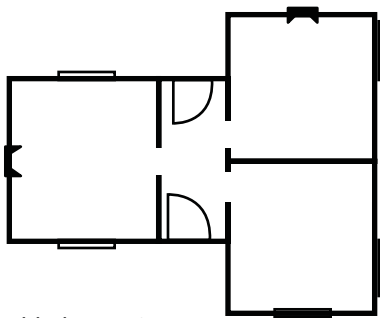
I-House

Multi-story: One room deep by two wide with central hallway

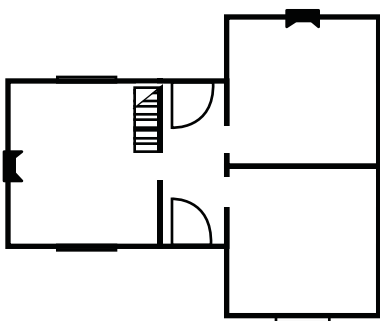
Gabled Wing Cottage

Single story: Asymmetrical massing with central hallway

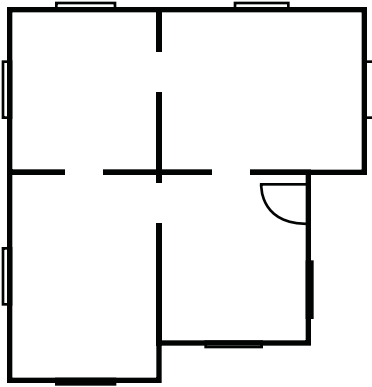
Gabled Wing House

Multi-story: Asymmetrical massing with central hallway

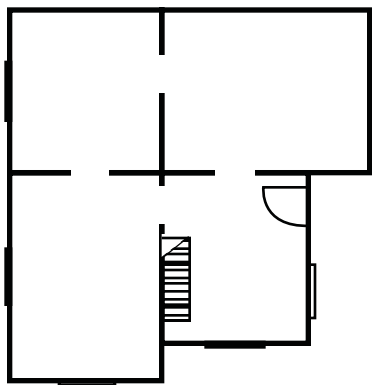
Queen Anne Cottage

Single story: Asymmetrical massing with no central hallway

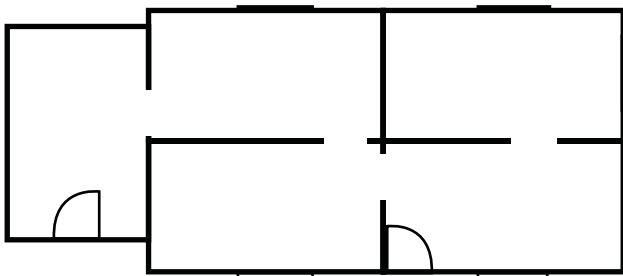
Georgian House

Multi-story: Two rooms deep by two rooms wide with central hallway

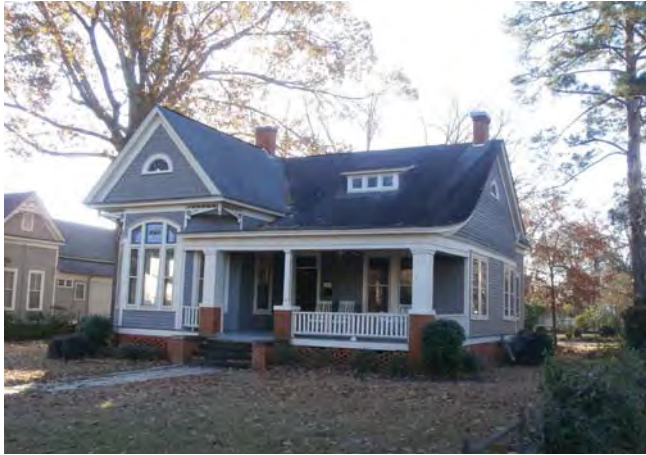
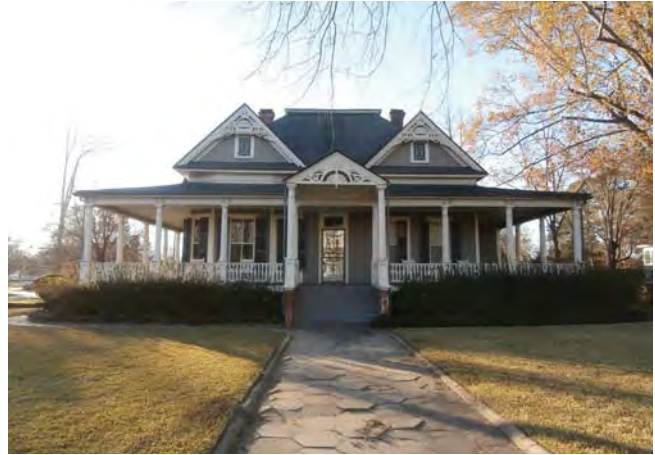
Folk Victorian 1870-1920

Folk Victorian houses were built across Georgia in very large numbers. They were simple house forms, or house types, with Victorian-era decorative detailing such as jigsaw woodworks including brackets, spindlework and gingerbread trim. This detailing generally was taken from the elaborate styles, such as Queen Anne or Italianate, that were popular during the mid to late 19th century. Features were borrowed and added onto such places as porches and roof gables. This provided some hint of stylistic detailing on what was otherwise an unadorned traditional house form. This style is actually more a way of decorating a house than a precise stylistic category; however, the Folk Victorian house is so widespread that it demands a name.

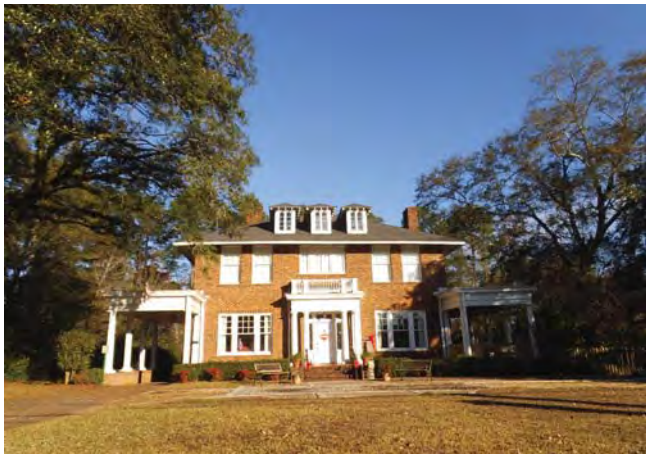
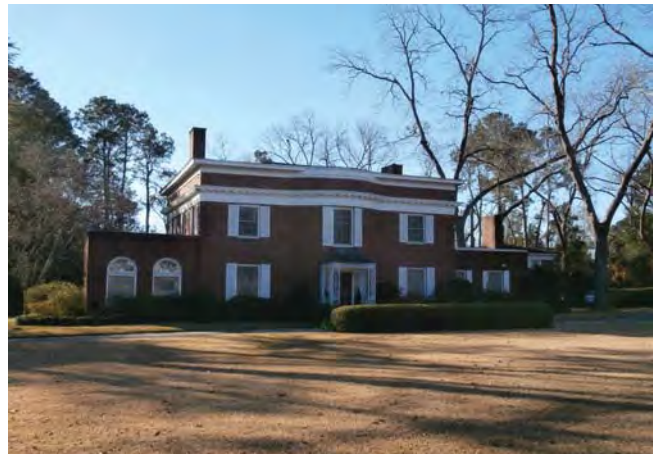
Colonial Revival 1890-1955

Most Colonial Revival houses are symmetrical. A central entranceway is elaborated with a pediment supported by pilasters or columns. The use of broken pediments, fanlights and sidelights is common. Classical cornices with dentils or modillions are usually present. These features tend to be larger than original colonial details. The roof may be hipped or side-gabled with dormers. Windows have double-hung sashes, usually with six-over-six or nine-over-nine panes and may be paired. Walls are of masonry, masonry-veneer or wood.
