Historic Resources Survey Report

Pierce County, Georgia

July 2016

The University of Georgia
College of Environment and Design
Center for Community Design & Preservation
Historic Resources Survey Report
Pierce County, Georgia 2016

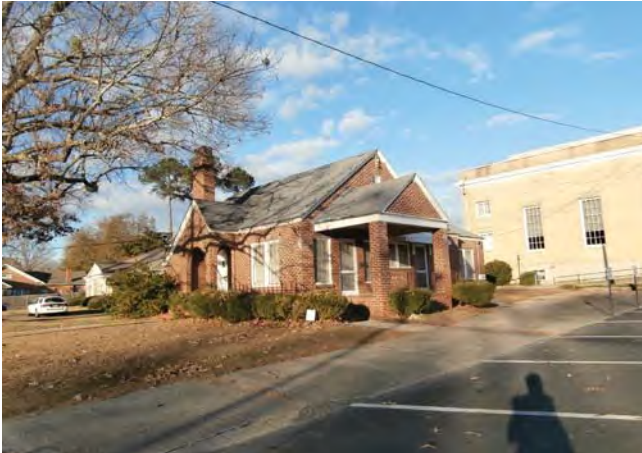
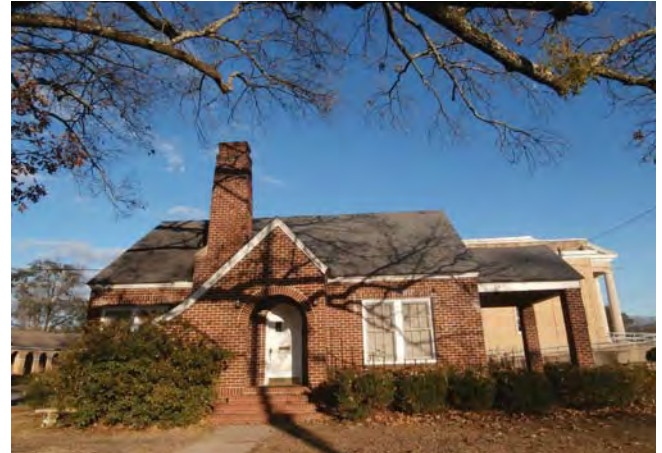
English Vernacular Revival 1900-1940

Characteristics of English Vernacular Revival houses are a steeply pitched gabled roof with dominant front-facing gable and decorative half-timbering in the gables. Almost all have masonry walls. Most are masonry-veneered, a recently developed technique for applying a thin layer of masonry to a wall. Some houses have patterned brickwork, while others may be completely stuccoed. Often a variety of materials are used, such as brick walls with stone trim, wood half-timbering, and stuccoed gables. Massive masonry chimneys with decorative tops are common. Windows are generally tall and narrow, grouped together, multi-paned, and casements rather than double-hung. Some openings, particularly the entrance, may be emphasized by a round arch. Houses of this style are generally asymmetrical.

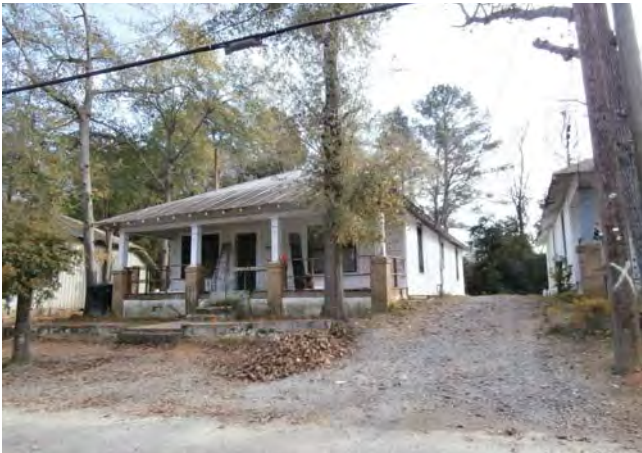
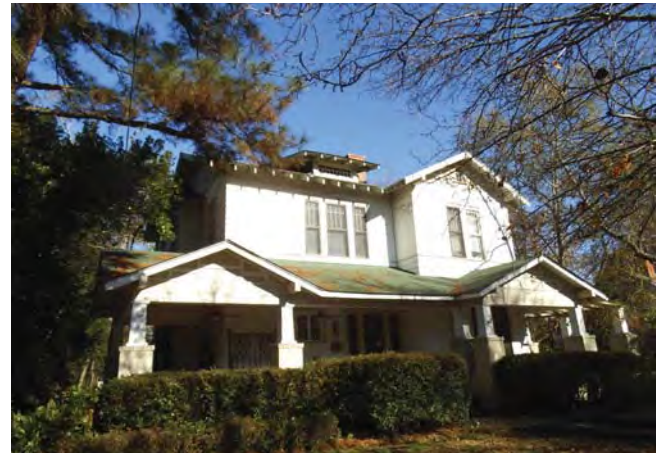
Craftsman 1910-1930

The Craftsman house uses a wide variety of materials both for its structure and decorative detailing. It has a low-pitched roof that is usually gabled but may also be hipped, giving a generally horizontal effect. The widely overhanging eaves are open with exposed rafters. Large gables have decorative brackets or braces at the eaves and may be covered with half-timbering. Roof dormers are sometimes found. Walls are most often wood but may also be covered with shingles or a masonry veneer of stone or brick. Porches have short square columns set on heavy masonry piers extending to the ground. Windows may have a multi-paned sash over a large one-pane sash. Craftsman houses are most often asymmetrical with a generally open and functional plan.

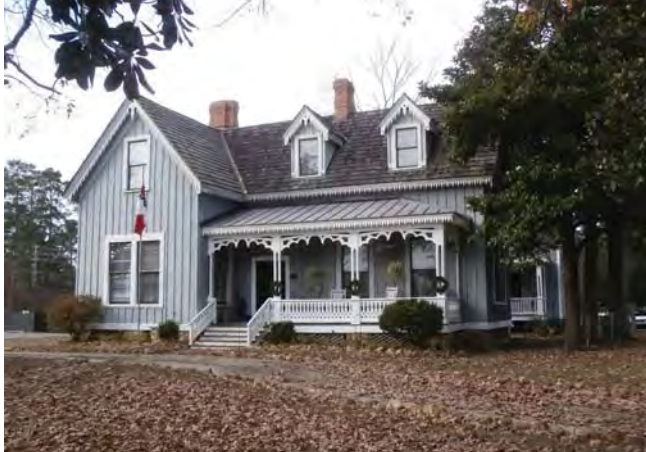
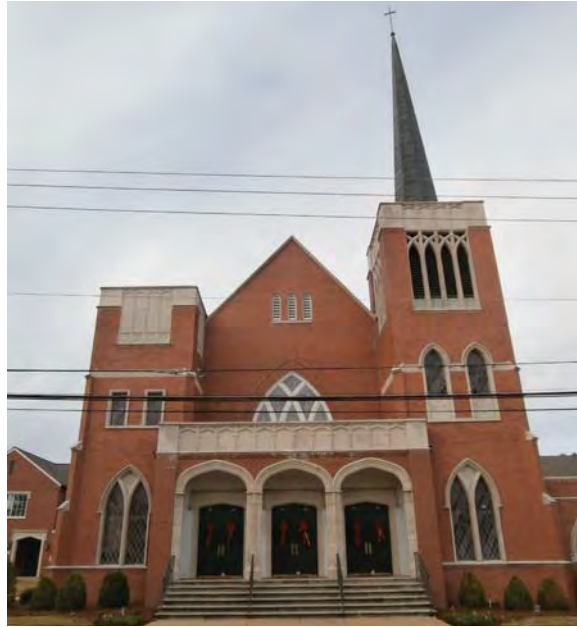
Gothic Revival 1850-1890

Gothic Revival houses typically have steeply pitched gabled roofs with both front-and side-facing gables. Decoratively sawn bargeboards are commonly found along the eaves. Window and door openings often have either pointed arched tops or heavily molded or pointed hoods. Porches are usually supported by slender posts with sawn woodwork forming flattened arches or brackets. Some houses have vertical board-and-batten siding. This style emphasized picturesqueness, verticality, and varied use of materials.

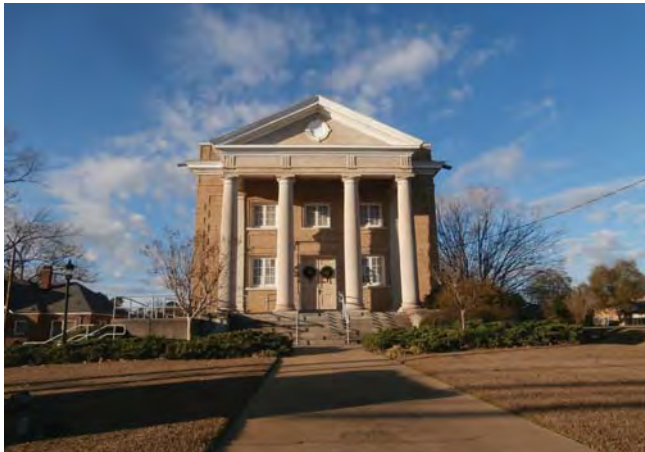
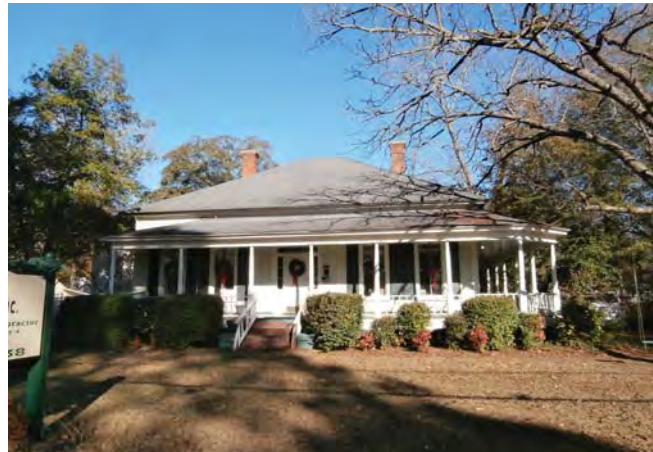
Greek Revival 1825-1860

The Greek Revival style is characterized by details such as prominent columns, pilasters, and wide plain entablatures that encircle a house. Proportions are large and heavy. A symmetrical, rectangular block has a symmetrical front facade with a central entrance. An elaborate door surround contains a rectangular transom, sidelights and pilasters. A typical expression of the Greek Revival in Georgia is a low-pitched, hipped roof supported by columns to form a full-width porch. Porticoes with triangular pediments are also found. Vernacular interpretations with simplified details, such as square rather than round columns, are common. Double-hung windows generally have six-over-six panes.

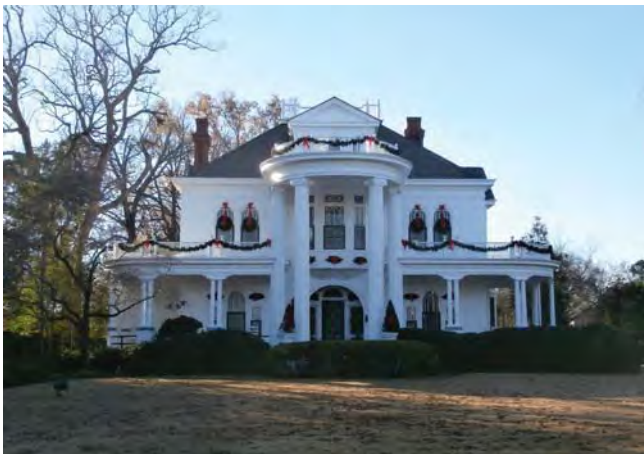
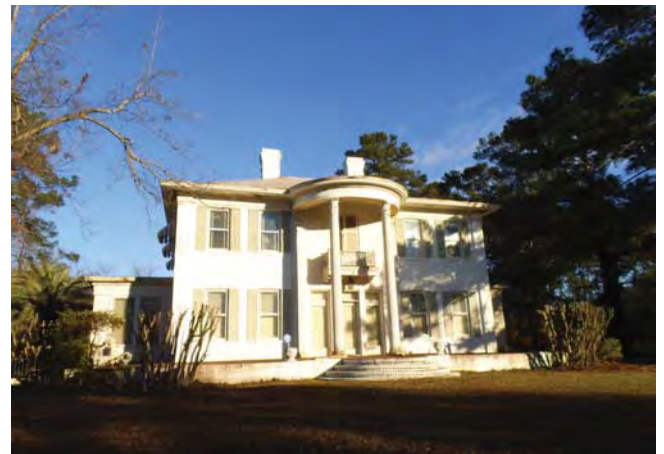
Neoclassical Revival 1895-1940

The most common feature of the Neoclassical Revival style is a dominant full-height front portico with classical columns. The portico may be at the entry or may cover the full facade; it may have a triangular pediment or be part of the overall roof. A full-height entry portico is often coupled with a one-story full-facade porch. The facade is more or less symmetrical, and the central entrance, surrounded with pilasters and columns, is elaborated with fanlights, sidelights, and transoms. There is almost always a classical cornice with dentils or modillions. The roof is usually low-pitched and hipped and may have a balustrade. A porte-cochere and side porches supported by columns are common.

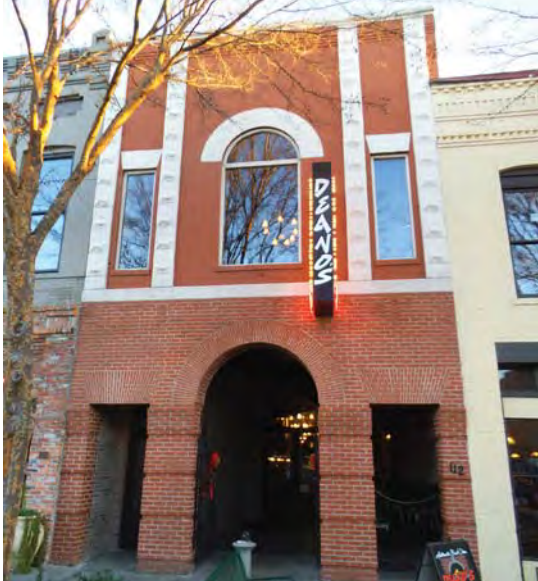
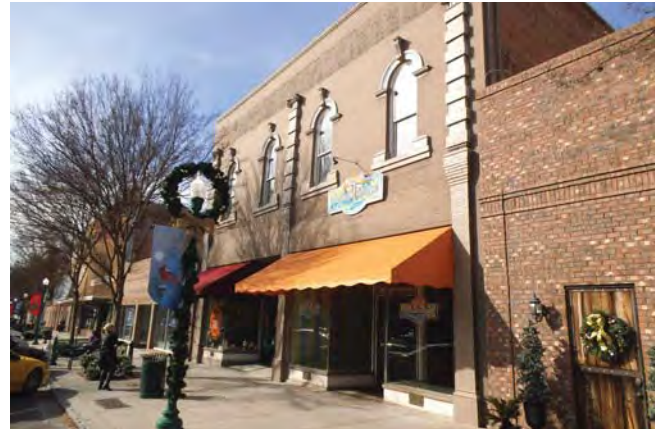
Italianate 1840-1885

Italianate houses are generally asymmetrical with an L-shaped or other irregularly shaped plan and gabled roof. Distinguishing features are the widely overhanging eaves with decorative brackets that emphasize the cornice. Typically tall narrow windows with large two-over-two or one-over-one panes are often paired, arched, and topped with elaborate hoods. Bay windows are also common. Italianate style residential architecture faded out during the 1880s; however, many Italianate style commercial blocks were constructed until the 1890s. The flat topped blocks with brackets and decorative window moldings were two or more stories tall and featured large storefront windows. Brackets beneath eaves are the most distinguishing characteristic of the Italianate commercial block.

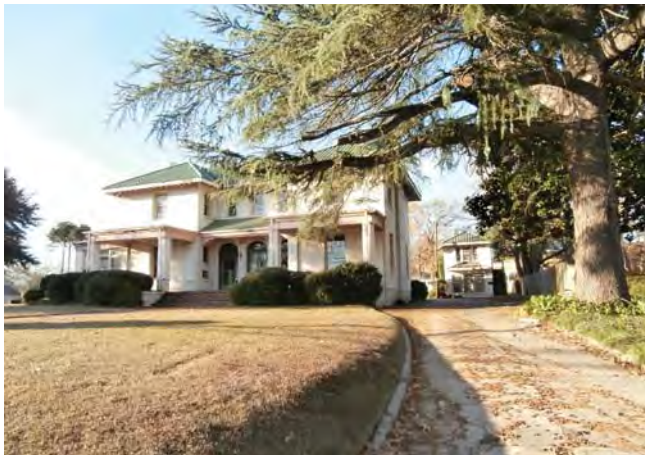
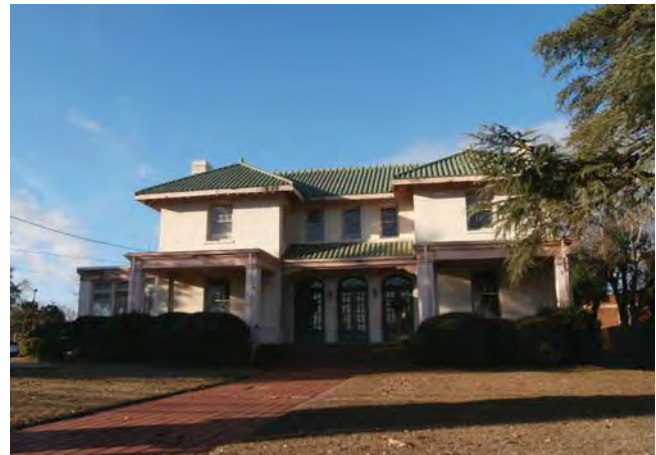
Mediterranean Revival 1890-1910

A Mediterranean Revival house has smooth stuccoed or masonry walls and is usually asymmetrical. The roof is covered with clay tile, is low-pitched, and may be either hipped or gabled. Houses following the Spanish tradition will have little or no eave overhang, while those following the Italian influence will have widely overhanging eaves with exposed rafters. Recessed and arcaded loggias, or open porches, are common. Windows are generally arched and may be grouped together. Sometimes columns and pilasters are used to elaborate openings.

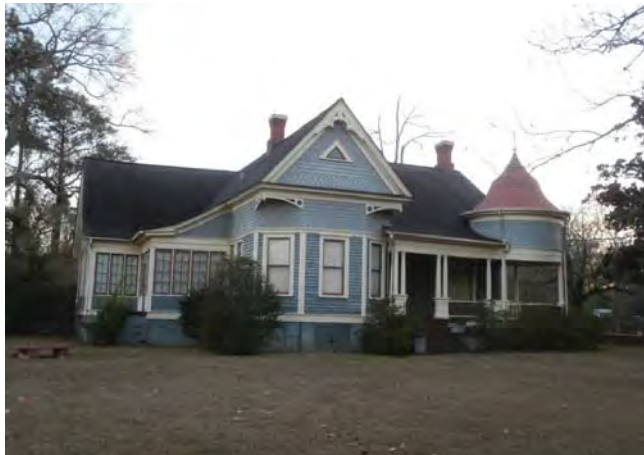
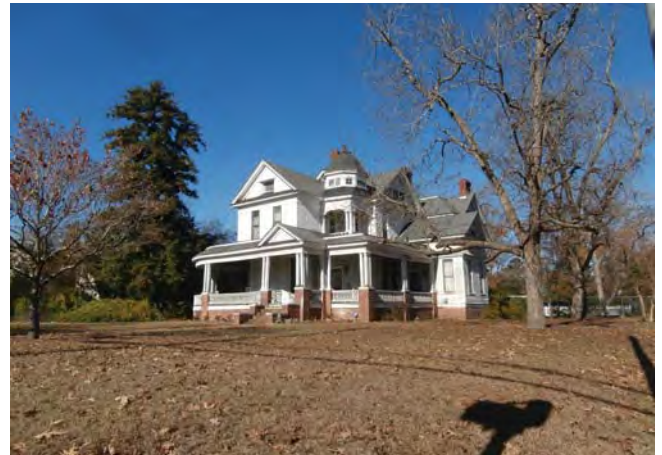
Queen Anne 1880-1915

A Queen Anne style house is asymmetrical with complex roof and wall shapes. It displays a variety of textures, materials, and detailing. The asymmetrical shape results from a floor plan that is open and flowing. The roof is often steeply pitched and hipped with both front-and side-facing, or cross, gables. Wall surfaces avoid a smooth appearance through the use of projecting bays and materials such as patterned shingles that provide texture. The porch is usually asymmetrical and often wraps around two sides of the house. It is supported with slender turned posts and often decorated with sawn brackets and spindlework friezes. Roof gables may also be decorated with sawn ornamentation or spindlework and covered with patterned shingles. There are often prominent and elaborate brick chimneys with patterned and corbeled brickwork. A round or multi-sided tower may be found at a corner.

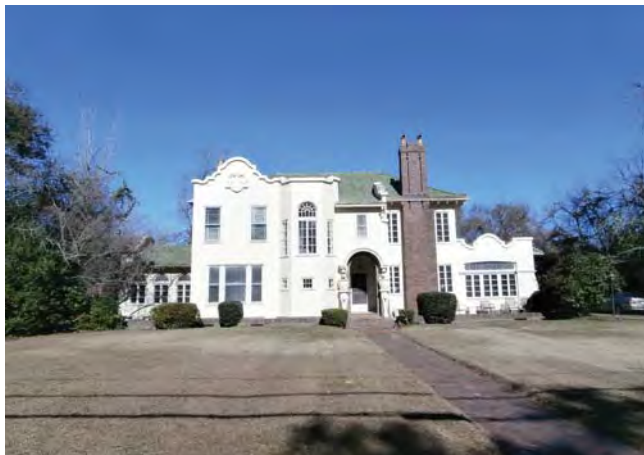
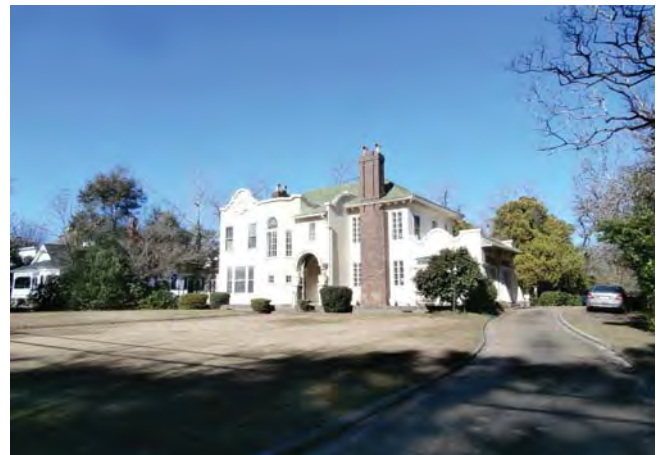
Spanish Colonial Revival 1900-1940

A Spanish Colonial Revival house has a clay tile roof that is usually gabled with little eave overhang. Walls are of smooth stucco. Arched openings and arcaded loggias, or open porches, are common. Windows are generally casement and grouped together. The roof may be elaborated with curvilinear gables or parapets from the mission tradition. Exposed roof beams may protrude from the walls to emphasize construction methods.
