Historic Resources Survey Report

Rockdale County, Georgia

December 2015

The University of Georgia
College of Environment and Design
Center for Community Design & Preservation
Historic Resources Survey Report
Rockdale County, Georgia 2015

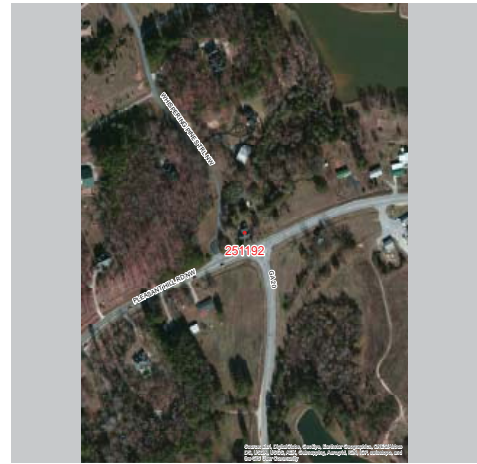
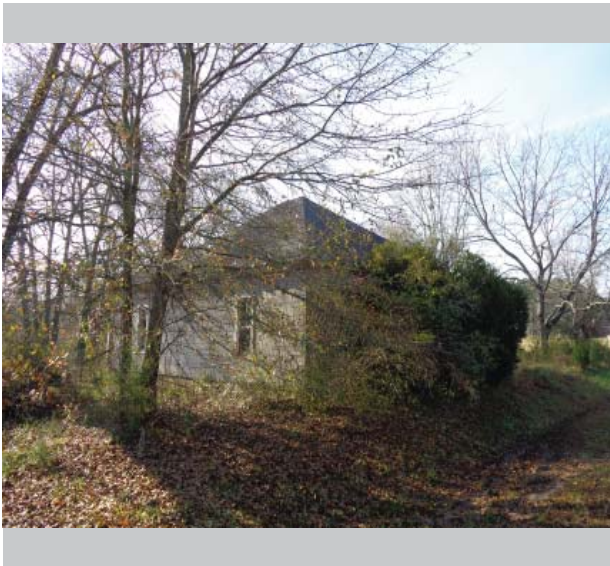
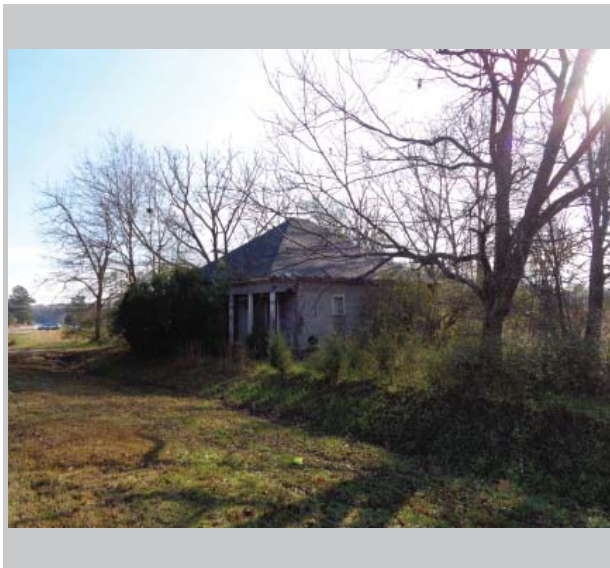
Field ID: RO-1
GNAHRGIS ID: 251192
County: Rockdale
Preliminary NR Assessment: Does not meet
Not Listed

52 Pleasant Hill Rd.

Resource Type Building

Resource Use Vacant/not in use

Foundation Continuous: concrete
CMU

Chimney None observed

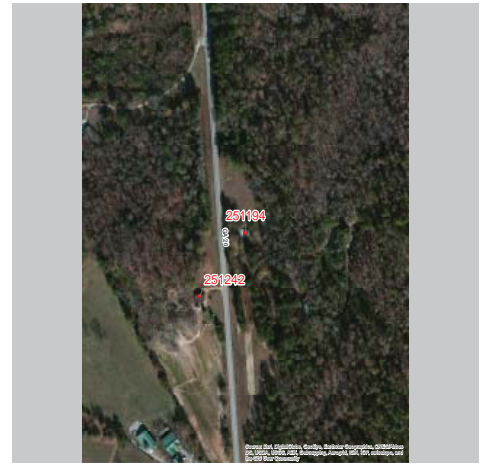
Field ID: RO-2
GNAHRGIS ID: 251194
County: Rockdale
Preliminary NR Assessment: May meet
Not Listed

4455 Hwy 20

- Resource Type** Building
- Resource Use** Single dwelling: residential
- Date of Construction** ca. 1900
- Building Type** Central hallway
- Structural System** Balloon Frame
- Style** No academic style
- Roof** Gable: side
- Exterior Cladding** Wood: weatherboard
P. synthetics: pat. asphalt
- Foundation** Unknown
- Porch** Stoop
- Windows** Double hung sash: 1/1
- Chimney** Gable end, exterior: fieldstone
- Alterations** Rear addition

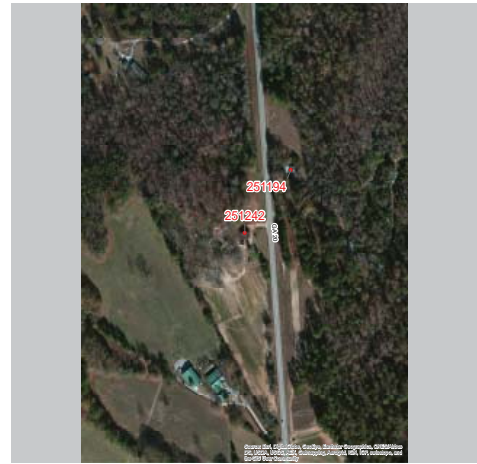
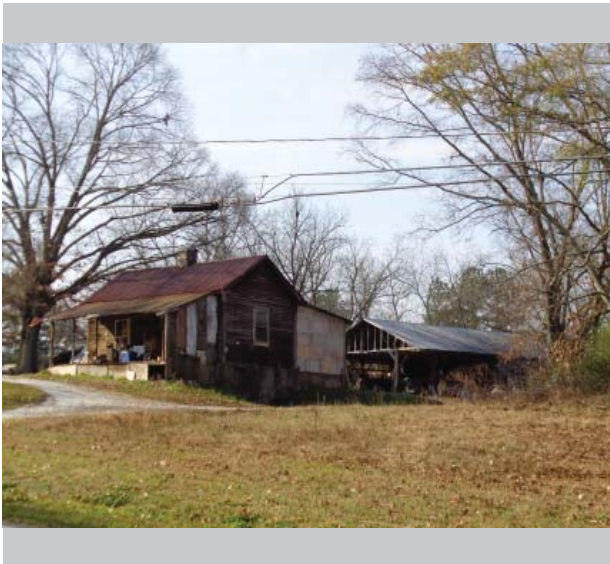
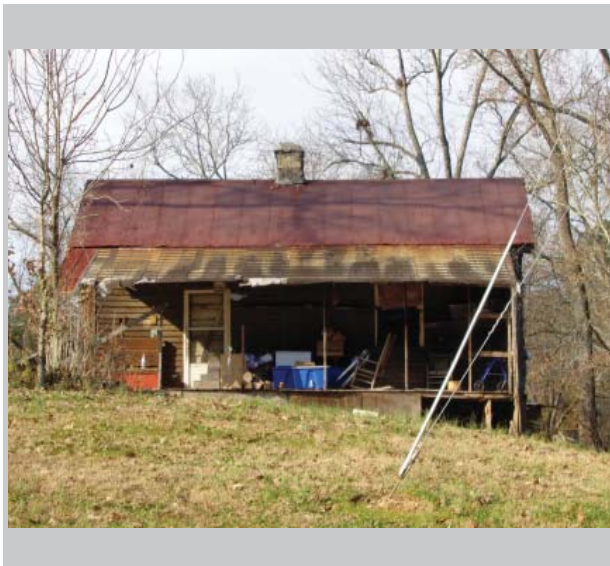
Field ID: RO-3
GNAHRGIS ID: 251242
County: Rockdale
Preliminary NR Assessment: Does not meet
Not Listed

4430 Hwy 20

Resource Type Building

Resource Use Single dwelling:
residential

Foundation Unknown

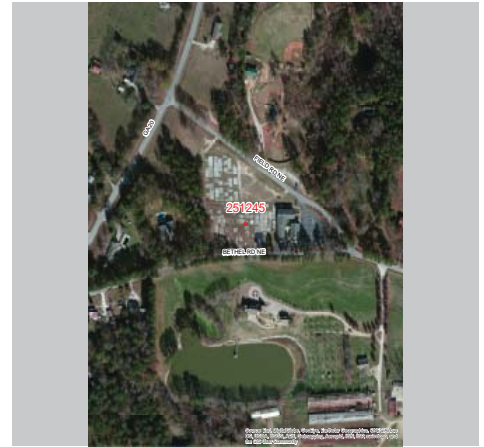
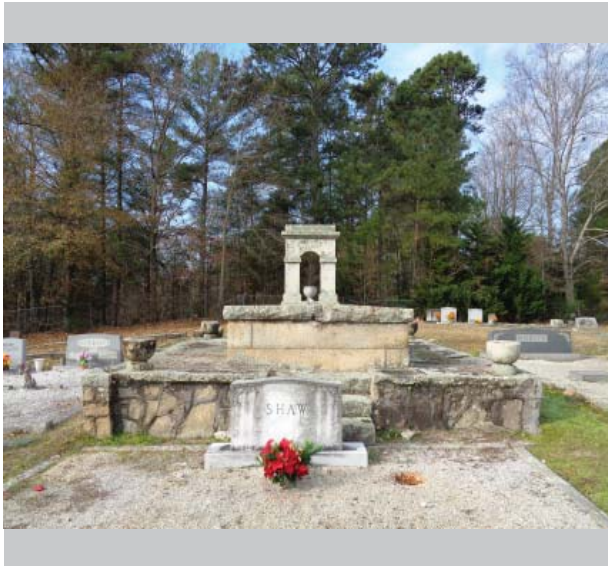
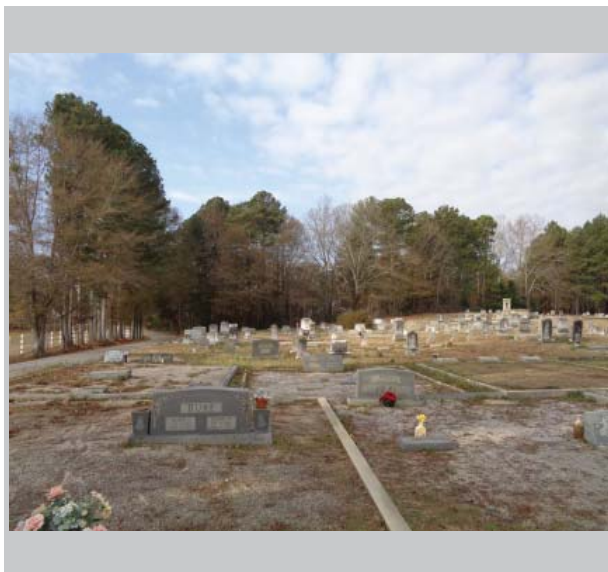
Field ID: RO-04
GNAHRGIS ID: 251245
County: Rockdale
Preliminary NR Assessment: Does not meet
Not Listed

Bethel Christian Church Cemetery
1930 Bethel Rd.

Resource Type Site

Resource Use Funerary: cemetery

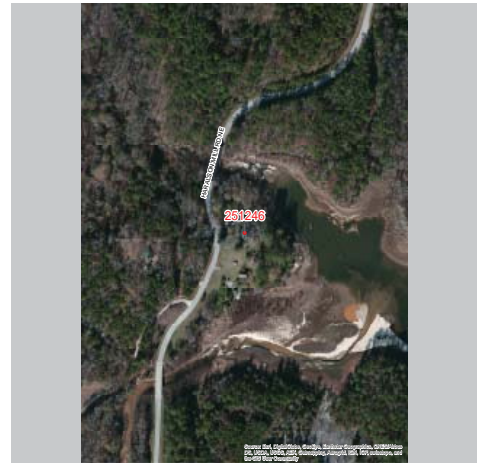
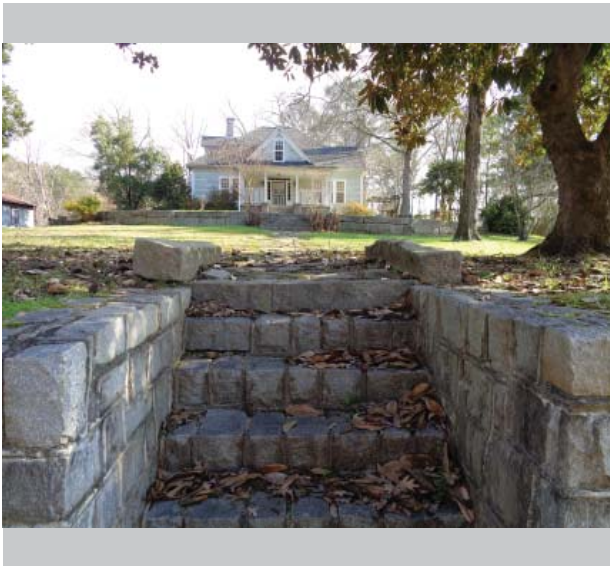
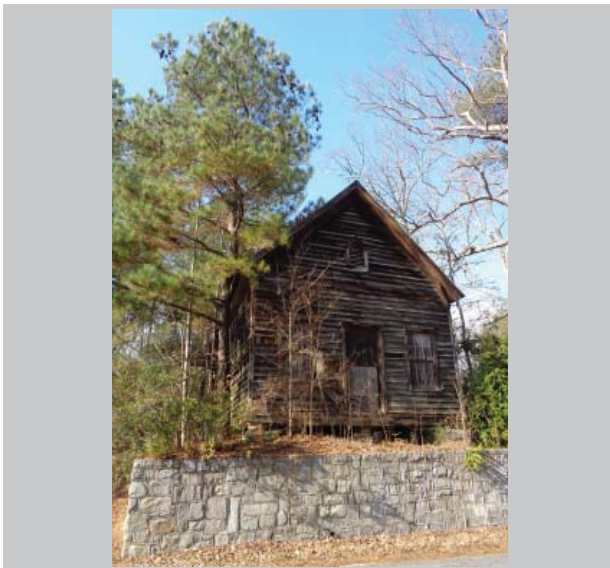
Field ID: RO-5
GNAHRGIS ID: 251246
County: Rockdale
Preliminary NR Assessment: Appears to meet
Not Listed

Haralson Mill/Parish
4279 Haralson Mill Rd.

Resource Type Building

Resource Use Single dwelling:
residential

Foundation Unknown

Alterations Replaced windows

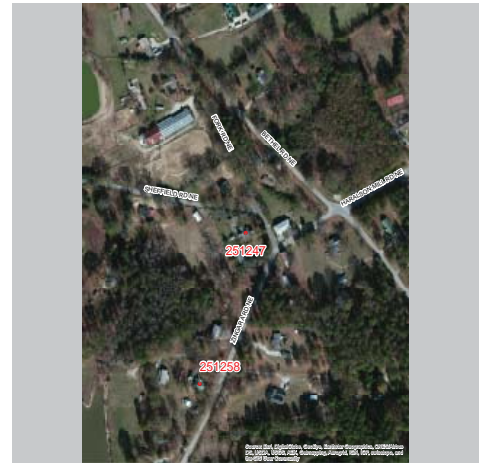
Field ID: RO-6
GNAHRGIS ID: 251247
County: Rockdale
Preliminary NR Assessment: Does not meet
Not Listed

2109 Sheffield Rd.

- Resource Type** Building
- Resource Use** Single dwelling: residential
- Date of Construction** ca. 1920
- Building Type** Central hallway
- Structural System** Balloon Frame
- Style** Craftsman
- Roof** Gable: side
- Exterior Cladding** Prism synthetics: vinyl/aluminum siding
- Foundation** Unknown
- Porch** Portico
- Windows** Double hung sash: 6/6
- Chimney** Gable-end and off-ctr within roof: fieldstone
- Alterations** Addition at right facade
Multiple material replacements

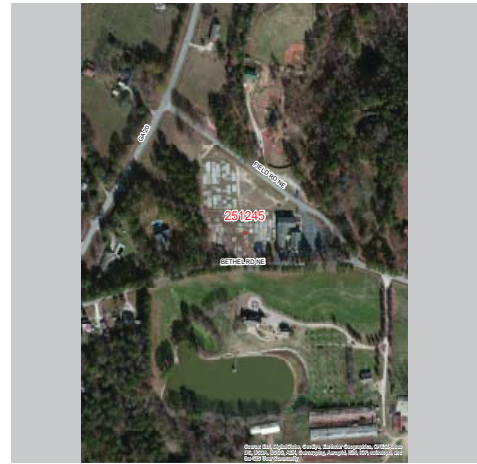
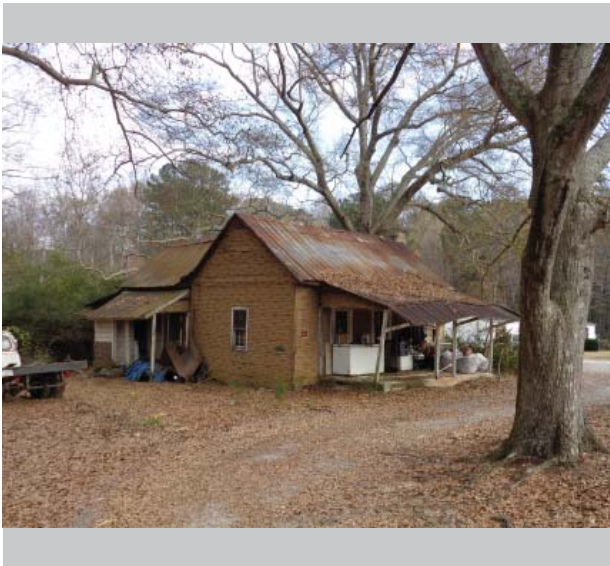
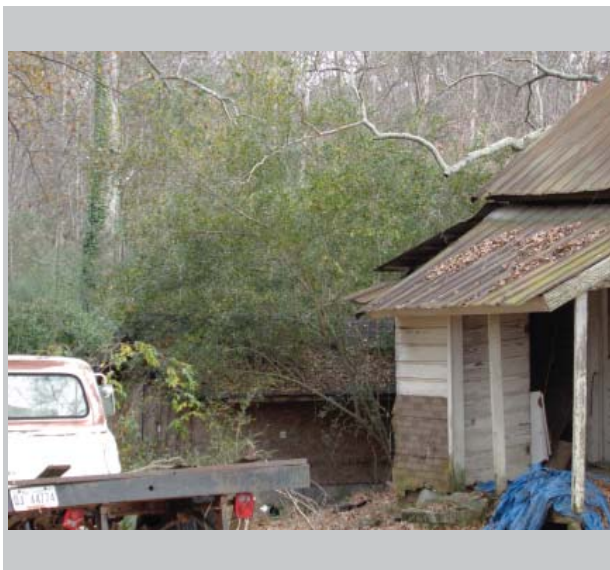
Field ID: RO-7
GNAHRGIS ID: 251248
County: Rockdale
Preliminary NR Assessment: May meet
Not Listed

128 Bethel Rd. NW

Resource Type Building

Resource Use Single dwelling:
residential

Foundation Unknown

Alterations Rear addition
Replacement siding

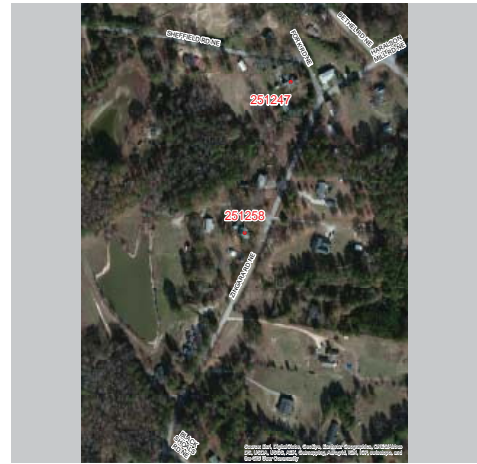
Field ID: RO-09
GNAHRGIS ID: 251258
County: Rockdale
Preliminary NR Assessment: Does not meet
 Not Listed

3800 Zingara Rd.

- Resource Type** Building
- Resource Use** Single dwelling: residential
- Date of Construction** ca. 1925
- Building Type** Bungalow: front gable
- Structural System** Balloon Frame
- Style** Craftsman
- Roof** Gable: front
- Exterior Cladding** Wood: weatherboard
- Foundation** Unknown
- Porch** Recessed
- Windows** Double hung sash: 6/6, 2/1
- Chimney** Center: brick
- Alterations** Multiple integrated rear and side additions
Multiple material replacements

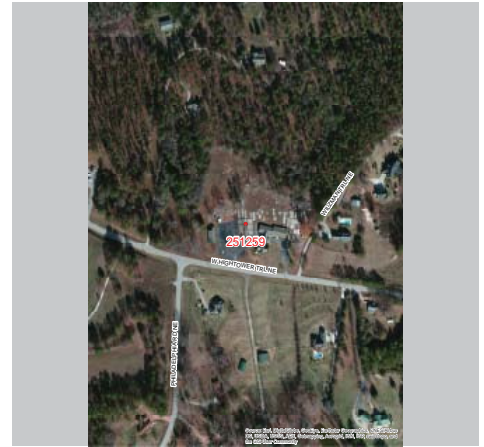
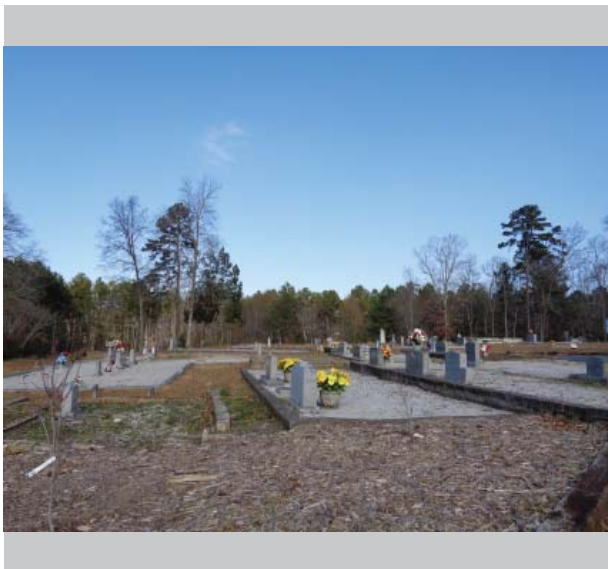
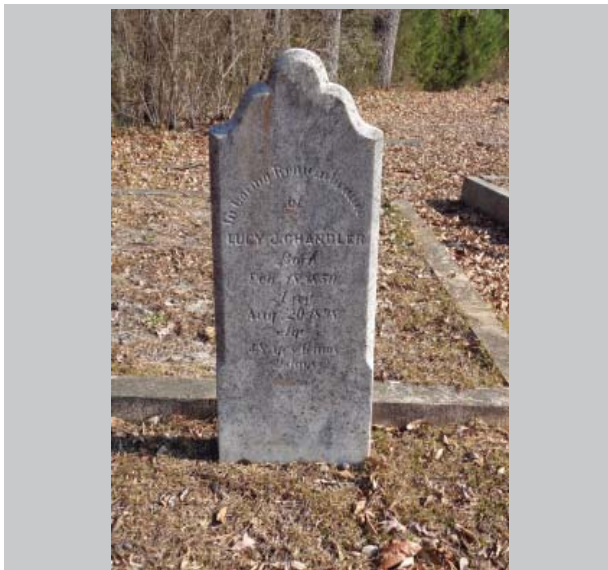
Field ID: RO-10
GNAHRGIS ID: 251259
County: Rockdale
Preliminary NR Assessment: Does not meet
Not Listed

2194 Hightower Rd.

Resource Type Site

Resource Use Funerary: cemetery

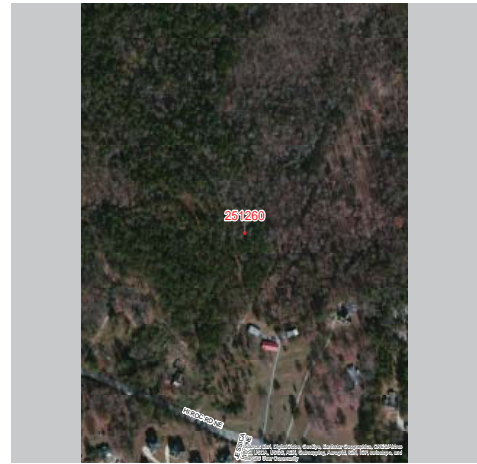
Field ID: RO-11
GNAHRGIS ID: 251260
County: Rockdale
Preliminary NR Assessment: Does not meet
 Not Listed

2250 Hiroc Rd.

- Resource Type** Building
- Resource Use** Single dwelling: residential
- Date of Construction** ca. 1920
- Building Type** Georgian cottage
- Structural System** Balloon Frame
- Style** No academic style
- Roof** Gable: front
- Exterior Cladding** Wood: weatherboard
- Foundation** Unknown
- Porch** Wrap-around
- Windows** Double hung sash: 6/1
- Chimney** Gable end, exterior: fieldstone
- Alterations** Stucco added to front
Replaced siding at left
Rear addition

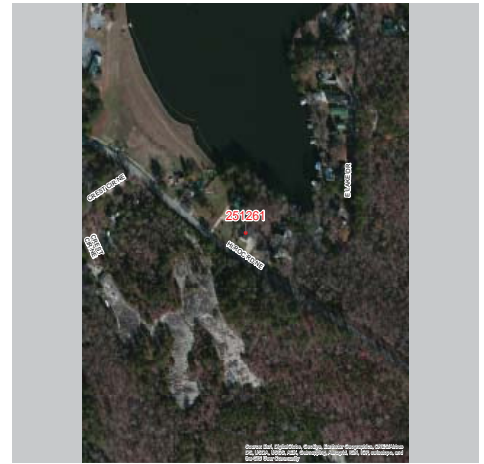
Field ID: RO-12
GNAHRGIS ID: 251261
County: Rockdale
Preliminary NR Assessment: May meet
Not Listed

2038 HiRoc Rd.

- Resource Type** Building
- Resource Use** Single dwelling: residential
- Date of Construction** ca. 1930
- Building Type** Bungalow: front gable
- Structural System** Balloon Frame
- Style** Craftsman
- Roof** Gable: front
- Exterior Cladding** Prism synthetics: vinyl/aluminum siding
- Foundation** Concrete
- Porch** Stoop
- Windows** Double hung sash: 9/1
- Chimney** None observed
- Alterations** Replacement siding
Infilled design on vent in gable

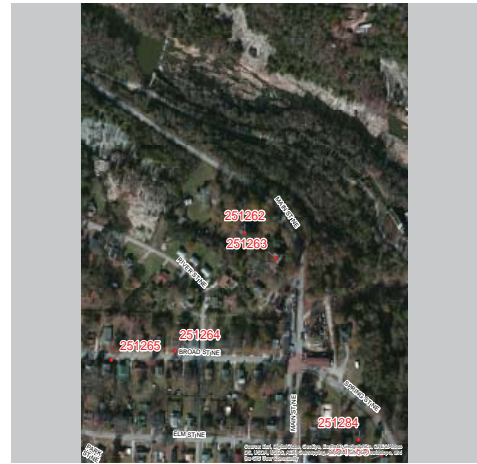
Field ID: RO-13
GNAHRGIS ID: 251262
County: Rockdale
Preliminary NR Assessment: May meet
 Not Listed

1750 Main St. NE

- Resource Type** Building
- Resource Use** Single dwelling: residential
- Date of Construction** ca. 1900
- Building Type** Georgian house
- Structural System** Balloon Frame
- Style** Colonial revival
- Roof** Hip
- Exterior Cladding** Stucco
- Foundation** Unknown
- Porch** Verandah
- Windows** Double hung sash: 1/1
- Chimney** Gable-end, exterior and center: fieldstone
- Alterations**

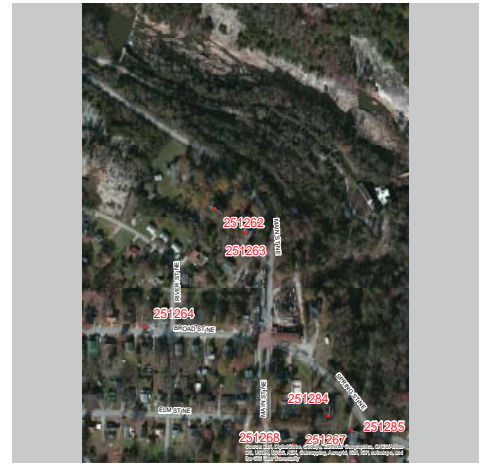
Field ID: RO-14
GNAHRGIS ID: 251263
County: Rockdale
Preliminary NR Assessment: May meet
Not Listed

24 Main St. NE

- Resource Type** Building
- Resource Use** Single dwelling: residential
- Date of Construction** ca. 1900
- Building Type** Georgian house
- Structural System** Balloon Frame
- Style** Colonial revival
- Roof** Hip
- Exterior Cladding** Stone: fieldstone
- Foundation** Continuous: stone
- Porch** Verandah
- Windows** Double hung sash: 2/2
Casement: 6 pane
- Chimney** Both gable ends: brick
- Alterations** Addition at front left

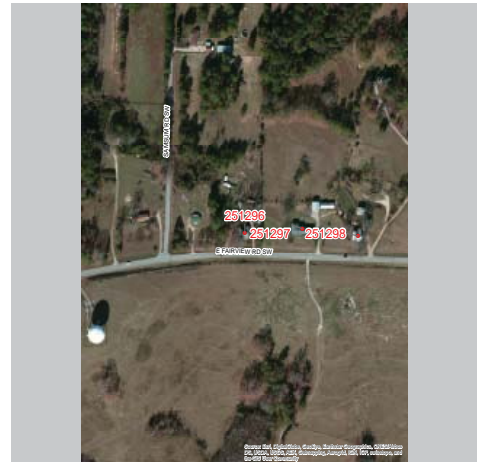
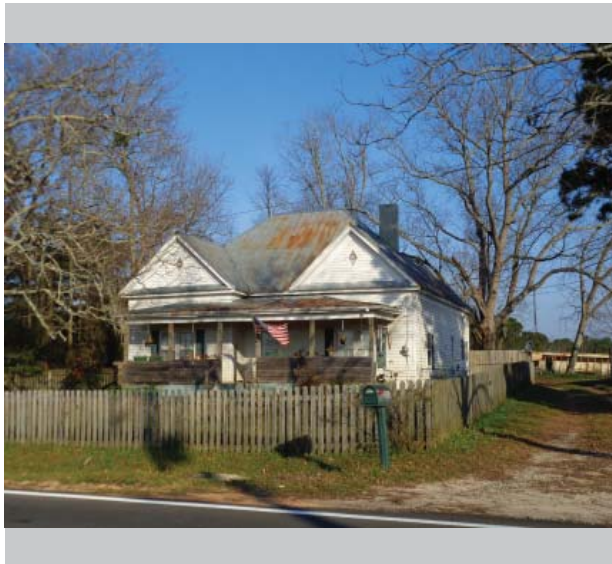
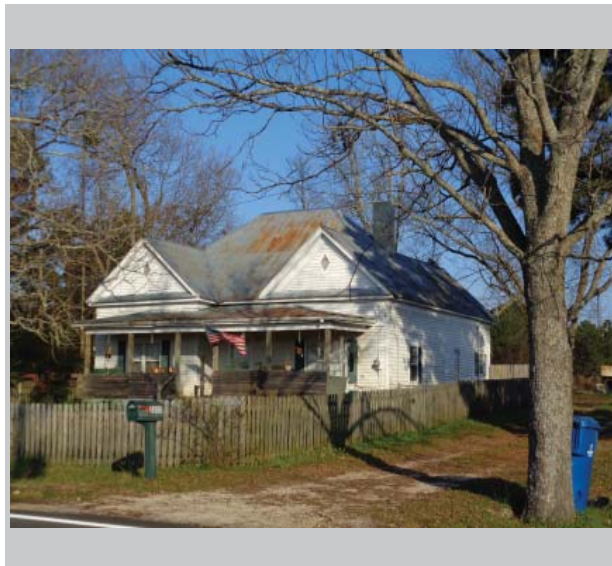
Field ID: RO-15
GNAHRGIS ID: 251296
County: Rockdale
Preliminary NR Assessment: May meet
Not Listed

5055 E Fairview Rd. SW

Resource Type Building

Resource Use Single dwelling:
residential

Foundation Unknown

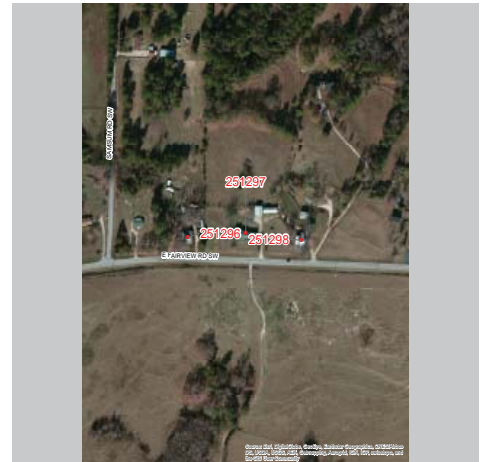
5025 E Fairview Rd. SW

Field ID: RO-16
GNAHRGIS ID: 251297
County: Rockdale
Preliminary NR Assessment: Does not meet
Not Listed

- Resource Type** Building
- Resource Use** Single dwelling: residential
- Date of Construction** ca. 1960
- Building Type** Ranch
- Structural System** Balloon Frame
- Style** Colonial revival
- Roof** Complex
- Exterior Cladding** Brick
- Foundation** Continuous: brick
- Porch** Portico
- Windows** Double hung sash: 2/2, 1/1
- Chimney** Off-ctr, ridgeline: brick
- Alterations** Large integrated addition

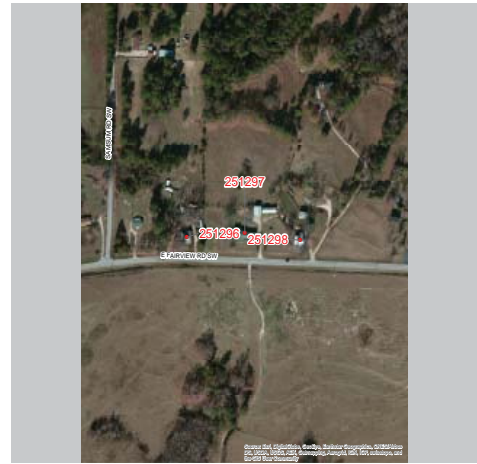
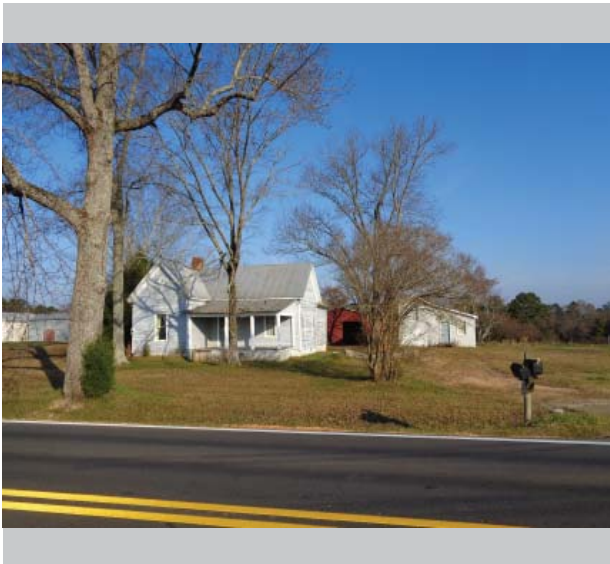
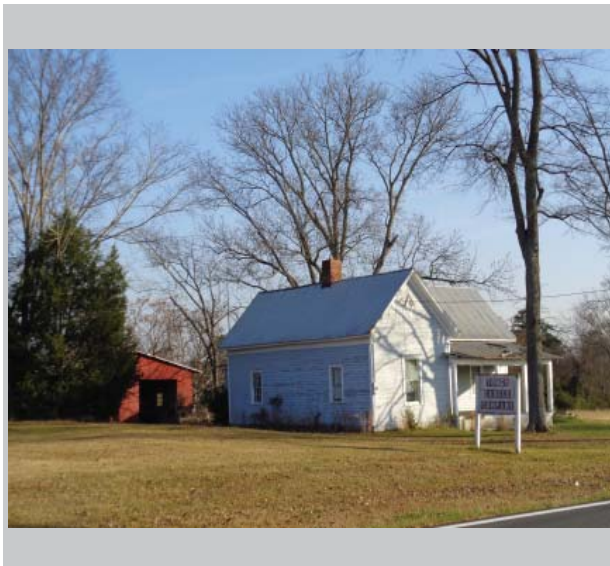
5012 E. Fairview Rd. SW

Field ID: RO-17
GNAHRGIS ID: 251298
County: Rockdale
Preliminary NR Assessment: Appears to meet
Not Listed

Resource Type Building

Resource Use Single dwelling:
residential

Foundation Pier with infill: concrete
CMU

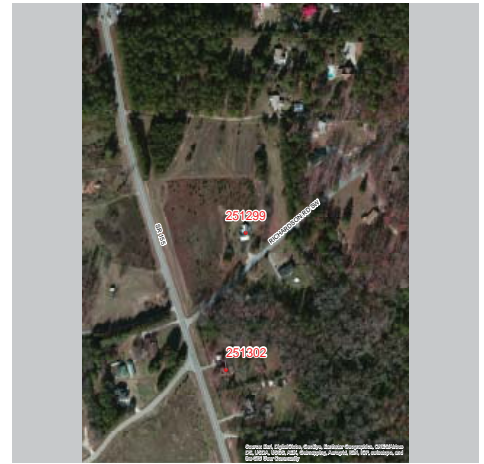
5005 Richardson Rd. SW

Field ID: RO-18
GNAHRGIS ID: 251299
County: Rockdale
Preliminary NR Assessment: Does not meet
Not Listed

- Resource Type** Building
- Resource Use** Vacant/not in use
- Date of Construction** ca. 1910
- Building Type** Central hallway
- Structural System** Balloon Frame
- Style** No academic style
- Roof** Gable: multiple
- Exterior Cladding** Prism synthetics: asbestos siding
- Foundation** Unknown
- Porch** Stoop
- Windows** Double hung sash: 2/2
- Chimney** Gable-end, exterior: brick
- Alterations** Rear addition
Replacement mid-century window

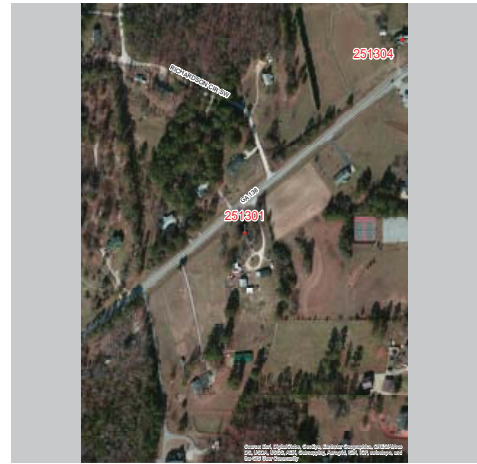
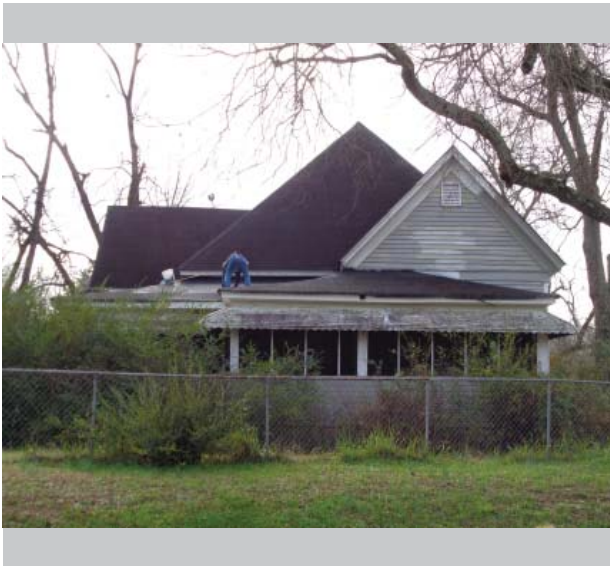
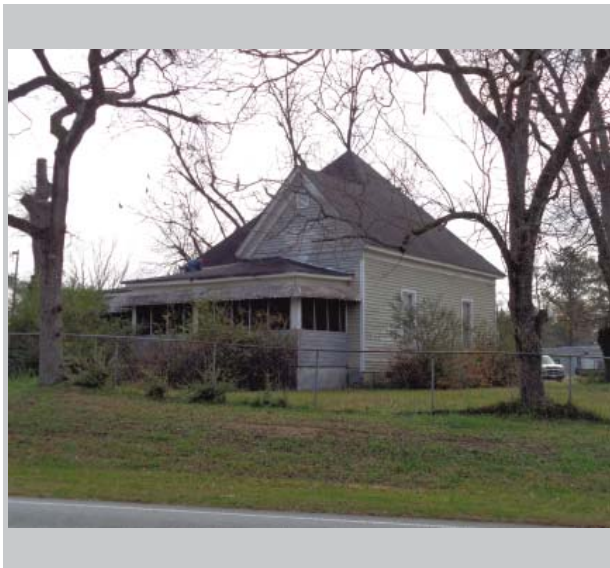
4698 Stockbridge Hwy

Field ID: RO-19
GNAHRGIS ID: 251301
County: Rockdale
Preliminary NR Assessment: May meet
Not Listed

Resource Type Building

Resource Use Single dwelling:
residential

Foundation Unknown

Chimney None observed

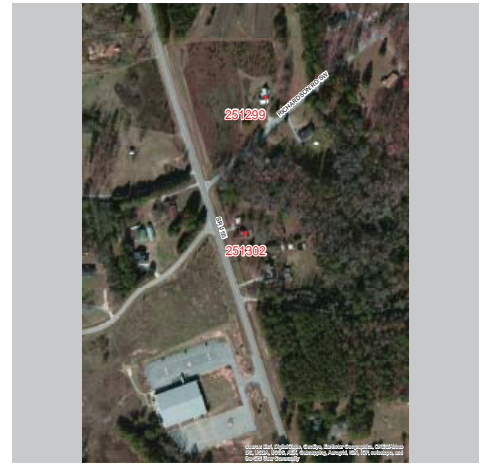
3710 Hwy 155

Field ID: RO-21
GNAHRGIS ID: 251302
County: Rockdale
Preliminary NR Assessment: May meet
Not Listed

- Resource Type** Building
- Resource Use** Single dwelling: residential
- Date of Construction** ca. 1910
- Building Type** New South cottage
- Structural System** Balloon Frame
- Style** No academic style
- Roof** Hip
- Exterior Cladding** Prism synthetics: vinyl/aluminum siding
- Foundation** Unknown
- Porch** Stoop
- Windows** Double hung sash: 6/6
- Chimney** Off-ctr within roof surface: brick (x2)
- Alterations** Rear shed addition
Replacement windows and siding

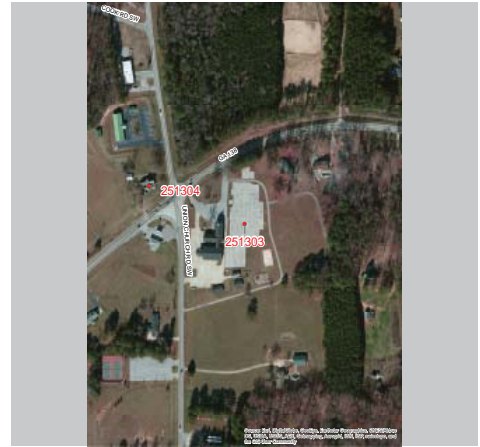
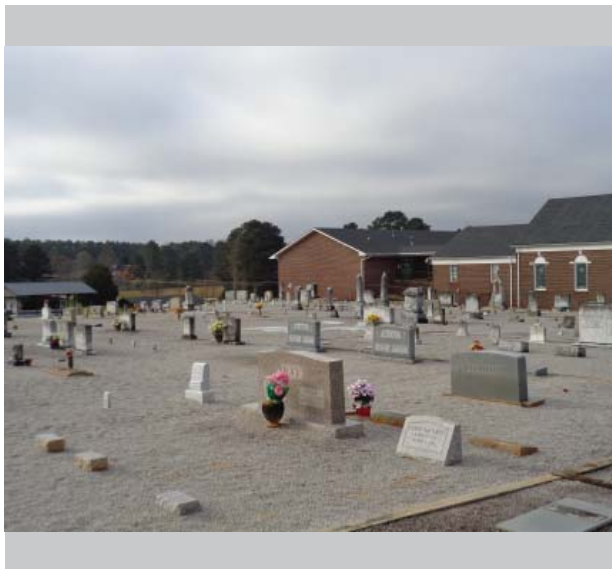
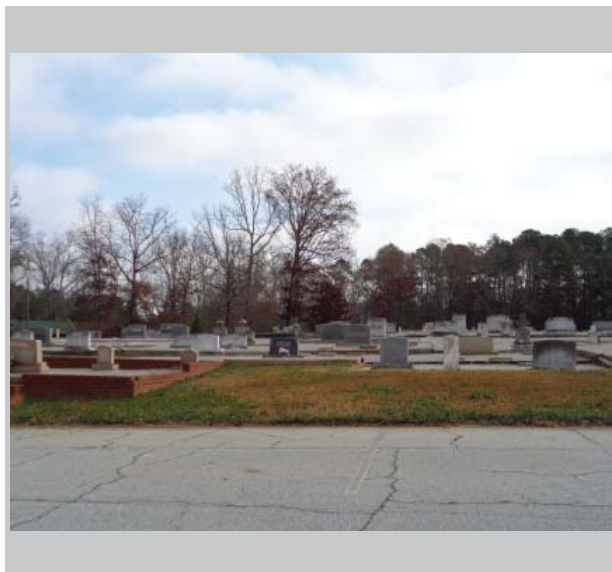
Corner of Union Church Rd. and Hwy 138

Field ID: RO-21
GNAHRGIS ID: 251303
County: Rockdale
Preliminary NR Assessment: Does not meet
 Not Listed

Resource Type Site

Resource Use Funerary: cemetery

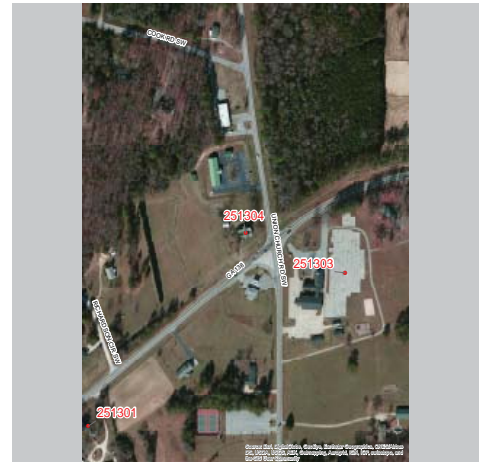
Corner of Union Church Rd. and Hwy 138

Field ID: RO-22
GNAHRGIS ID: 251304
County: Rockdale
Preliminary NR Assessment: Does not meet
Not Listed

- Resource Type** Building
- Resource Use** Vacant/not in use
- Date of Construction** ca. 1910
- Building Type** Gabled ell house
- Structural System** Balloon Frame
- Style** No academic style
- Roof** Gable: cross
- Exterior Cladding** Prism synthetics:
vinyl/aluminum siding
- Foundation** Unknown
- Porch** Stoop
- Windows** Double hung sash: 2/2
- Chimney** Gable-end, exterior and
off-ctr, ridgeline: brick
- Alterations** Replacement siding and
windows

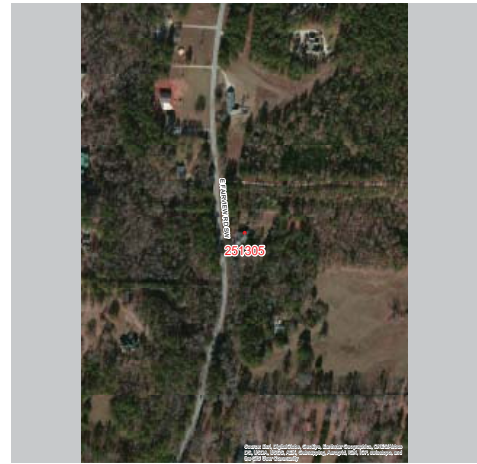
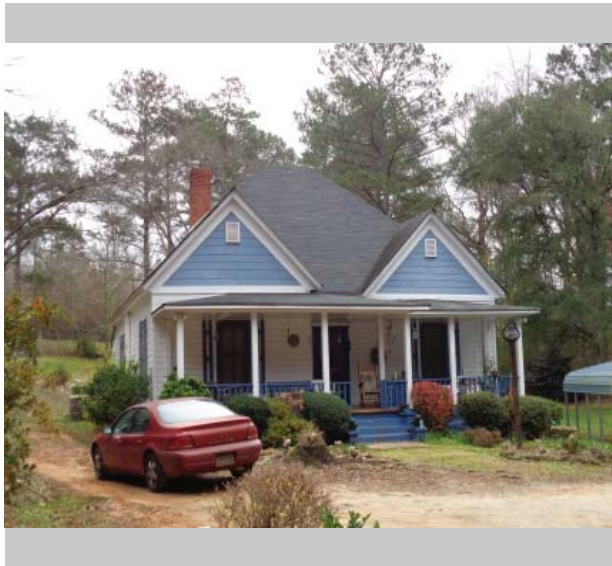
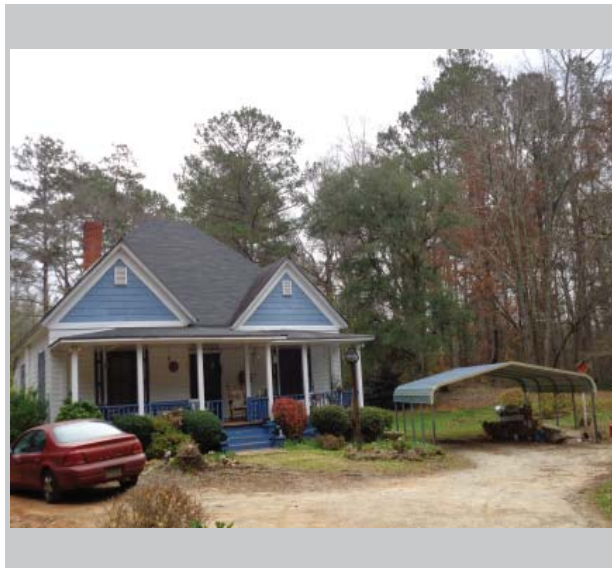
3091 E Fairview Rd.

Field ID: RO-23
GNAHRGIS ID: 251305
County: Rockdale
Preliminary NR Assessment: Does not meet
Not Listed

Resource Type Building

Resource Use Single dwelling:
residential

Foundation Unknown

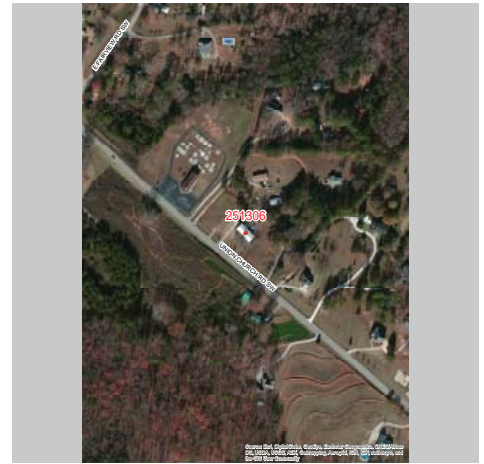
4150 Union Church Rd.

Field ID: RO-24
GNAHRGIS ID: 251306
County: Rockdale
Preliminary NR Assessment: May meet
Not Listed

- Resource Type** Building
- Resource Use** Single dwelling: residential
- Date of Construction** ca. 1960
- Building Type** Ranch
- Structural System** Balloon Frame
- Style** No academic style
- Roof** Gable: side
- Exterior Cladding** Brick
- Foundation** Continuous: brick
- Porch** Portico
- Windows** Double hung sash: 6/6
- Chimney** None observed
- Alterations**

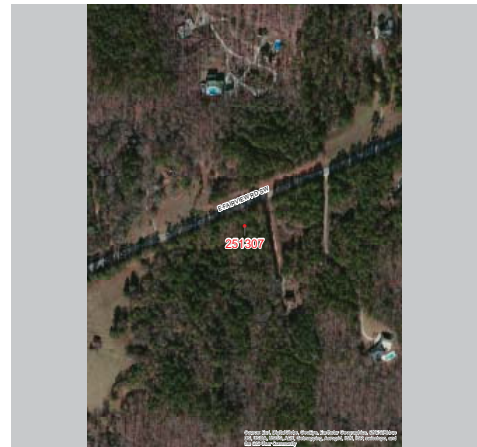
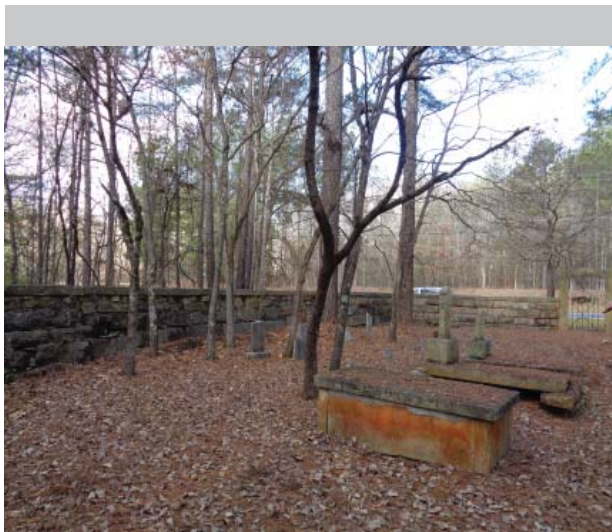
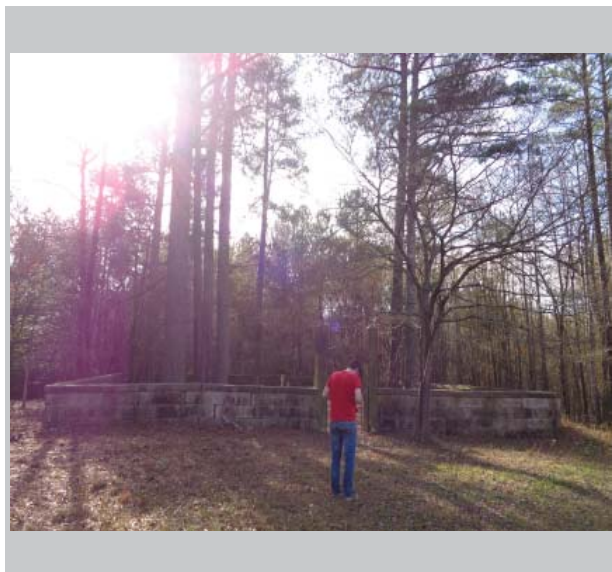
Albert's Graveyard
 .5 mi S of Union Church Rd. and Fairview Rd.
Coordinates: 33.58701, -84.10233

Field ID: RO-25
GNAHRGIS ID: 251307
County: Rockdale
Preliminary NR Assessment: May meet
 Not Listed

Resource Type Site

Resource Use Funerary: cemetery

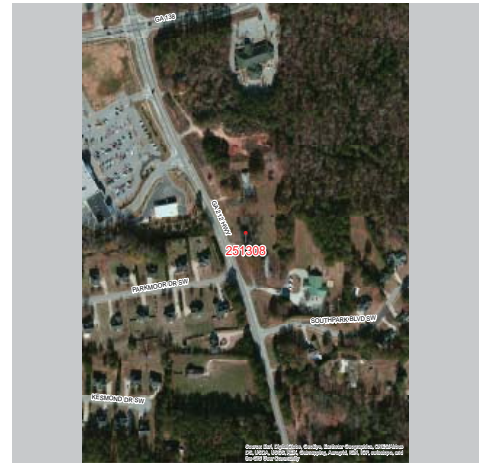
2819 Scott Hwy

Field ID: RO-26
GNAHRGIS ID: 251308
County: Rockdale
Preliminary NR Assessment: May meet
Not Listed

- Resource Type** Building
- Resource Use** Single dwelling: residential
- Date of Construction** ca. 1900
- Building Type** Georgian cottage
- Structural System** Balloon Frame
- Style** No academic style
- Roof** Hip
- Exterior Cladding** Drop siding: shingles
- Foundation** Unknown
- Porch** Stoop
- Windows** Double hung sash: 6/6, 1/1
- Chimney** Off-ctr within roof surface: brick
- Alterations** Addition at left
Chicago window added front left

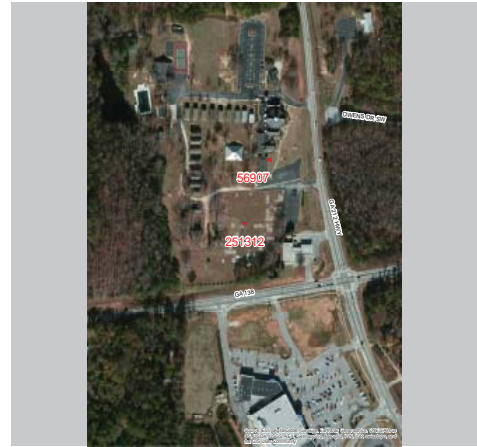
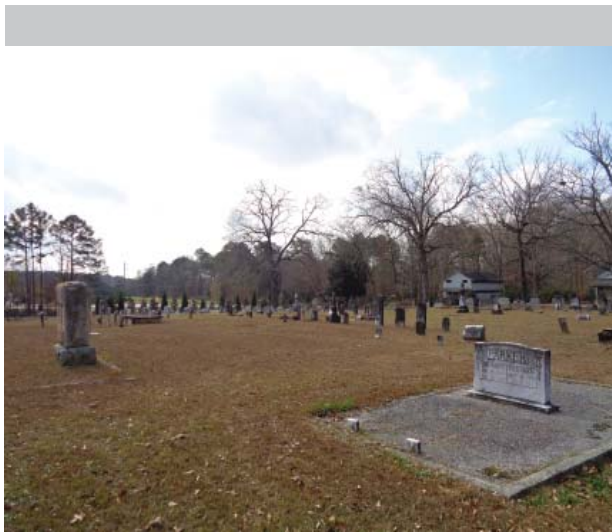
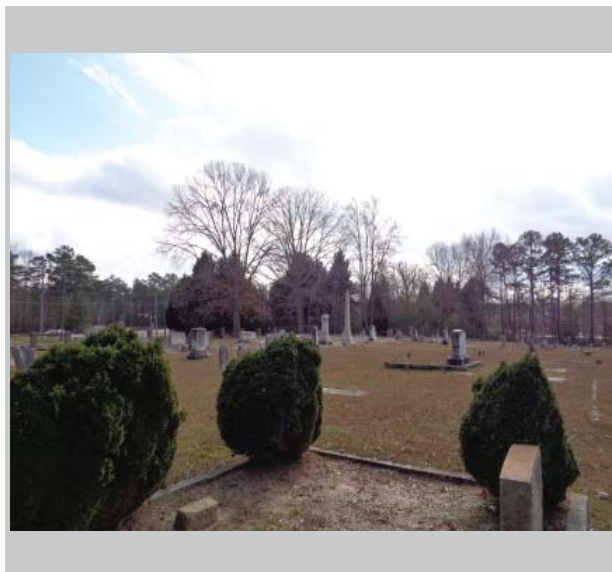
Hwy 138 and Hwy 212

Field ID: RO-27
GNAHRGIS ID: 251312
County: Rockdale
Preliminary NR Assessment: Does not meet
 Not Listed

Resource Type Site

Resource Use Funerary: cemetery

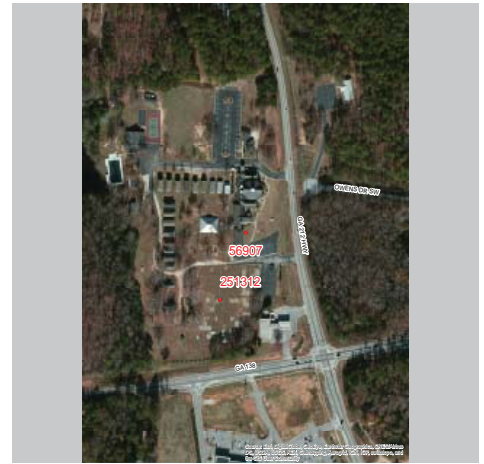
Smyrna Camp
Hwy 138 and Hwy 212

Field ID: RO-28
GNAHRGIS ID: 56907
County: Rockdale
Preliminary NR Assessment: Appears to meet
Not Listed

- Resource Type** Building
- Resource Use** Religious: campground
- Date of Construction** ca. 1910
- Building Type** Multiple
- Structural System** Varies
- Style** Craftsman
- Roof** Varies between structures
- Exterior Cladding** Varies between structures
- Foundation** Varies between structures
- Porch** Multiple types
- Windows** Multiple types
- Chimney** Varies between structures
- Alterations** Numerous buildings have been added since the start of the camp

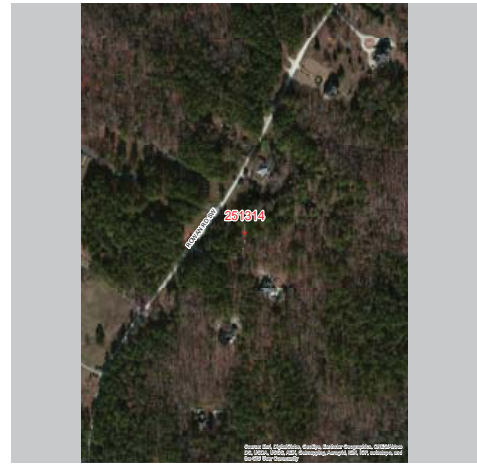
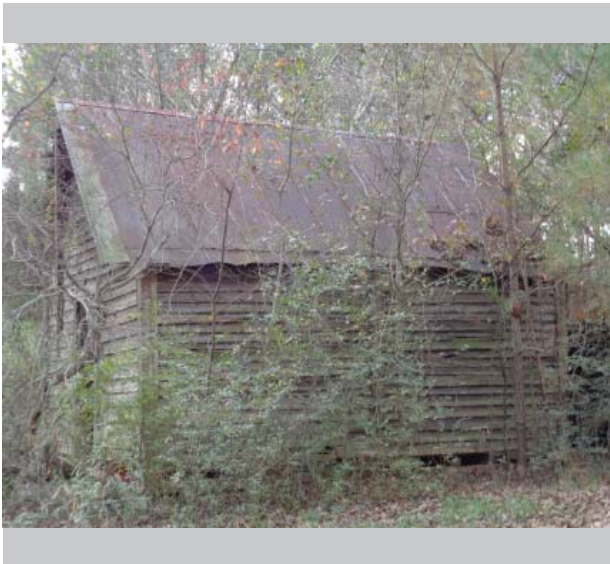
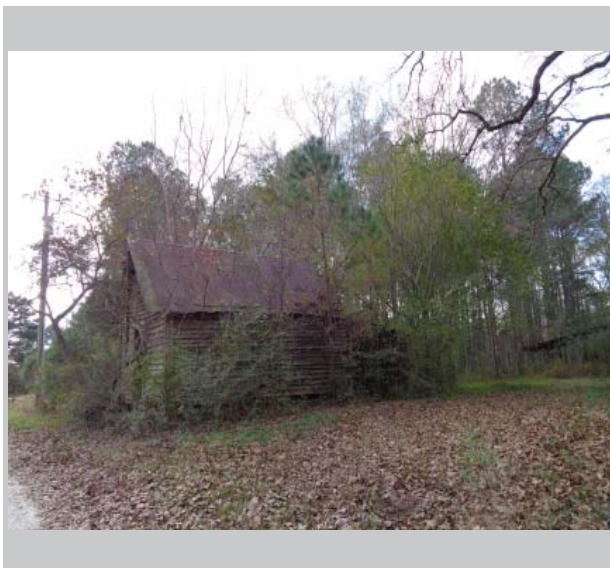
3350 Rowan Rd.

Field ID: RO-29
GNAHRGIS ID: 251314
County: Rockdale
Preliminary NR Assessment: May meet
 Not Listed

Resource Type Building

Resource Use Vacant/not in use

Foundation Pier: stone

Chimney None observed

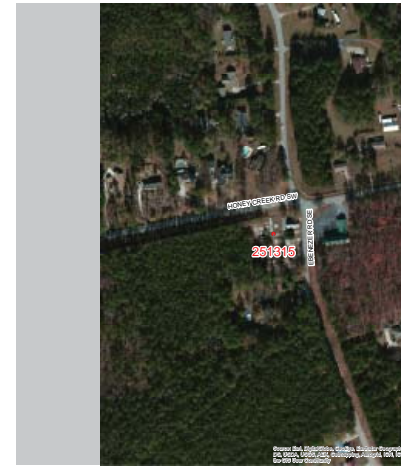
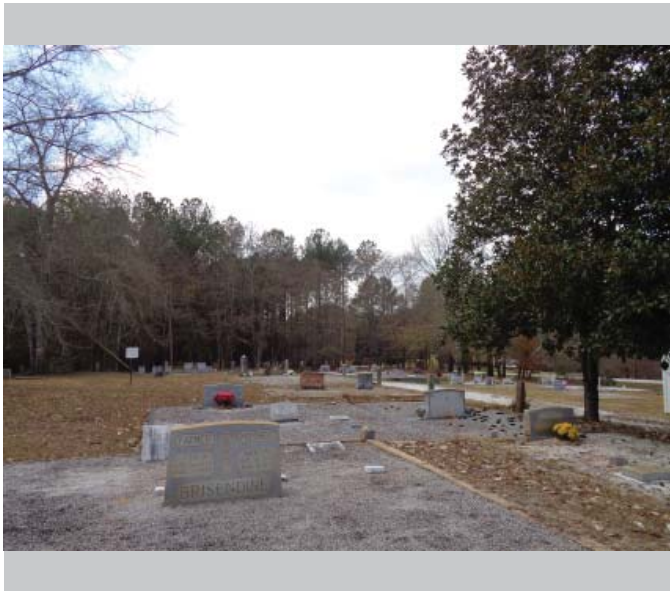
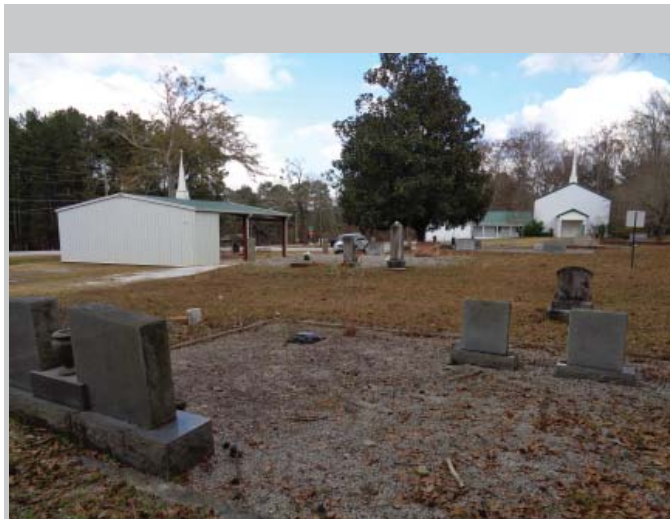
Corner of Honey Creek Rd. and Ebe

Field ID: RO-30
GNAHRGIS ID: 251315
County: Rockdale
Preliminary NR Assessment: Does not meet
Not Listed

Resource Type Site

Resource Use Funerary: cemete

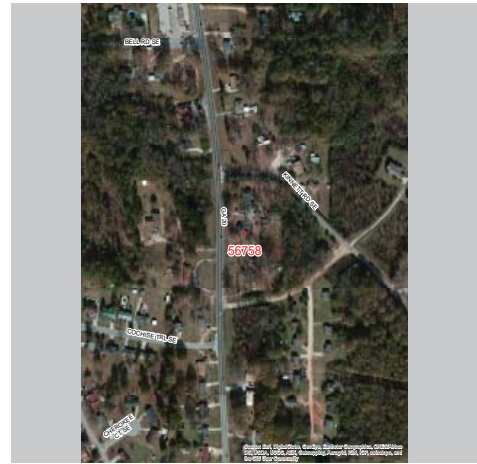
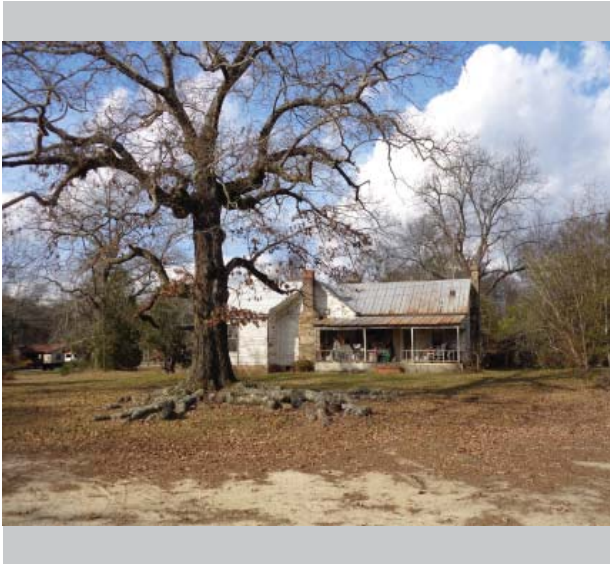
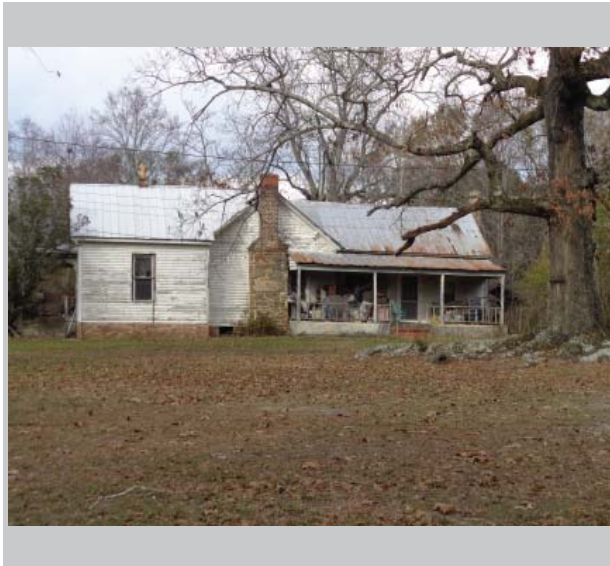
1995 Kinnet Rd.

Field ID: RO-31
GNAHRGIS ID: 56758
County: Rockdale
Preliminary NR Assessment: Does not meet
Not Listed

Resource Type Building

Resource Use Single dwelling:
residential

Foundation Pier with infill: brick

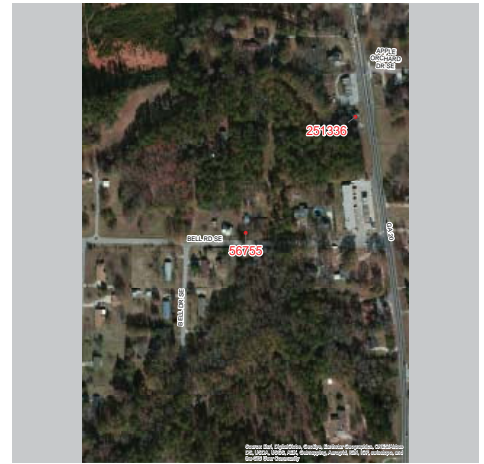
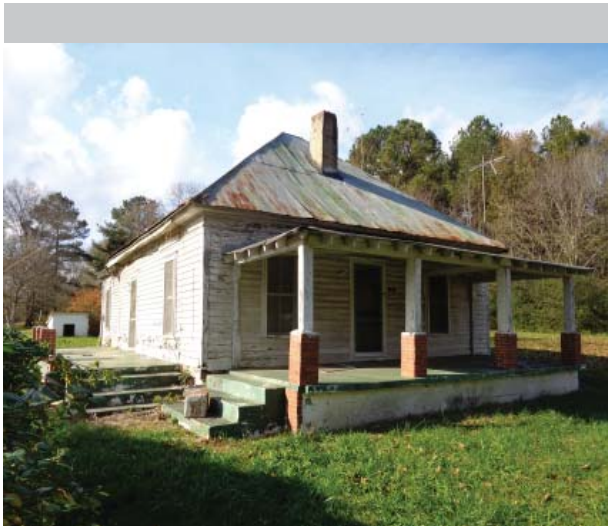
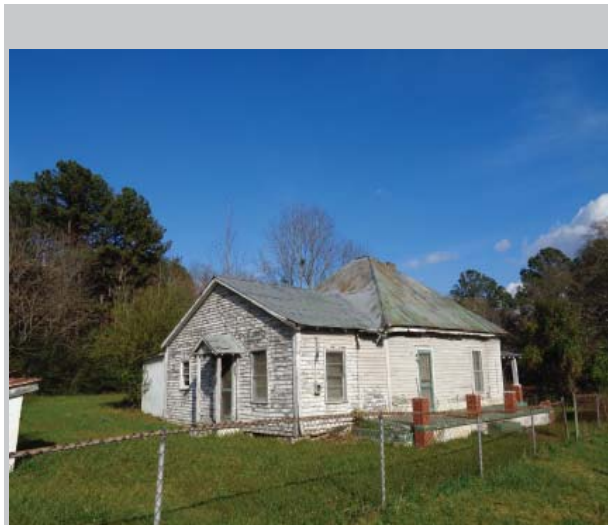
892 Bell Rd.

Field ID: RO-32
GNAHRGIS ID: 56755
County: Rockdale
Preliminary NR Assessment: Does not meet
Not Listed

- Resource Type** Building
- Resource Use** Vacant/not in use
- Date of Construction** ca. 1920
- Building Type** Georgian cottage
- Structural System** Balloon frame
- Style** Craftsman
- Roof** Hip
- Exterior Cladding** Wood: weatherboard
- Foundation** Pier: concrete
- Porch** Wrap-around
- Windows** Double hung sash: 2/2, 4/4
- Chimney** Off-ctr within roof surface: brick
- Alterations** Addition at rear w/ side entry

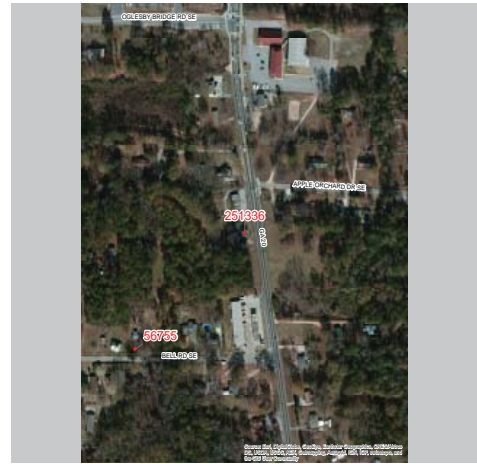
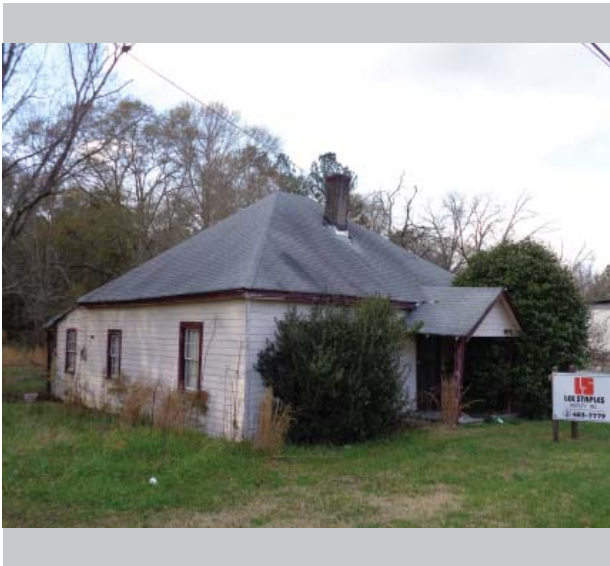
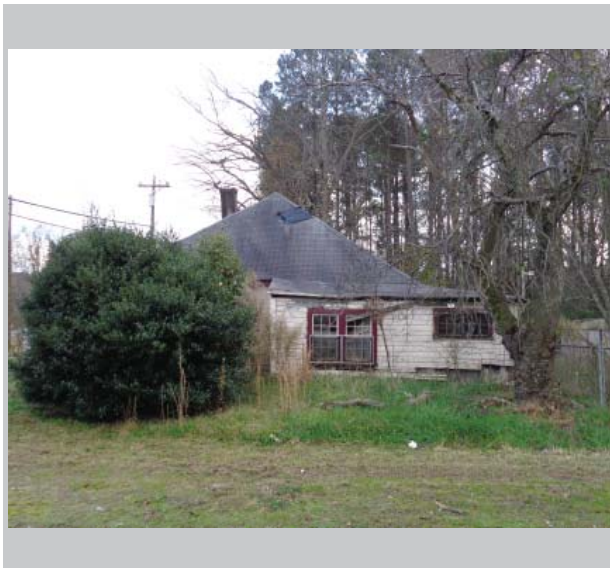
4625 McDonough Hwy

Field ID: RO-33
GNAHRGIS ID: 251336
County: Rockdale
Preliminary NR Assessment: Does not meet
Not Listed

Resource Type Building

Resource Use Vacant/not in use

Foundation Unknown
