Historic Resources Survey Report

Rockdale County, Georgia

December 2015

The University of Georgia
College of Environment and Design
Center for Community Design & Preservation
Historic Resources Survey Report
Rockdale County, Georgia 2015

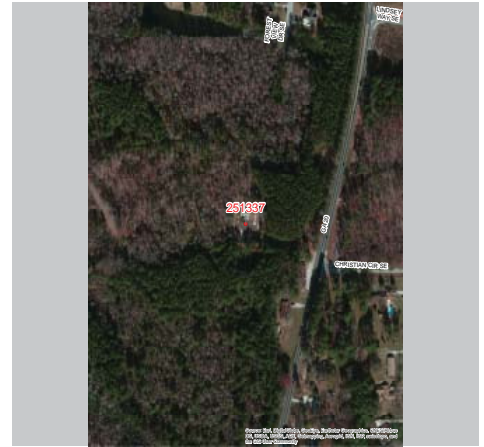
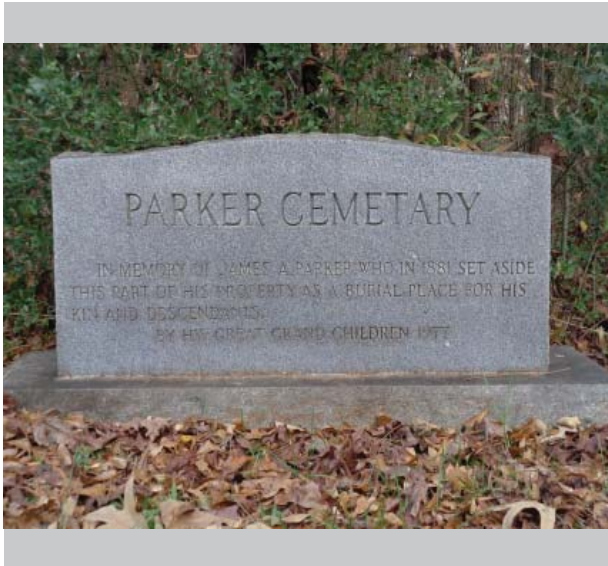
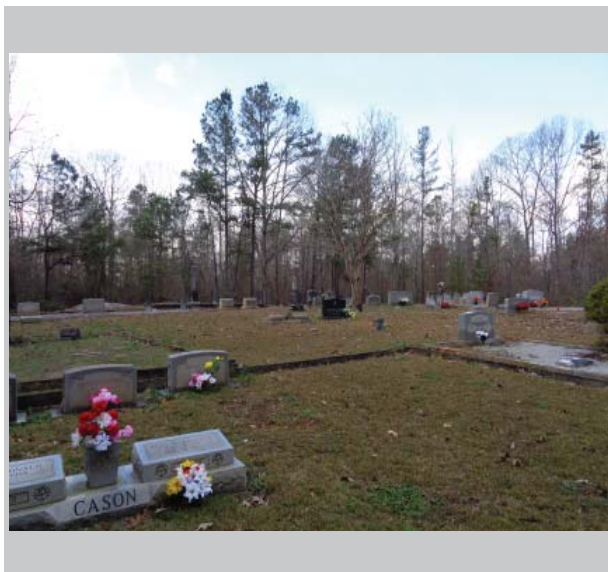
Field ID: RO-34
GNAHRGIS ID: 251337
County: Rockdale
Preliminary NR Assessment: Does not meet
Not Listed

Parker Cemetery
Hwy 20 and Christian Circle SE

Resource Type Site

Resource Use Funerary: cemetery

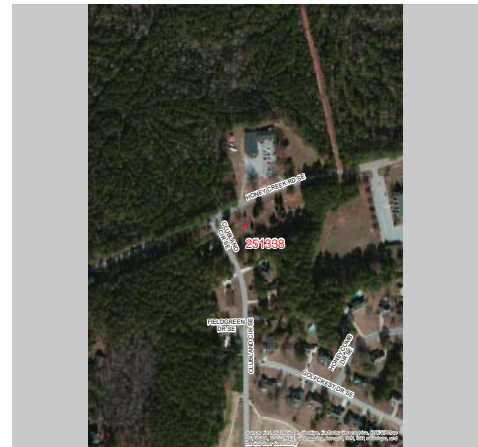
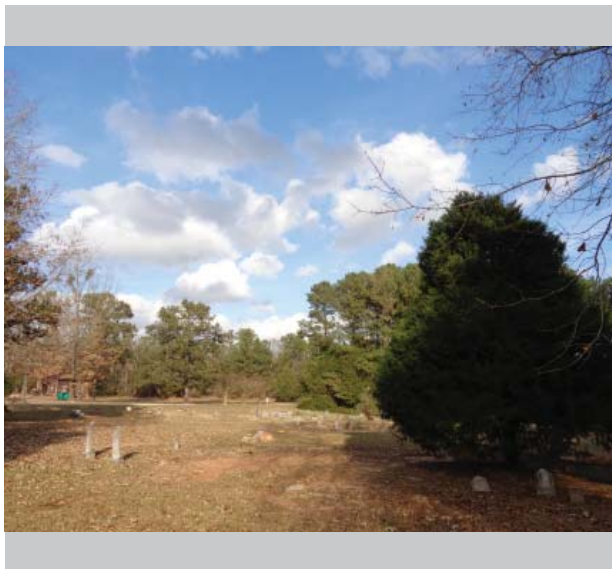
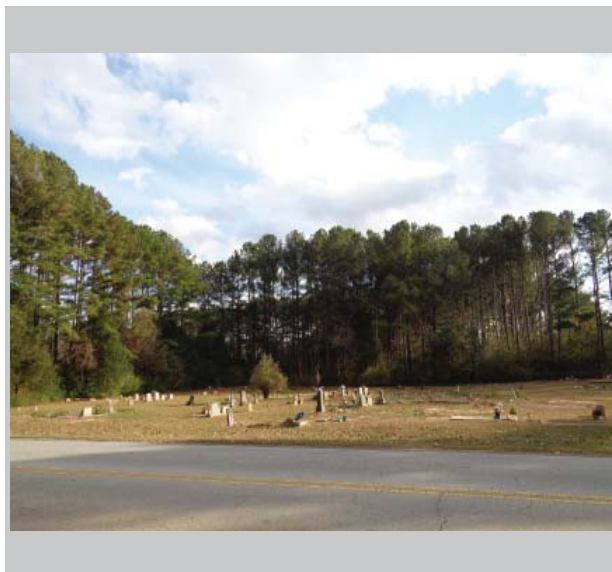
Field ID: RO-35
GNAHRGIS ID: 251338
County: Rockdale
Preliminary NR Assessment: May meet
 Not Listed

Old Pleasant Hill Memorial Garden
 SE corner of Honey Creek Rd. and Clubland Cir. SE

Resource Type Site

Resource Use Funerary: cemetery

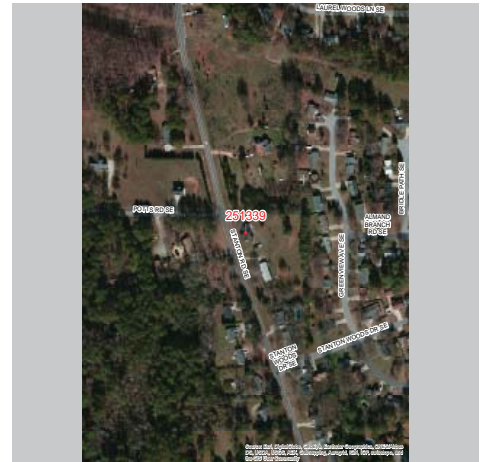
Field ID: RO-36
GNAHRGIS ID: 251339
County: Rockdale
Preliminary NR Assessment: Does not meet
Not Listed

2802 Stanton Rd. SE

- Resource Type** Building
- Resource Use** Single-dwelling:
residential
- Date of Construction** ca. 1930
- Building Type** Bungalow: cross gable
- Structural System** Balloon frame
- Style** Craftsman
- Roof** Gable: cross
- Exterior Cladding** Prism synthetics: asbestos
siding
- Foundation** Unknown
- Porch** Stoop
- Windows** Double hung sash: 6/6
- Chimney** None observed
- Alterations** Rear addition

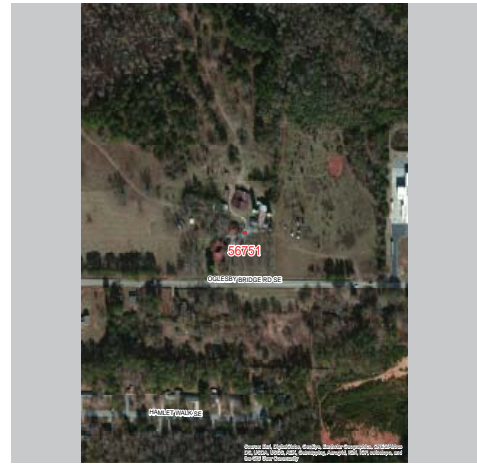
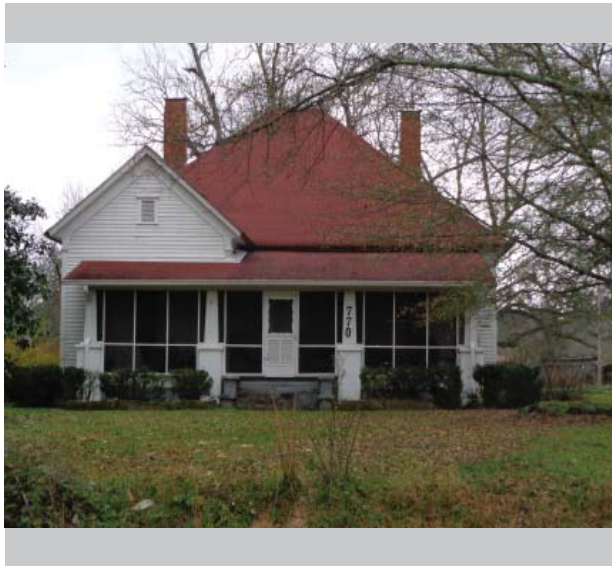
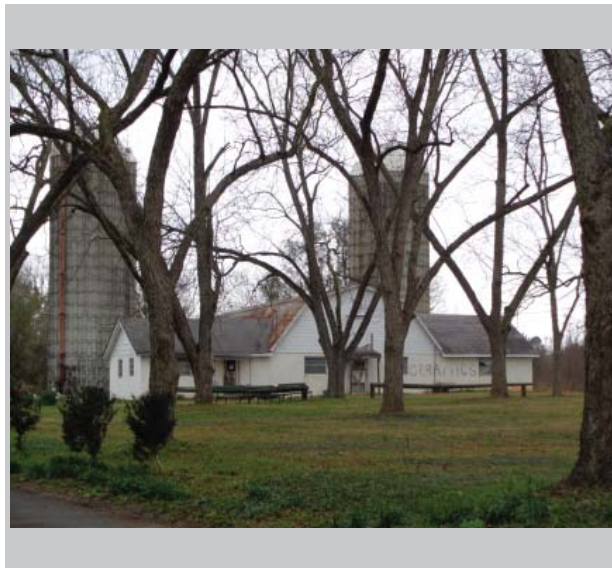
Field ID: RO-37
GNAHRGIS ID: 56751
County: Rockdale
Preliminary NR Assessment: May meet
 Not Listed

770 Oglesby Bridge Rd.

Resource Type Building

Resource Use Single-dwelling:
residential

Foundation Unknown

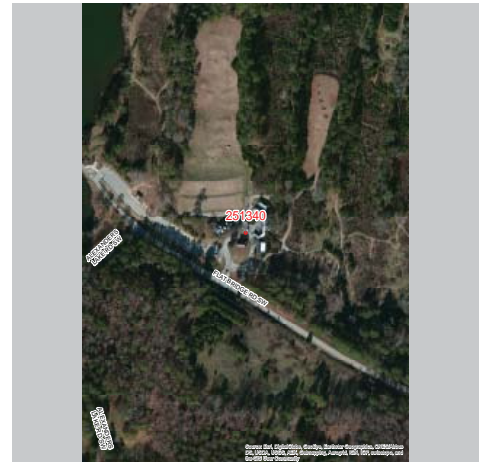
Field ID: RO-38
GNAHRGIS ID: 251340
County: Rockdale
Preliminary NR Assessment: May meet
Not Listed

Panola State Park Archery
4871 SW Flat Bridge Rd.

- Resource Type** Building
- Resource Use** Vacant/not in use
- Date of Construction** ca. 1890
- Building Type** Plantation plain
- Structural System** Balloon frame
- Style** No academic style
- Roof** Gable: side
- Exterior Cladding** Wood: weatherboard
- Foundation** Pier: brick
- Porch** Verandah
- Windows** Double hung sash: 6/6, 4/4
- Chimney** Both gable ends: brick
- Alterations**

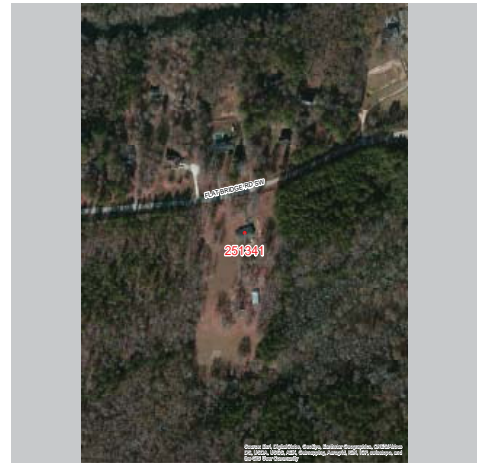
Field ID: RO-39
GNAHRGIS ID: 251341
County: Rockdale
Preliminary NR Assessment: May meet
 Not Listed

1573 Flat Bridge Rd. SW

- Resource Type** Building
- Resource Use** Single dwelling: residential
- Date of Construction** ca. 1960
- Building Type** Ranch
- Structural System** Balloon frame
- Style** No academic style
- Roof** Complex
- Exterior Cladding** Brick
- Foundation** Continuous: brick
- Porch** Recessed
- Windows** Double hung sash: 6/6, 1/1
- Chimney** Off-ctr within roof surface: brick
- Alterations**

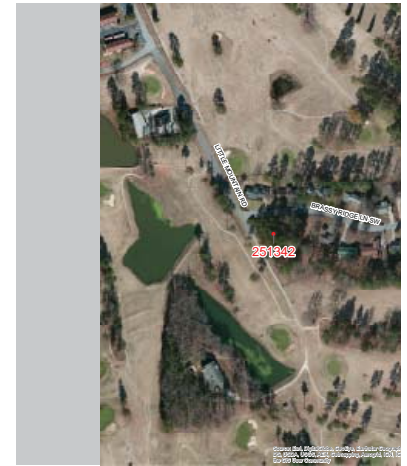
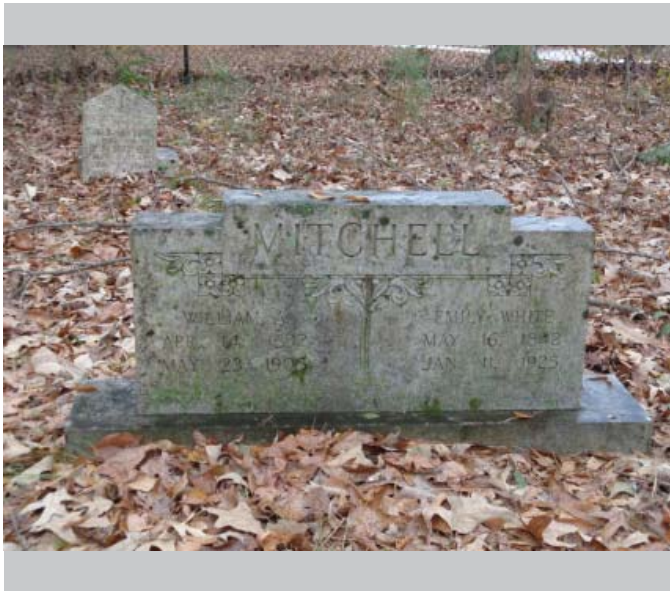
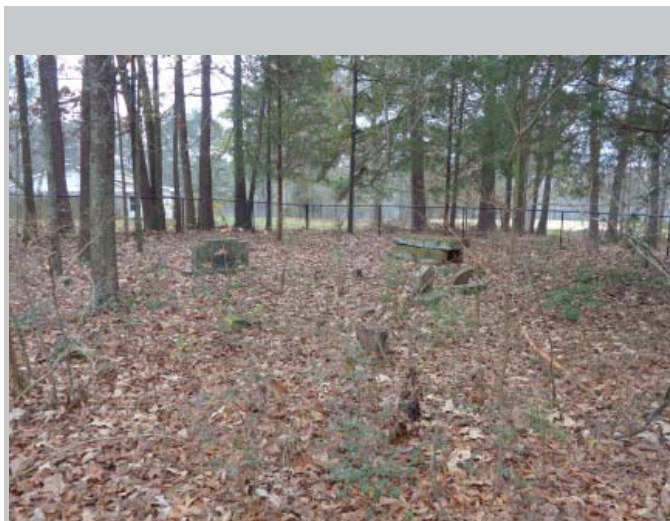
Field ID: RO-40
GNAHRGIS ID: 251342
County: Rockdale
Preliminary NR Assessment: May meet
Not Listed

Mitchell Cemetery
Little Mtn. Rd. and Brassie

Resource Type Site

Resource Use Funerary: cemetery

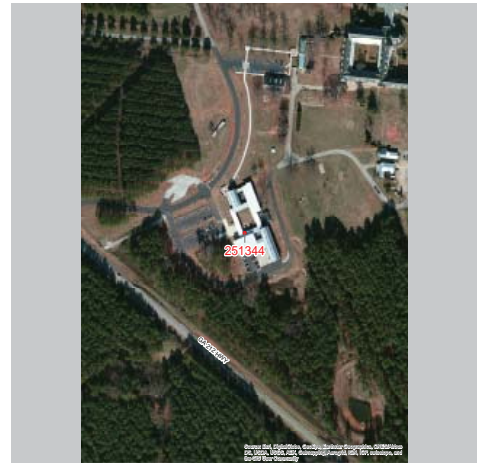
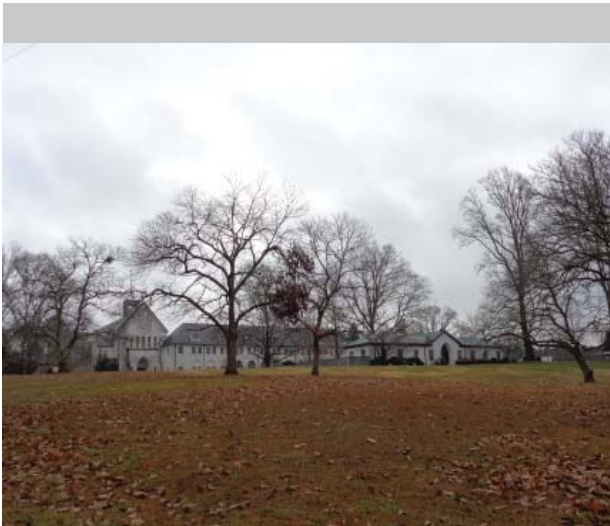
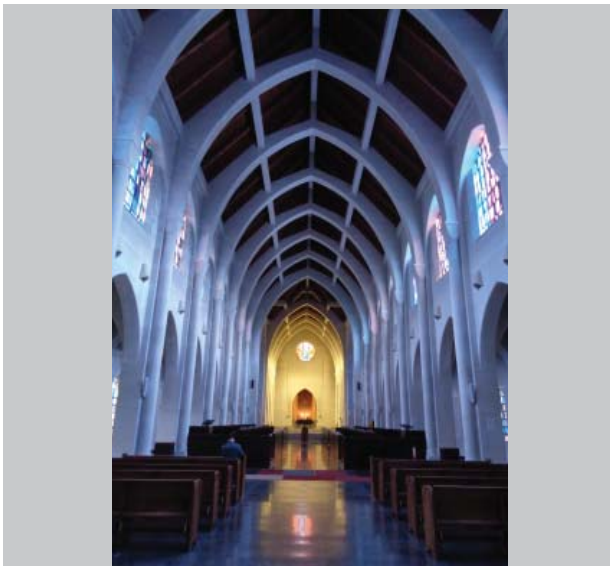
Field ID: RO-41
GNAHRGIS ID: 251344
County: Rockdale
Preliminary NR Assessment: Appears to meet
 Not Listed

Monastery of the Holy Ghost
 2573 Hwy 212

Resource Type Building

Resource Use Religious: church structure, housing, retreat

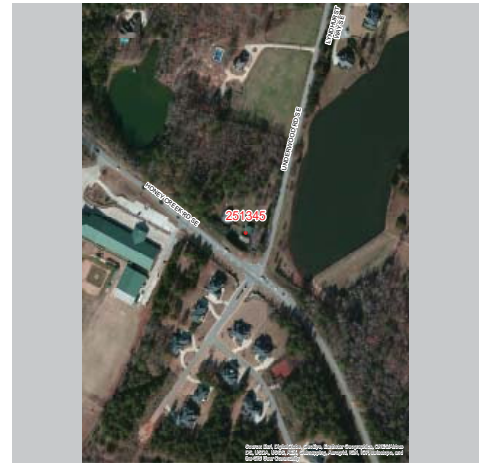
Field ID: RO-42
GNAHRGIS ID: 251345
County: Rockdale
Preliminary NR Assessment: Does not meet
Not Listed

3795 Underwood Rd.

- Resource Type** Building
- Resource Use** Single dwelling: residential
- Date of Construction** ca. 1900
- Building Type** Plantation plain
- Structural System** Balloon frame
- Style** No academic style
- Roof** Gable: side
- Exterior Cladding** Wood: weatherboard
- Foundation** Pier with infill: brick
- Porch** Recessed
- Windows** Double hung sash: 1/1, fixed single-pane square
- Chimney** Both gable ends: brick
- Alterations** Carport added at rear
Dormer added
Multiple rear additions
Replacement windows

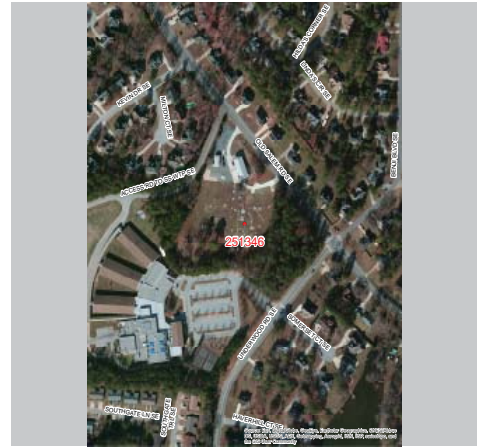
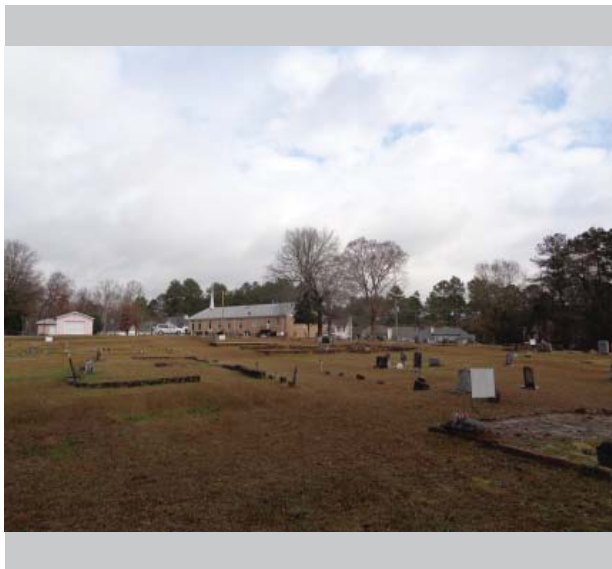
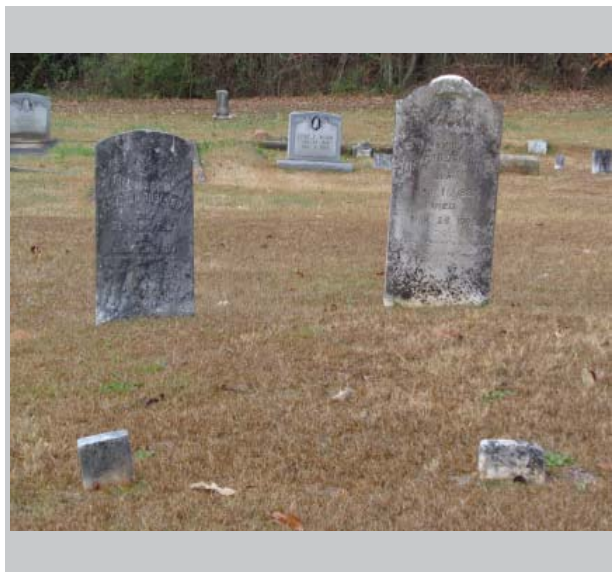
Field ID: RO-43
GNAHRGIS ID: 251346
County: Rockdale
Preliminary NR Assessment: May meet
 Not Listed

Corner of Kevin Dr. SE and Old Salem Rd. SE
Coordinates: 33.60392, -83.98895

Resource Type Site

Resource Use Funerary: cemetery

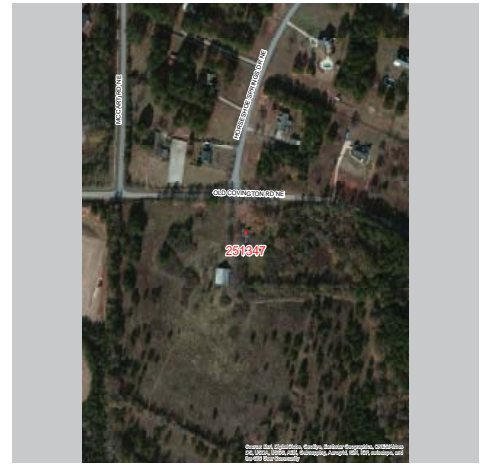
Field ID: RO-44
GNAHRGIS ID: 251347
County: Rockdale
Preliminary NR Assessment: Does not meet
Not Listed

Old Covington Rd. and Horseshoe Springs Dr.

- Resource Type** Building
- Resource Use** Vacant/not in use
- Date of Construction** ca. 1910
- Building Type** Gabled ell cottage
- Structural System** Balloon frame
- Style** No academic style
- Roof** Gable: cross
- Exterior Cladding** Wood: weatherboard
- Foundation** Unknown
- Porch** Stoop
- Windows** Double hung sash: 6/6
- Chimney** Off-ctr, ridgeline: stuccoed masonry
- Alterations**

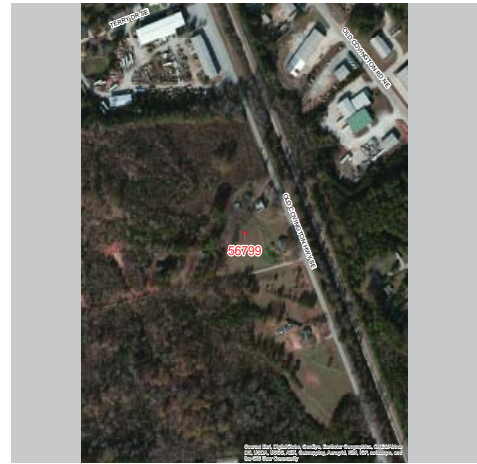
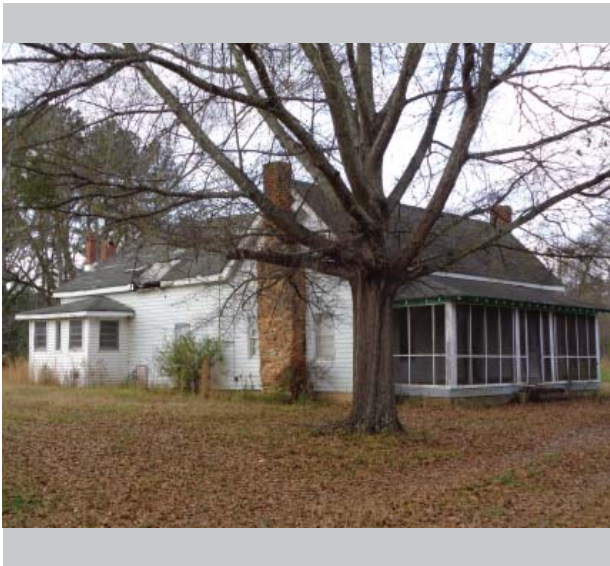
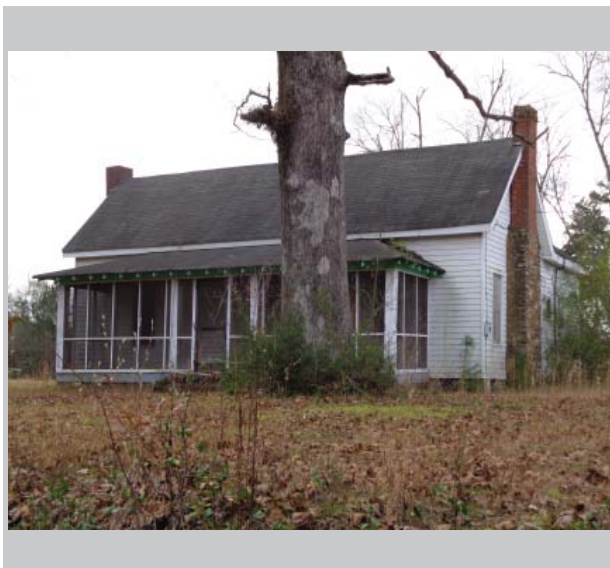
Field ID: RO-45
GNAHRGIS ID: 56799
County: Rockdale
Preliminary NR Assessment: Does not meet
Not Listed

1906 Old Covington Hwy SE

Resource Type Building

Resource Use Vacant/not in use

Foundation Continuous: concrete

Alterations Replacement siding
Non-historic rear addition
Historic rear addition

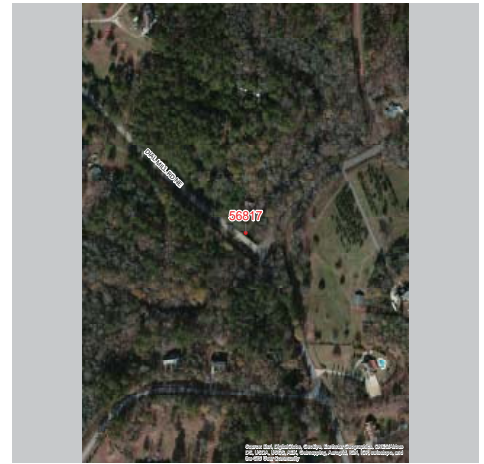
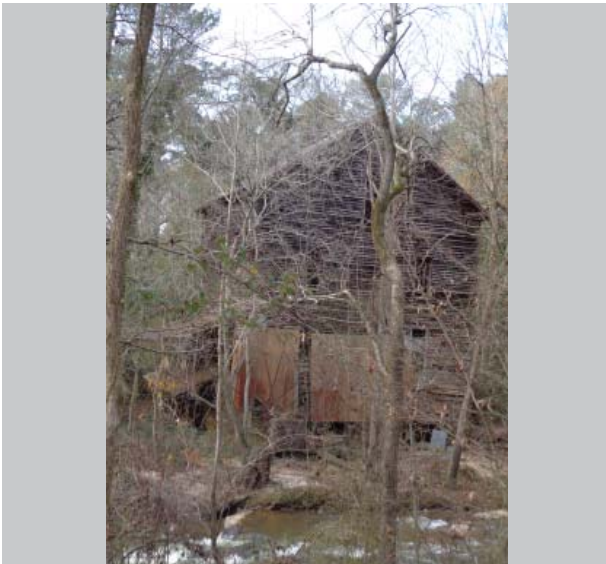
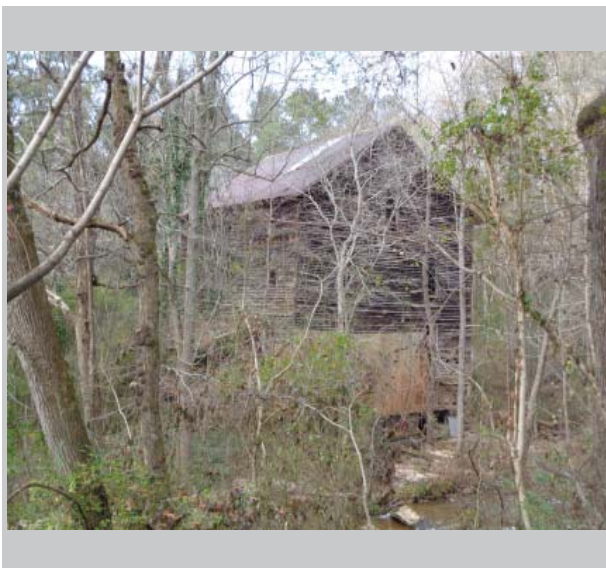
Field ID: RO-46
GNAHRGIS ID: 56817
County: Rockdale
Preliminary NR Assessment: May meet
Not Listed

Dial Mill Rd. and Hightower Trail

Resource Type Building

Resource Use Vacant/not in use

Foundation Pier: stone

Porch None observed

Chimney None observed

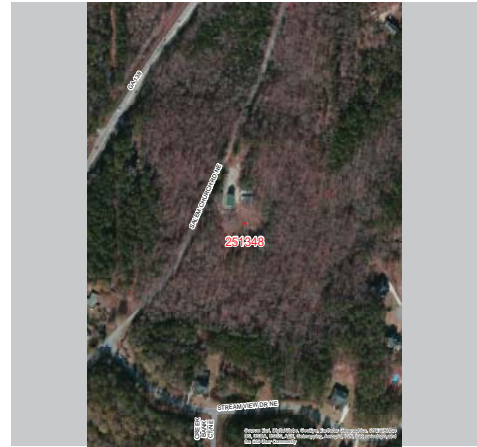
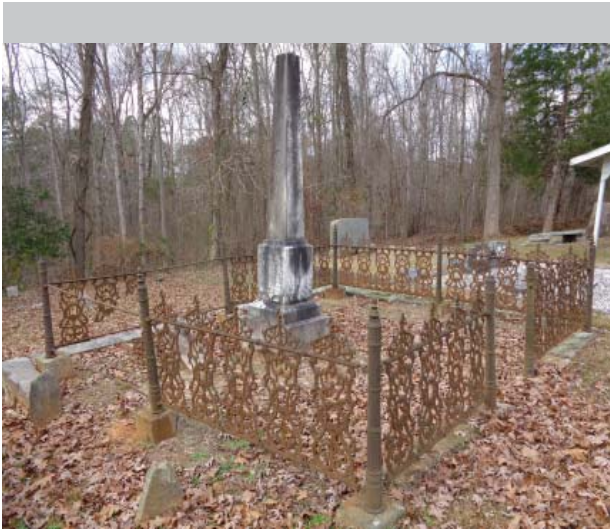
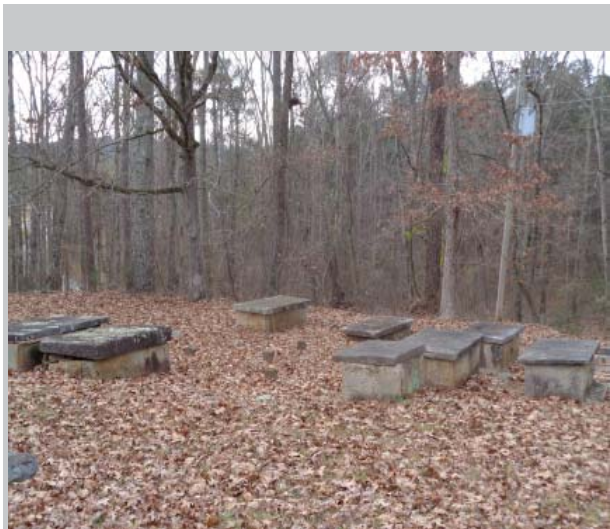
Field ID: RO-47
GNAHRGIS ID: 251348
County: Rockdale
Preliminary NR Assessment: May meet
Not Listed

Historic Salem Baptist Church Cem.
Salem Church Rd. .5 mi N of Hwy 138

Resource Type Site

Resource Use Funerary: cemetery

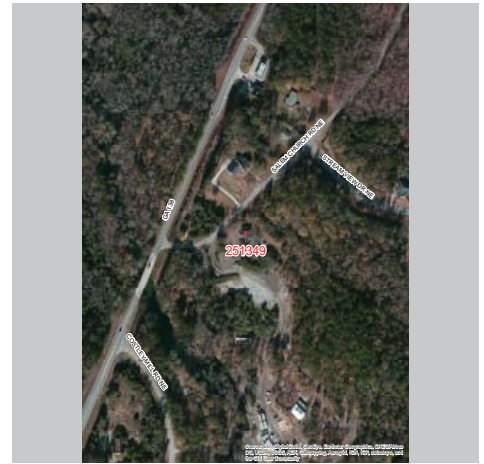
Field ID: RO-48
GNAHRGIS ID: 251349
County: Rockdale
Preliminary NR Assessment: May meet
Not Listed

2599 Salem Church Rd.

- Resource Type** Building
- Resource Use** Single dwelling: residential
- Date of Construction** ca. 1900
- Building Type** New South cottage
- Structural System** Balloon frame
- Style** No academic style
- Roof** Hip
- Exterior Cladding** Wood: weatherboard
- Foundation** Continuous: stone
- Porch** Stoop
- Windows** Double hung sash: 9/9, 2/2
- Chimney** Both gable ends: fieldstone
- Alterations**

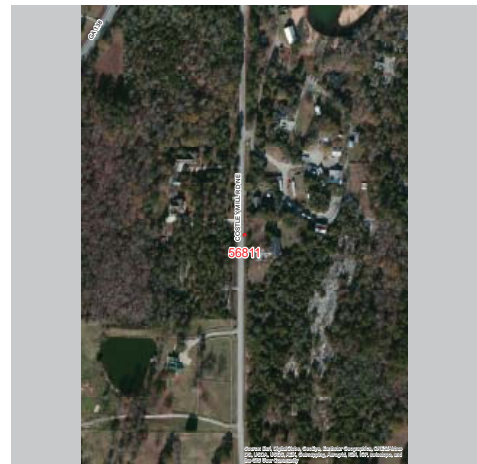
Field ID: RO-49
GNAHRGIS ID: 56811
County: Rockdale
Preliminary NR Assessment: May meet
 Not Listed

2445 Costly Mill Rd. NE

- Resource Type** Building
- Resource Use** Single dwelling: residential
- Date of Construction** ca. 1910
- Building Type** Central hallway
- Structural System** Balloon frame
- Style** No academic style
- Roof** Gable: side
- Exterior Cladding** Wood: weatherboard
- Foundation** Pier with infill: stone
- Porch** Verandah
- Windows** Double hung sash: 6/6,4/4
- Chimney** Both gable ends: fieldstone
- Alterations** Rear addition
Newer poured concrete foundation

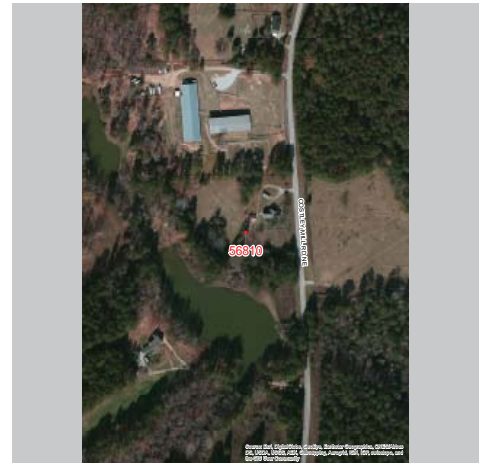
Field ID: RO-50
GNAHRGIS ID: 56810
County: Rockdale
Preliminary NR Assessment: Appears to meet
Not Listed

1810 Costly Mill Rd.

- Resource Type** Building
- Resource Use** Single dwelling: residential
- Date of Construction** ca. 1920
- Building Type** Bungalow: cross gable
- Structural System** Balloon frame
- Style** Craftsman
- Roof** Gable: side
- Exterior Cladding** Wood: weatherboard
- Foundation** Continuous: stone
- Porch** Stoop
- Windows** Double hung sash: 3/1
- Chimney** Off-ctr, ridgeline: brick (x2)
- Alterations**

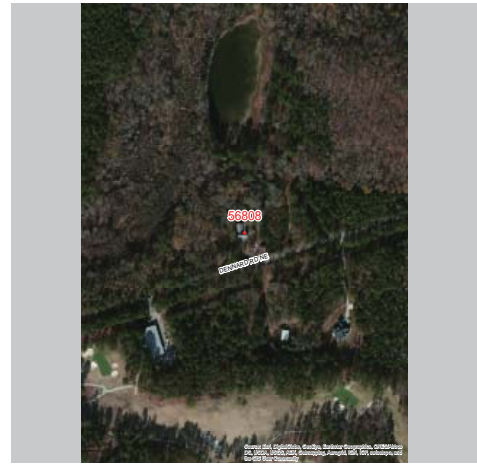
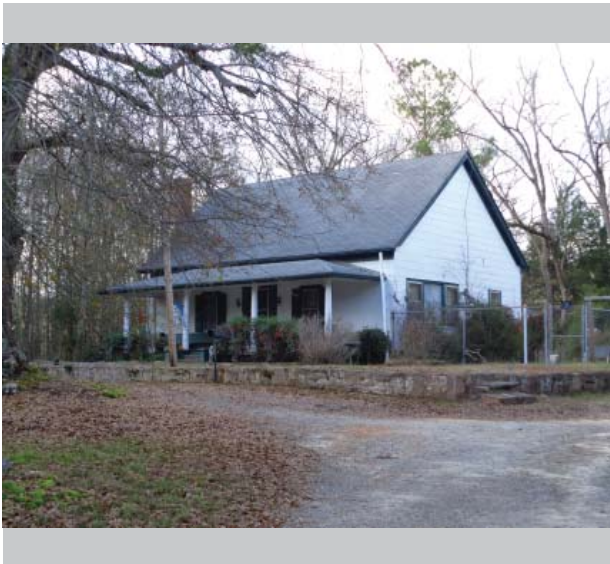
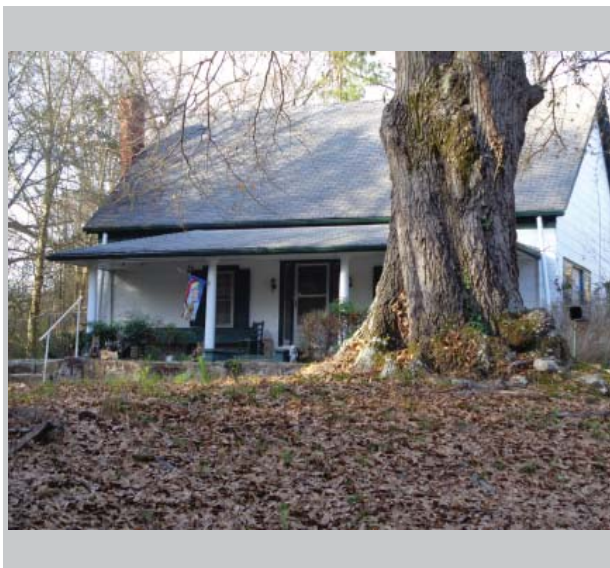
Field ID: RO-51
GNAHRGIS ID: 56808
County: Rockdale
Preliminary NR Assessment: May meet
Not Listed

3440 Dennard Rd. NE

Resource Type Building

Resource Use Single dwelling:
residential

Foundation Unknown

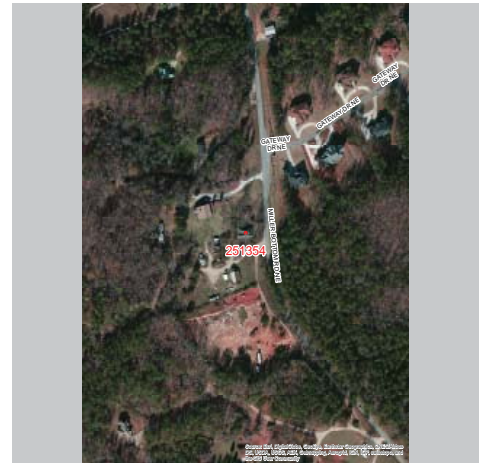
Field ID: RO-52
GNAHRGIS ID: 251354
County: Rockdale
Preliminary NR Assessment: Appears to meet
Not Listed

3900 Miller Bottom Rd.

- Resource Type** Building
- Resource Use** Vacant/not in use
- Date of Construction** ca. 1910
- Building Type** New South cottage
- Structural System** Balloon Frame
- Style** Craftsman
Queen Anne
- Roof** Hip
- Exterior Cladding** Wood: weatherboard and shingles
- Foundation** Continuous: stone
- Porch** Stoop
- Windows** Double hung sash: 1/1
- Chimney** Off-ctr within roof surface: brick
- Alterations** Newer house on property
Rear addition

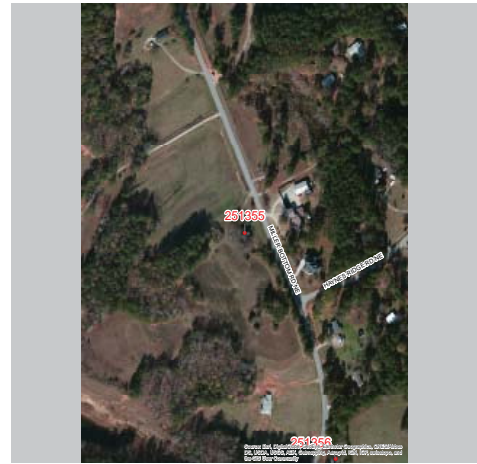
Field ID: RO-53
GNAHRGIS ID: 251355
County: Rockdale
Preliminary NR Assessment: Does not meet
Not Listed

3522 Miller Bottom Rd.

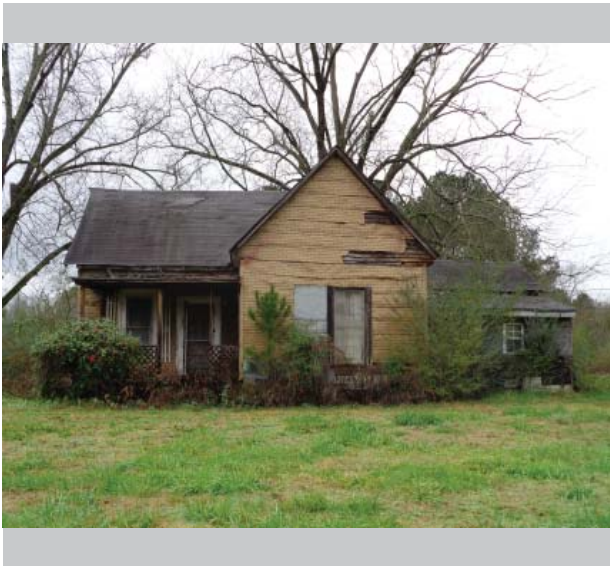
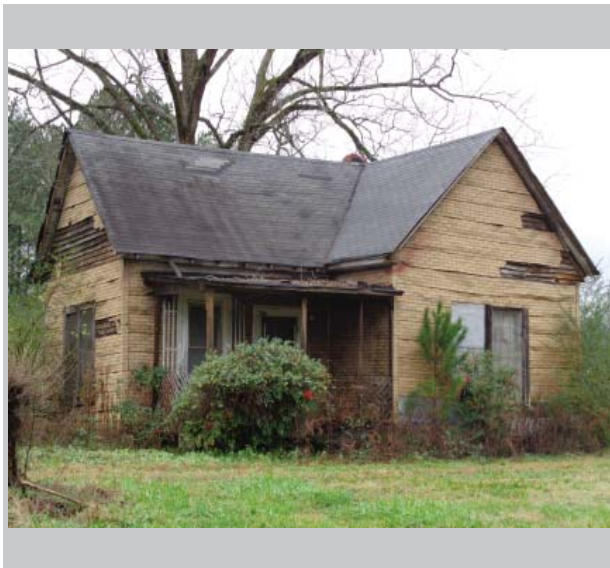
Resource Type Building

Resource Use Vacant/not in use

Foundation Unknown

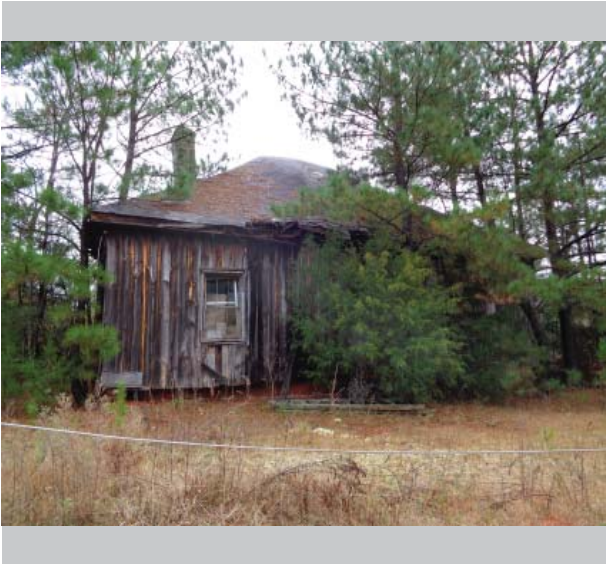
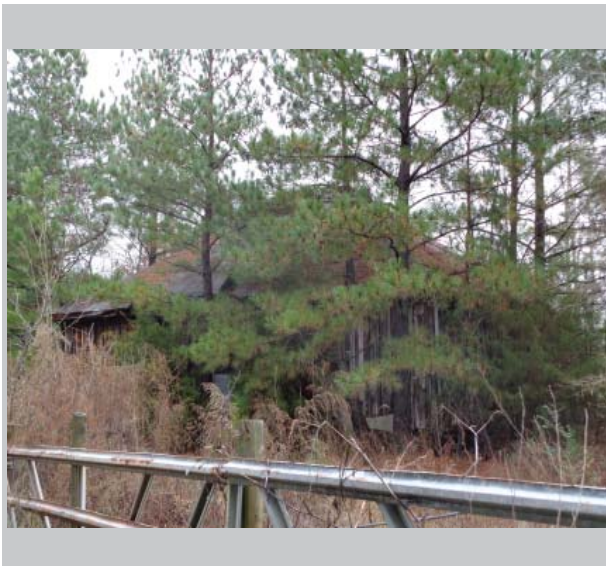
Coordinates: 33.73465, -83.92521

- Resource Type** Building
- Resource Use** Vacant/not in use
- Date of Construction** ca. 1910
- Building Type** Georgian cottage
- Structural System** Balloon Frame
- Style** No academic style
- Roof** Hip
- Exterior Cladding** Board-and-batten
- Foundation** Pier with infill: stone
- Porch** None observed
- Windows** Double hung sash: 1/1
- Chimney** Off-ctr within roof surface: fieldstone
- Alterations**

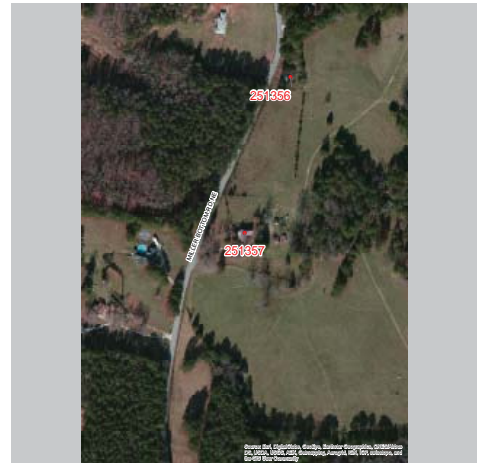
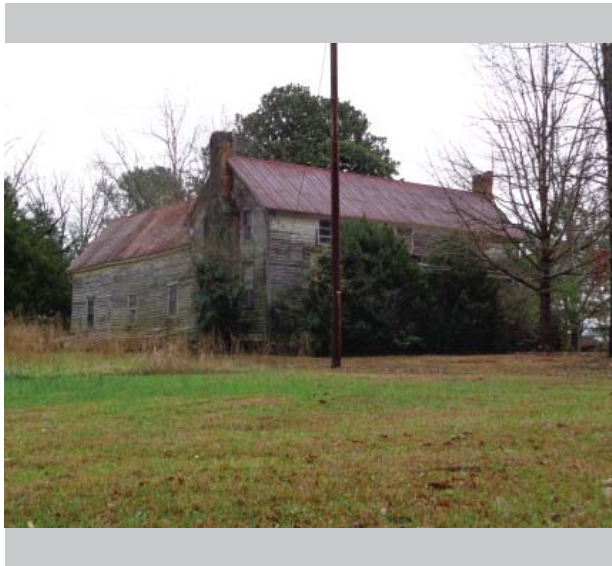
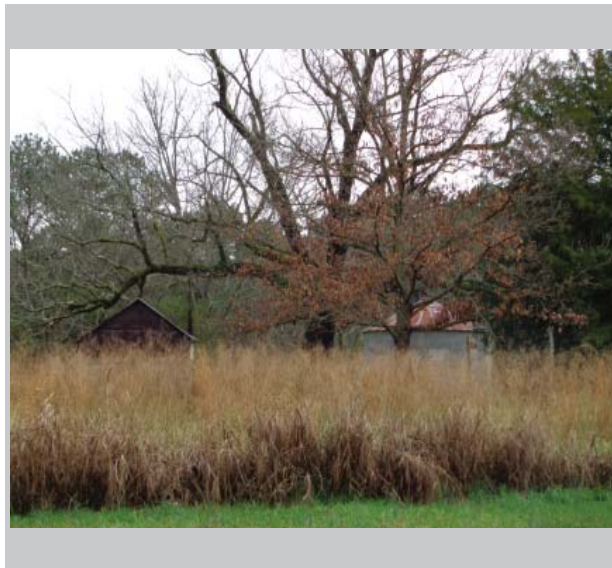
3341 Miller Bottom Rd.

Resource Type Building

Resource Use Vacant/not in use

Foundation Pier: stone

Alterations Large additions on rear form ell
Replacement mid-century window on second story

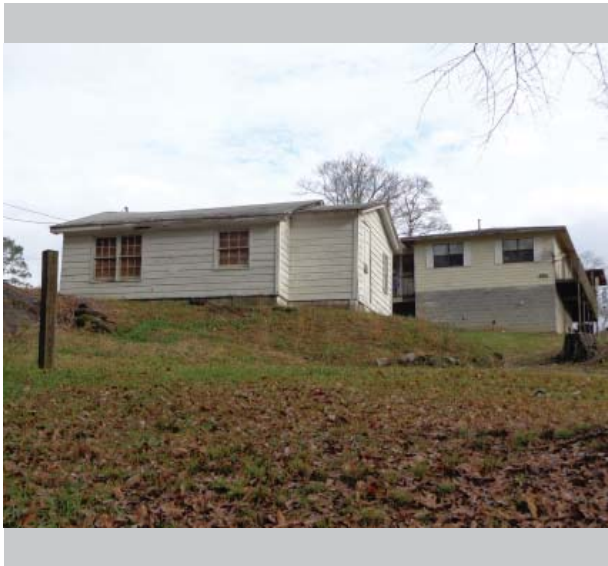
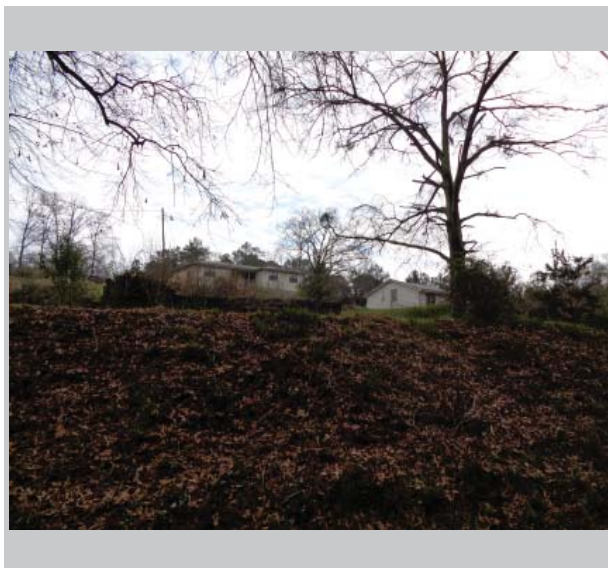
Coordinates: 33.69599, -83.99413

- Resource Type** Building
- Resource Use** Vacant/not in use
- Date of Construction** ca. 1920
- Building Type** Shotgun
- Structural System** Balloon Frame
- Style** Craftsman
- Roof** Gable: front
- Exterior Cladding** Board-and-batten: novelty siding
- Foundation** Continuous: concrete
- Porch** None observed
- Windows** Double hung sash: 6/6
- Chimney** None observed
- Alterations** Rear addition with entry
New house on property

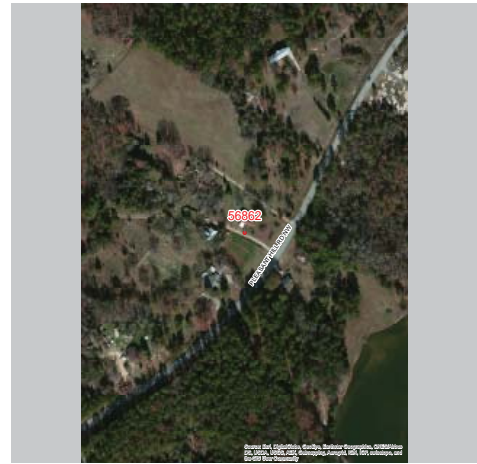
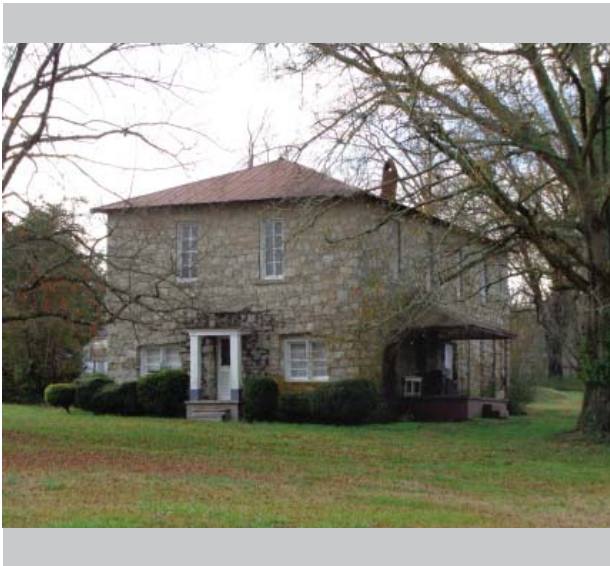
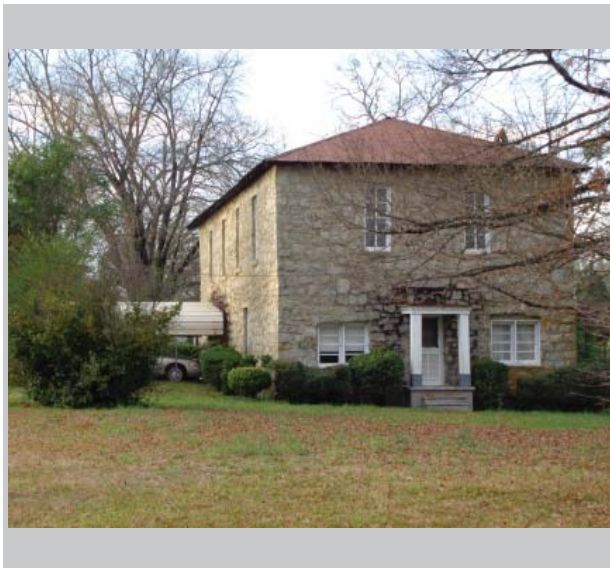
1085 Pleasant Hill Rd.

Resource Type Building

Resource Use Single dwelling:
residential

Foundation Continuous: stone

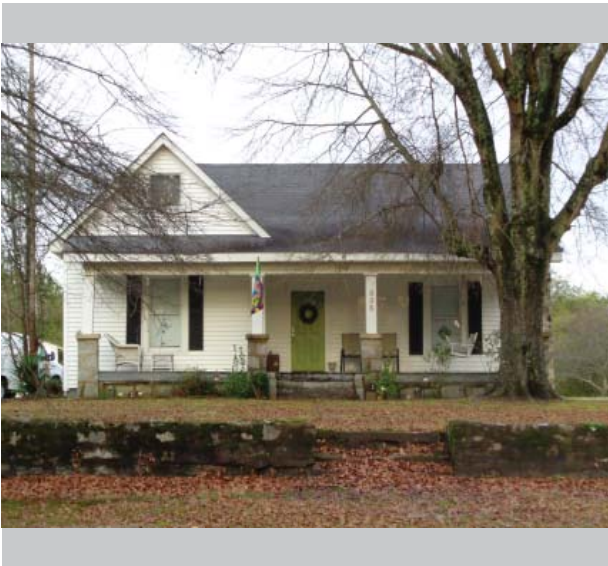
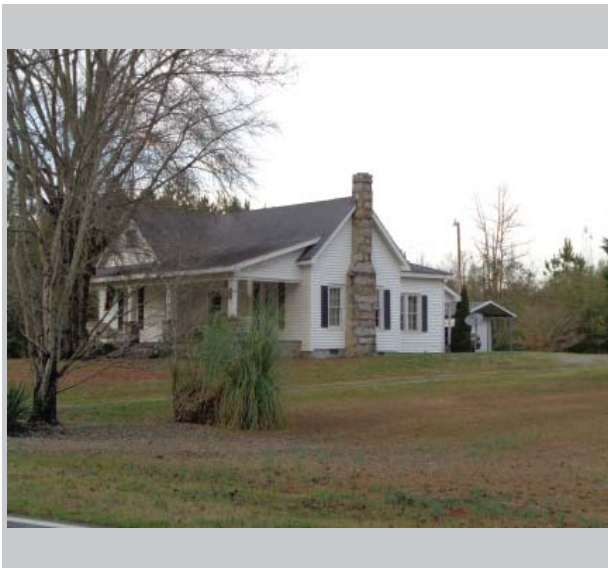
Coordinates: 33.75331, -84.01313

- Resource Type** Building
- Resource Use** Single dwelling: residential
- Date of Construction** ca. 1915
- Building Type** Gabled ell cottage
- Structural System** Balloon Frame
- Style** No academic style
- Roof** Gable: multiple
- Exterior Cladding** Prism synthetics: vinyl/aluminum siding
- Foundation** Continuous: concrete
- Porch** Verandah
- Windows** Double hung sash: 1/1, 6/6
- Chimney** Gable-end, exterior: fieldstone
- Alterations** Replacement siding

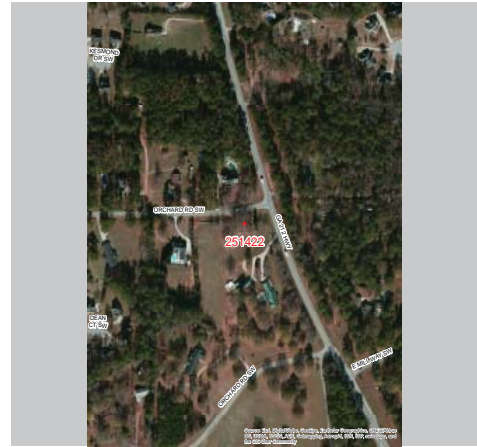
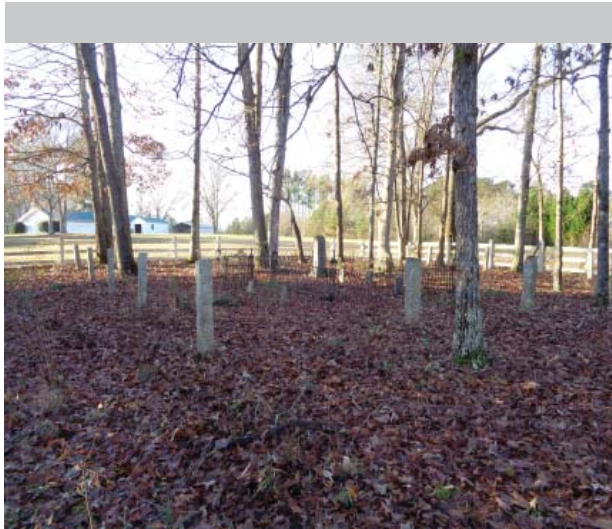
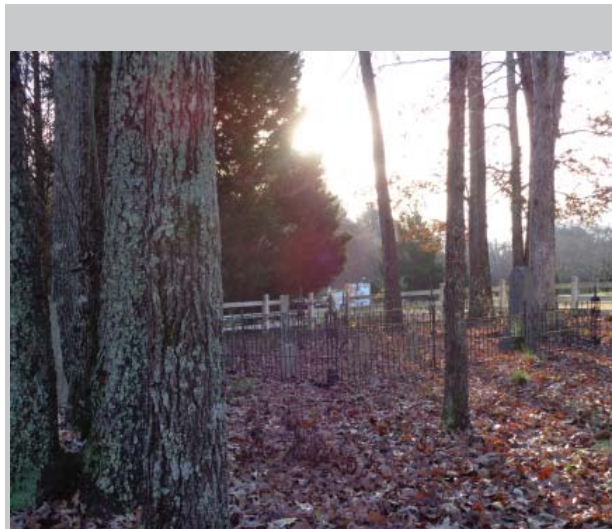
Parker Cemetery
GA Hwy 212 and Orchard Rd. SW

Resource Type Site

Resource Use Funerary: cemetery

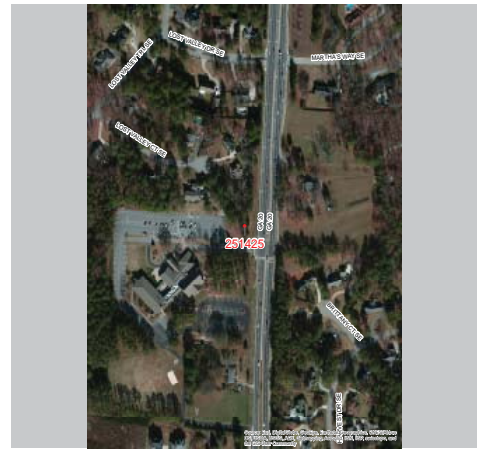
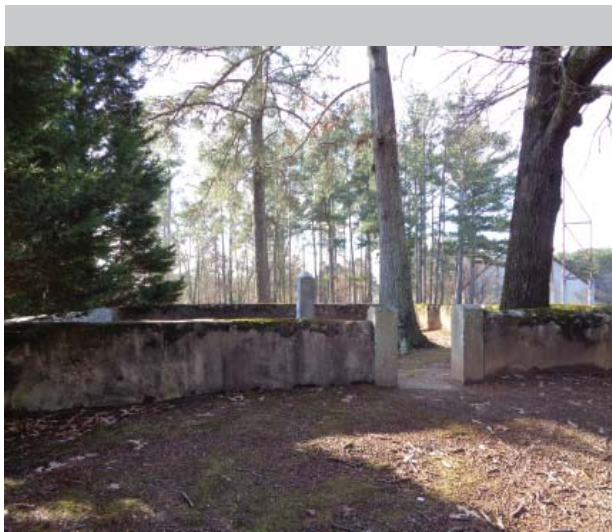
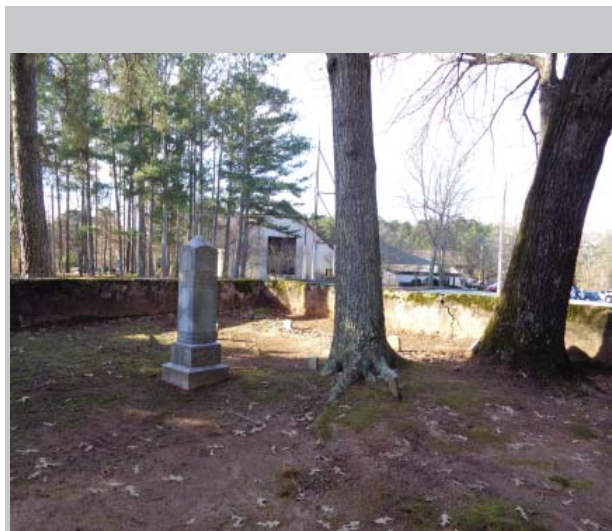
Whitaker Cemetery
 GA Hwy 20 at St. Pius Catholic Church

Resource Type Site

Resource Use Funerary: cemetery

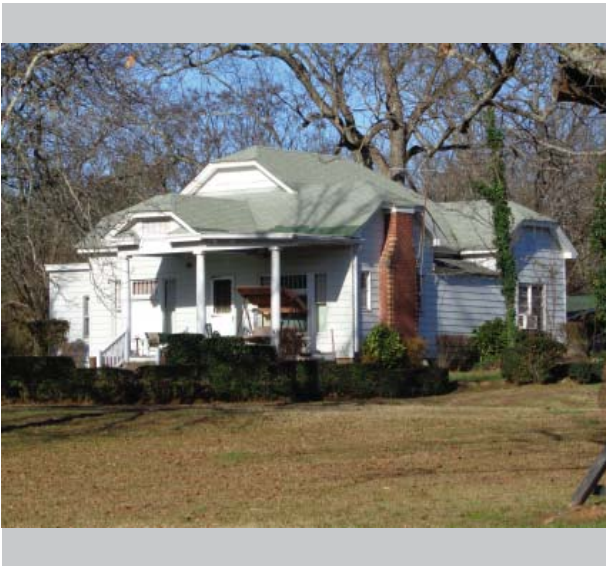
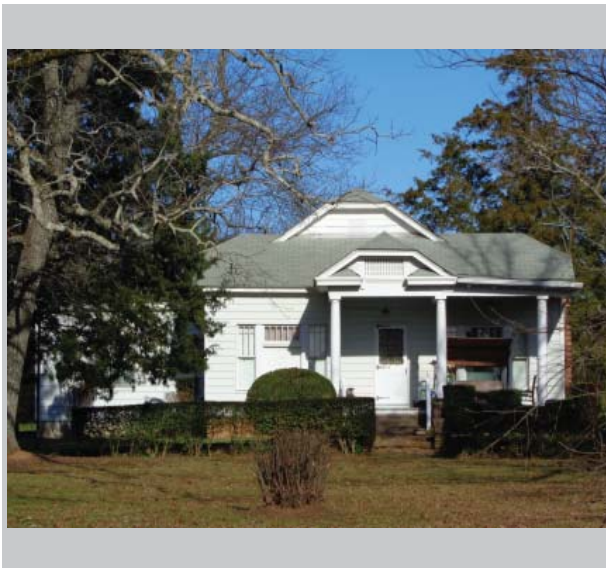
Coordinates: 33.63488, -84.02706

- Resource Type** Building
- Resource Use** Single dwelling: residential
- Date of Construction** ca. 1920
- Building Type** Bungalow: cross gable
- Structural System** Balloon Frame
- Style** Craftsman
- Roof** Gable: cross
- Exterior Cladding** Prism synthetics: asbestos siding
- Foundation** Continuous: brick
- Porch** Portico
- Windows** Double hung sash: 3/1
- Chimney** Gable-end, exterior: brick
- Alterations** Addition on left

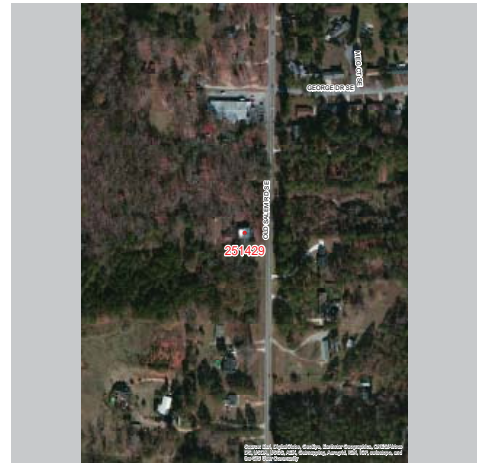
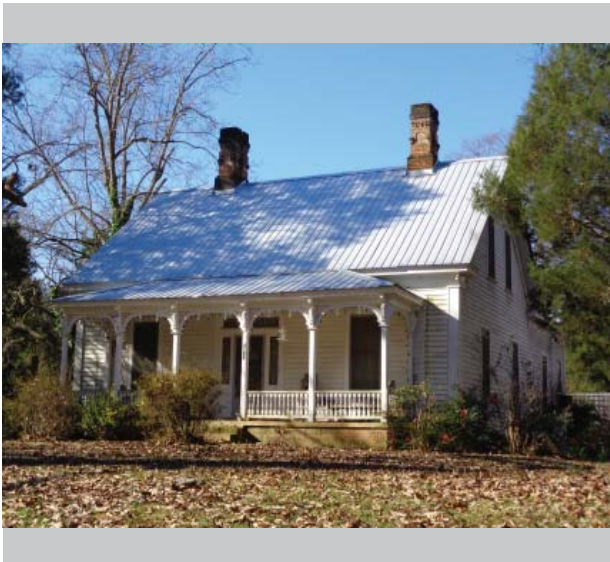
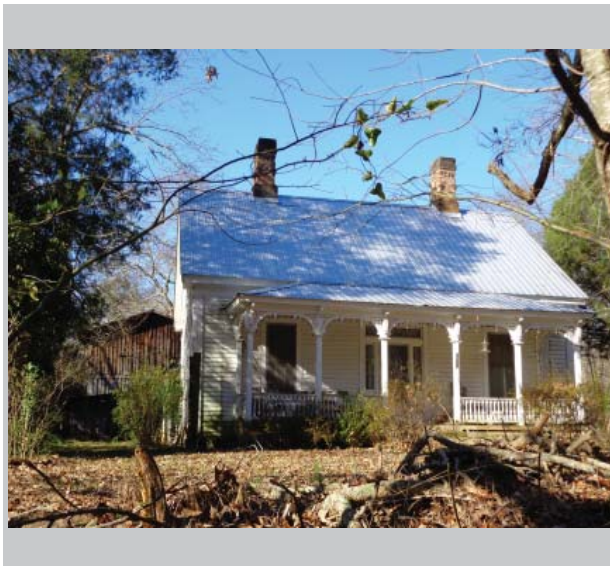
2185 Old Salem Rd.

Resource Type Building

Resource Use Single dwelling:
residential

Foundation Unknown

Alterations Rear addition
Replacement siding

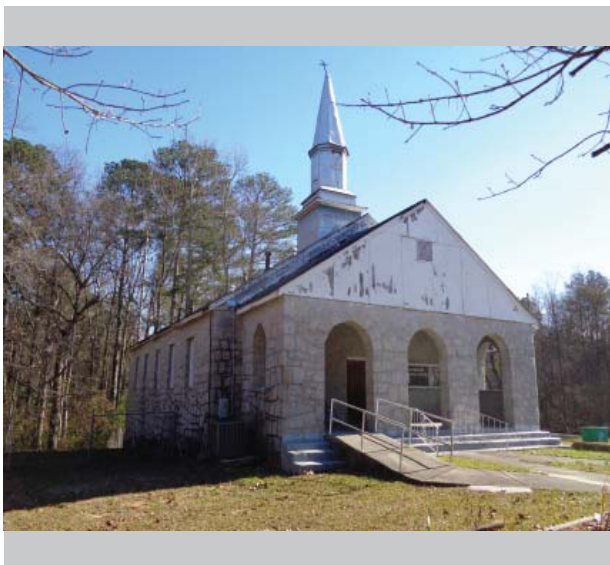
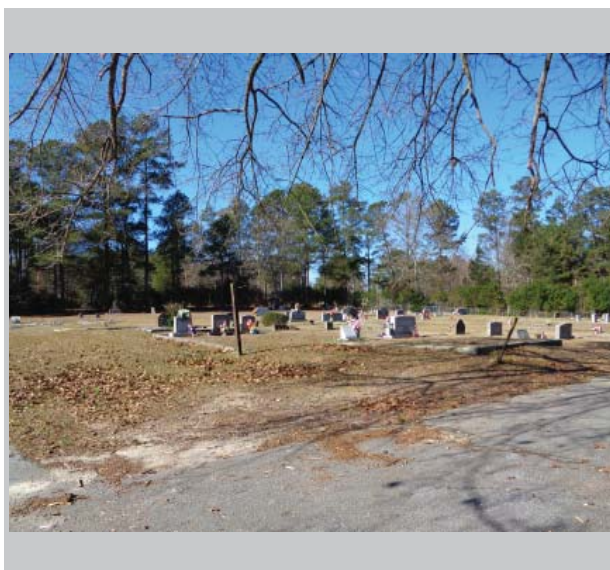
Coordinates: 33.64212, -84.05287

- Resource Type** Building
- Resource Use** Religious: church structure
Funerary: cemetery
- Date of Construction** ca. 1950
- Building Type** Front gable church
- Structural System** Balloon Frame
- Style** No academic style
- Roof** Gable: front
- Exterior Cladding** Vertical board, stone:
fieldstone
- Foundation** Continuous: stone
- Porch** Verandah
- Windows** Factory sash: stained glass
- Chimney** None observed
- Alterations** Church founded in 1870,
rebuilt in 1950
Active use cemetery with
approx. 100 markers
