Historic Resources Survey Report

Rockdale County, Georgia

December 2015

The University of Georgia
College of Environment and Design
Center for Community Design & Preservation
Historic Resources Survey Report
Rockdale County, Georgia 2015

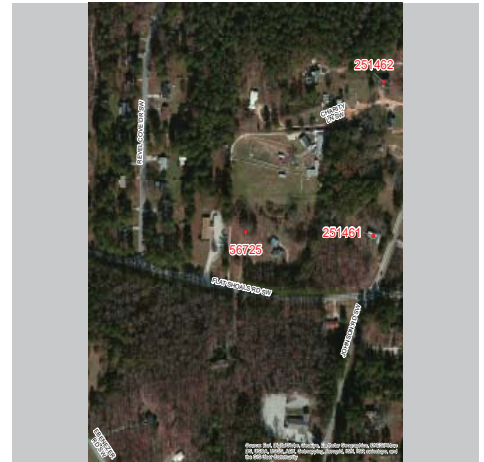
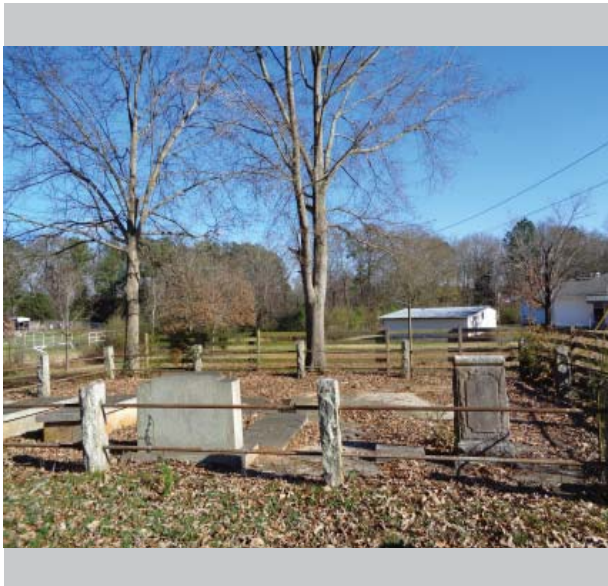
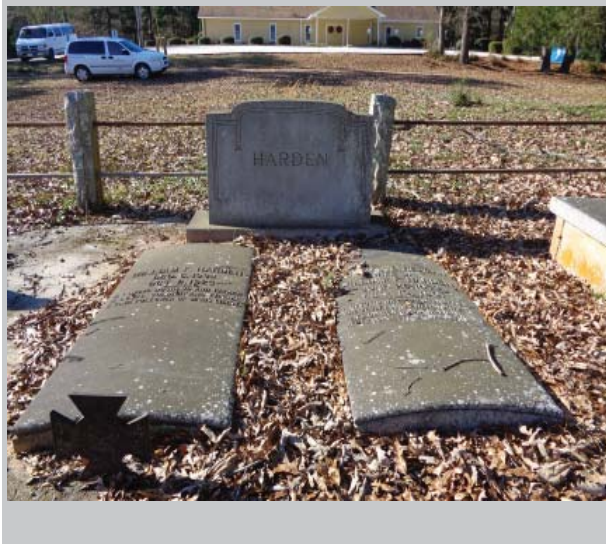
Flat Shoals Rd. .5 mi E of Johnson Rd. SW

Resource Type Site

Resource Use Funerary: cemetery

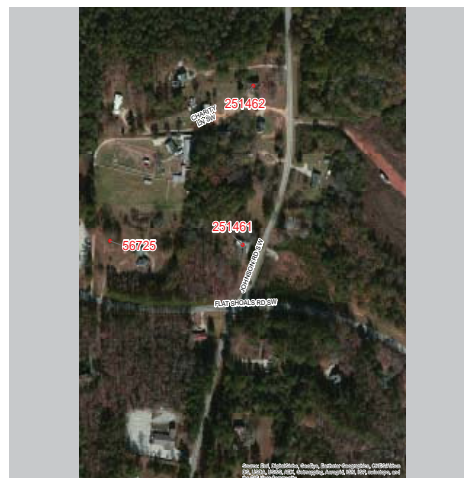
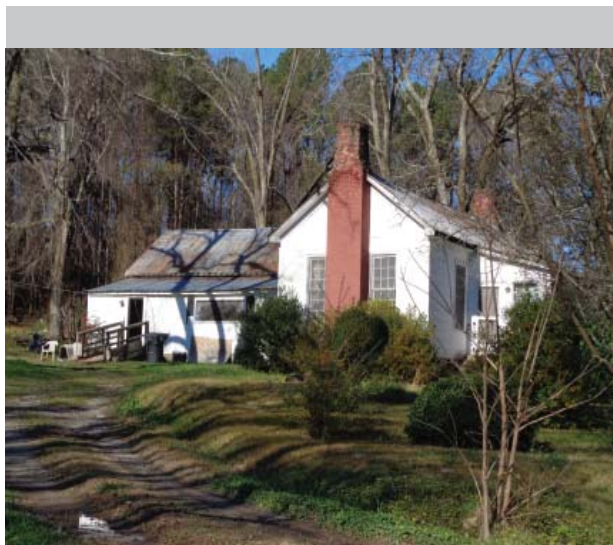
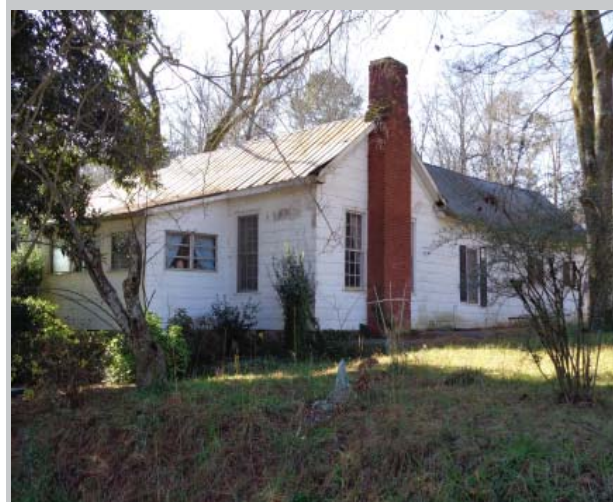
1505 Johnson Rd. SW

Resource Type Building

Resource Use Single dwelling:
residential

Foundation Continuous: stone

Porch None observed

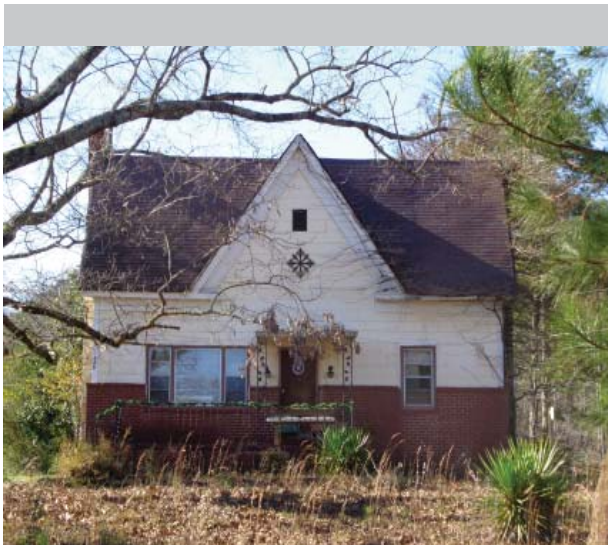
1437 Johnson Rd. SW

- Resource Type** Building
- Resource Use** Single dwelling: residential
- Date of Construction** ca. 1910
- Building Type** Central hallway
- Structural System** Balloon Frame
- Style** No academic style
- Roof** Gable: cross
- Exterior Cladding** Prism synthetics: asbestos siding
- Foundation** Unknown
- Porch** Stoop
- Windows** Double hung sash: 2/2
- Chimney** Both gable ends: brick and fieldstone
- Alterations** Rear addition
Brick added to lower 1/3 of building

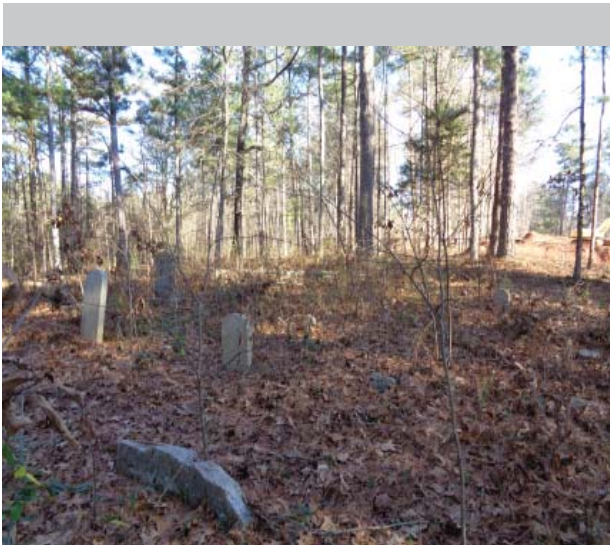
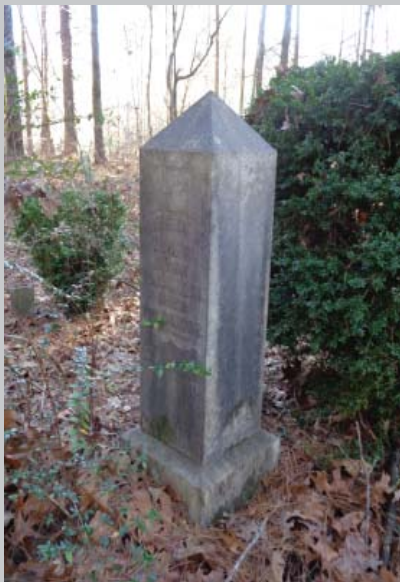
Turner Rd. just inside Rockdale County Line

Resource Type Site

Resource Use Funerary: cemetery

Cemetery Description Obelisks
Tabletop markers
Surrounded by chainlink
fencing
Many covered by
vegetation
Many unmarked

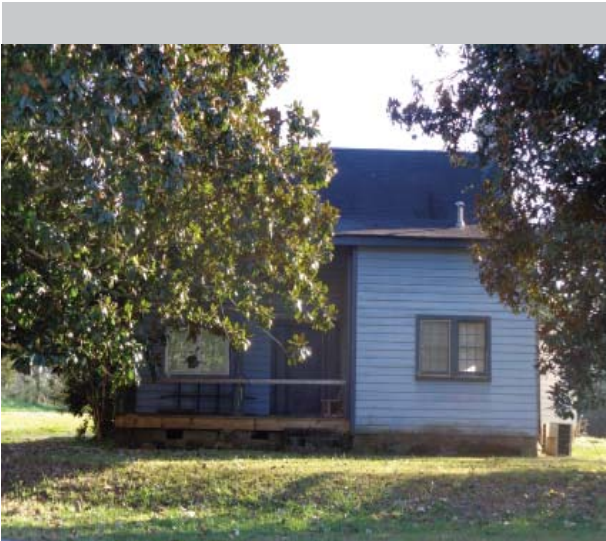
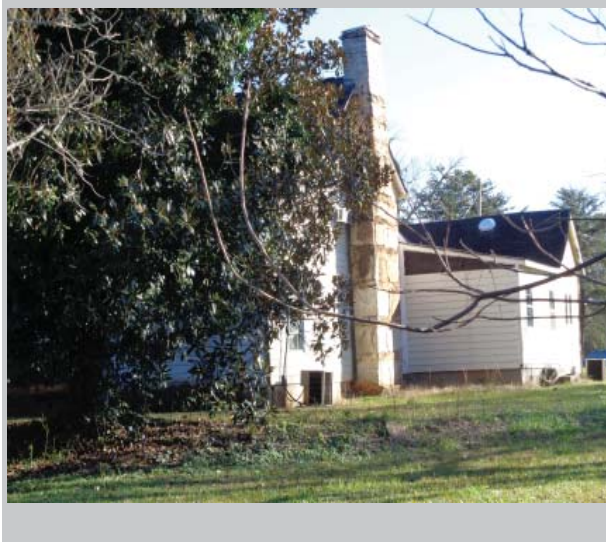
315 Hurst Rd. SW

- Resource Type** Building
- Resource Use** Single dwelling: residential
- Date of Construction** ca. 1910
- Building Type** I-house: central hallway
- Structural System** Balloon Frame
- Style** No academic style
- Roof** Gable: cross
- Exterior Cladding** Wood: weatherboard and novelty siding
- Foundation** Pier with infill: stone
- Porch** Stoop
- Windows** Double hung sash: 6/6
- Chimney** Both gable ends: fieldstone
- Alterations** Replacement siding and windows
Addition at right
Large addition forming ell at left

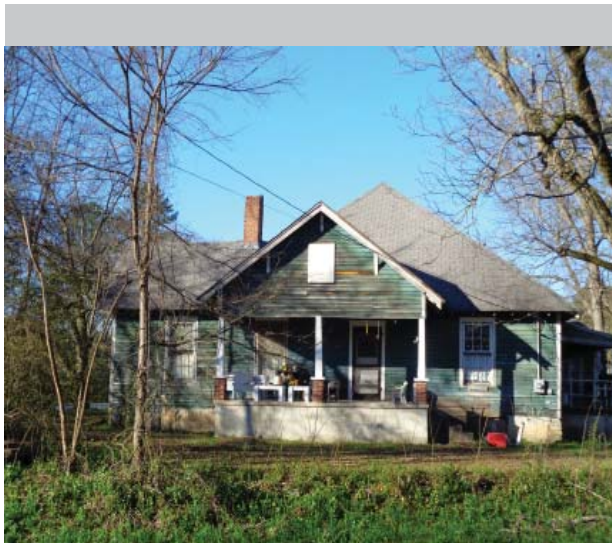
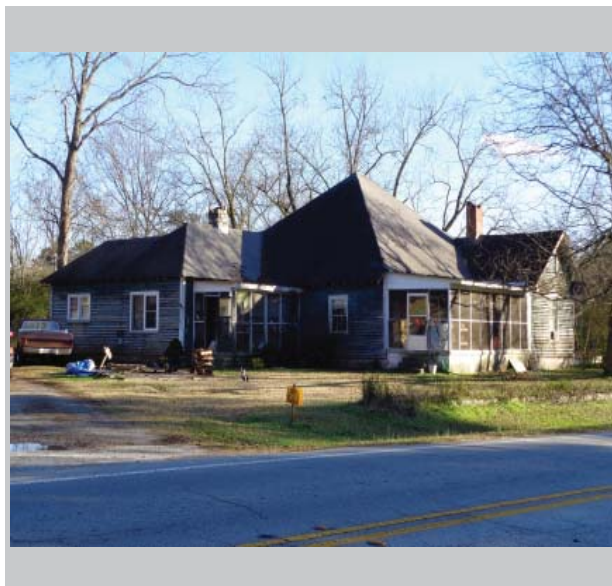
2645 Flat Shoals Rd. SW

Resource Type Building

Resource Use Single dwelling:
residential

Foundation Continuous: concrete and
stone

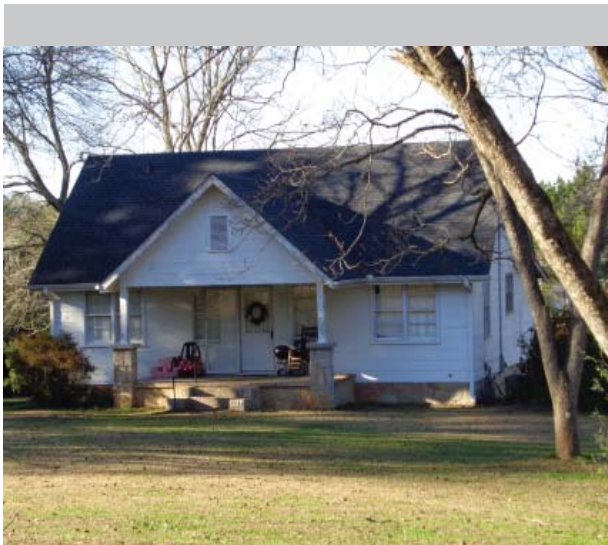
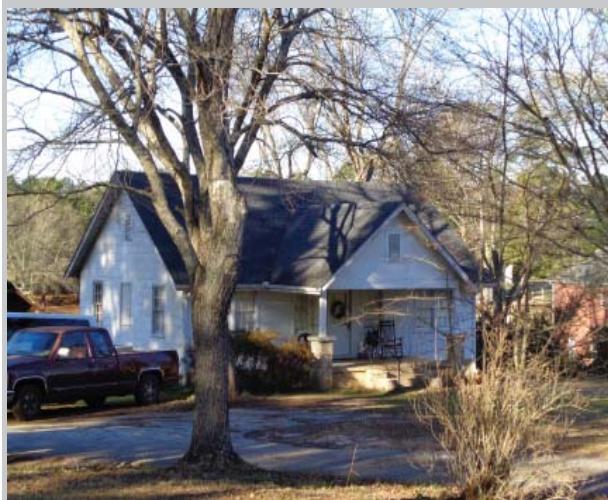
2363 Flat Shoals Rd. SW

Resource Type Building

Resource Use Single dwelling:
residential

Foundation Continuous: stone

Chimney None observed

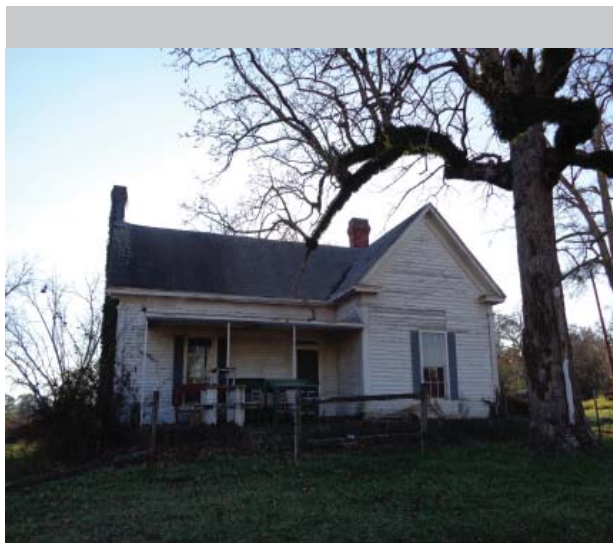
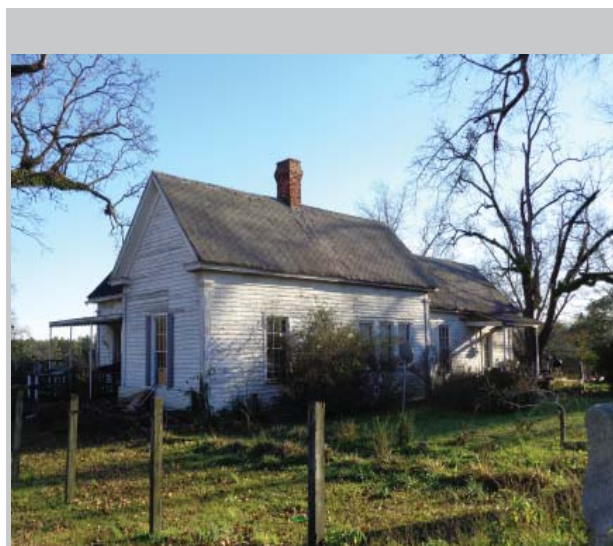
3080 Scott Hwy

Resource Type Building

Resource Use Single dwelling:
residential

Foundation Unknown

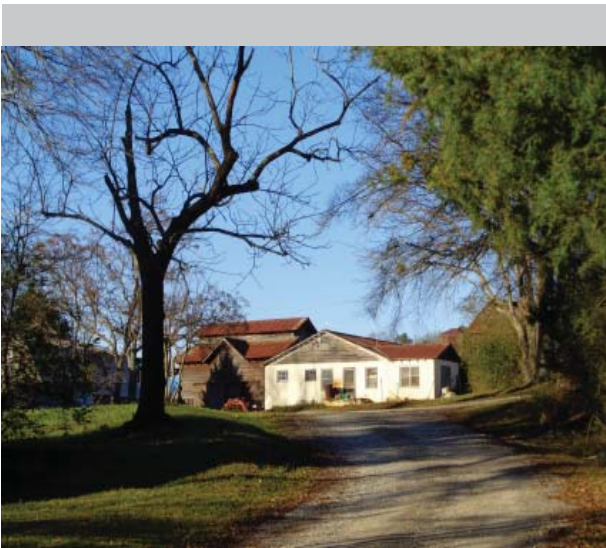
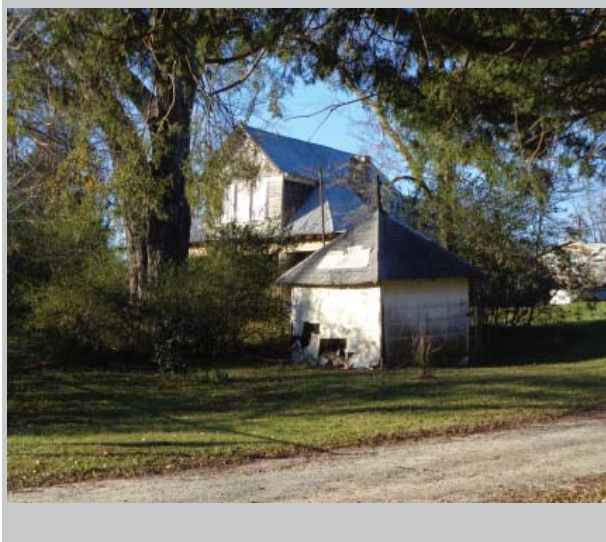
3211 Scott Hwy

Resource Type Building

Resource Use Single dwelling:
residential

Foundation Unknown

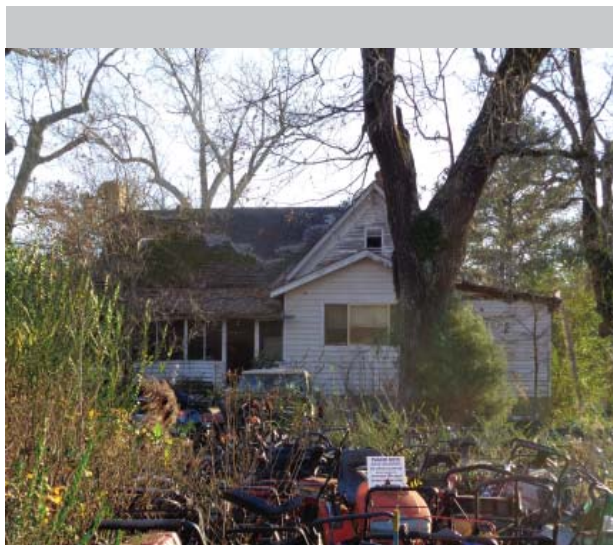
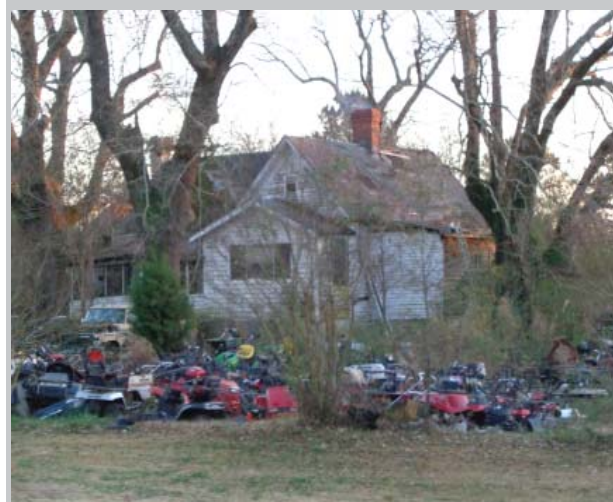
3455 Scott Hwy

Resource Type Building

Resource Use Single dwelling:
residential

Foundation Unknown

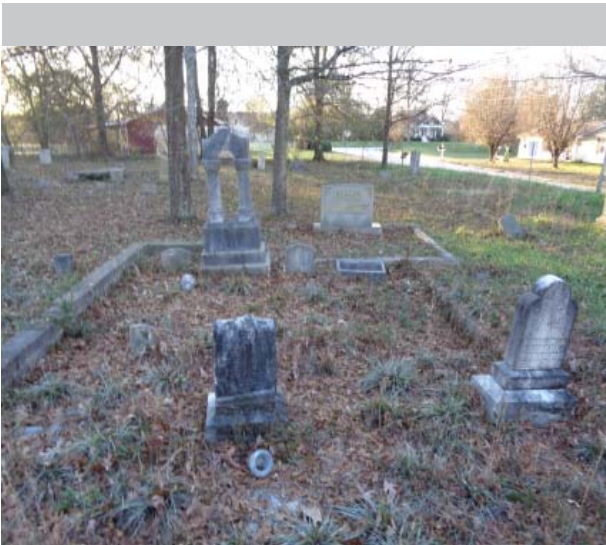
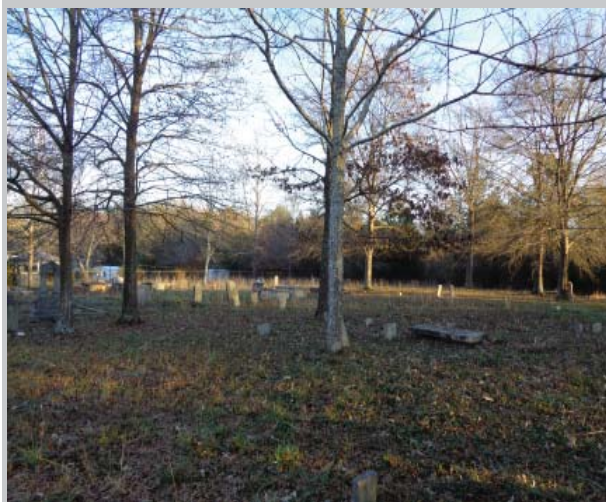
Leigh Dr. .1 mi E of Smyrna Rd.

Resource Type Site

Resource Use Funerary: cemetery

Cemetery Description In neighborhood
Tabletop markers
Unmarked stones
Few broken stones

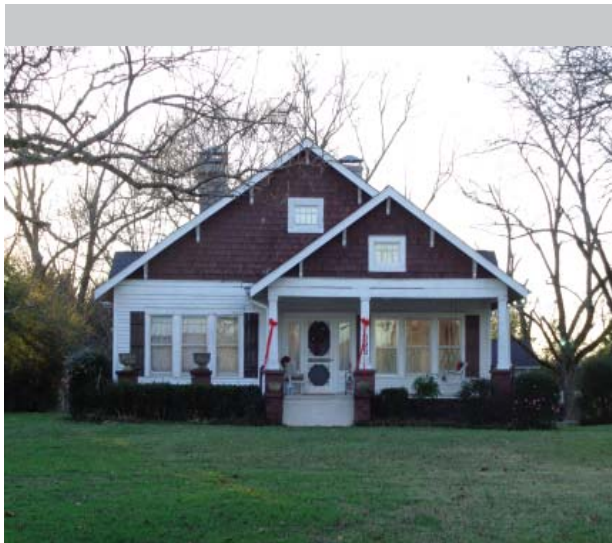
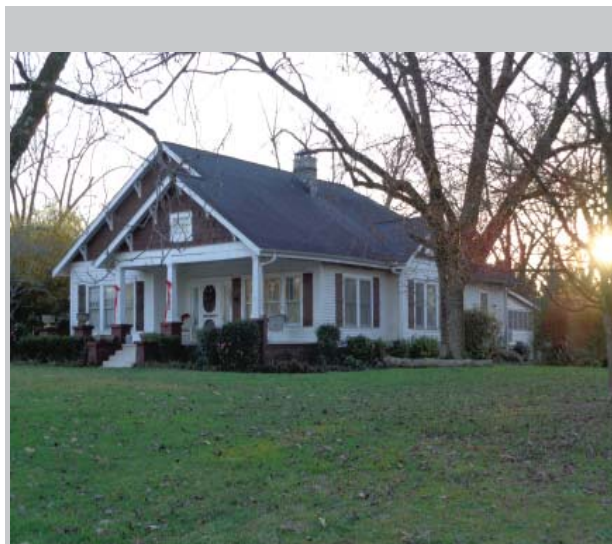
895 Smyrna Rd.

Resource Type Building

Resource Use Single dwelling:
residential

Foundation Unknown

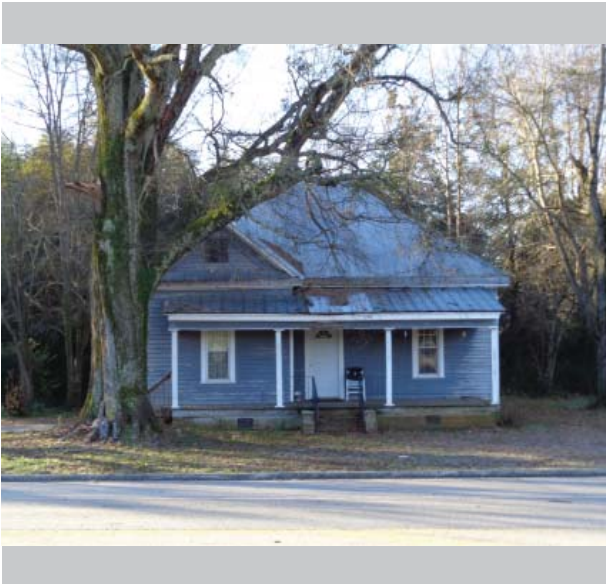
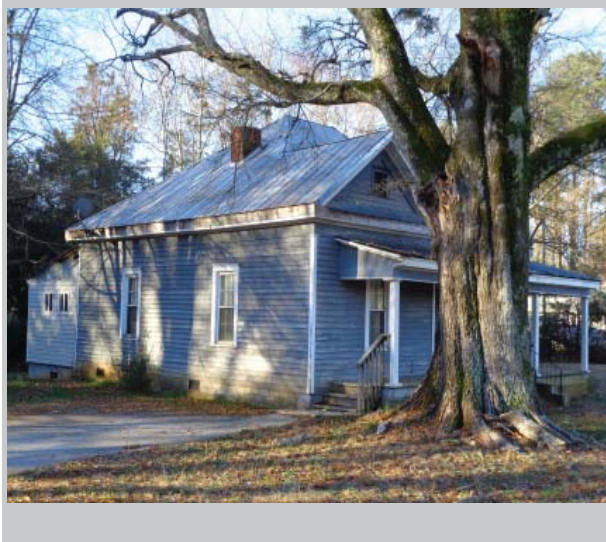
4092 Hwy 138

Resource Type Building

Resource Use Single dwelling:
residential

Foundation Continuous: concrete

Alterations Replacement windows
and door
Rear shed addition

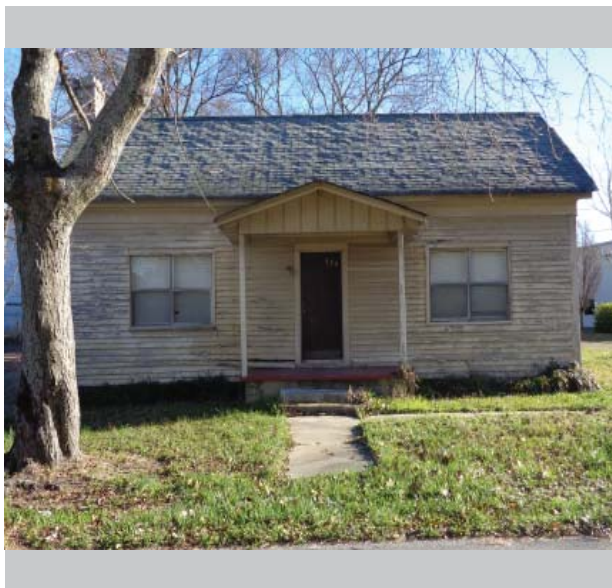
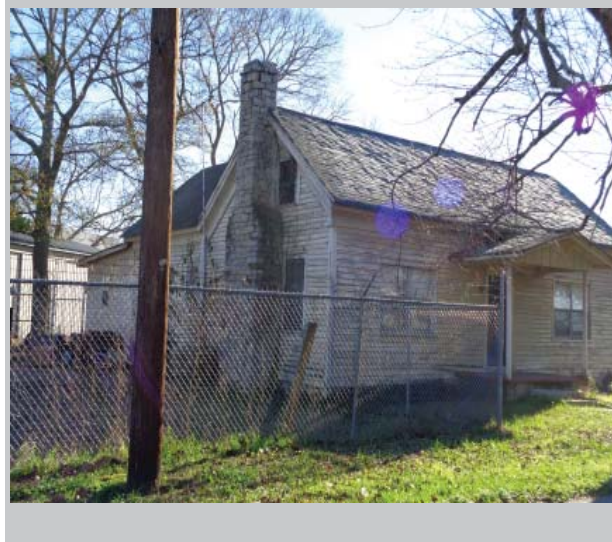
534 Smyrna Rd.

Resource Type Building

Resource Use Single dwelling:
residential

Foundation Unknown

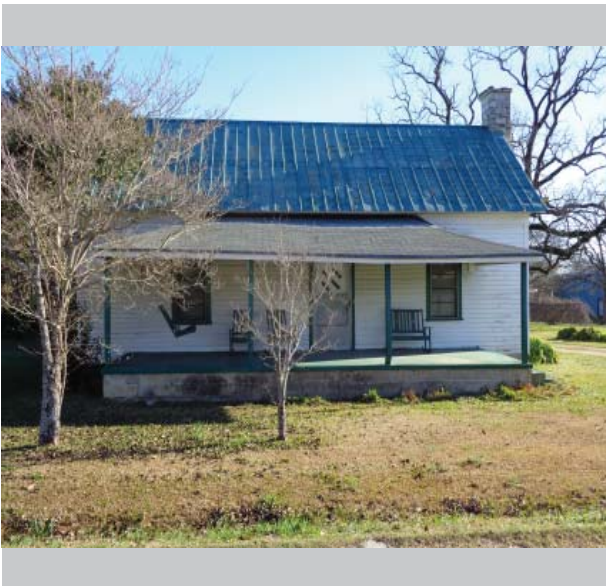
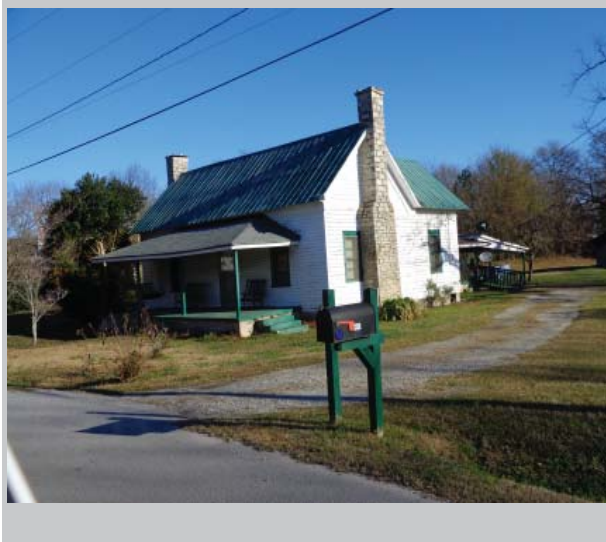
582 Smyrna Rd.

Resource Type Building

Resource Use Single dwelling:
residential

Foundation Pier with infill: stone

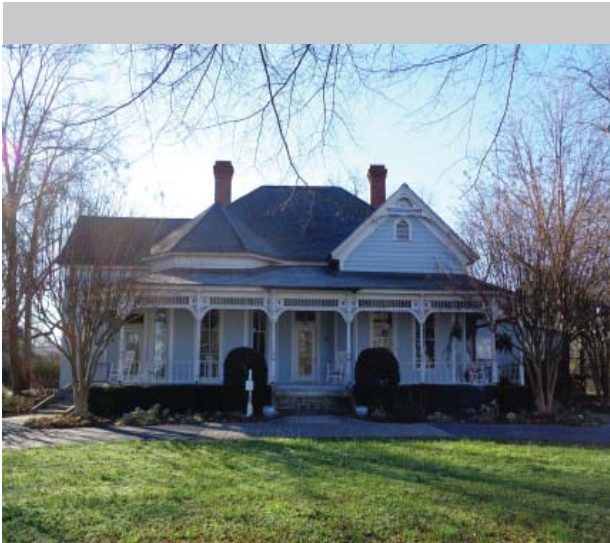
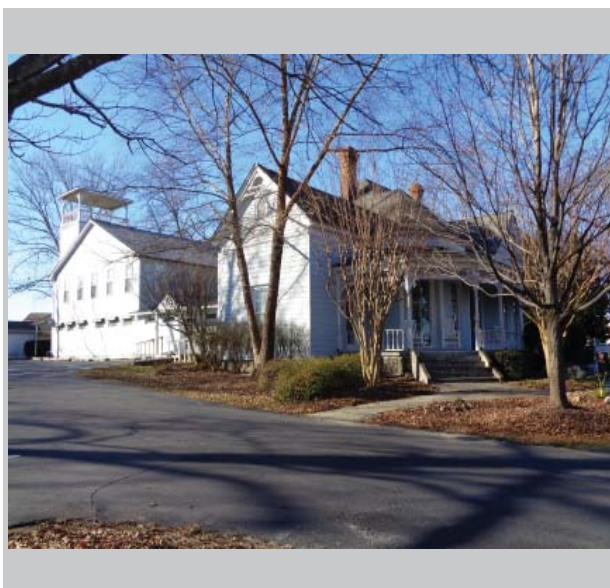
2140 Old Covington Rd.

Resource Type Building

Resource Use Commercial:
professional/office

Foundation Continuous: stone

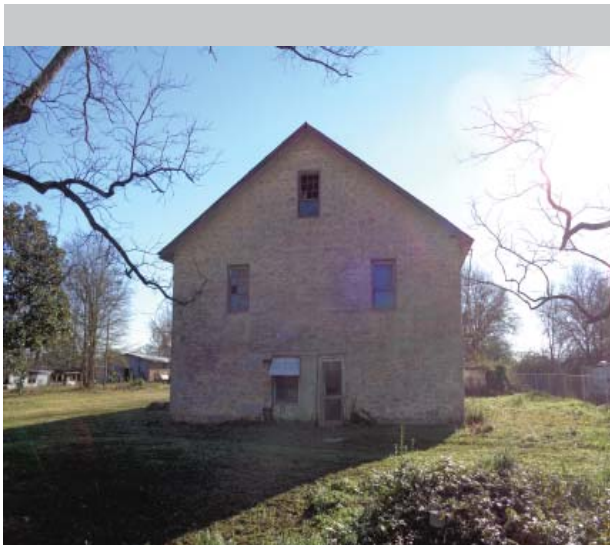
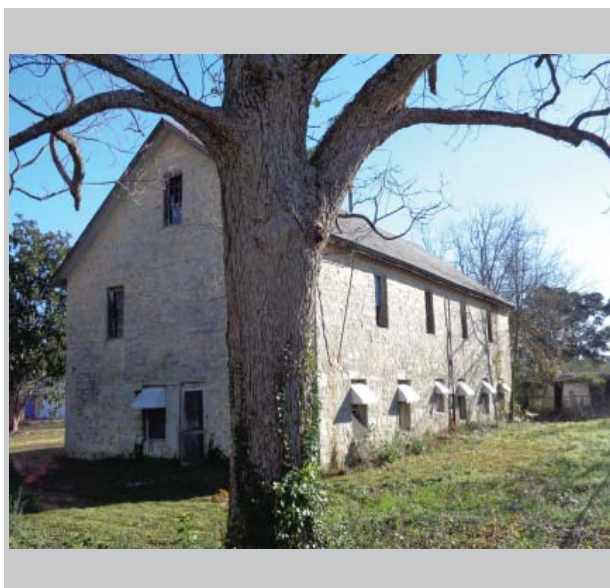
2140 Old Covington Rd.

Resource Type Building

Resource Use Vacant/not in use

Foundation Continuous: stone

Porch None observed

Chimney None observed

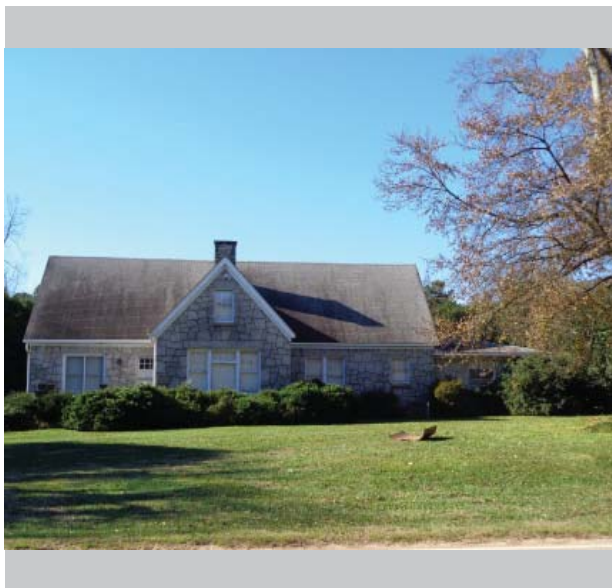
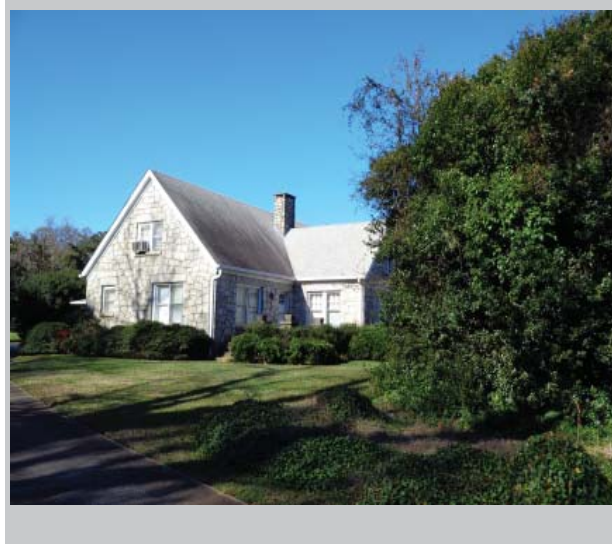
2420 Old Covington Rd.

Resource Type Building

Resource Use Single dwelling:
residential

Foundation Continuous: stone

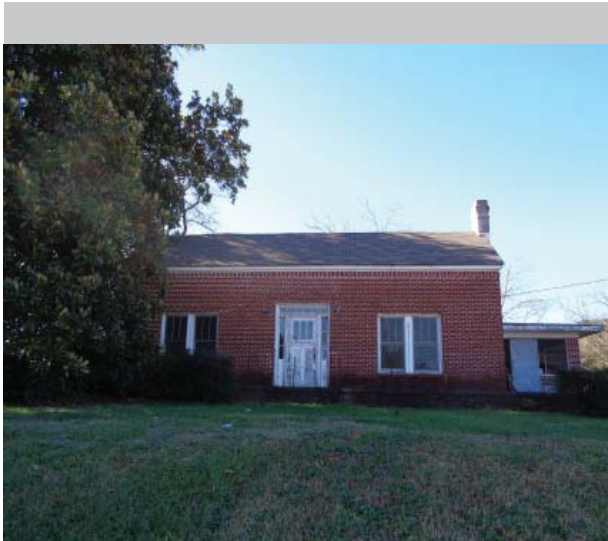
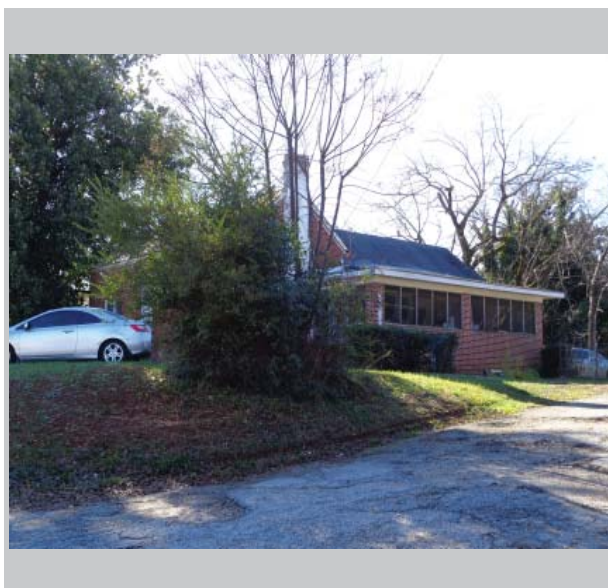
2432 Old Covington Rd.

Resource Type Building

Resource Use Single dwelling:
residential

Foundation Continuous: brick

Alterations Rear addition
1930's replacement paired
double hung sash windows

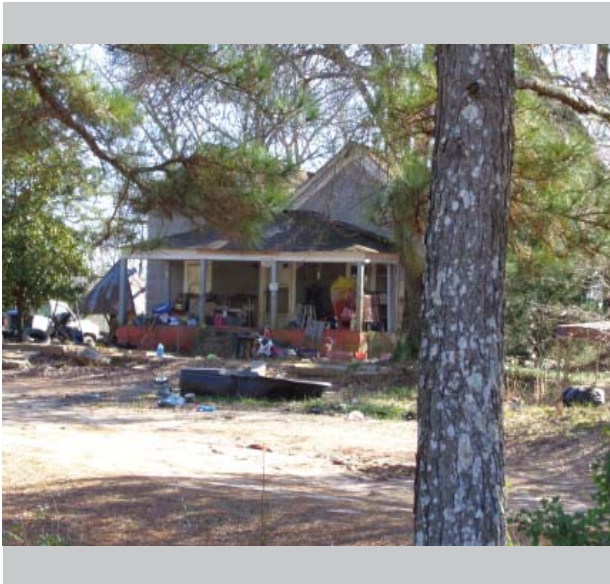
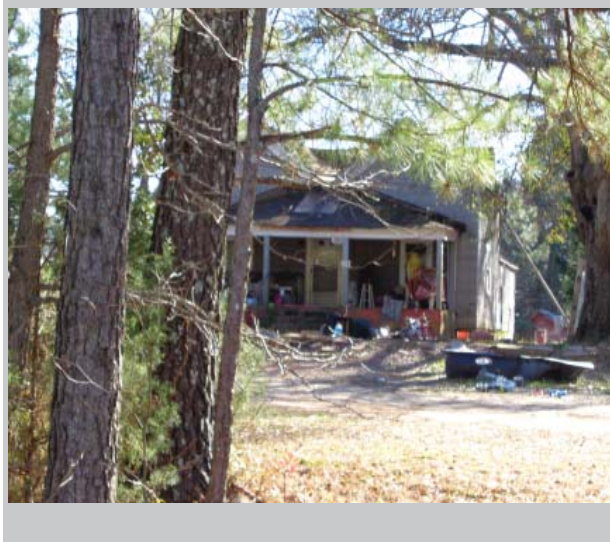
770 Corley Rd.

Resource Type Building

Resource Use Single dwelling:
residential

Foundation Unknown

Alterations Rear shed addition
Mid-century replacement
door

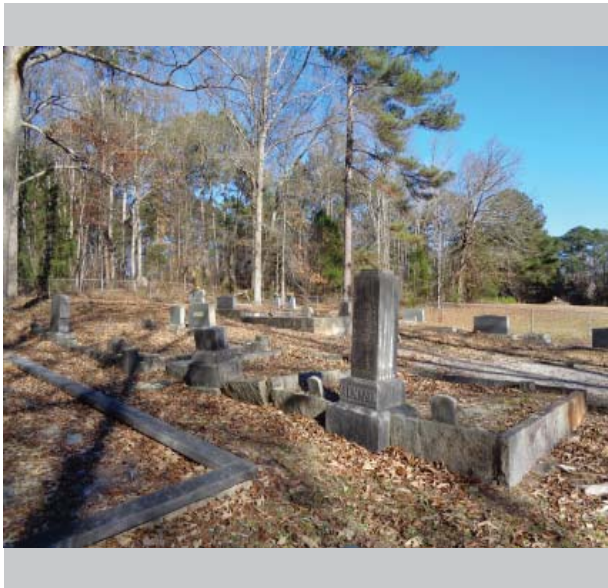
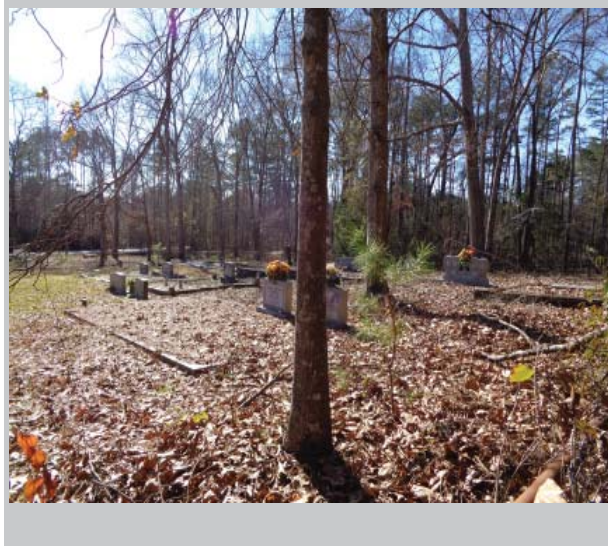
Historical Mt. Zion Cemetery
855 Mt. Zion Rd. NW

Resource Type Site

Resource Use Funerary: cemetery

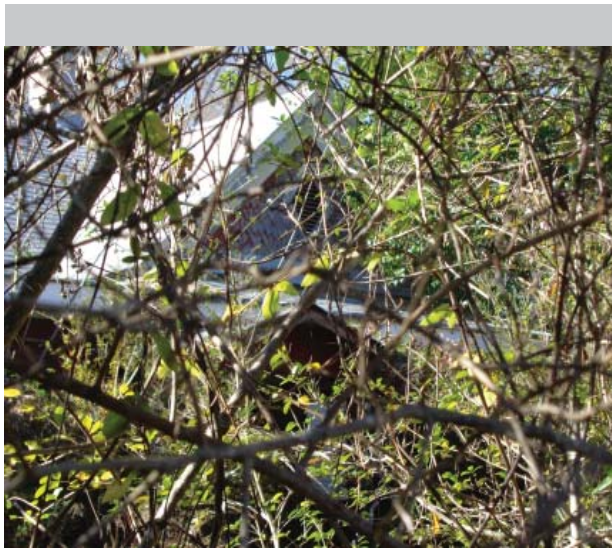
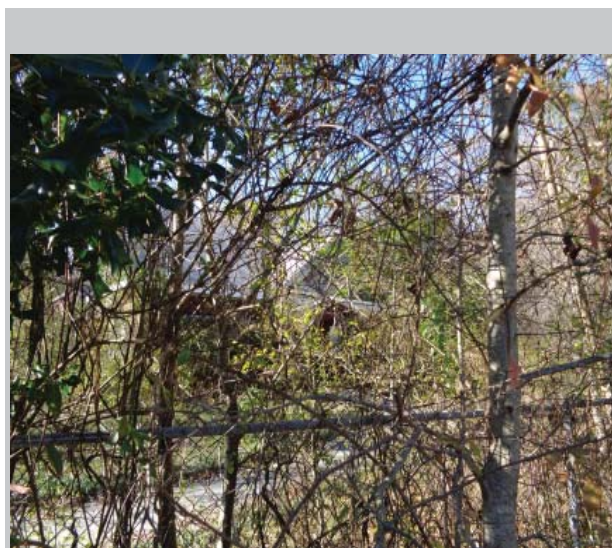
3610 Irwin Bridge Rd.

Resource Type Building

Resource Use Single dwelling:
residential

Foundation Unknown

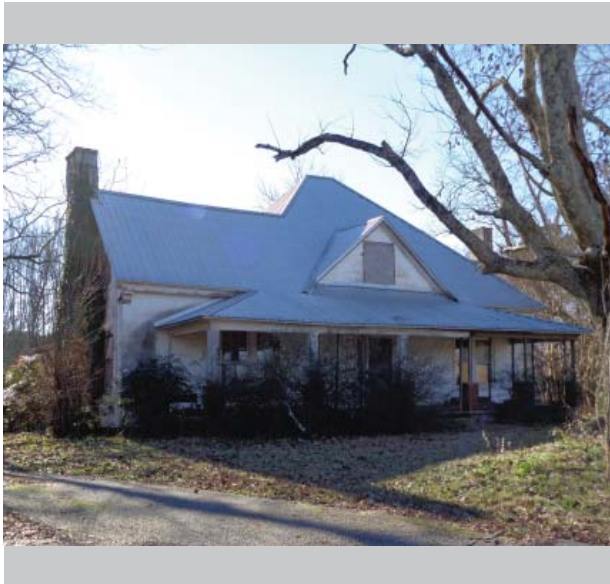
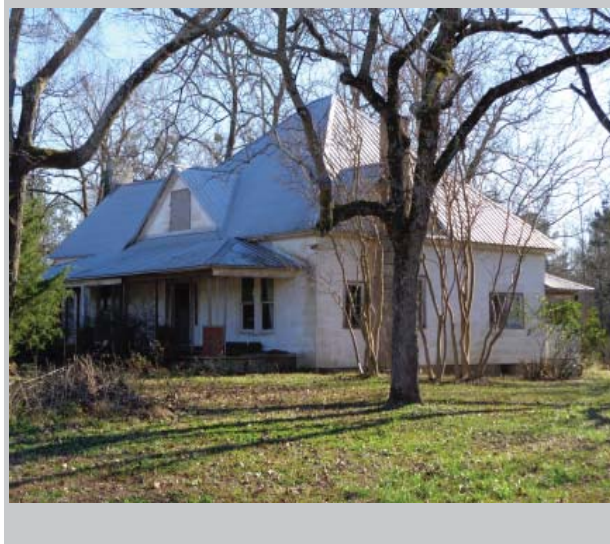
Coordinates: 33.74639, -84.00577

- Resource Type** Building
- Resource Use** Single dwelling: residential
- Date of Construction** 1910
- Building Type** New South cottage
- Structural System** Balloon Frame
- Style** No academic style
- Roof** Hip
- Exterior Cladding** Prism synthetics: asbestos siding
- Foundation** Unknown
- Porch** Stoop
- Windows** Double hung sash: 6/6
- Chimney** Both gable ends: fieldstone
- Alterations** Rear addition
Large side gabled addition

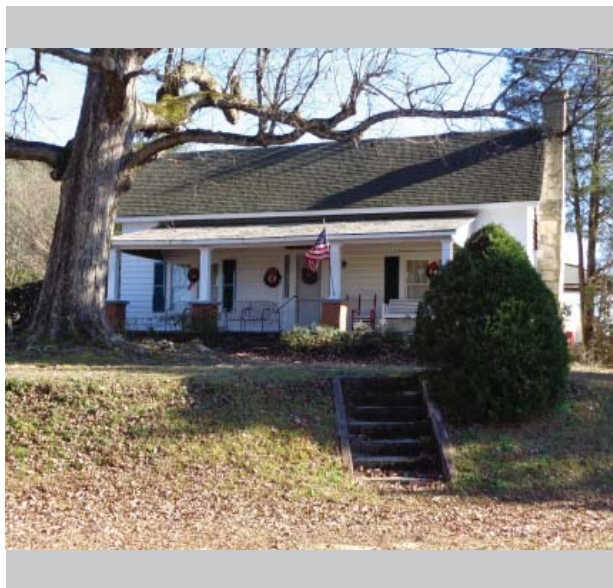
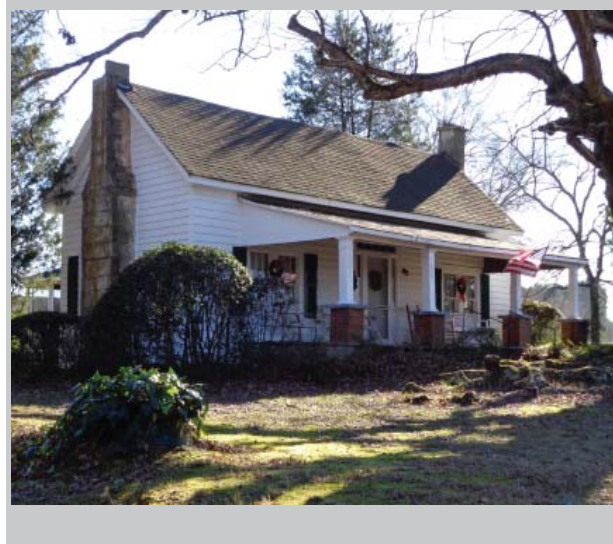
Corner of Hightower Trail and Irwin Bridge Rd.

Resource Type Building

Resource Use Single dwelling:
residential

Foundation Pier: stone

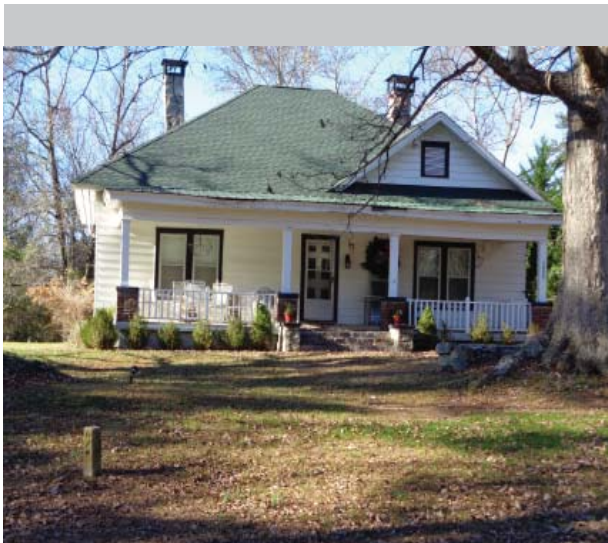
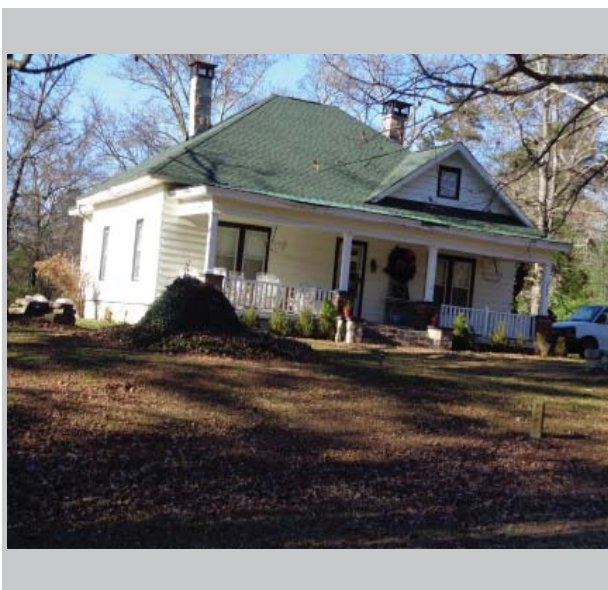
3380 Irwin Bridge Rd.

Resource Type Building

Resource Use Single dwelling:
residential

Foundation Continuos: concrete

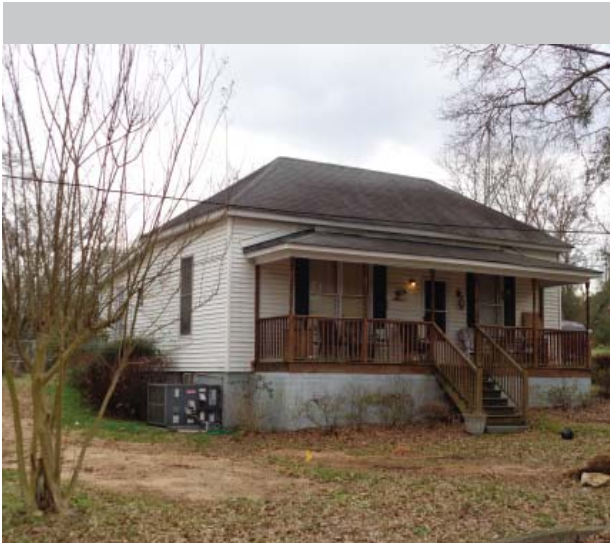
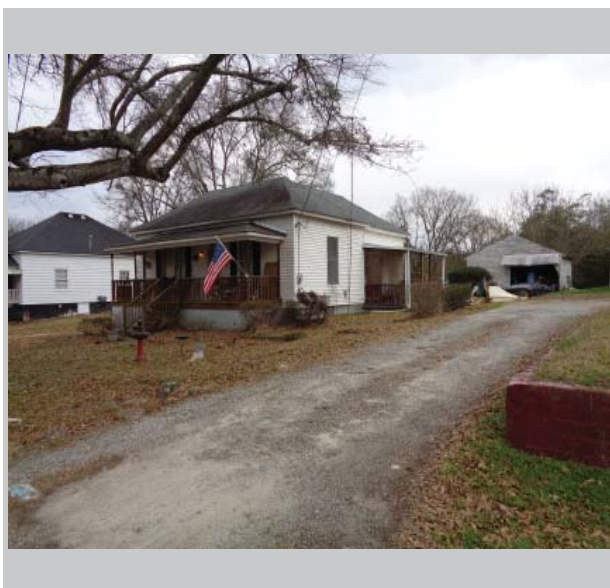
1781 River St. NE

Resource Type Building

Resource Use Single dwelling:
residential

Foundation Pier with infill: stone

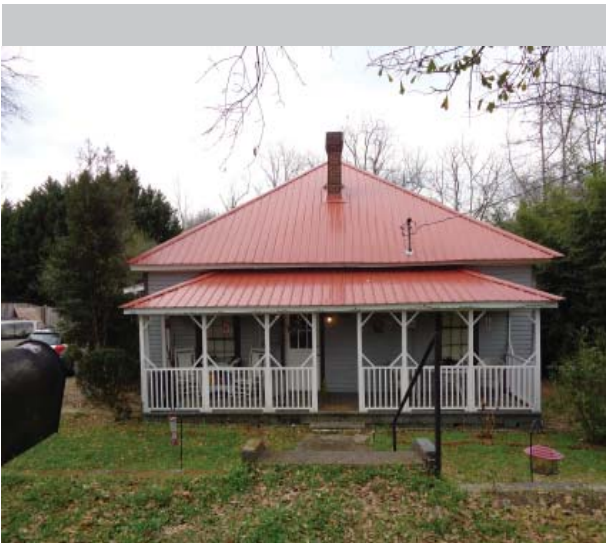
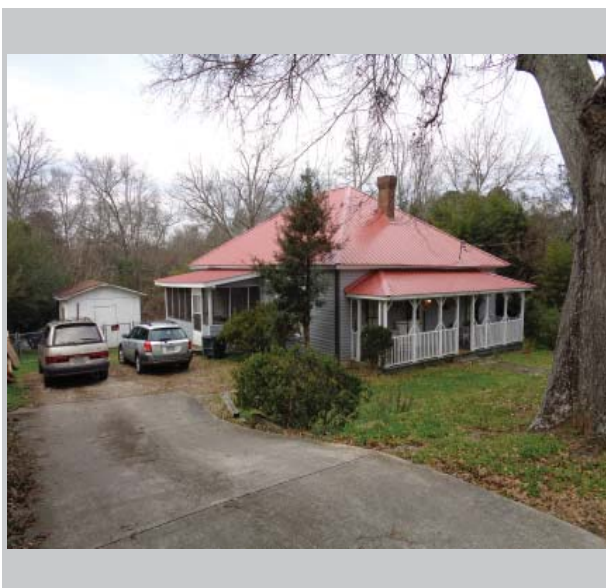
186 River St. NE

Resource Type Building

Resource Use Single dwelling:
residential

Foundation Pier with infill: stone

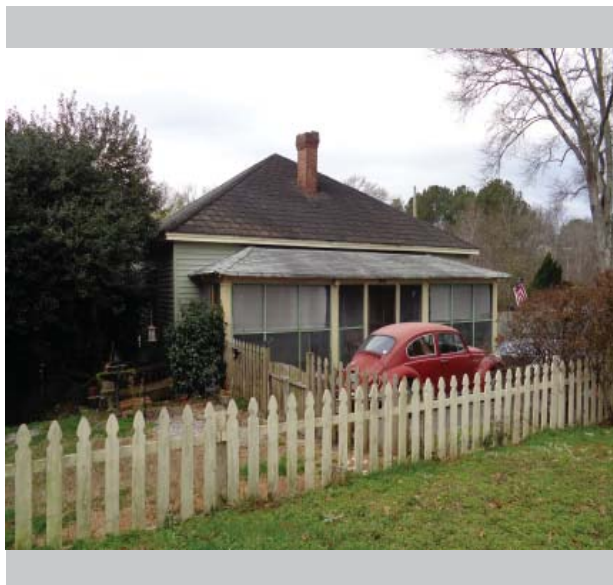
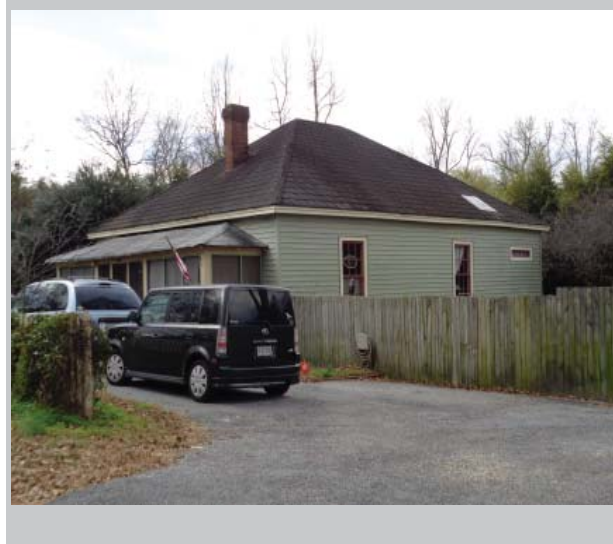
1996 River St. NE

Resource Type Building

Resource Use Single dwelling:
residential

Foundation Unknown

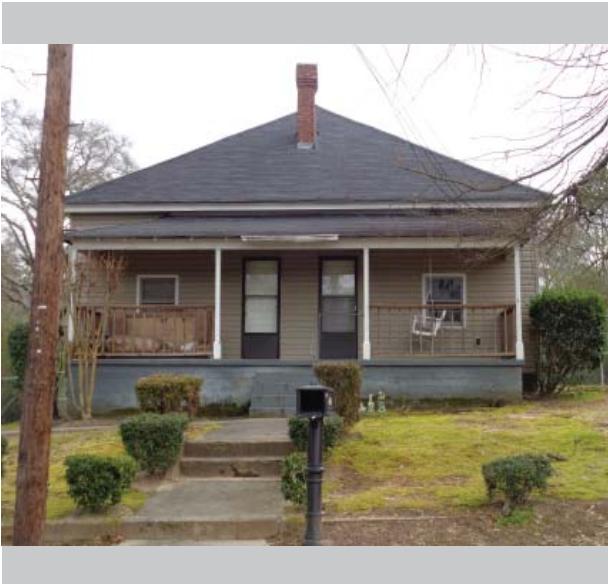
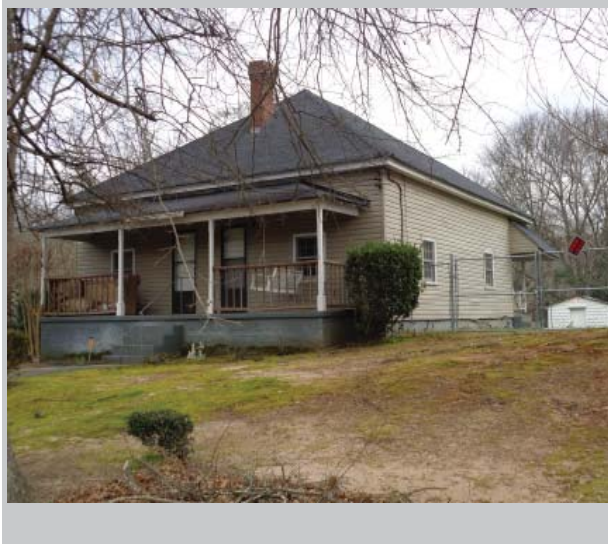
1805 River St. NE

Resource Type Building

Resource Use Single dwelling:
residential

Foundation Pier with infill: stone

Alterations Replacement siding

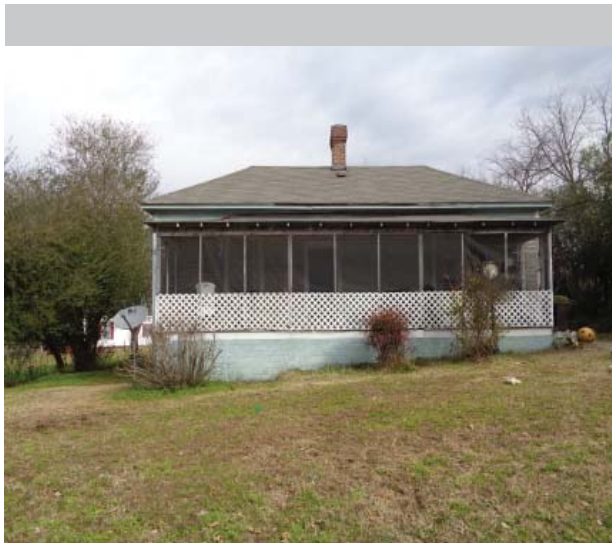
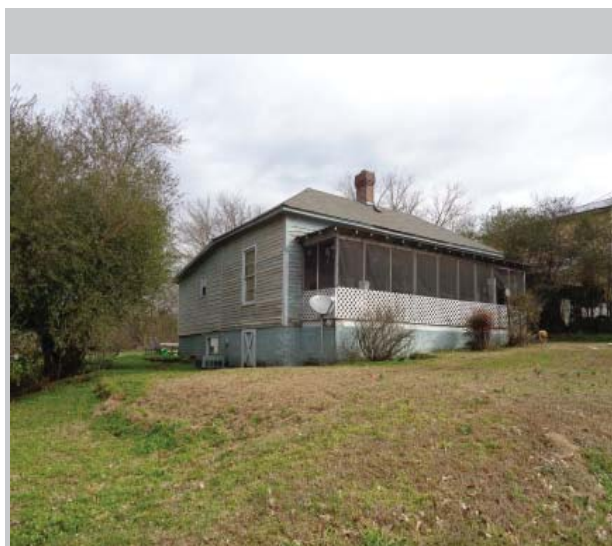
1754 River St. NE

Resource Type Building

Resource Use Single dwelling:
residential

Foundation Pier with infill: stone

Alterations Replacement door
Original baluster replaced
Rear shed addition

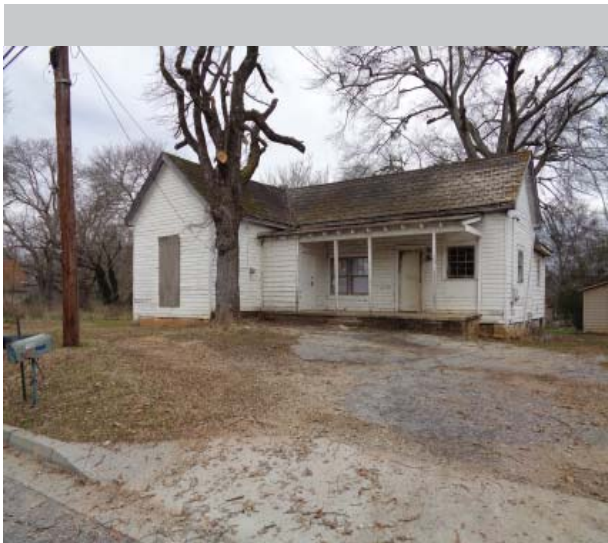
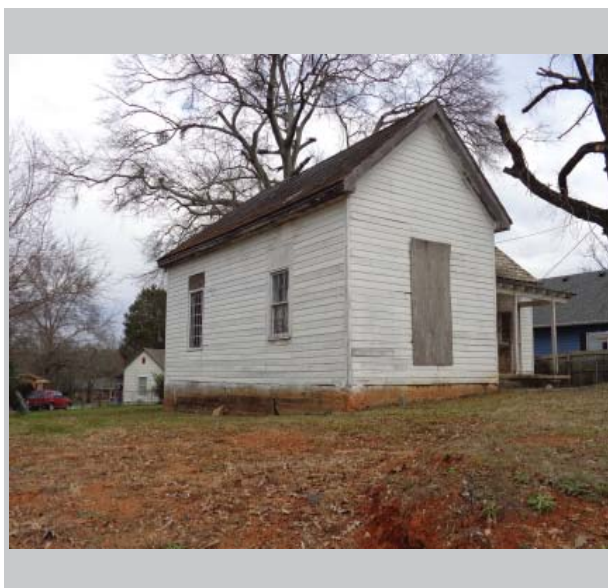
1588 Broad St. NE

Resource Type Building

Resource Use Vacant/not in use

Foundation Pier with infill: stone

Alterations Replacement windows
Rear shed addition

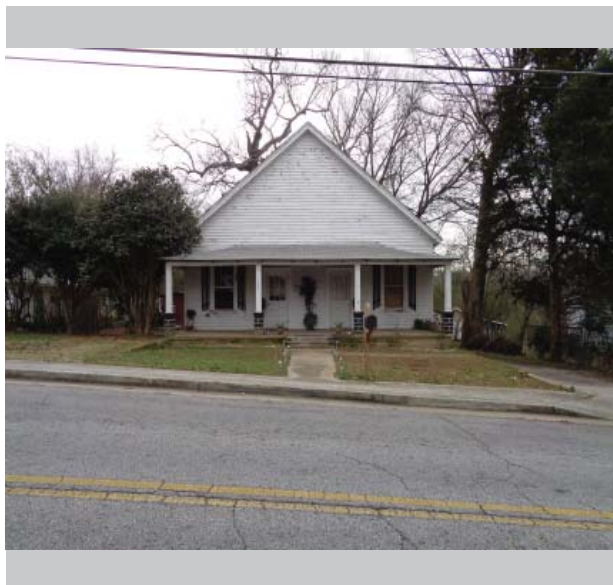
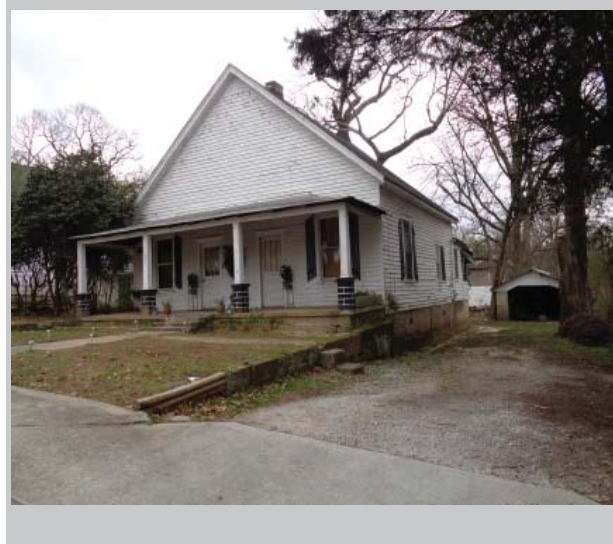
1557 Broad St. NE

Resource Type Building

Resource Use Single dwelling:
residential

Foundation Pier with infill: stone
