Historic Resources Survey Report

Rockdale County, Georgia

December 2015

The University of Georgia
College of Environment and Design
Center for Community Design & Preservation
Historic Resources Survey Report
Rockdale County, Georgia 2015

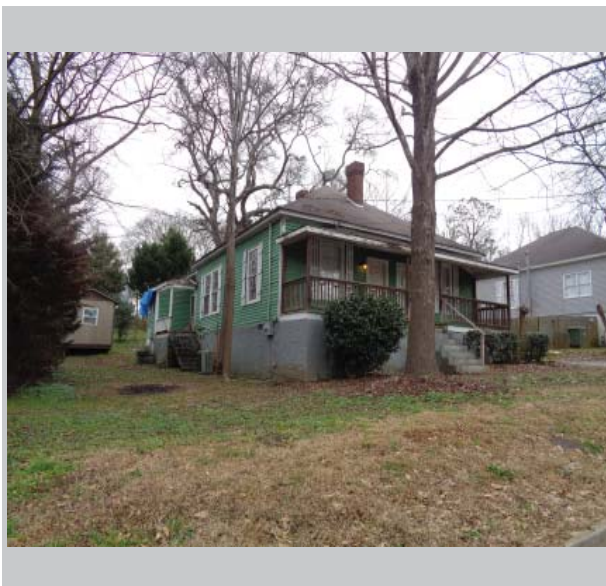
Coordinates: 33.68782, -83.99569

- Resource Type** Building
- Resource Use** Single dwelling: residential
- Date of Construction** 1910
- Building Type** Double shotgun
- Structural System** Balloon Frame
- Style** No academic style
- Roof** Hip
- Exterior Cladding** Wood: weatherboard
- Foundation** Unknown
- Porch** Verandah
- Windows** Double hung sash: 6/6, 1/1
- Chimney** Off-ctr within roof surface: brick (x2)
- Alterations** Replacement 1/1 window on side
Rear additions
Replacement balustrades

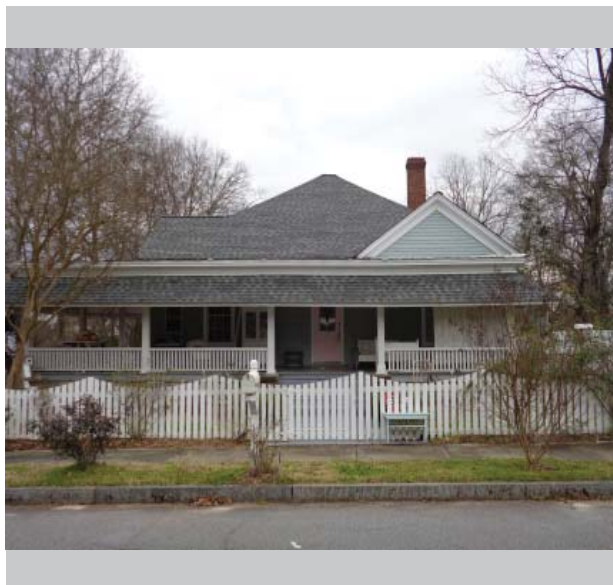
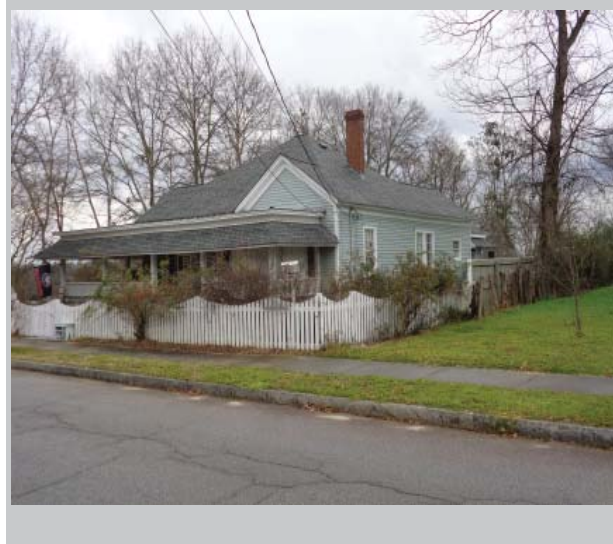
1655 Main St. NE

Foundation Continuous: stone

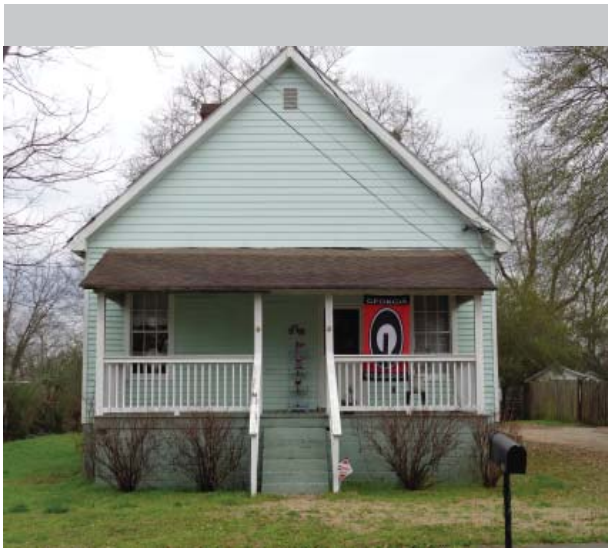
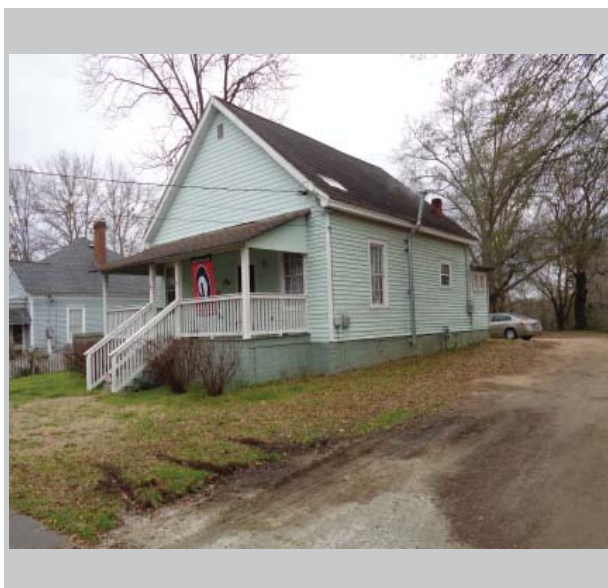
1645 Main St. NE

Foundation Pier with infill: stone

Alterations Replacement balustrades
Rear addition
Replacement siding in
gable

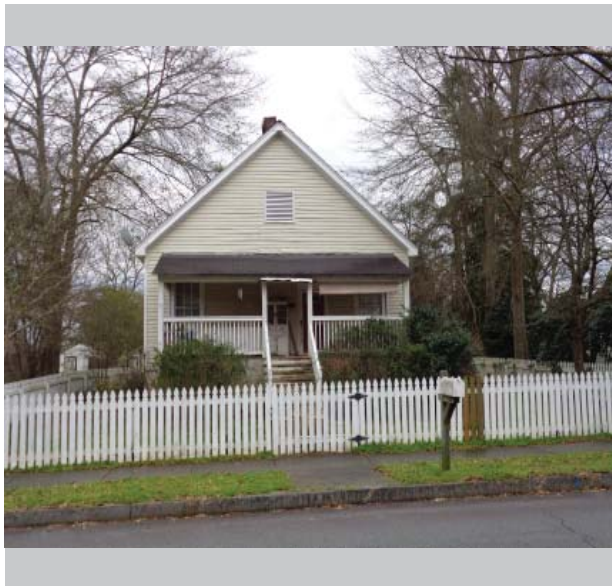
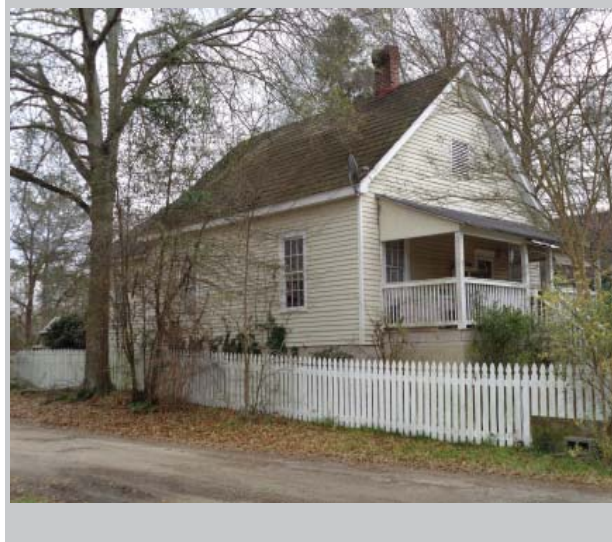
1639 Main St. NE

Foundation Pier with infill: stone

Alterations Rear addition
Replacement door
Replacement balustrades

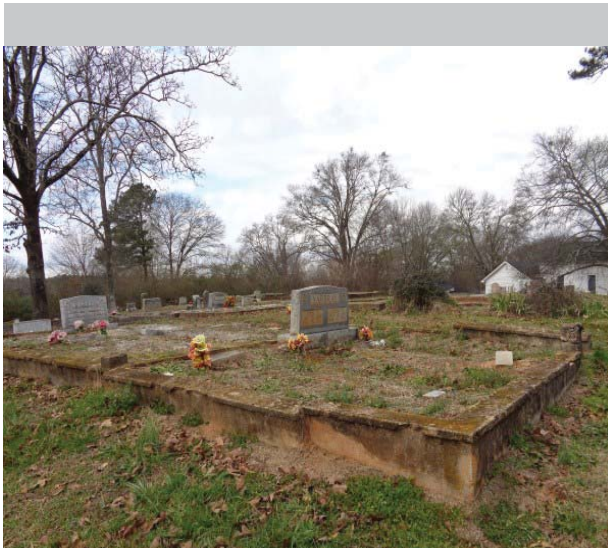
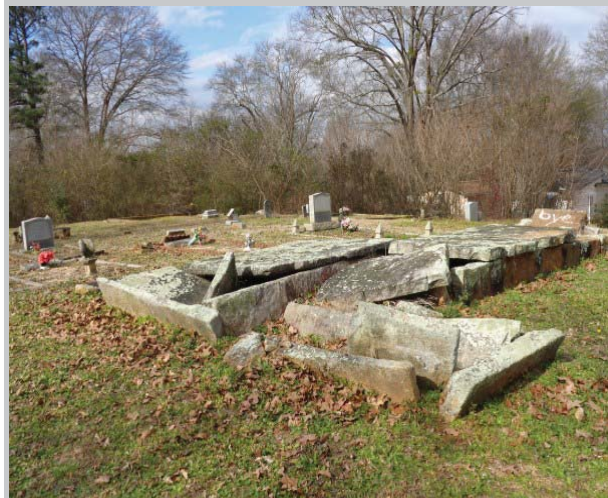
1627 Main St. NE

Cemetery Description Active use
Concrete and granite outlined family plots
Stone tabletop markers
Many broken stones

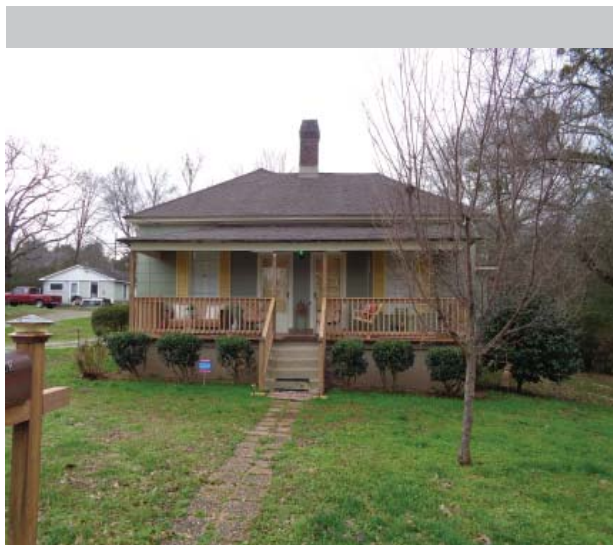
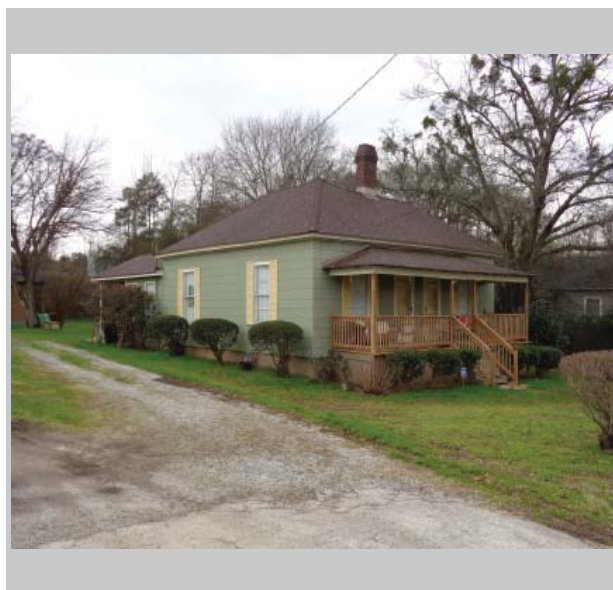
1565 Main St. NE

Foundation Pier with infill: stone

Alterations Rear addition
Replacement windows

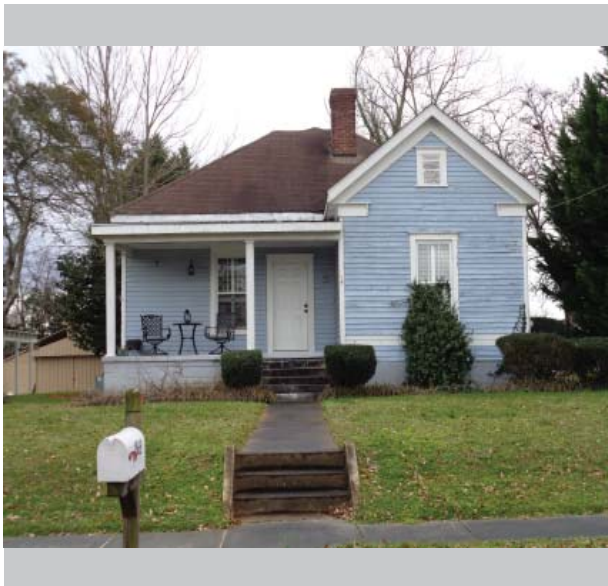
Coordinates: 33.68430, -83.99261

- Resource Type** Building
- Resource Use** Single dwelling: residential
- Date of Construction** 1900
- Building Type** Gabled ell cottage
- Structural System** Balloon Frame
- Style** No academic style
- Roof** Gable: cross
- Exterior Cladding** Board-and-batten: shiplap
- Foundation** Pier with infill: stone
- Porch** Verandah
- Windows** Double hung sash: 6/6
- Chimney** Off-center, ridgeline and lateral exterior: brick
- Alterations** Integrated carport at rear (removable)
Large rear addition

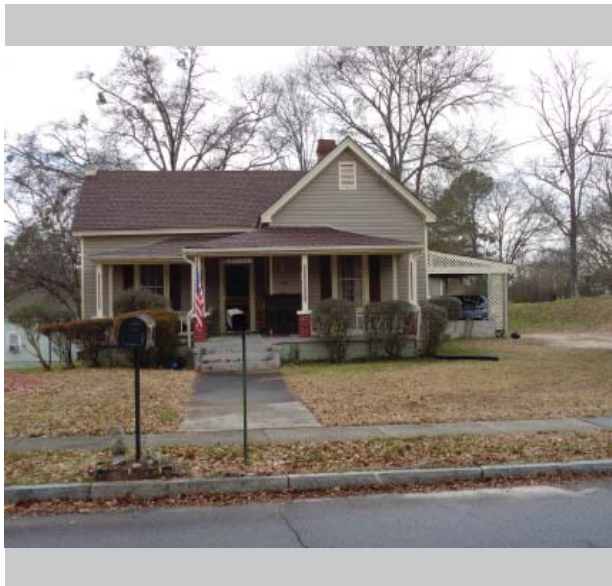
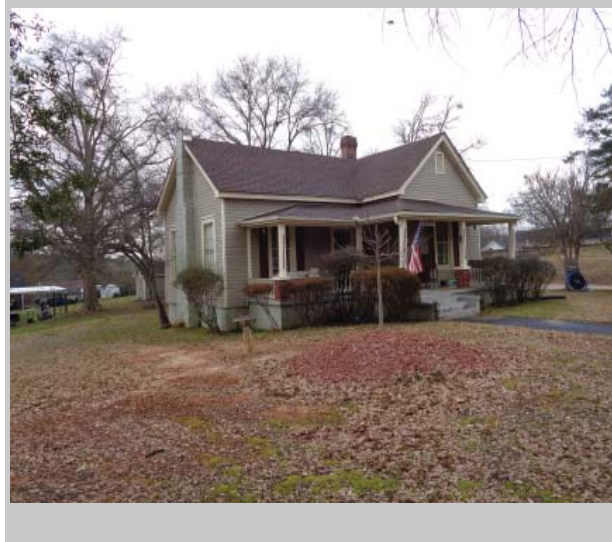
1597 Park St. NE

Foundation Pier with infill: stone

Alterations 1930's replacement door
Screened addition on left
Large rear shed addition

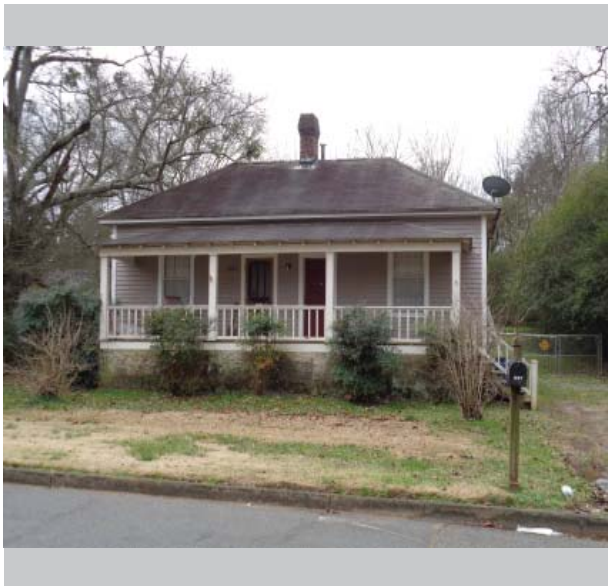
Coordinates: 33.68400, -83.99335

- Resource Type** Building
- Resource Use** Single dwelling: residential
- Date of Construction** 1900
- Building Type** Saddlebag: 2 doors
- Structural System** Balloon Frame
- Style** No academic style
- Roof** Hip
- Exterior Cladding** Prism synthetics: asbestos siding
- Foundation** Pier with infill: stone
- Porch** Verandah
- Windows** Double hung sash: 6/6
- Chimney** Center: brick
- Alterations** Rear gabled additions
Replacement balustrade and porch supports

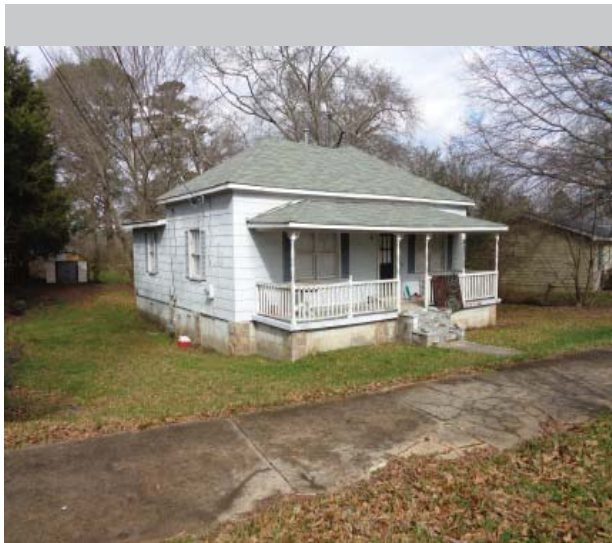
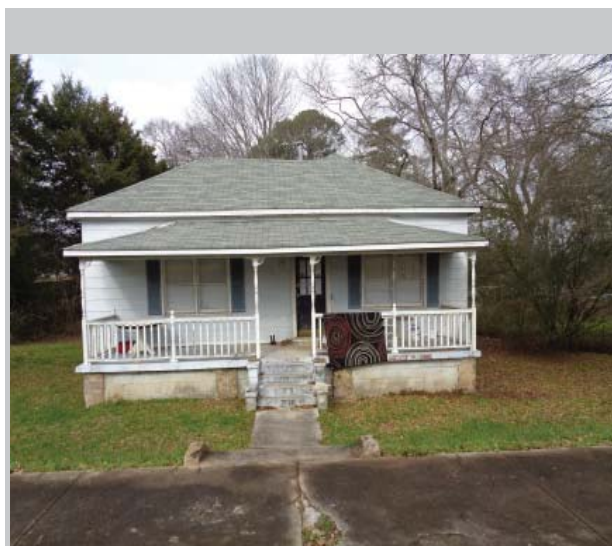
1690 Hill St. NE

Foundation Pier with infill: stone

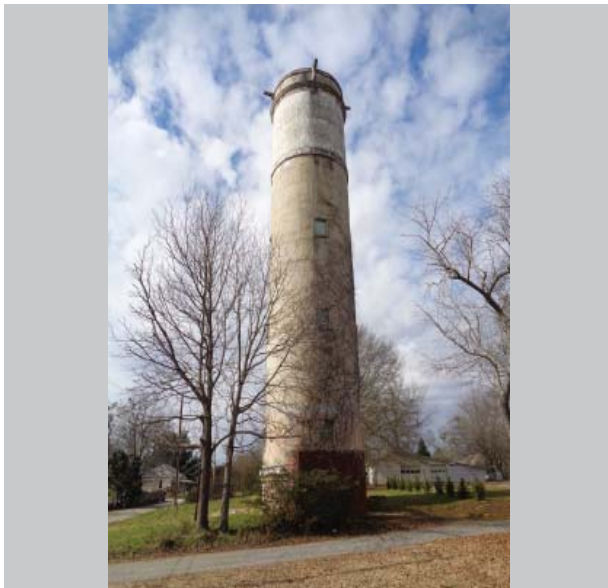
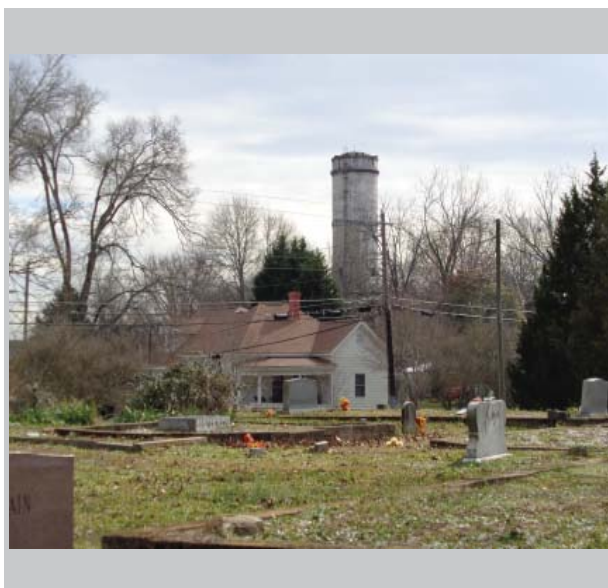
Coordinates: 33.68354, -83.99114

- Resource Type** Structure
- Resource Use** Single dwelling:
residential
- Date of Construction** 1900
- Building Type** Water tower: vacant/not in
use
- Structural System** N/A
- Style** No academic style
- Roof** N/A
- Exterior Cladding** N/A
- Foundation** Continuous: brick and
concrete
- Porch** N/A
- Windows** Double hung sash: 1/1
- Chimney** None observed
- Alterations**

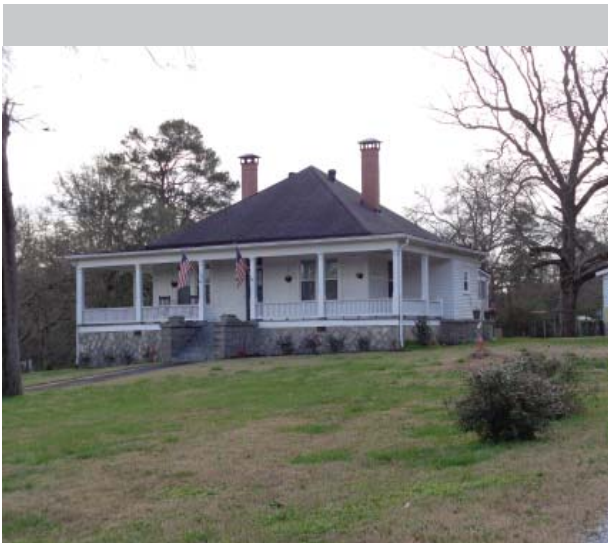
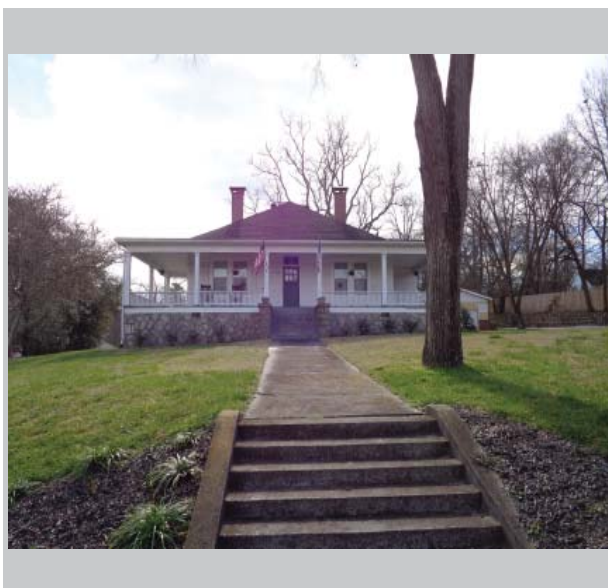
1669 Spring St. NE

Foundation Continuous: stone

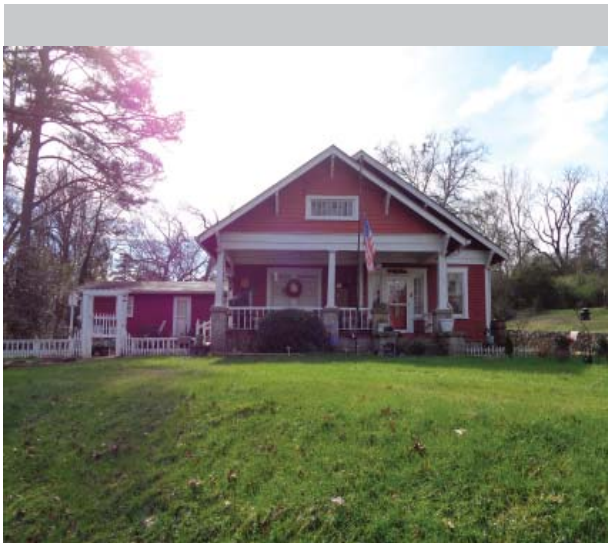
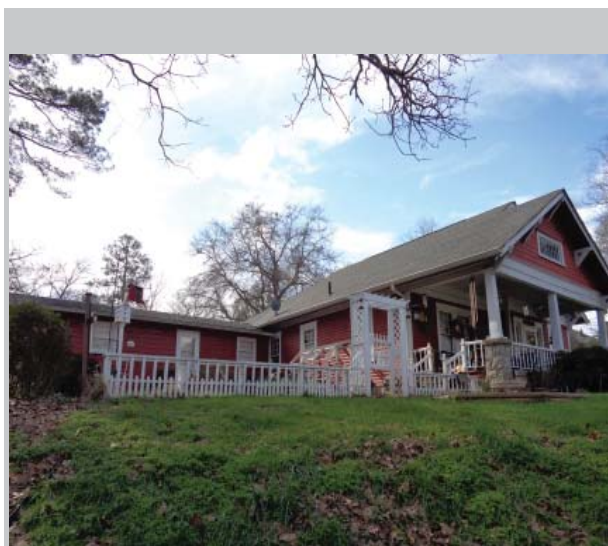
1683 Spring St. NE

Foundation Continuous: stone

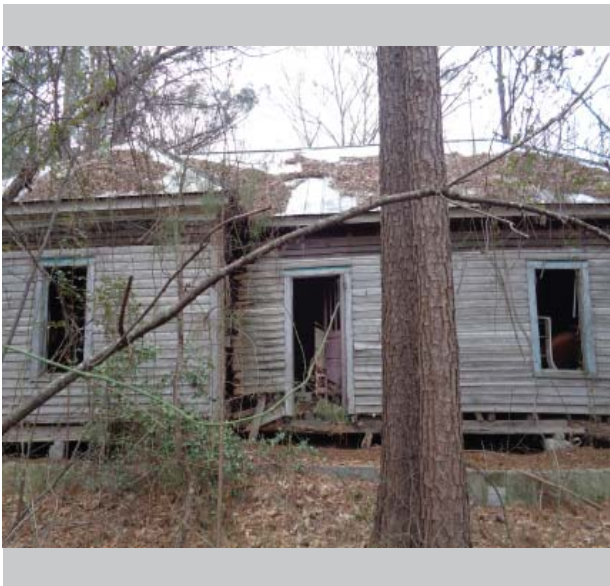
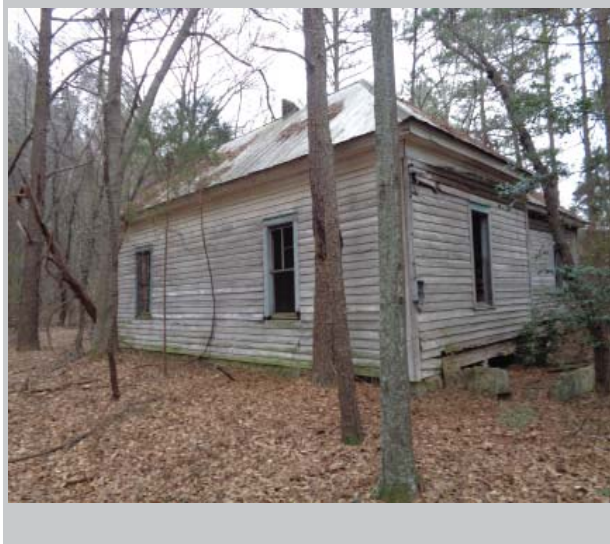
Corner of Farmer Rd. and Sigman Rd.

Foundation Pier: stone

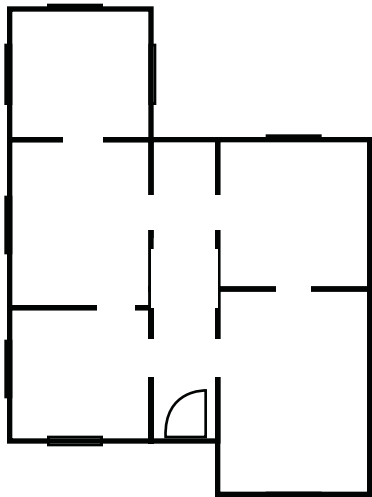
Queen Anne House

Multi-story: Asymmetrical massing with no central hallway

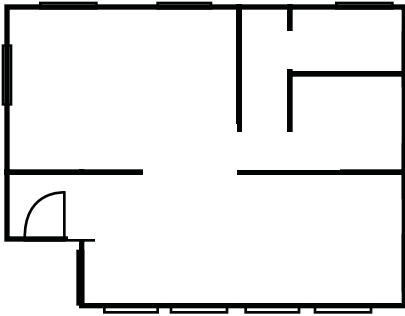
New South Cottage

Single story : Asymmetrical massing with central hallway

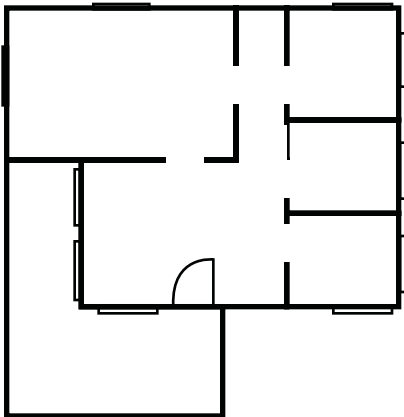
Bungalow (Front Gabled)

Single story: Irregular floor plans; one of four subtypes identified by a front gable roof shape

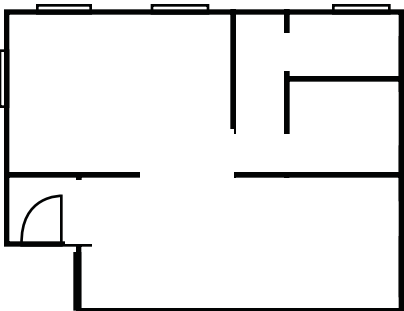
Bungalow (Cross Gabled)

Single story : Irregular floor plans; one of four subtypes identified by a cross gable roof shape

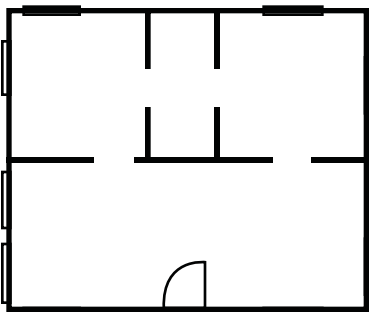
Bungalow (Hipped)

Single story: Irregular floor plans; one of four subtypes identified by a hipped roof shape

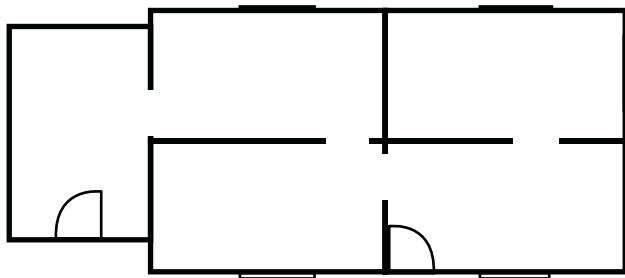
Georgian House

Multi-story: Two rooms deep by two rooms wide with central hallway

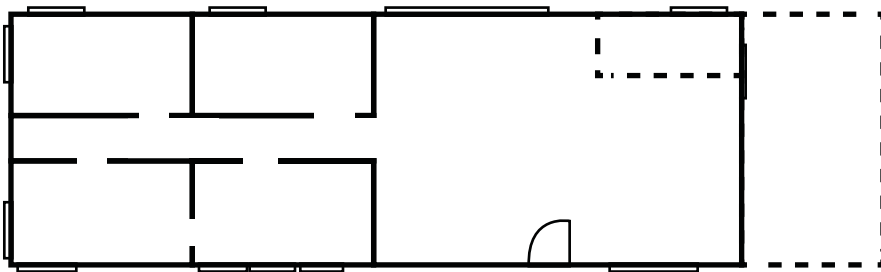
Side Hallway

Multi-story: Two rooms deep by one wide with side hallway

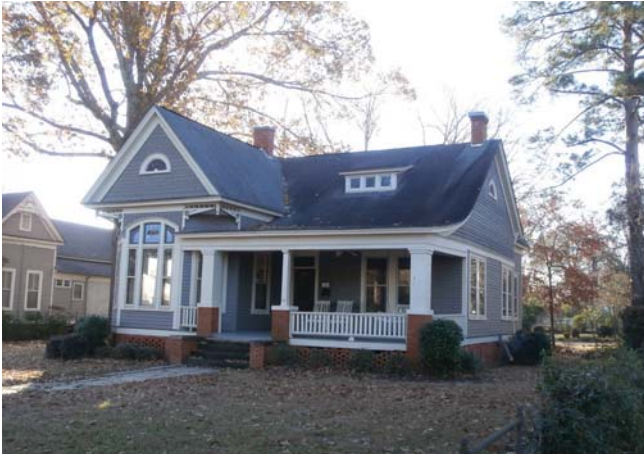
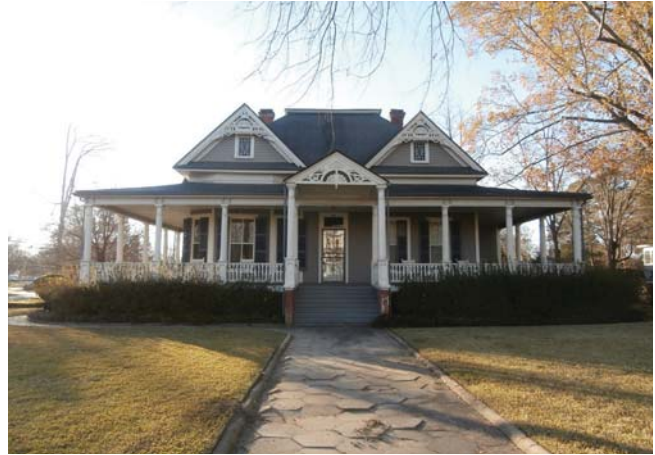
Folk Victorian 1870-1920

Folk Victorian houses were built across Georgia in very large numbers. They were simple house forms, or house types, with Victorian-era decorative detailing such as jigsaw woodworks including brackets, spindlework and gingerbread trim. This detailing generally was taken from the elaborate styles, such as Queen Anne or Italianate, that were popular during the mid to late 19th century. Features were borrowed and added onto such places as porches and roof gables. This provided some hint of stylistic detailing on what was otherwise an unadorned traditional house form. This style is actually more a way of decorating a house than a precise stylistic category; however, the Folk Victorian house is so widespread that it demands a name.

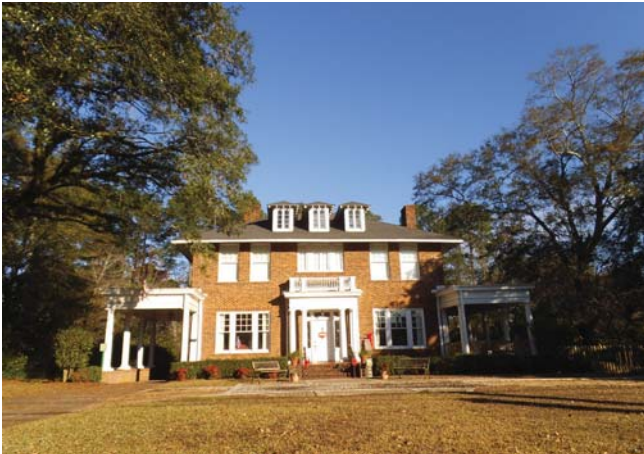
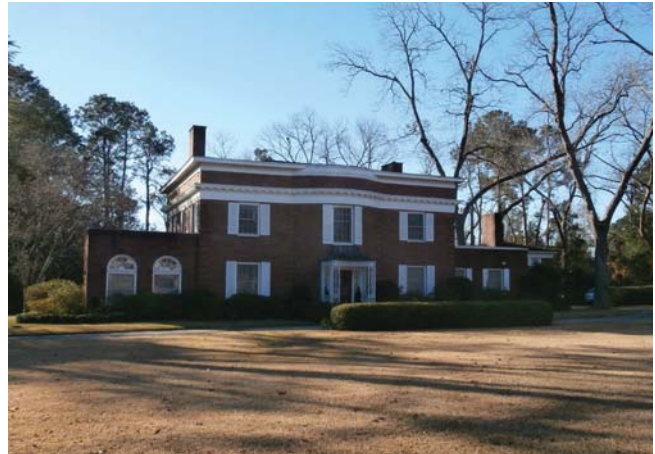
Colonial Revival 1890-1955

Most Colonial Revival houses are symmetrical. A central entranceway is elaborated with a pediment supported by pilasters or columns. The use of broken pediments, fanlights and sidelights is common. Classical cornices with dentils or modillions are usually present. These features tend to be larger than original colonial details. The roof may be hipped or side-gabled with dormers. Windows have double-hung sashes, usually with six-over-six or nine-over-nine panes and may be paired. Walls are of masonry, masonry-veneer or wood.

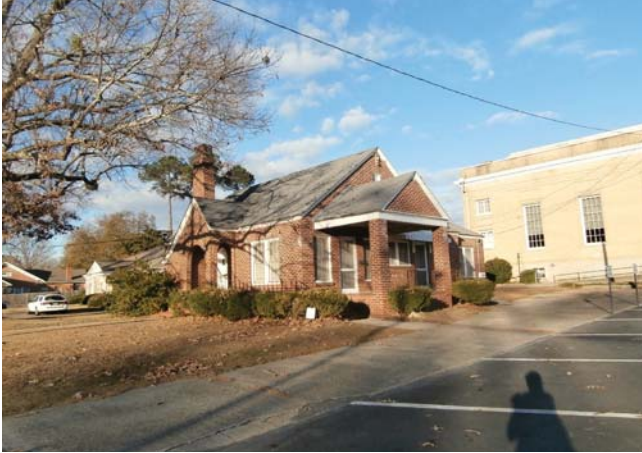
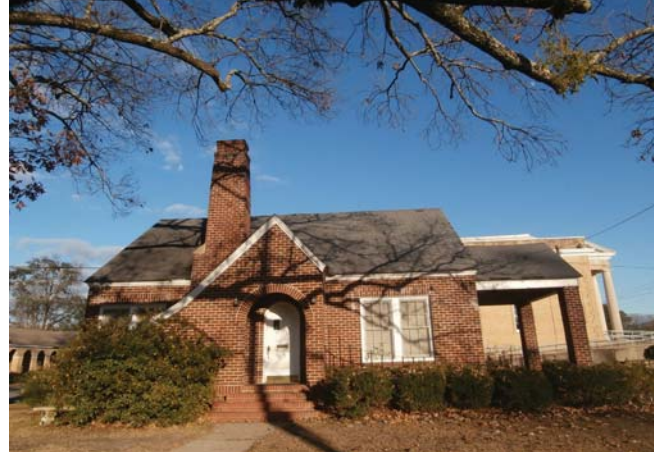
English Vernacular Revival 1900-1940

Characteristics of English Vernacular Revival houses are a steeply pitched gabled roof with dominant front-facing gable and decorative half-timbering in the gables. Almost all have masonry walls. Most are masonry-veneered, a recently developed technique for applying a thin layer of masonry to a wall. Some houses have patterned brickwork, while others may be completely stuccoed. Often a variety of materials are used, such as brick walls with stone trim, wood half-timbering, and stuccoed gables. Massive masonry chimneys with decorative tops are common. Windows are generally tall and narrow, grouped together, multi-paned, and casements rather than double-hung. Some openings, particularly the entrance, may be emphasized by a round arch. Houses of this style are generally asymmetrical.

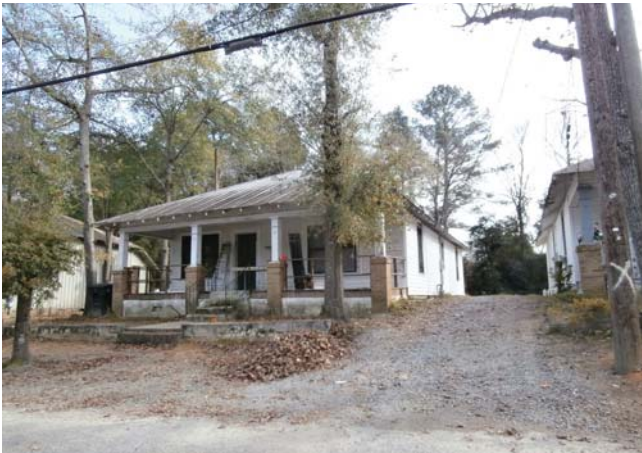
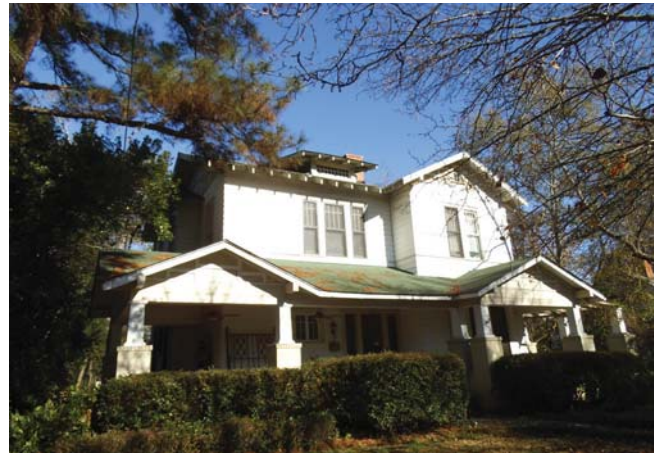
Craftsman 1910-1930

The Craftsman house uses a wide variety of materials both for its structure and decorative detailing. It has a low-pitched roof that is usually gabled but may also be hipped, giving a generally horizontal effect. The widely overhanging eaves are open with exposed rafters. Large gables have decorative brackets or braces at the eaves and may be covered with half-timbering. Roof dormers are sometimes found. Walls are most often wood but may also be covered with shingles or a masonry veneer of stone or brick. Porches have short square columns set on heavy masonry piers extending to the ground. Windows may have a multi-paned sash over a large one-pane sash. Craftsman houses are most often asymmetrical with a generally open and functional plan.

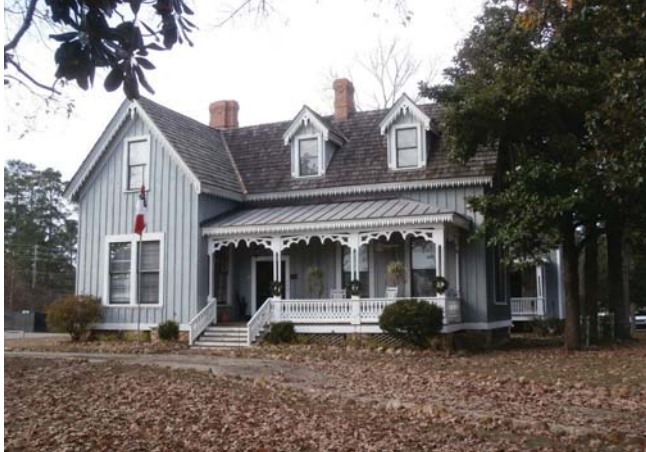
Gothic Revival 1850-1890

Gothic Revival houses typically have steeply pitched gabled roofs with both front-and side-facing gables. Decoratively sawn bargeboards are commonly found along the eaves. Window and door openings often have either pointed arched tops or heavily molded or pointed hoods. Porches are usually supported by slender posts with sawn woodwork forming flattened arches or brackets. Some houses have vertical board-and-batten siding. This style emphasized picturesqueness, verticality, and varied use of materials.

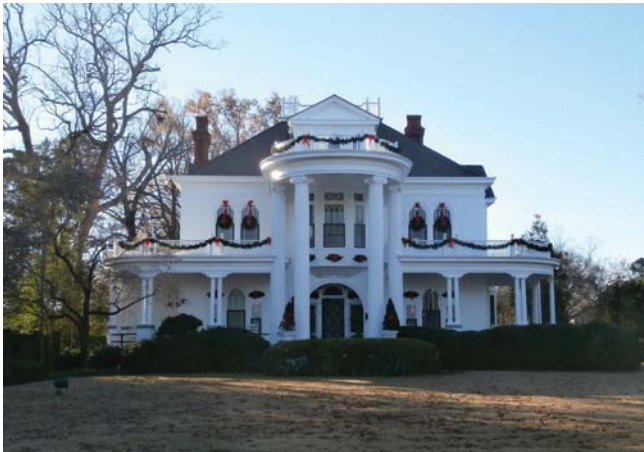
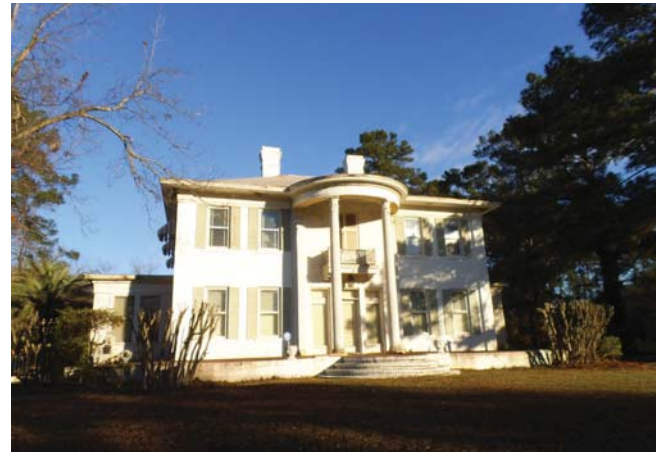
Neoclassical Revival 1895-1940

The most common feature of the Neoclassical Revival style is a dominant full-height front portico with classical columns. The portico may be at the entry or may cover the full facade; it may have a triangular pediment or be part of the overall roof. A full-height entry portico is often coupled with a one-story full-facade porch. The facade is more or less symmetrical, and the central entrance, surrounded with pilasters and columns, is elaborated with fanlights, sidelights, and transoms. There is almost always a classical cornice with dentils or modillions. The roof is usually low-pitched and hipped and may have a balustrade. A porte-cochere and side porches supported by columns are common.

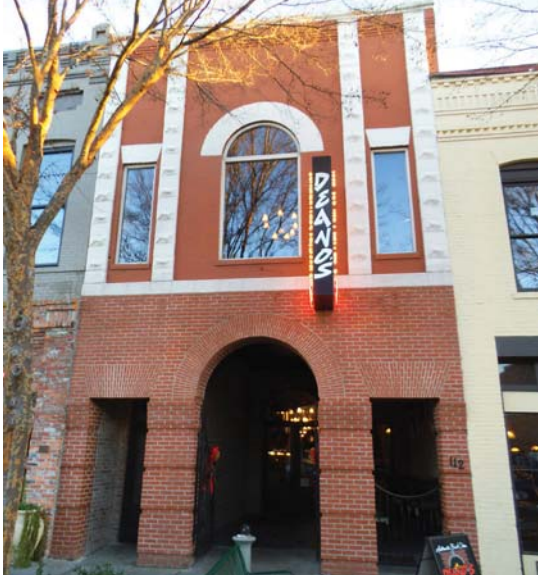
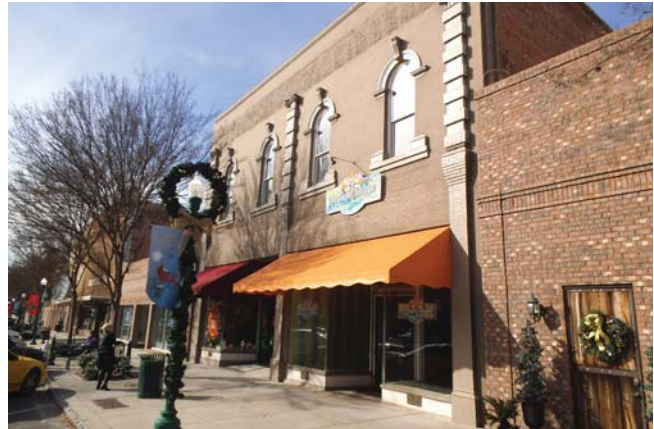
Italianate 1840-1885

Italianate houses are generally asymmetrical with an L-shaped or other irregularly shaped plan and gabled roof. Distinguishing features are the widely overhanging eaves with decorative brackets that emphasize the cornice. Typically tall narrow windows with large two-over-two or one-over-one panes are often paired, arched, and topped with elaborate hoods. Bay windows are also common. Italianate style residential architecture faded out during the 1880s; however, many Italianate style commercial blocks were constructed until the 1890s. The flat topped blocks with brackets and decorative window moldings were two or more stories tall and featured large storefront windows. Brackets beneath eaves are the most distinguishing characteristic of the Italianate commercial block.

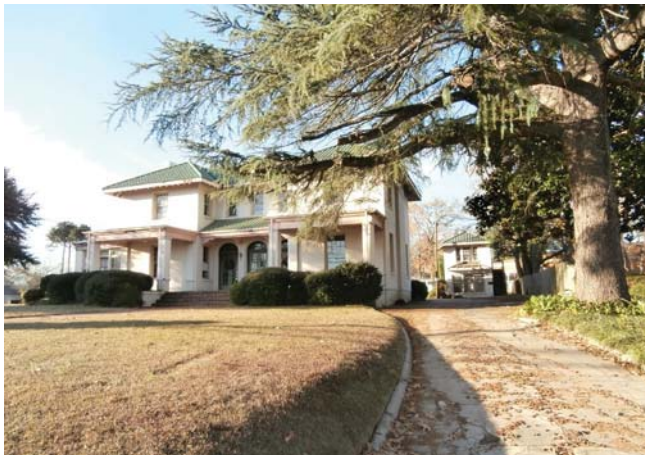
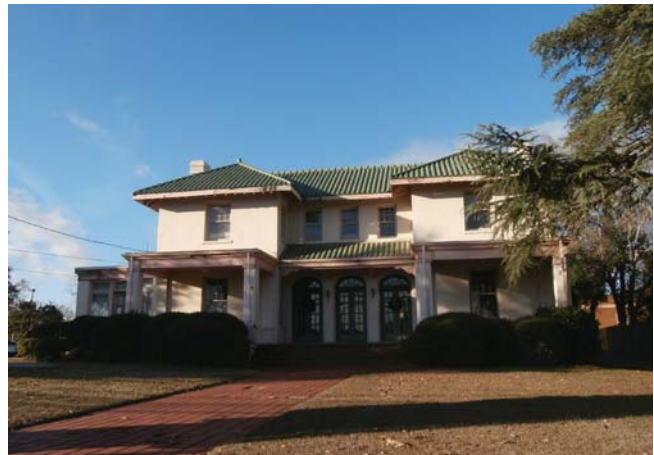
Mediterranean Revival 1890-1910

A Mediterranean Revival house has smooth stuccoed or masonry walls and is usually asymmetrical. The roof is covered with clay tile, is low-pitched, and may be either hipped or gabled. Houses following the Spanish tradition will have little or no eave overhang, while those following the Italian influence will have widely overhanging eaves with exposed rafters. Recessed and arcaded loggias, or open porches, are common. Windows are generally arched and may be grouped together. Sometimes columns and pilasters are used to elaborate openings.

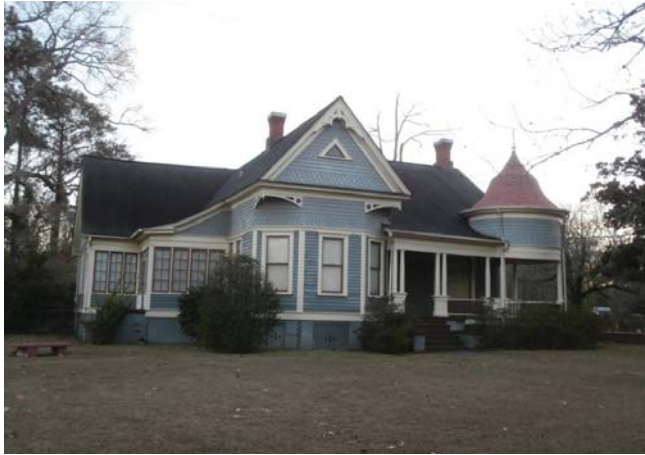
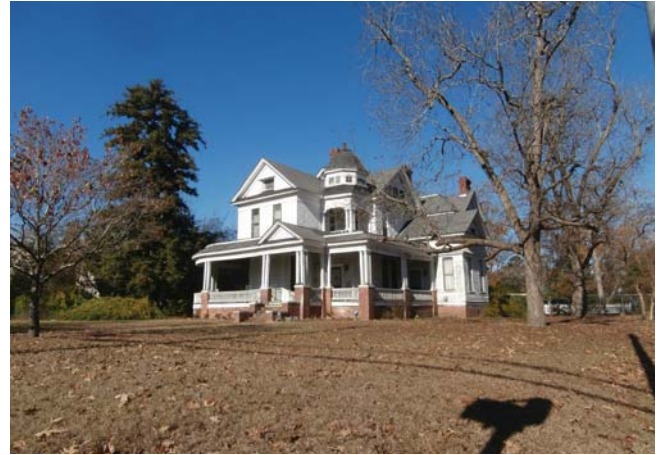
Queen Anne 1880-1915

A Queen Anne style house is asymmetrical with complex roof and wall shapes. It displays a variety of textures, materials, and detailing. The asymmetrical shape results from a floor plan that is open and flowing. The roof is often steeply pitched and hipped with both front-and side-facing, or cross, gables. Wall surfaces avoid a smooth appearance through the use of projecting bays and materials such as patterned shingles that provide texture. The porch is usually asymmetrical and often wraps around two sides of the house. It is supported with slender turned posts and often decorated with sawn brackets and spindlework friezes. Roof gables may also be decorated with sawn ornamentation or spindlework and covered with patterned shingles. There are often prominent and elaborate brick chimneys with patterned and corbeled brickwork. A round or multi-sided tower may be found at a corner.

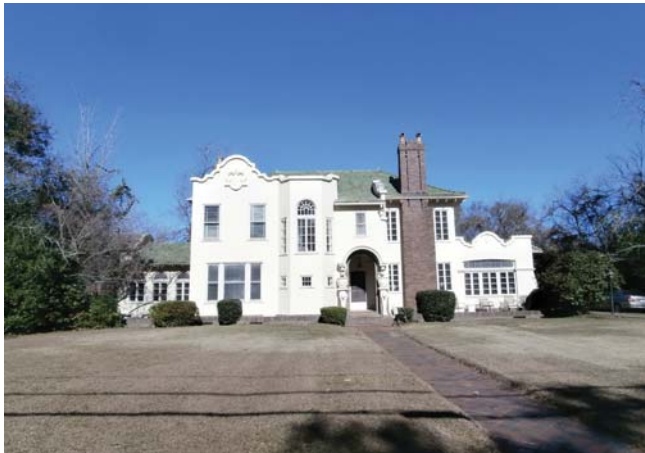
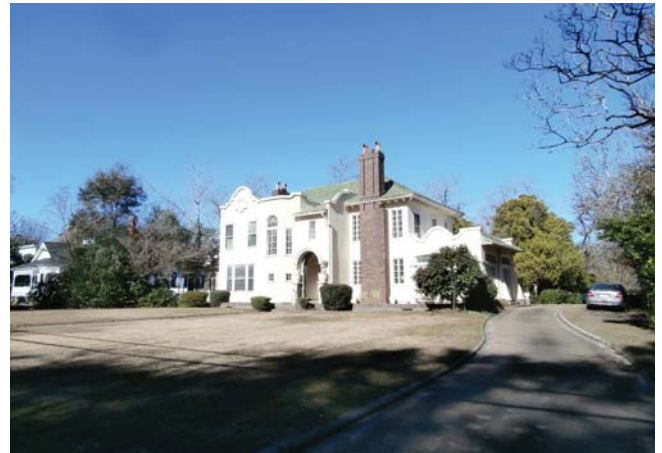
Spanish Colonial Revival 1900-1940

A Spanish Colonial Revival house has a clay tile roof that is usually gabled with little eave overhang. Walls are of smooth stucco. Arched openings and arcaded loggias, or open porches, are common. Windows are generally casement and grouped together. The roof may be elaborated with curvilinear gables or parapets from the mission tradition. Exposed roof beams may protrude from the walls to emphasize construction methods.
