DENMARK HALL

Historic Structure Report

Prepared by:
Rebecca McManus
Alexandra Green
Sophia Latz

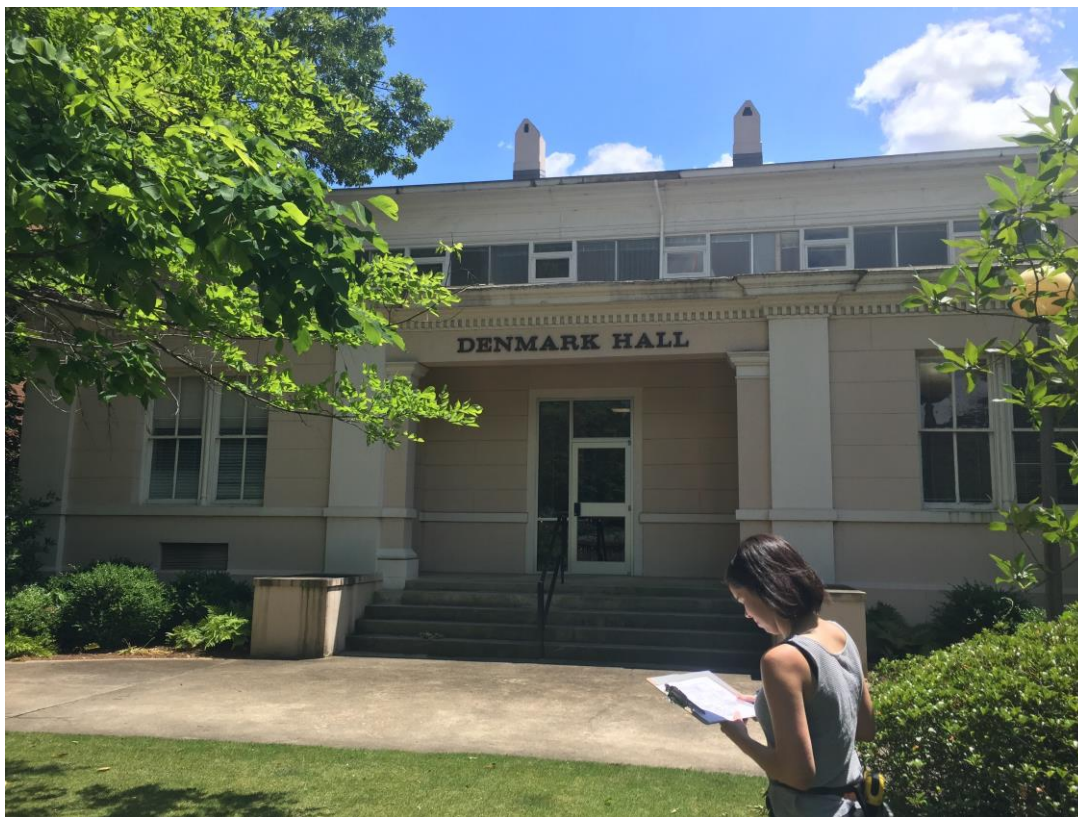
1. NORTH FAÇADE

Denmark Hall is a Neoclassical Revival building constructed during the early years of the style’s popularity (1901). Nowhere on the building is this better reflected than the north elevation, or, the primary façade from which the building can be entered. The first floor displays a continuous belt course that runs around the entirety of the historic footprint of the building, approximately four feet from ground level, and the entrance is flanked by squared, engaged columns with Doric capitals. These columns are also subject to the building’s belt course. The front doors to Denmark, once flanked by an additional two columns in the Doric style (removed), were replaced mid-century by a single door with a sidelight and transom light. The double windows on both sides of Denmark Hall’s entrance are double-hung sash windows, all of which are painted shut. There are two lights in each sash, making a total of four panes per window. Each set of double windows has a decorative column, made of turned wood, between them: this column does not comply with any particular architectural order, looking like a mix

While the decorative cornice on the edge of the former porch is in sore need of repair (the almost-nonexistent gutter system retrofitted into it has no actual downspouts), the former porch itself is suffering an immense deal of damage. The majority of this damage is from issues both related to water and extraneous equipment (wiring, plumbing, pipes, air conditioning systems, et cetera) that still clings to the building's walls. Much of this satisfies no purpose and is non-functional. The louvered windows cannot easily be opened without a special crank, and there is no weather-strip on the door that leads into the interior of the building.

the window wall, and in various pockets spotting the roof. The asphalt itself is long past its due date for replacement, cracked in many places and bubbling up from the roof. Close to the window wall and on the left edge of the former porch it is evident that mosses and lichens have been growing on the asphalt. The gutters are full of organic detritus and two vents peeking out from the middle of the roof have not been appropriately waterproofed. Most of running board along the window wall has been “repaired” with bathroom caulking, which is neither appropriate nor beneficial in the long run. Its removal would damage original historic elements of Denmark Hall. On the right side of the former porch is a non-functioning air conditioning unit.

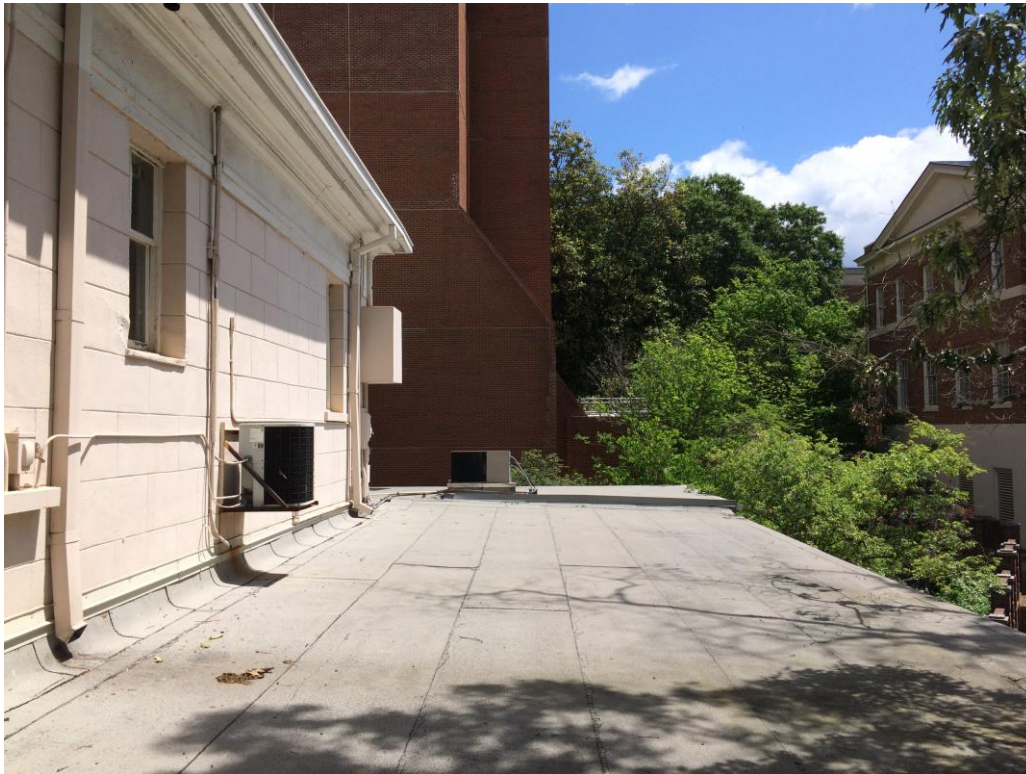
The second story of the south side of Denmark Hall has three windows, all of which are double-hung sash windows (with the characteristic two lights per sash, making four lights total per window). All but one window are painted shut. These windows look out onto the newest addition's roof, which has little slope. Fortunately, the south side of the building receives the most sunlight during the day, and therefore has few issues with water penetration or moisture damage. Less promising are the multitude of tension cracks in different areas spanning the entire exterior wall, and the parts of the roof that are placed directly under the trees surrounding Denmark. Many of the gutter placements do not make sense, and water drains directly onto the roof, where it pools. The tension cracks are primarily located under the small, single-light windows dotting the exterior wall of the basement computer lab, which can be accessed through the south side of the building.

Another problem with the south side of Denmark Hall is an excess of equipment (pipes, wires, air conditioning units) that is non-functional and serve no purpose to the building. They add to the load that the building must support, and have been largely painted over to “camouflage” them. This attempt has been ineffective, at best.

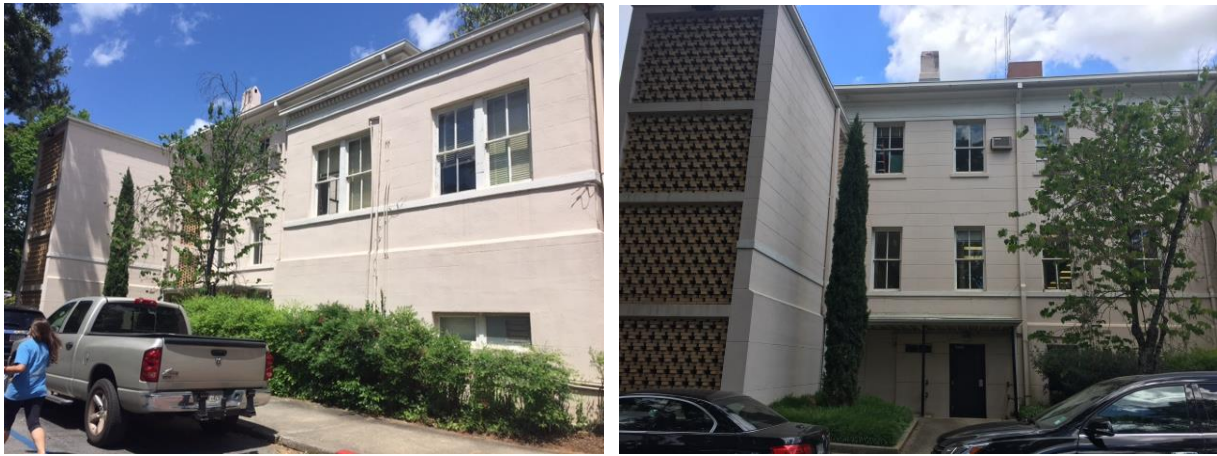
This side of the building does not suffer any serious moisture damage except in the southwest corner, which is where the Cultural Landscapes Lab is located. Reports have stated that the CLL flooring has withstood intensive and persistent water penetration, which has caused minor flooding and forced many of the interior floor tiles to peel away. The small windows looking into the Cultural Landscapes Lab, built into the by-1935 addition, have been mostly blocked up (partly with a vent) due to a threat of burglary. The decorative keystone lintel over the windows is precisely that: decorative, and etched into

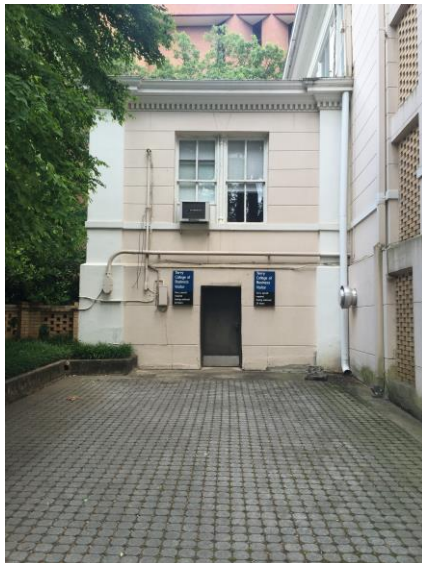
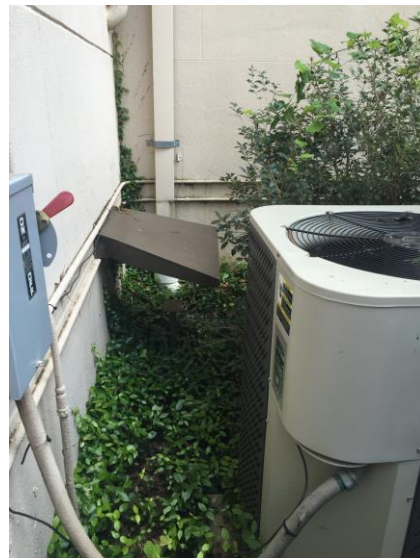
Denmark Hall's west side features four bays on the second floor, all of which have the characteristic two-over-two lights in a double-hung sash. Three of the four open into offices for professors. As with the rest of the original part of Denmark Hall, this side of the building features a decorative cornice that meets the contemporary standing-seam roof. Similar to other sides of Denmark Hall, the west side has an excess of superfluous equipment (pipes, wires, air conditioning units) that is non-functional and serves no purpose to the building.

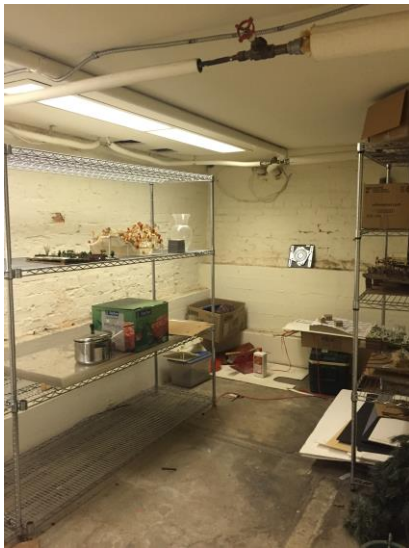
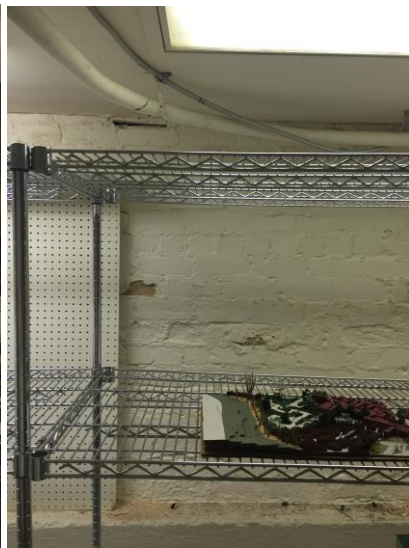
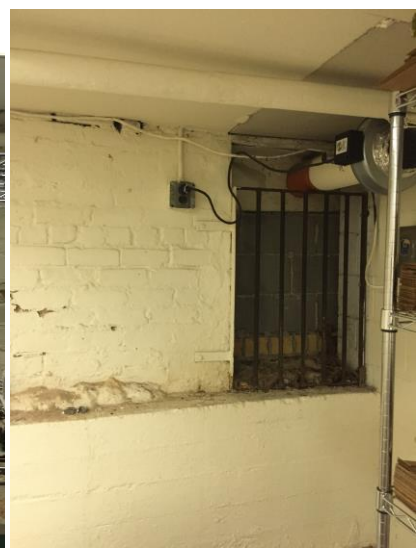
0022C is yet another storage room with barely anything in it. It has wall-to-wall shelving. The floor is concrete, the walls are painted concrete block and brick, and a drywall ceiling. Said ceiling is 7'0" at height.

The walls have severe deterioration, efflorescence and spalling in the concrete block sub-foundation. The ceiling has mild damp, but in fair condition.

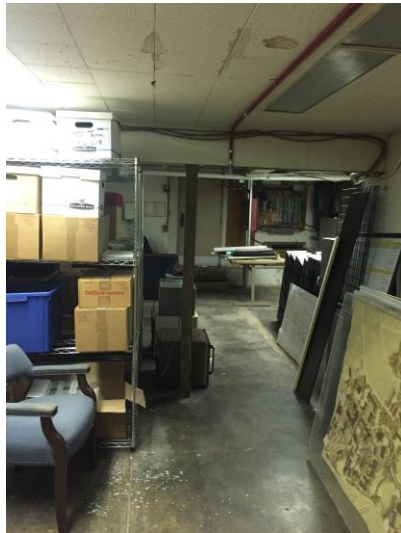
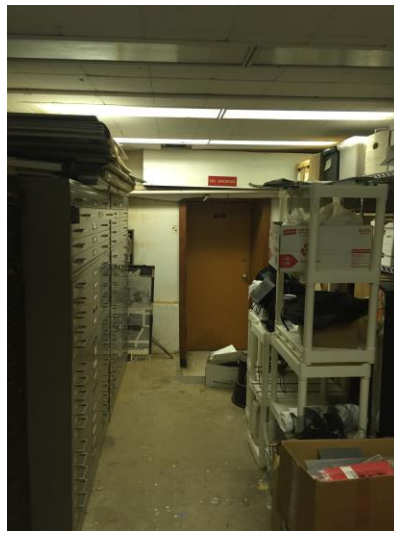
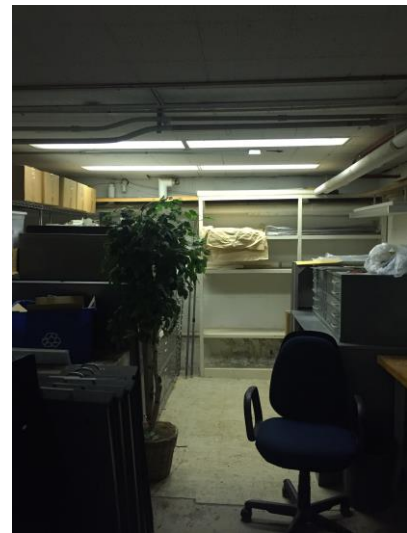
0022D is a former model-making shop, now utilized as excess storage for the Landscape Architecture program. With an irregular shape, it is one of the largest rooms in Denmark Hall. Its walls are brick and concrete block, with concrete flooring, and an acoustic tile ceiling.

The brick in the north wall is immensely deteriorated; almost dust, while the northeast corner of the ceiling is saturated with water penetration. The flooring is fair and the acoustic tiles have been tremendously damaged by moisture. It is possible there is a leak somewhere in the ceiling. Much of the equipment in this room is non-functional, and the bricks on the north wall are spalling. Salt crystals have formed on the mortar.

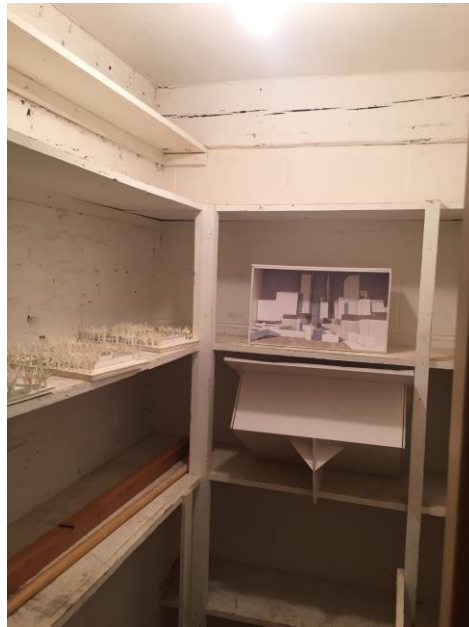
0022F is a storage unit, with concrete flooring, concrete block walls, and a plaster ceiling. It is in good condition.

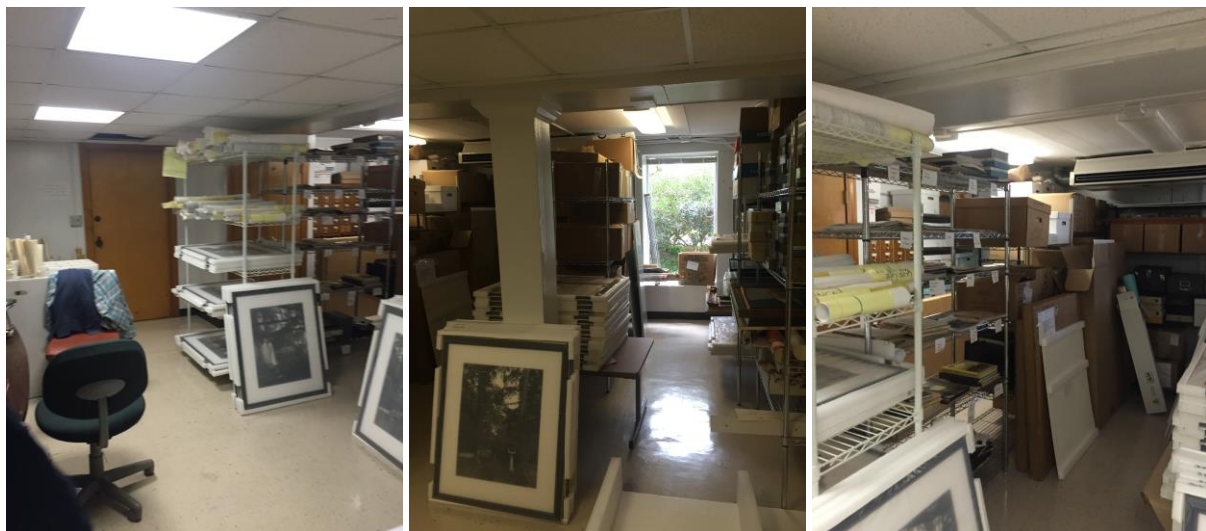
0025 is the Cultural Landscape Lab storage room. It has vinyl tile flooring, drywall, and a drop ceiling. It is in good condition.

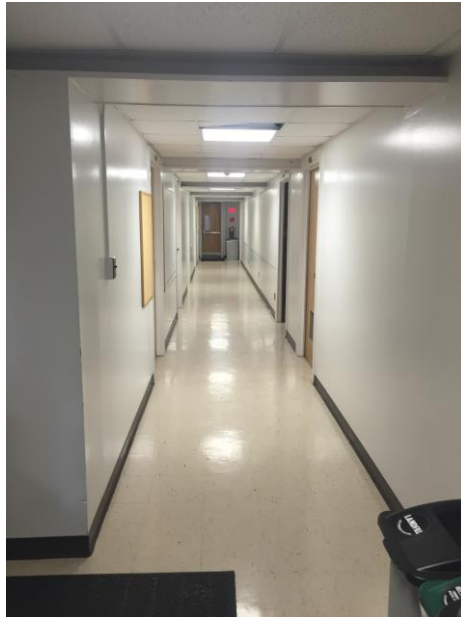
0099A is a hallway running the length of the basement, east to west. It is situated between 0020 and the 0020A-D offices, and it opens to the 0094A stair and a western entrance. The hall has vinyl tile flooring, drywall, and a drop ceiling. It is in good condition.

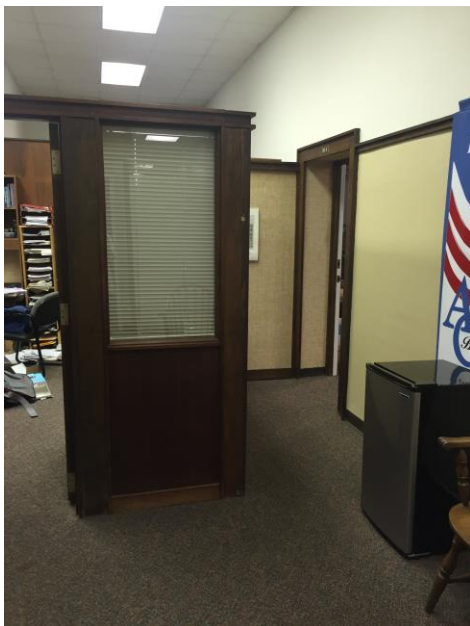
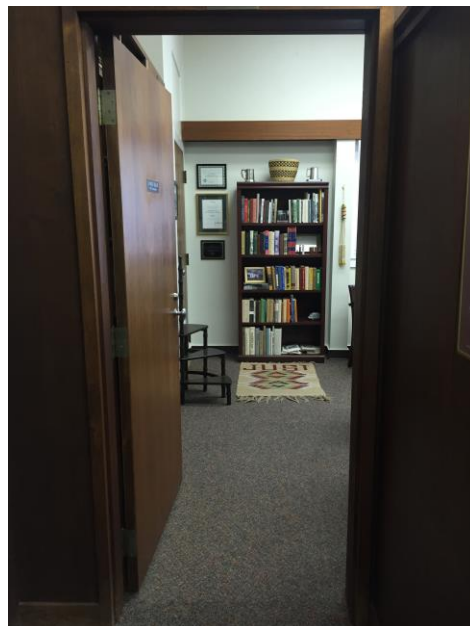
0102 is the vestibule leading to a set of offices. It has carpeting, drywall, and a drop ceiling. It is in fair condition.

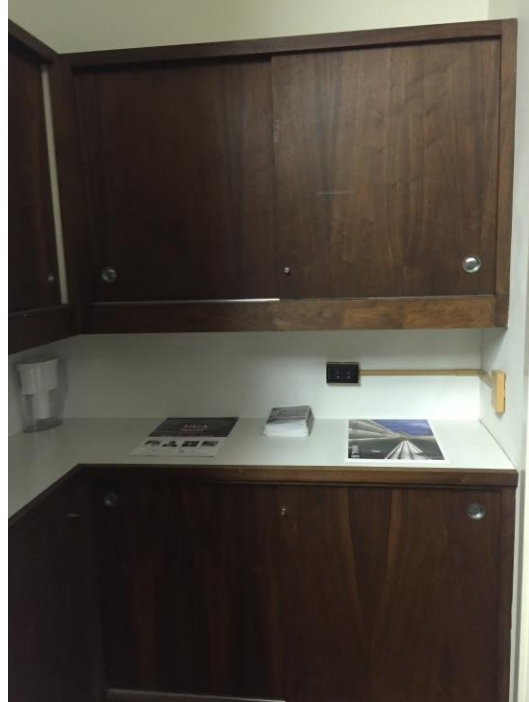
0102A is a service area, mostly consisting of shelving. It has carpeting, drywall, and a drop ceiling. It is in good condition.

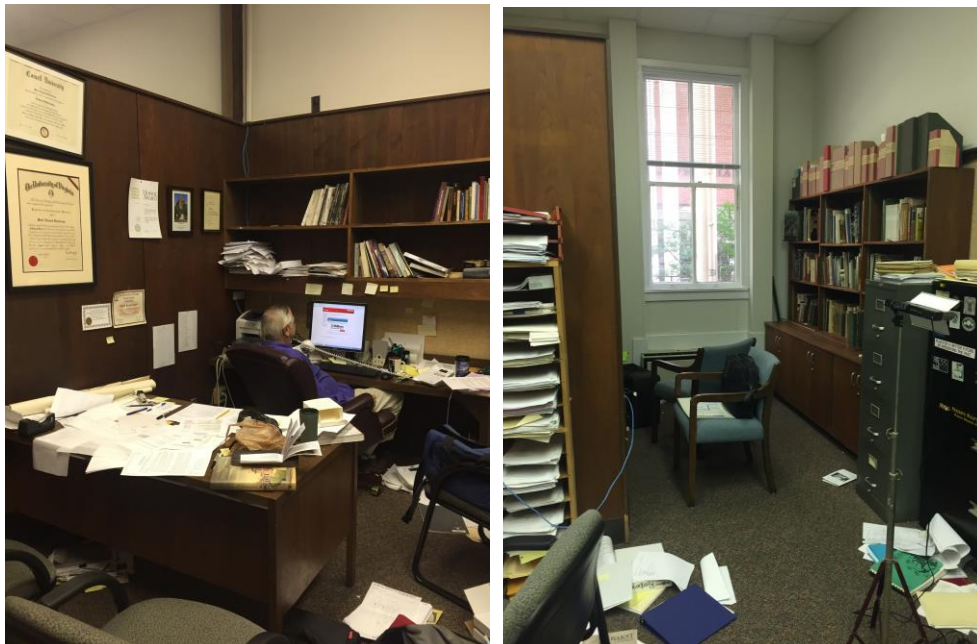
0102B is a large office space with partition walls. It has carpeting, drywall, and a drop ceiling. It is in good condition.

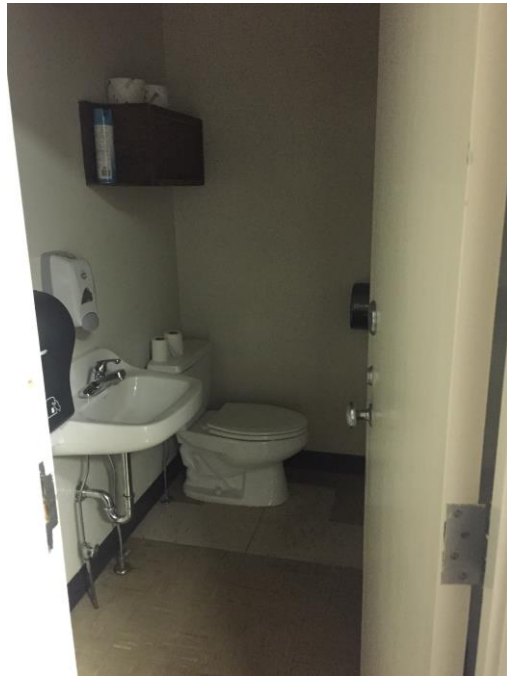
0102R is a small private restroom. It has vinyl tile flooring, concrete block walls, and a drop ceiling. It is in fair condition.

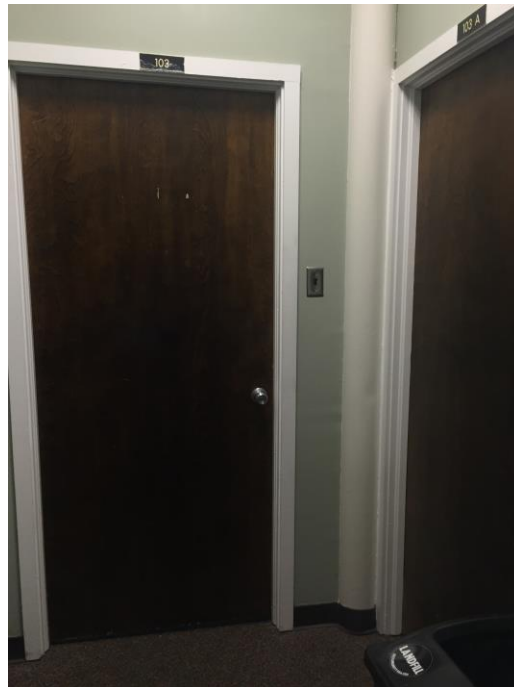
0103 is a vestibule leading to a classroom and which contains a storage room. It has carpeting, drywall, and a drop ceiling. It is in good condition.

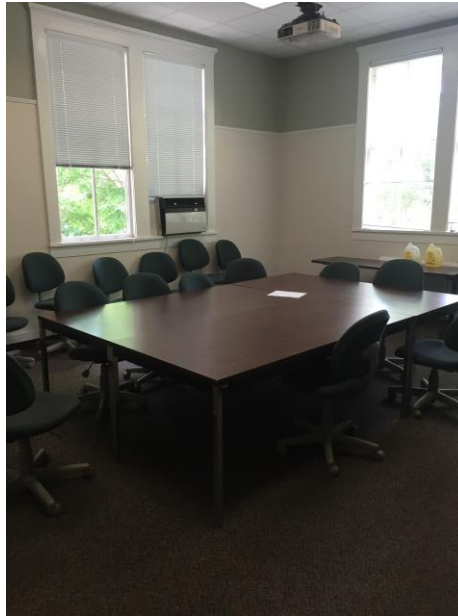
0103B is the first and largest of two classrooms in Denmark. It has carpeting, pin board and drywall, and a drop ceiling. It is in good condition.

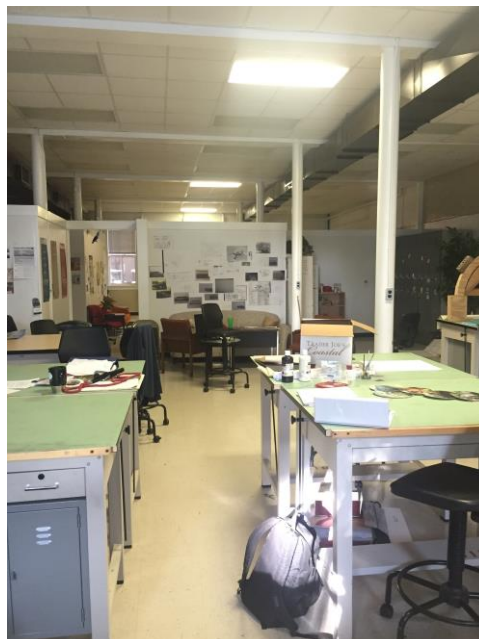
0104 is the large studio space on the first floor. It has vinyl tile flooring, pin board and drywall, partition walls, and a drop ceiling. It is in good condition, but its partition walls make for awkward distribution of natural light, and break up the space necessary for students to properly organize their worktables.

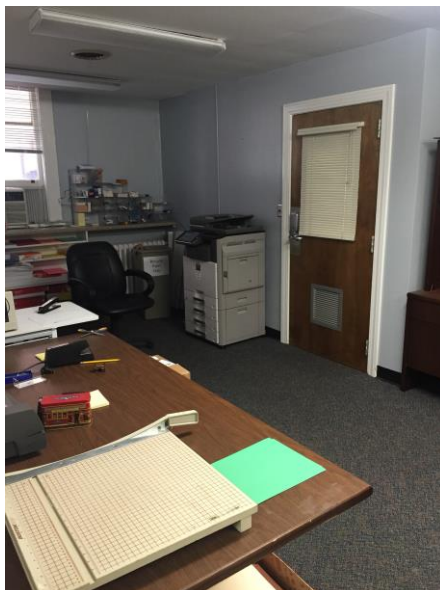
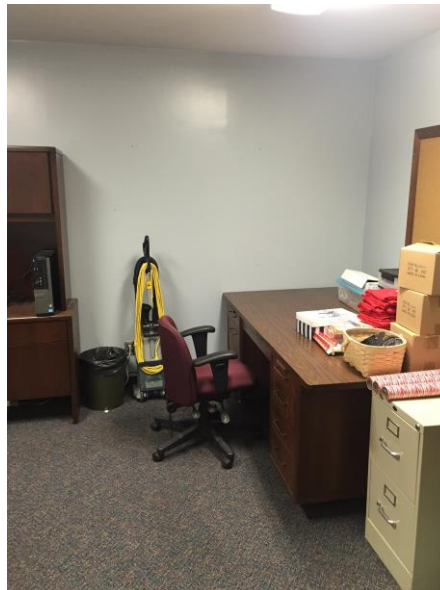
0104B is a copy room connected to the 0101-0102 office complex. It has carpeting, drywall, and a drop ceiling. It is in fair condition.

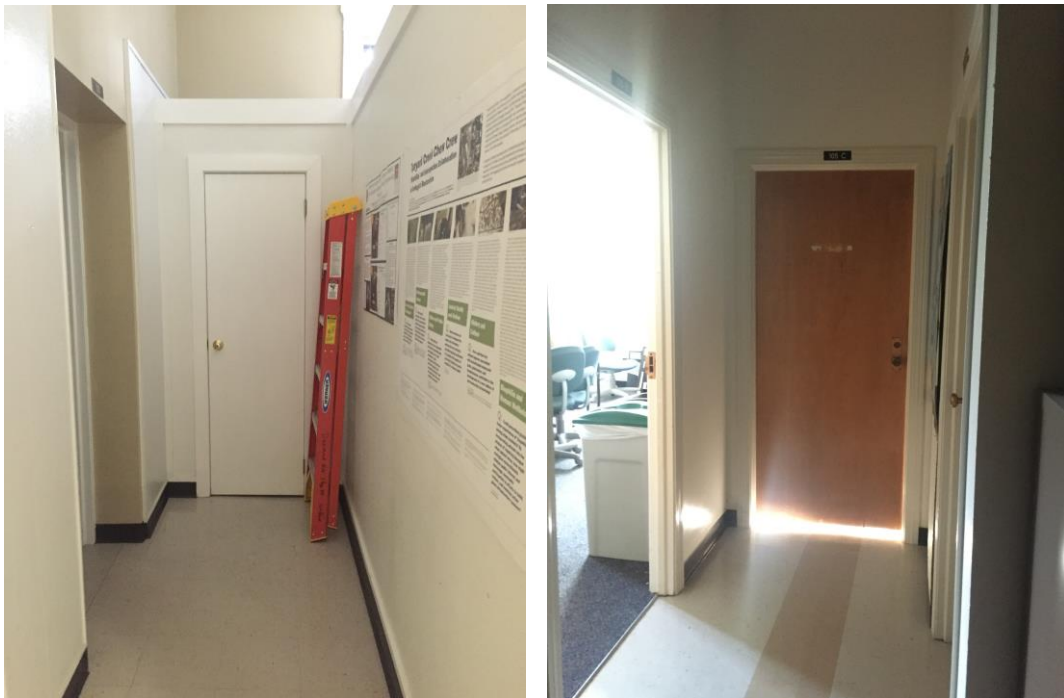
0105 is a hall leading to the back office complex. It has carpeting, drywall, and a drop ceiling. It is in fair condition.

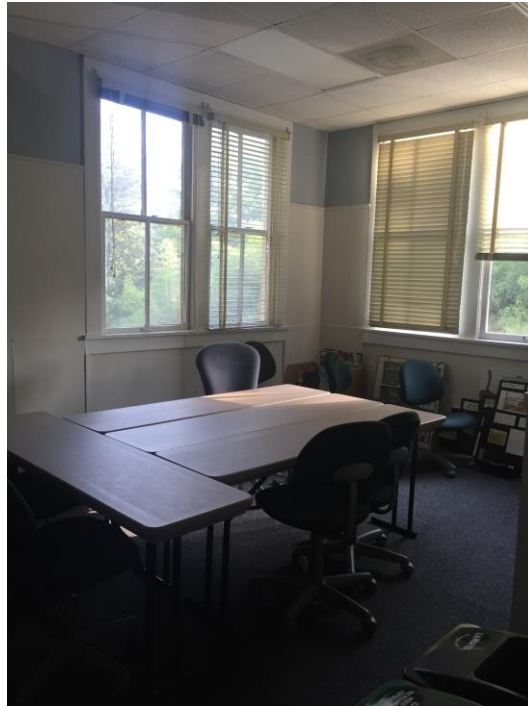
0105B is the only conference room in Denmark Hall, that is ironically not being used as conference space. Or for anything. Smaller than 0103B, it has carpeting, drywall, and a drop ceiling. It is in good condition.

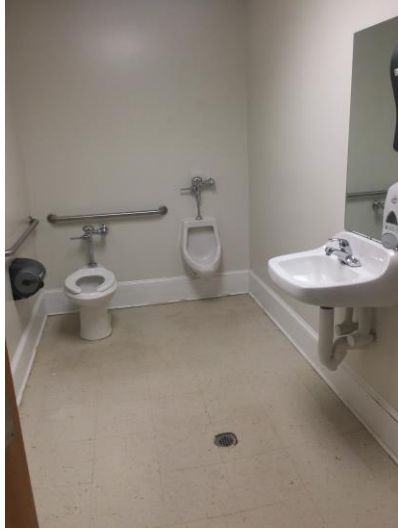
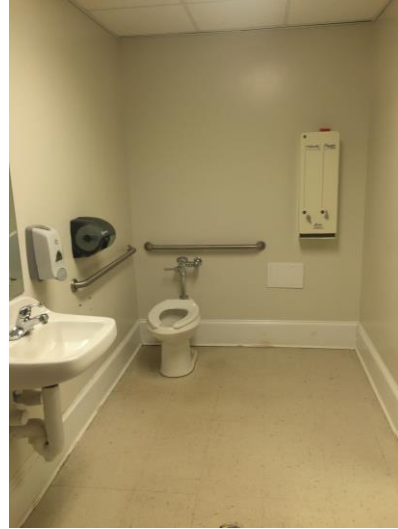
0106B mirrors 106A— it is one of five unisex restrooms. It has vinyl tile flooring, drywall, and a drop ceiling. It is good condition.

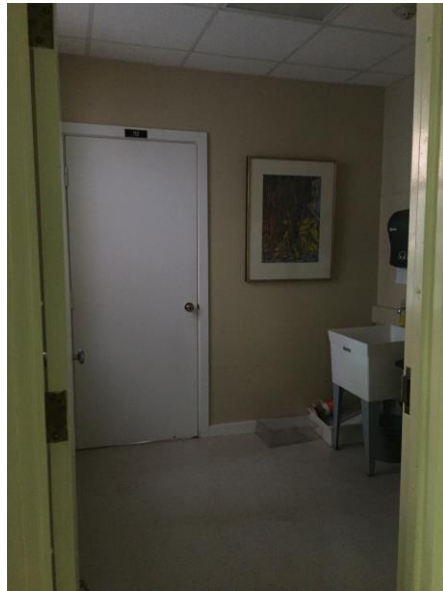
0110A – Vestibule

0110A is a vestibule leading to 0110 and containing a wash station. It has vinyl tile flooring, drywall and concrete walls, and a drop ceiling. It is in fair condition, but reeks of mildew.

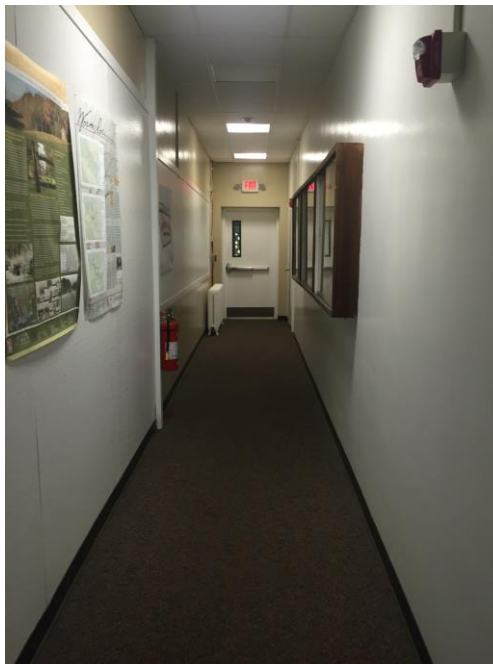
0199A is a hall extending east to west in the front half of Denmark. It has carpet flooring, drywall, and a drop ceiling. It is in fair condition.

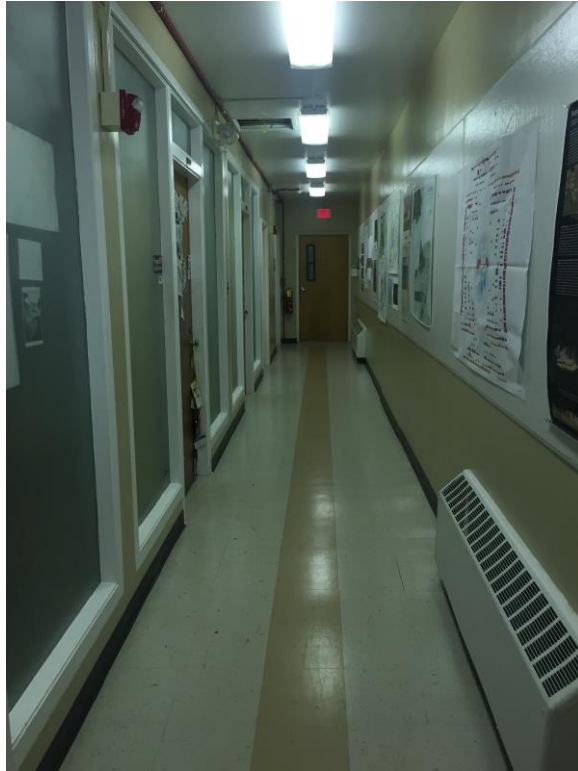
0199B is another hall extending east to west in the back half of Denmark. Three offices and two restrooms open to the hall. It has vinyl tile flooring, drywall and concrete walls, and a drop ceiling. It is in fair condition.

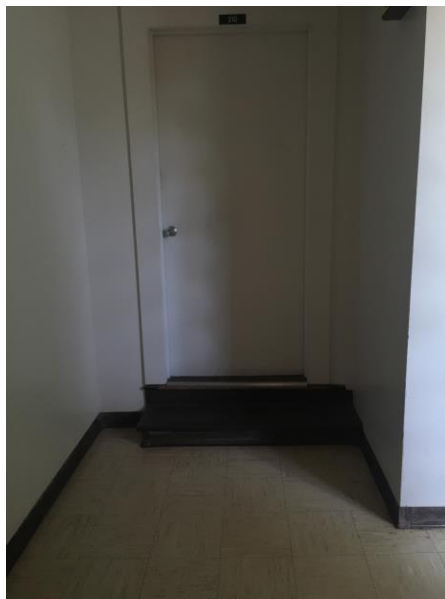
0202 is the second of eight office spaces on the second floor. The current occupant created an opening between its south wall and **0203**'s north wall, forming a passageway and making a larger office. It has carpeting, drywall, and acoustic tile ceiling. It is in good condition.

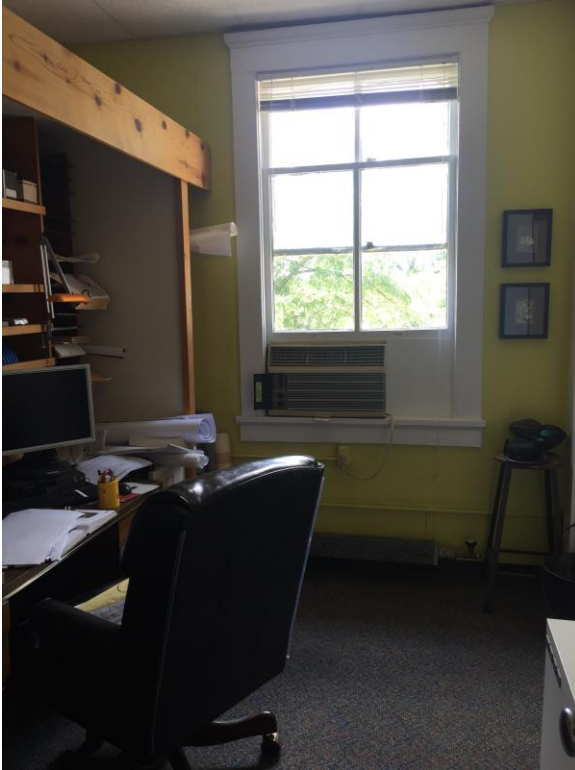
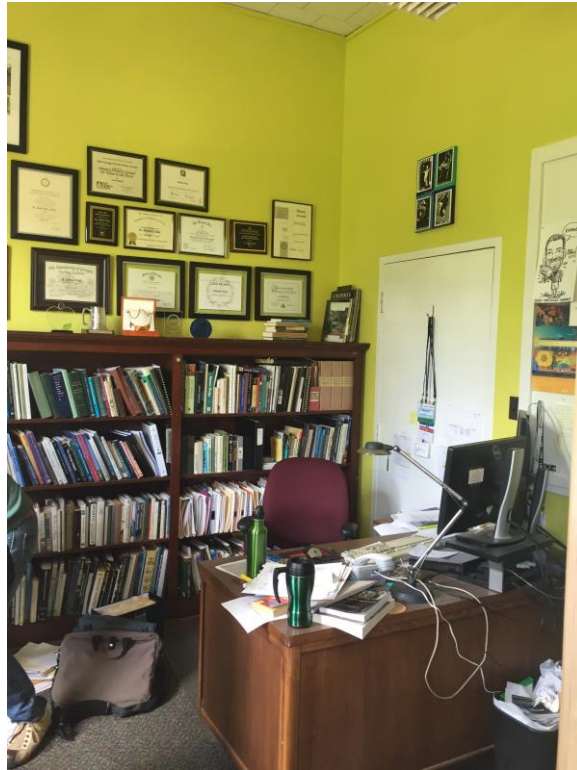
0203 is the third of eight office spaces on the second floor. It was recently combined into one office space with **0202** by the current occupant (see above). It has carpeting, drywall, and a drop ceiling. It is in good condition.

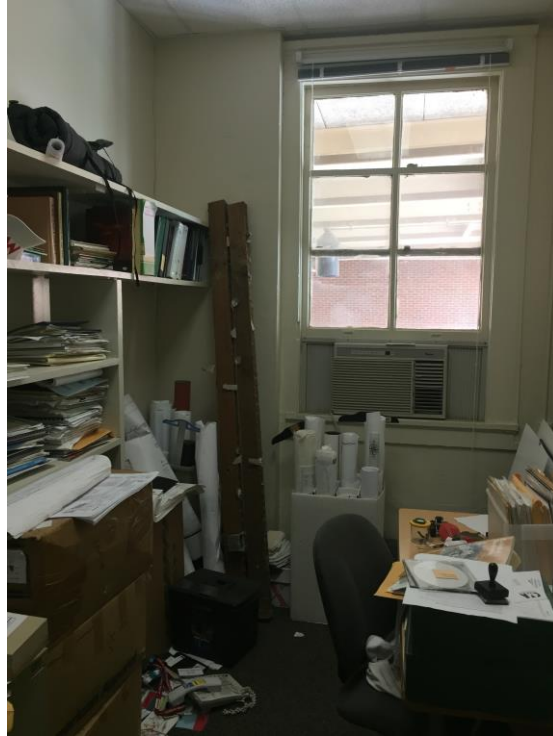
0206 is the sixth of eight office spaces on the second floor. It has carpeting, drywall, and a drop ceiling. It is in fair condition.

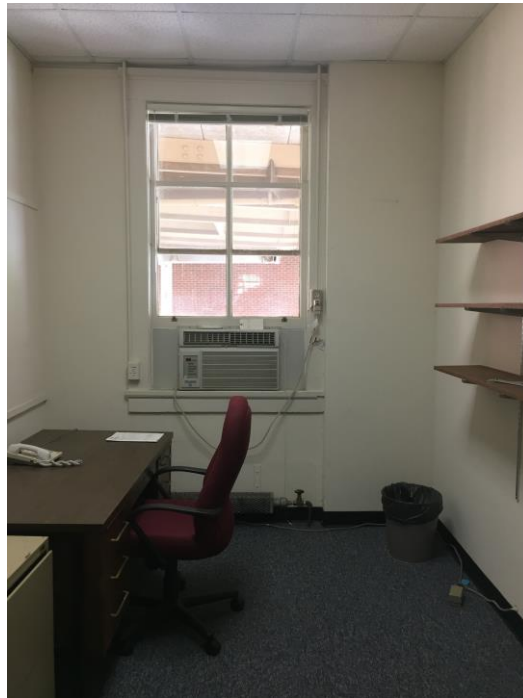
0209 is an exterior storage room. Its only exit is to the 210A lounge area, rather than to the studio like the remaining offices. It has carpeting, concrete and drywall, and a drop ceiling. It is in fair condition.

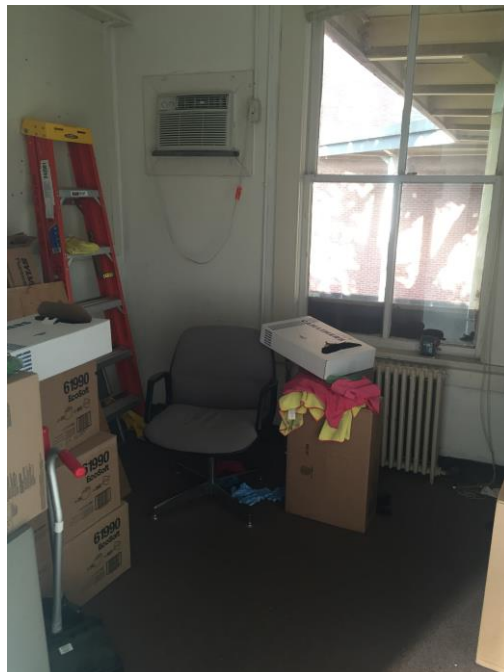
0210A is a lounge area taking up a third of the old, converted covered porch, and it leads to the conference room. It has vinyl tile flooring, concrete, pin board, and window walls, and acoustic tile ceiling. It is in fair condition.

Renovations include removing Rooms 0210, 0210A, and 0210B to open this block to the outside, hiding the structural columns inside wooden Doric columns, reinstalling a balustrade along the perimeter of the porch, and regrading and paving the porch to assure proper drainage. Since this area was originally a porch, the structure below should be sufficient to support a new one. There is sufficient office space elsewhere to relocate the faculty member currently in 0210.

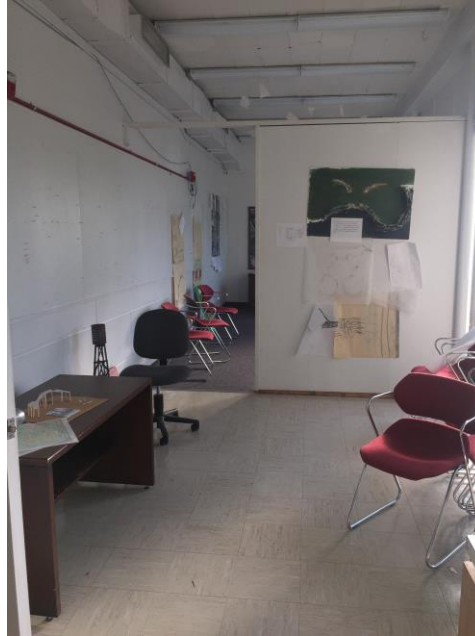
0210B is a conference room that takes up the middle third of the old, converted covered porch. It has carpeting, concrete, pin board, and window walls, and acoustic tile ceiling. It is in fair condition.

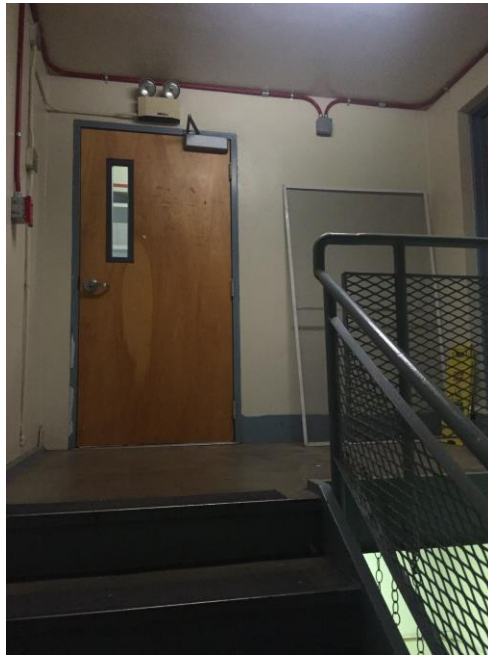
0298B is the south stairway, continuing from the basement. Like the previous floors, it has concrete flooring, concrete block and brick walls, and concrete ceiling. It is in fair condition.
