Outbuilding of the Wright House

Lincolnton, Georgia

HISTORIC STRUCTURE REPORT

Prepared by: Mark Reinberger, Tim Brown
and Caitlyn McSwigan
University of Georgia, 2020

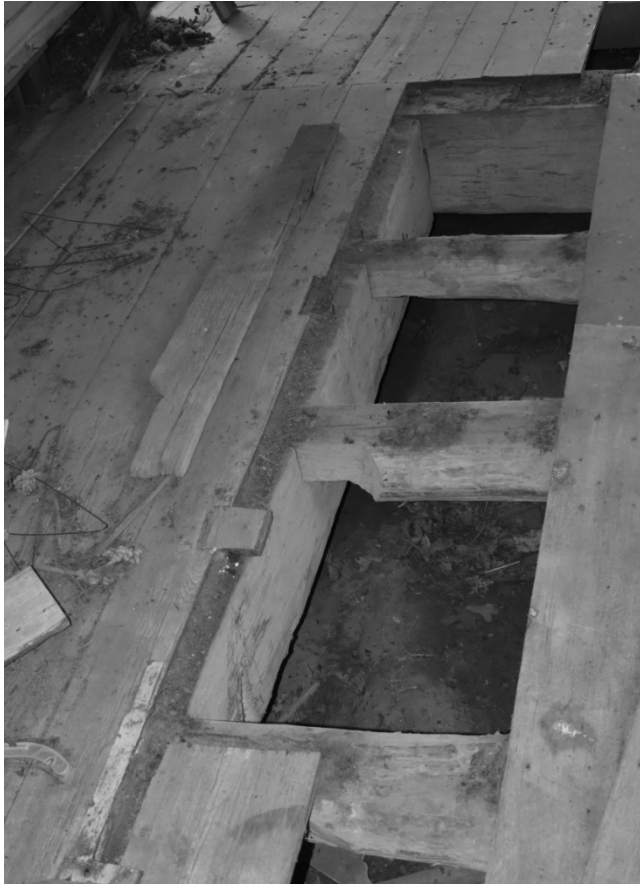
Figure 5: typical floor joists seen from above

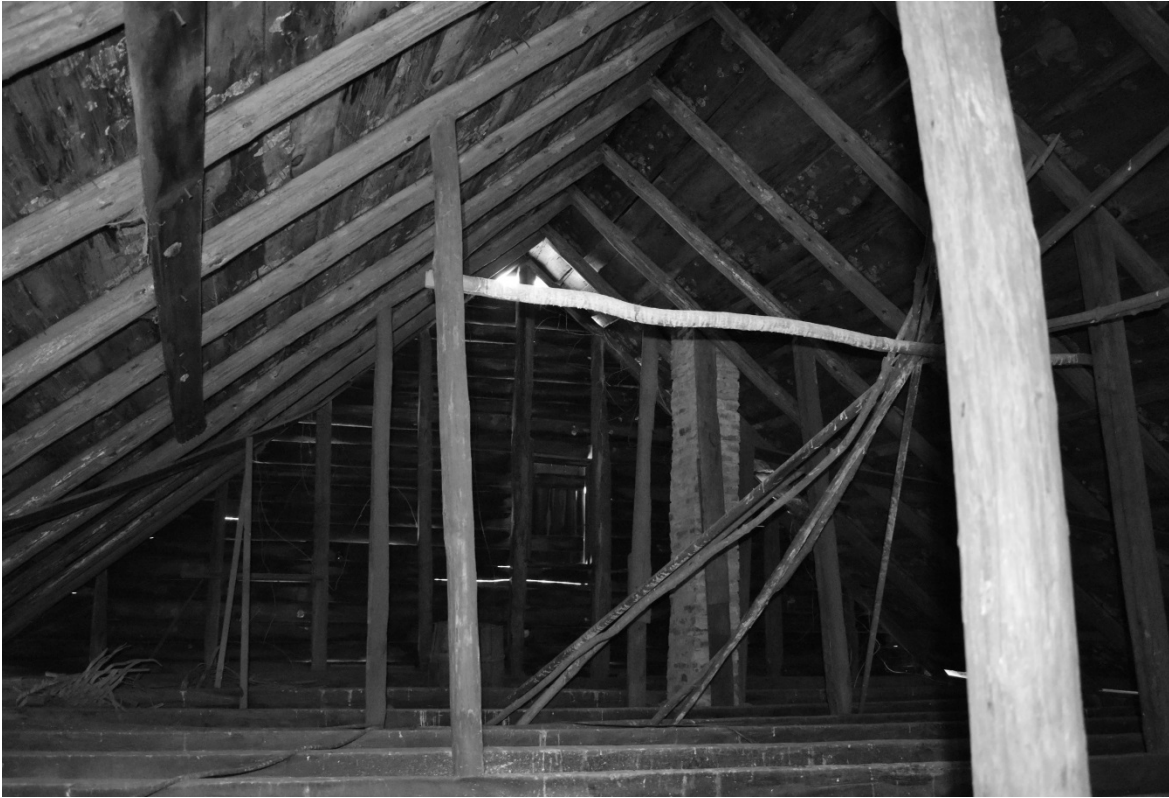
Figure 10: Attic

In addition to the bottom of the frame, some repairs will be necessary in the attic. Several ceiling joists are rotted and in need of sistering for continued stability, especially near the end of the building with the fireplace. There are both old and current leaks in this area, and there have been leaks around both stove chimneys. For both structural liability and historical accuracy it is recommended that both stove chimneys be removed. The rest of the attic frame appears sound, though some roof lath may need replacement when the roof is restored with wood shingles.

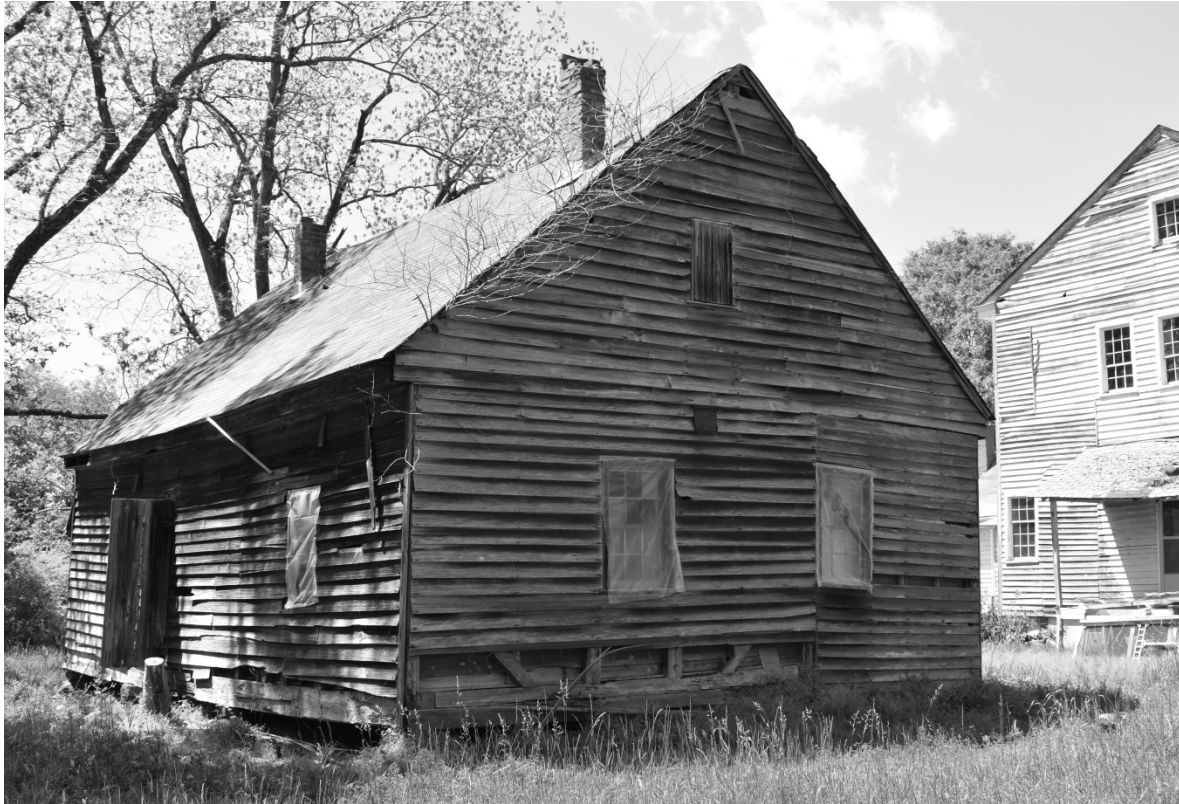
Figure 14: from southeast

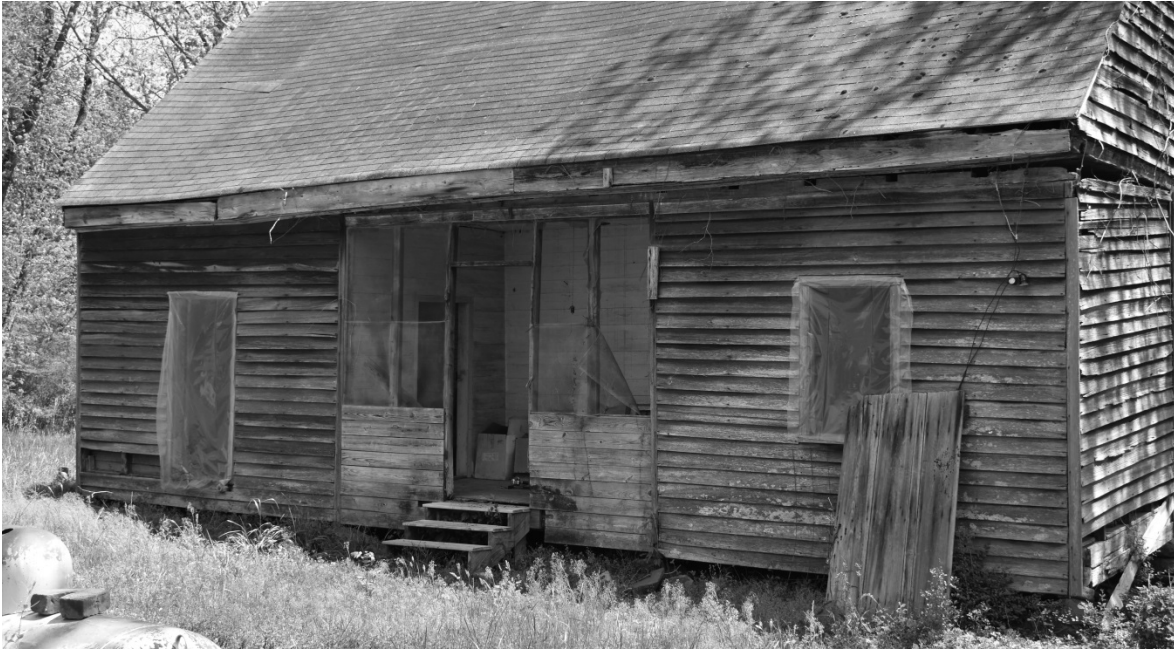
Figure 15: North Front

The exterior doors will be dealt with in the room-by-room descriptions below. None of the windows of the building are original; very likely it had none, although it may have had a window opening in the slave quarters at the east end (Room 104); more investigation needs to be done on the side and rear wall during restoration. All window sash in the structure date from the 20th century: two windows in Room 104, both wood and six-over-six double-hung; one in Room 105, made of two reused and randomly placed six-light sash; and one in Room 101 beside the fireplace, again a random reused sash. There is a window opening to the attic in the east gable, the opening closed by a shutter; this would have given light and ventilation in that space. A simple set of recently-built wooden steps rises at the center of the front, but none at the rear.

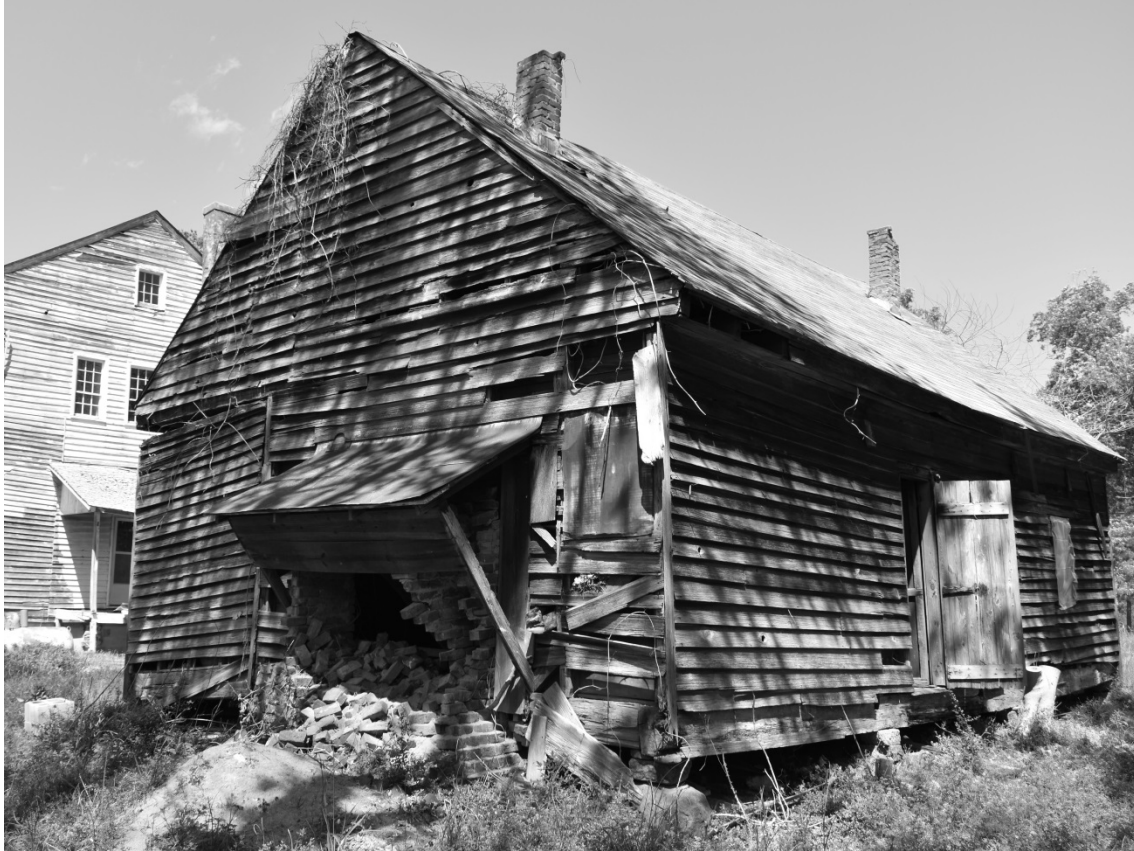
Two brick square stove chimneys pierce the roof near the center and east end, on the rear slope; they have fairly crude metal flashings. The original fireplace chimney is long gone, its remains covered with a sloping wood hood. The base of the fireplace is stepped out as it drops below hearth level, with seven steps, a typical treatment for the antebellum period.

Figure 17: from southwest

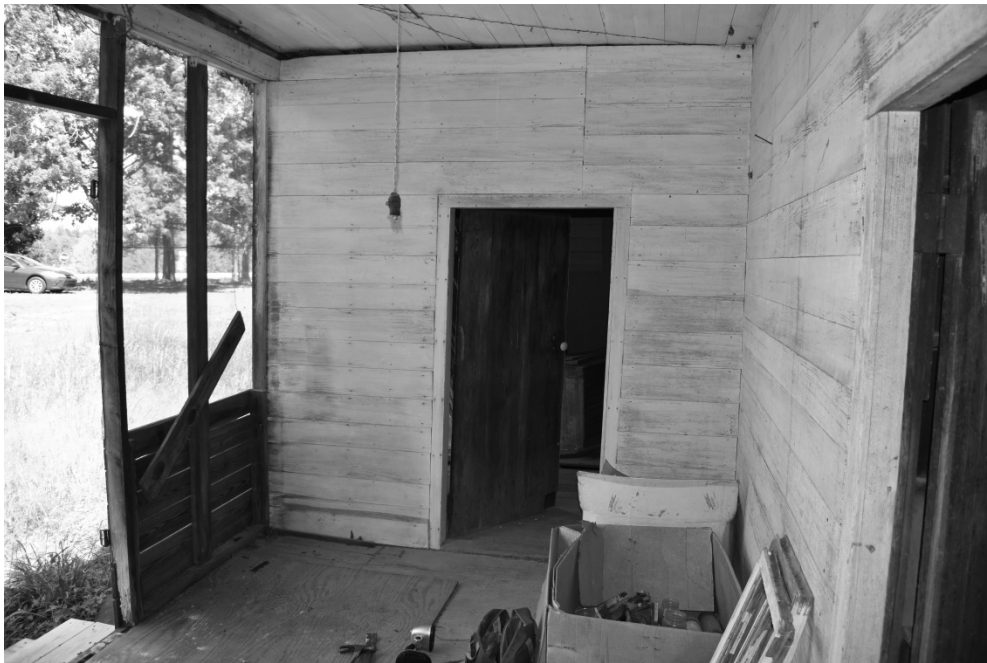
This space is the remnant of the original continuous front porch. Most of the flooring, the ceiling, and the wall with the kitchen have their original finishes, which match those described above in Room 102: Pantry. The wall on the east end of the space, with Room 104, is covered with 5”-6” wide butted boards, painted, and attached with cut nails different from those fastening the original boards of the wall with 101. Those boards on the wall with 104 show evidence of having been removed, reworked and refastened. Perhaps they formed part of the wall surface between the original porch and slave quarters. This wall also received a base board with molded cap. The front wall, open to the outside, consists of modern 2 x 4s and 3 x 4s that hold floor to ceiling screening. The screen door is missing.

Figure 25: Room 103, looking east

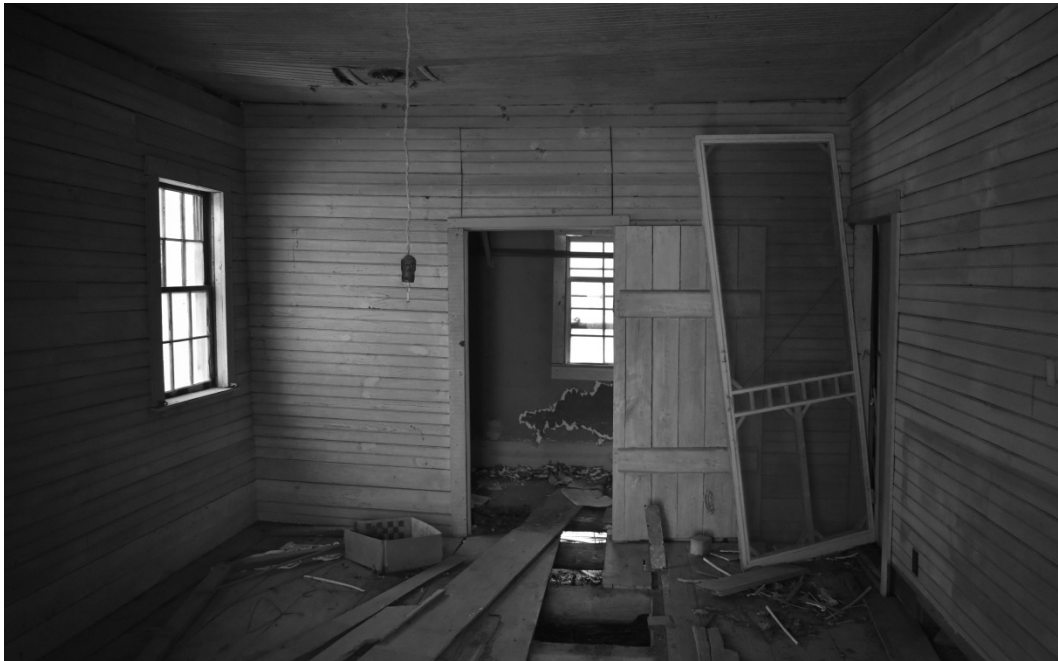
Figure 26: Room 104, looking south

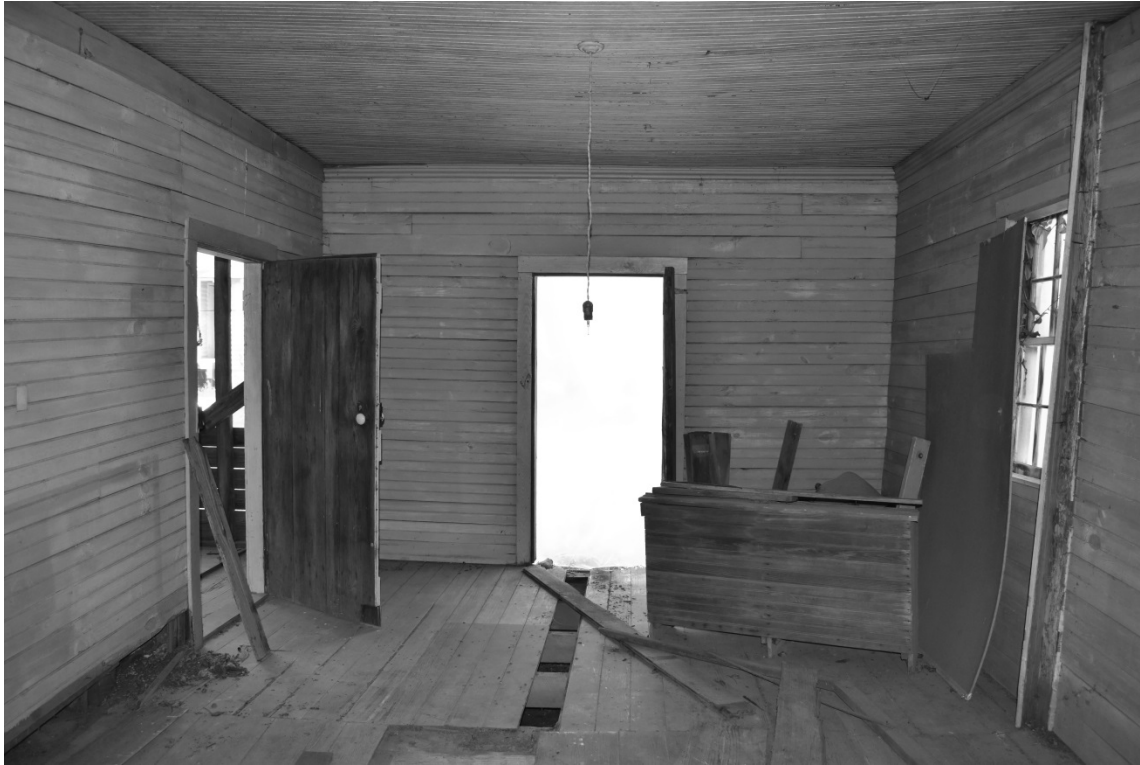
The two windows in the side wall are from the 20th century, though the opening in the original side wall could be original. Neither interior nor exterior siding was removed to investigate this. The question of original openings into this space is an important one if restoration is to be attempted. Clearly there was a door to the porch, but what other openings were present is unclear. There is no sign of an exterior door to the side or in the rear wall (in Room 105). Window and door casings are simple 1x4s boards.

Figure 27: Room 104, looking north

- Remove the root system and other plant growth that is invading the structure and further exacerbating foundation problems.
- Remove pile of dirt on south wall that is funneling water toward the building.
- Restore cedar shingles on the roof.
- Restore front porch.
- Remove window in Room 105; replace side window in Room 104 with shuttered opening.

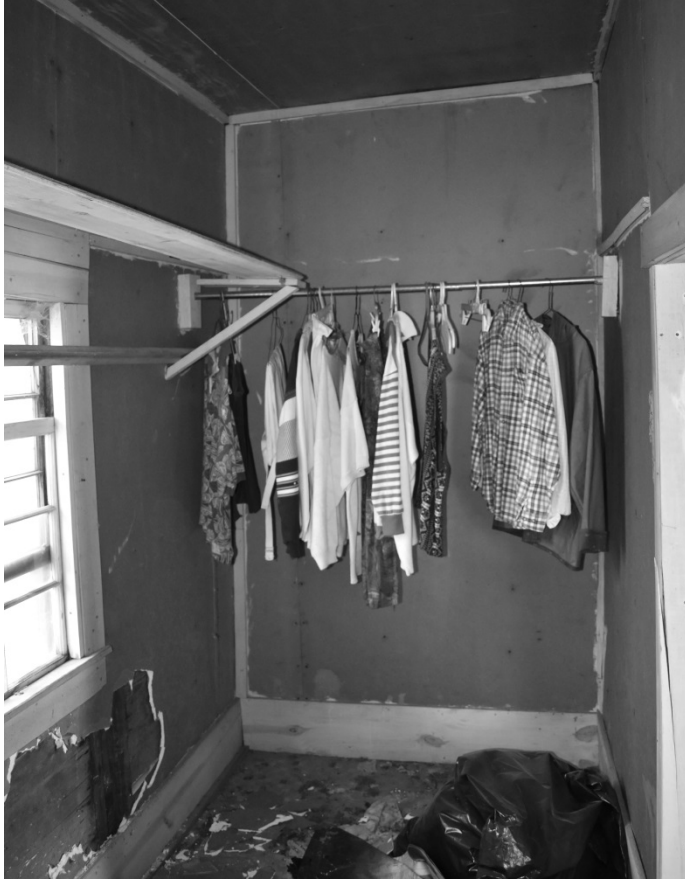
This room was divided off from 104 fairly late in the building's history. The floor is the same as Room 104. Newspapers from the 1950s were scattered on the floor, along with remnants of linoleum. The walls and ceiling are now covered with unpainted 3/8" thick drywall, probably the latest change to the building. Where this was removed from the rear wall the same boards as in the kitchen walls (presumably original) were found. The rear wall contains a fairly modern and very narrow window, the opening of which is cased in 1x4s. Above it runs a shelf supported on diagonal brackets.

Figure 28: Room 105, looking west
