Shields-Ethridge Heritage Farm

Historic Structures Report
Building Materials Conservation Class 2009
Master of Historic Preservation Students
The University of Georgia

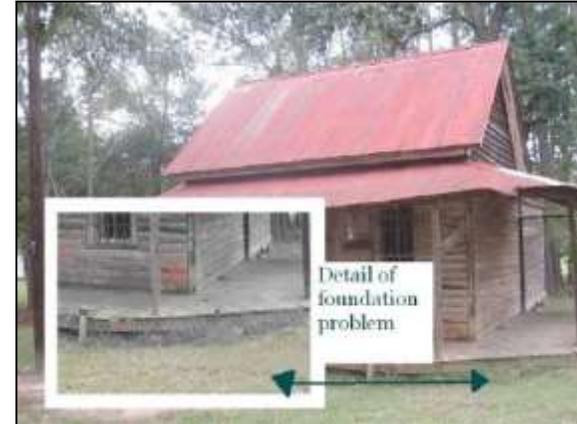
Over time, the east side of the original building has settled significantly. This settling impacts the overall stability of the building

because it leads to problems in the framing. The settling has caused the sill around the perimeter to rotate and slip off the frame on the west side of the building. As the east foundation settled, the structural support on the west side has been compromised and is currently a safety hazard. While an attempt was made to repair the problem, this section is not currently stable. The southern half of the crawl space was not accessible and foundation/subfloor problems could not be obtained, but it can be assumed that there are similar problems with the framing so close to the ground.

Figure A-6: Foundation problem

- The sill on the west side of the building is not currently bearing on any support system. The sill and joists needs to be stabilized on blocks until the east side foundation can be addressed. This is an immediate threat to the structure.

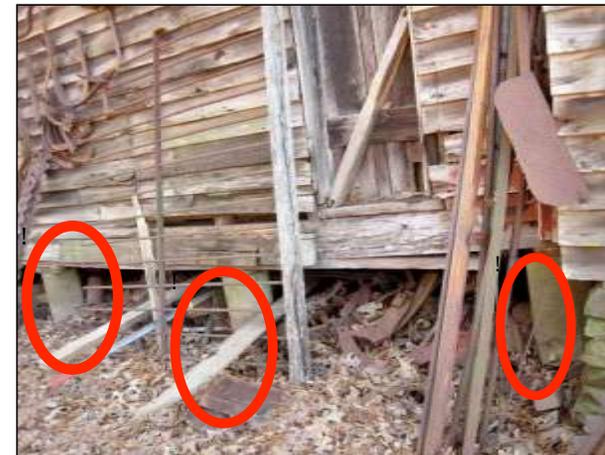
The commissary is raised on a pier foundation with no footings, with most piers made of dry laid stone. Along the west side, four have been replaced with poured, tubular concrete piers, indicating changes in the building's evolution. Some stacked brick is also present. Piles of stone near the poured concrete tubes are likely the stone from the original pier. Brick piers were used as interior foundation supports and are in good condition because they have been protected from the weather.

Figure A-7: Poured tubular concrete cribs

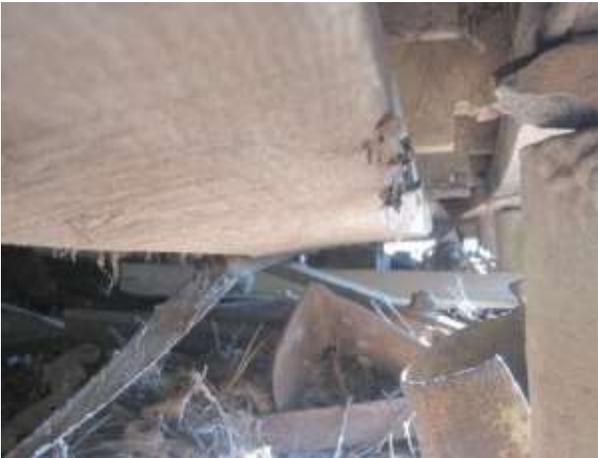
Figure A-8: Sill (west side), slipped off foundation

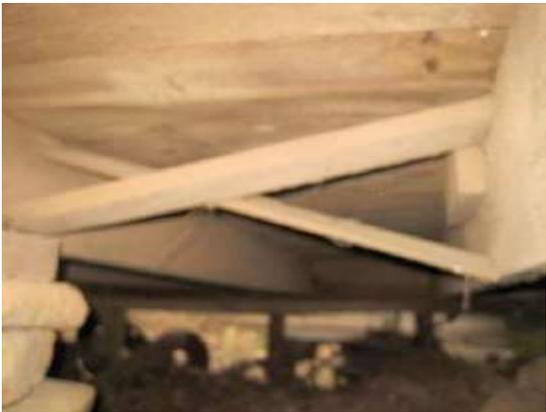
The floor joists span are 2x8 circularly sawn wood planks placed 24" inches on center with a 15' span. According to the joist table with $E = 1,400,000$ and a live load of 40 psi, the maximum span should be 10'10". Given the size, spacing, and span of the joists, the current sub floor and foundation is not sufficient. The sill is 6x8. The subfloor on the original/rear section of the building, is circularly sawn 1x6s running perpendicular to the joists. At mid span along the joists are 1x4 X-bridging, which adds structural reinforcement to the floor.

Figure A-9: X-Bridging sub-floor

- A proper girder should be constructed and installed. This will cut the span in half and provide appropriate structural support.
- The grading and slope of the land around the commissary needs immediate attention because the water and moisture is causing problems to the foundation, wood clapboards, etc. A series of foundation drains need to be installed around the entire building, which would move water away from the site.

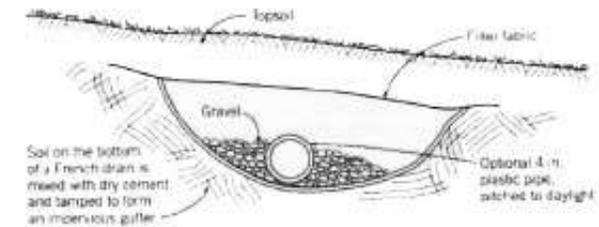
Figure A-10: French Drain example

French Drain

French drains collect and transport water. Sometimes the discharge is into a drywell rather than above ground.

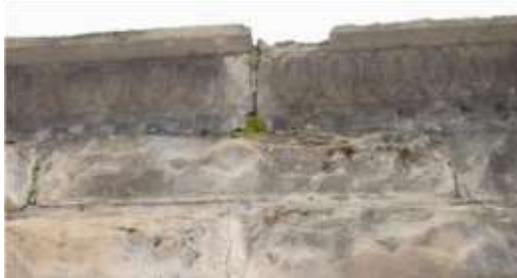
Figure C-7: Egg and dart cast parapet cap with missing section

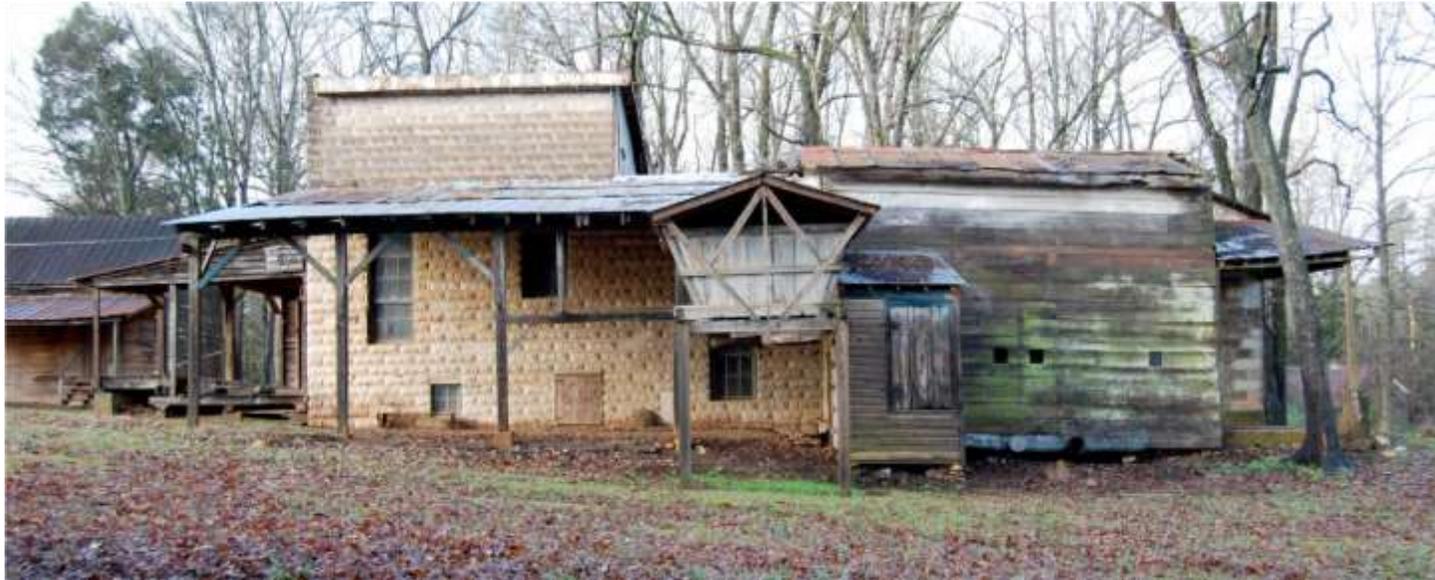
Figure C-11: Cotton Gin east elevation. Note the shed structure, to the right in this image , which is shielding the weight station.

hollow concrete block resting on a concrete foundation wall (Figure C-11). There are concrete lintels over each of the wooden windows in varying states of decay, with some of the concrete completely spalled off exposing the wood lintel beyond. A crack that mimics that on the west elevation is located between the main building and the north building extension. It, too, is approximately 1” wide at the foundation and opens up to approximately 4” at the roofline.

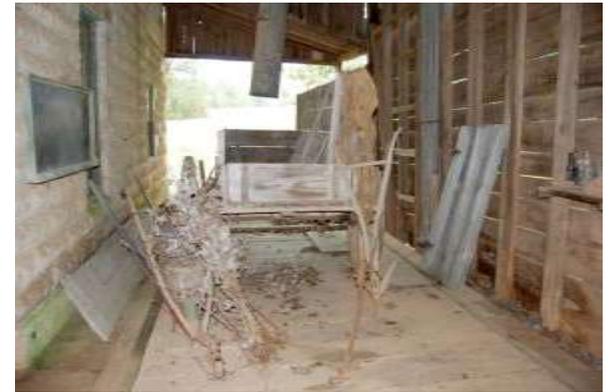
At the wagon scale, there is a wall that supports the east side of the porch roof that is constructed of 6" x 6" posts located at each end of the wall (Figure C-12). 2" x 6" vertical studs spaced at 24" on center are located between these 6" x 6" posts. These were all originally resting on a wood sill which has since largely rotted away. Only a small piece of the sill located on the southern end of the wall still exists. Because of the deterioration of the sill, the ends of the vertical studs are now generally resting on the ground, are wicking water, which in turn is saturating the lower portion of the siding, causing fungal growth to appear on the wall. Additionally, the north end of the wall (where the sill has completely disintegrated) has sunk, causing the siding boards to slope downwards from south to north. As this wall has dropped, it has pulled the roofing such that it is now pitched at an odd angle.

Figure C-12: Weigh station with wall supporting porch roof to the right in this image

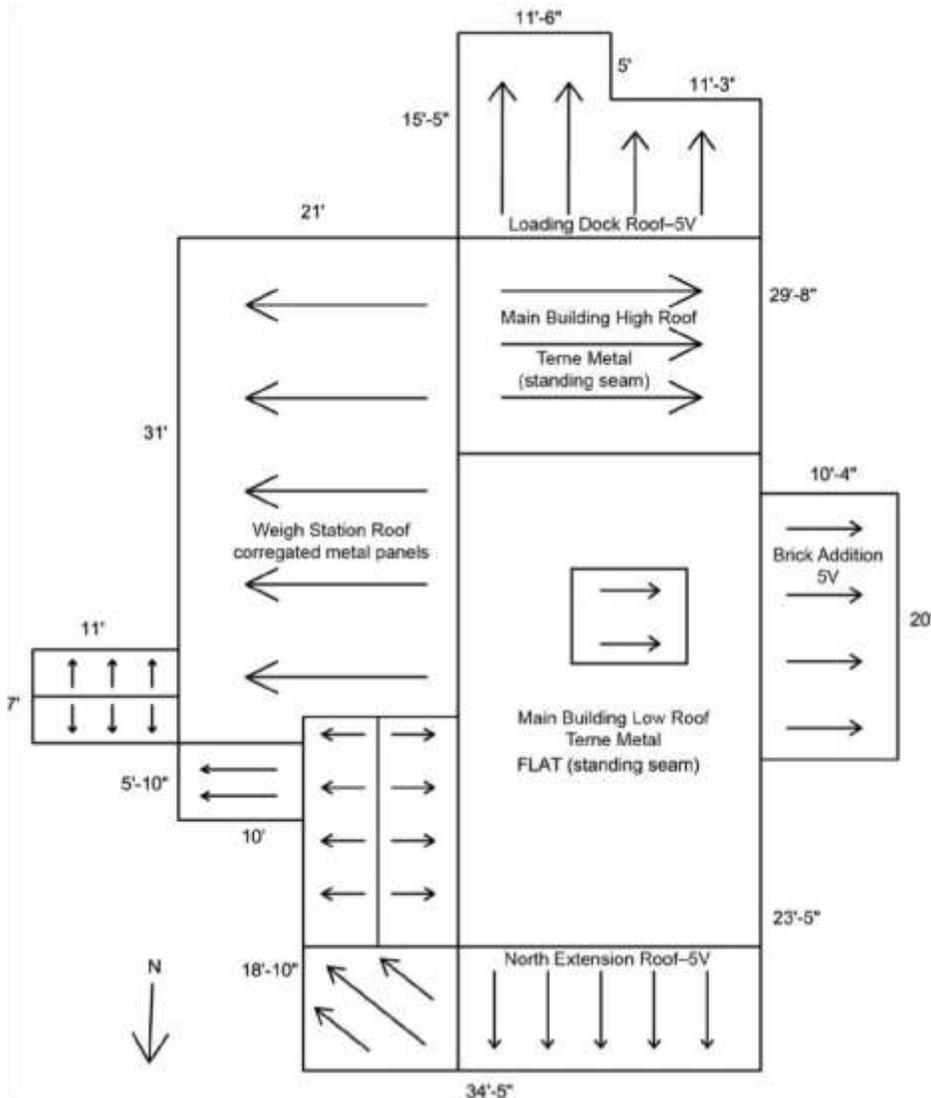
Figure C-13: The Cotton Gin-Roof Plan

The roof is not formed by a continuous plane, but has many elevations (Figure C-13). All are covered with either standing seam terne metal or five-V metal panels. All are in dire need of basic maintenance and cleaning, having accumulated a multitude of leaves, dirt and debris. In some cases, the accumulation is sufficient to have allowed vegetative growth to begin. There are numerous trees located in close proximity to the Gin that drop leaves, walnuts, branches, and other organic matter onto the roof, exacerbating the problem. There is a significant amount of rust evident on all of the roofing surfaces as well. Additionally, with the exception of the terne metal roof areas that have no visible mechanical fasteners, all other areas of roofing have been attached to the substrate with face nails. In most cases, the nails have either popped up or the rubber washer has deteriorated providing an opening susceptible to water infiltration. There is a significant amount of water infiltration into the building from many of these nail holes, from failing metal roof seams, as well as from improperly flashed transitions between roof planes.

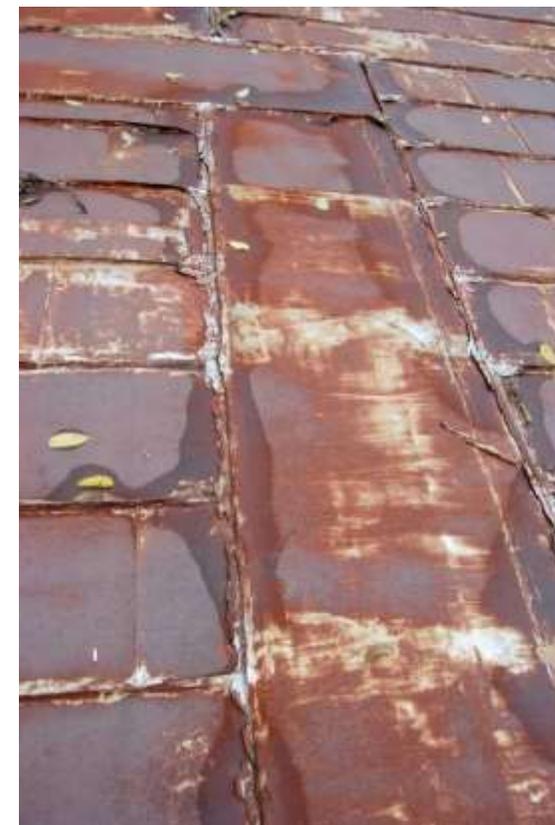
The highest-level roof is a single slope constructed of standing seam terne metal and located on the southern most section of the building (Figure C-14). It slopes shallowly, with the west side being the higher elevation and sloping towards the east at a uniform rate. The roof metal itself shows evidence of having been patched in an "L" configuration and the intersection of the original metal and the patches have been sealed with what appears to be caulk and/or an aluminized coating that has exceeded its life expectancy and is peeling off.

Figure C-14: Standing seam terne metal roof with "L" shaped patch

All of the roofing with the exception of that on the east elevation porch shed appears to have surpassed its usable life span and should be replaced in its entirety with a suitable metal roof. Ideally, the roofing would be replaced with a terne-coated stainless steel, similar to the original but not needing paint. Until the roof is replaced, the existing roof should be broom cleaned of debris and loose materials to allow a more complete evaluation of the condition and the extent of the repairs that are needed. Possible repairs could include re-attaching the loose metal pieces and installing roofing screws at all locations where the existing nails are loose or popped out. Additional roof patches are needed at the transitions from one level of roofing to another to insure the watertight integrity of these intersections. The gutters should be replaced with the same type of half-round gutter, and it is recommended that a gutter also be installed on the north end to assist in insuring that future settlement of the soil at the north foundation does not occur.

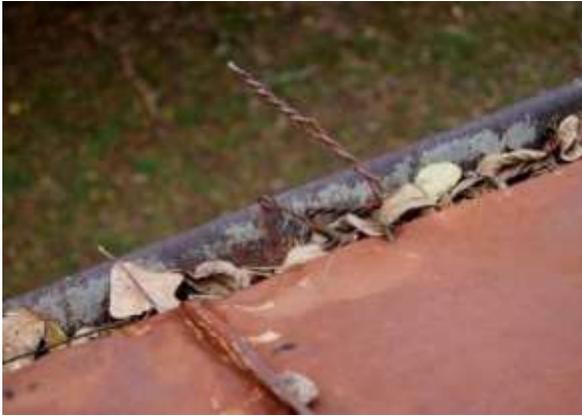
Figure C-15: Half-round gutter remains on the Cotton Gin

On the west side of the roof, the remains of a half-round gutter are visible although not functional, as it is largely deteriorated and what little remains is filled with debris (Figure C-15). The gutter appears to have been attached to the structure with a twisted loop wire. Some of the vertical roof seams located near the gutter have been flattened.

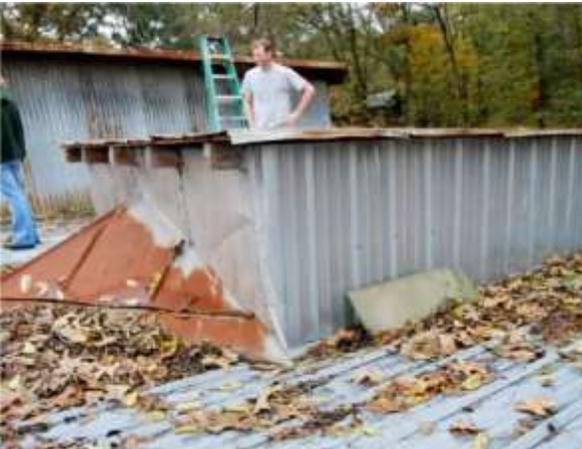
Figure C-16: Mixture of standing-seam terne metal and modern 5V metal surrounding former clerestory

This roof is a single slope covered with a mixture of standing seam terne metal and a more modern five-V metal roof located between the southernmost high roof and the north extension roof (Figure C-16). There is no significant pattern to the variations in metal types, seeming to be a mixture of patches and repairs in random places. The roof slopes shallowly, with the west side being the higher elevation and sloping towards the east at a uniform rate. The terne metal portion of the roofing measures in panels 2'-0" wide by approximately 2'-2" long.

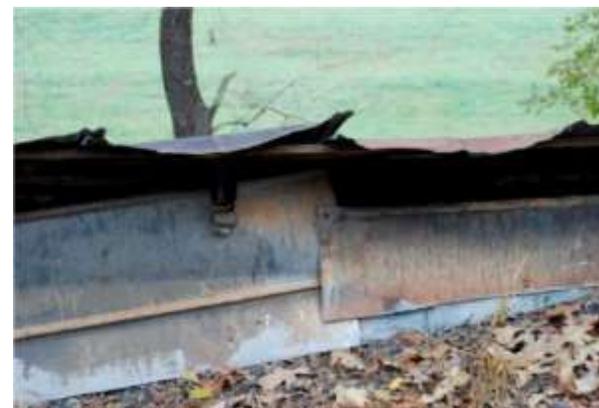
This roof is covered with five-V metal roof panels that slope uniformly from the south down to the north end. The metal decking is installed on spaced lath over 2" x 4" rafters. The condition of this roof, like the others, is poor and in need of replacement.

Figure C-17: North elevation 5V roof with haphazard metal wall panels

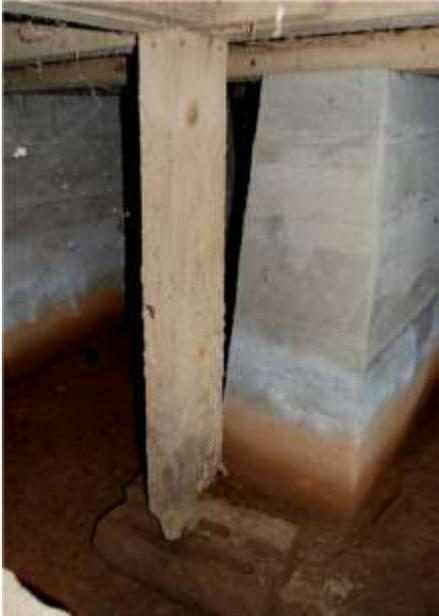
Figure C-18: Battered concrete piers in

crawlspace; also note the extensive insect and water damage to wooden support.

have been rotted and damaged by termites, these should be replaced with either pressure treated lumber or with steel supports. The use of pressure treated lumber, while not historical, would allow the material to remain wood, consistent with the original construction, while the use of steel supports would be more costly, but would provide for a more long-term solution. Because there is already some steel in the building, it would not be introducing a new material; however, it would be uncharacteristic of what would have been done at the time. All of the existing vertical wood supports with the exception of one are already resting on concrete piers, which are in good condition and can remain. One concrete footing will need to be poured for the post that is resting on a concrete block.

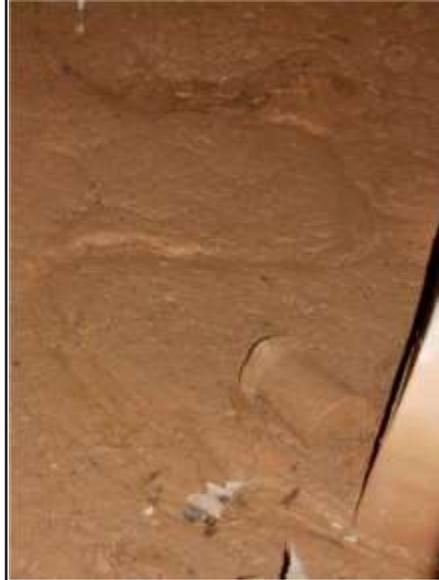
Figure C-19: Water rivets in the crawlspace indicating continued water penetration.
South Loading Dock Roof

The crawl space is taking on a significant amount of water, partly as a result of water seeping through the wall, and partly because of the openings within the space that are not sealed (an access door and a window opening with no window in it). A replacement window should be installed in the previous window opening that is constructed of the same wood, details, glass and glazing as the original. It is suggested that for the access door, an interior storm window be installed. This will prevent it from being visible, as it will be hidden beneath the crawl space, but will prevent water infiltration from the access door into the crawl space. Additionally, a vapor barrier should be installed on the floor of the crawl space to minimize moisture infiltration.

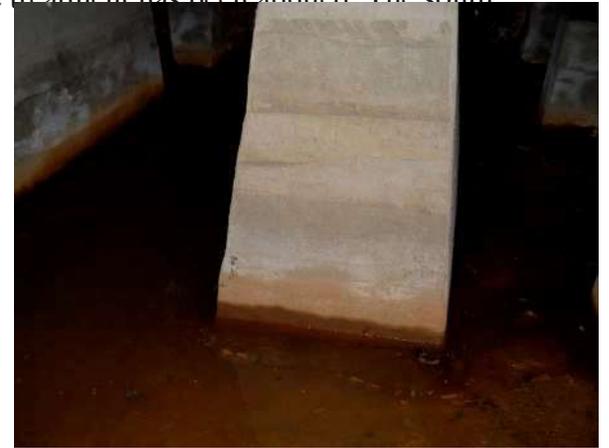
The crawl space has a dirt floor, perimeter concrete foundation walls on all sides, and is approximately 4'-6" high to the underside of the floor joists. Within the crawl space are three substantial battered concrete piers that taper from 1'-4 1/2" wide at the top to 2'-6" wide at the bottom and 7'-2" long at the top to 8'-0" long at the bottom (Figure C-18). These piers support the bale press that rests on them. The crawl space framing is constructed largely of 6" wide by 8" deep floor joists spaced at approximately 2'-2" on center that are supported by 4" x 8" wood posts resting on concrete piers. All of the wood posts have visible signs of termite damage, powder post beetle damage and water damage. Without exception, penetration into the base of each of the posts reaches 1/2". Additionally, many of them are significantly rotted out at the bottom. There is also evidence of continuing water infiltration into the crawl space, as rivulets in the dirt floor are visible (Figure C-19) and much of the surface of the concrete foundation walls is spalling due to rising damp. Additionally, on one trip, shortly after a rainstorm, standing water was observed in the crawlspace (Figure C-20).

Figure C- 20: Standing water in the Gin crawlspace after and rain storm.

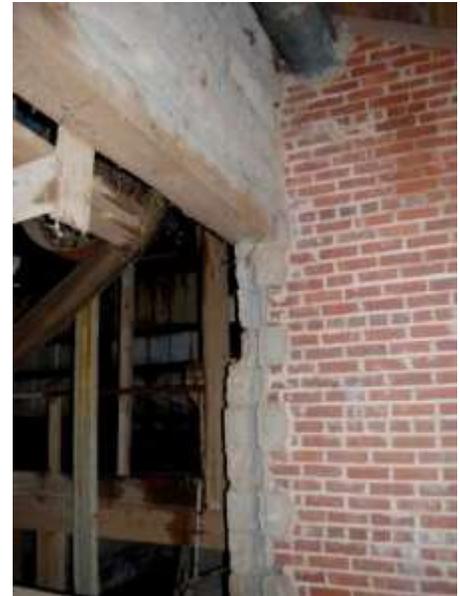
Figure C-21: Opening from the west addition into the main structure. Note the rough block edges and the wooden lintel.

At the west brick addition, what was previously a window opening (evident by the concrete lintel that remains in the wall just above the new lintel) has been enlarged to a wide doorway. However, the opening in the wall was created very roughly, with no regard to aesthetics or to performing a "neat" job. The block edges are rough and broken and there is no consistent jamb opening (Figure C-21). A wood lintel has been installed with insufficient bearing to properly support the concrete block located above, and cracking is evident in a triangular pattern above the lintel. The floor is concrete slab on grade, the walls are exposed brick, and the roof structure is exposed above.

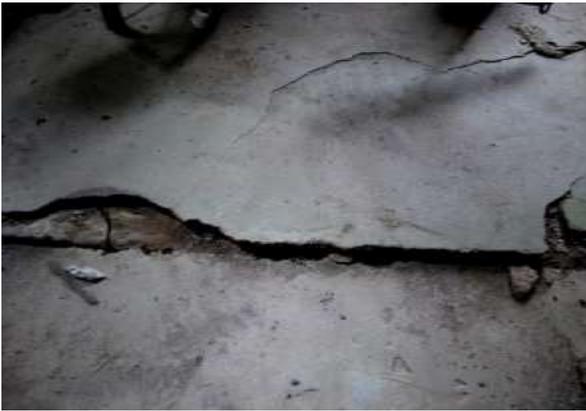
At the north building extension, significant cracking is occurring between the end of the original building (exceeding 4" in width at its widest point) and the "new" extension, as if the extension is "falling away" from the original building (Figure C-22). The floor slab is heaving upwards at this line as well, and is already displaced approximately 2". As with the rest of the building, the walls are the inside of the exposed concrete block and the roof structure is exposed above.

Figure C-22: Crack between the end of the original building and the extension. The floor slab of the “new” addition is heaving upwards.

Regarding the north extension of the building that appears to be separating itself from the main structure, it appears that it is likely continuing to move, and it is suggested that it be stabilized initially with temporary shores applied to the north face of the wall until such time that a more permanent remediation, such as tie rods that will span the length of the building, can be professionally engineered and installed. Once these are in place, a crack monitoring system should be applied to the building face and periodically inspected through an entire change of seasons to verify that movement has ceased. Once this is determined, the cracks in the exterior wall can be filled with mortar.

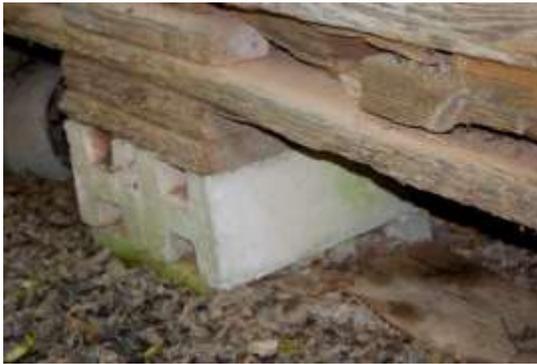
The building is situated on a slightly sloped grade, with the floor ranging from zero feet above grade at the south end to approximately 2'-1" above grade at the north end. The foundation consists of piers constructed either of fieldstone or of concrete block leftover from the construction of other buildings on-site, such as the Cotton Gin. The piers measure approximately 12" x 24" (Figure D-1). On top of the piers are random sized shim boards and 6" x 6" wood sills with a 6" x 6" girt located at midspan. The floor joists are 2" x 8" spaced approximately 24" on center. All of these pieces of wood are exhibiting various stages of rot and termite infestation.

Figure D-1: Concrete block pier

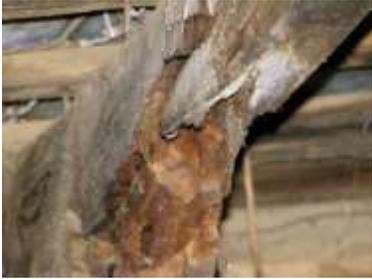
Figure E-6: Closer view of northeast Interior Rafter #4-white rot damage

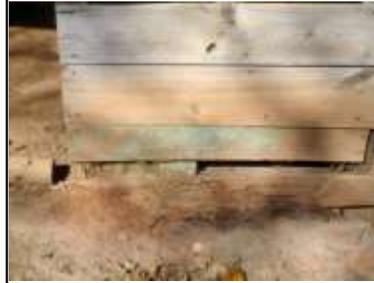
Figure F-4: Rot and termite damage on shed sill

caused damage to multiple portions of the structure: the sill on the shed has been rotted out and eaten by termites, posts have had to be shortened, and sheathing damaged.

- The south elevation and the east elevation of the shed attachment needs to have the entire wall replaced, including the top plate, sill, and multiple studs, because of extensive rot, termite damage, and structural failure which has caused sagging in the door. The new wood should be the same kind as the original.
Replace sill and foundation on closet.
The closet is separating from the main structure because of settling of the foundation. To close the gap the foundation should be lifted.

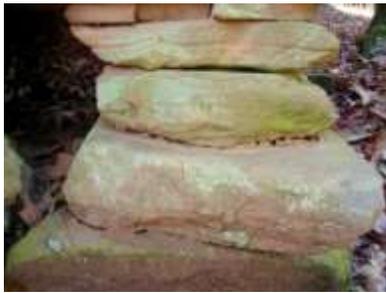
Figure F-5: Field stones support structure
Existing Site Condition

The grist mill is supported on piers consisting of field stones with clay based mortar joints (Figure F-5). Both of those visible appear to be in good condition. The back of the closet sits on a board that sits directly on the ground and has subsequently rotted.

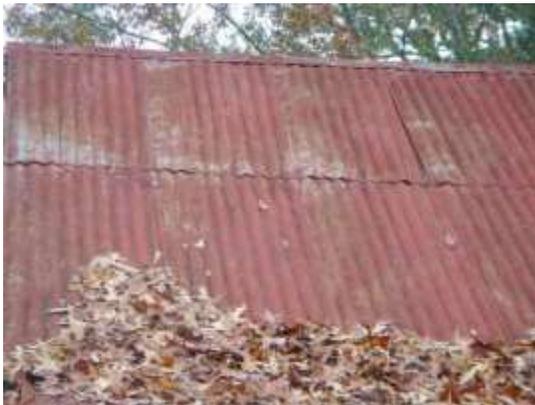
Figure F-9: Corrugated Steel Roofing

The building is currently protected by a corrugated galvanized steel roof, except for the southwest corner of the shed which has a 5-V crimp metal roof; both types are common throughout the property (Figure F-9). There is a lack of flashings on the building, which has contributed to leaking at connection points. The roof has multiple small holes, both on the main and shed portions of the building; the shed also has more substantial holes from rust. These holes have caused rot in the ceiling joists, false plate and spaced lath. The roofing is attached to spaced and continuous lath on the southwestern shed using nails.

- All debris needs to be removed from the roof and all holes need to be located. project further off of the eaves and verge board. This will keep the water away
- The roof of the entire structure should be replaced with corrugated steel. The from the structure and minimize splash back. meets the back shed and on the
- Flashings should be installed to the part of the shed roof where the side shed porch roof where it meets the front elevation.

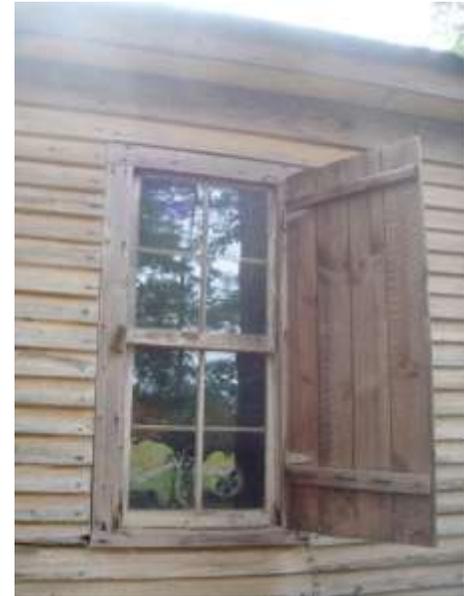
Figure F-10: North Elevation window and shutter

The windows consist of wood 4 over 4 double-hung sashes, with plain 1 1/2" x 3 3/4" casing on the north elevation (Figure F-10). These two windows have simple board and batten shutters on them; these shutters currently have contemporary metal strap hinges holding them up and are sagging. The window on the south elevation is missing and there is just a screen covering the opening. The dimensions of the opening suggest that it would have had the same size window as on the north elevation. This window does not have any indication, such as nail holes, of ever having shutters like that on the north elevation. The back window differs from the others in a few ways; it is a 6 over 6 double-hung with an extra long sill and an opening below it for the belt from the engine to go through. All windows have sills that are properly sloped to allow water to flow off. The storage closet has a board and batten window on the north elevation which has a 24" by 29" opening. It is attached with contemporary metal hinges and does not close properly from sagging.

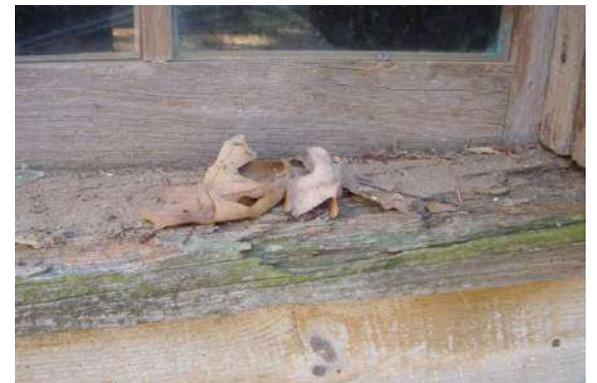
Figure F-11: Rotted window sill

The windows and exterior trim on the south elevation and on the west elevation are in good condition, due to being covered by the shed. The windows and trim on the north elevation are not in as good condition and suffer from rot (Figure F-11).

Both windows have extensive dry rot on the sills and on the casing; the rot on the left window is also on the interior portion. The

window frames have gaps between them and the clapboard which has allowed water to penetrate into the structure causing rot on the sill and bottom of the studs under the right window. The right window on the north elevation has one pane missing from the top sash, but all other panes in the building are in good condition. The shutters are not fastened very tightly, which makes it difficult to open and close smoothly.

- The windows on the north elevation need a repair class II treatment to stabilize them (see appendix) and to prevent more water from infiltrating the structure.

- The window sills on the two north elevation windows and the closet window need to be replaced.

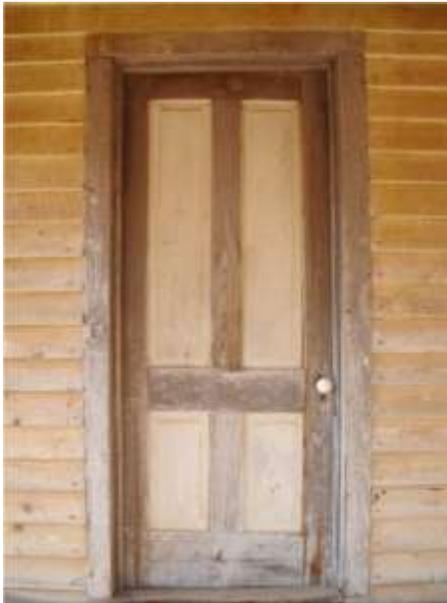
! **Figure F-12: Main entrance**

There is only one door servicing the main portion of the grist mill and it is a fourpaneled door, put together with cope and stick joints (Figure F-12). A rim lock is used for the main entrance. The door casing, stiles, and rails are painted a dark red color, and the panels are whitewashed. The door is in fair condition with separation occurring between the stiles and panels. It is attached to the frame with strap hinges that are nailed down. The addition in the back has a board and batten door with strap hinges which appear to be original; they are fastened with nails and screws with square nuts. The shed has a large 84 1/4" x 86" panel door on the east elevation; it is attached with strap hinges and has considerable sagging.

- The opening at the bottom of the back window needs to have the hole for the belt covered up if the belt is not to be replaced in order to keep animals out.
- The missing pane on the right window of the north elevation needs to be replaced.
- The window on the south elevation needs to be replaced with an identical window as on the north elevation.
- The shutters need to be tightened to stop the sagging.
- The entire structure needs to be cleaned and whitewashed with the trim receiving a coat of darker paint.
- The main door needs to be repaired by tightening all the joints.

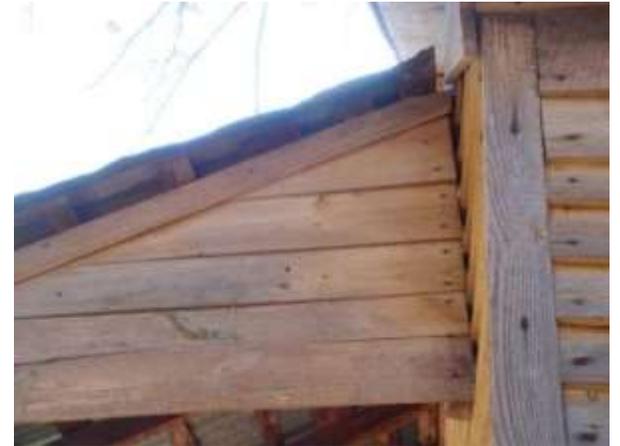
Figure F-17: Gap between porch roof and main structure

-
-
- The front porch needs to be lifted in the front in order to seal the gap where the roof meets the east elevation.
- The open portion of the south elevation shed has a top plate that is deflecting.
- It should be replaced with a new top plate which is a similar material to the original.
- The shed's west elevation has a top plate that is starting to bend which needs to be replaced with like materials.
- All the posts supporting the shed portion of the structure need to be replaced with similar posts.
- The weight of the grinding machine has caused the two floor joists to bend; this should be corrected by adding a concrete pier under the floor joists.
- The sill under the right window of the north elevation needs to be repaired with epoxy where water has rotted it.
- The stud that frames the right window of the north elevation needs to be

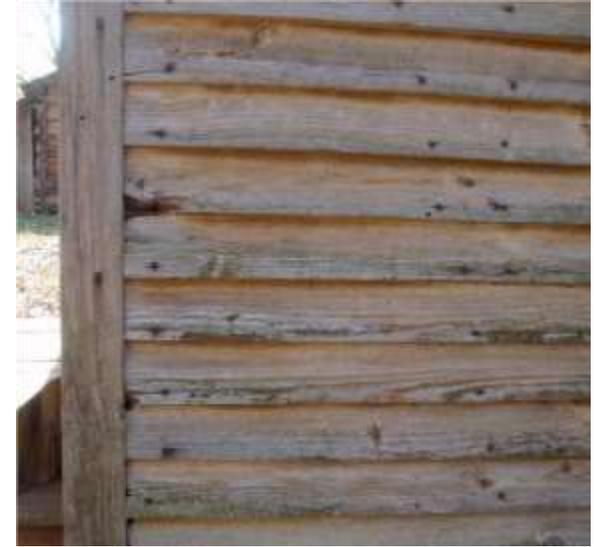
Figure F-19: Clapboards

- The vertical planks at the top left side of the front shed that are missing need to be replaced.
- The clapboard on the south elevation has termite damage at the southwest corner. This should be replaced with materials that match the old.

- The clapboard on the north elevation needs to be replaced on the eastern most side and in any area which has any broken pieces. They should be replaced with materials which match the old.

- The clapboard on the north elevation, where it meets the sill near the right window needs to be made tighter in order to close a gap.
- The clapboard where the south shed meets the west shed needs to be replaced with materials that match the old.

- The clapboard on the east elevation that has been patched with metal should be replaced with materials which match the old.
- The boards on the north elevation of the closet needs to be replaced.

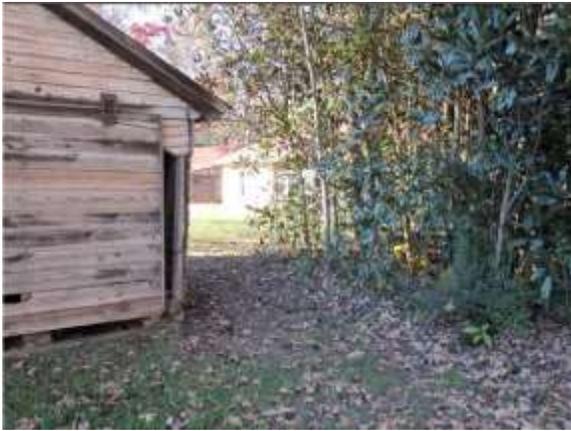
Figure G-1: Proximity of magnolia and build up of soil.

wall. Water also drains from the road towards the east wall. The large magnolia tree to the northeast of the structure has caused soil build up on the north elevation (Figure G-1). The large pecan tree to the west of the structure has caused soil build up on the west elevation. Plants are growing along all four elevations, particularly the south and west walls.

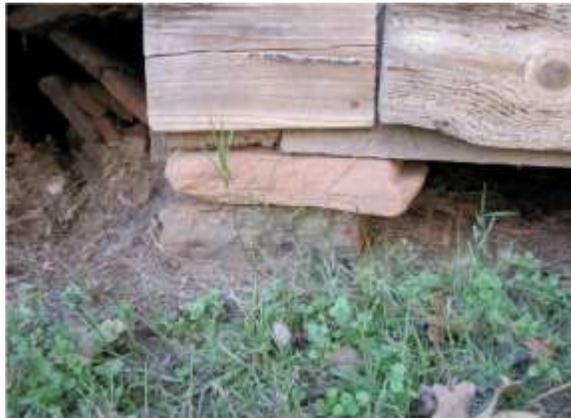
Figure G-2: Fieldstone pier foundation.

The Wheat House rests on fieldstone piers (Figure G-2). Each pier is an irregularly sized shallow grouping of stones and is dry laid. There are four piers under each elevation; one pier in each corner, the others intermittently placed. Additional piers support the interior walls of the central room; one pier in each corner and one under the center of each interior wall. There is no footing to the foundation; piers rest directly on the surface of the ground or slightly below grade. When the Wheat House was moved from its original location, the piers were most likely replaced.

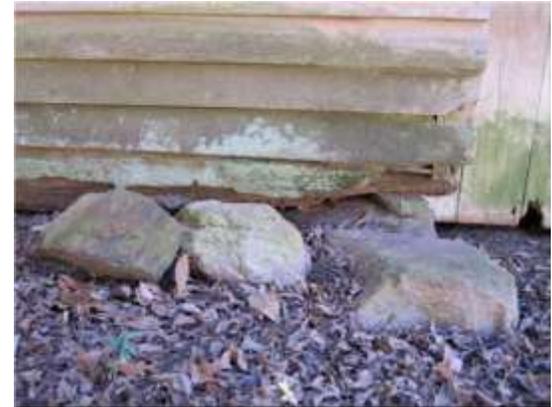
The foundation is failing or missing at most points. If a loose clay-based mortar at one time existed, it no longer does, and all fieldstone piers are in effect dry laid. The combination of settlement and soil build up causes the building to rest directly on the ground in several locations. Where the building is raised above grade, it is only resting on a few small stones. The building's proximity to the ground has led to both insect and water damage. (Figure G-3.)

Figure G-3: Failing fieldstone pier on north elevation and deterioration of siding

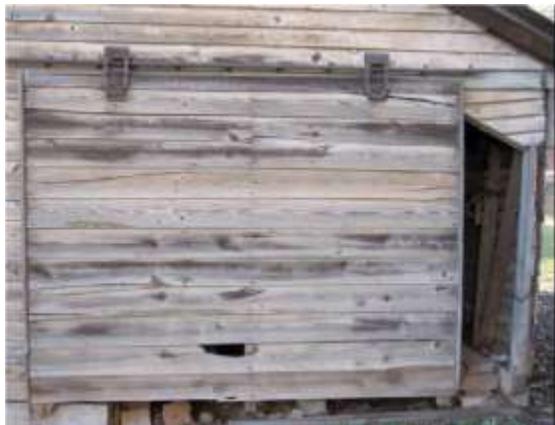
Sliding pine doors form entrances to the shed portions of the structure. The doors are 9' wide by 8' tall and hang from a steel rolling track system which traverses the façade. Door boards are 1" x 8" clapboard siding, held in place by 1" x 3" framing. The first course of siding on each door is missing. (Figure G-6.)

Figure G-6: Sliding track and north shed door.

11. The missing or deteriorated bottom portion of each sliding door should be replaced in-kind.
12. All wood building fabric should be sprayed with Bora-Care, or a similar product, to protect against further insect damage. The ground should receive professional pest control treatment.

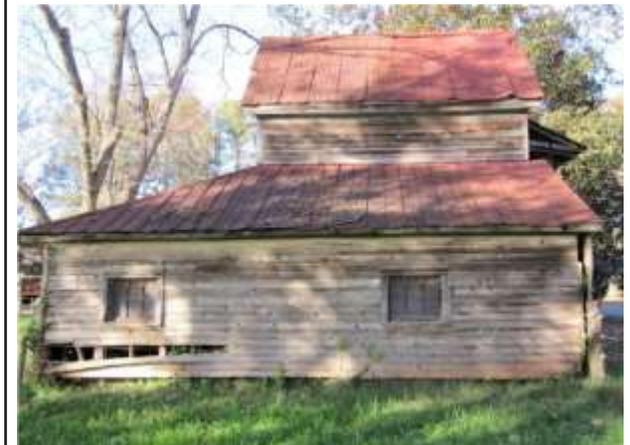
The south elevation (Figure G-8) shed has two fixed 6-light windows with 2" x 4" frames, and 2" x 8" sills. Both windows are missing glass panes and the left window is missing a muntin. There is 1" x 6" fascia board on the second story roof, and 1" x 4" fascia board on the shed roof.

Figure G-8: South elevation

13. The pecan tree behind the west elevation wall is a potential hazard and should be removed.
14. Window repairs should be made as follows: The missing glass panes and muntins should be replaced in the north and west shed windows. In the south shed windows, the missing glass panes should be replaced as well as the missing muntin in the left window.

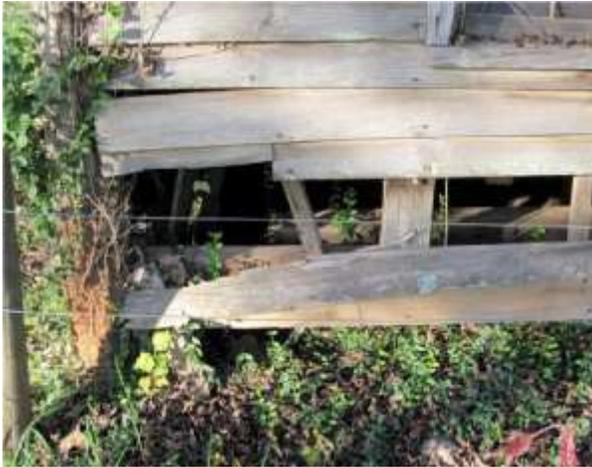
The southwest corner post has severe termite damage, which has spread to the sill and siding. The first six courses of siding in west corner of the south elevation are missing or deteriorated (Figures G-9 and G-10).

Figure G-9: Missing siding and deterioration of southwest corner post.

9. The northwest and southwest shed corner posts have severe insect and water damage and should be partially or fully replaced in-kind.
10. Insect or water damaged siding should be partially or fully replaced in-kind. Damage exists on the north, south, and west elevations, ranging from the first to the ninth course of siding. See “Existing Conditions” section for exact locations.

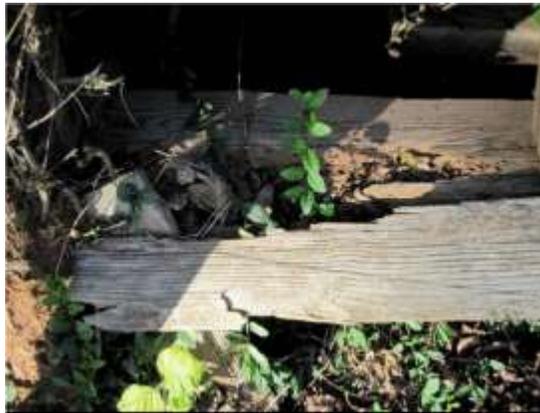
Figure G-10: Termite damage on sill.

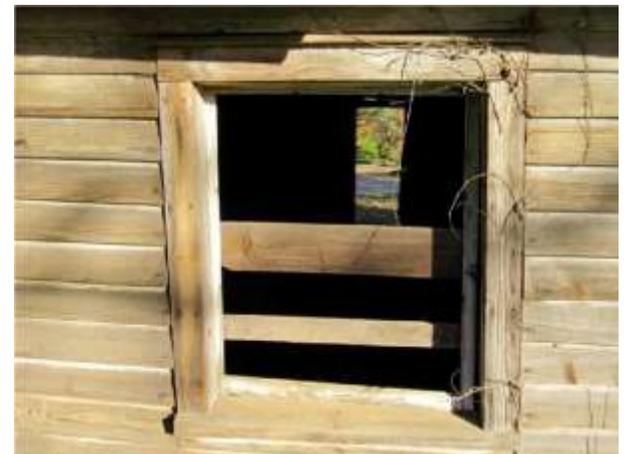
Figure G-12: First story shed window missing glass panes and muntins.

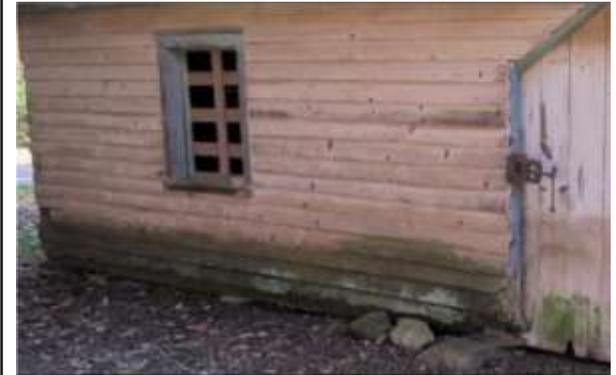
Water damage resulting from grade changes and foundation failure has led to fungal growth and rot. The sill and first five siding courses show deterioration (Figure G-15).

Figure G-15: Water damage to sill and first five courses of siding.

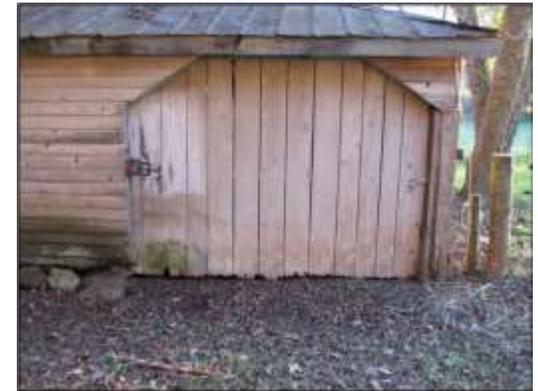
Figure G-16: Sliding door and water damage.

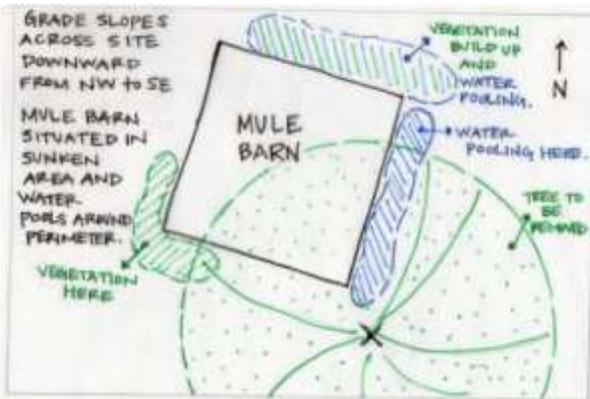
Figure H-9: Detailed site plan

The Mule Barn is located in the southeastern quadrant of the Shields-Ethridge Heritage Farm. The site is bounded by open pasture to the south, the Wheat House and Ethridge Road to the east, the Log Crib with Addition to the north, and the Concrete Corn Crib and additional sheds to the west. The grade slopes slightly from the northwest to the southeast. The southeast corner of the mule barn is at a lower grade, with the northwest corner showing more evidence of water retention and a build-up of soil and leaf litter. The Mule Barn and other structures are situated within a small paddock where animals are actively housed. In general, the site retains a lot of moisture. There is extensive vegetation around the perimeter of the building, in some cases right up to the foundation. There are several trees near the building that pose potential problems. These trees are also producing leaf litter on the site (Figures H-8 and H-9).

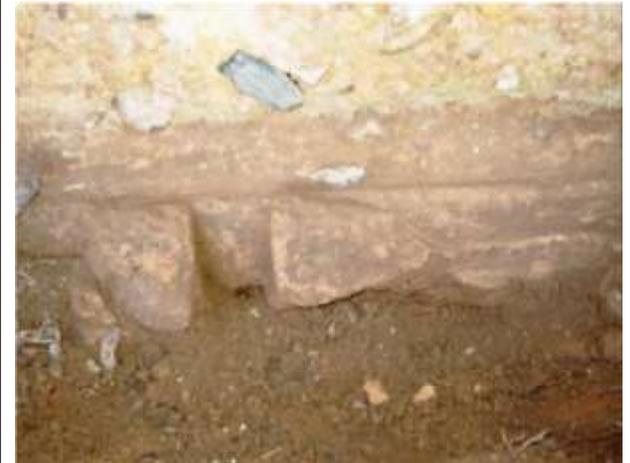
The Mule Barn has a poured concrete foundation. A trench was dug and 1" x 12" form boards were nailed to 4" x 4" posts which held the forms in place. The ghosting of these elements is present (Figure H-10). The footing of the foundation extends not only around the perimeter but also forms two aisles within the Mule Barn. Form boards were placed at either side of the open bay of the south and north elevations to create the raised concrete wall foundations. The concrete is composed of locally sourced aggregate and binder. The aggregate for the foundation is composed of rubble and fieldstones ranging in length from 1" to 8." In general the stones that compose the aggregate are larger at the base of the foundation and become smaller in size near the top (Figures H-11 and H-12). The binder in the concrete is composed of clay and lime, with some sand and a range of fine aggregate mixed in as well to create a mortar. This technique is no longer used in pouring concrete; it is a rare, early example of the use of concrete in structures.

Figure H-10: Ghosting of posts and form boards

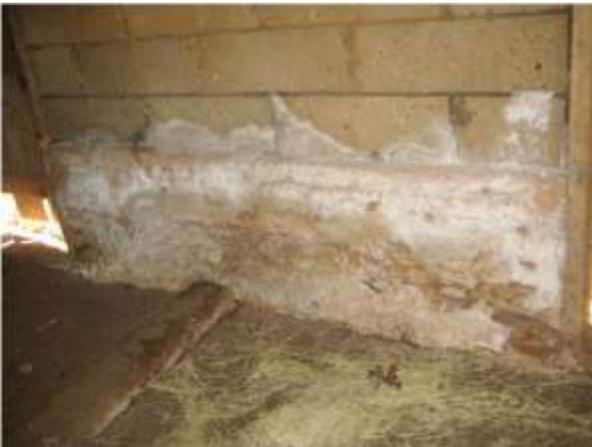
Several sections of the foundation have been patched more recently with Portland cement; some patches are flush while others have a beveled edge, serving as a water table (Figure H-13). The foundation shows extreme external deterioration, particularly in sections that have not been subsequently patched using modern methods and materials. The majority of damage in the historic unrepaired sections is a result of rain and rising damp. The deterioration results from a failure of the original materials. The sections patched with Portland cement show less external deterioration, but have exacerbated moisture problems on the interior wall, as water unable to wick through the Portland cement is being pushed out through the interior un-patched foundation (Figure H-14). There is also noticeable deterioration of the foundation on the southeast corner of the mule barn where missing masonry units above have left the foundation exposed (Figure H-15). There are also visible cracks in the foundation where water has leaked straight into it from the mortarless joints in the above masonry units (Figures H-16 and H-17).

Figure H-13: Efflorescence in foundation section where exterior foundation is patched

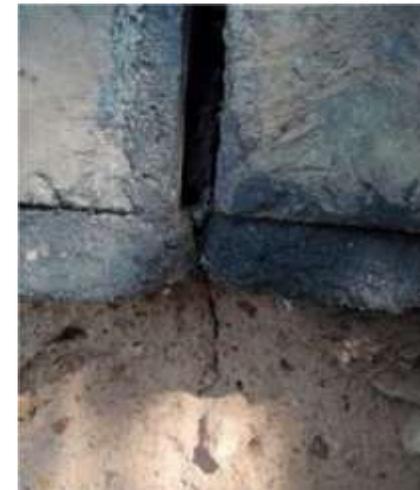
Figure H-15: Foundation crack below mortarless joint

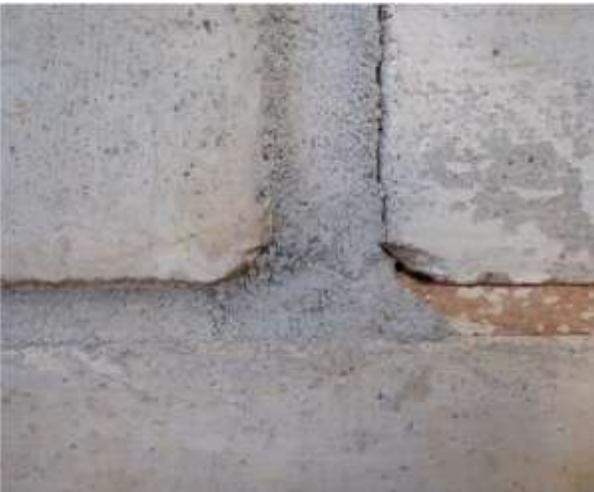
Figure H-16: Repointed with Portland Cement

The bowed masonry wall on the east should be squared by being relaid; that on the west can simply be repointed. Afterwards other parts of the structure should be repointed where necessary. When repointed, careful attention should be paid to the mortar composition; new mortar should match the old in composition, color, and joint profile. Lintels should be repaired or replaced.

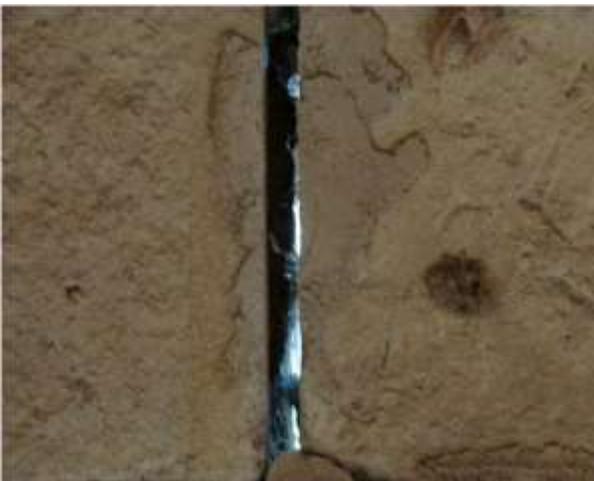
Figure H-17: Joint with missing mortar

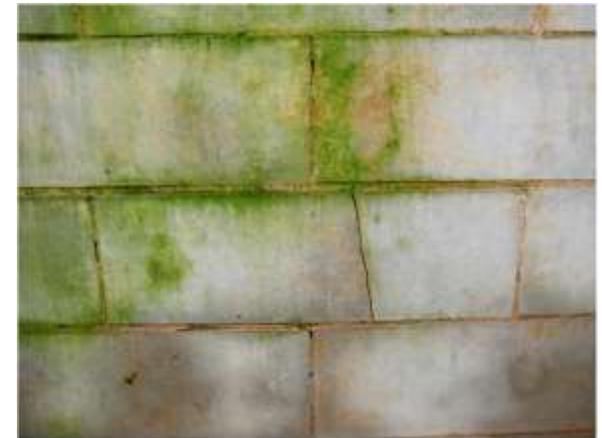
Most of the individual units are completely intact, with the exception of four, which show small cracks (Figures H-18 and H-19). Units that have been compromised due to water damage are wet to the touch, are darker in color where they have been wet the longest, have fungal growth on the exterior, and fungal growth and efflorescence on the interior.

Figure H-18: Fungal growth and cracked masonry unit

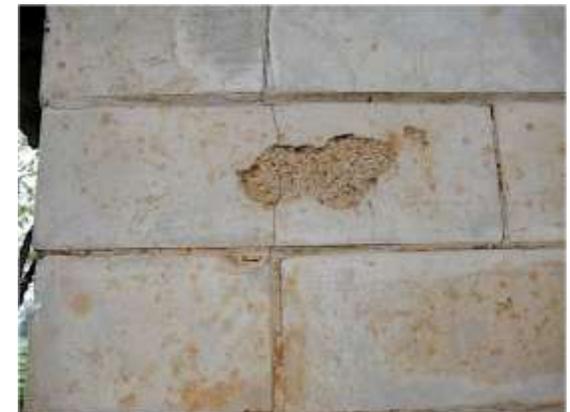
Figure H-19: Cracked masonry unit and spalling

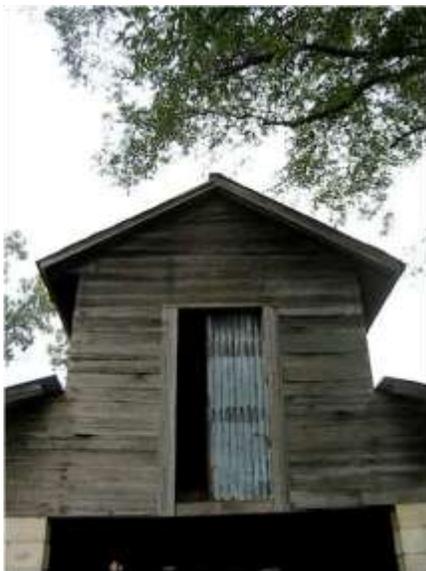
The north elevation has flush horizontal wooden siding on the first story. These boards are 1/2" x 6" and span the entire 10' opening. These boards are slightly warped and cupped and have mold and fungal growth on them. The insides have dark staining and are moist to the touch. On the second story, the clapboard overlaps. This siding is made of various lengths. The siding also encloses a second story window opening (Figures H-21 and H-22).

Figure H-21: Flush siding and opening on south elevation

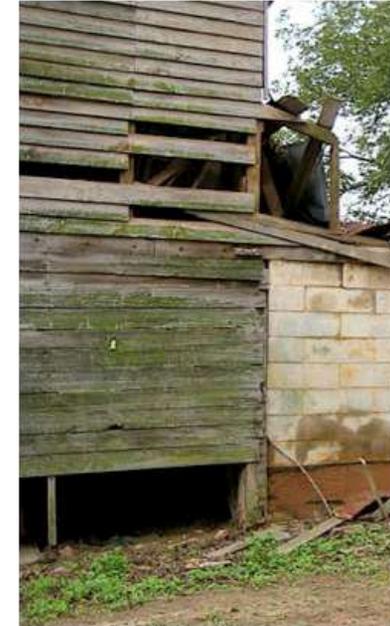
Figure H-23: Fungal growth in siding

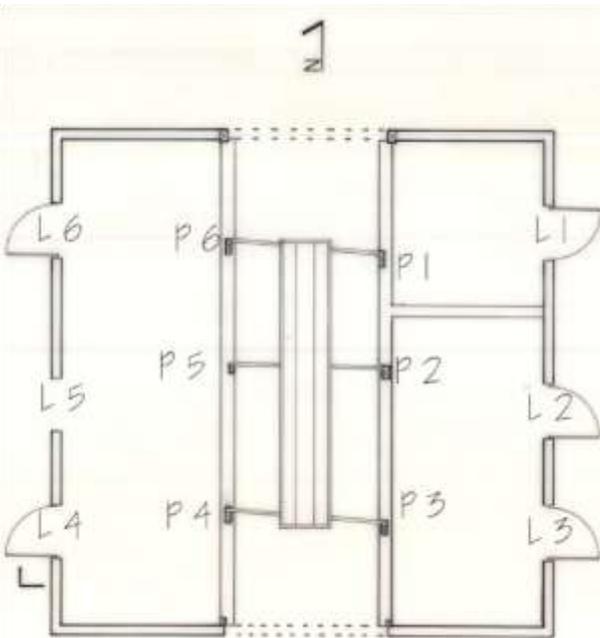
**Treatment Recommendations: In all cases, the lintels have failed from being over spanned. [?]Existing lintels should be reinforced with steel. The reinforcements should extend beyond the width of door opening, as previous lintel reinforcements did not.*

Figure H-24: Posts and Lintels
