Shields-Ethridge Heritage Farm

Historic Structures Report
Building Materials Conservation Class 2009
Master of Historic Preservation Students
The University of Georgia

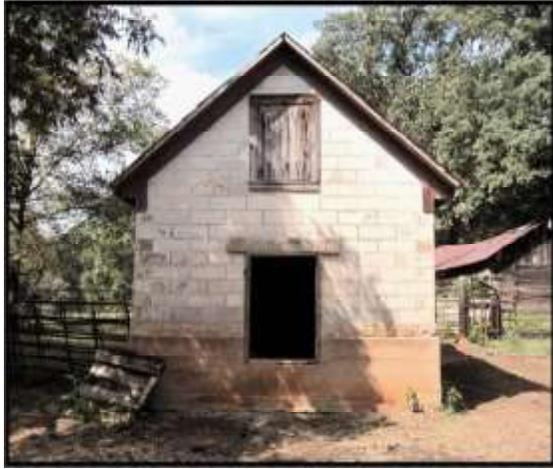
Figure I-1: East elevation

The entrance door is located in the center of the east elevation, approximately 30" above grade and 43" x 60" in dimension. A cast concrete lintel above the door is engraved with 'Ethridge 1916.' A wooden doorframe outlines the entry. The wood batten door is currently detached from the structure and laying on the adjacent ground (Figure I-1)

8. Any deteriorated fascia board should be replaced, as needed, beginning with the fascia board on the west elevation.
9. The entry door on the east elevation should be reconstructed to replicate the historic appearance. The door would control entry to the building, which may be important to an adaptive use of the structure.

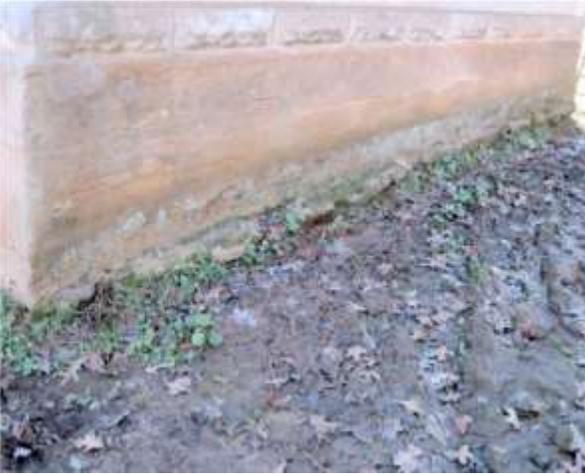
The grade surrounding the Concrete Crib has changed over time. Currently, the grading channels water towards the structure. Water movement is primarily from northwest to southeast, depositing water along all four elevations but primarily along the north and east walls. As a result, the grade is lowest along the east wall. Plants grow at the foundation line along all four elevations. Water pools and turns the soil to mud along the north elevation and to a higher degree along the east elevation (Figure I-5).

Figure I-5: Plants and mud along north elevation wall

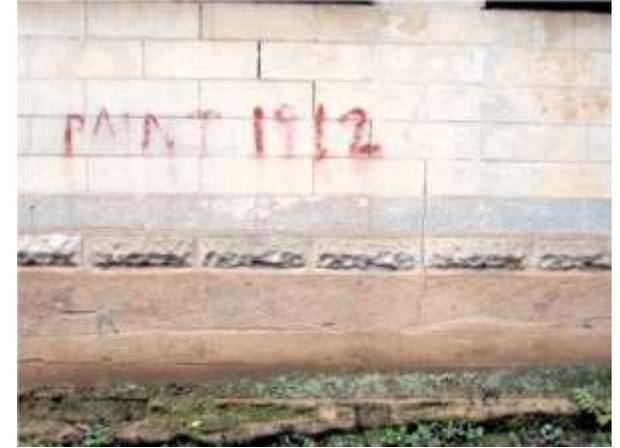
Figure I-7: Exterior view of North elevation cracks

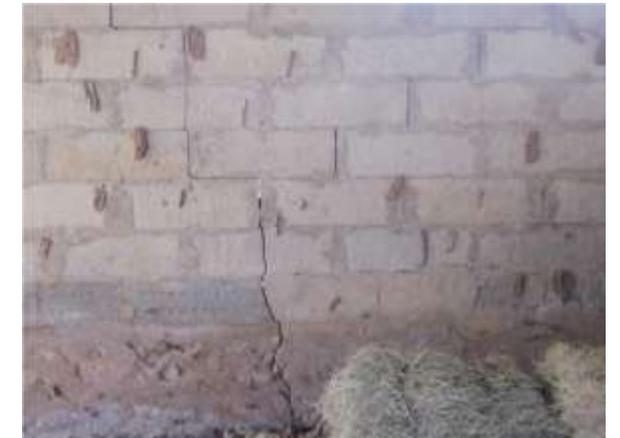
Figure I-8: Interior view of South elevation cracks

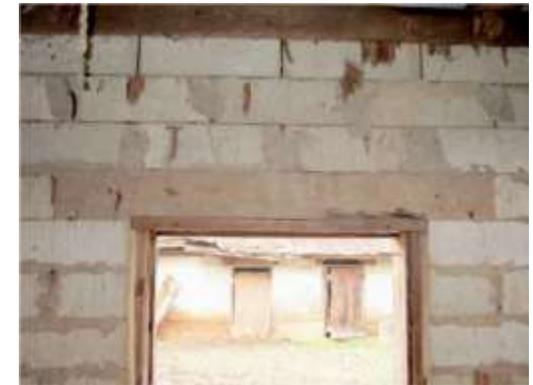
Figure I-12: Cast concrete lintel above entry door. Note deterioration above right door corner.

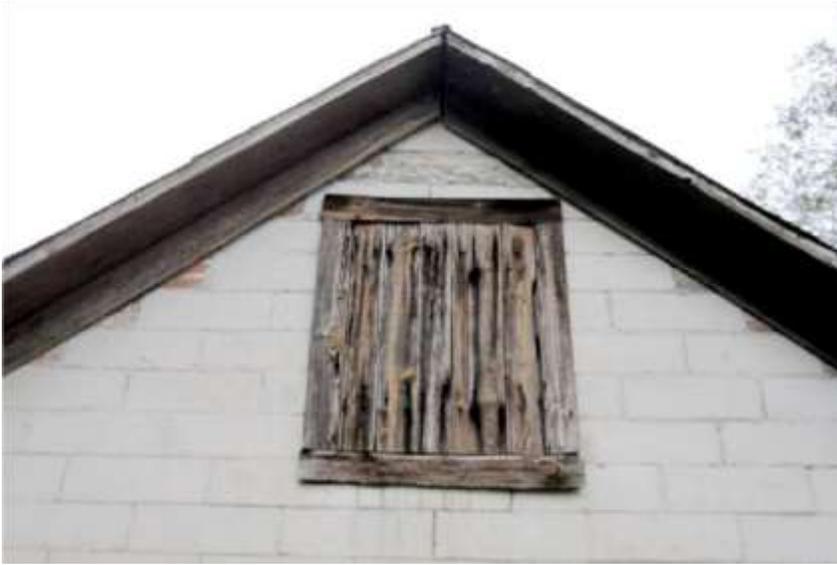
The upper doors are in fair condition, but show signs of weathering from sun and rain exposure (Figure I-13).

from sun and rain exposure

Figure I-13: Upper west elevation door, weathering

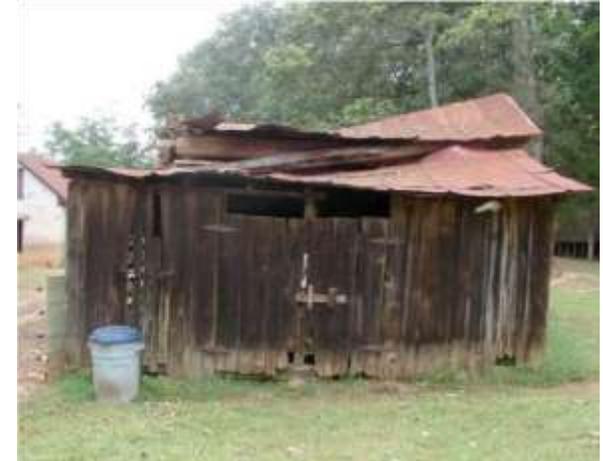
Figure J-3: East elevation

In general, the walls all exhibit water and insect damage to a varying degree, particularly on the north elevation which shows the most extreme deterioration. The logs forming the east elevation are in the best condition, as they have been protected from the elements by the shed addition. Logs on the south elevation also appear to be in good condition, while on the west elevation, the lowest logs are on grade and show

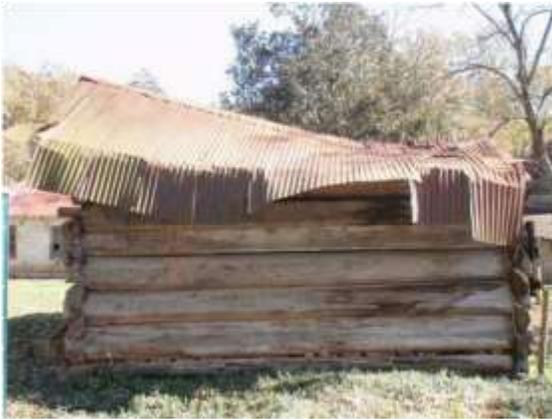
Figure J-5: West elevation

The sill on the west side is on grade and badly deteriorated. The sill on the east side is not as exposed to the elements because of the protection from weather offered by the adjoining addition, and is still on top of its foundation piers. Both sills show water and insect damage at the end grain. The north and south sill are in different conditions. The sill on the south side has been notched to allow pigs under the structure and appears to be in good condition. On the north side, the sill has been exposed to more weather and has rotted through on its northwest corner.

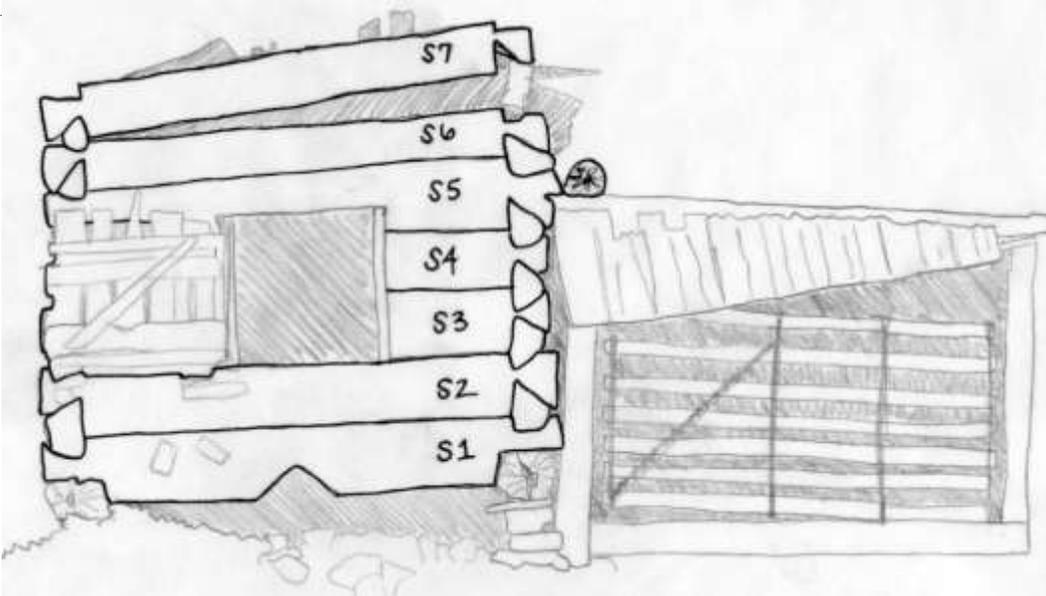
S1 Some evidence of rot and termite damage, though relatively intact.

S2 Some rot, primarily at window opening and along that grain line.

S5 Notch cut out of member to accommodate top of window opening.

Treatment: Repair with epoxy. Apply Boracare.

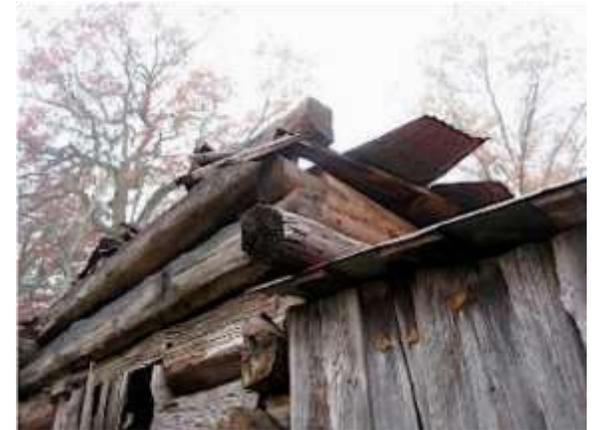
Figure J-21: Top plate now resting on Shed Addition roof

The top course of logs connect the walls to the roof system. Like the sills, these logs are smaller round logs, hewn on the top and bottom, and bear on the log below them with a half-lapped notch, instead of a half-dovetail notch. These top plates were also attached to the course below with large, round, wooden pegs. While there should be two top logs, one each on the east and west elevations, there is only one, as the top log on the west has fallen and is missing entirely. This has caused the other top plate on the east side to shift out of place, and it is now resting directly on the roof of the shed addition (Figure J-21).

Exposure from displaced roof has created inappropriate load at western corner.

Treatment: Replace in kind. Apply Boracare.

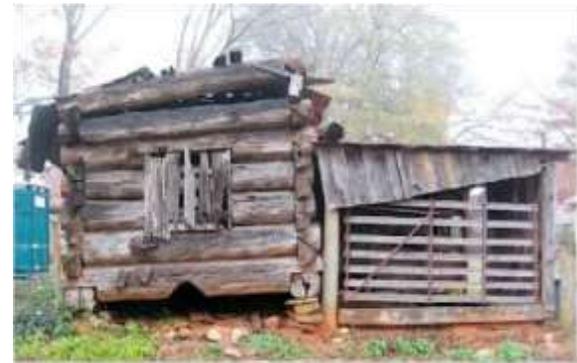
Figure J-23: South elevation exhibiting damaged roof and missing gable

A gabled roof is covered with a skin of horizontal planks of wood. These are nailed to non-load bearing, gable end studs. These are round, vertical log poles that have been toenailed into the uppermost log course. The top of these gable end studs are beveled and toenailed to the rafters. The gable on the north elevation is extant and appears in good condition (Figure J-22). The gable on the south elevation no longer exists, as it has been crushed in the roof damage sustained by a tree that fell directly on the roof (Figure J-23).

The spaced lath is composed of non-uniformly sized, sash-sawn boards ranging in width from 4” to 1’3” and is nailed into the rafters. There is no material between the spaced lath and the sheets of corrugated, galvanized steel that forms the roof skin. Scattered nails in the spaced lath indicate that the roof once had a wood shingle finish. A ridge cap, also of corrugated metal, is present. The spaced lath shows water damage and rot. Some appear broken and cracked. The metal roof has been damaged beyond repair by the fallen tree.

intervention recommended, the metal roof should be replaced and restored with wood shingles. The shingle size should be dictated by the spacing of existing spaced lath.

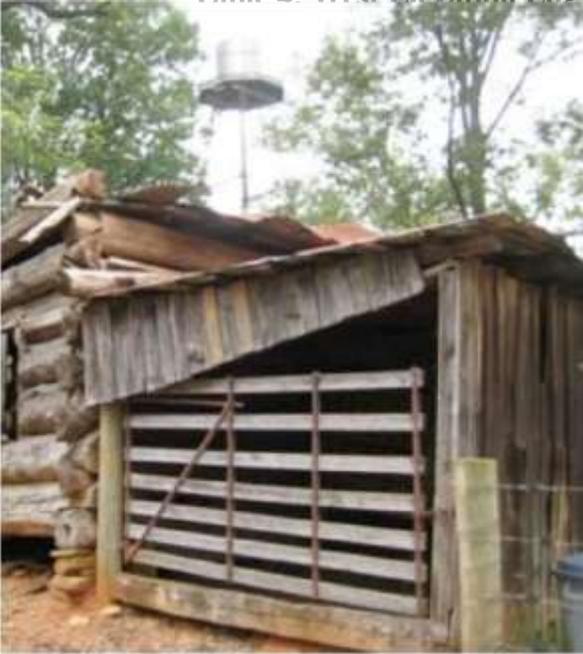
Figure J-26: South elevation gate

The south elevation has no wall, but is simply a gate of horizontal wooden members supported by four metal braces (Figure J-26). This gate is hinged to the southwestern corner post. The corner posts on the east elevation are both wooden posts measuring 4" x 4". The corner post on the southeast corner shows damage by powder post beetles. The corner post at the northeast shows termite damage at the footing.

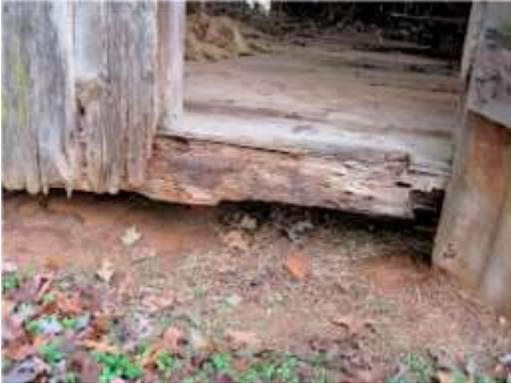
Figure K-11: Damaged sill

Bearing on the foundation piers are large, hand hewn sills measuring approximately 9" x 9" (Figure K-11). The sills appear to be connected with mortise and tenon joints; however, it is very difficult to see the sill-to-sill connection without removing the floorboards above or siding around it. Each sill is heavily damaged by termites and rot. A large, hand-hewn center girder, measuring 12" x 14" runs the length of the structure roughly halfway between the north and south walls. It does not connect to the sill and is deeply checked and shows rot. The girder does not appear to be original. There are notches in the sill what can be seen underneath the structure. These empty notches indicate where floor joists were located at one point (Figure K-12). Originally there were four floor joists. The two center joists have now been replaced by the large girder. Between the sills, on either side of the girder, are two extant floor joists, which run the length of the structure, east to west. These joists measure 4" x 6" and are sash sawn. The joists do not appear notched but seem to butt up to the sill on the west side. One

floor structure should be inspected by removing the floorboards. In this removal, all historic fabric should be retained and numbered so that it can be reapplied in its original position. Each floorboard should be inspected before being returned. Only the floorboards that are structurally damaged should be replaced, with the others preserved. The center girder is in poor condition; it should be replaced with in kind materials that are the same species and size. Damaged sections of the sills and joists should be epoxied or replaced depending on the severity of deterioration. If replaced, the sills, joists and floorboards should all be replaced with in kind materials that are the same species and size. Because the floor joists appear to be altered from original attachment method, these should be reinforced in some manner. After sills and joists have been assessed for damage, the site under the structure should be excavated and cleared of debris to lower the grade, allowing for greater distance between floor structure and the ground. Supporting elements may need to be introduced under the center sill to get it off the ground and prevent further insect or water damage.

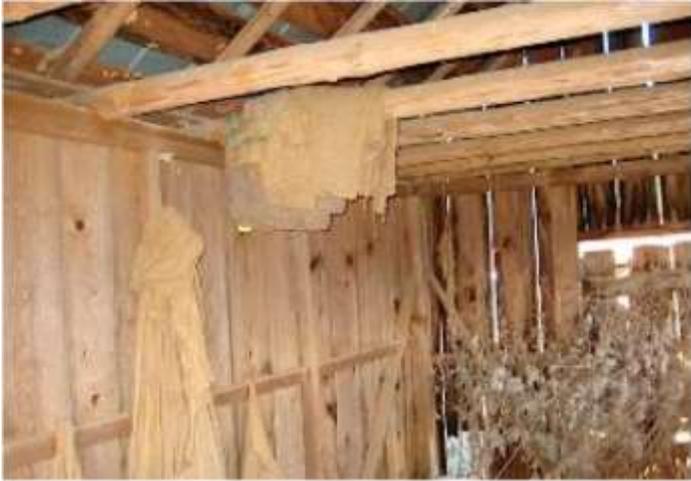
Figure K-13: Joists

The ceiling joists are small de-barked logs that range in size from 3 1/2" to 5" in diameter (Figure K-13). These joists bear on the

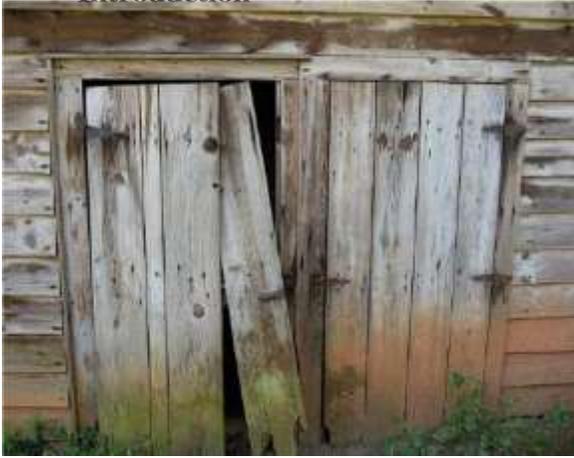
Figure L-1: Shed doors: Left door needs replacement

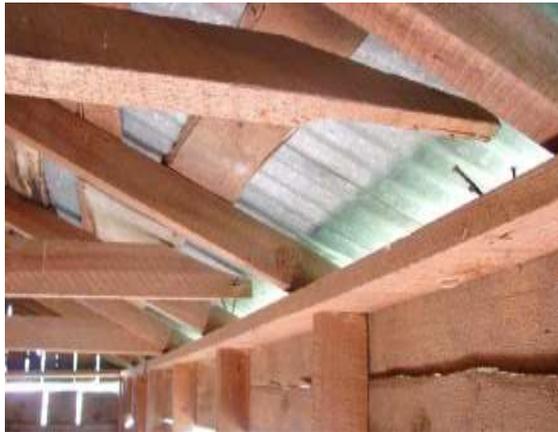
Figure M-7: Interior beams pulling away from the top plate or the structure on the southern side

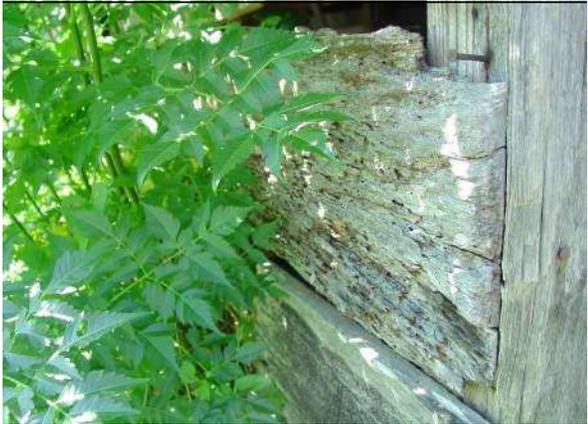
Figure M-8: Example of plants growing in and around the structure, as well as insect damage

Like all the other wooden structures at the site, this structure needs to be treated for insects. The sill plate on the north elevation, as well as the bottom board on this elevation, have suffered from termite damage and are in need of replacing. But before replacing the sill, the general foundation issues should be addressed.

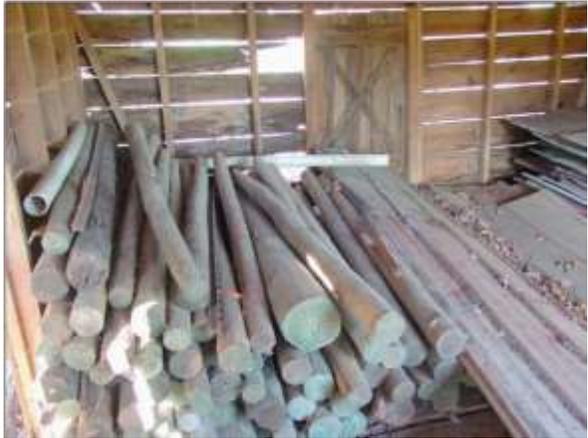
Figure M-9: Various materials being stored in the Cattle Barn at the moment, including posts and sheet roofing material

The top priority in maintaining this structure is the removal of all materials being stored inside. Currently, the barn is packed with a large quantity of wood and sheet metal salvaged from other historic structures. The intent of storing this material was most likely to have them on hand for future repairs to structures on the Shields Ethridge site. However, much of the material being stored in here suffers from insect and rot damage and would not be appropriate for such a use. Instead, the material should be removed and disposed of. The presence of these materials has made access to parts of the structure difficult, rendering most of the necessary repairs impossible. Additionally it is attractive to insects and contributes to moisture retention within the structure. All plants, including overhanging tree branches, must be cleared from the perimeter of the structure, particularly on the southern side of the structure. The general recommendation for all structures on the site is to remove any trees within ten feet of any structure. The farm equipment around the structure is also contributing to the pooling of water around the structure on the north elevation and should be relocated to allow for routine and major maintenance activities. A drainage swale must be installed so that water flows away from the structure. Once these measures are taken, a more thorough evaluation of the foundation of the structure can be done.

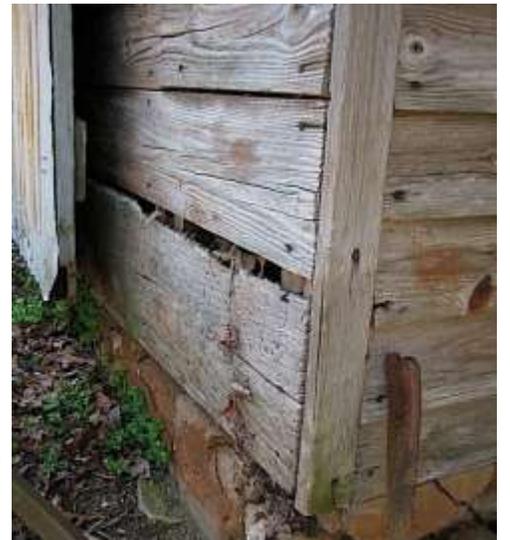
exterior clapboards; need
replacement

5. Replace deteriorated siding near bottom of north wall.
6. Replace metal sliding door on east elevation.
7. Replace deteriorated boards on west elevation.

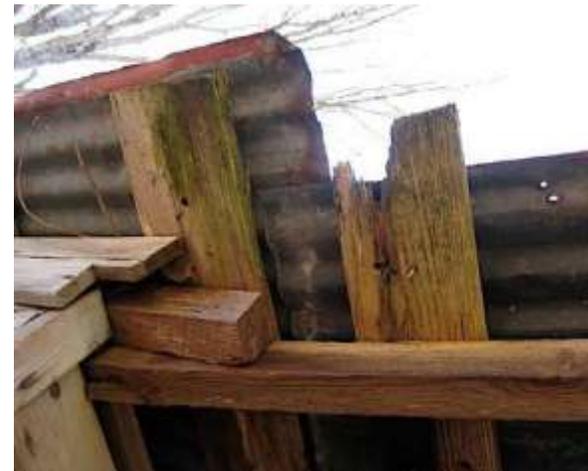
Figure N-2: Rotting rafters on the east facade

The warehouse needs a new roof as holes in the roof are currently allowing water to seep in and rot the wooden rafters and walls. There is also significant termite damage to the rafters on the west end of the roof structure. A new roof, along with a swale to direct water away from the building on the ground, will help prevent the water damage from getting any worse.

8. Repair termite damage to rafters on west end.
9. Replace rotted stud, posts, ledger, and splice in new rafter ends at east end of north elevation.
10. Replace 6" x 4" double stud mid-wall on south wall.

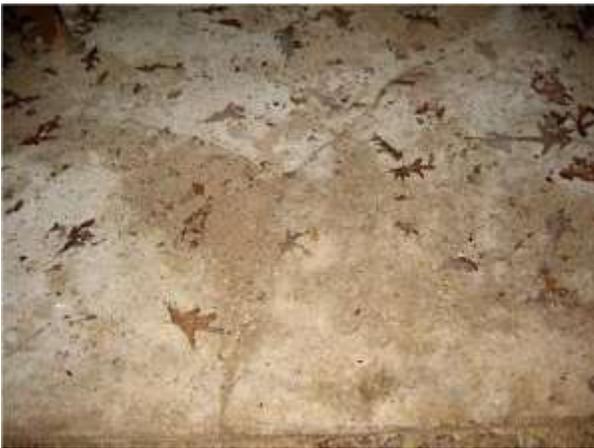
Figure N-5: Cracking and eroding concrete floor

The two side bays of the warehouse have a concrete floor, while the center drive is earthen. The southwest corner's concrete floor has eroded both due to holes in the roof allowing water to leak onto the floor and rising damp. This should be monitored and later patches in the floor will most likely be necessary. If a swale is put in place to direct water away from the building, less damage to the walls and floor will occur.

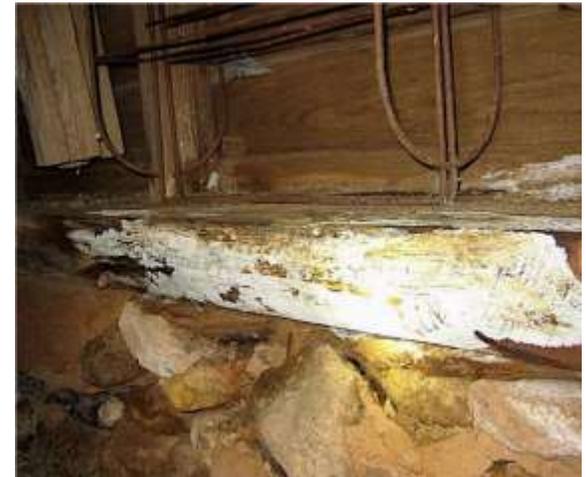
Figure N-6: Indication of rot on the south wall.

The south wall is experiencing some termite damage, especially on the west end where it is made worse by water infiltration. The eastern corner's floor is also very wet due to rising damp. Occurring approximately mid-wall, one of the 6" x 4" double studs is badly eaten by termites and needs replacement. Also, the lath and junction between the original and extension roofs have deteriorated due to water seeping in between the two roof sections. There is also significant termite damage towards the west end of the wall and on the bottom sill. As long as the sill is kept dry and monitored it does not need replacement.

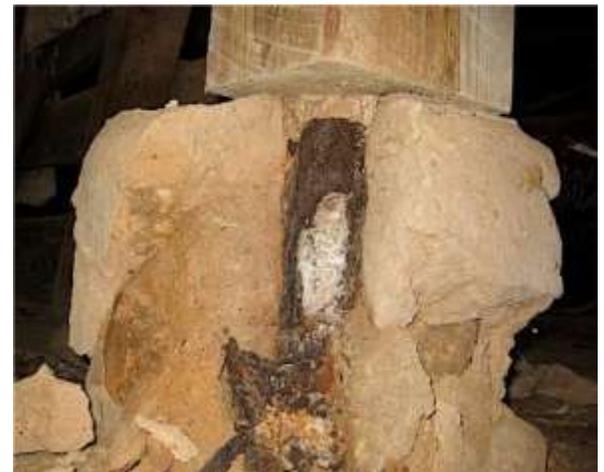
Figure N-7: Iron jacking in base of northeast and southwest piers

foundation piers are in poor condition. They are concrete, with the large aggregate typical elsewhere on the farm and are crumbling due to age and iron jacking. The jacking comes from the rusting of an iron pipe that was used to center the piers and around which the piers were formed. The piers need to be replaced. Both posts should be jacked up and supported by struts and then reset into solid concrete blocks with a stucco covering. Under the block piers new concrete footings should be wider than the originals to better spread the load.

11. Replace concrete interior pier foundations holding loft supports.
12. Replace rotted board in loft floor.

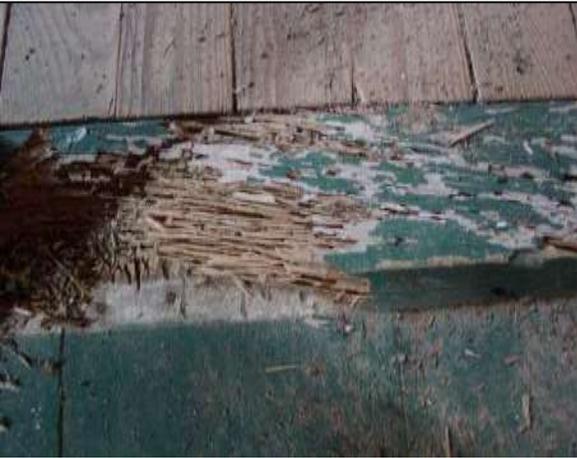
The interior also shows evidence of a powder post beetle infestation as well as an active termite infestation. The termites seem to be coming in from the outside through a rotting sill beam that is in contact with the ground, and larvae were noted within the doorframe between the bedroom and kitchen. The source of the powder post beetles is unclear, although the infestation is most extensive in the bedroom. There is evidence that the powder post beetles are also affecting wooden furniture within the house. When addressing treatment of the building, it will also be necessary to treat any wooden and cloth artifacts within the structure.

Figure O-8: Active termite infestation in the interior of the house, at the door frame from the kitchen to the bedroom addition

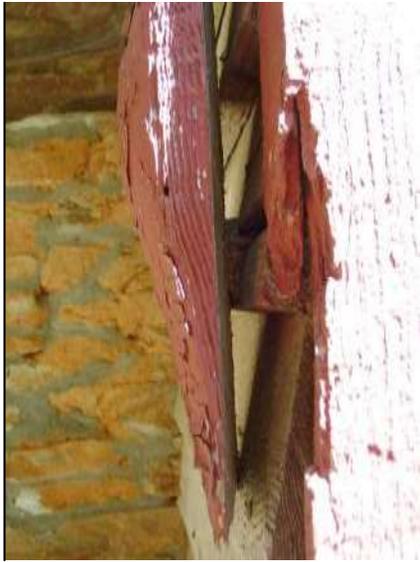
Figure O-9: Detail of the poor construction of the porch, offering no support and pulling away from the structure

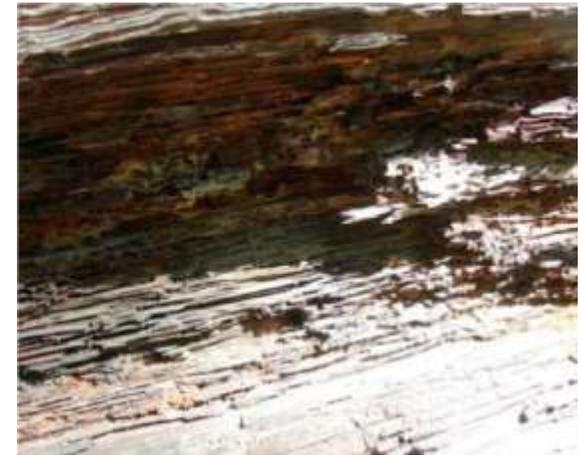
As with virtually all wood on the Shields-Ethridge site, there is evidence of insect damage, and the crib will similarly have to be treated with insecticides. The crib is also suffering from racking, at least partially due to the removal of three ceiling joists. It is likely that the racking occurred during moving, but the crib should be monitored for further movement and be reinforced by additional structure if movement is observed.

Figure P-7: Termite damage within the bottom bog on the western side of the West Log Crib
